**U.S. NAVAL BASE, PEARL HARBOR, CHIEF PETTY OFFICER'S  
QUARTERS**

**HABS No. HI-444**

**(Facility No. 90)**

**HISTORIC AMERICAN BUILDINGS SURVEY**

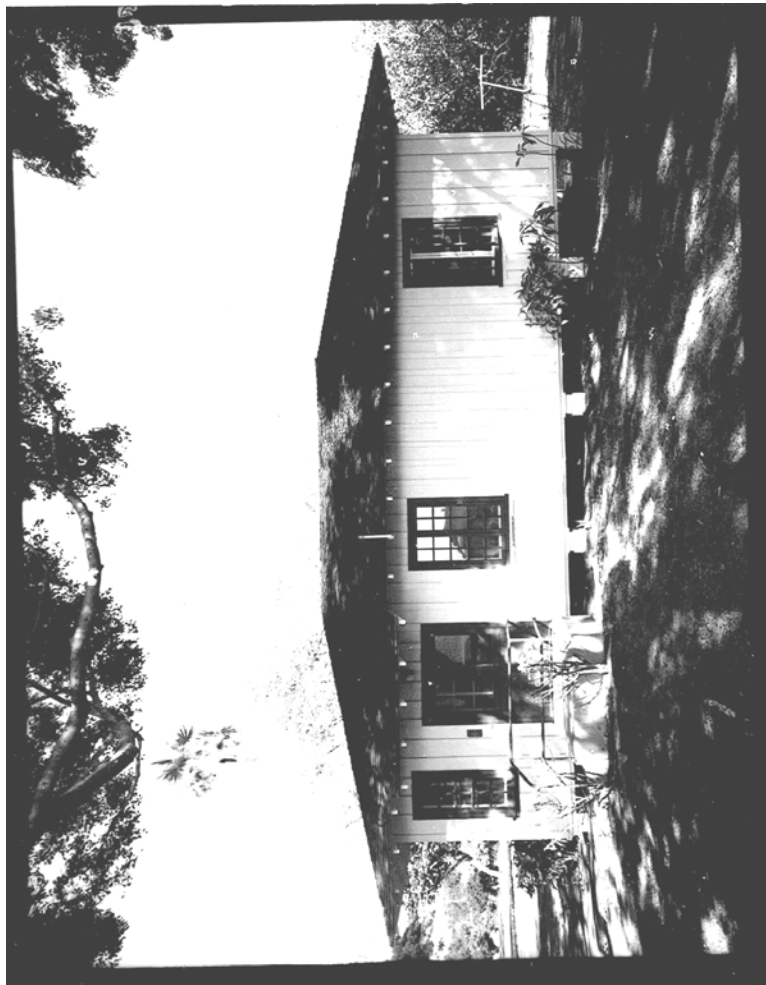
**HABS NO. HI-444-1**

| HI-444-1 | VIEW OF MAIN ENTRY SIDE. |

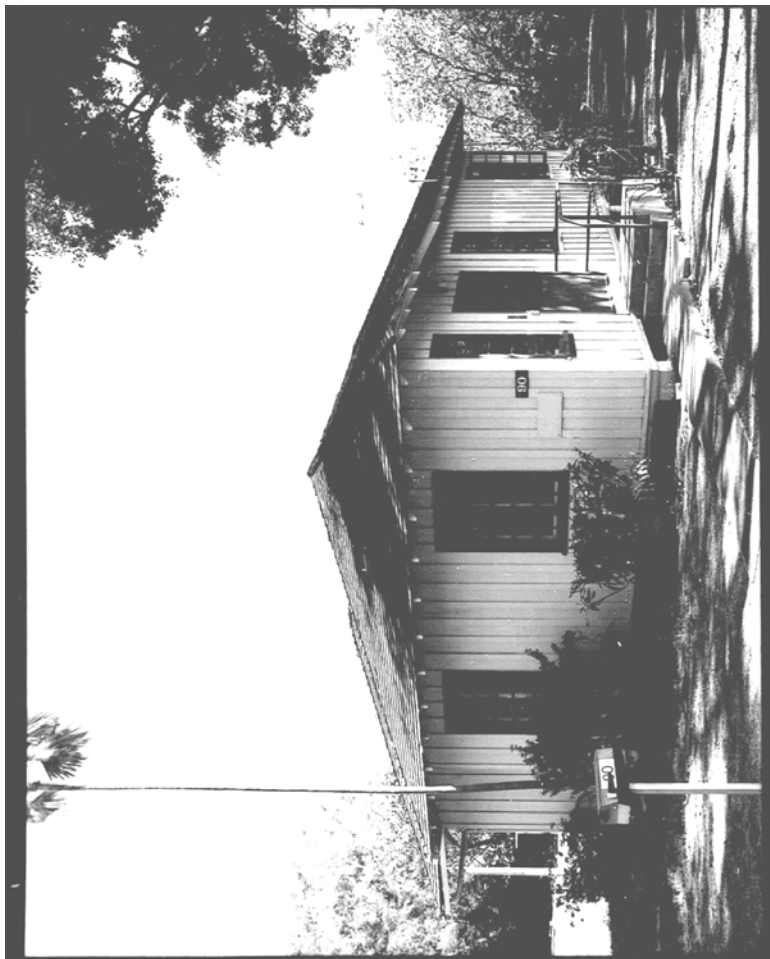
**HABS NO. HI-444-2**

| HI-444-2 | OBLIQUE EXTERIOR VIEW OF MAIN ENTRY SIDE AND END NEAREST THE STREET. |

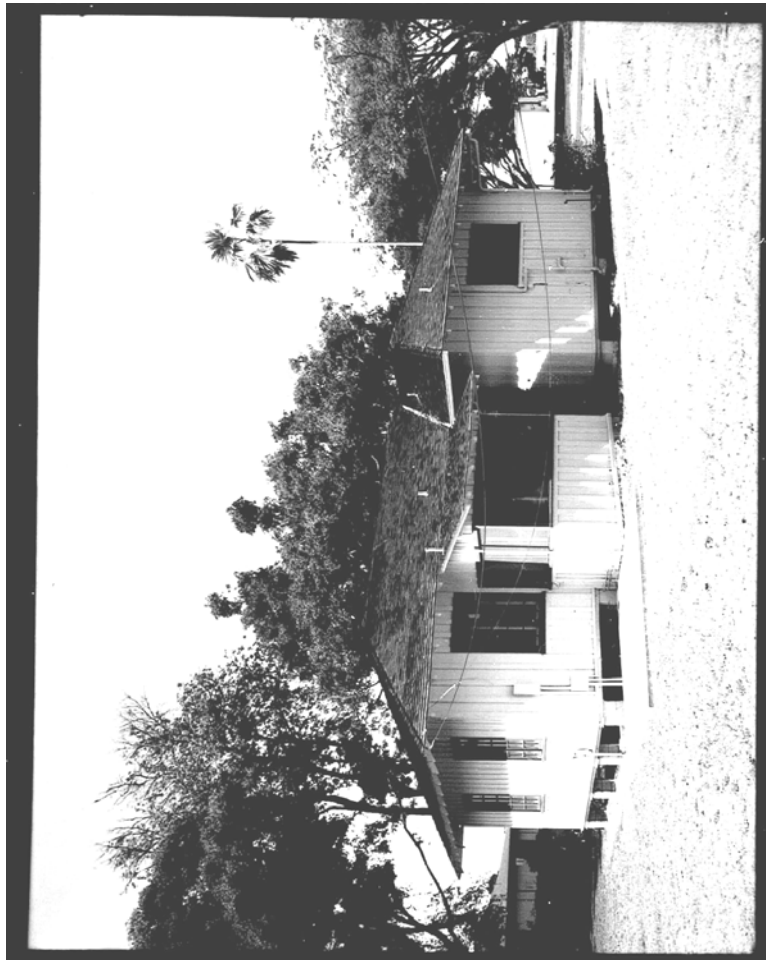
**HABS NO. HI-444-3**

| HI-444-3 | OBLIQUE EXTERIOR VIEW OF REAR SIDE AND END NEAREST THE WATER. |

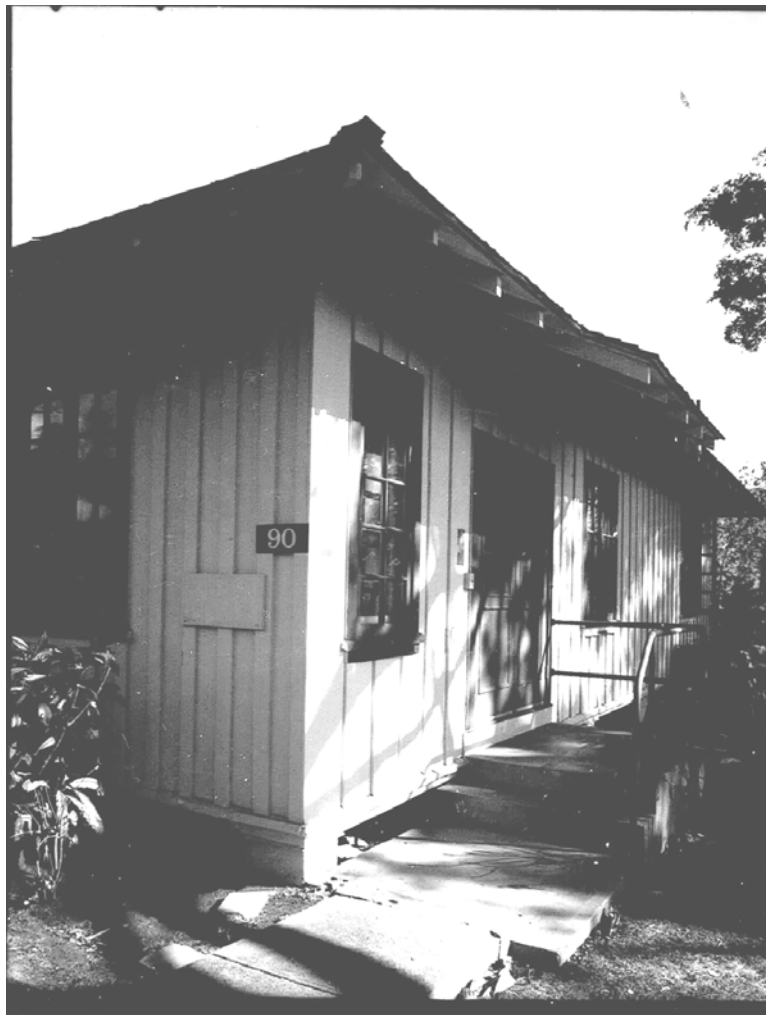
**HABS NO. HI-444-4**

| HI-444-4 | DETAIL OF EAVES, WINDOWS AND BATTENS ON NORTHWEST CORNER, SHOWING MAIN ENTRY. |

The house has a complex hipped roof and is the only Ford Island quarters that retains its original wood shingles. Projecting wide eaves have exposed rafters with plumb-cut ends and tongue-and-groove boards as roof underlayment. There are gutters and downspouts located at both sides of the kitchen projection. Narrow bands of ventilation screening are located under the eaves at the corners of the house.

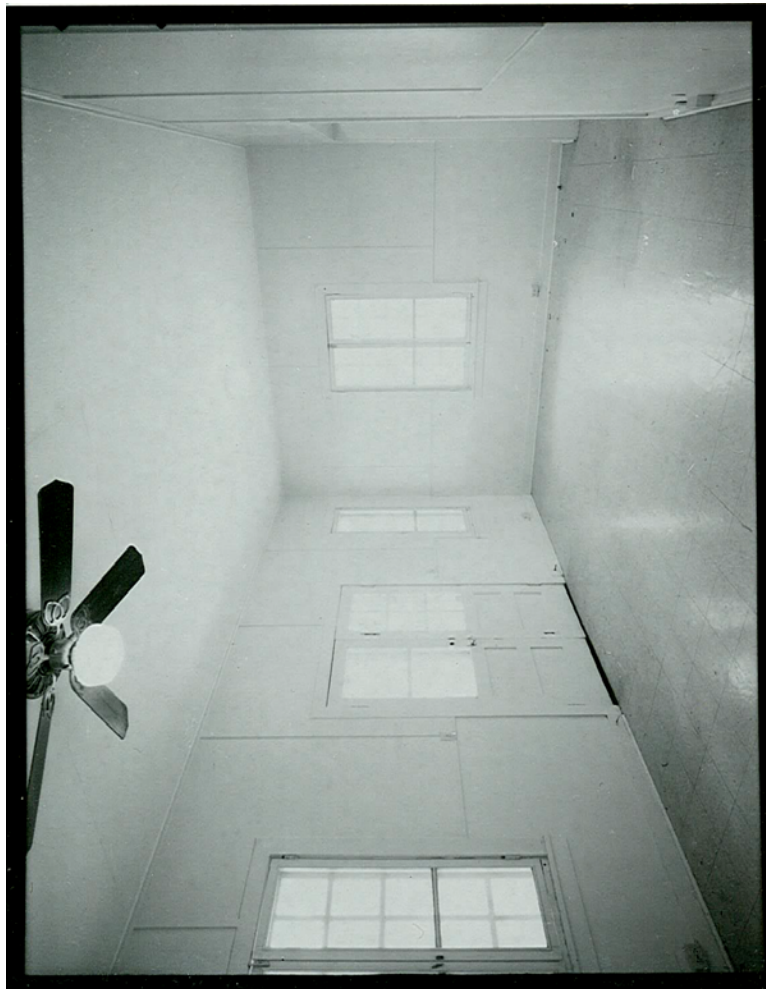
**HABS NO. HI-444-5**

| HI-444-5 | INTERIOR VIEW OF LIVING ROOM AND ENTRY DOORS, AS SEEN FROM HALL. |

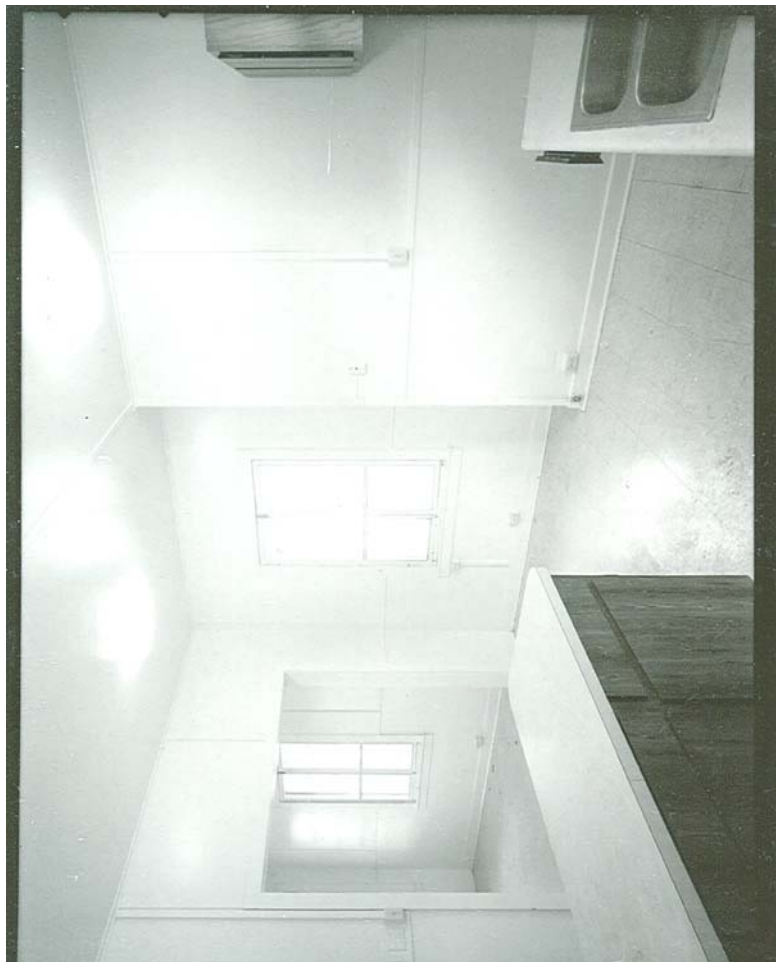
**HABS NO. HI-444-6**

| HI-444-6 | INTERIOR VIEW OF KITCHEN/DINING AREA, LOOKING TOWARD LIVING ROOM. |

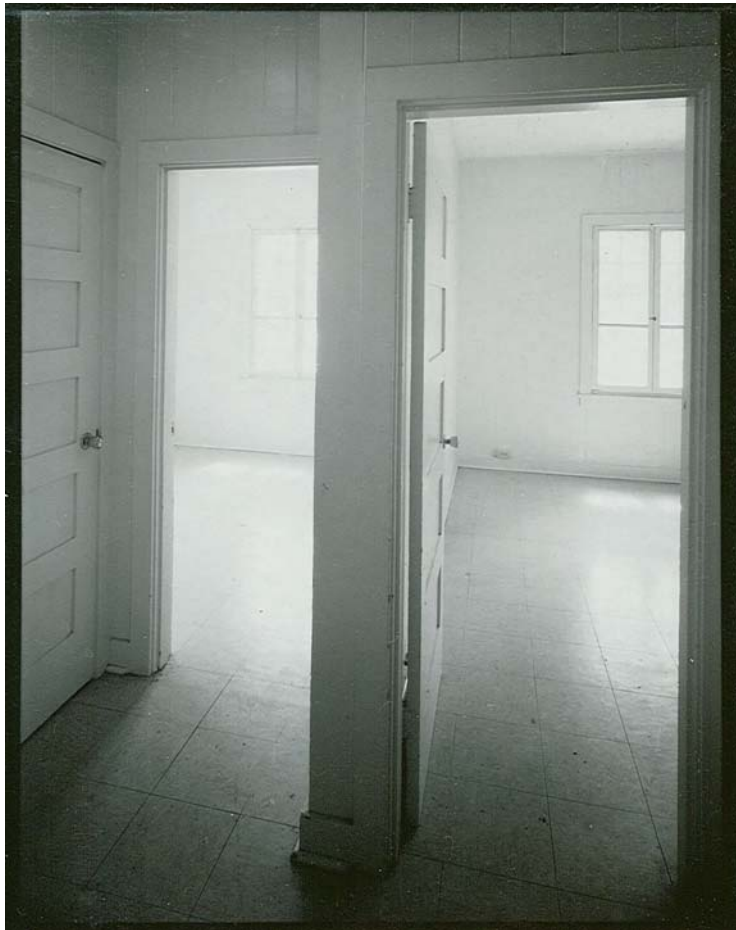
**HABS NO. HI-444-7**

| HI-444-7 | INTERIOR VIEW OF HALL, SHOWING ENTRIES TO TWO BEDROOMS. |
