Appendix C: Significance Evaluation and Condition Assessment

SIGNIFICANCE EVALUATION OF THE HOTEL BY AREA

THE AHWAHNEE
Historic Structures Report

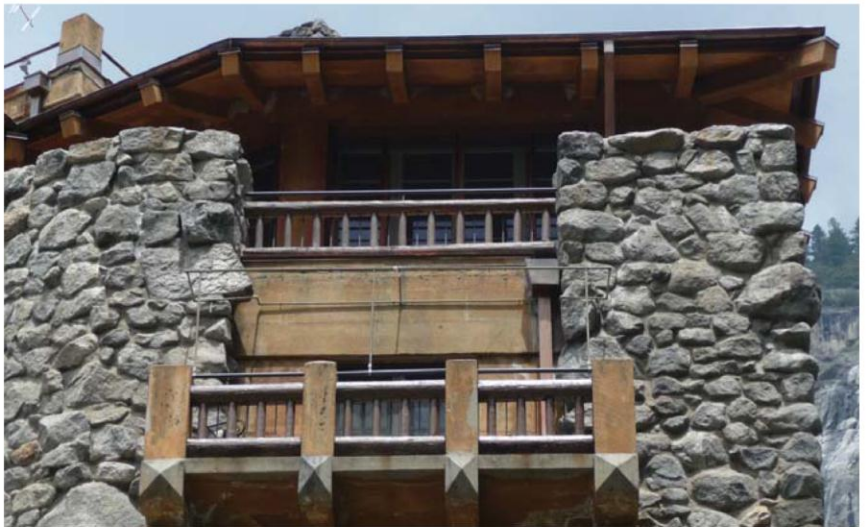
Figure 250: Detail view of fourth and fifth floor balconies, 2009. (Source: ARG)

- Wood hopper windows
- Wood shutters
- Exterior wood stile and rail doors (lower panel of wood and upper panel glazed)
- Solid wood doors at service areas
- Multi-light transoms of fixed sash
- Stamped and stained concrete slabs at loggias and terraces
- Concrete decks at balconies
- Peeled log balcony railings (altered)
- Log and wood fence at north side of Service Yard
- Awnings
- Ornamental light fixtures

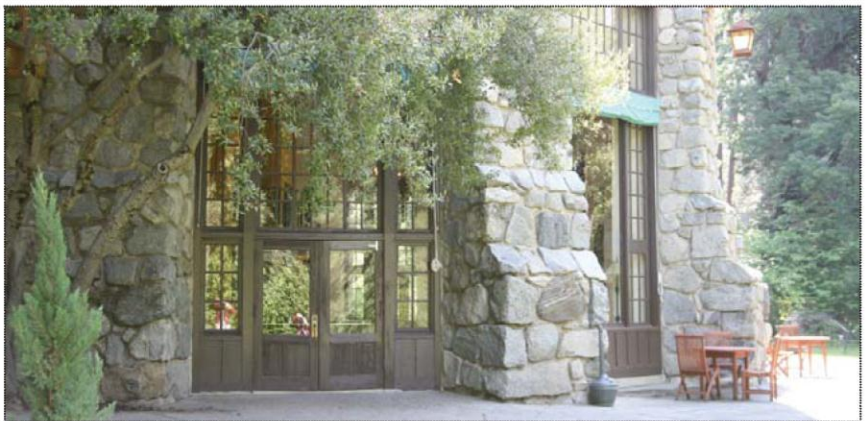
Figure 251: Detail view of the granite piers at the Solarium, 2009. (Source: ARG)

- Granite masonry
- Stained reinforced concrete walls
- Log and wood wall siding
- Peeled log and wood construction at Dining Room, Porte Cochere and covered entrance walkway
- Vermont slate roofing
- Concrete rafter tails²
- Log and wood wall with painted decorative patterns between covered entrance walkway and Service Yard
- Wood-framed window walls in public areas
- Stained glass windows
- Leaded windows at sixth floor
- Steel casement windows at Service Yard

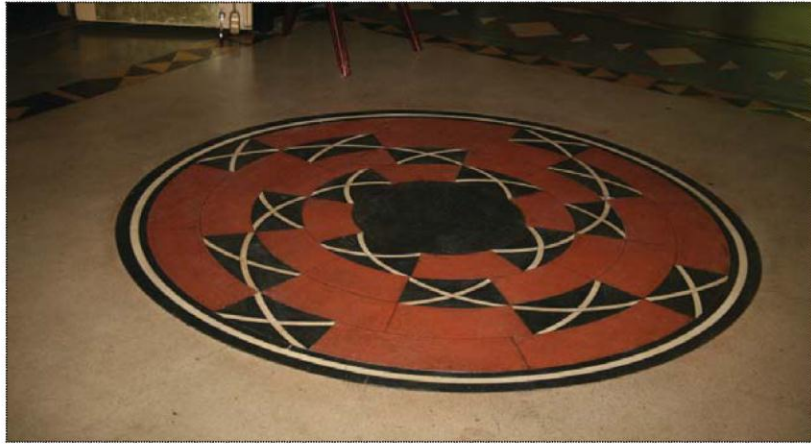
Figure 252: Detail view of the Registration Lobby rubber floor tiles, 2009. (Source: ARG)

- Stained concrete floors with decorative scored patterns
- Inlaid rubber tile patterns and borders
- Textured plaster walls, columns, and ceiling
- Stenciled decorative band on walls and columns

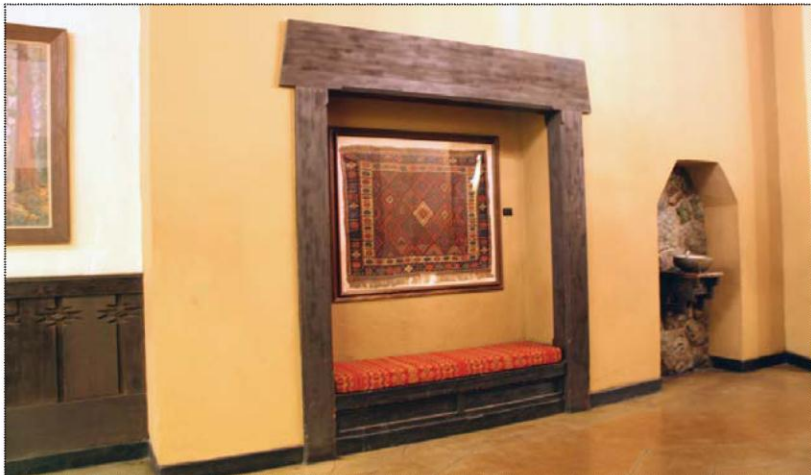
Figure 253: View of recessed bench and drinking fountain at Registration Lobby hallway, 2009. (Source: ARG)

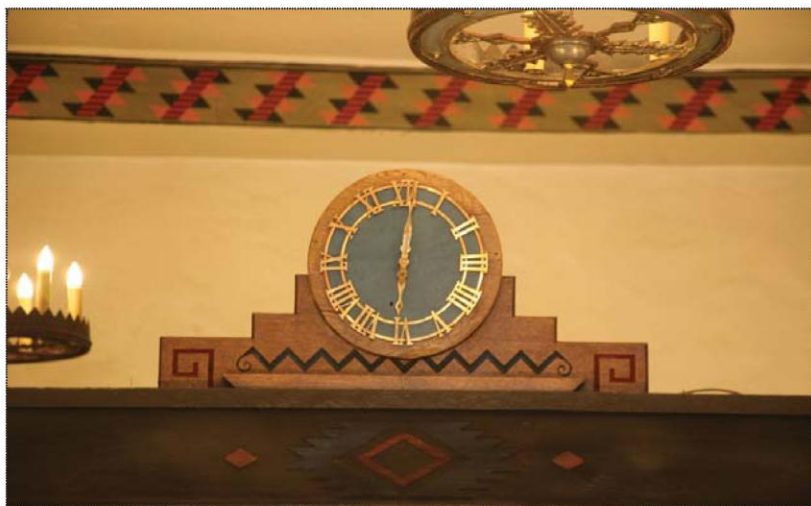
Figure 254: Detail view of clock at registration desk, 2009. (Source: ARG)

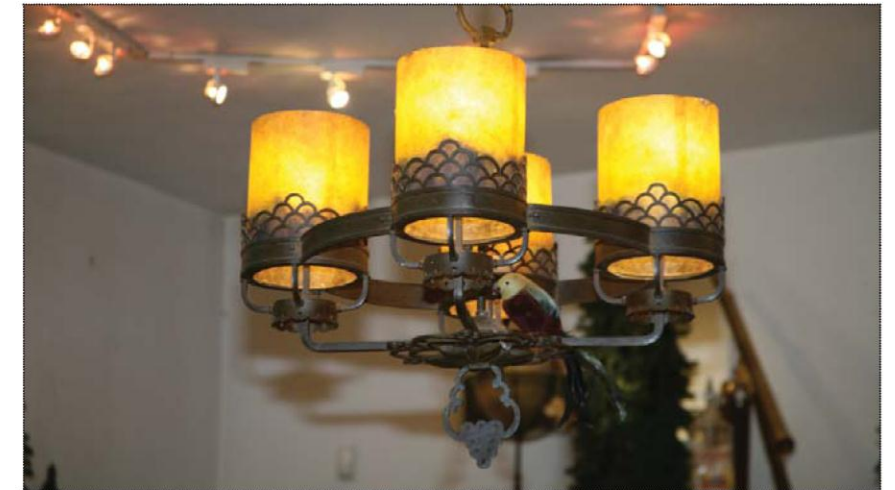
Figure 255: Detail view of original Sweet Shop pendant light fixture, 2009. (Source: ARG)

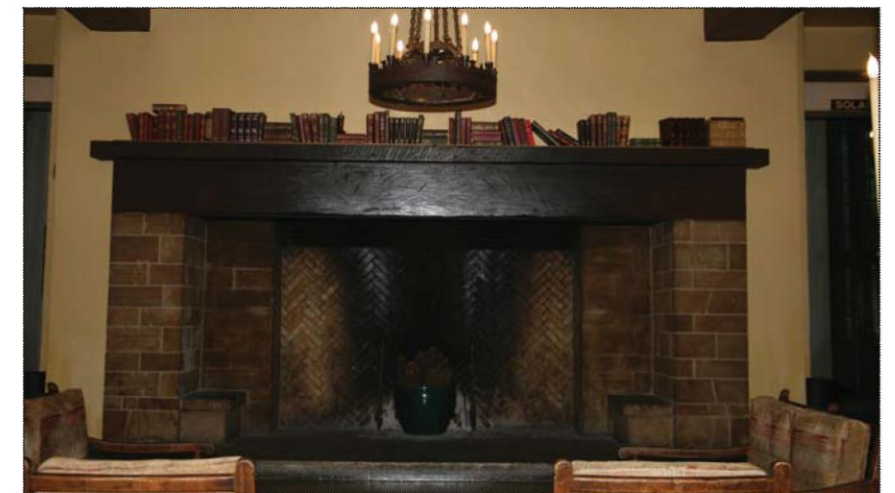
Figure 256: Detail view of the Under Lounge fireplace, 2009. (Source: ARG)

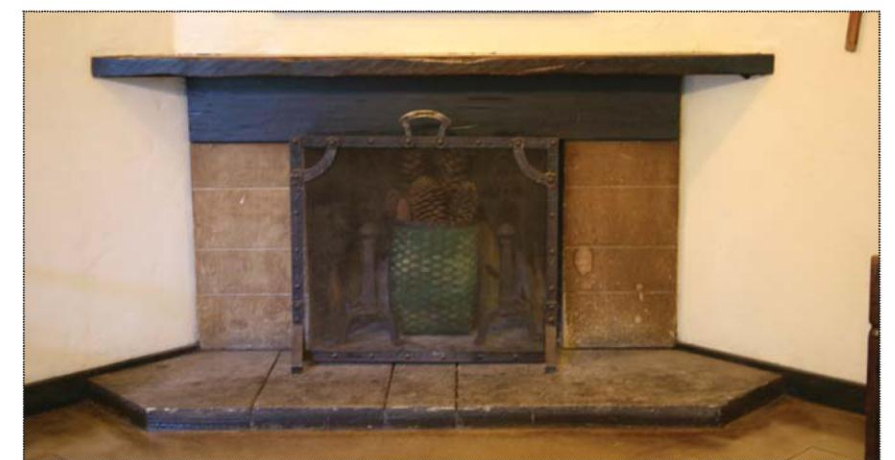
Figure 257: Detail view of the Winter Club Room fireplace, 2009. (Source: ARG)

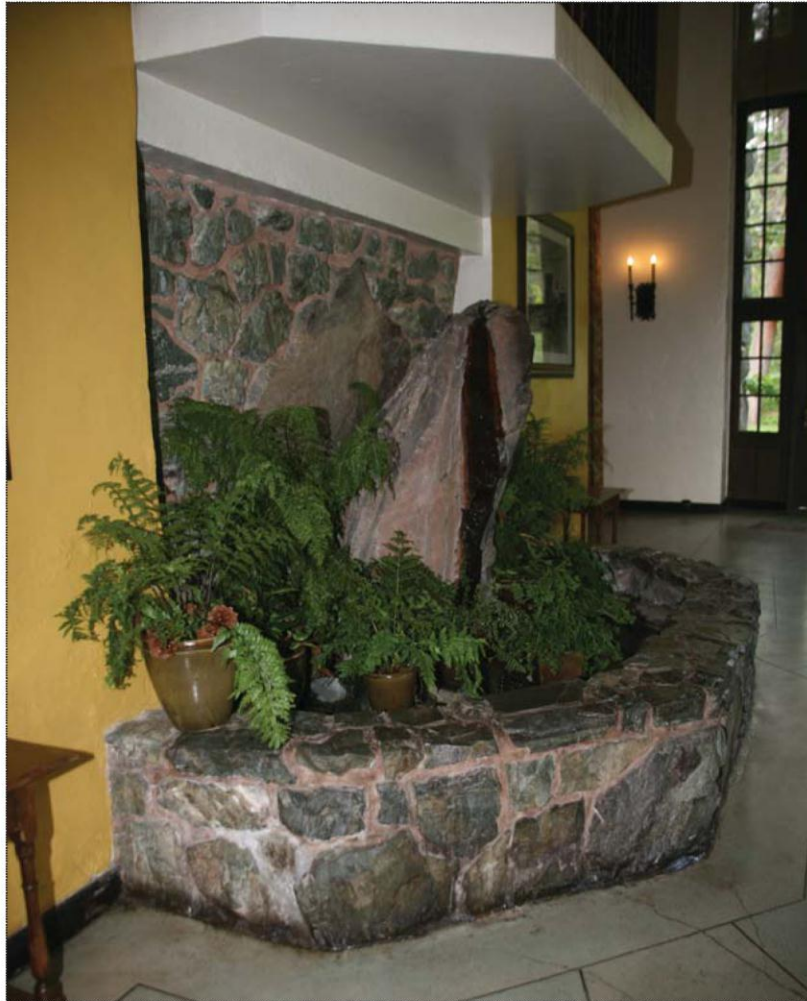
Figure 258: Detail view of the Solarium fountain, 2009. (Source: ARG)

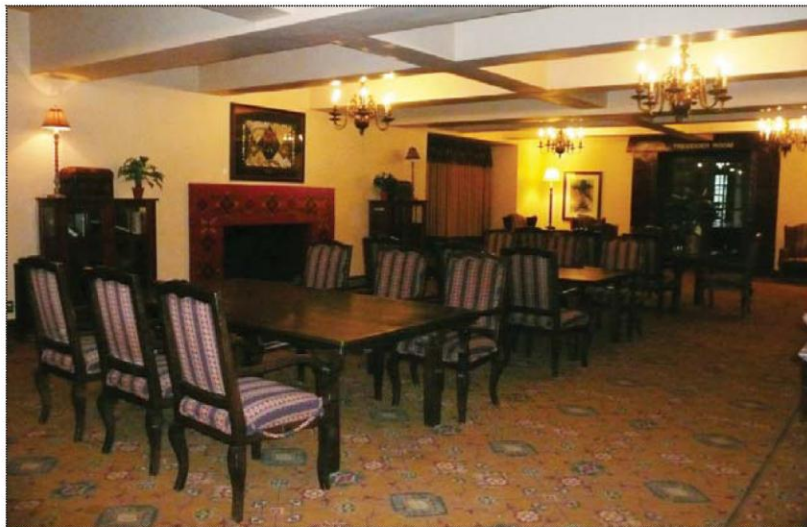
Figure 259: Overall view of the Tudor Lounge, 2009. (Source: ARG)

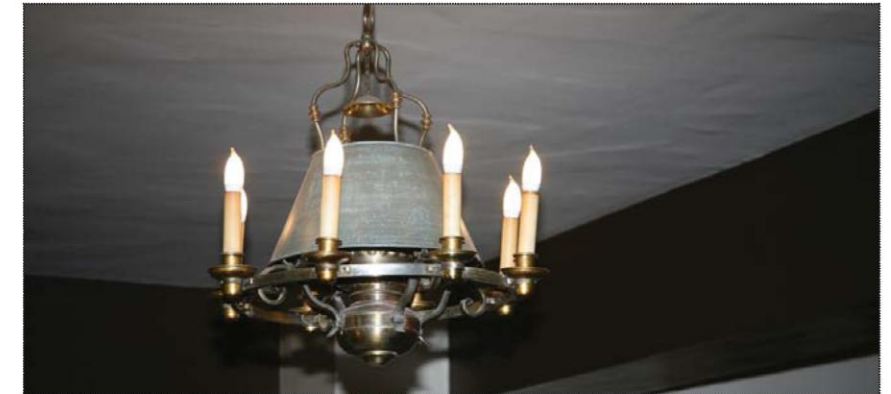
Figure 260: Detail view of light fixture in the North Mezzanine Lounge, 2009. (Source: ARG)

- Oak strip flooring with accent strips at 12 inches on center (replacement-in-kind)
- Carved wood balustrade at wall openings to North Mezzanine Lounge
- Wood walls and windows at Tudor Lounge
- Plaster walls, piers, ceiling, and beams
- Wood baseboard
- Stencils on ceiling beams (many missing)
- Stained wood doors and windows
- Stained wood wainscot
- Stained glass windows
- Fireplace with cast-stone surround and hearth, brick fire box, and wood mantel
- Wrought-iron pendant fixtures
- Cast-iron steam radiators

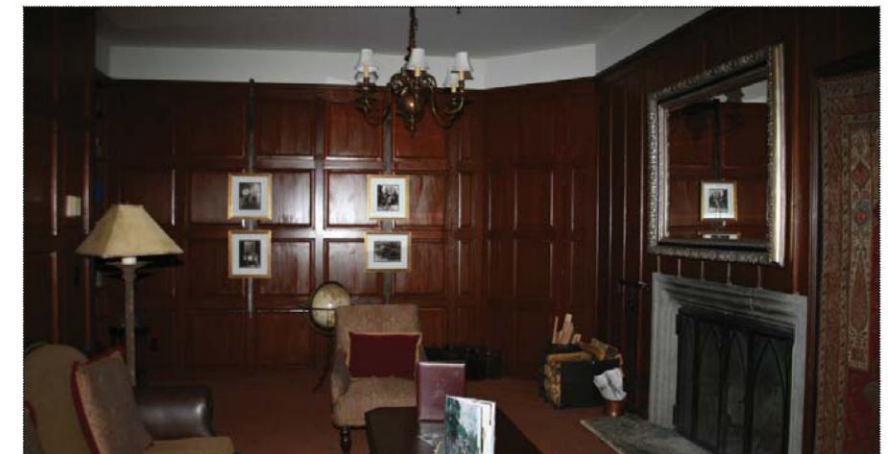
Figure 261: View of wall paneling in former Library, now room 602, 2009. (Source: ARG)

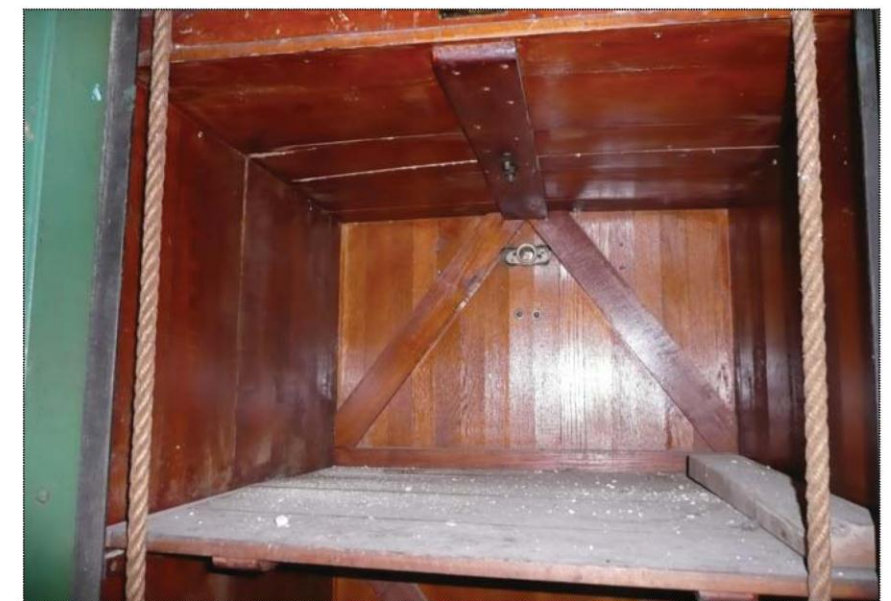
Figure 262: Detail view of dumbwaiter in Basement, 2009. (Source: ARG)
