# Chapter 1

## Purpose And Need

This Final Environmental Impact Statement (FEIS) for the Going-to-the-Sun Road Rehabilitation Plan

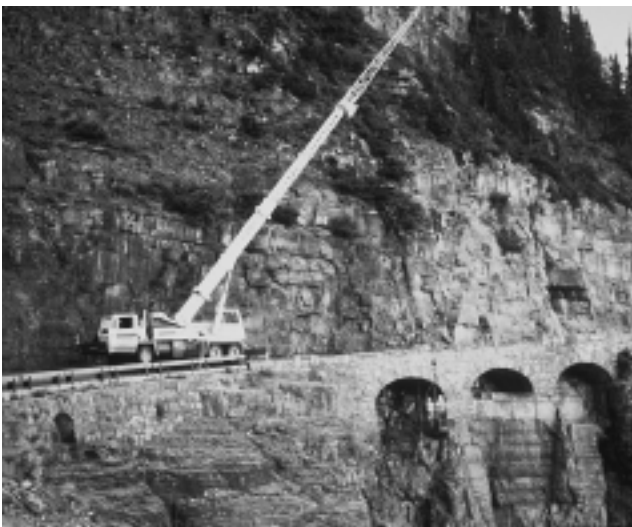
**Repair work on Triple Arches**

Stone retaining walls, primarily between The Loop and Siyeh Bend, are in various states of disrepair (Figure 2). The upper 3 to 8 feet (1 to 2.4 meters) of many of the walls are in distress, with loose or missing stones and crumbling mortar. In some locations, the original retaining walls were replaced with concrete walls and stone-veneer work has not been completed. Stone arch half-bridges have minor to moderate levels of mortar deterioration, except Crystal Point Arch and Triple Arches, which have significant and potentially dangerous deterioration.

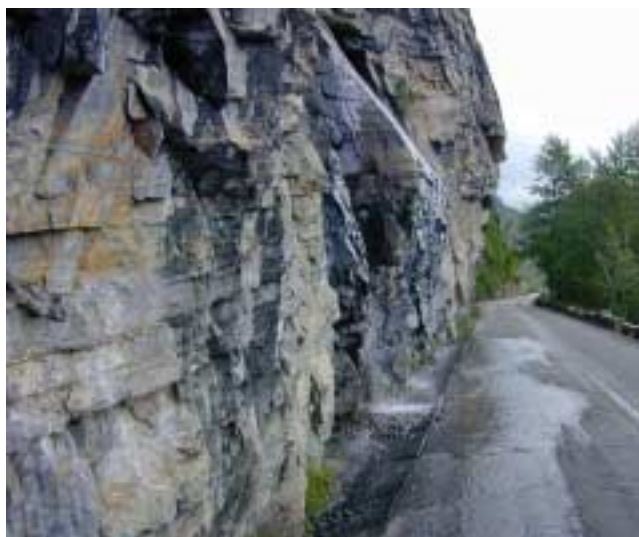
Inadequate roadway drainage

would occur. Most of the runoff from melting snow occurs over a short time period in the spring. Narrow and shallow ditches, undersized culverts, and a general lack of drainage features along the Road, particularly in the vicinity of guardwalls and retaining walls, cannot adequately convey the volume of runoff water. This results in water flowing over the roadway surface and infiltrating into the subbase under the pavement. Frequent freezing and thawing of the subsurface moisture results in frost heaving and damage to the Road's pavement and structures.

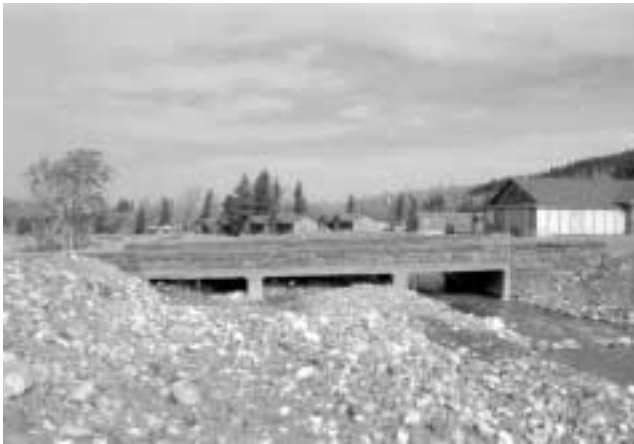
#### **Sediment deposition at Divide Creek Bridge**

Several drainages that cross the Road, including Divide Creek, carry high amounts of rock and gravel (Figure 2). The deposition of this material at the bridges restricts flow during large runoff events, which can adversely affect the integrity of the bridge structures and the adjacent roadway. Divide Creek is of particular concern because of the potential for flooding. Previous floods have frequently resulted in impacts to the Road, the historic Divide Creek Bridge, Park residential and maintenance facilities, the St. Mary Visitor Center, and other adjacent lands

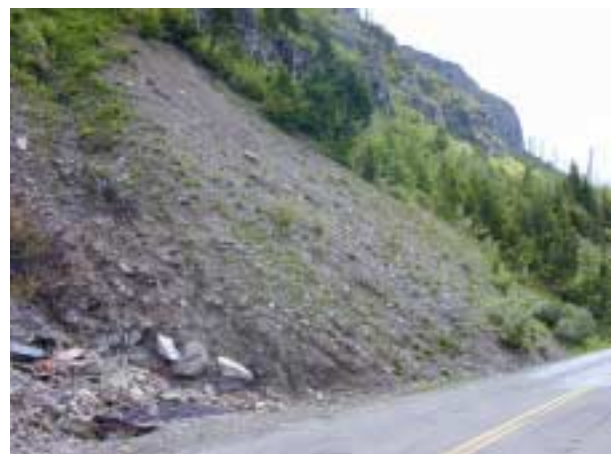
**Eroding cut slope**

In several locations steep, unstable cut slopes above the Road are actively eroding. This leads to further erosion of the cut slope, loss of soil material, and the loosening of large rocks that roll down the slope onto the roadway. Rockfall hazards are a safety concern on portions of the steep high elevation Road between The Loop and Golden Stairs Point (Figure 2). Through natural freeze/thaw processes and erosion, loose rocks periodically break free and land on the roadway. Approximately 70 avalanche chutes are present throughout the high elevation portions of the Road and although not readily controllable, they continue to damage Road guardwalls and other appurtenances. Debris flows along gullies and drainages contribute to Road deterioration from erosion of the roadbase or deposition of materials on the Road.

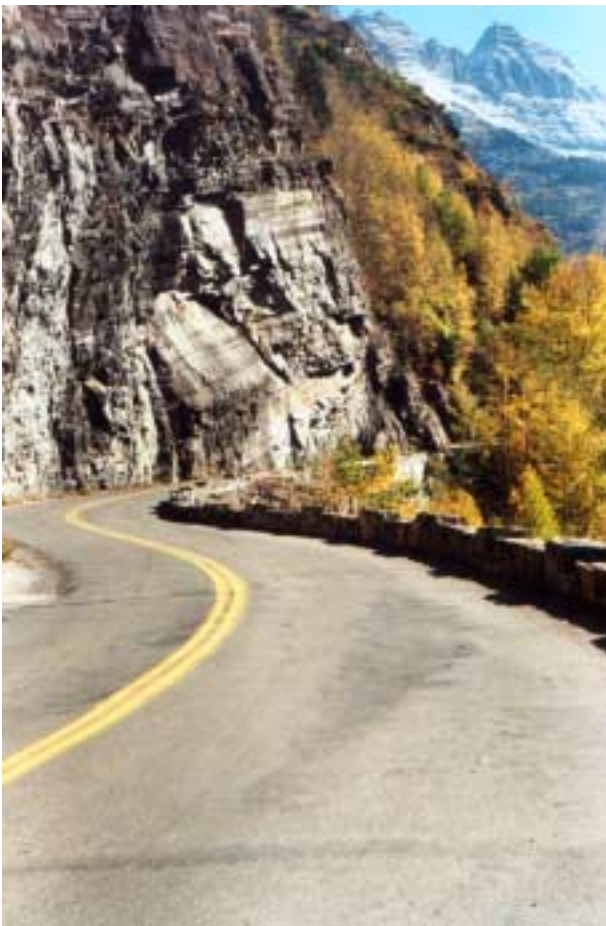
**Rockfall hazard area**

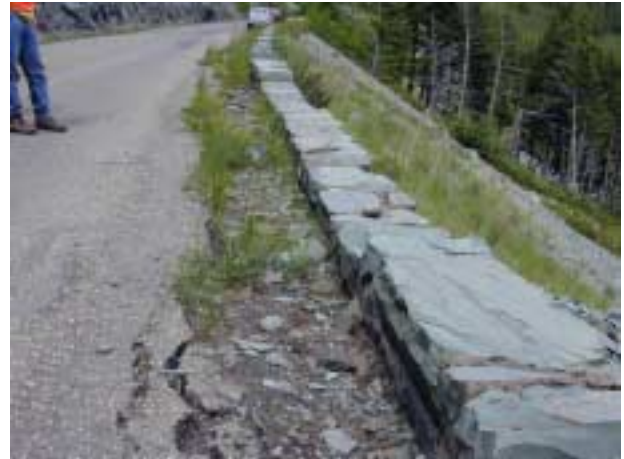
**Inadequate guardwall height due to settling and successive pavement overlays**

Guardwalls include stone masonry guardwalls, removable timber rails, large barrier rocks, and temporary concrete barriers. Many of the historic stone masonry guardwalls are missing, leaning away from the Road, or have been displaced due to poor drainage, lack of adequate foundations, avalanche and snow weight pressures, vegetation and root damage, and in some cases insufficient maintenance practices. In some locations, guardwalls have settled and/or their height has been encroached upon by pavement overlays or patching that reduces their

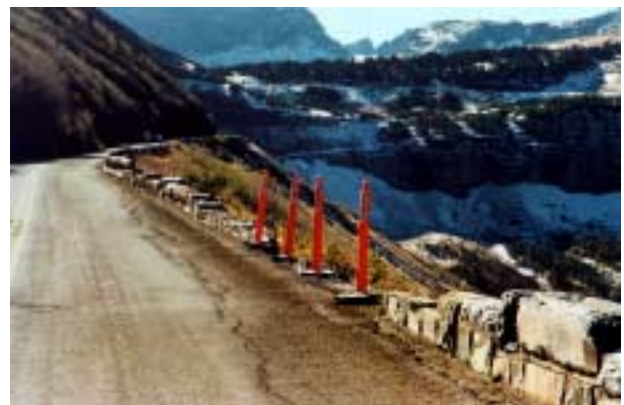
**Damaged guardwall**

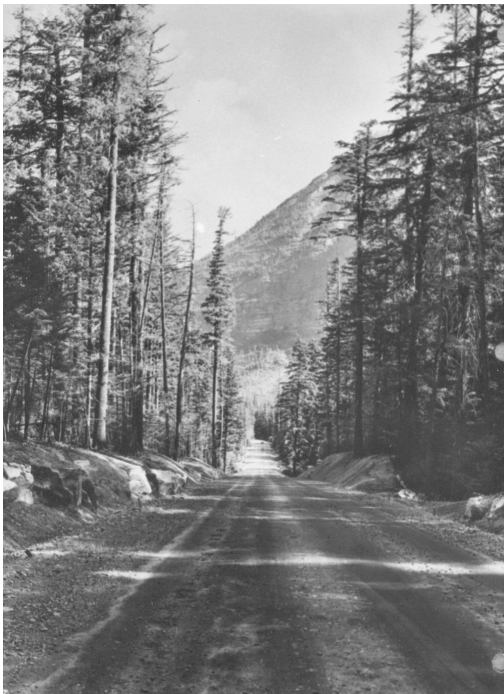
**Figure 3. Roadside Vegetation in 1939 (left); Roadside Vegetation Near the Same Location in 1987 (right).**

The Road provides exceptional scenic views of the landscape, which is the primary reason that most visitors drive the Road. Since the original Road construction, vegetation growth adjacent to the Road shoulder has blocked scenic vistas, diminishing the quality of the visitor experience the Road was intended to provide. As seen in Figure 3, vegetation growth along the Road has increased substantially since original construction because of the additional light and moisture available along the roadway margin. Scenic viewpoints such as The Loop, Jackson Glacier Overlook, Sun Point, along Lake McDonald and elsewhere no longer provide the scenic vistas originally intended along the Road.
