The Washington House at Ferry Farm: An Architectural Study

Mesick Cohen Wilson Baker, Architects

**March 14, 2012
(Updated July, 2015)**

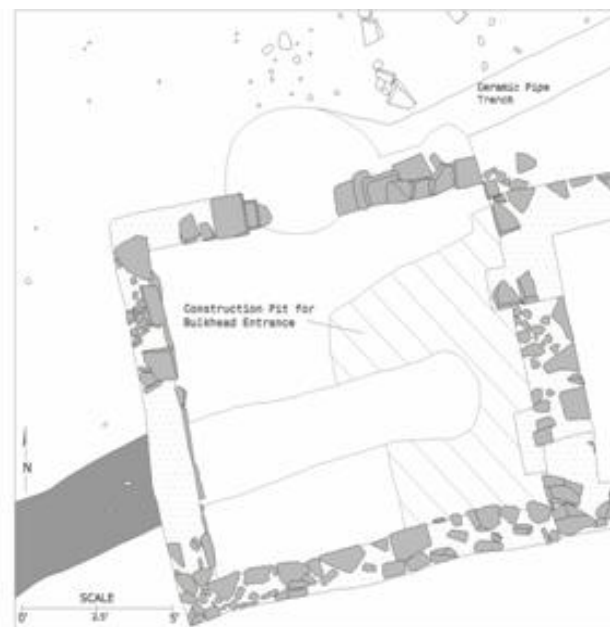
Figure 6. Archaeological Plan, Period II Cellar. Note west door of period I cellar shown at left. George Washington Foundation.

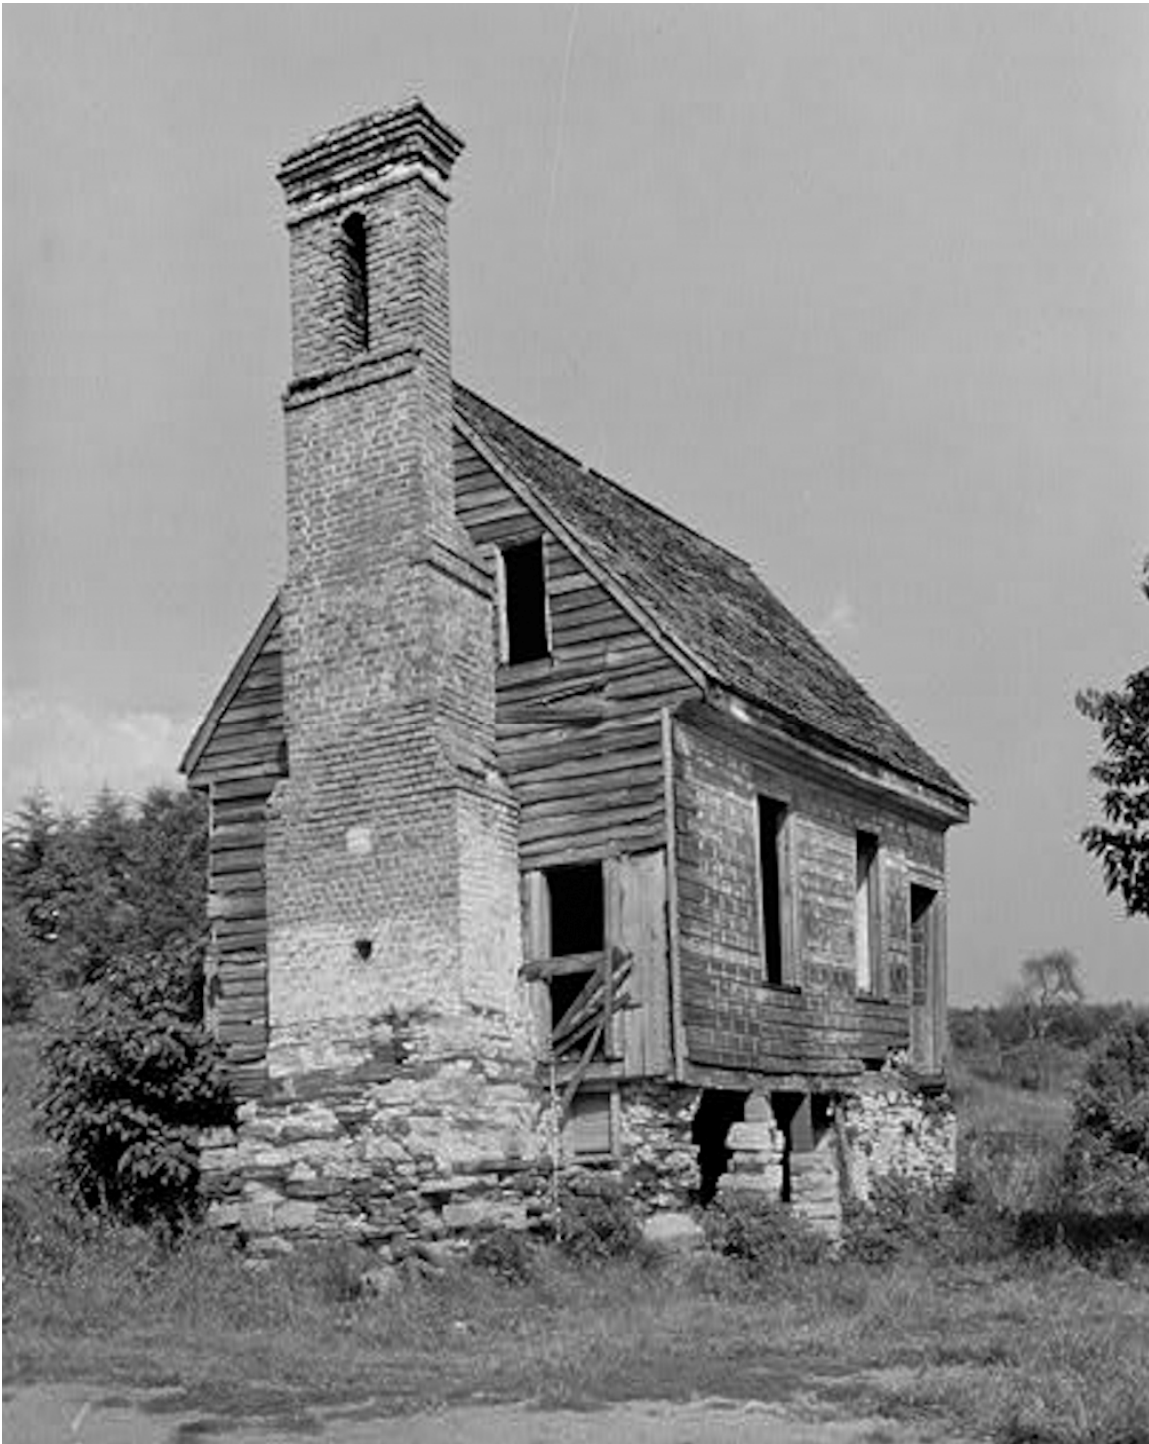
Figure 12. Merchant House. Dumfries, Virginia. (Destroyed).
Stone foundation of chimney extends above finished floor.
HABS, Library of Congress. (1933).

Another approach is to stop the stone at or near finished floor level of the downstairs rooms. Two 18th-century examples--the Merchant House in Dumfries, Virginia, (Figure 12), and the “The Chimneys” in Fredericksburg, (Figure 13)--are earlier and thus more relevant to Ferry Farm than the examples previously described. The Merchant House, now destroyed, was recorded by the Historic American Buildings Survey shortly before its demise. The date of this building cannot be determined with precision; however the sculptural treatment of the chimney, with a blind arch between flues and plaster necking at the cap, certainly suggests a pre-Revolutionary construction date. At the chimney, the coursed ashlar foundation extended a short distance above the FFL, but doesn’t seem to have been visible on the fireplace interior—the jambs of the larger, earlier fireplace opening appear to have built entirely of brick.²⁶ In this case, the stone foundation of the chimney stepped in at the bottom of the wooden siding.

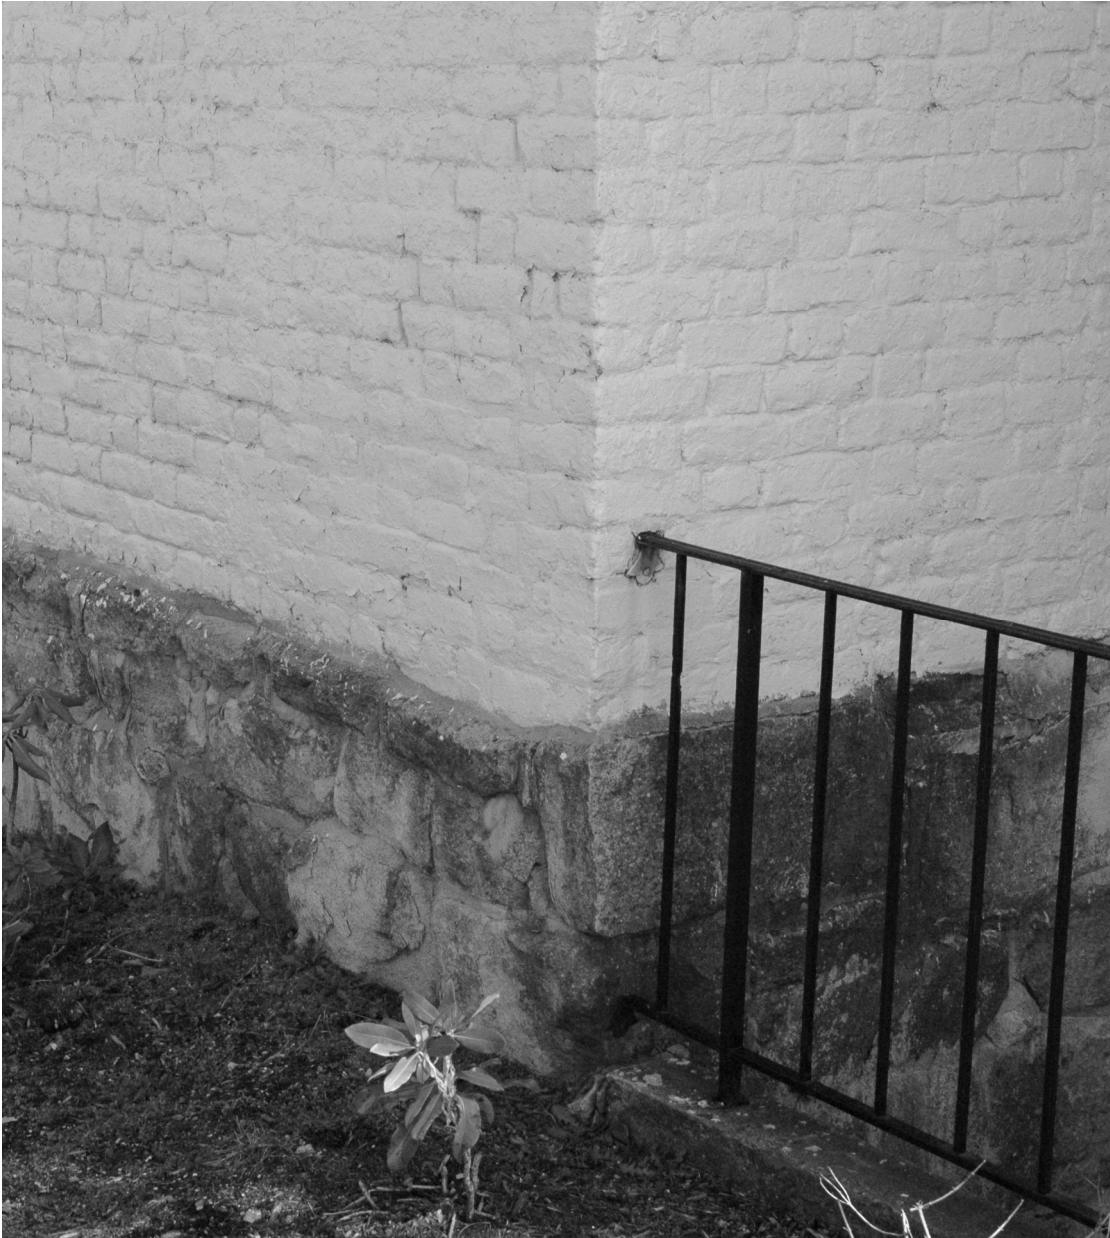
Figure 13. “The Chimneys.” Fredericksburg, Virginia.
Brick chimney borne on a stone foundation.
Jennifer Glass (2012).

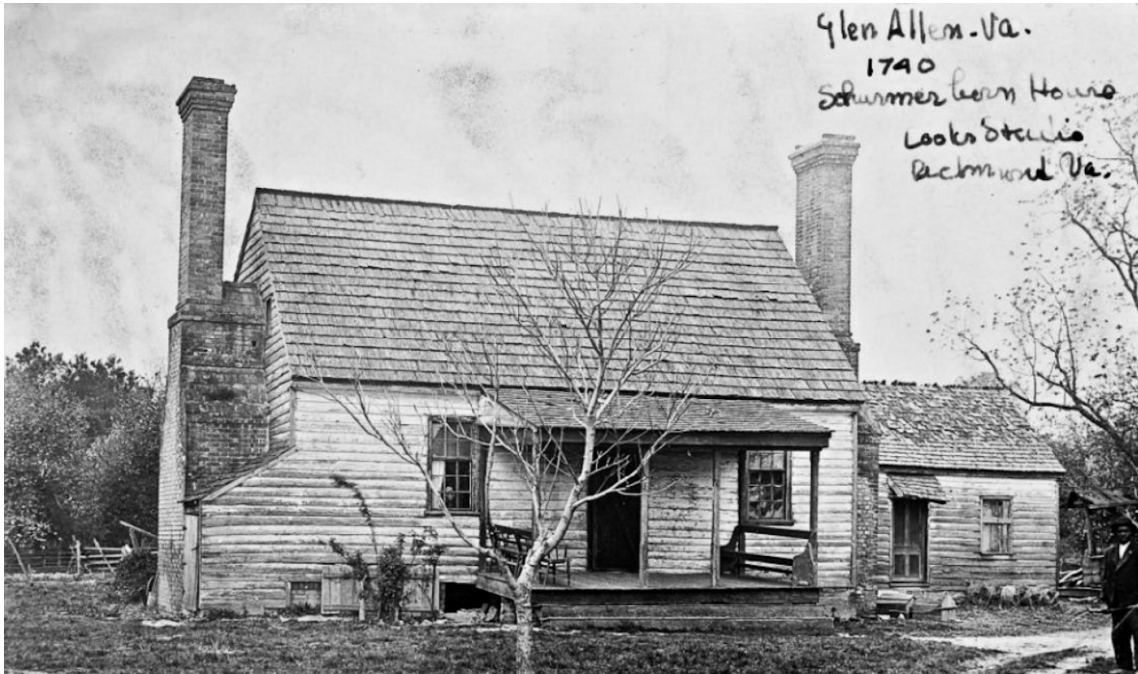
Figure 14. Schurmerberg House. Glen Allen, Virginia. (Destroyed).
Deep chimneys, with weatherings on three faces.
Valentine Museum. (Date unknown).

Above ground, the unusual depth of the Parlor (north) chimney foundation demands the identification of surviving or documented chimneys of comparable proportions. The Schurmerbern House, formerly in Glen Allen, Virginia (Figure 14), boasted two chimneys of the kind that the north foundation at Ferry Farm seems to represent. Assuming 9” stretchers and 4 ¼” headers, the chimney at the

left of the photo would measure about 4'-10" deep—very nearly the same as the Ferry Farm foundation. Assuming a stepped chimney foundation like that at Merchant House, the breadth of the south chimney, as determined from the fragmentary foundation and the associated root cellar, was approximately 9'-4 ½" above the step, very nearly the same as the smaller exterior chimney at Lynnhaven House, which is also stepped. (Figure 15).

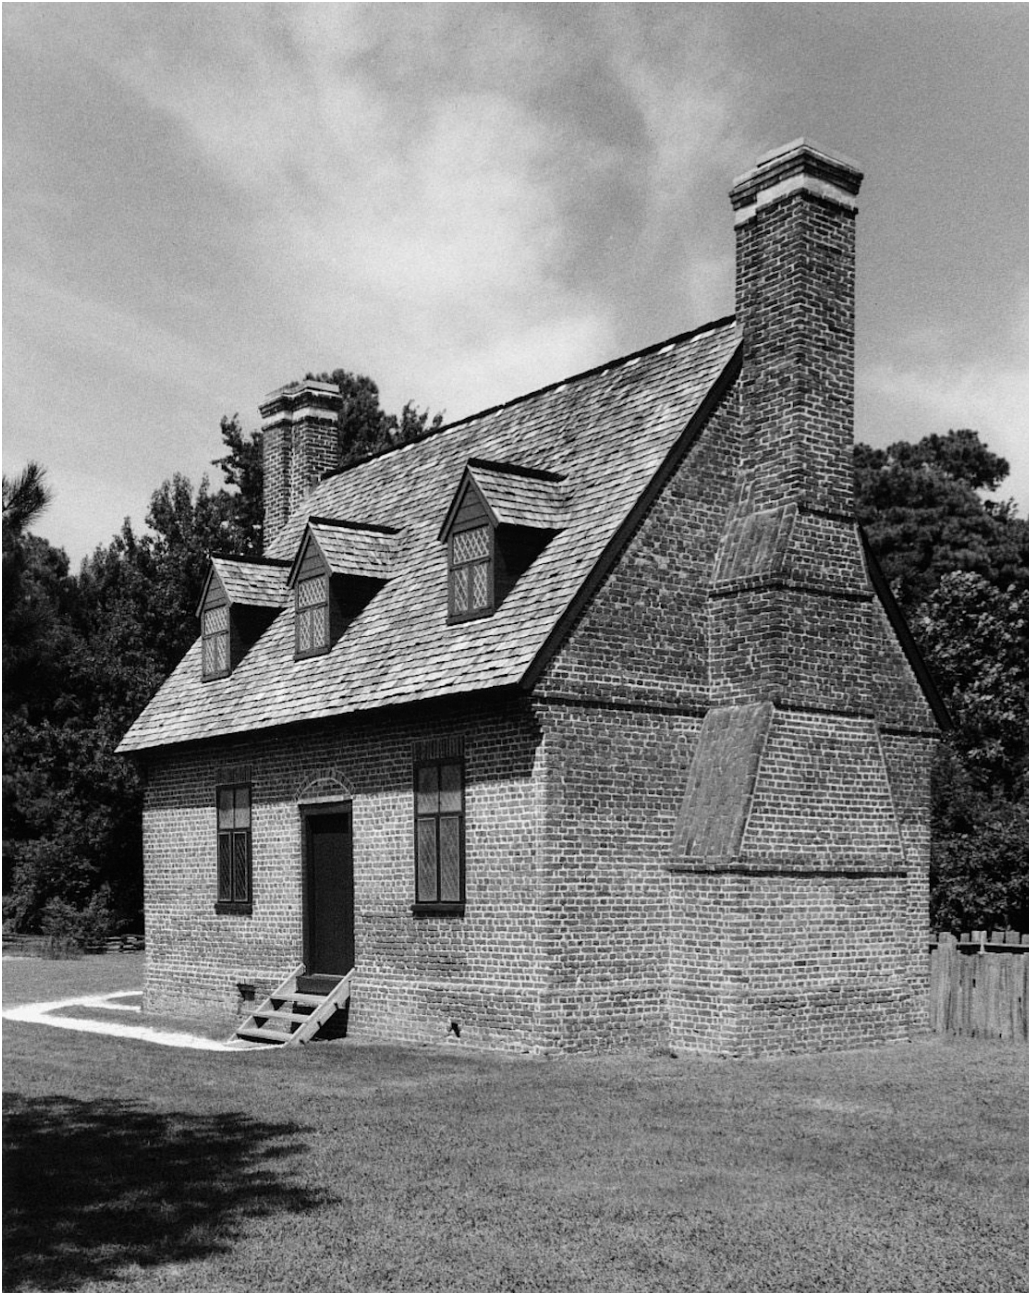
Figure 15. Lynnhaven (Wishart) House. Virginia Beach, Virginia.
Large chimney, with foundation stepped at grade.
National Register of Historic Places. (1969).

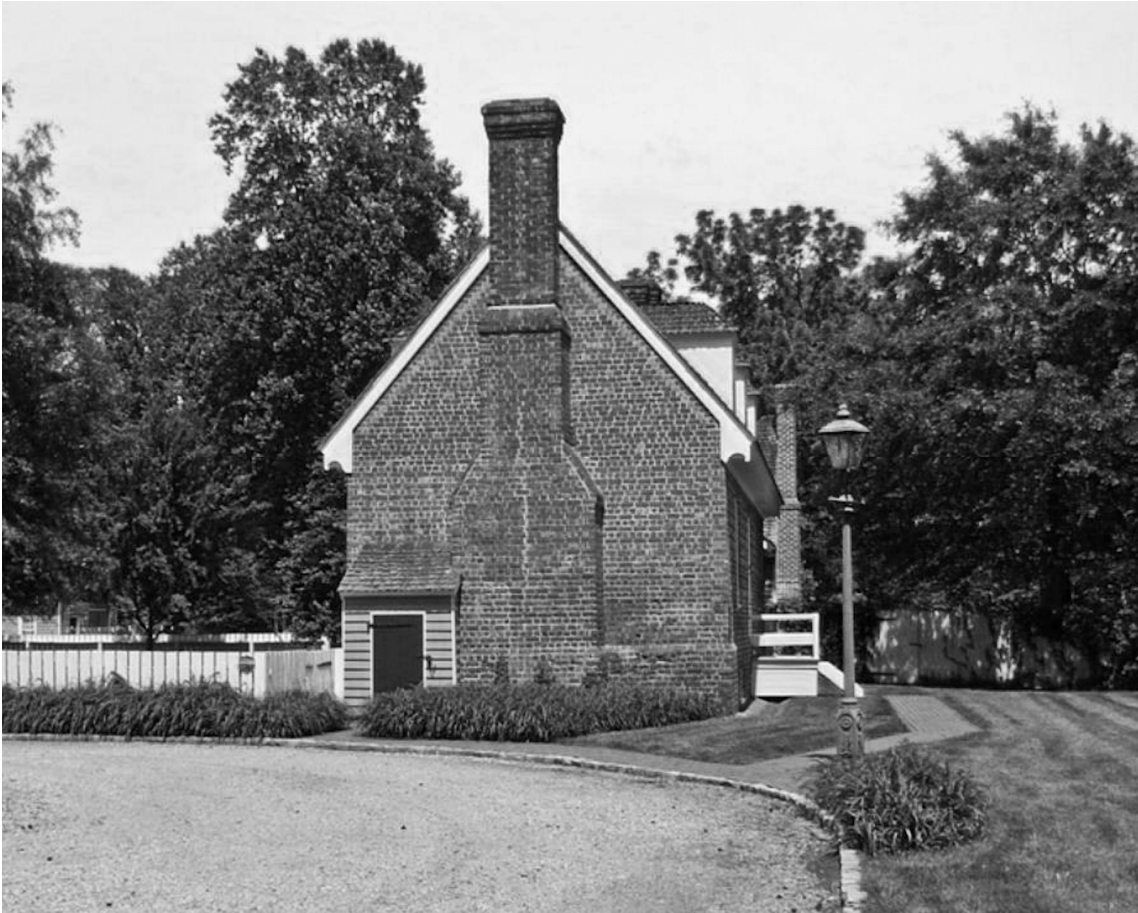
Figure 16. Eagle's Nest (Claybank). Charles City County, Virginia.
Weatherings below stack on three sides. *DHR*.

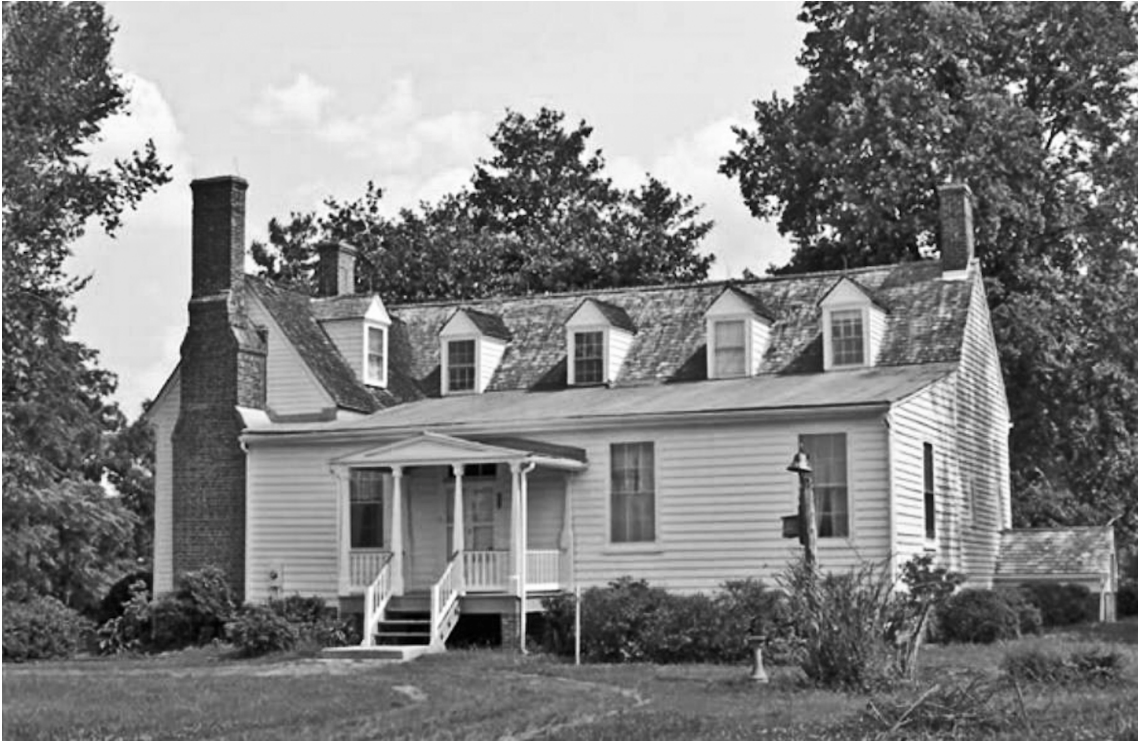
Figure 19. Kittiewan. Charles City County.
Added shed abuts rear ell. (2007).

walls of rear sheds are not unknown among early houses, but they were never as common as gable-end examples.³¹ One alternative to the shed addition shown in our drawing would be a perpendicular wing with a gabled roof, centering the chimney on a rear gable. This option is plausible within the reconstructed plan of the house—Augustine Washington could have extended the extant shed—the Hall Room Back—to meet a new, gable-roofed wing, resulting in a covered porch between the two rear spaces. Kittiewan, in Charles City County, Virginia (Figure 19), embodies a similar process of expansion, though the added shed is probably a 19th-century structure.

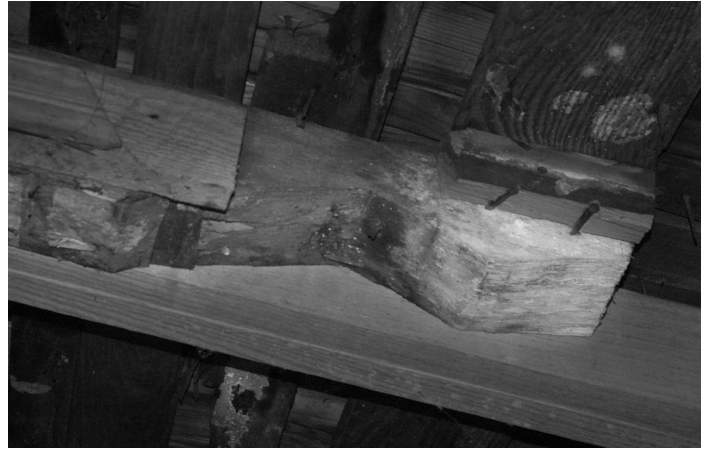
Figure 20. 304 Queen Street, Edenton, North Carolina.

Assuming a shed roof for the back rooms at Ferry Farm, that roof, whether original or added, was almost certainly framed over the rear slope of the main roof, the shed rafter attaching either at the ridge, or at some lower point along the backs of the main rafters. An example of the latter can be seen in Edenton, NC where remnants of an early shed survive behind a newly discovered house that probably dates to the second quarter of the 18th century. The shed rafters attach to the rear of the main roof 4’-6” above the eave, measured along the back of the main rafter. This places the ends of the added rafters over the tops of the knee wall studs or “ashlars,” presumably for added the added support they could provide. In recent years the old shed rafters were tilted upward and lengthened. Consequently, they stand at a shallower pitch today than they did originally. It is clear, however, that the lower ends of these members once bore on a horizontal surface—probably on top of the rear wall plate (Figure 20). If correct, this supposition allows us to determine the original pitch of the shed roof, based on the present angle of the rafter’s bearing surface. In any event, the tails of these

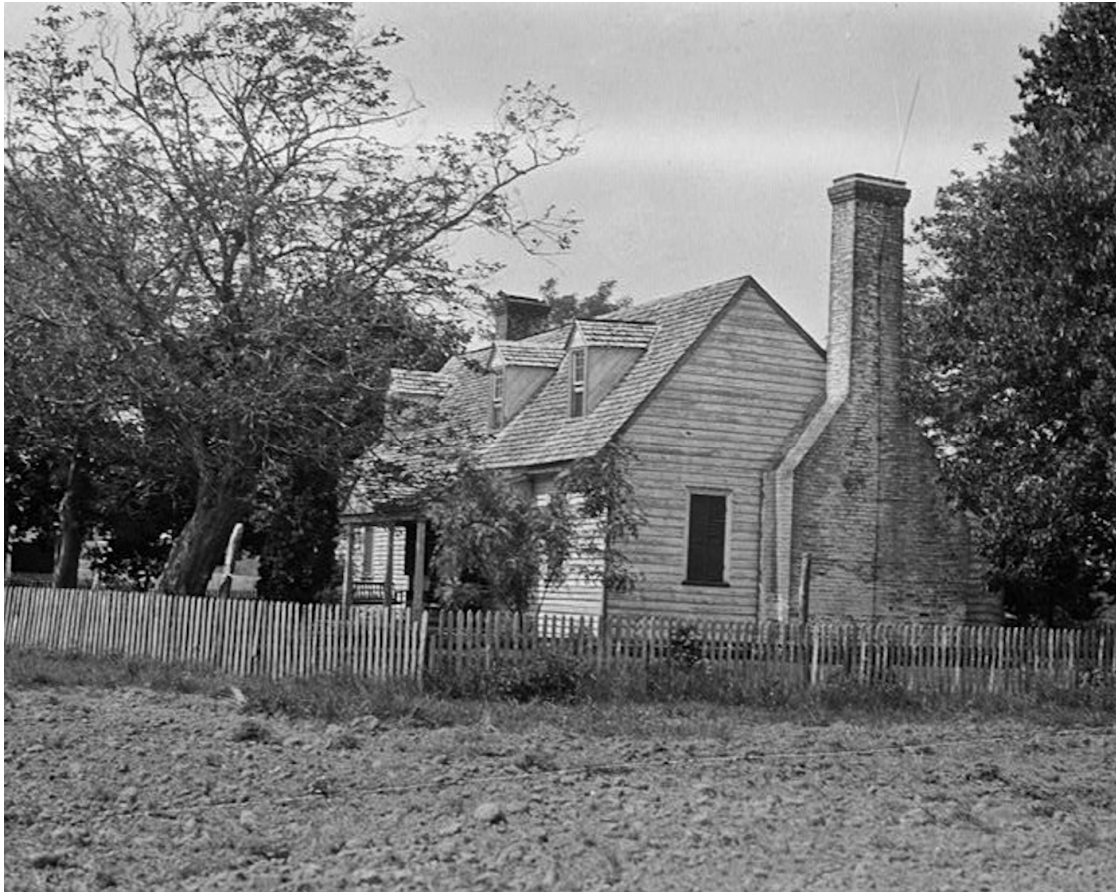
Figure 21. Linden Farm. Richmond County, Virginia.
Side elevation shows shed rafters attaching at ridge of main roof.
National Register of Historic Places. (1976).

The early shed at Linden Farm (Figure 21) illustrates an alternative to the Edenton roof profile, having rafters that attached at the apex of the main roof. This created a large dead space above the ceilings of the shed rooms. Often such spaces served as storage areas or “cuddies.” At “The Reward” in Kent County, Maryland (Figure 22), at Hungar’s Glebe in Northampton County, Virginia (Figure 23), and at Belvidere, in Perquimans County, NC (Figure 24), these rooms are lit by small, gable-end windows. However, no leftover rooms or “cuddies” of this sort are identifiable in either of the Ferry Farm inventories. Consequently, we conclude that the shed was framed off the lower third of the main rafters—low enough to preclude their use as rooms, but high enough to preclude the use of dormers on the rear of the main roof. (See A2.1).

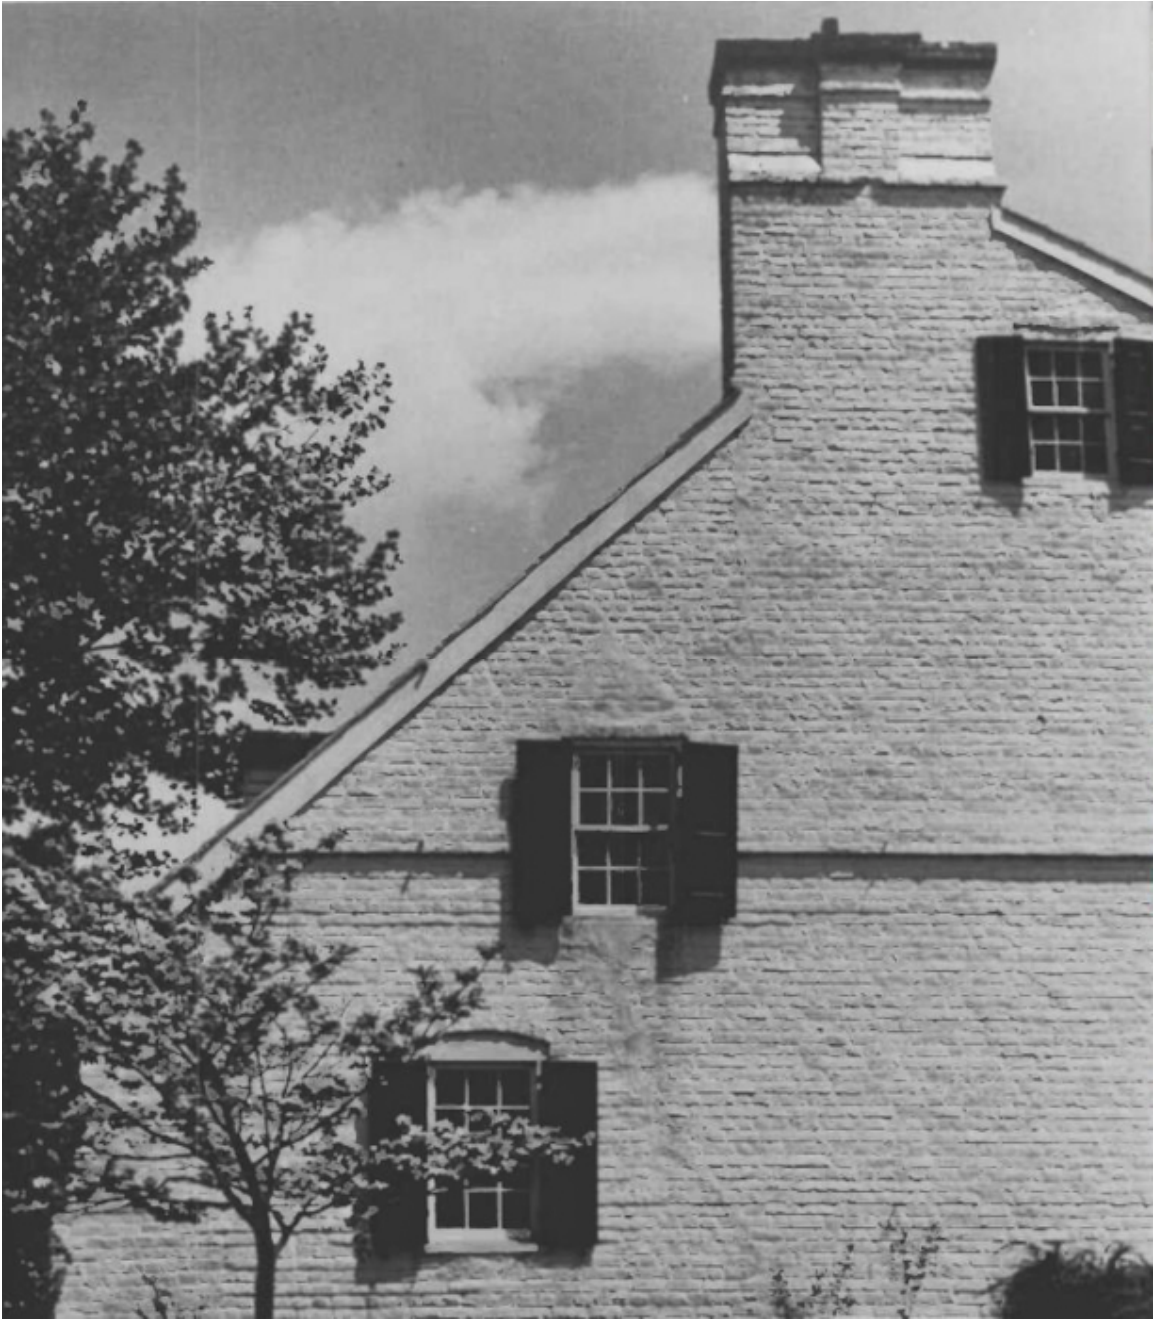
Figure 22. The Reward. Kent County, Maryland.
Gable end window above ceiling of rear shed.
National Register of Historic Places. (1977).

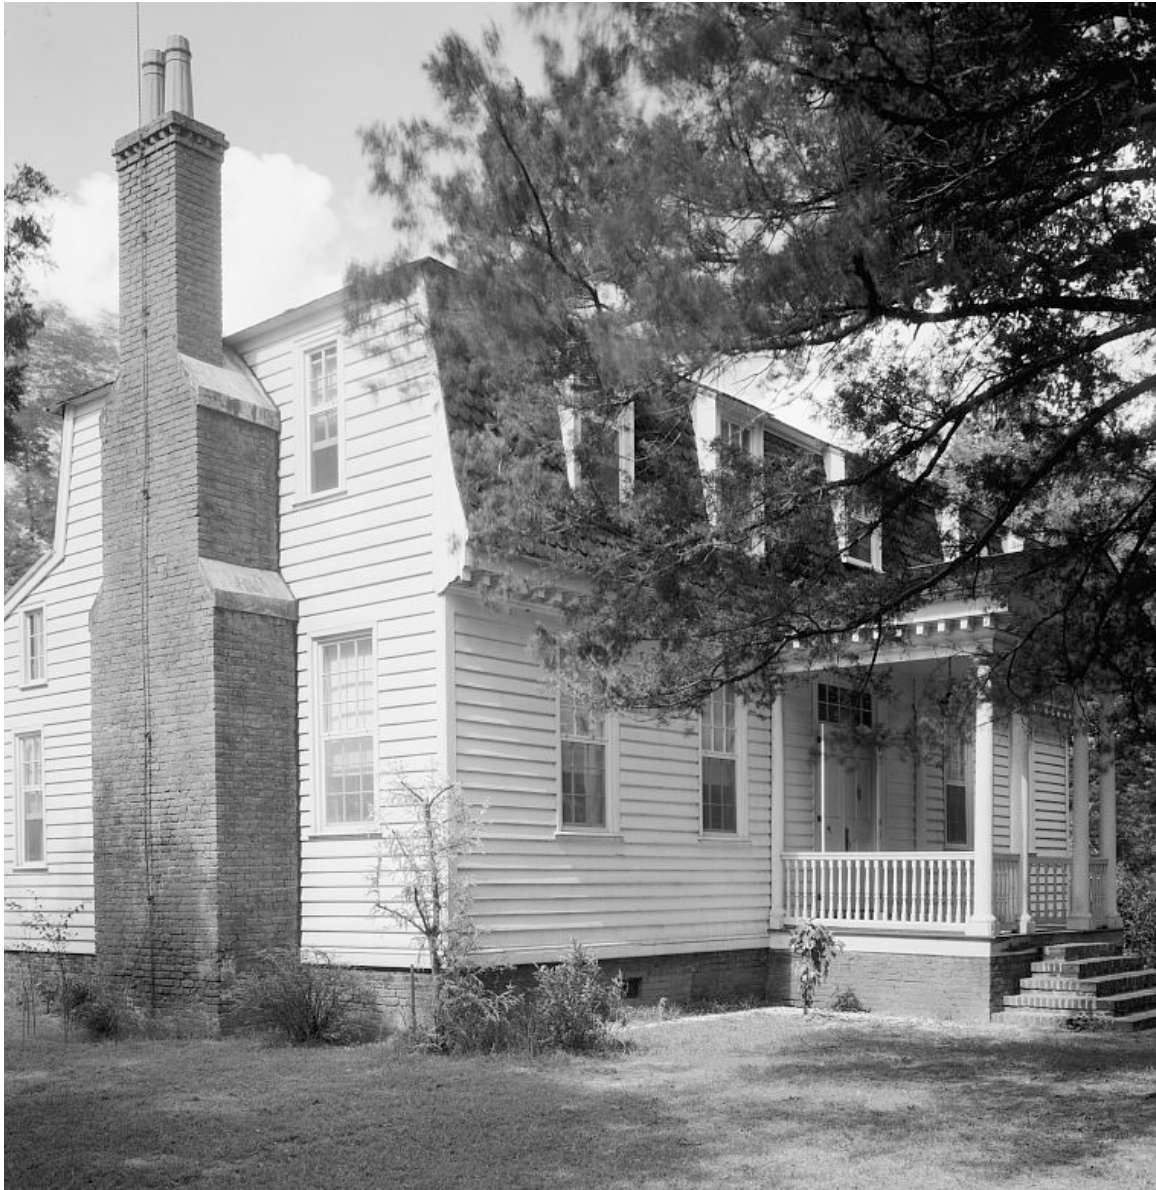
Figure 24. Belvidere, Perquimans County, North Carolina.
Gable-end window above shed ceiling.
Frances Benjamin Johnston, Library of Congress. (1936).

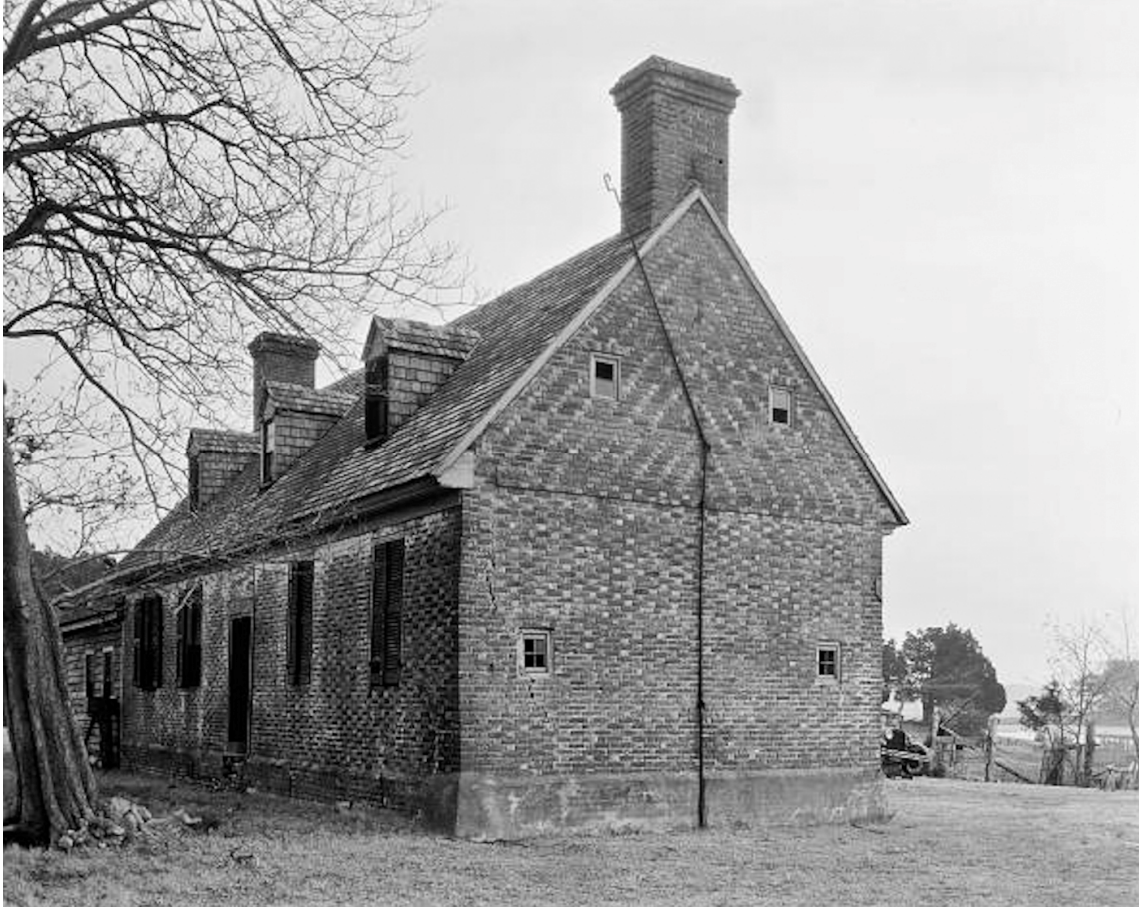
Figure 25. Keeling House. Virginia Beach, Virginia.
End windows lighting ground-floor closets.
HABS, Library of Congress. (1930).

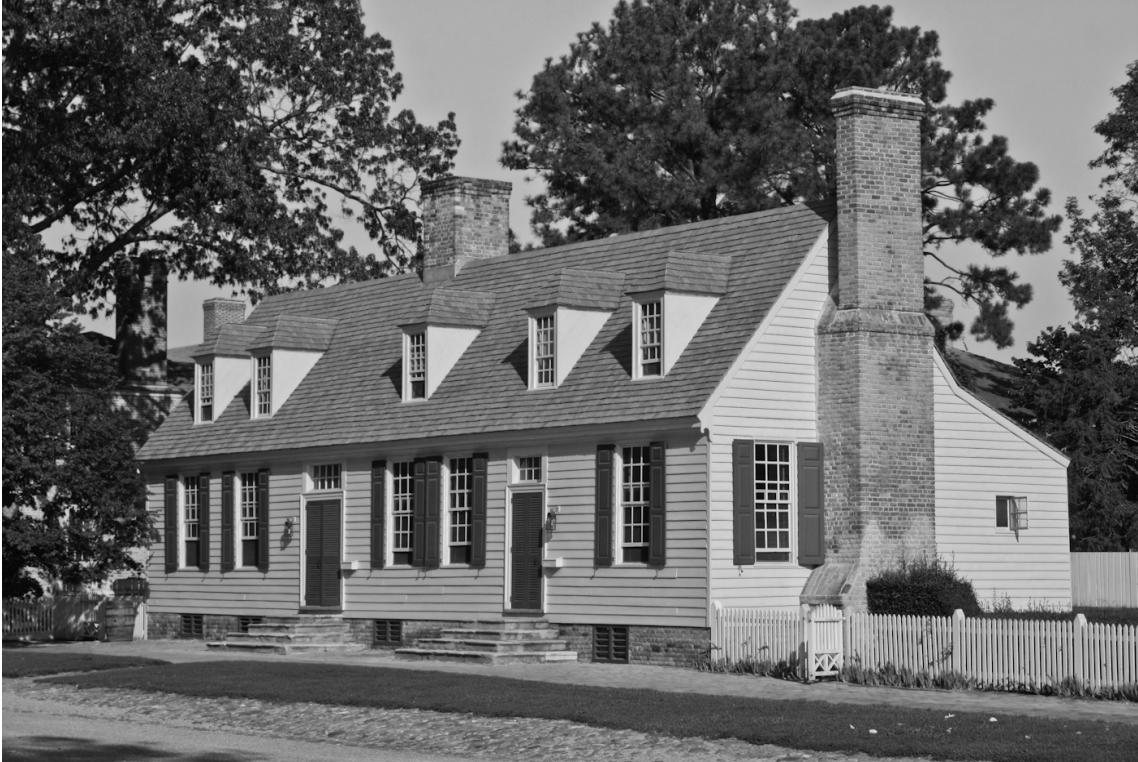
Figure 26. John Blair House. Williamsburg, Virginia.
Period I house between chimneys. Note window arrangement.
Jennifer Glass. (2012).

A customary inequality in the sizes of the front rooms often led to unequal numbers of windows on either side of the front doorway (Figure 26). This was especially common in houses built before the regularizing impulse of the classical

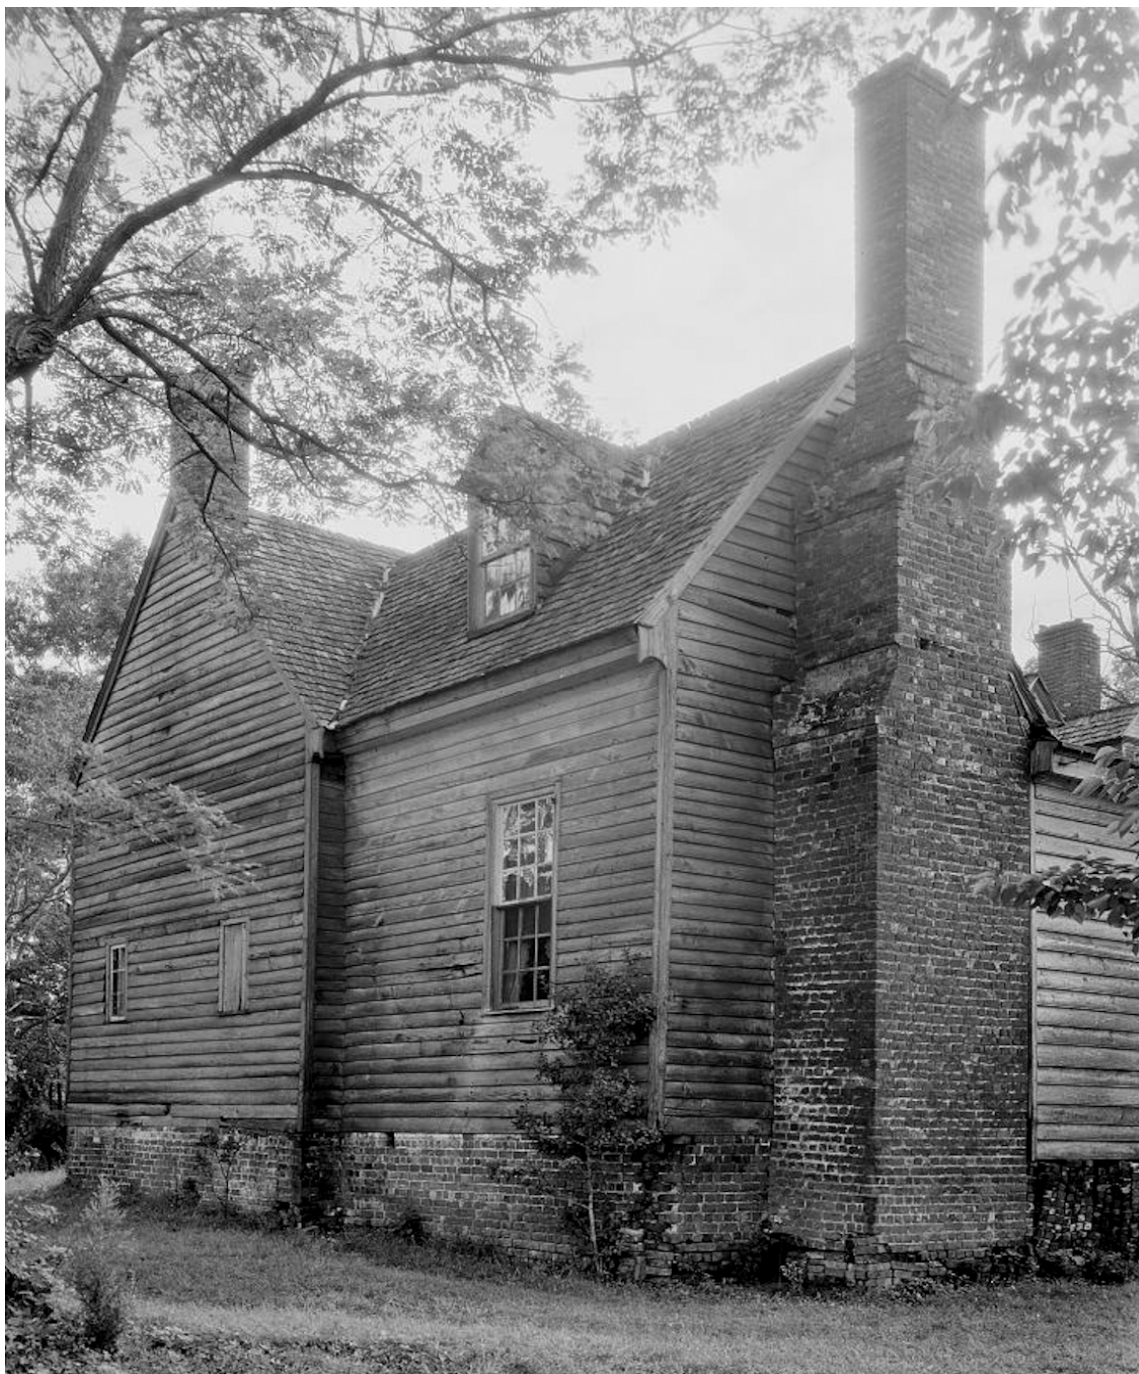
Figure 27. Kittiewan. Charles City County, Virginia.
Gable end of rear ell.
HABS, Library of Congress. (1930).

Granted the number and location of windows proposed above, where were the windows of the Back Room--the space behind the Parlor? In the case of a gable-ended wing, the fireplace wall seems an unlikely location for windows at this early date. At Kittiewan, the gable-ended rear ell has no windows on the fireplace wall (Figure 27).

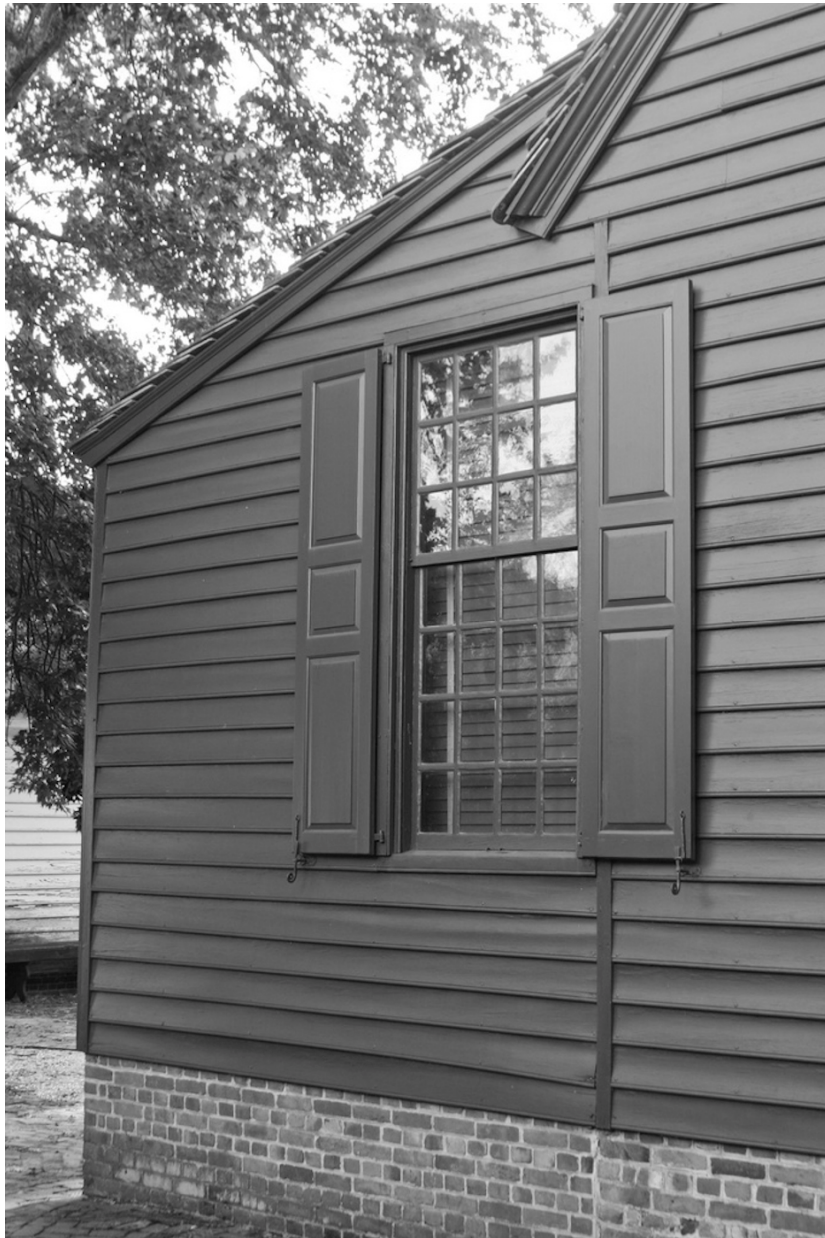
Figure 28. Wetherburn's Tavern. Williamsburg, Virginia.
Window in end of rear shed.
Jennifer Glass. (2012).

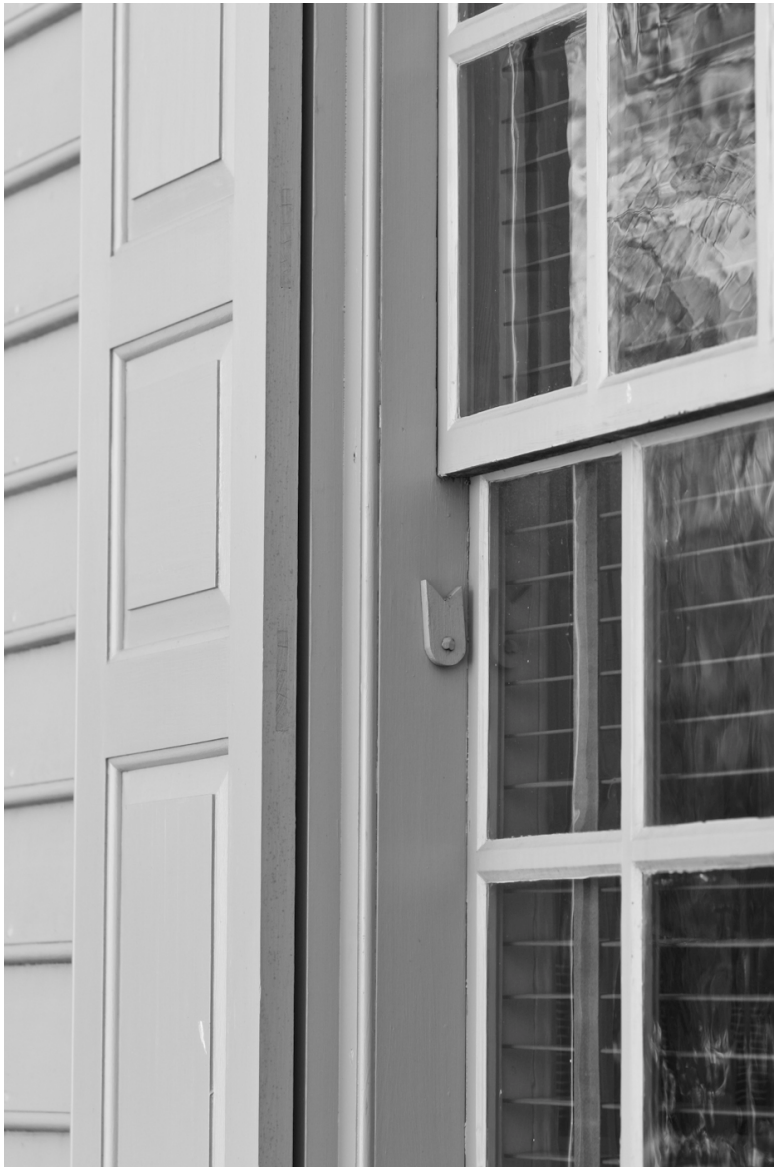
Figure 29. Charlton's Coffeehouse. Williamsburg, Virginia.
Pivoting cleat to hold lower sash open.
Jennifer Glass. (2012).

One of the earliest surviving sashes in Virginia is a single specimen at the Mason House, in Accomac County, Virginia, a brick dwelling dated by dendrochronology to 1729. Significantly, the sash was never counter-weighted. Here, as in most cases, the upper sash was fixed in place. In lieu of sash weights, a pivoting cleat was sometimes attached to the inner cheek of the window frame serving to hold the operable lower sash open. In Williamsburg, one of these cleats was among re-used elements recovered from the Armistead House, among the many elements salvaged from Walthoe's 1749 Storehouse. Identical cleats were subsequently incorporated into the reconstructed building (Figure 29). An early example of a similar fitting survived until recently at the Timson House, also in Williamsburg, but unfortunately this example has disappeared—evidently removed by some vandal.

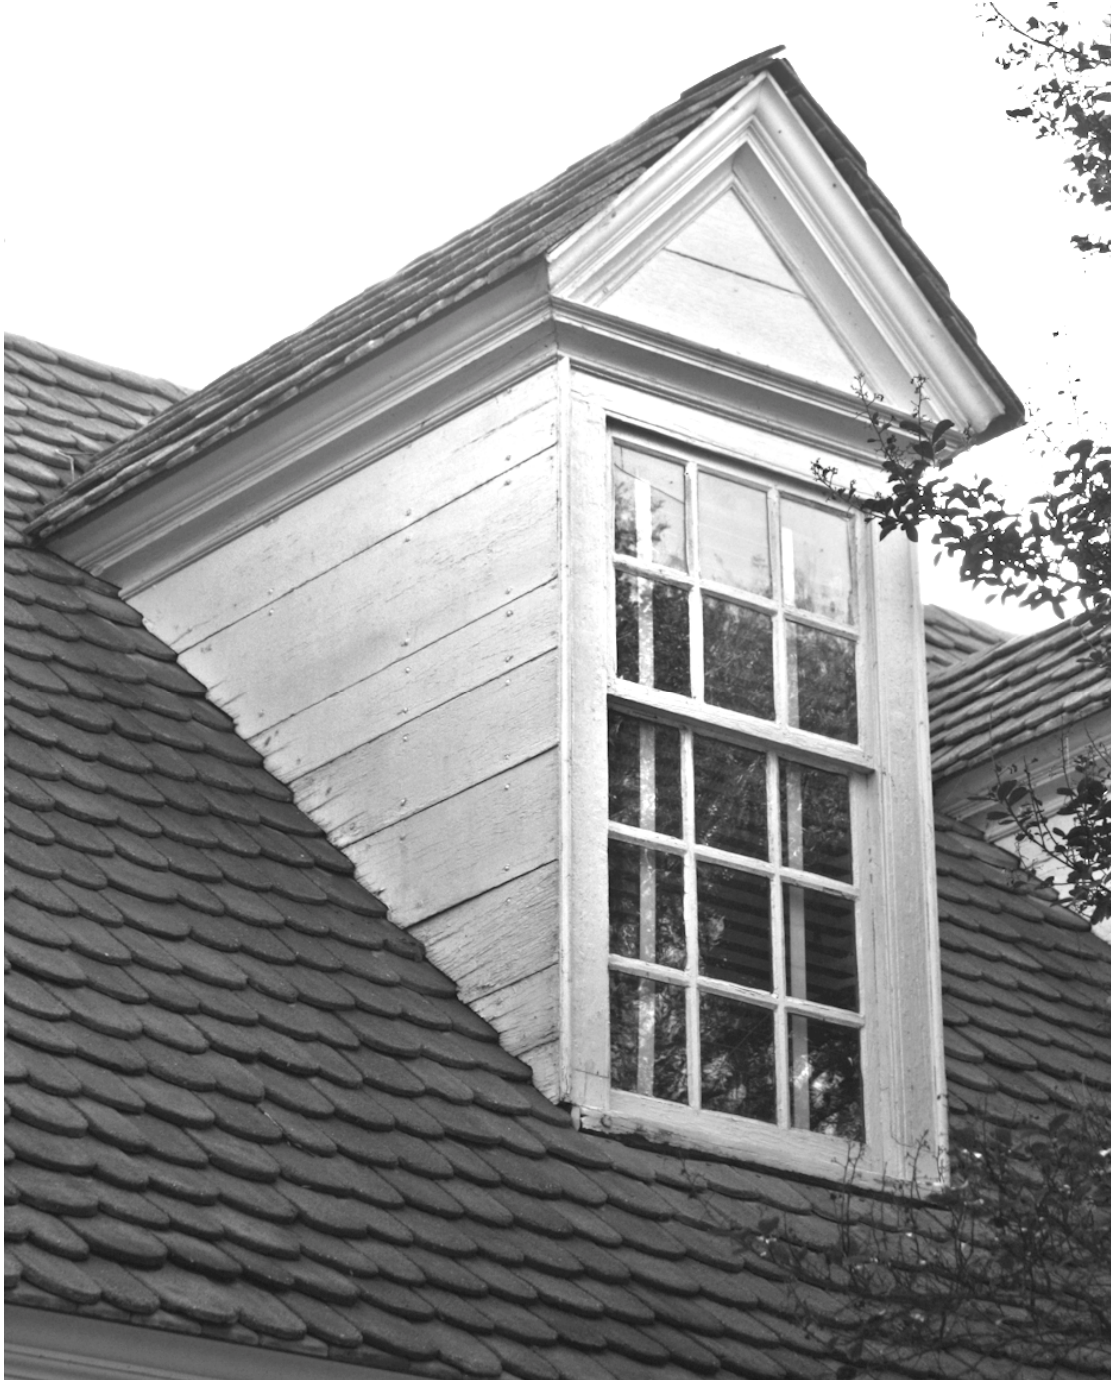
Figure 30. Everard House. Williamsburg, Virginia.
Horizontal sheathing on dormer cheeks.
Jennifer Glass. (2012).

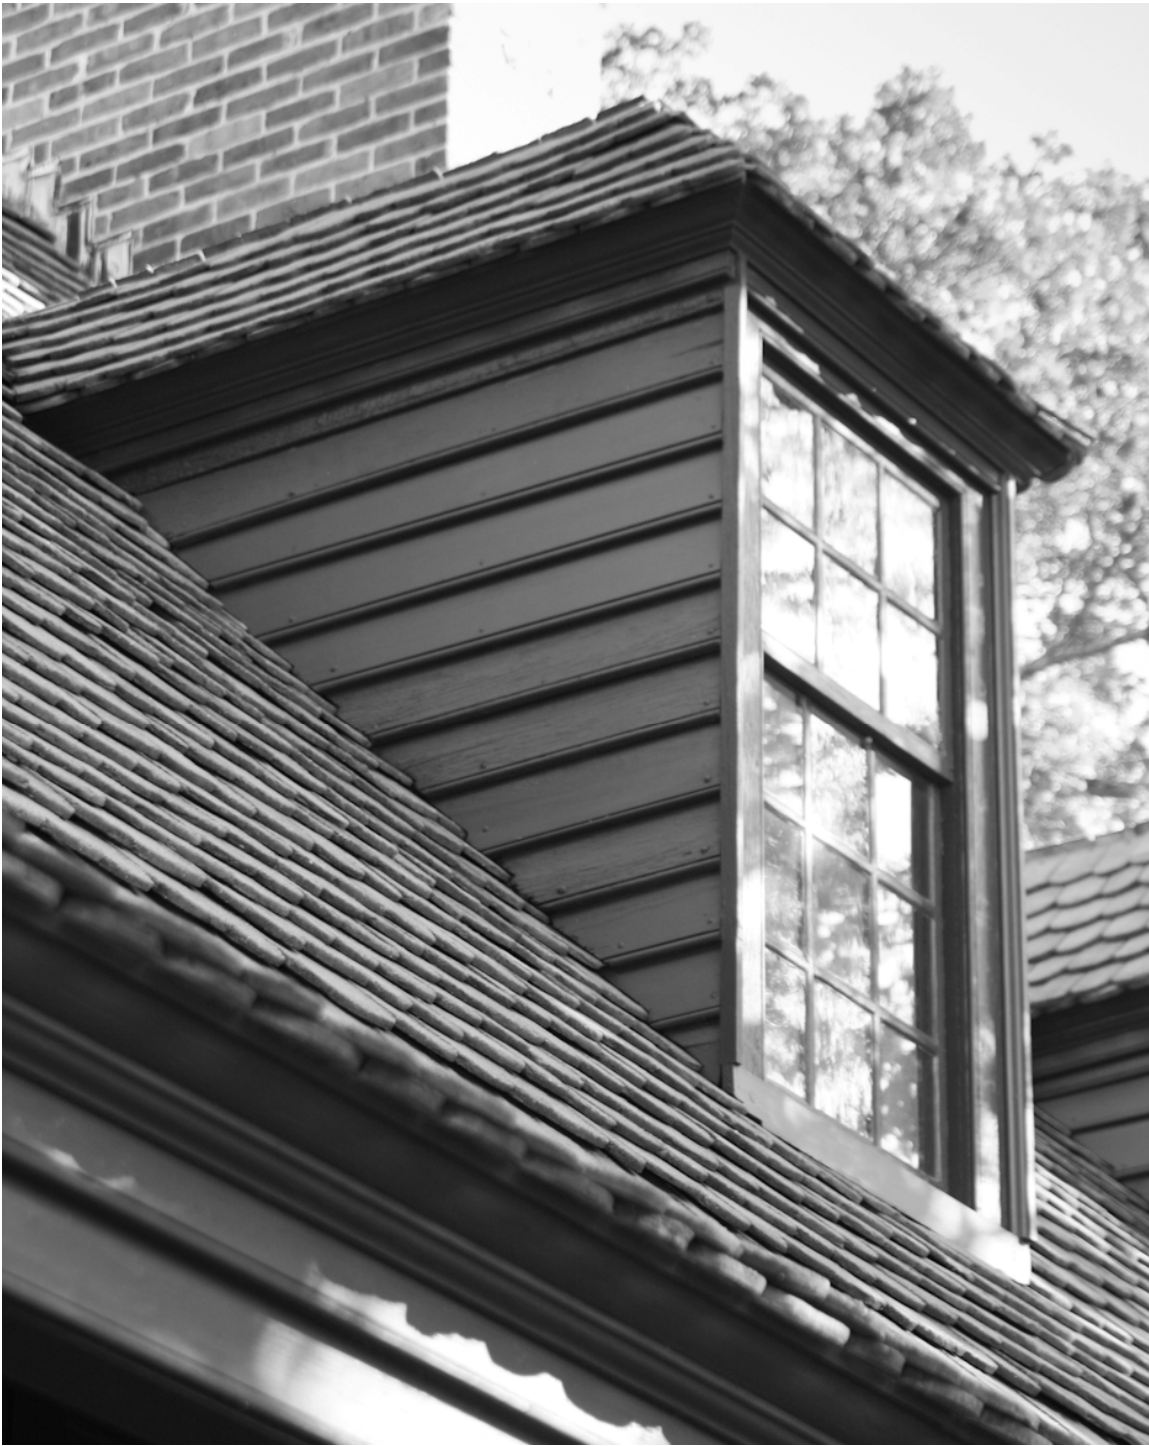
Figure 31. Wetherburn's Tavern. Williamsburg, Virginia.
Beaded weatherboards on dormer cheeks.
Jennifer Glass. (2012).
