The Washington House at Ferry Farm: An Architectural Study

Mesick Cohen Wilson Baker, Architects

**March 14, 2012
(Updated July, 2015)**

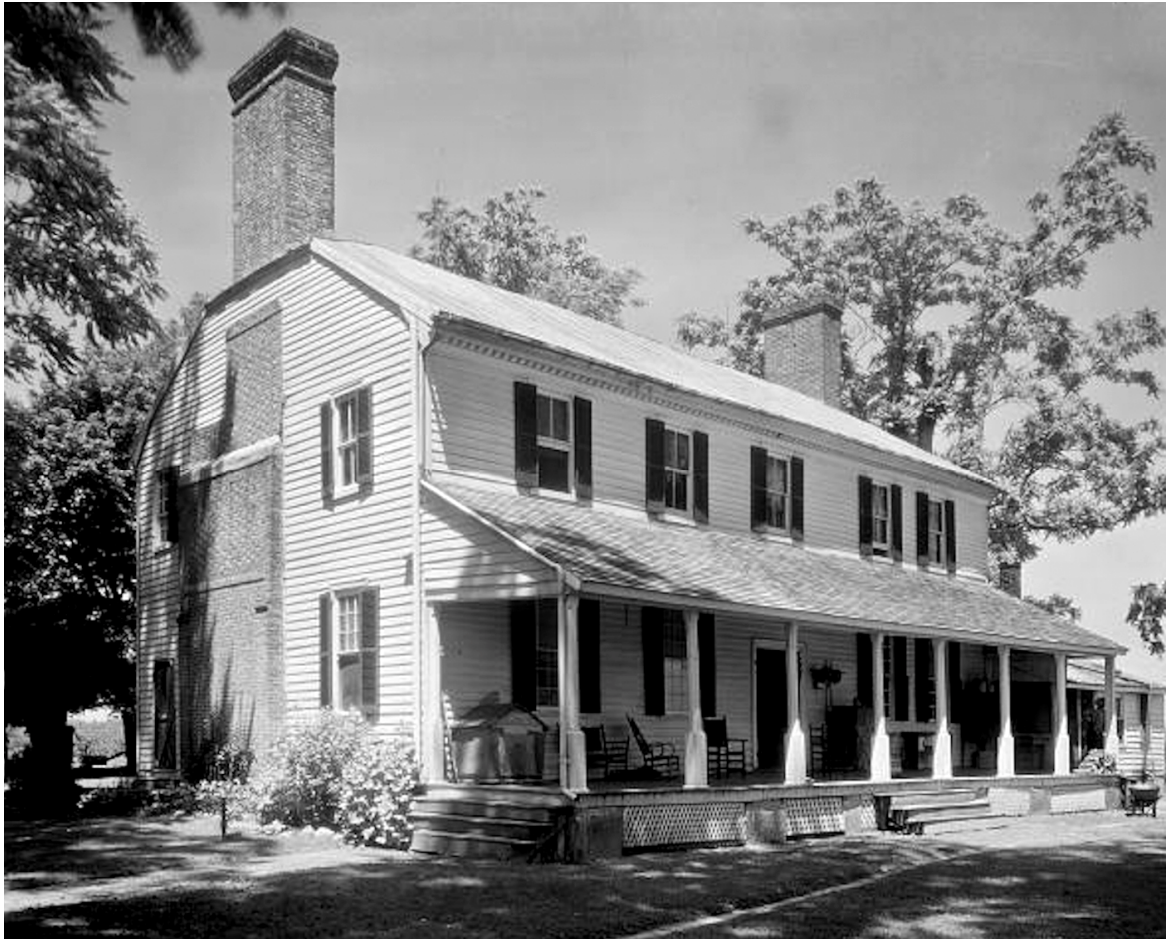
Figure 32. Marmion. King George County, Virginia.
Early porch with rafters exposed under shingles.
Frances Benjamin Johnston, Library of Congress. (1935).

Based on several early examples associated with genteel families, we believe that the underside of the shingles and framing would have shown on the porch interior. As noted earlier, covered rear porches at the Everard House and at Kittiewan were framed against one or both rear wings. (At Kittiewan, archaeologists reportedly have seen racking for the foundation of a second wing, suggesting an arrangement similar to the Everard house.) In both cases, it is clear that the underside of the porch roof bore no finish. At Marmion, in nearby King George County, Virginia, an early, full-length shed porch still stands on the back side of the house (Figure 32). This porch has no ceiling--the shingles, laths, and rafters are all visible from below, and none has ever been painted. Finally, the Williamsburg House of St. George Tucker offers a later instance of exposed framing and shingles under a roof. In this case, the plaster walls of the second-floor passage extended up into the attic and died against the underside of shingles of the main roof, leaving the unpainted shingles, laths, and framing wholly visible from the bottom of the stair, several flights down. On the basis of these examples, we suppose that the underside of the rear porch could have remained exposed—and also that the shingles of the main roof could have been encapsulated by the added porch.

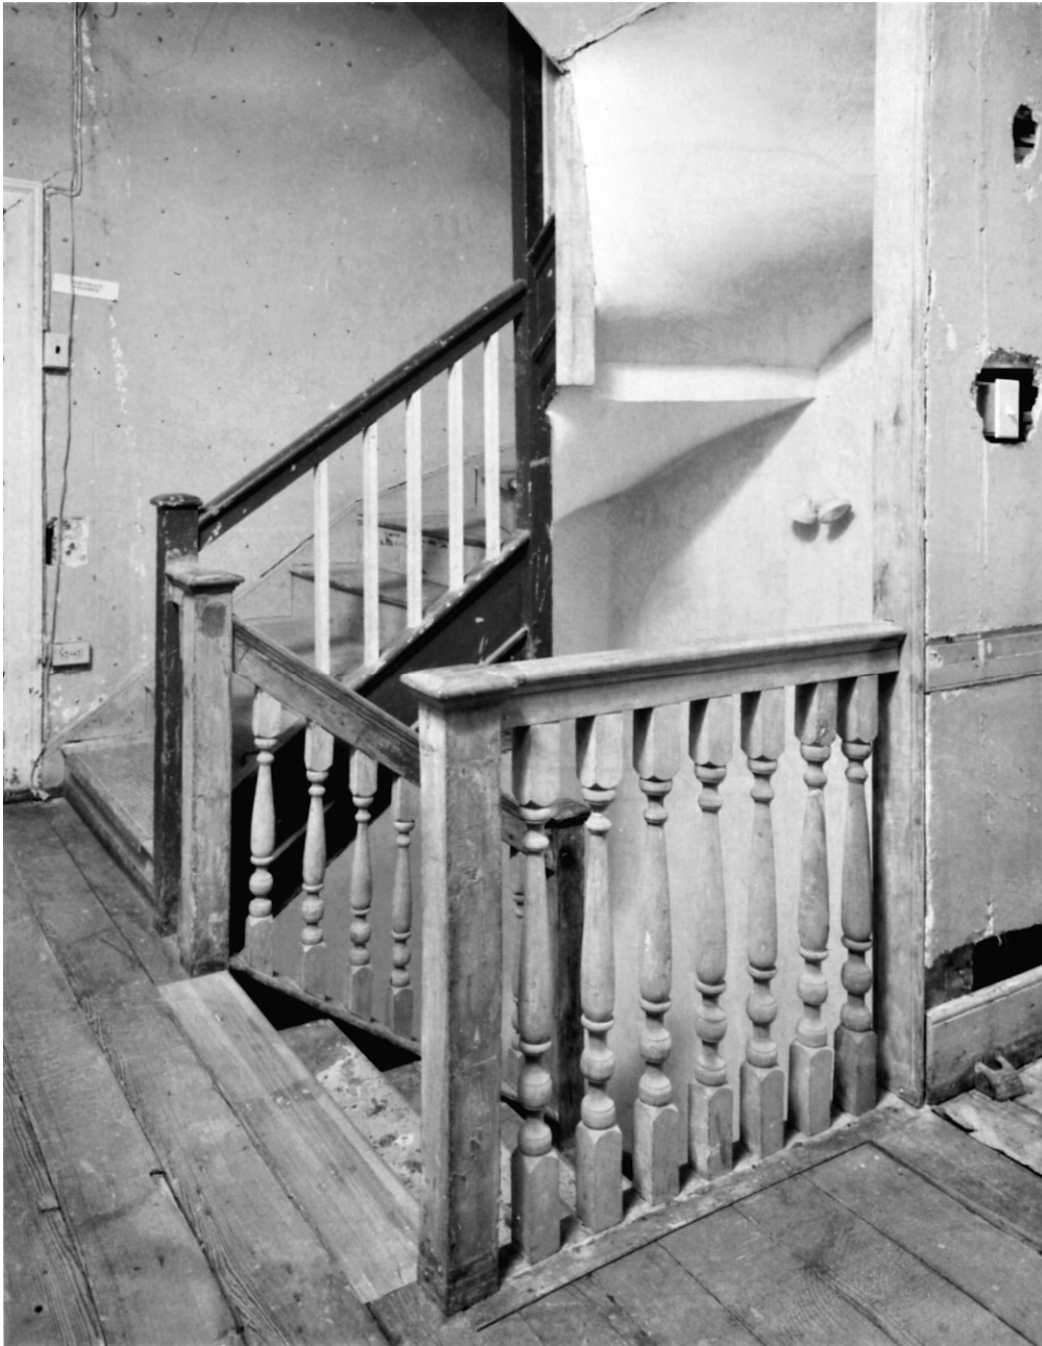
Figure 36. Charles Carroll House. Annapolis, Maryland.
Closed-string stair, with cap details for raking and horizontal railings.
Willie Graham. (1997).

Chiswell-Bucktrout House, in Williamsburg—all Virginia examples. In Annapolis Maryland, the Charles Carroll House also has an early closed-string stair, dating from the 1740s (Figure 36).

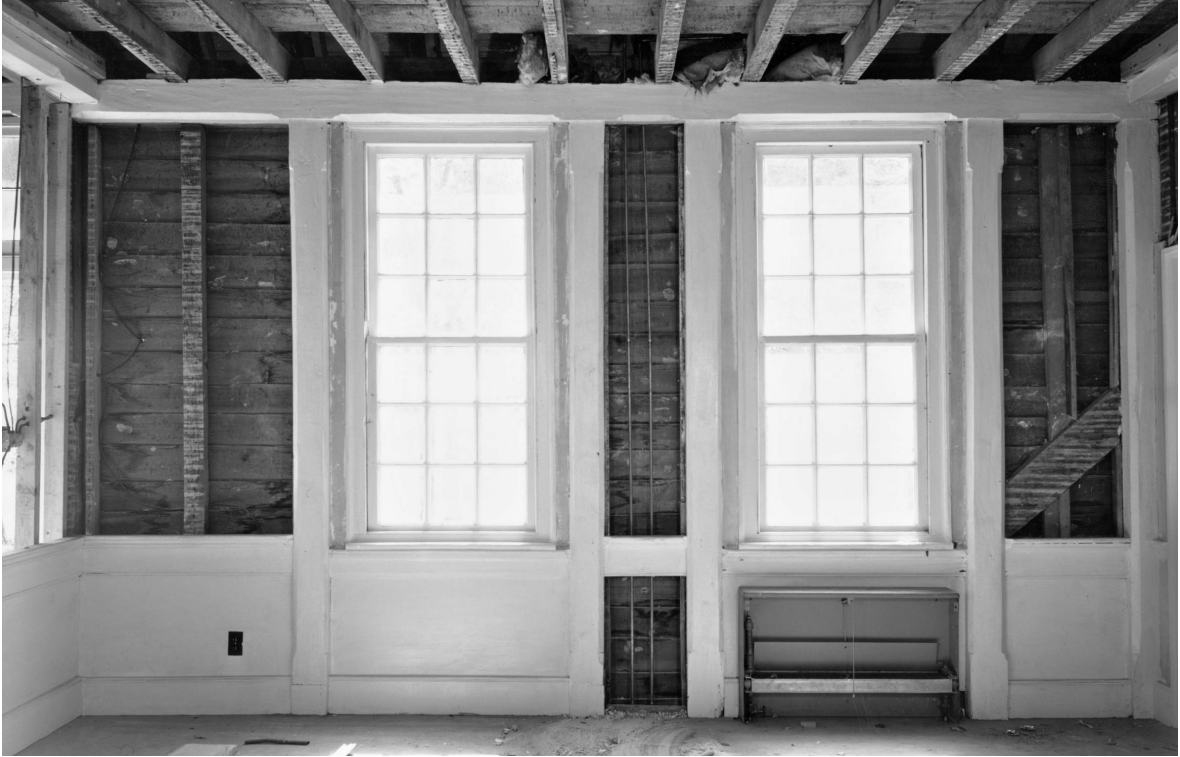
Figure 38. Belle Air. Charles City County, Virginia. Exposed Framing.
Willie Graham.

For framed structures the universe of possibilities is adequately defined by several survivors, which together show the varying extent to which the frame could be exposed. The early dwelling recently discovered in Edenton epitomizes the “all visible” approach, having once showed *everything*—even the perimeter studs. (Until the early decades of the 19th century, the interior finish featured faux wainscoting painted onto the backs of the weatherboards). At Pear Valley, plaster originally hid the studs but left everything else exposed. At Belle Air, in Charles City County, date unknown, both the joists and the studs were concealed, leaving only the major posts, the plates, and the end girts visible (Figure 38).

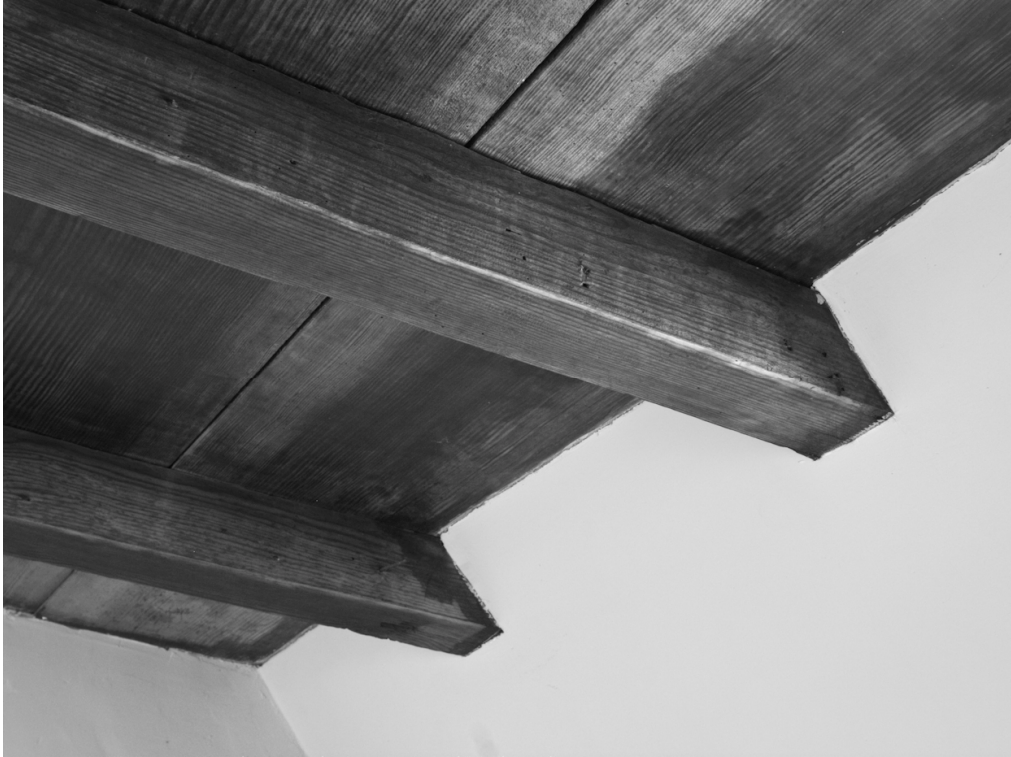
Figure 39. Lynnhaven House – Virginia Beach, Virginia.
Exposed collar ties, eased edges.
Jennifer Glass. (2012).

In a number of single-story houses pre-dating 1750, collar ties carrying the second-floor ceiling were originally exposed to view by laying a plank floor over them, rather than applying plaster to the undersides. Because this practice disappeared after mid-century, exposed collars are a characteristic aspect of the second-quarter “look” displayed by early Chesapeake interiors (Figure 39). The lower edges are typically treated in one of three ways—eased, beaded, or molded with a cyma. The molded edges are visually arresting, and more importantly, they make the point that exposed framing was regarded as a part of the interior adornment. Because the cyma had a characteristic “kick” in the early decades of the 18th century, this molding offers one more way to suggest that the house is earlier than the typical dwelling visitors are likely to have seen.

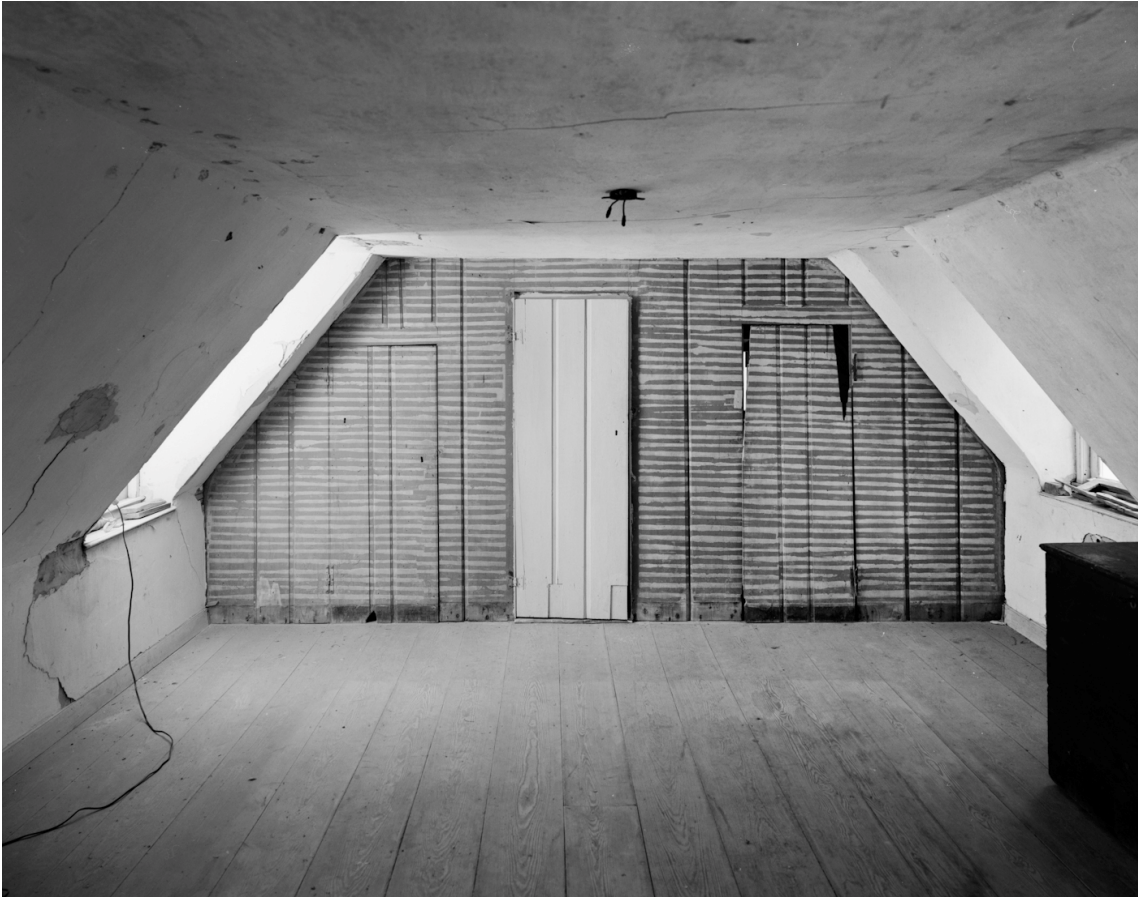
Figure 40. Bound's Lott, Wicomico County, Maryland.
Plank wall, upper floor.
HABS, Library of Congress. (1976).

The prevalence of plaster bearing evidence of lathing suggests that most of the walls were framed. However, several early Chesapeake houses had plank partitions on the upper floors. Bound's Lott, a second-quarter dwelling in Wicomico County, Maryland (Figure 40), is an example. The method of constructing these partitions was for planks to be molded, alternately, as stiles and panels, each joining the one next to it in the manner of raised-panel joinery. Bloomfield, in Talbot County, Maryland, and the Powel House, in Somerset County, Maryland, exhibited doors made in the same manner.⁴⁸ A room from the latter house is now to be seen at the Museum of Early Southern Decorative Art.

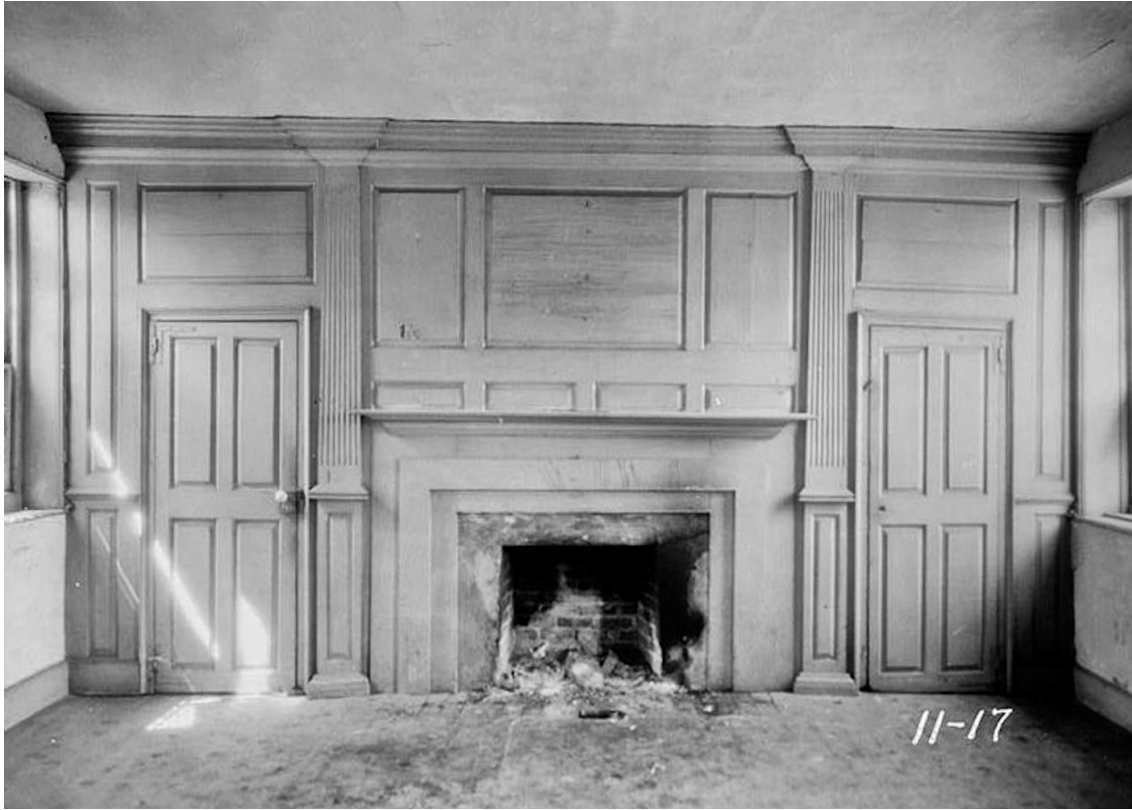
Figure 41. Keeling House. Hall Wainscot. *HABS, Library of Congress.* (1934).

The last element—the "Cornish"—is demonstrably absent in at least some rooms at Ferry Farm, which seems to rule out full-height paneling in those spaces. However, it is possible that some rooms and not others had cornices, or that a particular cornice adorned only one wall or only a portion of one wall in a given room. An example is the Keeling House, in Virginia Beach, where the fireplace wall is fully paneled, with a cornice, while the other walls are entirely plastered, without so much as a chair board to break the plaster between the ceiling the baseboard. The crown molding and the surbase on the wainscot run clear to the adjoining walls—without evidence of miters or coping—strongly suggesting that the naked treatment of those adjacent walls is an early condition. (Figure 41).
