SAND POINT/MUNISING USCG LIFE SAVING STATION
PICTURED ROCKS NATIONAL LAKESHORE
Cultural Landscape Report and Environmental Assessment

February 20, 2017
Public Review Draft

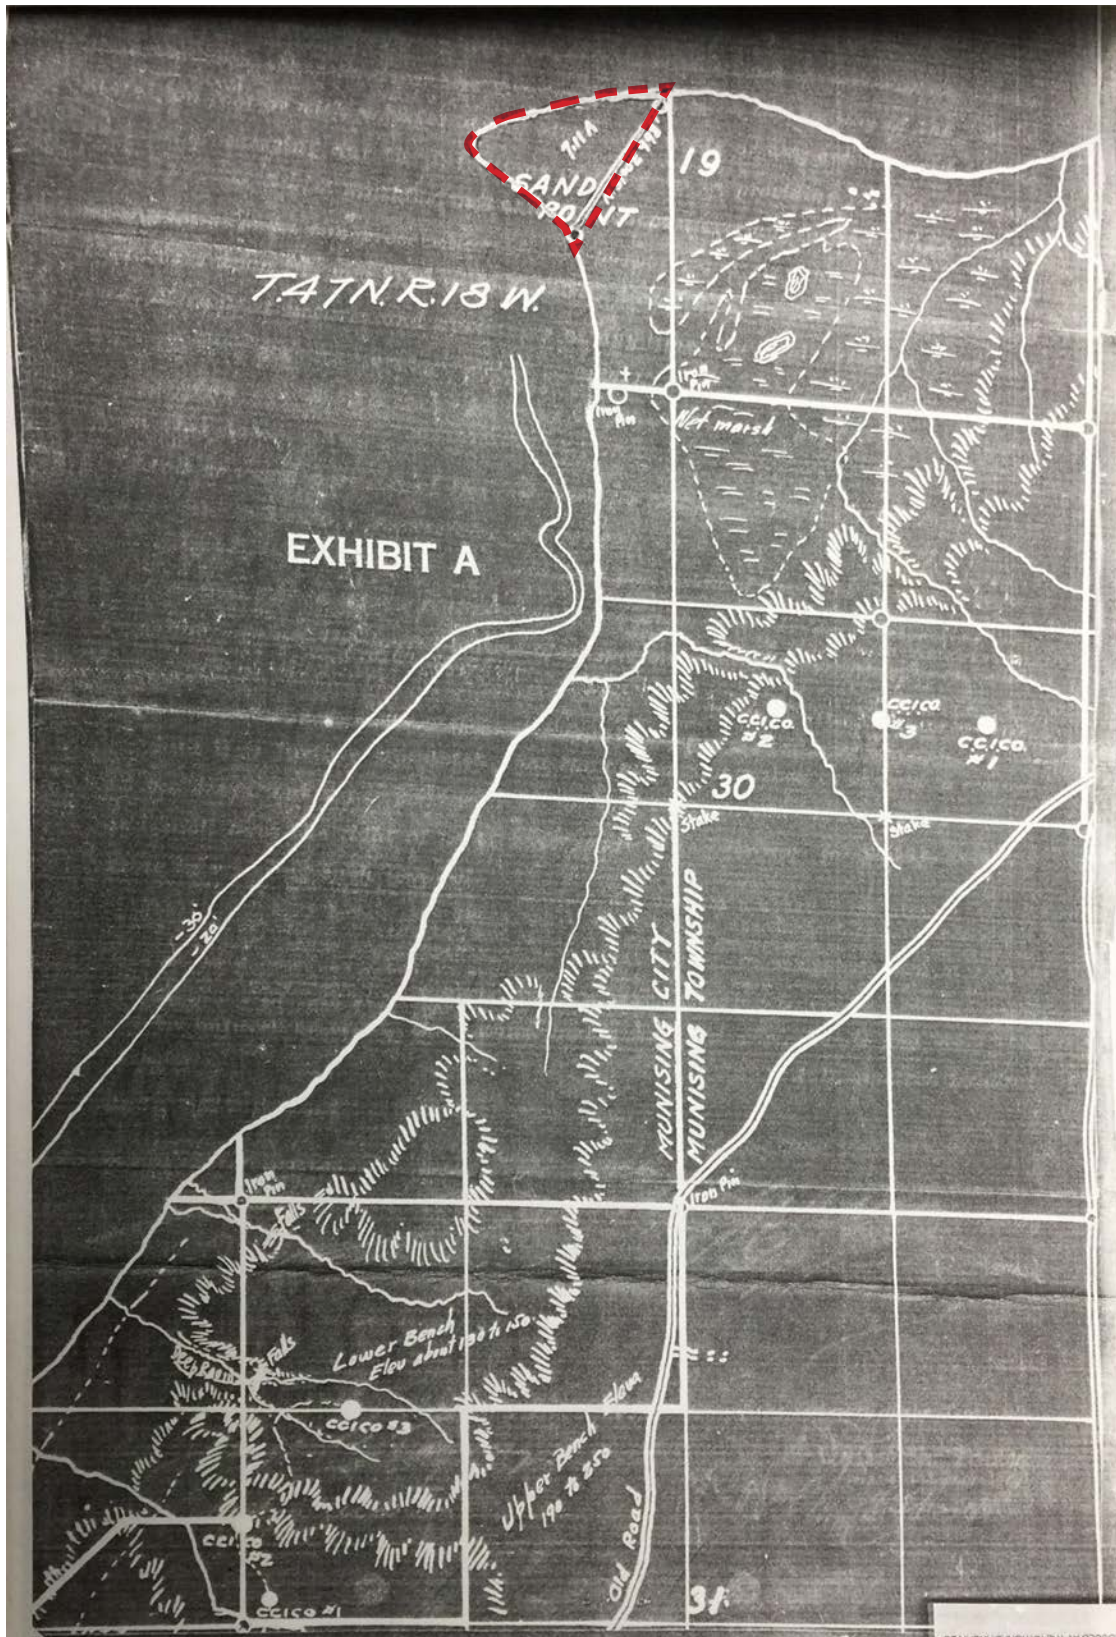
Figure 2-5. Map illustrating portion of land set aside for the U.S. Coast Guard Station, 1932. The 7.11 acre plot encompassed the tip of Sand Point. (source: PIRO Archives)

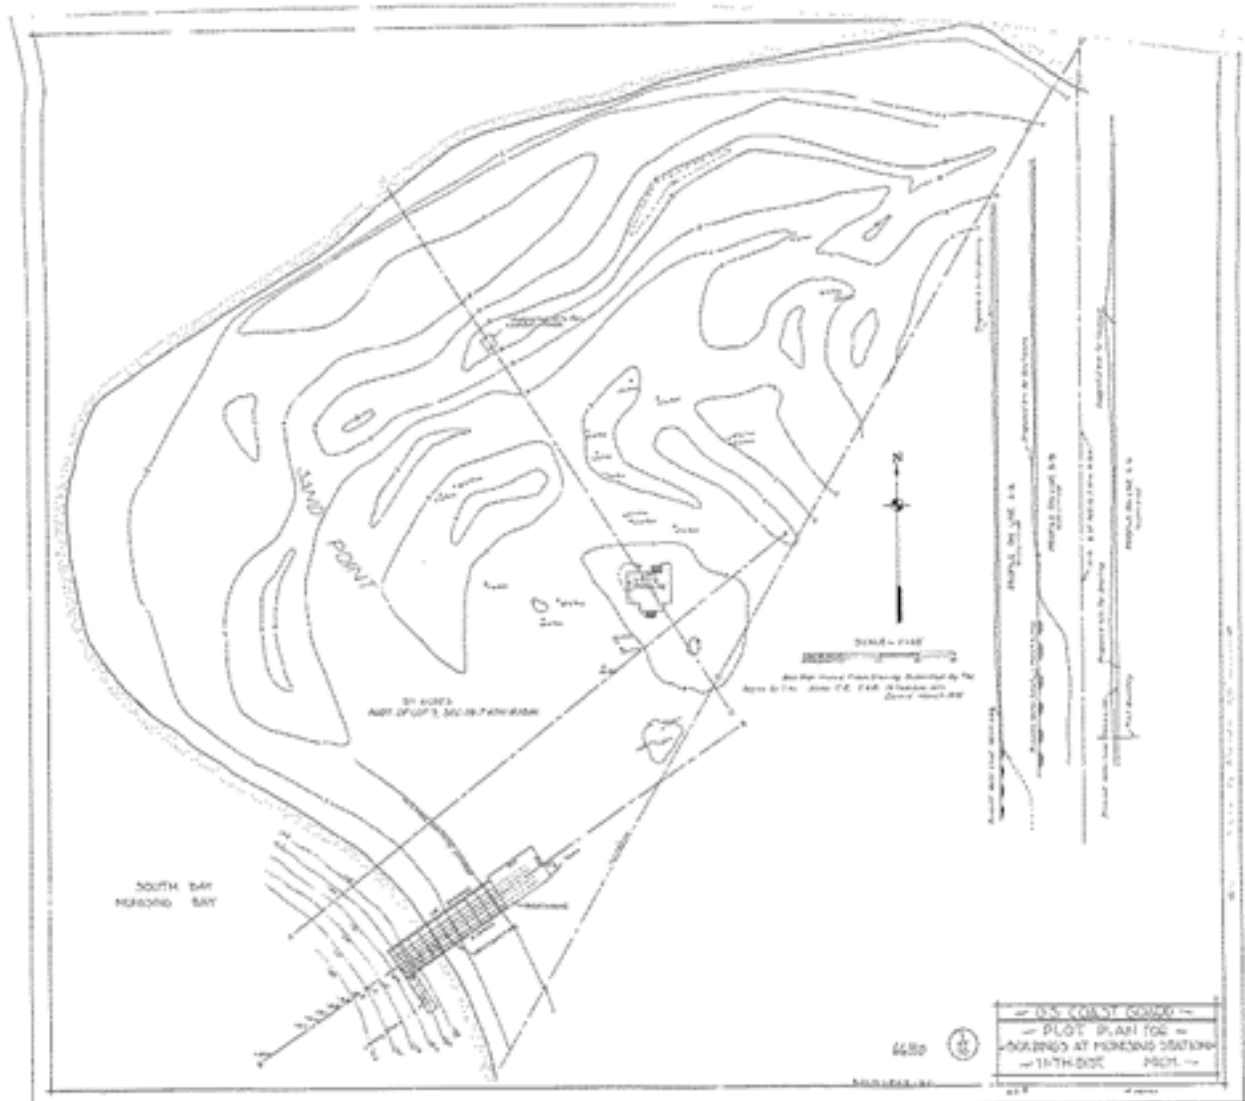
Figure 2-6. Plot plan of the new station, 1932. (source: PIRO Archives)

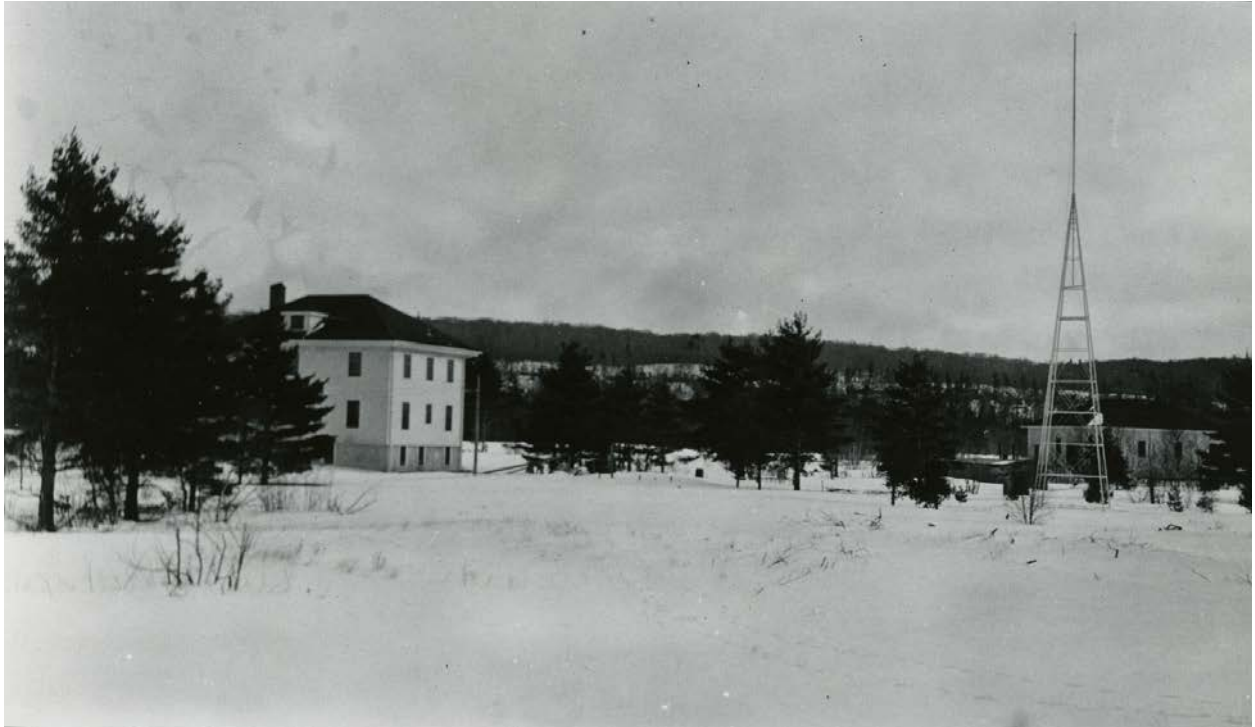
Figure 2-7. Munising Life Saving Station (HS-01) and Communication Tower, 1933. (source: Keweenaw NHP, Lake Superior Collection Management Center)

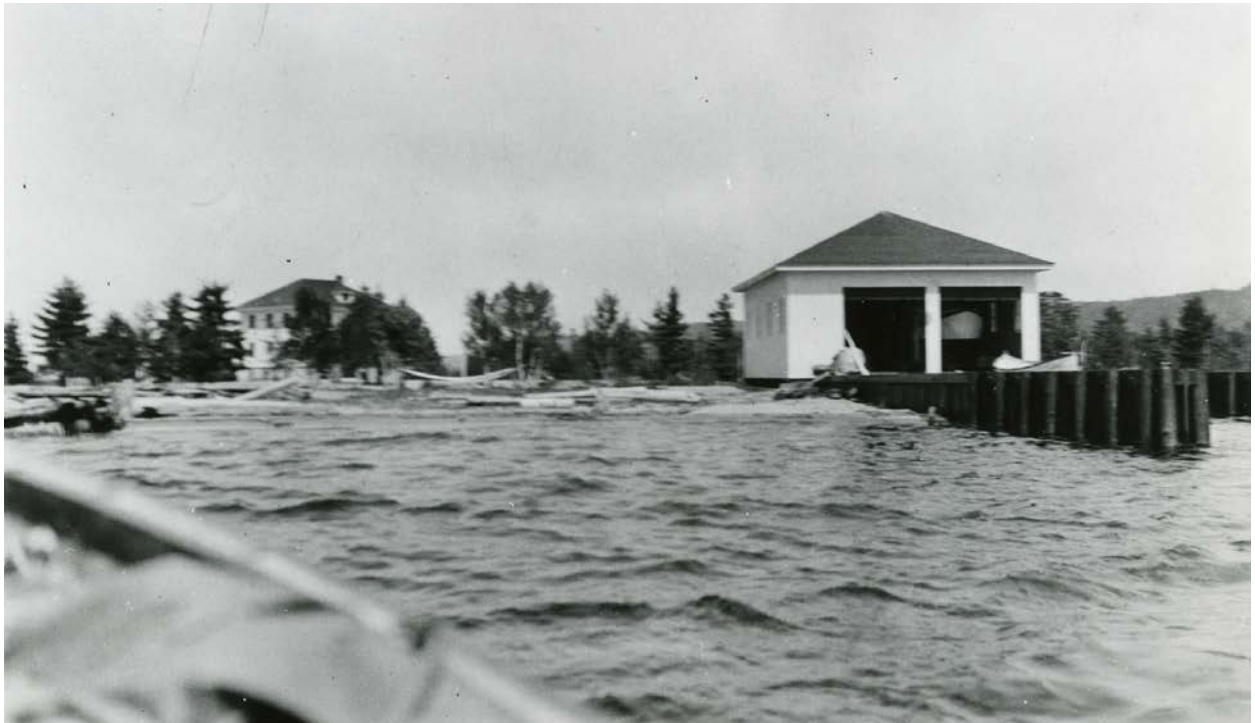
Figure 2-8. Munising Life Saving Station (HS-01) and Boathouse and Launchway (HS-08), 1933. (source: Keweenaw NHP, Lake Superior Collection Management Center)

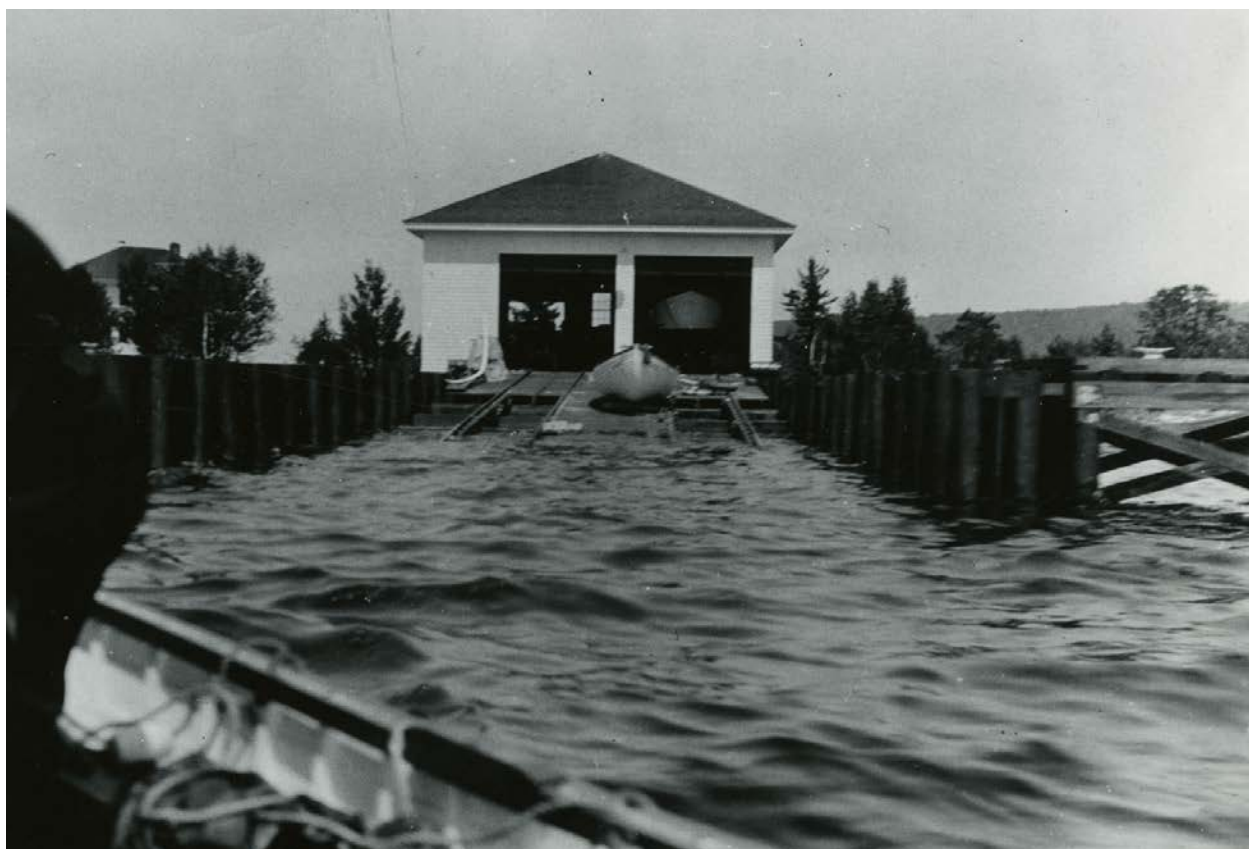
Figure 2-9. Boathouse and Launchway (HS-08), 1933. (source: Keweenaw NHP, Lake Superior Collection Management Center)

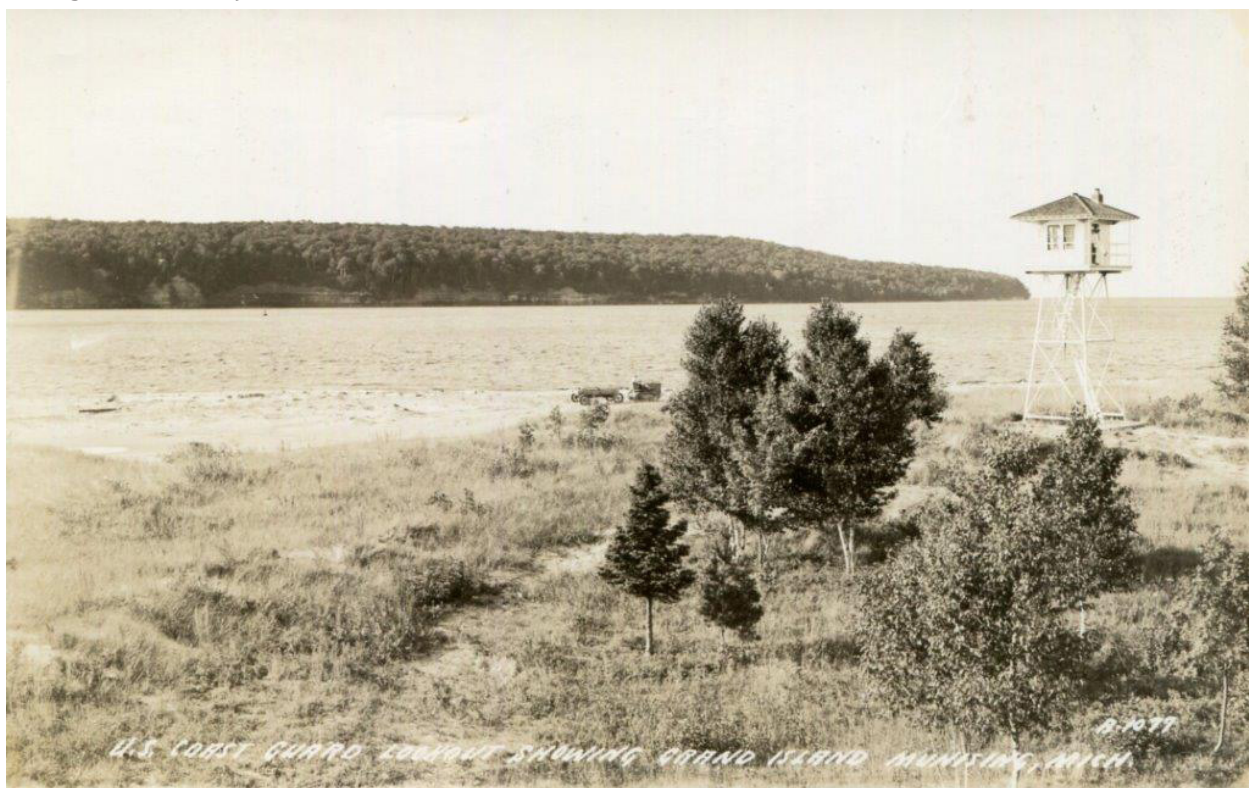
Figure 2-10. Station beach and lookout tower; undated but probably circa 1930s. (source: Alger County Historical Society)

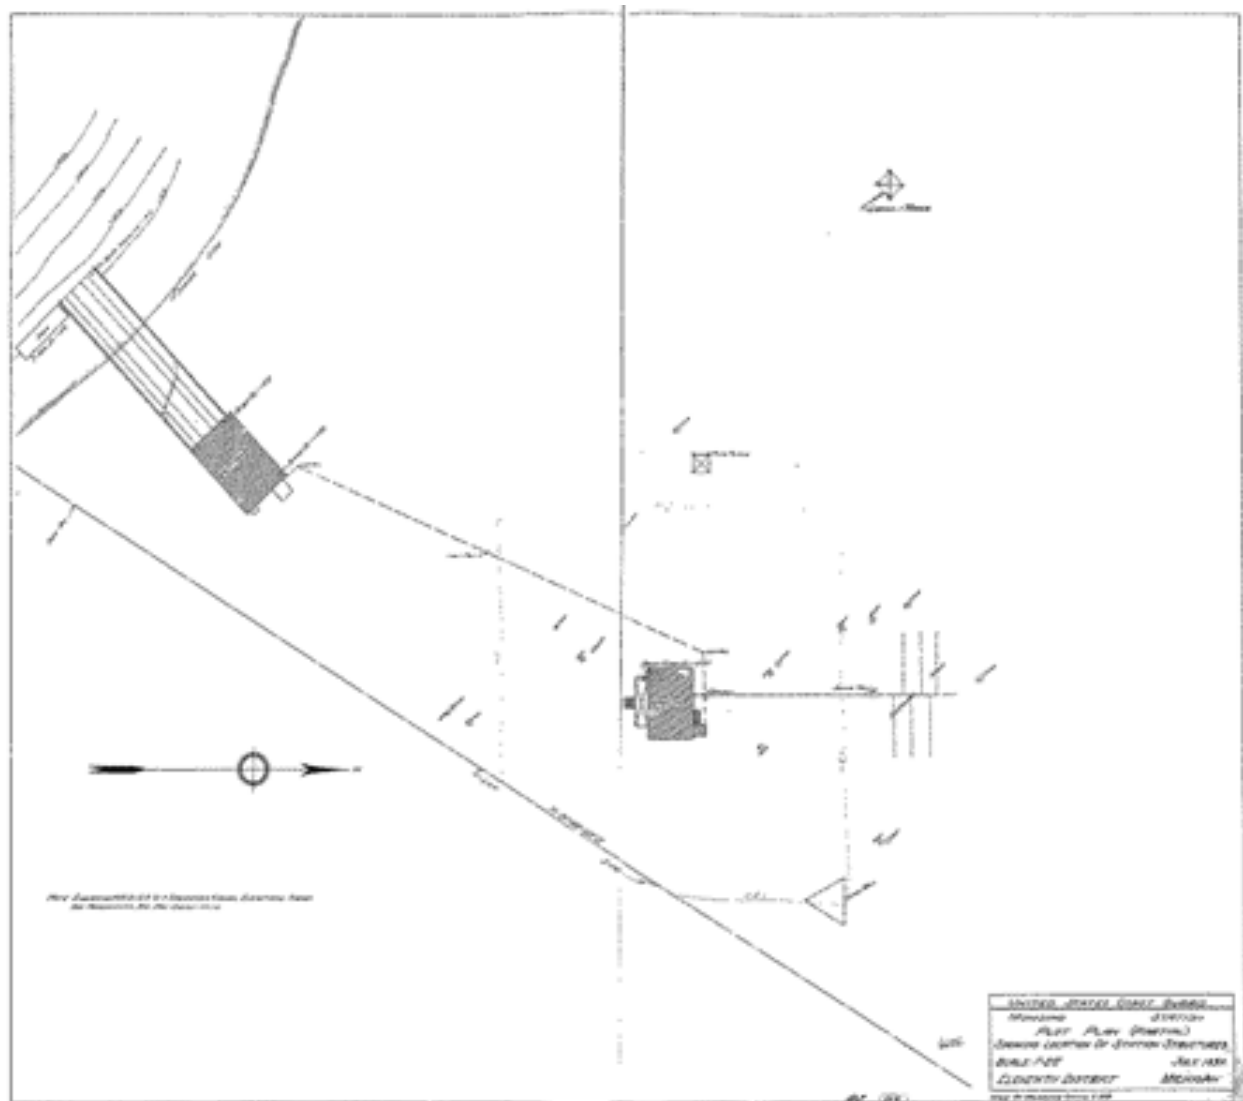
Figure 2-11. Sand Point/Munising USCG Life Saving Station, plot plan showing location of structures, 1933.
(source: PIRO Archives)

1 the placement of telephone and power lines.
 2 In addition to the buildings, there was a 55
 3 foot steel flag tower. There was no wireless
 4 station; distress calls were instead telephoned
 5 from Sault Ste. Marie, Grand Marais, or
 6 Marquette.^{2.39}

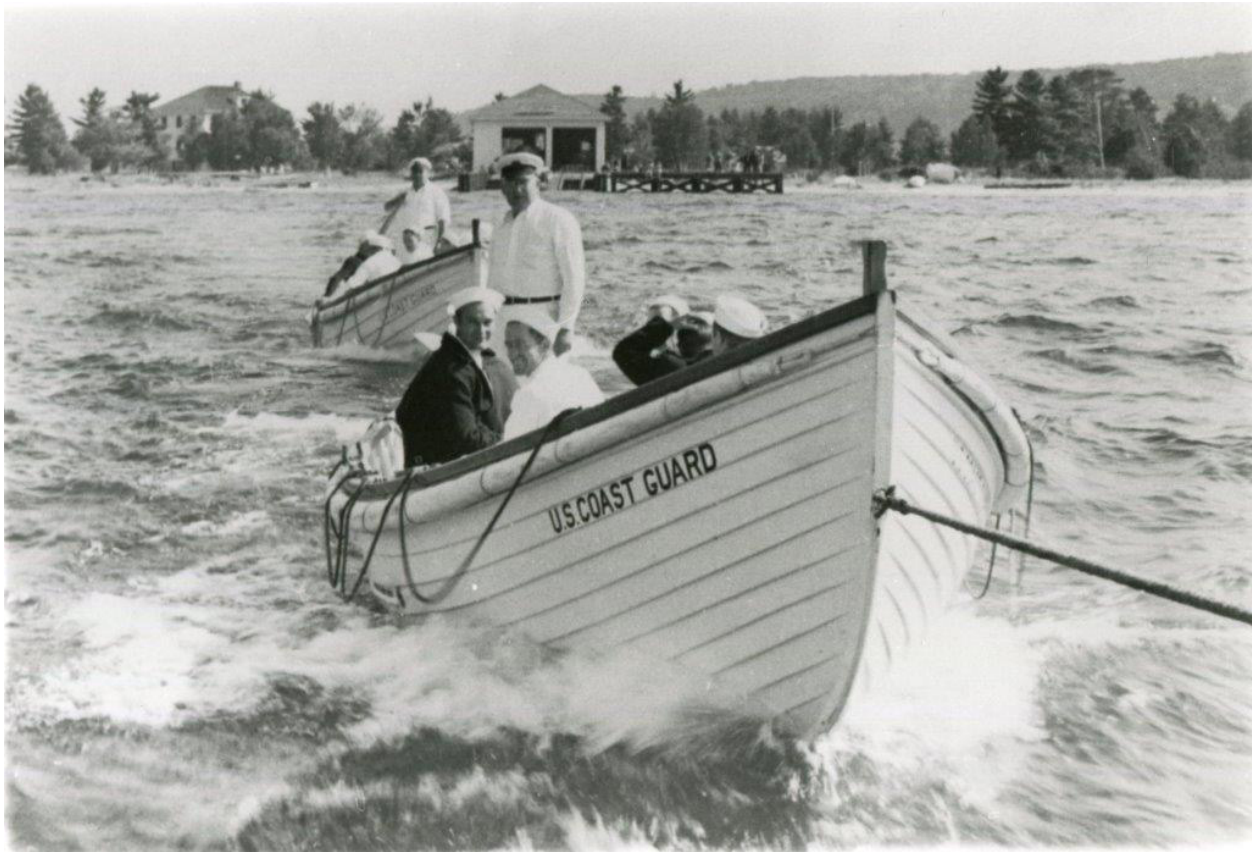
Figure 2-15. The design of the station relied upon easy water access and views to Lake Superior. In the 1930s, a view from the lake to the Boathouse, Launchway and dock, and the Life Saving Station was available. (source: PIRO Archives)

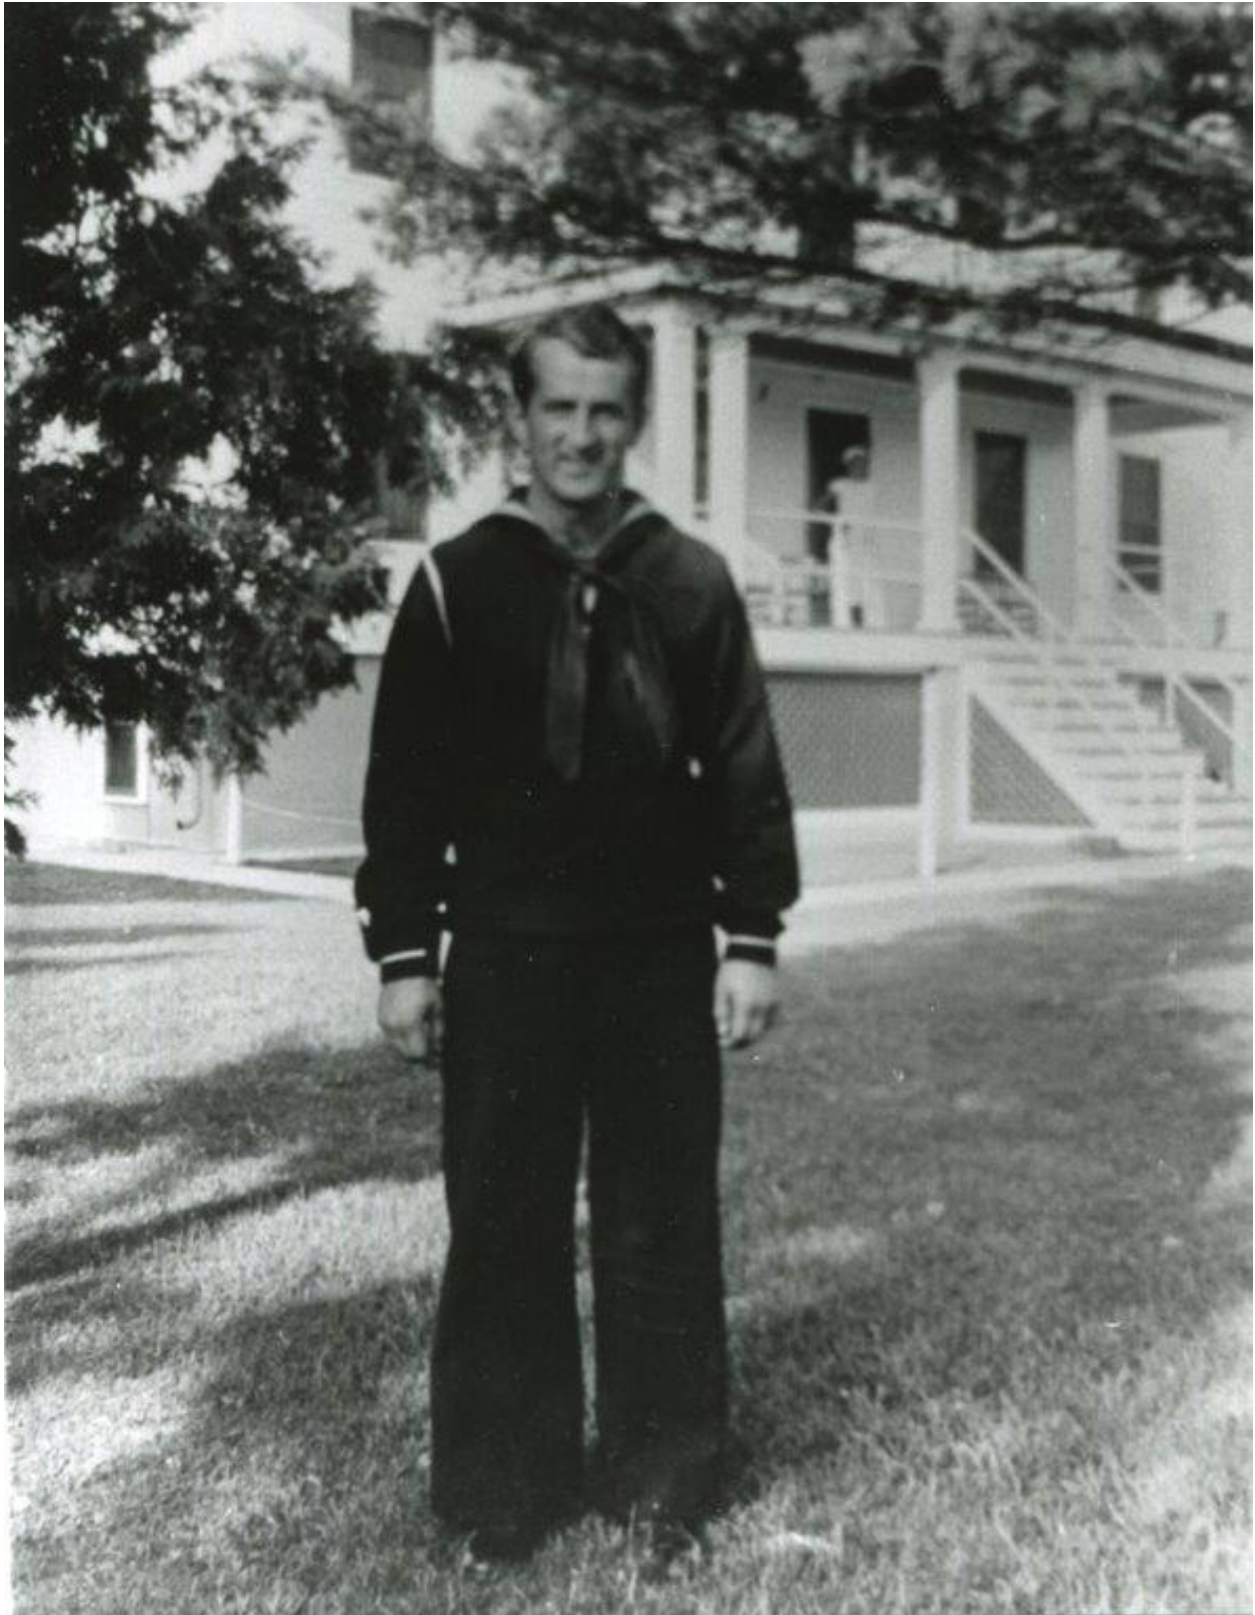
Figure 2-16. In 1934 the grounds of the Life Saving Station were complete, with a perimeter walk and lawn surrounding the building. (source: PIRO Archives)
