Tassi Ranch Site Management Plan

Environmental Assessment

PEPC-79750

November 2018

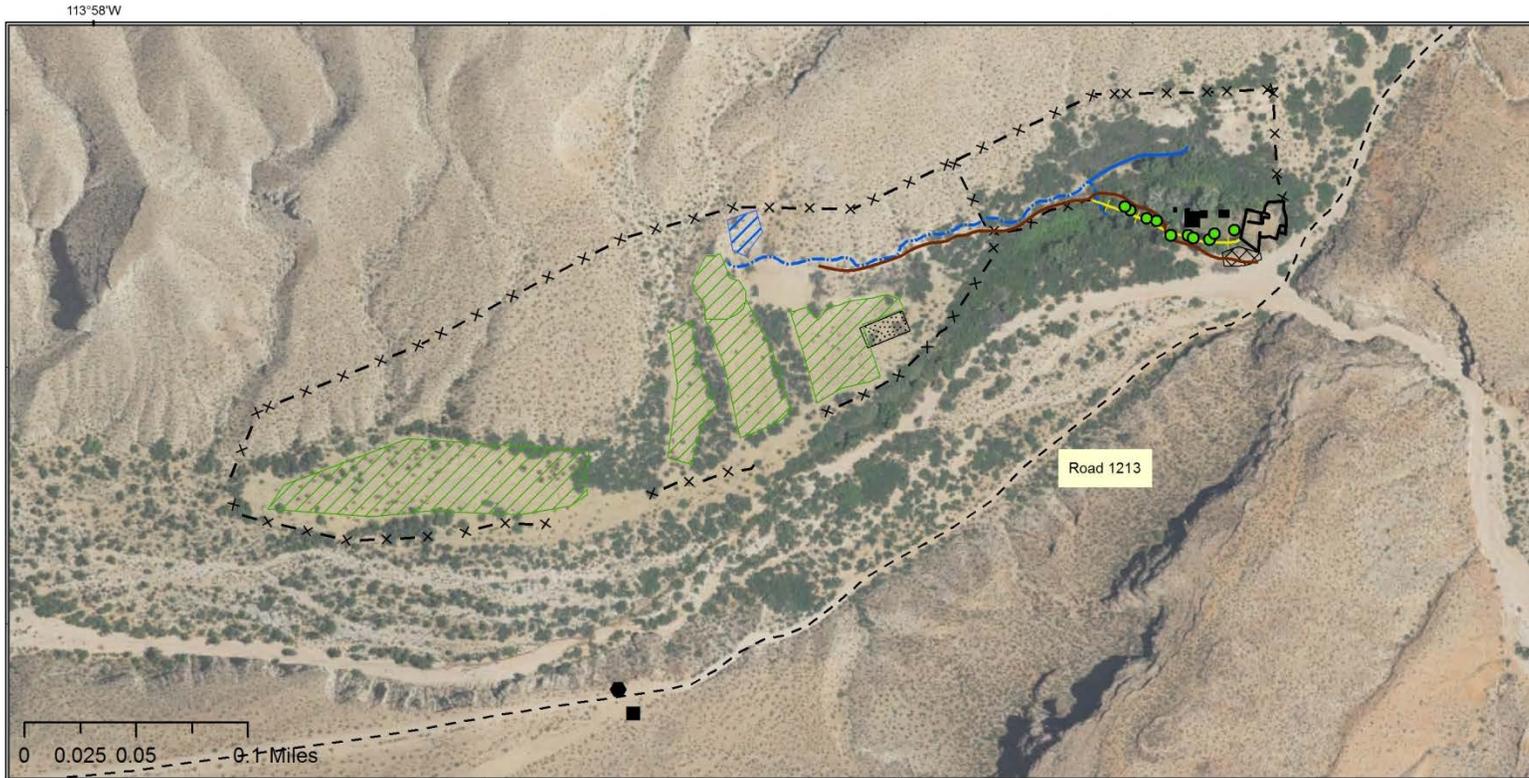
Map 2-1. Tassi Ranch Site Management Plan Site Overview
NEPA Number PEPC-79750/DOI-BLM-AZ-A030-2018-0006
 Department of the Interior - National Park Service - Grand Canyon-Parashant National Monument

The proposed project area is Tassi Ranch and Springs, Mohave County, Arizona within PARA. The project area is within T. 33 N., R. 16 W., sec. 13, Gila and Salt River Meridian, Arizona. See Map 2-1 below.

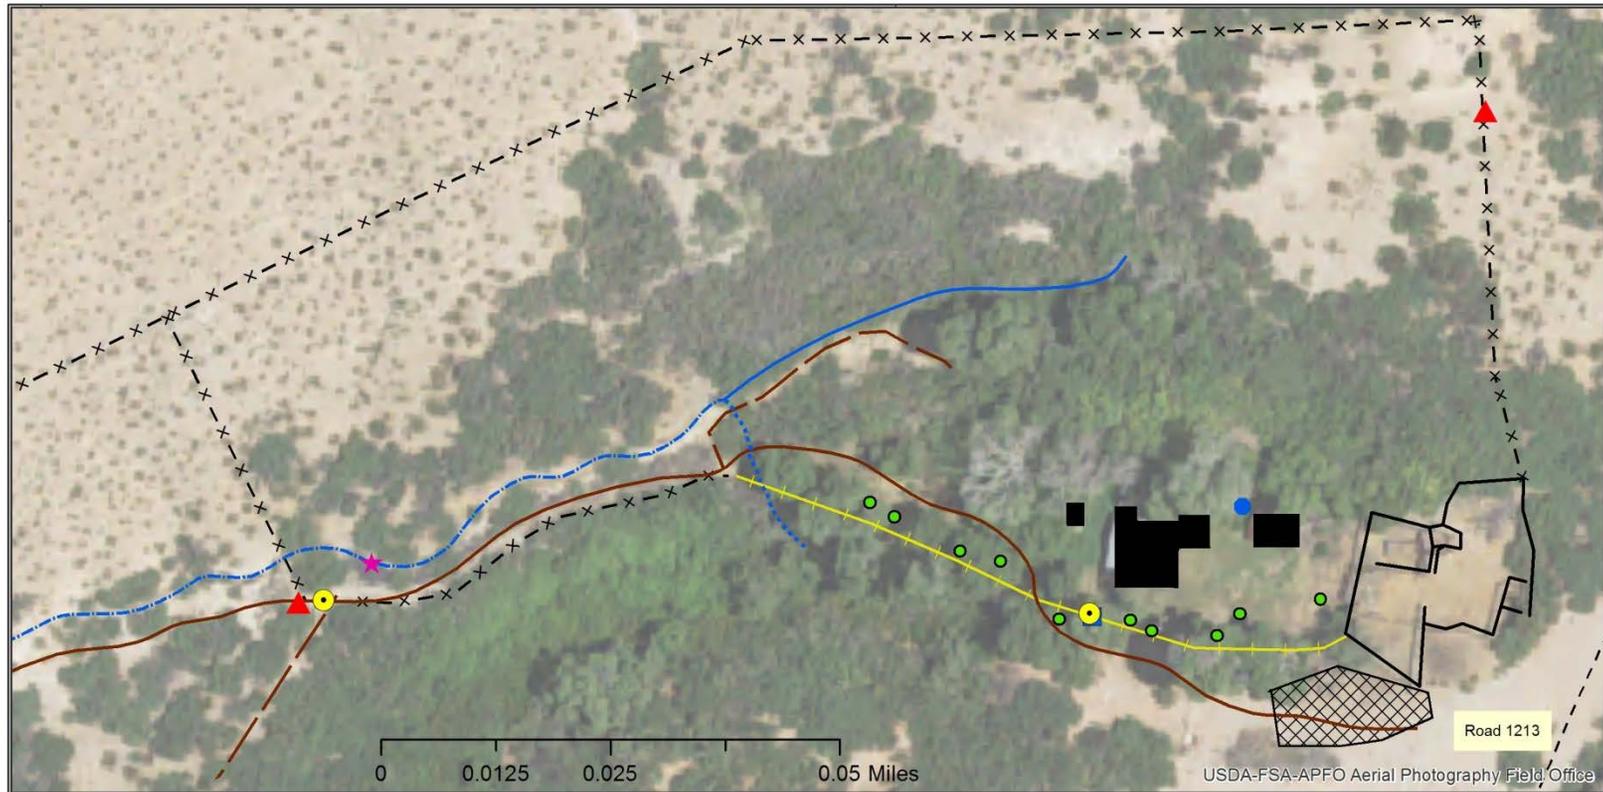
Map A-2. Tassi Ranch Site Management Plan Ranch Core
NEPA Number PEPC-79750/DOI-BLM-AZ-A030-2018-0006

| ★ Approximate Location of New Breach | | |

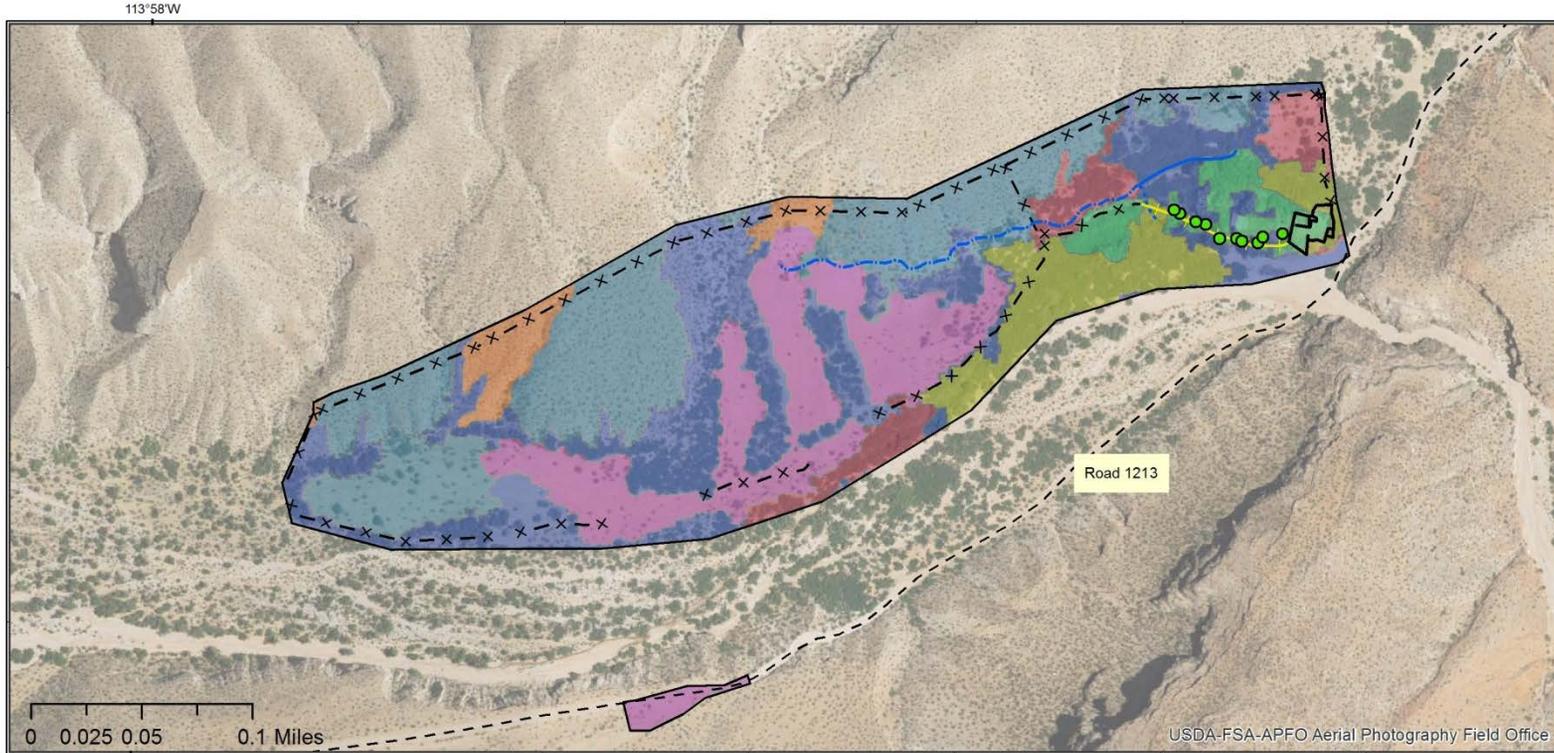
Map A-4. Tassi Ranch Site Management Plan Vegetation Map
NEPA Number PEPC-79750/DOI-BLM-AZ-A030-2018-0006

- Vegetation Alliance**
- NPS Road
 - - - Dry Ditch
 - Ditch/Springbrook
 - x - x Historic Fence
 - Corral
 - Modern Fence
 - Cottonwood Tree
- Acacia greggii Shrublands
 - Baccharis spp. - Salix exigua - Pluchea sericea Shrubland Alliance
 - Larrea tridentata - Ambrosia spp. Shrubland Alliance
 - Larrea tridentata - Encelia spp. Shrubland Alliance
 - Populus fremontii - Salix gooddingii Woodland Alliance
 - Prosopis glandulosa var. torreyana Shrubland
 - Unvegetated Surfaces and Built Up Areas

Neither set of mapping captured the wetland and riparian vegetation well. Along the currently wet ditch or springbrook, wetland and riparian plant species include native *Carex* spp., *Typha* spp., *Anemopsis californica* and *Salix* spp. In addition, *Anemopsis* has been found near the ranch house and shed due to shifts in the water table and the malfunctioning French drain system that no longer keeps the ranch yard dry. On a roughly 1-3 year cycle, the wetland vegetation along the springbrook is cut back to provide good breeding habitat for the relict leopard frog and Grand Wash springsnail. This has had no apparent long term effects on the vegetation species or their relative abundances in the springbrook.

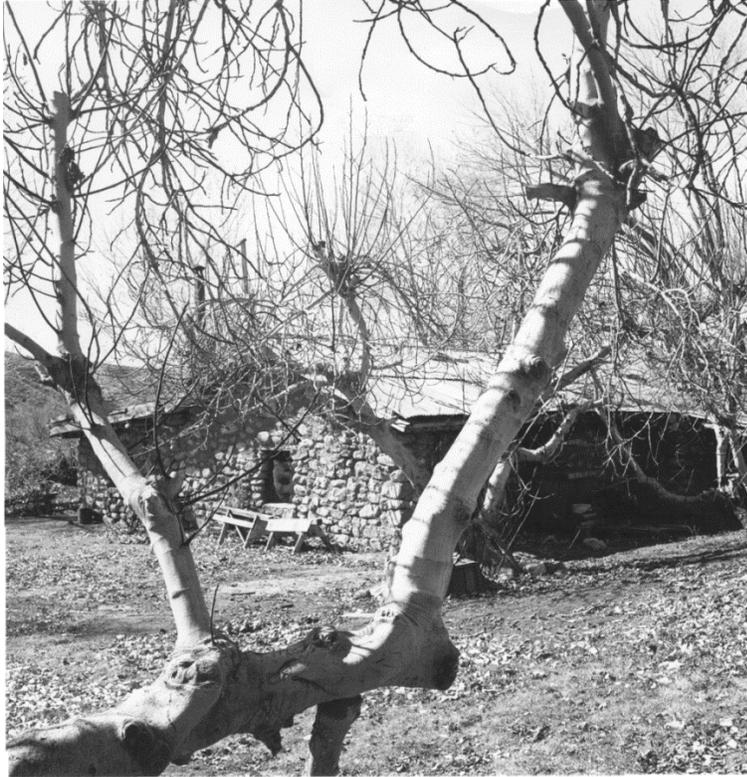
Figure C-1. Tassi Ranch house looking southwest on February 5, 1947. Note the bathhouse addition had not yet been built. Vegetation around the house was low grasses and scattered cottonwood trees. Ground level sloped gently up away from the house to the north.

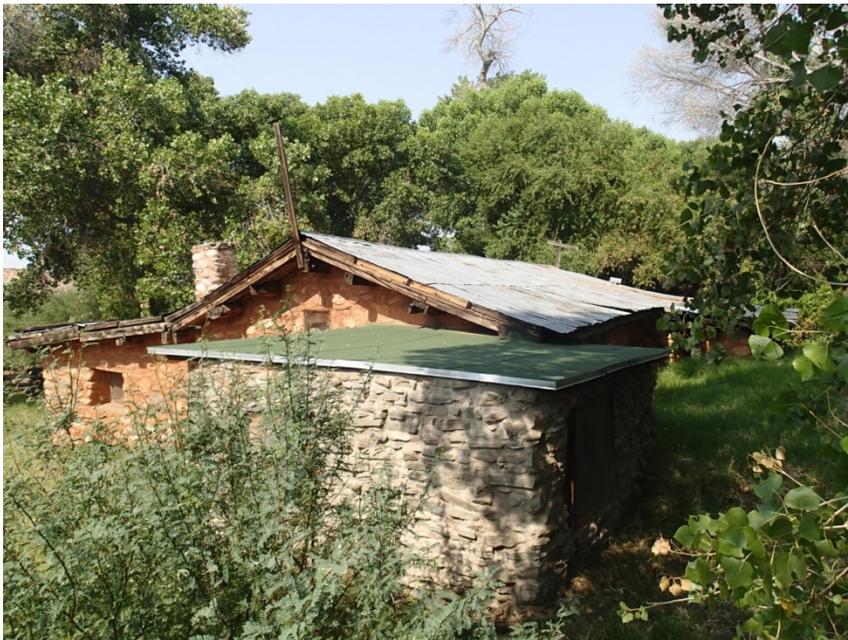
Figure C-2. Similar view as C-1 on July 31, 2018. Note the addition of the bathhouse to the house. Since 1947, large shrubs have encroached on the ranch yard and the gentle slope to the north has shifted up against the back of the house.

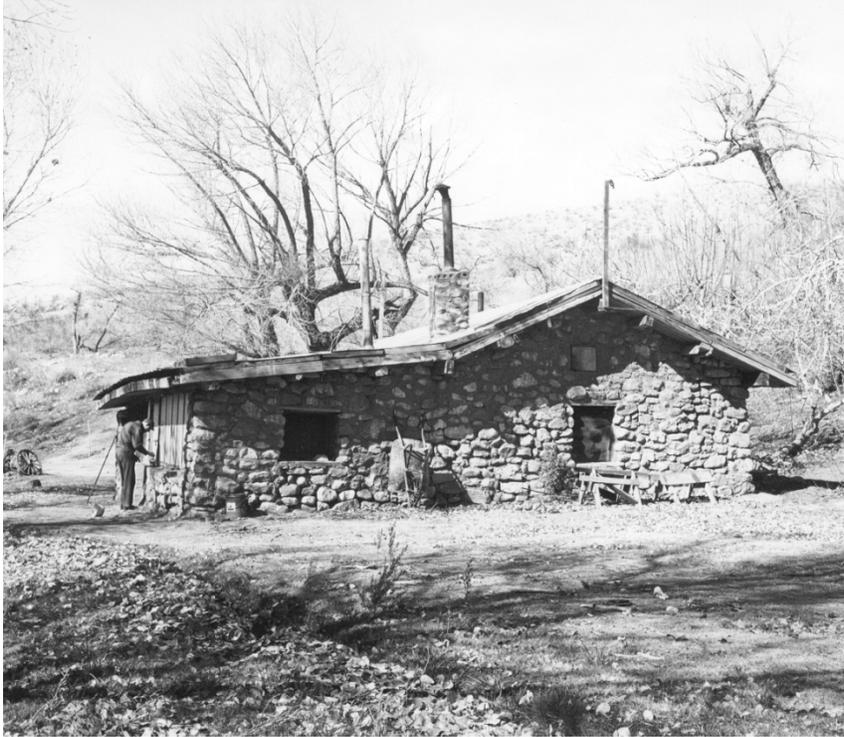
Figure C-3. Tassi Ranch house looking west on February 5, 1947. The ranch road is visible in the left lower corner. View behind the house to the west shows a continuation of the open ranch yard and scattered trees up the slope.

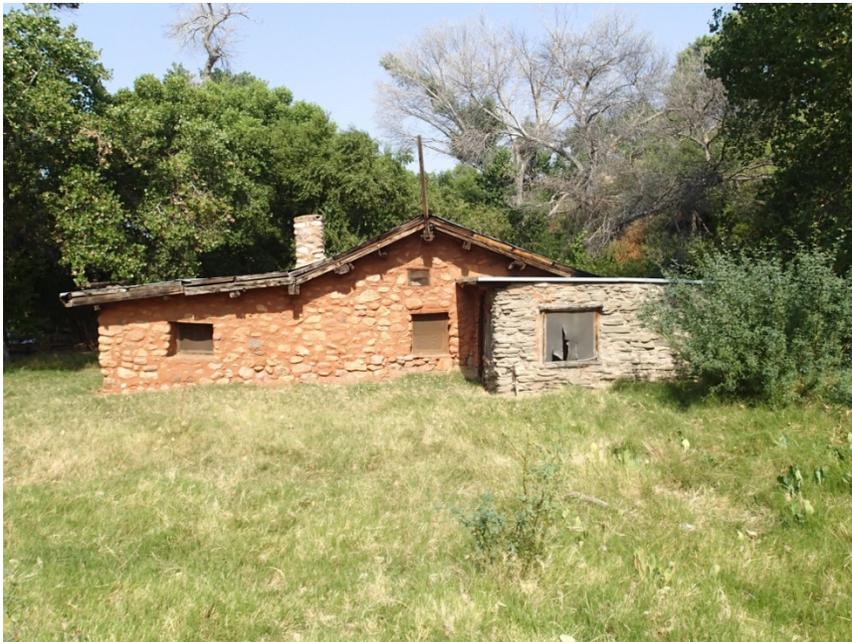
Figure C-4. Tassi Ranch house looking west on July 31, 2018. Note the addition of the bathhouse to the house. Since 1947, the ground level of the ranch yard has risen due to the accumulation of silt from flooding, soil from ground excavations and organic matter from decaying vegetation. As can be see, the encroachment of shrubs and trees into the ranch yard is not limited to just next to the ranch house.

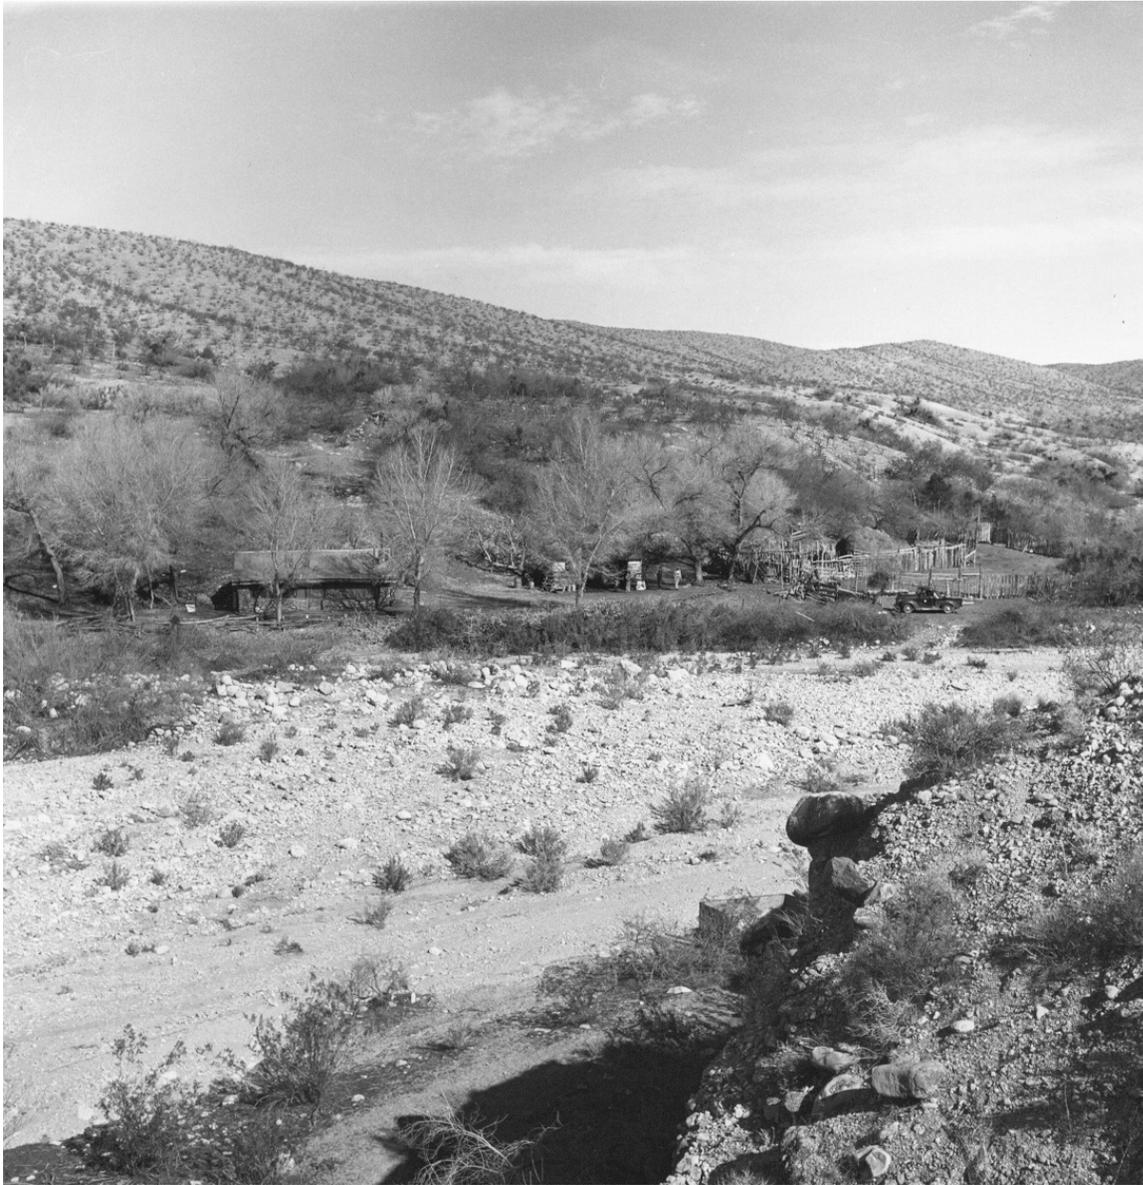
Figure C-5. Tassi Ranch Core looking northeast across Pigeon Wash on February 5, 1947. Note the small section of split rail fence visible in front of the ranch house. This fence was no longer apparent by 1998. The location of the current parking area is obscured by shrubs growing in the wash.

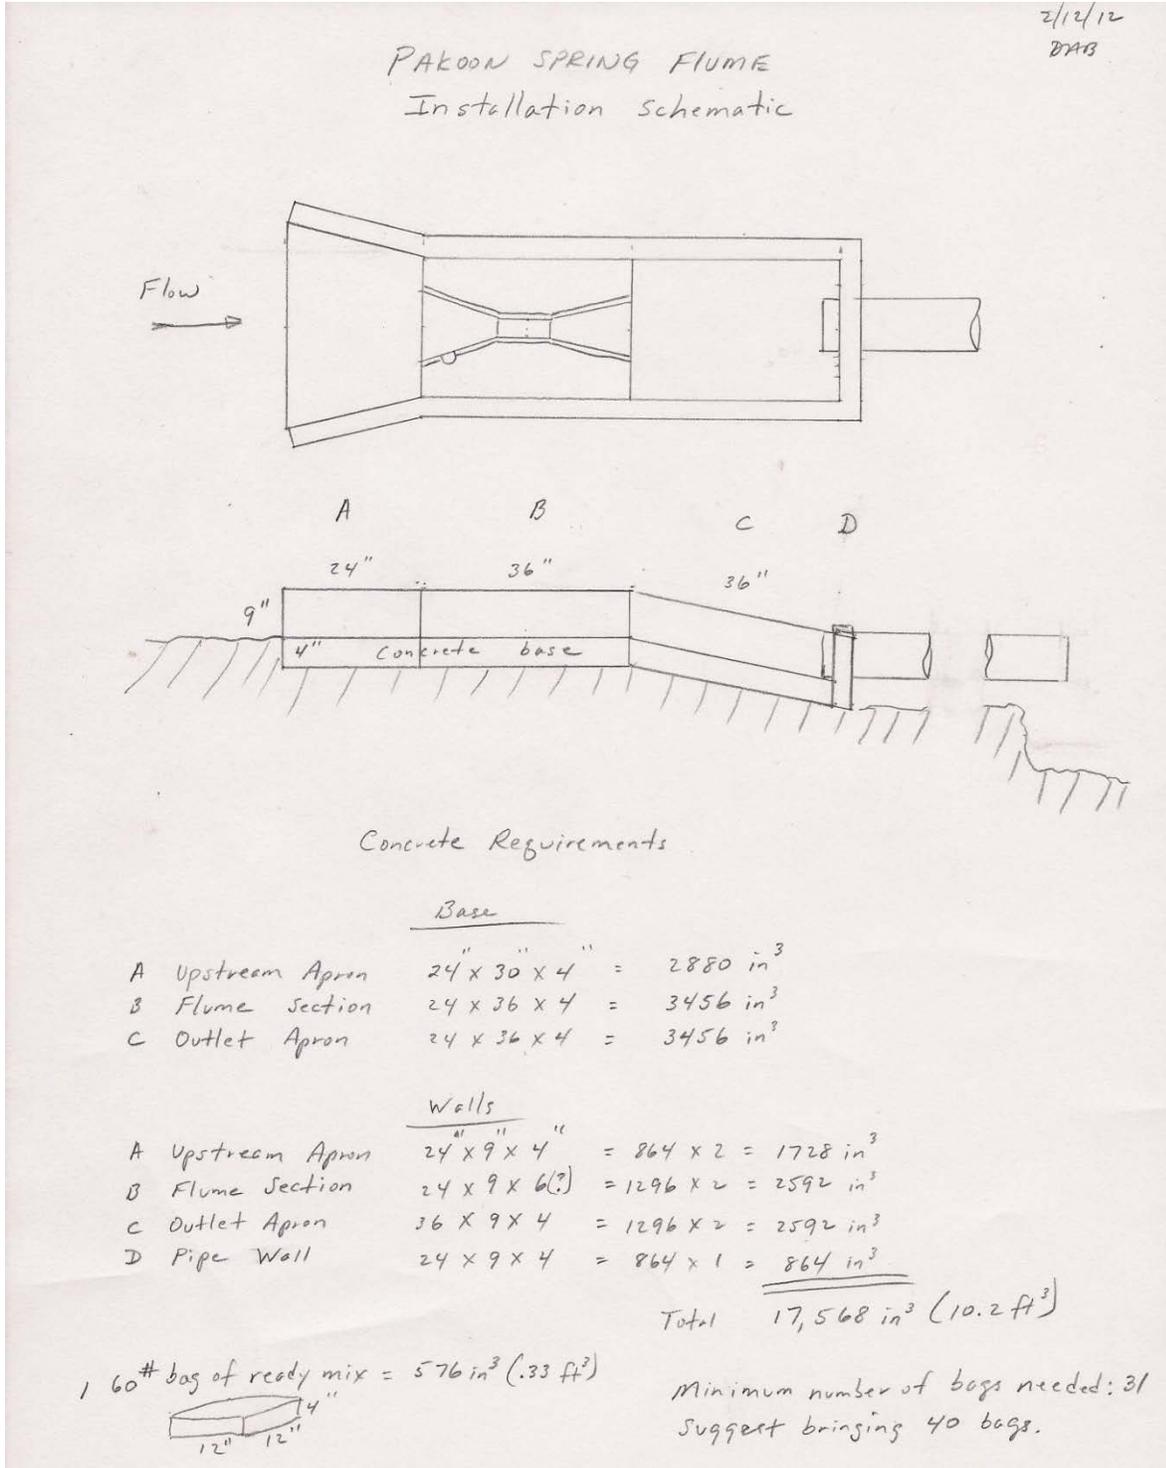
Weir/flume:

Design from 2012 of similar flume at nearby Pakoon Springs.

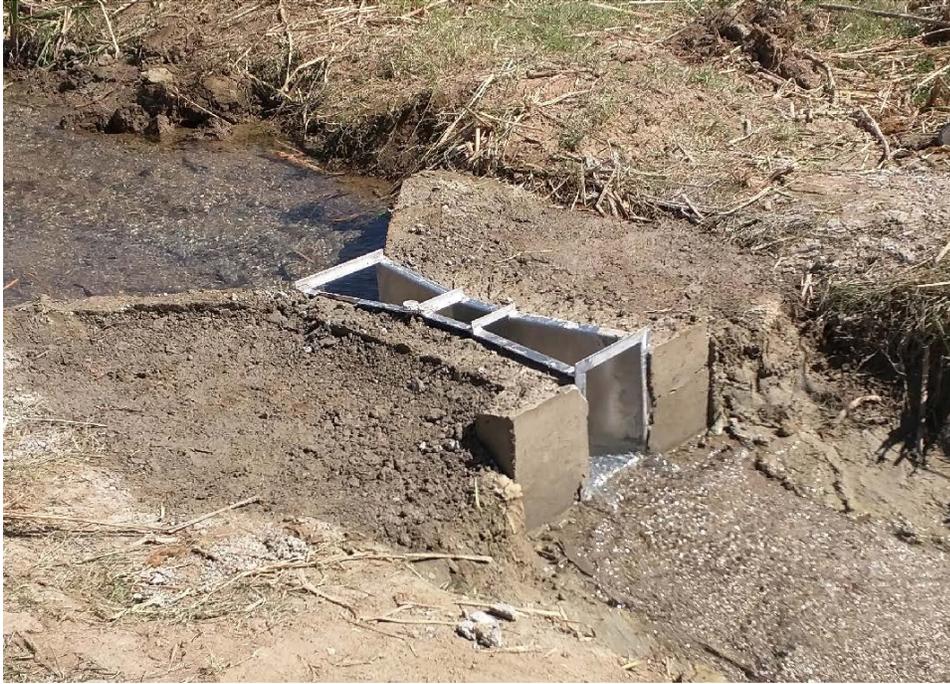
Image of similar flume installed at Pakoon Springs in 2018.

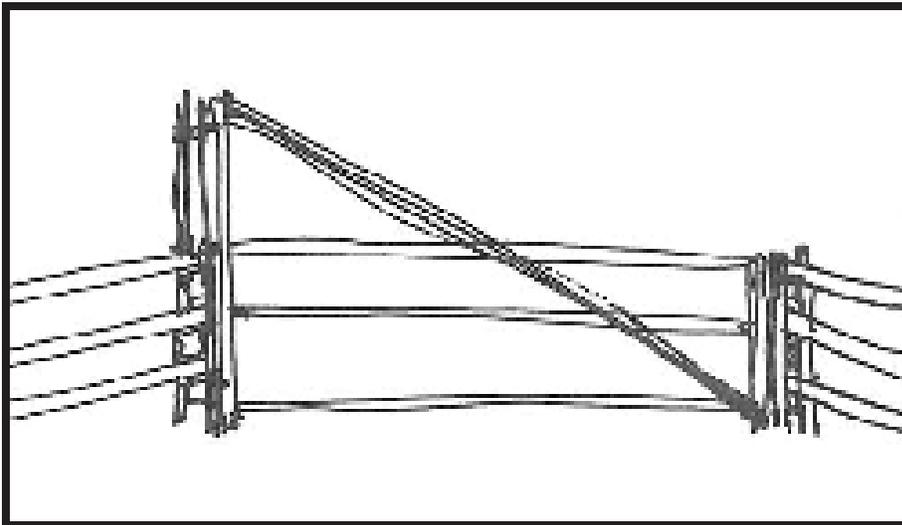
Proposed service gate design for new split rail fence in front of house.

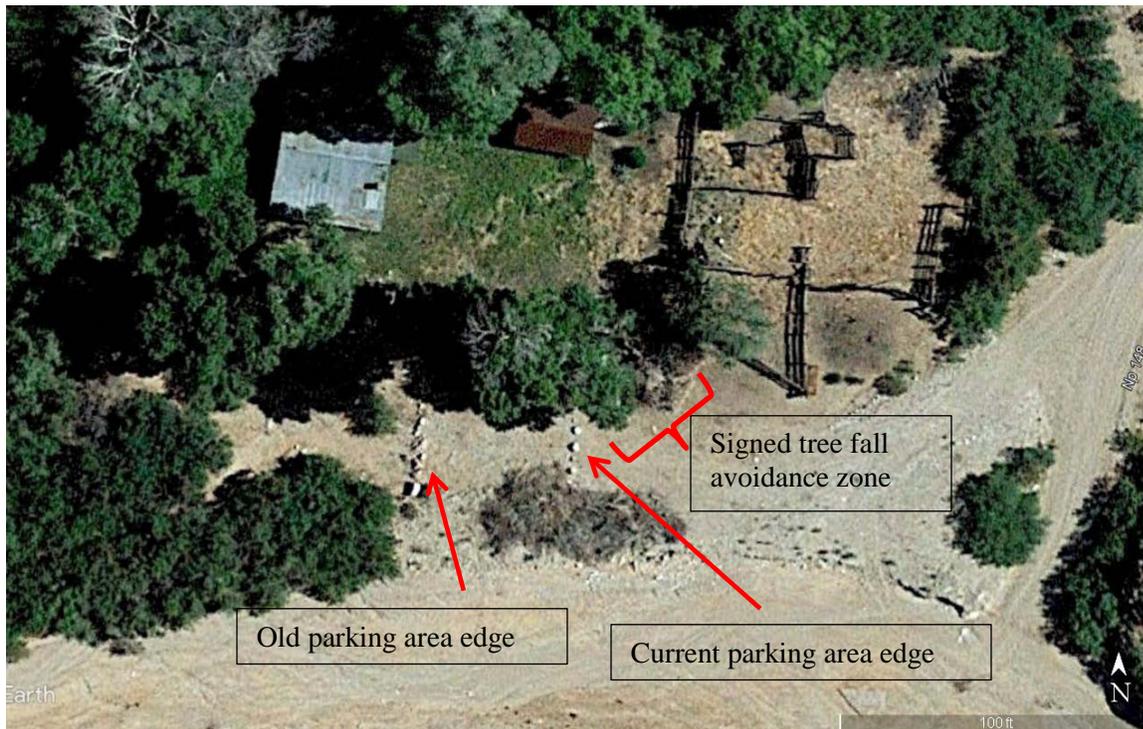
Figure F-1. Parking area configuration as of June 2018. Image courtesy of Google.

Starting in 2017, several of the large cottonwood trees nearest the parking area began to drop large branches. The parking was shifted away from the likely fall zones and the barrier rocks for the parking edge were shifted as well to minimize potential risks to visitors (Fig. F-1).

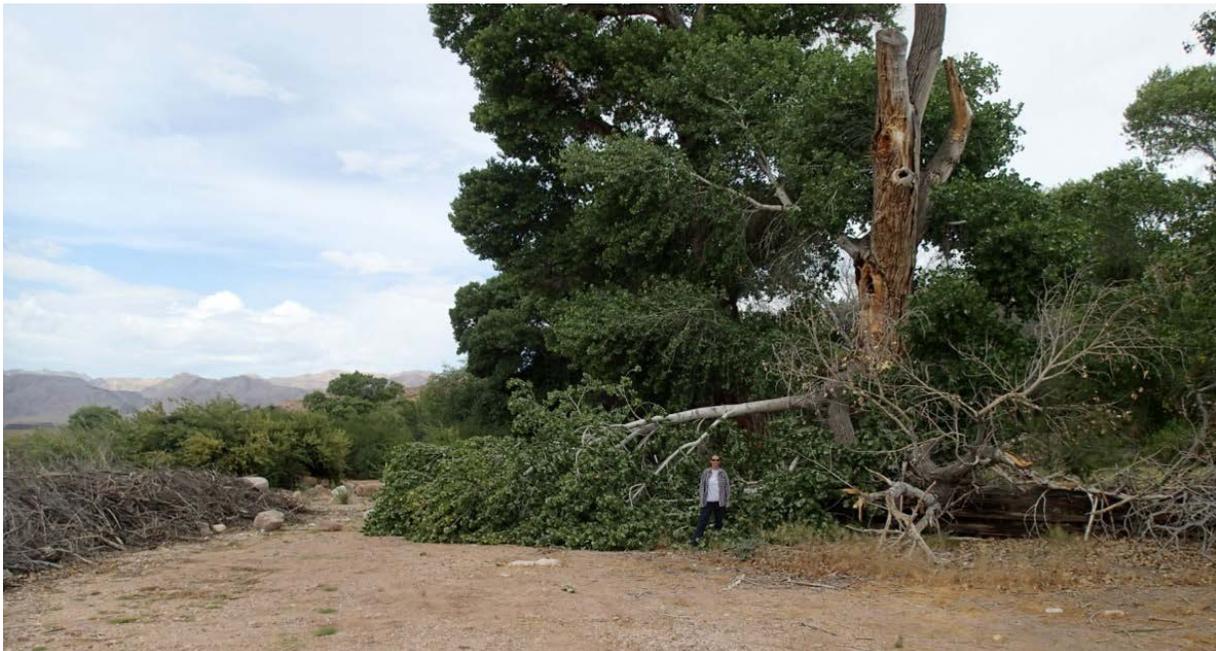
Figure F-2. Early 2018 treefall into current parking area. Note human for scale.

This decision was timely because, in early 2018, another large branch dropped off a cottonwood tree in the new parking area (Fig F-2). This branch fell on top of the hazardous trees sign. This pattern is continuing (Fig F-3) with two other trees in the cottonwood row losing major or all branches since early 2018. Until all the aging trees are replaced, the current parking area is anticipated to remain. After the trees have been dealt with, allowing horses to be tethered to hitching posts near the fence and vehicles parking nearer to the fence will be reconsidered.

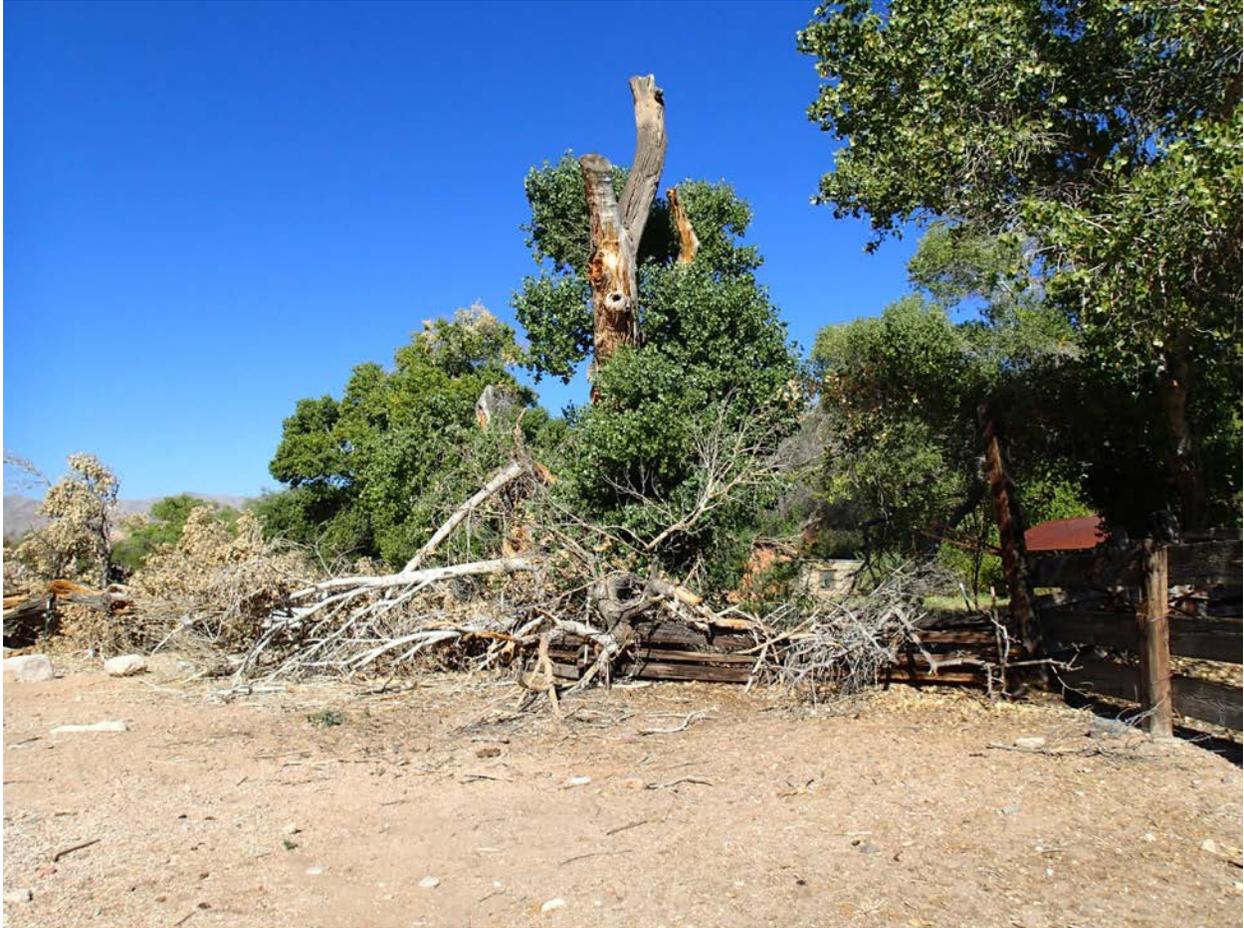
Figure F-3. Mid 2018 treefall. Tree behind early 2018 incident has now lost all branches.

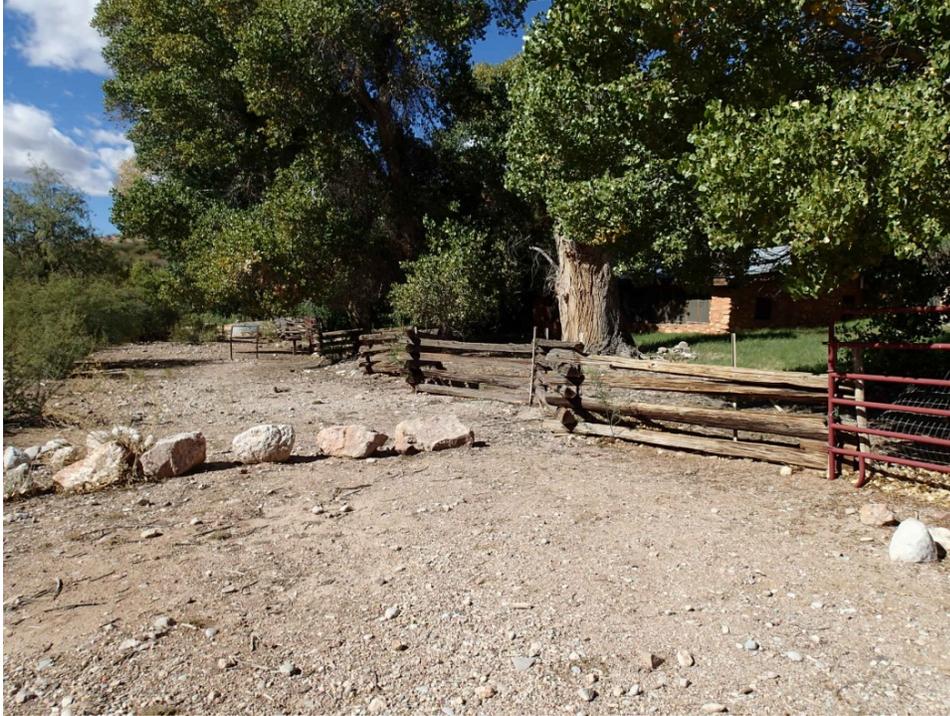
Figure F-4. Pre-2014 flood image of the parking area. Note the fence has 4 rails clearly above ground level.

During 2014 flood, the parking area was raised by over a foot in places. This was determined by comparing the height of the trail register and adjacent wayside pre and post flood. As part of the ranch yard recontouring, the SMP would bring the parking area back to the pre-flood level. This can be determined by using the aforementioned known heights of the visitor use infrastructure (signs and trail register), the pre-flood pictures of the worm fence (Fig. F-4 and Fig. F-5) and the known location of the valve box for the French drain system in the old parking area.

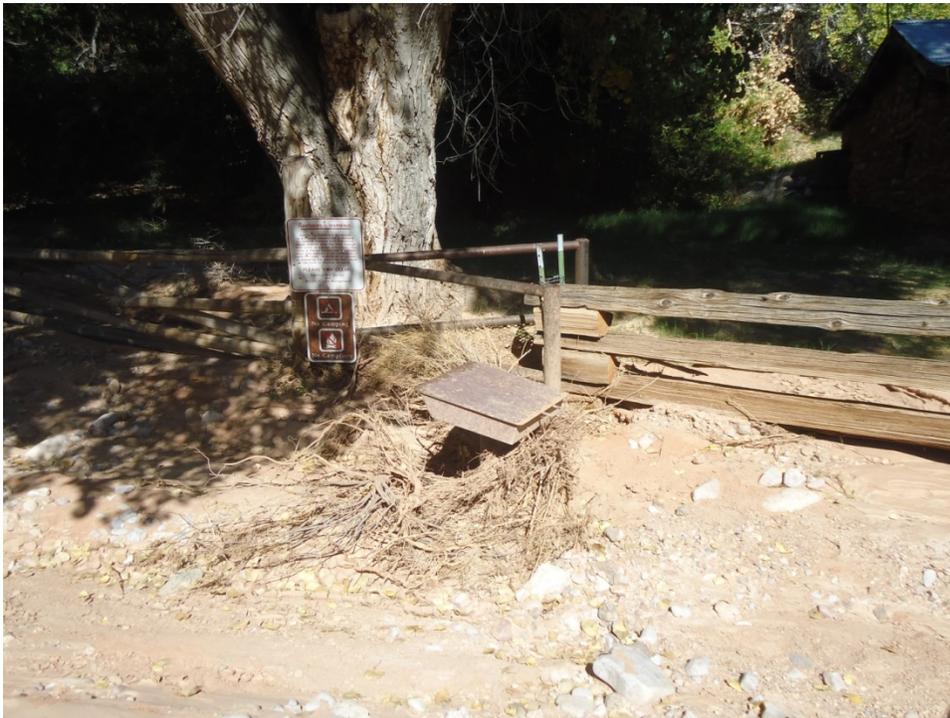
Figure F-5. Post 2014 flood. Note the bottom rail is completely buried in sediment. The trail register, when opened, was full of fine silt.

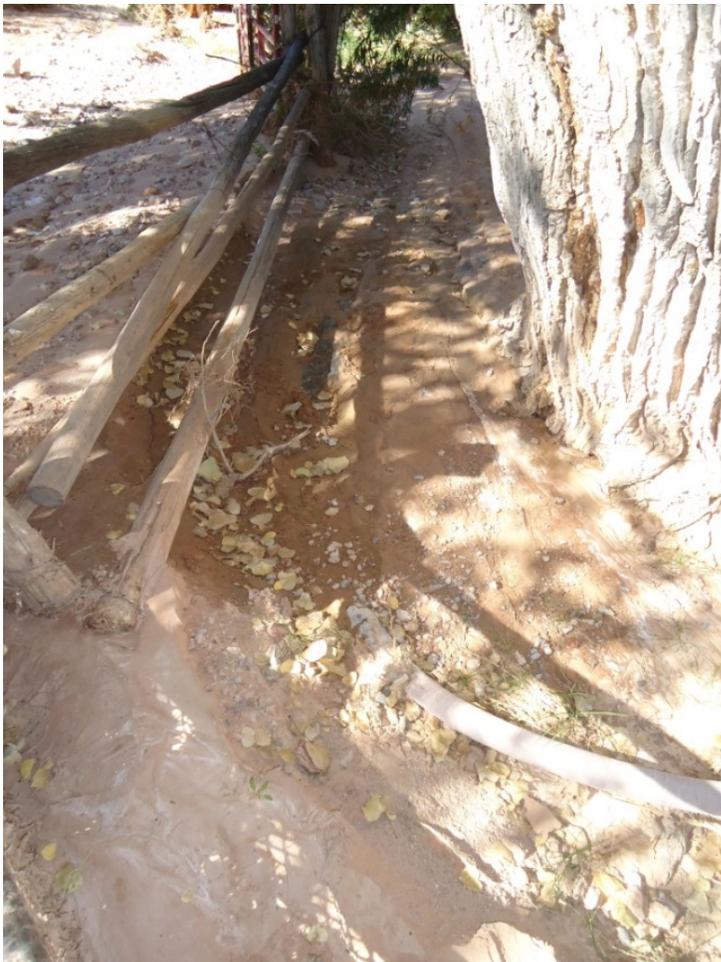
Figure F-6. Post 2014 flood. Location of buried stock tank.

Partially in response to the 2014 flooding and partially in response to modern activities in the ranch yard, the SMP deviates from the CLR by proposing to contour the ranch yard with a slight slope toward Pigeon Wash to the south and expand the French drain in the existing footprint before installing new, non-historic ditches. The 2014 flood associated sediment deposition did not stop at the fence line. The stock tank (part of the irrigation system) is completely buried (Fig. F-6) and the portion of the ranch yard just south and west and in front of the house accumulated a visible layer of sand (Fig F-7). To restore the previous look of the stock tank, the area would need to be lowered. It is more difficult to determine how far north into the ranch yard the flood extended near the barn because of the almost immediate surge in vegetation growth to the west of the house but, given the extensive sedimentation near the fenceline, several inches of sediment could have been deposited.

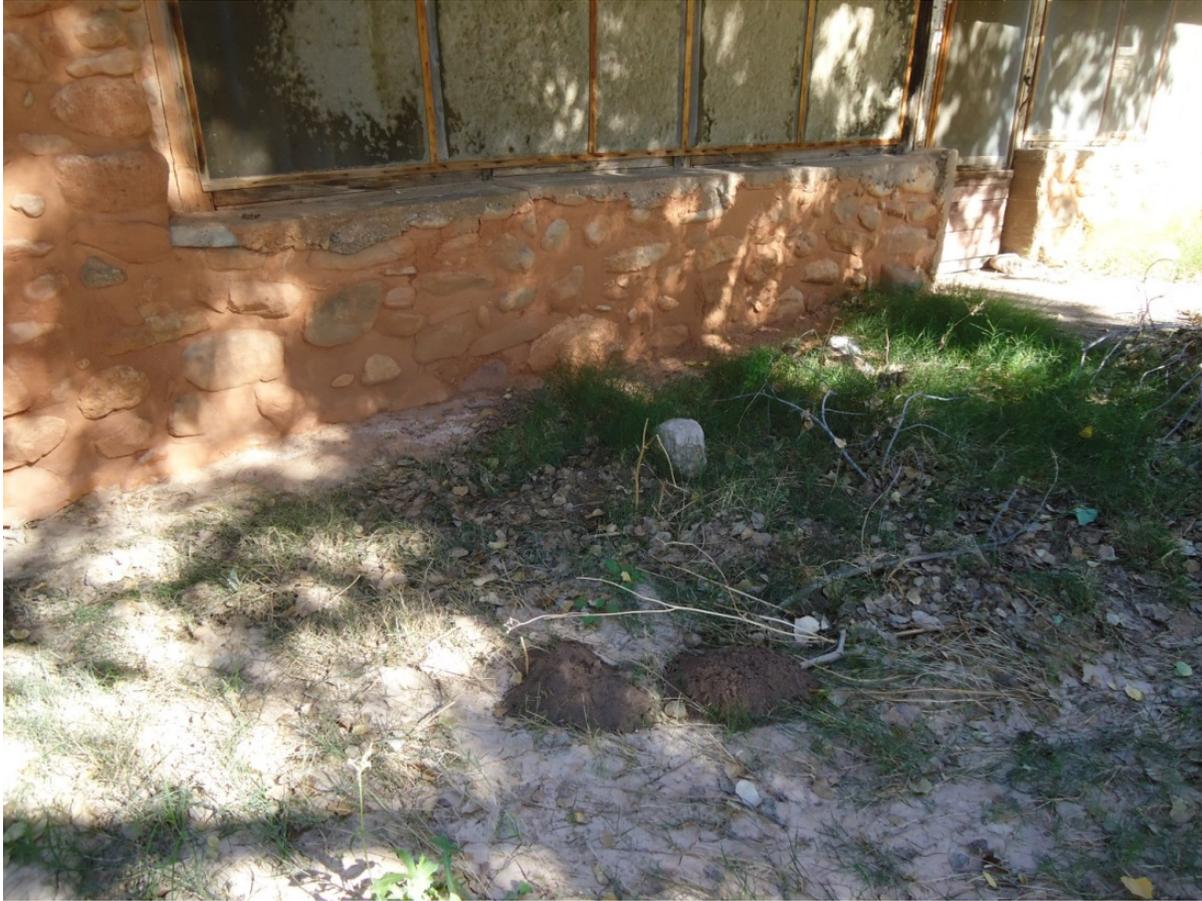
Figure F-7. Post 2014 flood. Closest visible sediment deposition to ranch house.

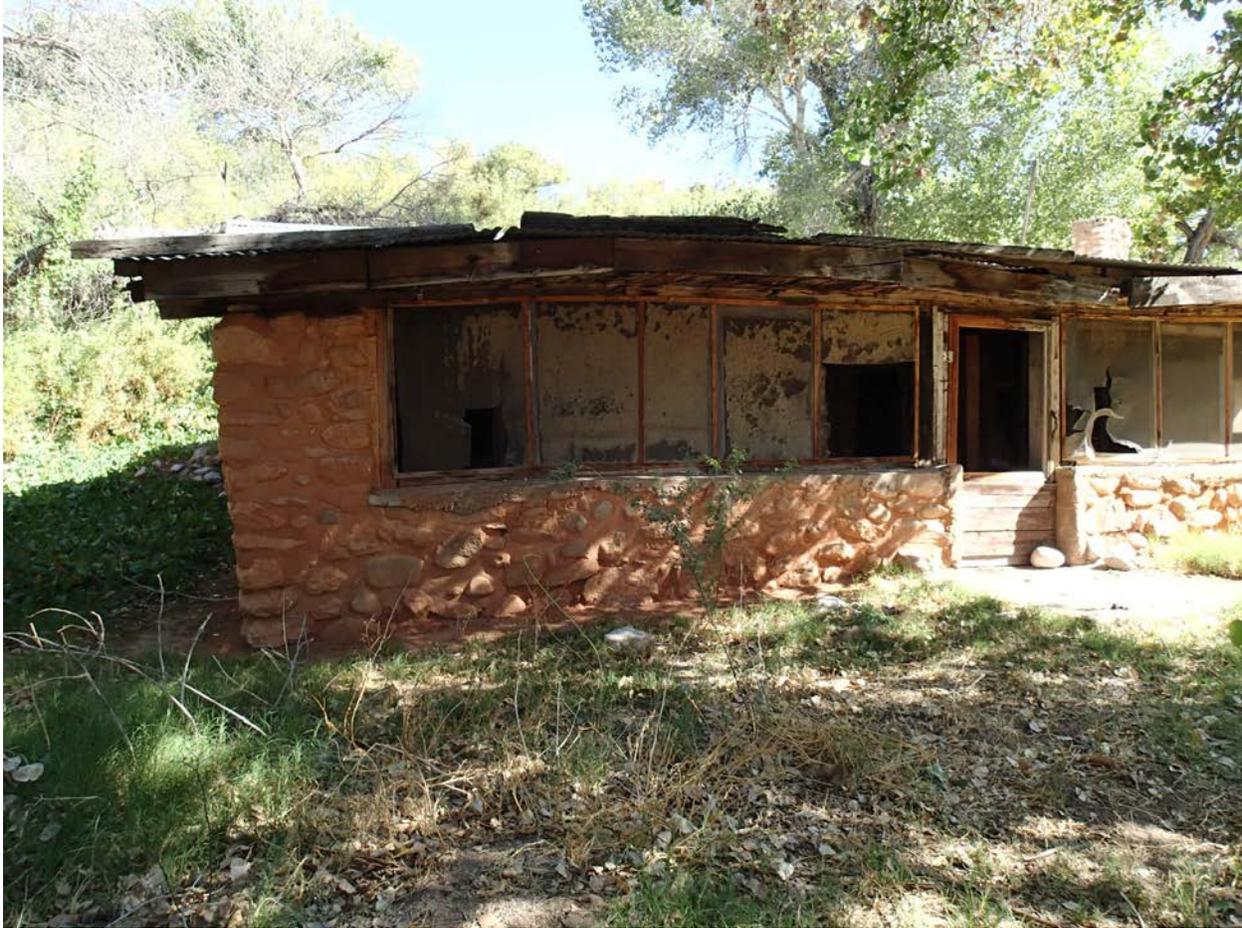
Figure F-8. Front of house showing some of the damaged screens (September 19, 2018)

In this case, the SMP proposes to add material such as expanded metal to the entry points and windows of the ranch house. This would be placed behind the existing doors and screens and repaired screens to maintain the historic look and feel of the house. Since 2013, the bathhouse door has fallen off its hinges and several screens have been damaged, most likely by a burro that learned how to walk through the visitor gate in 2015 (Fig. F-8). Visitors do not regularly close the functioning doors to the house either, leaving the house open to wildlife. Such animals, if the doors are closed at a later time by wind or other visitors, could attempt egress by boring through the screens.

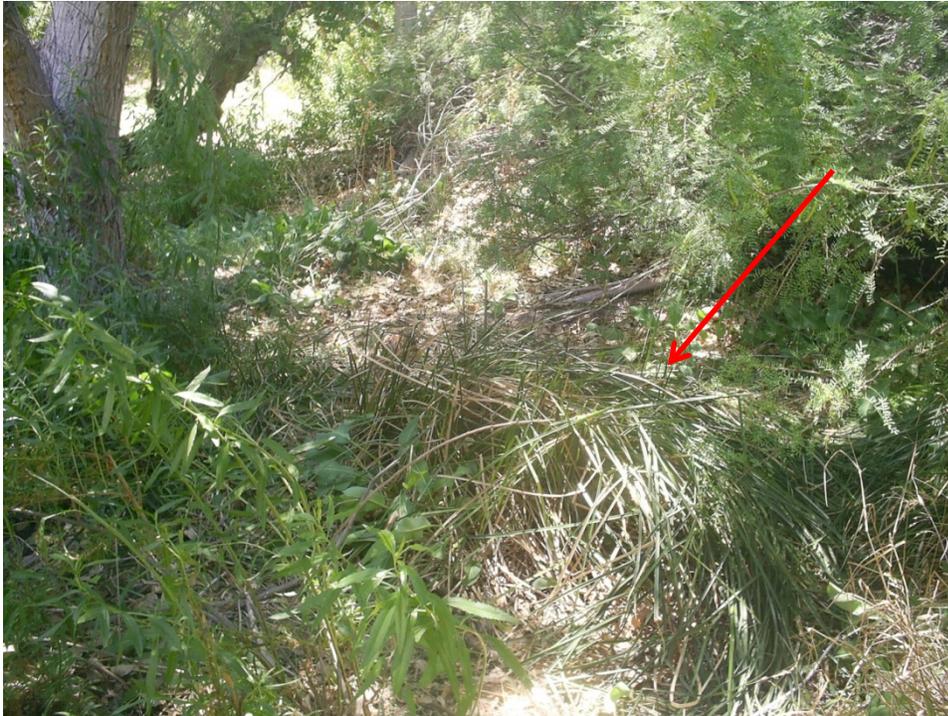
Figure F-9. June 15, 2006. Tassi Spring B source directly behind shed. Note presence of *Typha*.

In 2006, a small seep was noted by NPS spring survey personnel behind the shed. This seep, from the images, appears to be perennial. In 2016, a large sunken area was noted on the slope, approximately where the old springhead was found. After clearing the area, the seep was clearly visible. Currently this seep appears to be gaining flow (Fig. F-9 through 11).

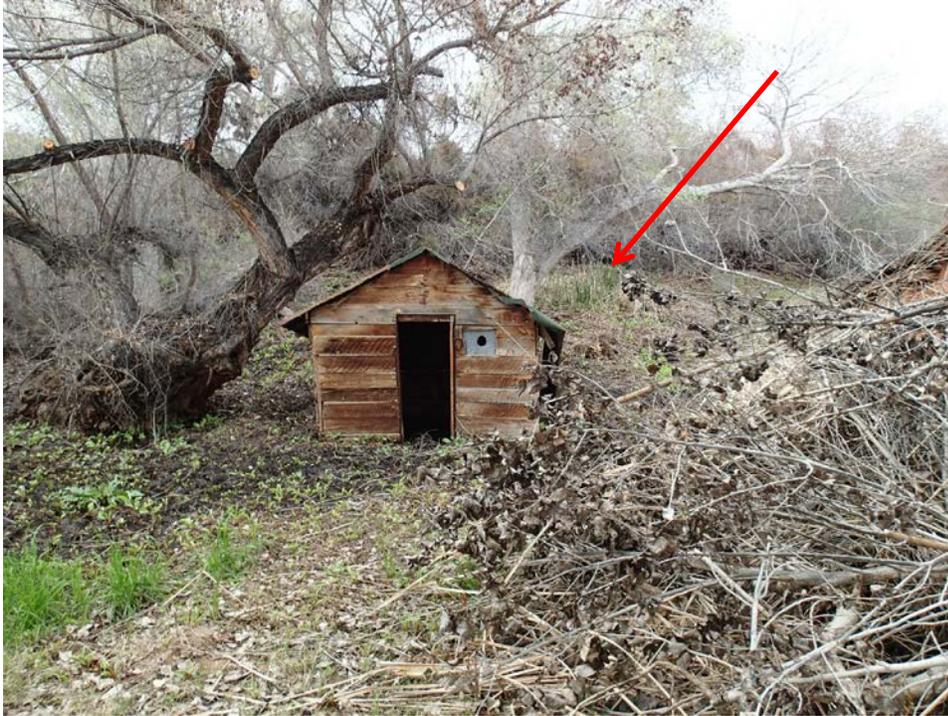
Figure F-10. Tassi B spring February 21, 2017. Note presence of *Typha* and cottonwood tree behind shed

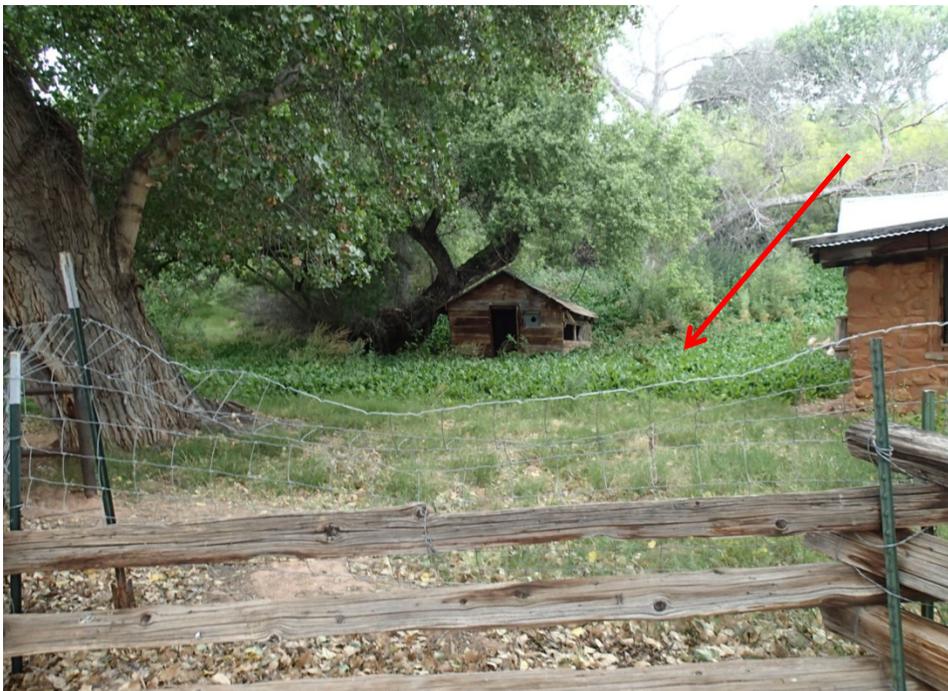
Figure F-11. Tassi May 22, 2018. Note cottonwood tree appears dead, likely caused by roots now in saturated soil. Also note *Anemopsis* (yerba mansa) growth as the entire area to the west of the house is now either wetted or has flowing water.
