CULTURAL LANDSCAPE REPORT FOR POPLAR GROVE NATIONAL CEMETERY

PETERSBURG NATIONAL BATTLEFIELD
DINWIDDIE COUNTY, VIRGINIA

DRAFT APRIL 2007

Olmsted Center for Landscape Preservation
National Park Service, Boston, Massachusetts 2007

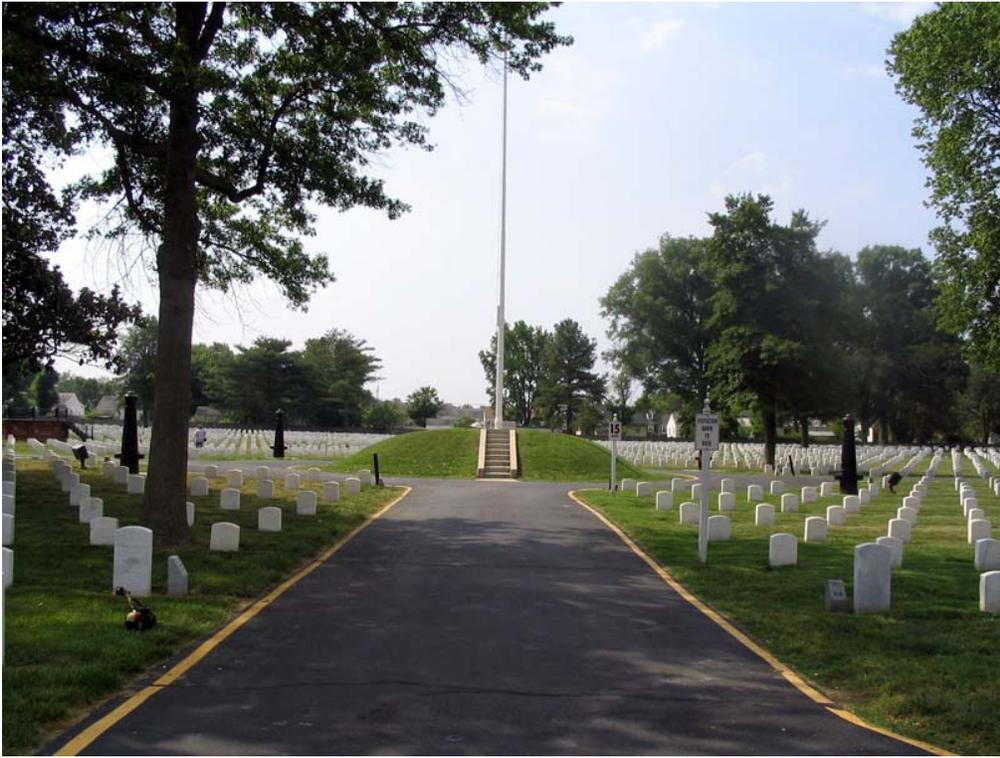
Figure 4.1: Well-tended character of VA-administered national cemeteries illustrated at Civil War-era Richmond National Cemetery (Richmond, Virginia), view looking south toward the central flagstaff mound. Note neatly trimmed grass and clean marble headstones. SUNY ESF, 2006.

become a hallmark of national cemeteries, as well as through a high level of maintenance and care in the landscape. These characteristics are evident at the National Cemetery Administration's Civil War-era Richmond National Cemetery (fig. 4.1). The Operational Standards and Measures outline requirements ranging from the percentage of the lawn that must be weed free, to the percentage of headstones that must not show evidence of debris or objectionable accumulations (fig. 4.2).⁸ Although the National Shrine Commitment only pertains to the National Cemetery Administration, its standards designed to impart honor, memory, majesty, serenity, and beauty were also found historically in the development of all first-generation national cemeteries, including Poplar Grove. Some current National Cemetery Administration standards, however, such as recommendations for installing contemporary memorial walks and avenues of flags, or even certain standards of maintenance, may not be appropriate where there is a conflict with National Park Service cultural resource management guidelines. The character of most National Park Service-administered national cemeteries, such as Antietam, differs largely through the level of maintenance directed toward the headstones and lawn (fig. 4.3).

contemporary site features (benches, signs, plantings) that are incompatible with the historic character of the landscape, or cleaning headstones to a pristine white three times per year that may impact the long-term conservation of the stone (see figs. 4.1, 4.2).¹³ The National Park Service, in contrast, does not routinely clean its headstones or maintain the lawn to the same uniform quality (see fig 4.3). As discussed under the preceding framework for treatment, the park service is not obligated to follow the National Cemetery Administration's landscape policies and regulations, except as they pertain to the design of headstones and markers. Despite this, a low level of maintenance in the landscape—even though it may be the best preservation approach in a material sense—may inappropriately evoke an unintended message of disrespect for the soldiers. The National Park Service must therefore carefully guard against certain aspects of maintenance and treatment that may be perceived as disrespect, but at the same time also preserve the historic character and materials of the landscape. In summary, this issue may be best addressed at Poplar Grove by adhering to historic National Cemetery Regulations (1931), in particular with regard to the cleanliness of the gravestones and overall level of landscape maintenance that may be greater than is typically found at National Battlefields or other National Park Service historic sites.

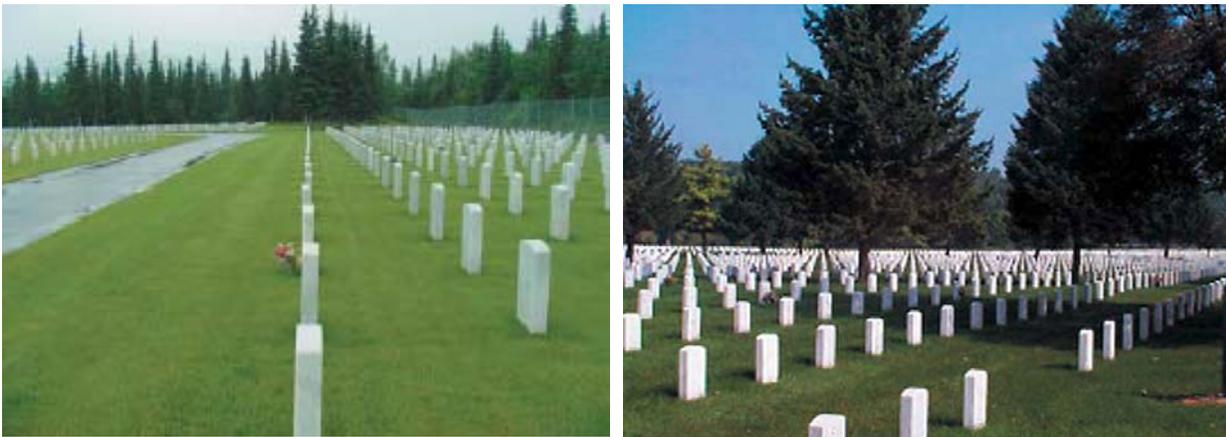
Figure 4.2: Illustrations from the VA's "Operational Standards and Measures," accompanying the standard for markers that are described as showing "turf edged vertically even with the marker and free of trimming debris" (left) and "headstones, markers and niche covers that do not show evidence of debris or objectionable accumulations." The identity of the national cemeteries pictured is not indicated. Department of Veterans Affairs, National Cemetery Administration, "National Shrine Commitment Operational Standards and Measures" (Version 2.0, October 2004).

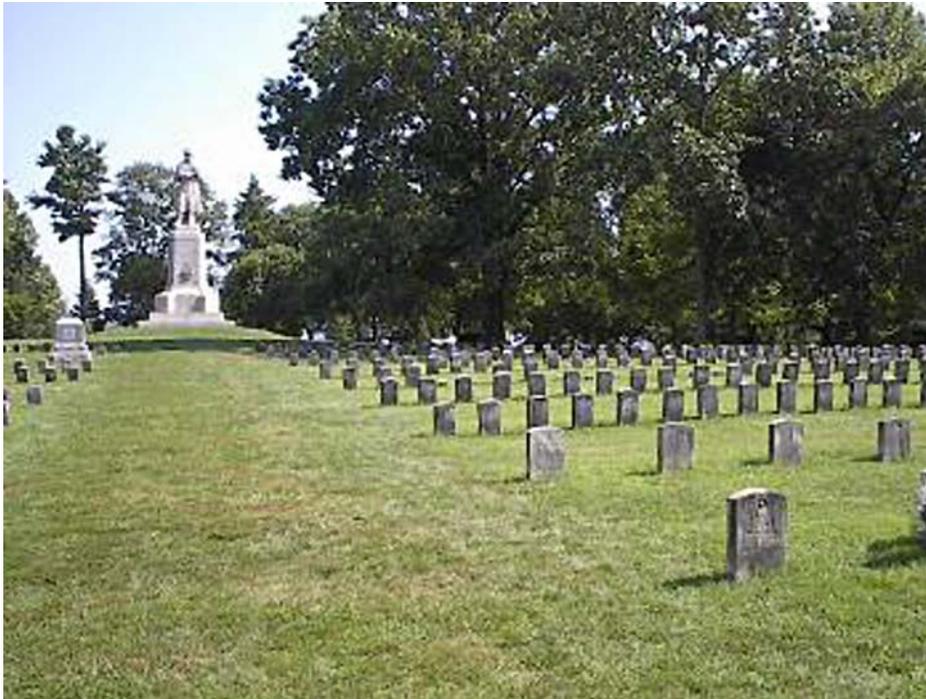
Figure 4.3: Antietam National Cemetery looking toward “At Rest” monument showing character of an NPS-administered national cemetery. Note difference in maintenance of headstones and lawn compared with figures 4.1 and 4.2. National Park Service.

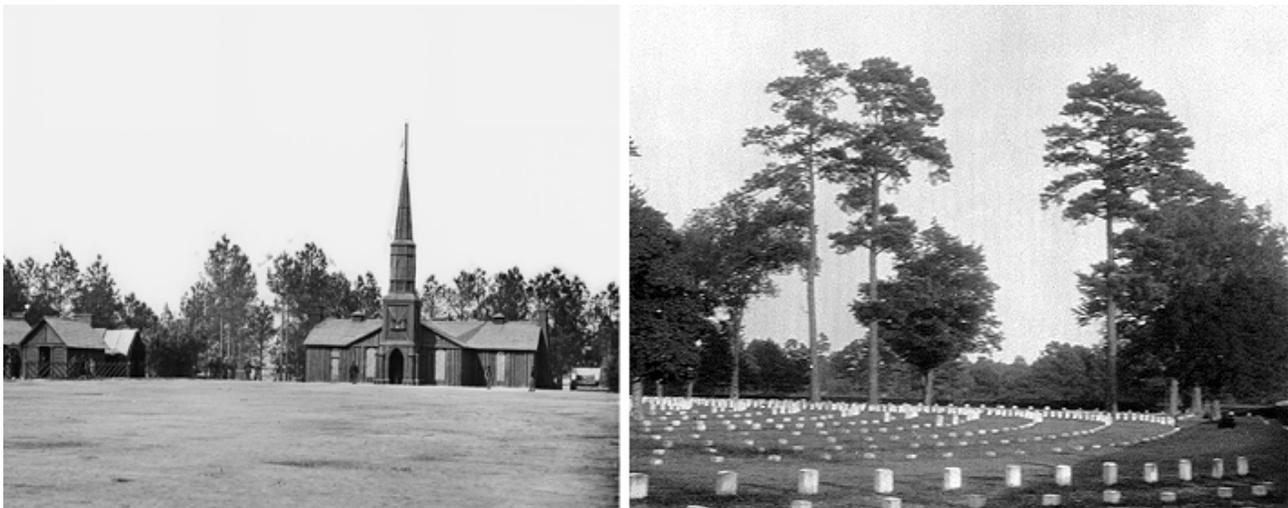
Figure 4.4: Landscape as interpretive feature for Civil War period: Loblolly pines at Engineers Camp, c. March 1865 (left), and same loblolly pines sixty-six years later in 1931. Only four loblolly pines remain in the cemetery today. Details of photographs from Library of Congress and National Archives (see figs. 1.20 and 1.65).

Interpretation of the Civil War events prior to the establishment of the cemetery in 1866, while outside of the period of significance for Poplar Grove, can still be achieved through the landscape. Reestablishment of the grave markers in their historic upright position will provide visitors with a clear understanding of the vast numbers of fallen soldiers, and large percentage of them who were never identified as represented by the blocks (square posts). The Camp of the 50th New York Volunteer Engineers, and its namesake for the cemetery, Poplar Grove Church, can also be interpreted in the landscape. Aside from the relationship between the camp and the cemetery plan, the continued survival of loblolly pines—which surround the camp and were retained in the development of the cemetery—provide the sole surviving physical link to the camp landscape (fig. 4.4). Only four loblolly pines remain today. Reestablishing and sustaining these trees in the landscape should be a priority for treatment.

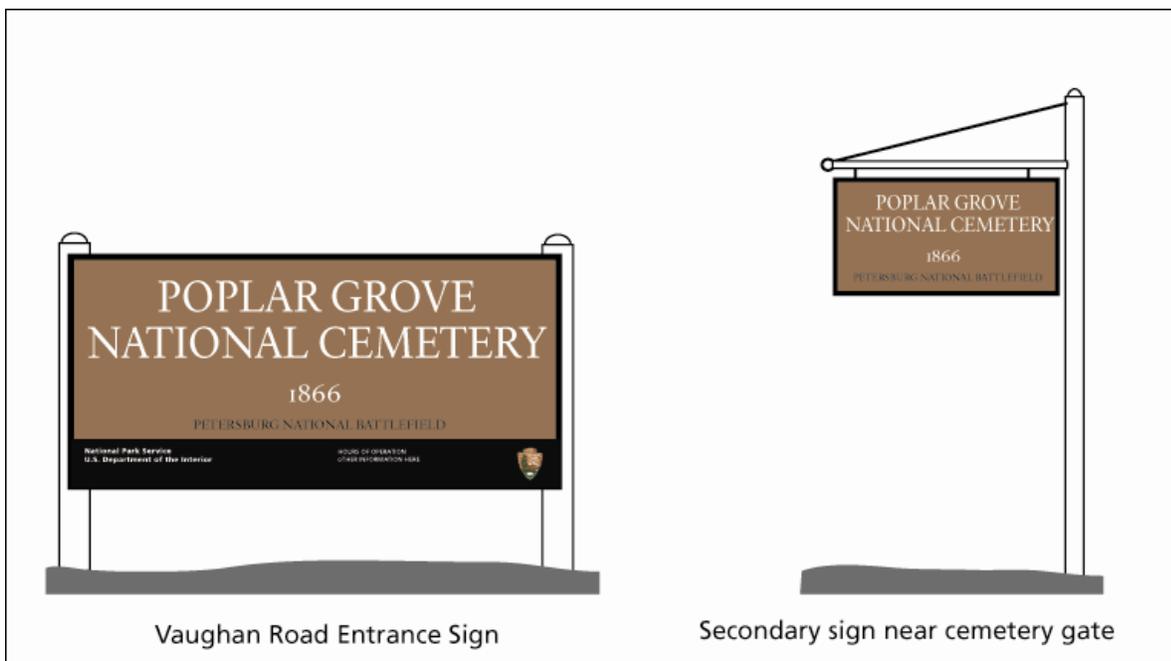
Figure 4.6: Suggested designs for signs at Vaughan Road and at the cemetery gates (not to scale). SUNY ESF.

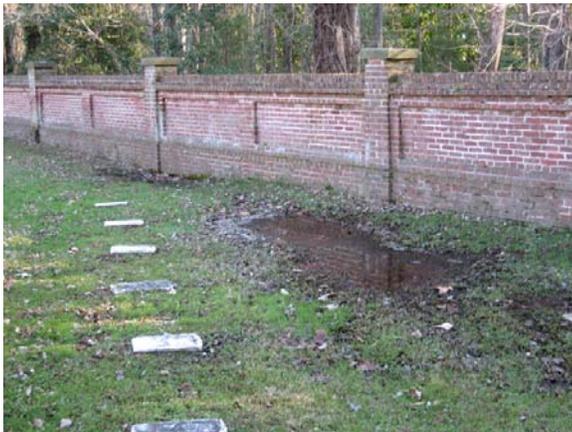
Figure 4.8 (left): Flooding in Division A along south side of inclosure wall related to inadequate grade and drainage through the wall. SUNY ESF, 2006.

Modify inadequate drainage openings in the inclosure wall to enhance surface drainage from the burial grounds (Drawing 7). There are presently two drainage openings that are not functioning adequately: one in Division A along the south side of the wall and a second in Division D at the northwest corner of the cemetery (cemetery low point) that feeds into a concrete drainage ditch extending into private property.¹⁷ During times of moderate to heavy rain, the ground floods near these drain openings (fig. 4.8). In Division D, the water often covers nearby grave markers.

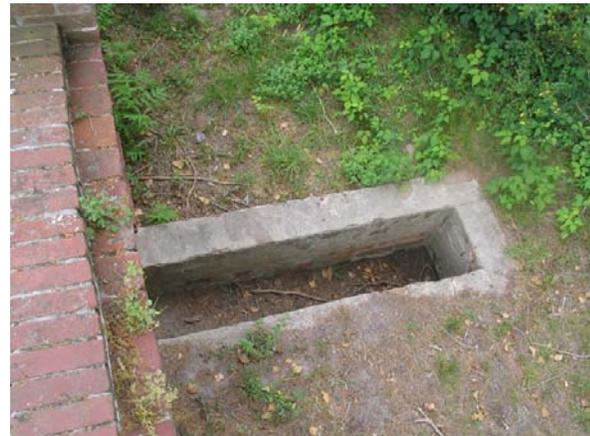
Figure 4.9 (right): Brick outflow basin at drainage opening along south side of inclosure wall. These boxes appear to have no outlets. SUNY ESF, 2006.

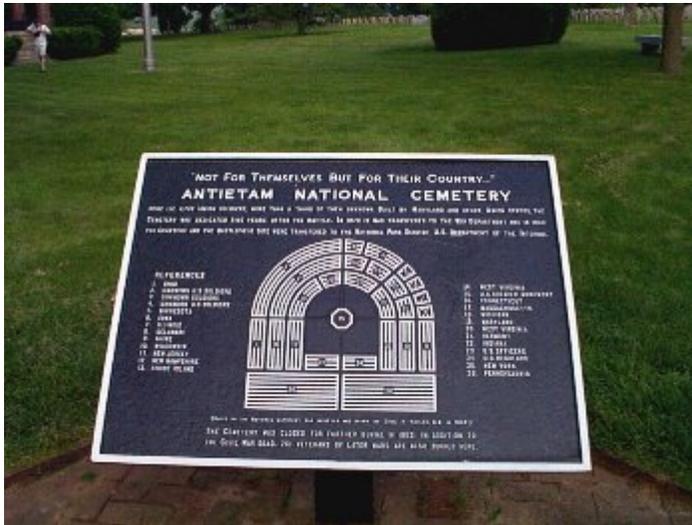
Figure 4.10: Example of an appropriate style for a new sign that would be part of an information wayside within the lodge grounds. National Park Service, Antietam National Cemetery website.

An appropriate model for a sign in this wayside is one at the National Park Service-administered Antietam National Cemetery, which reproduces a historic graphic plan of the cemetery (fig 4.10). This sign relates to the historic style of signs at National Cemeteries through its use of cast metal with raised letters, but is distinguished by a different finish.

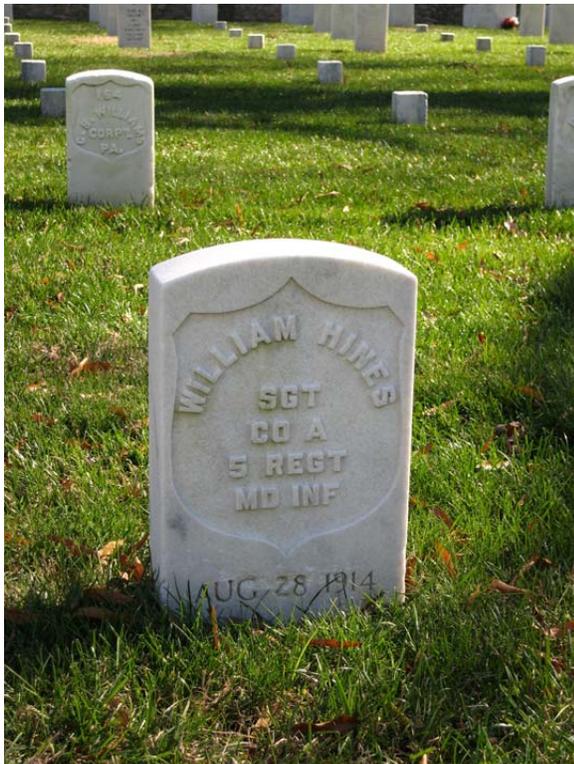
Figure 4.11: Example of recently installed National Cemetery Administration (VA) historical style stone "XA" at Glendale National Cemetery, with added inscription below. Note that the grave number, historically within the shield, was not replicated. SUNY ESF, 2006.

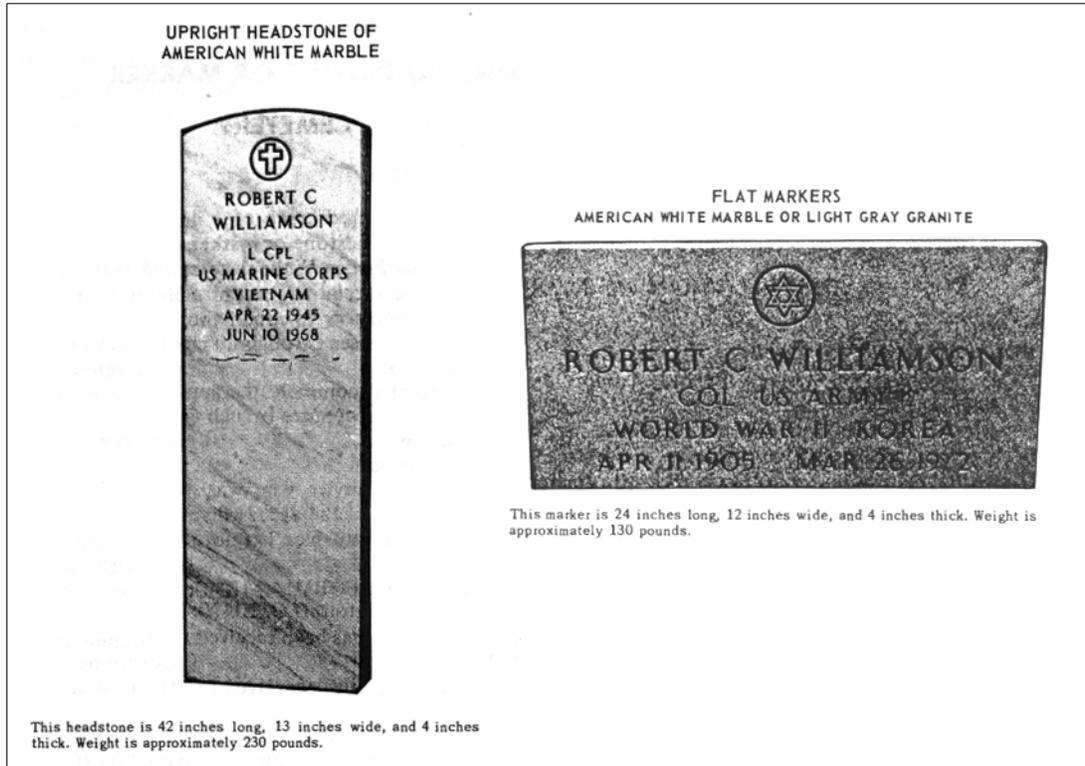
Figure 4.12 Current standard National Cemetery Administration General-style headstone (left) and flat marker (right, shown in granite). Department of Veterans Affairs, Department of Memorial Affairs, "Headstones and Markers" (Manual M40-3, December 1, 1982), Figure F.1. Note: Manual M40-3 is presently being revised.

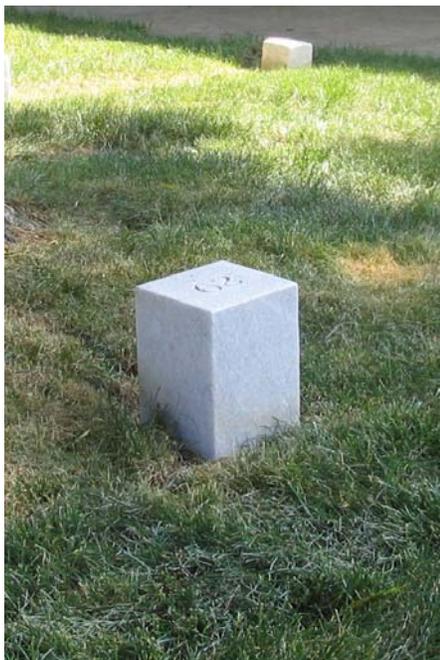
Figure 4.13: Reproduction Civil War-style block at Seven Pines National Cemetery. The font used for the grave number does not match the historic font; in addition, this block was installed at approximately 10" high, while historically the blocks were installed at 6" (historic block in background). SUNY ESF, 2006.

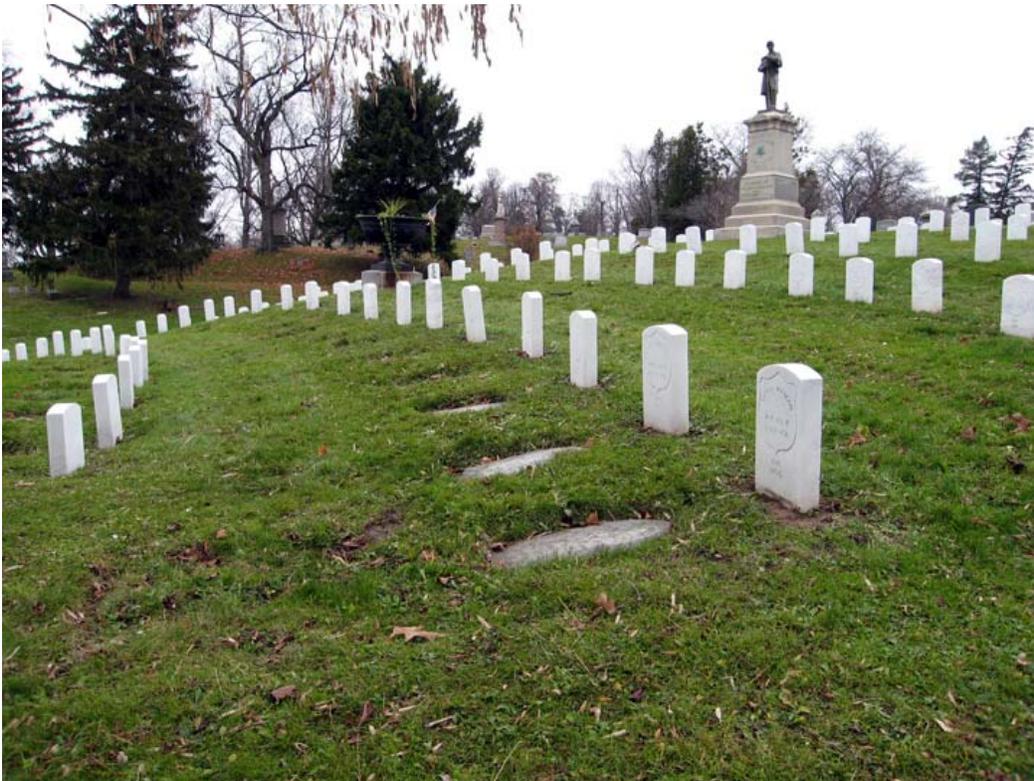
Figure 4.14: Illustration of alternative A implemented at the Soldiers Plot of Oakwood Cemetery, Syracuse, New York. The old headstones were laid flush with the ground and new government-issued General-style headstones were installed at the top of the grave. Note that the old headstones recede in the landscape. SUNY ESF, 2006.

This alternative has been implemented on a few graves at the National Park Service-administered Fredericksburg National Cemetery, where new headstones were installed due to errors in the inscription of the old.³¹ It was implemented on a comprehensive level in c.2000 at the Soldiers Plot of Oakwood Cemetery, Syracuse, New York, a Civil War-era military plot in a private cemetery. Here, the old weathered headstones were laid flush with the ground, and new government-issued General-style headstones were installed at the top of each grave (fig 4.14). Viewed in its entirety, the retention of the old markers has a subtle impact on the historic character of the landscape. This impact is outweighed by the value of retaining the old headstones, which were not replicated in-kind, thus retaining visual historical record. The end result would be the same at Poplar Grove, the only difference being the existing grave markers were set flush in the ground many years before.

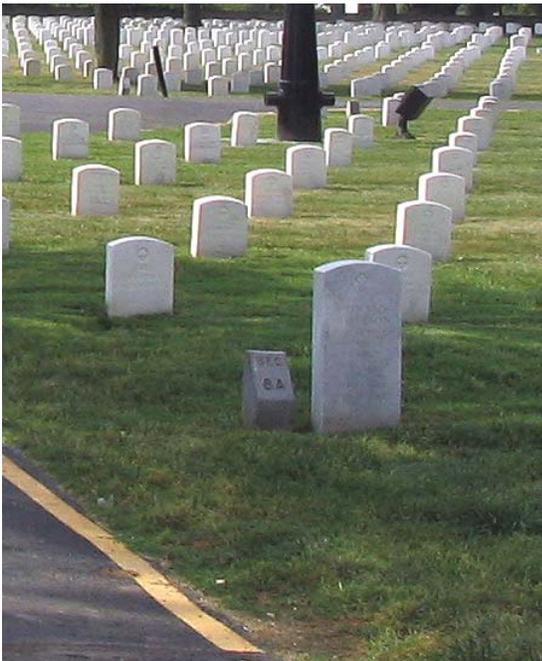
Figure 4.15: Granite post section marker at the Civil War-era Richmond National Cemetery (National Cemetery Administration). SUNY ESF, 2006.

Alternative A: Install low granite posts, with angled tops inscribed with the Division and Section classification, at each section (total of thirty-one sections). This type of section marker is used at the Civil War-era Richmond National Cemetery (fig. 4.15). Given the radial plan of the cemetery, the most visible place for the grave markers is at the front of the section, in the middle along the circular drive (Drawing 7). Installing

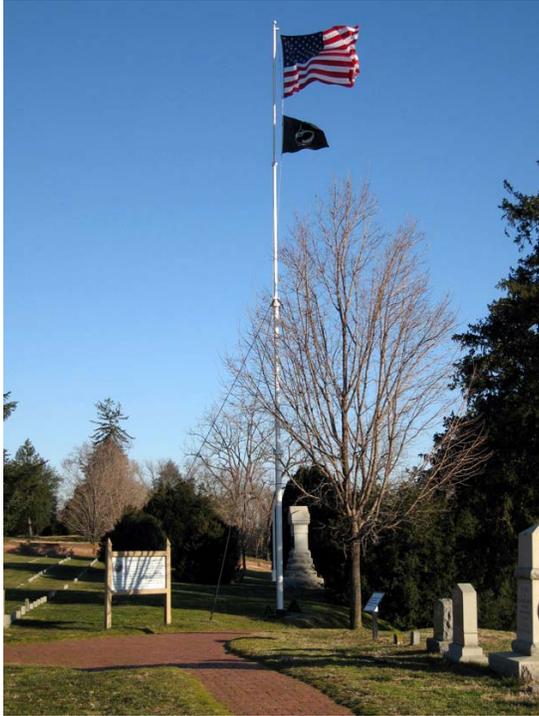
Figure 4.16: Flagstaff at Fredericksburg National Cemetery showing the same type of flagstaff as installed at Poplar Grove in 1930. The existing flagstaff at Poplar Grove had its upper sections and guy wires removed after the historic period. SUNY ESF, 2007.

Alternative A: Restore the existing flagstaff by replacing the missing upper sections and reinstalling the guy wires, and painting according to the specifications in the 1931 National Cemetery Regulations: black base and guy wire turnbuckles, white shaft and guy wires.³² This option would restore the flagstaff to its historic appearance, at a height of approximately 80' or sufficiently high to reach above the tree canopy. The flag should be visible from Vaughan Road once the west woods are removed (CSA-Task 2). The flagstaff was historically fabricated of sections bolted together at flanges. The same style of flagstaff was installed at Fredericksburg National Cemetery, where it remains standing intact (fig. 4.16). This flagstaff, although shorter, could be used as a model for restoring the Poplar Grove flagstaff.

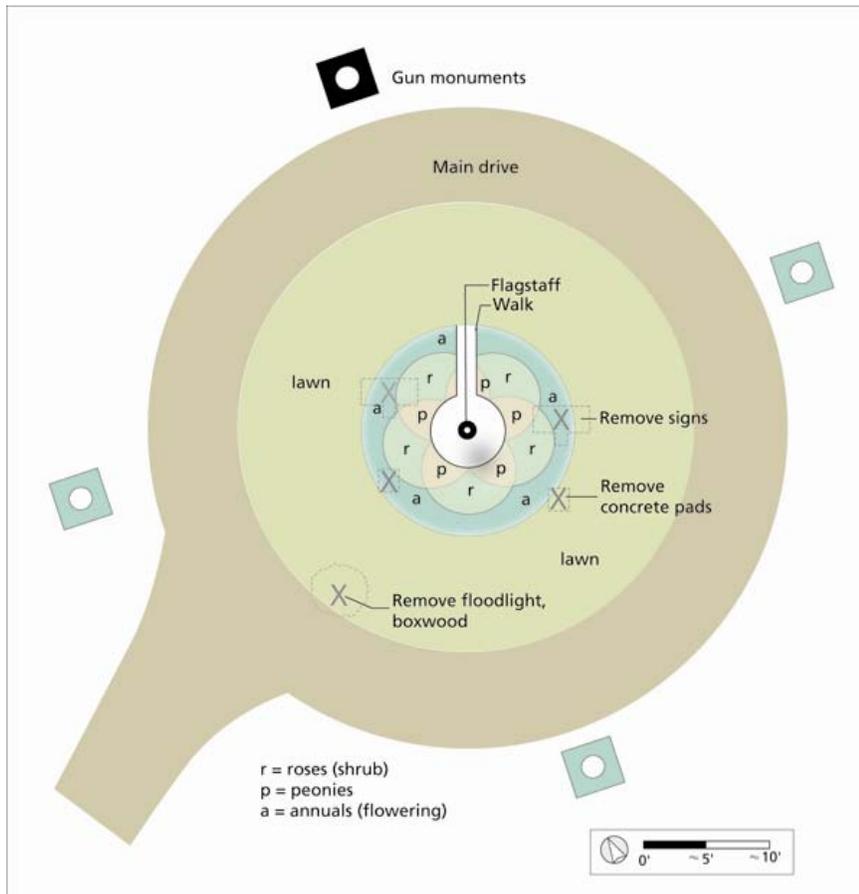
Fig 4.14: Central circle showing suggested planting plan for flowerbed surrounding the central flagstaff. SUNY ESF.

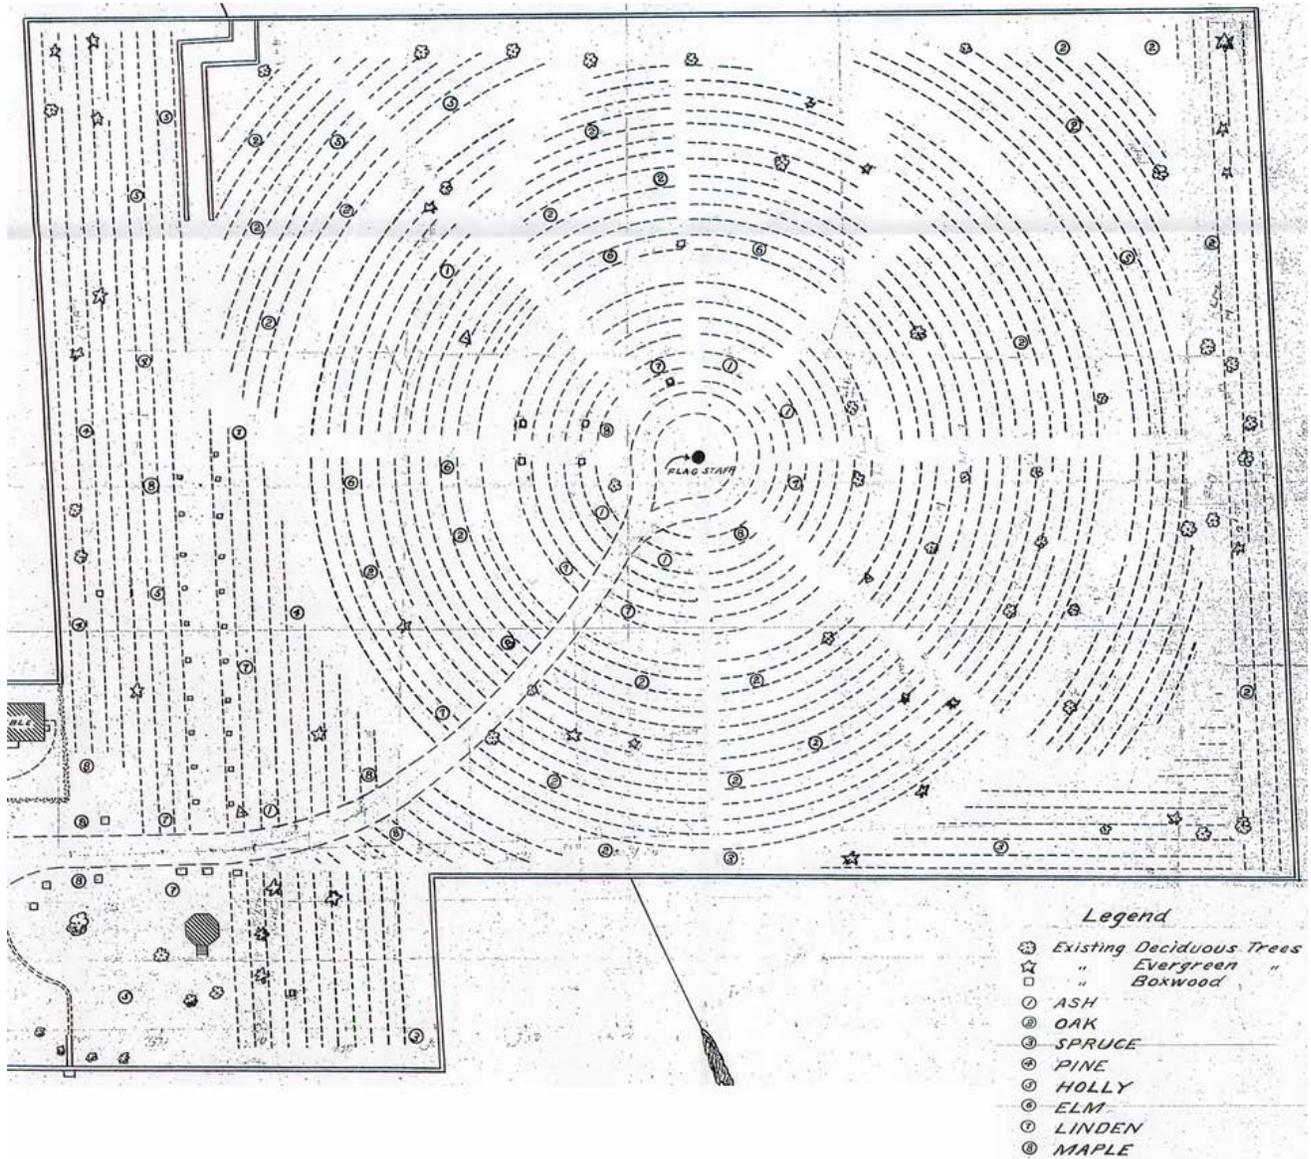
4.18: Detail, War Department 1931 planting plan, "Tree Planting Layout" illustrating distribution of specimen trees (see figure 1.64 for complete plan). The ash specified was European mountain ash; oak, pin oak; pine, Austrian pine; spruce, Norway spruce; and maple, Norway maple. This plan does not identify the species of existing trees, but these were documented on subsequent plans produced by NPS.

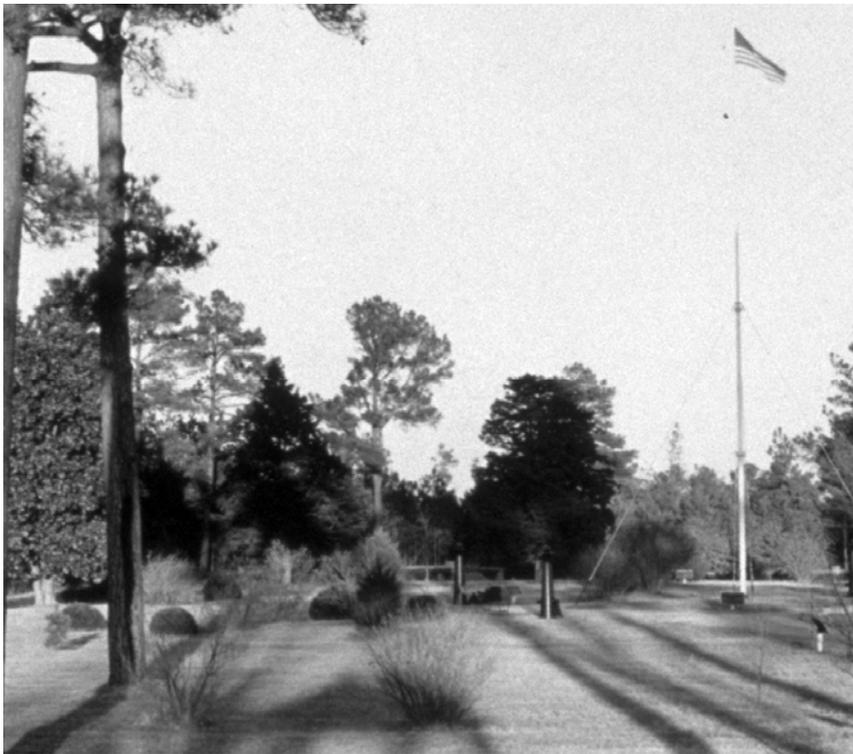
Figure 4.19: Detail of 1939 photograph (Figure 1.71) showing low, clipped mounded boxwood shrubs along east-west walk west of the flagstaff. These shrubs were documented on the 1931 War Department planting plan. This photograph also shows near the right lower edge one of the iron tablets.

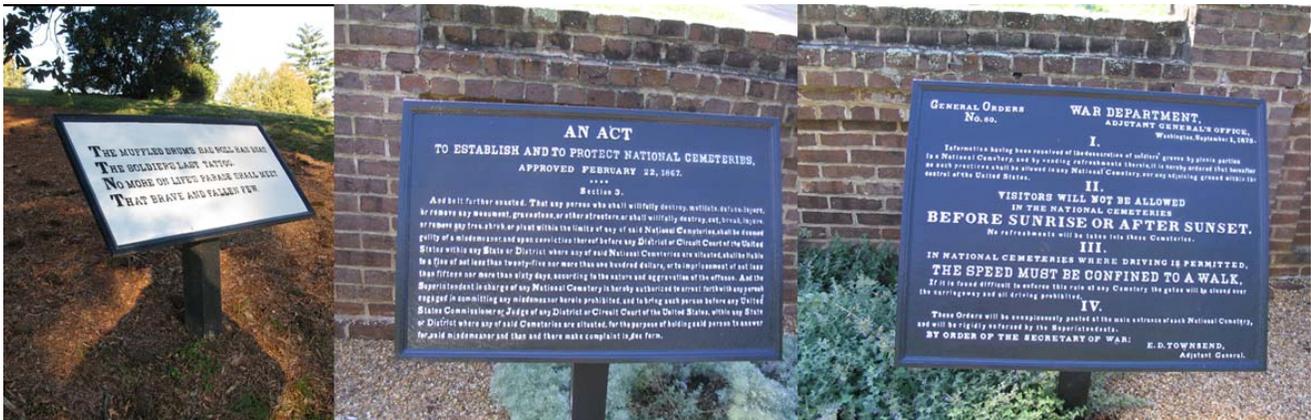
Figure 4.20: Iron tablets: Bivouac of the Dead at Fredericksburg National Cemetery (painted incorrect colors); General Orders and Act to Establish and Protect National Cemetery tablets at Culpeper National Cemetery (painted correct colors). No examples of the “Visitors Notice” tablet were found. SUNY ESF, 2006-2007.

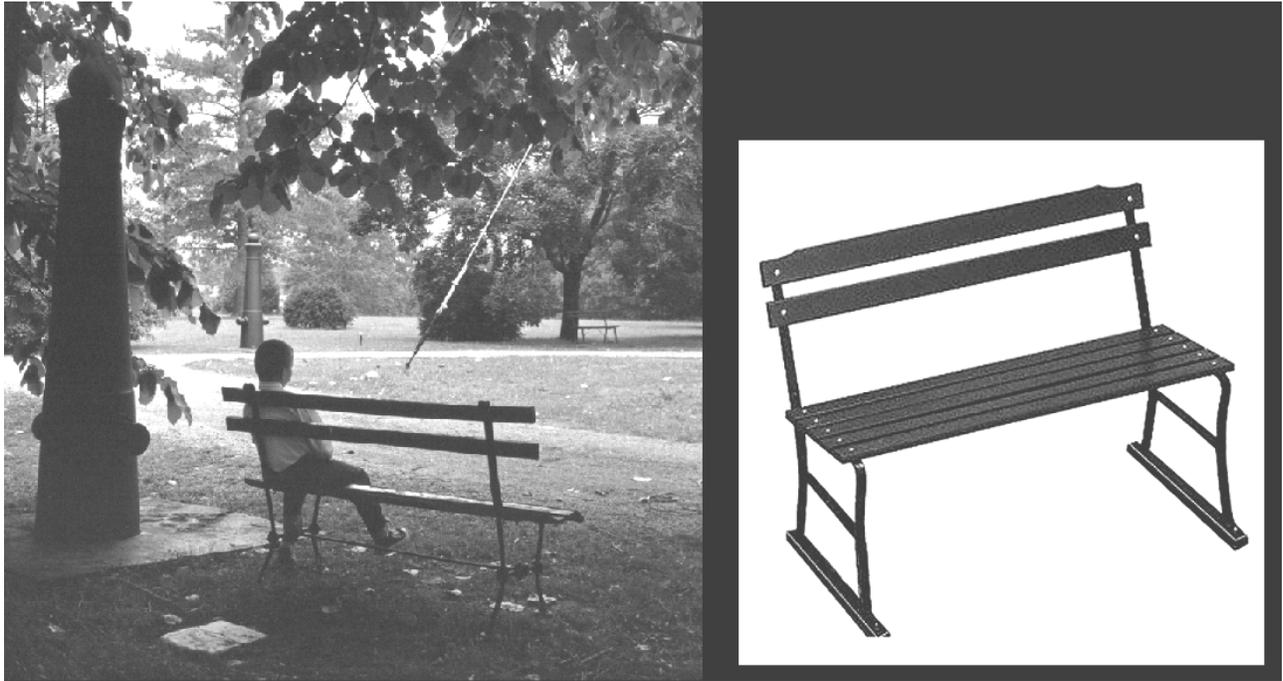
Figure 4.21: Detail of 1968 photograph showing c.1877 wood-slat and iron frame settees (left), and example of a contemporary bench with similar design. This bench is item AL006, "Traditional Garden Bench," at Benches.com, www.benches.com, accessed 12 February 2007.

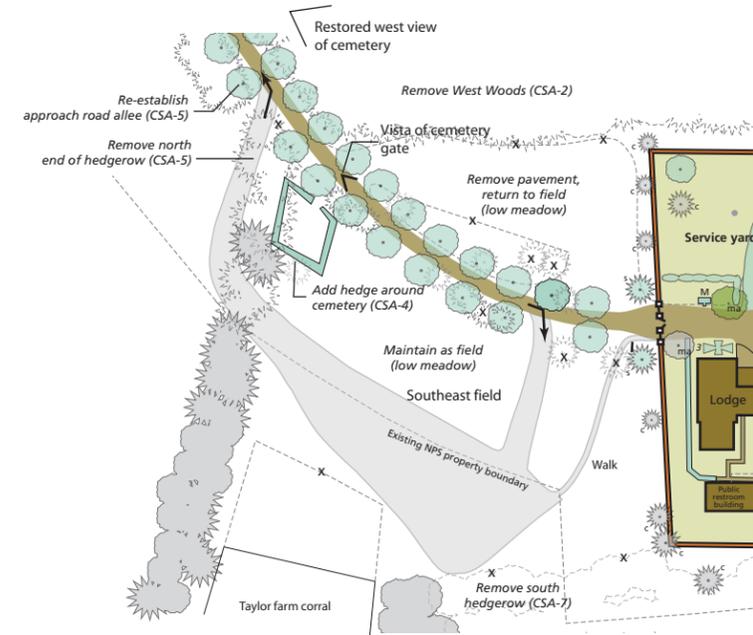
Alternate A: Parking lot relocation with NPS acquisition of Taylor farm (using approximate existing parking lot footprint).

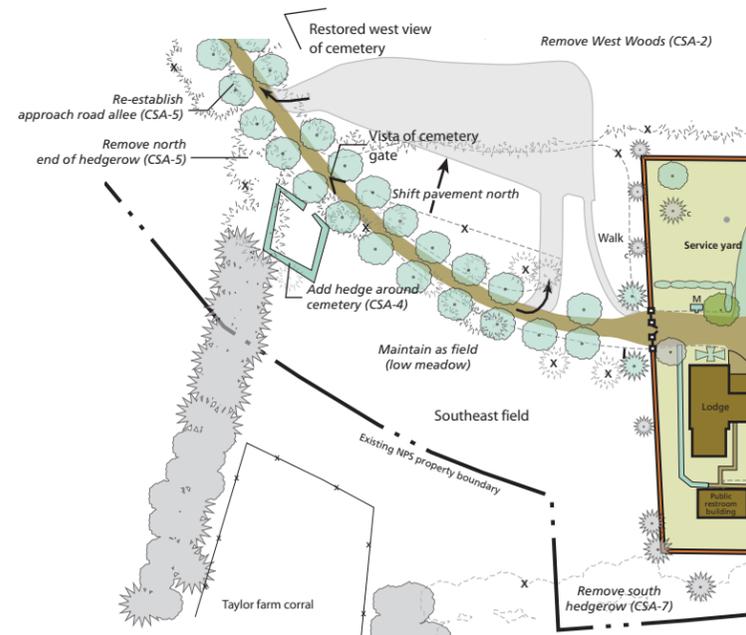
Alternative B: Shift existing parking area north and west (using approximate existing parking lot footprint).

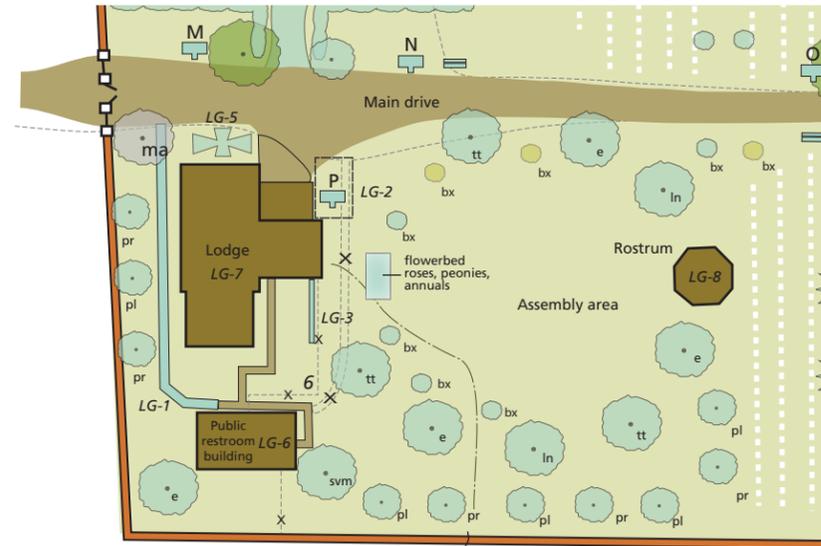
Alternate #1: Contemporary Planting Scheme Evoking Turn-Around

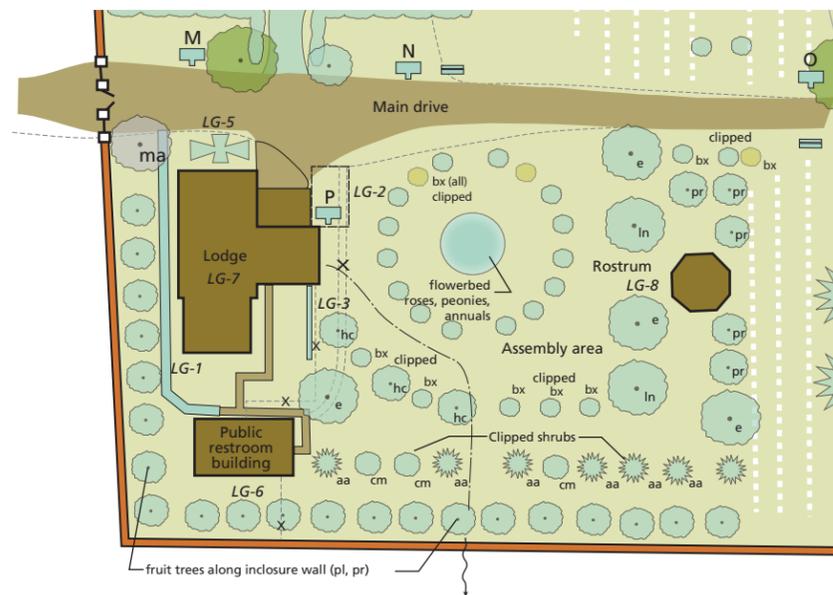
Alternative #2: Plantings Based on 1892 Quartermaster General Plan

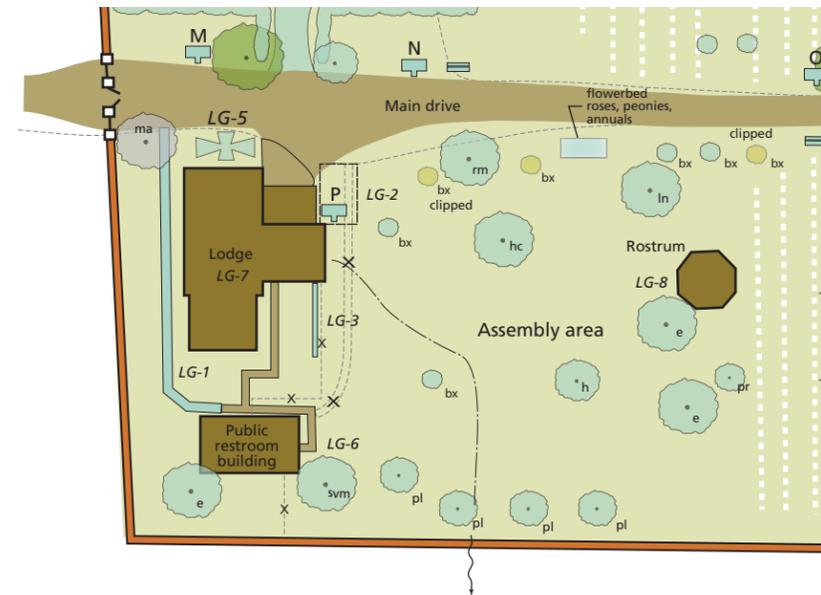
Alternative #3: Planting Based on 1931 War Department Planting Plan
