Perry's Victory and International Peace Memorial

Environmental Assessment

**Restore North and South Seawalls at Perry's Victory to
Safeguard Site Project, Ottawa County, Ohio
PEVI-200745**

Environmental Assessment
Final
November 2020

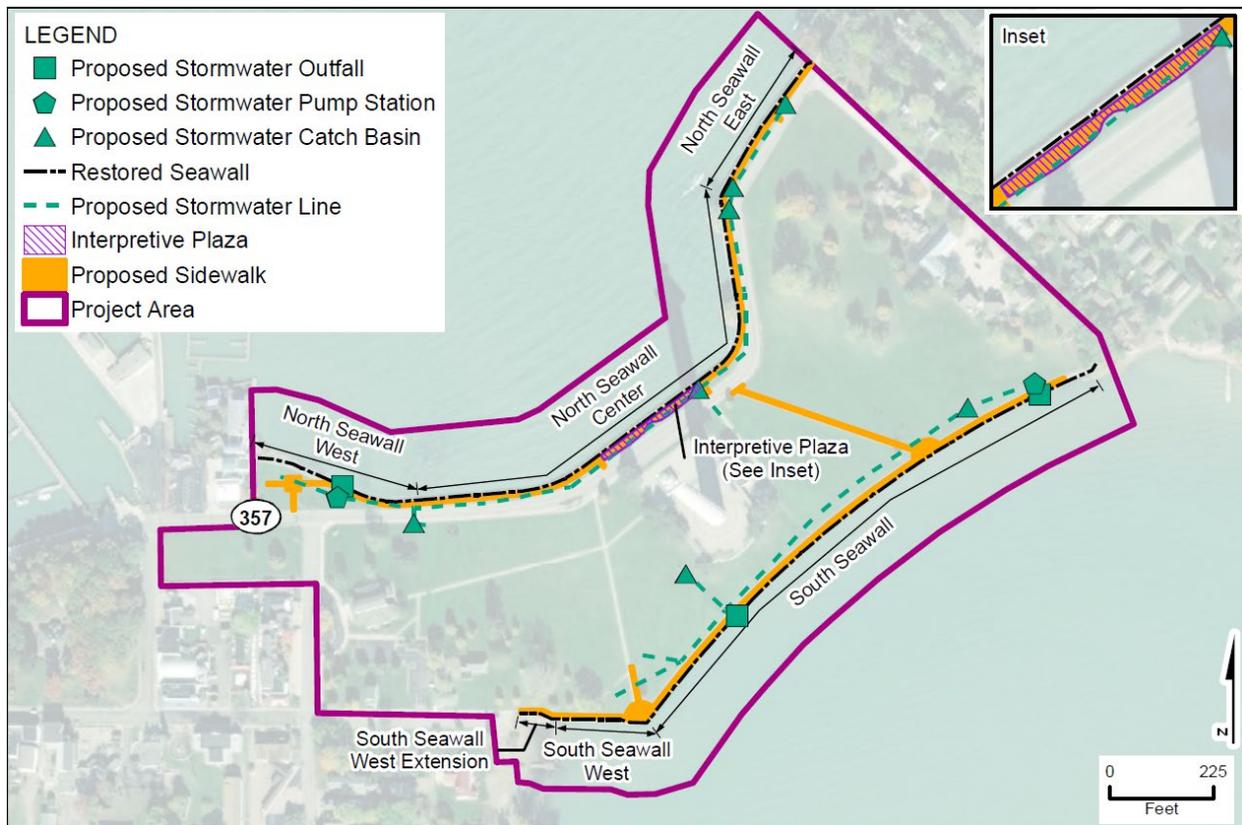
Figure 2-1. Components of the Proposed Action

Seawall restoration activities would provide partial or full replacement of 3,322 LF of the existing North and South Seawalls, provide 80 LF of new seawall by extending the length of the South Seawall, and patch repairs to the South Seawall (**Figure 2-1**). It includes elements from several of the alternatives considered and is tailored to meet varying seawall restoration needs. All of the restoration activities would be designed with a Galveston profile, consistent with the existing seawall design, because it could provide protection with a relatively small footprint and lower wall height than other alternatives.

The South Seawall would be restored in 2022. The South Seawall (1,270 LF) would be partially demolished and then rebuilt to a new elevation (**Figure 2-1**), which would be typically 18 inches above the existing height. One void on the South Seawall would also be repaired.

As part of the Proposed Action, the stormwater system would be upgraded to increase its capacity, prevent lake water from backflowing on the site, and convey Park stormwater and water that overtops the seawalls to the lake through a combination of gravity outlets and pumping stations. The improvements would include new drainage pipes; two new pump stations, one on the north side of the Park and one on the south side; and replacing nine catch basins with improvements sized to manage larger flow volumes. A new 10-inch outfall would be drilled into the North Seawall and two 10-inch outfalls would be added on the South Seawall. The locations of new pipe, and catch basins are shown on **Figure 2-1**.

The Proposed Action also includes features recommended in the Cultural Landscape Treatment Plan (NPS 2018) to enhance visitor access to PEVI and promote a greater understanding of the Park's cultural resources and historic significance. New sidewalk would be installed along the North Seawall, a 128-LF section of the North Seawall would be realigned, and step-lighting would be installed in the North and South Seawalls. These actions would improve pedestrian safety and provide new access for visitors. The existing sidewalk along the South Seawall would be replaced (**Figure 2-1**).

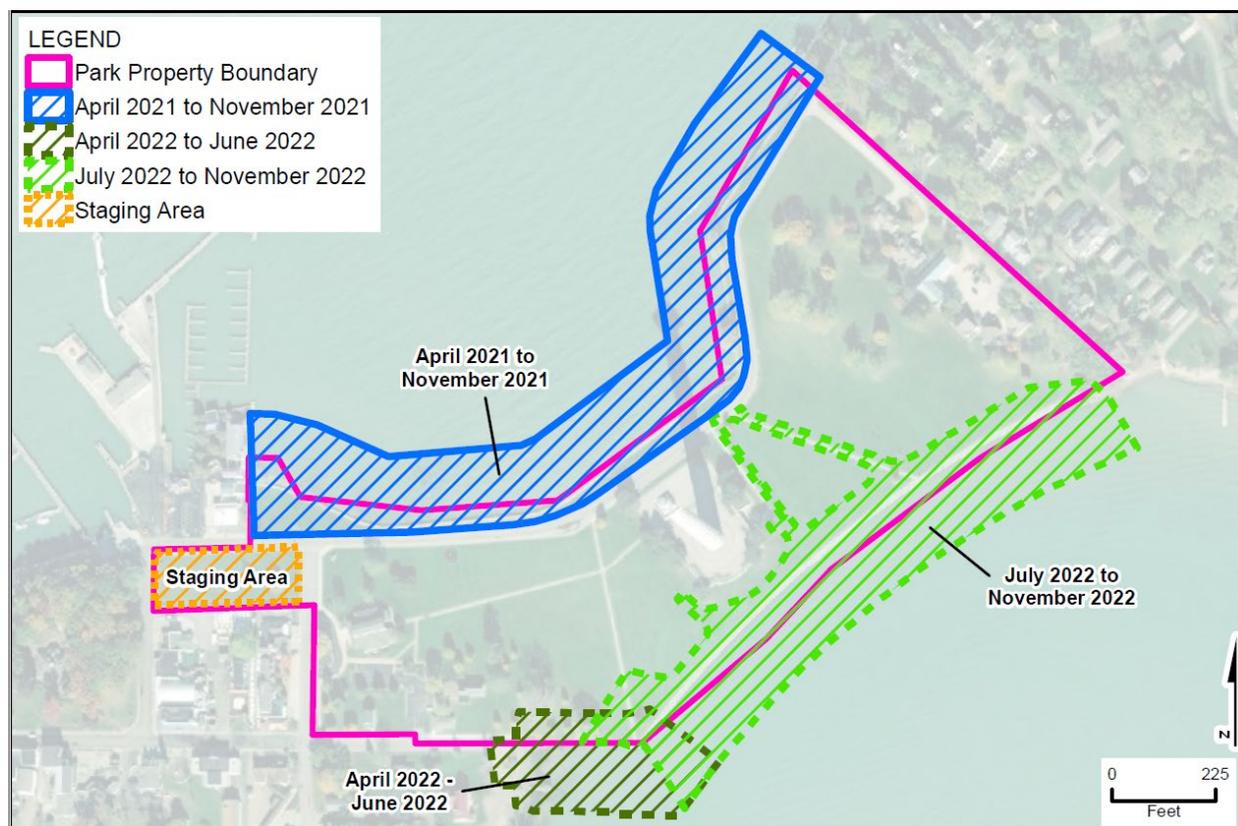
Figure 2-2. Construction Workspaces and Phasing

Figure 2-2 shows the planned staging area near the entrance to the Park at the Peace Garden Lawn. This temporary upland staging area would support the contractor's offices and provide a place to store materials and equipment during both construction phases. During construction, the work areas and staging area would be fenced off and

South Seawall construction would be split into two phases, with construction of the Seawall—West Extension and repairs to South Seawall—West occurring between April and June 2022 to minimize impacts to the Public Beach. The remaining South Seawall construction would follow.

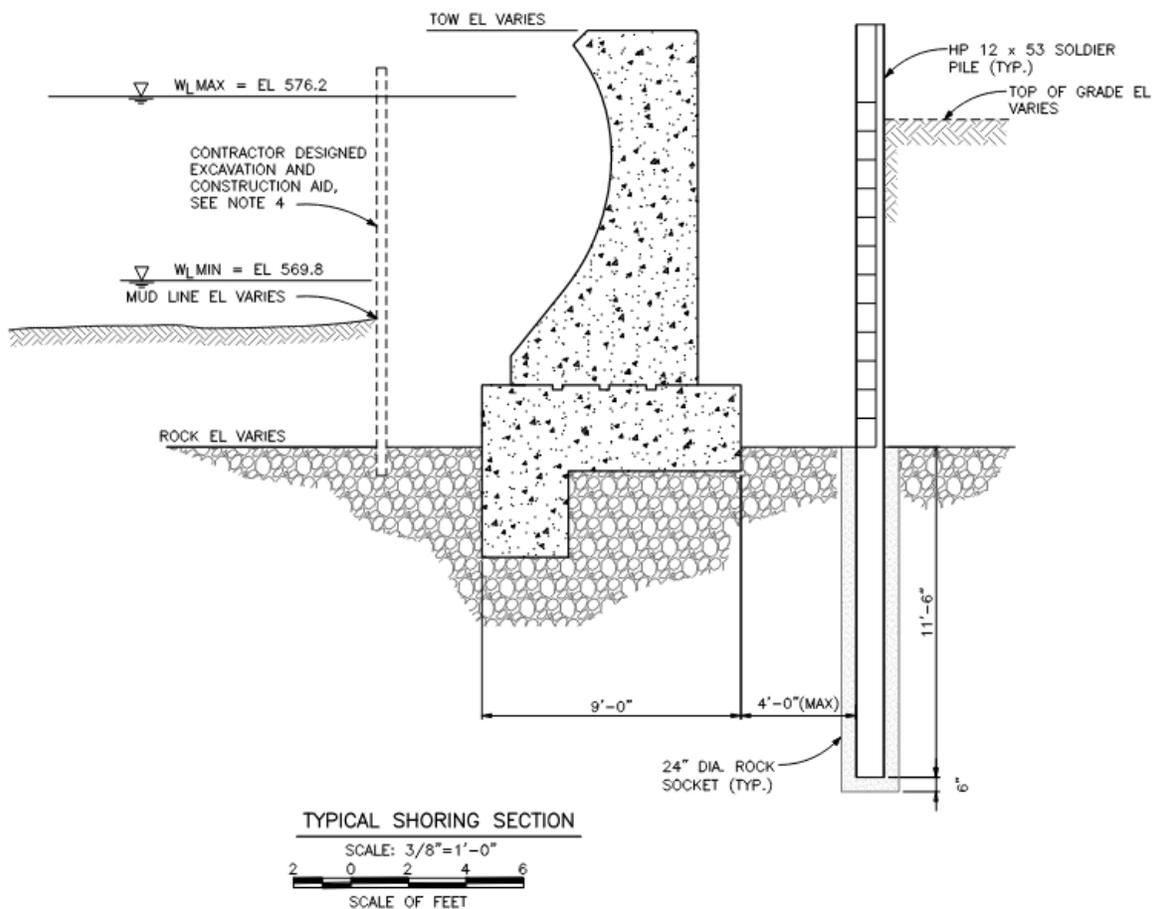
Figure 2-3. Typical Shoring System

The center section of the North Seawall is the only portion of seawall that would be completely demolished and replaced. The contractor would install a shoring and excavation system on the landward side of the existing North Seawall—Center section, consisting of soldier piles with concrete lagging, to stabilize sediments in the construction area. This shoring system protects and stabilizes the roadway throughout construction. After the shoring and excavation system is installed, the existing seawall would be demolished, and then barriers would be installed lakeward of the new wall alignment, to allow the contractor to excavate to bedrock, shown on **Figure 2-3**. The barriers would allow the contractor to perform underwater excavation and protect the construction from waves.

bottom. Temporary shoring would be installed, and a trench shield would be used to hold back loose soil, as described in Chapter 2.

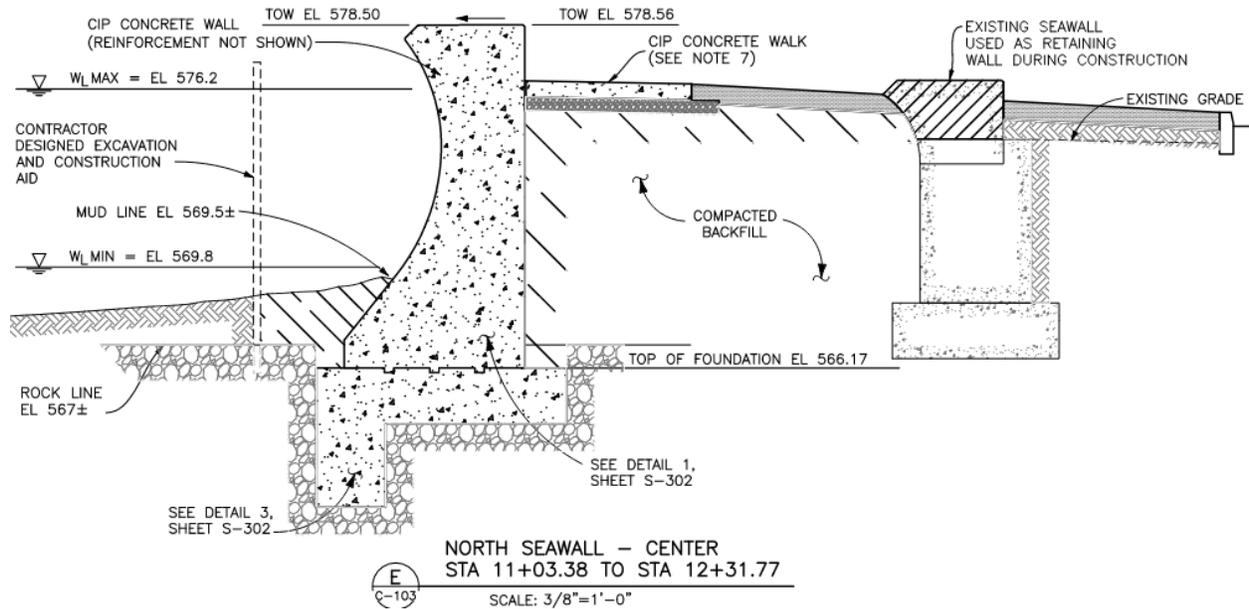
Figure 2-4. Existing Seawall Used as Shoring

The 128-foot realigned section of the North Seawall—Center section, would be constructed in a similar way. However, the existing wall would be used for shoring (**Figure 2-4**) and removed below grade after construction is completed.

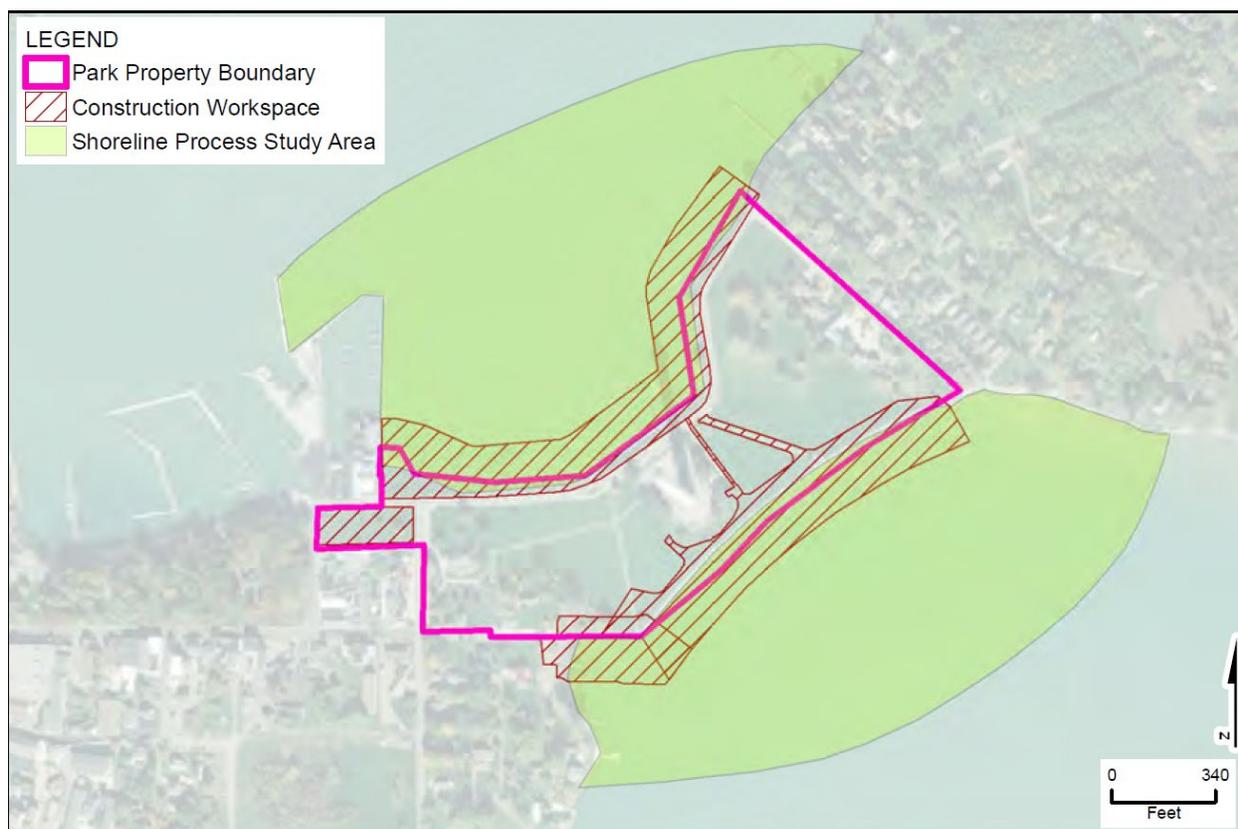
Figure 3-1. Affected Environment Study Area

This chapter provides an overview of existing resources at the Park. The affected environment includes the overall project area as described in Chapter 2 and shown on **Figure 3-1**. As part of this EA the affected environment includes the 24-acre Park property, adjacent shoreline, and approximately 10.4 acres of temporary in-water workspace. The Park is comprised of 25 acres of landscaped grounds, including the 352-foot-tall Monument, approximately 6 acres of well-tended lawn, the Visitor Center, the Monument plaza, walkways, Park maintenance buildings, and the North and South Seawalls. The Park is used as a resting spot and walkways for visitors. The open spaces in the Park attract casual visitors year-round but are also commonly frequented by visitors who picnic in the Park during summer. SH 357 crosses the Park and is the only road connecting the east and west sides of South Bass Island. The neighboring properties use this road through the Park as the only access to essential services on the island.

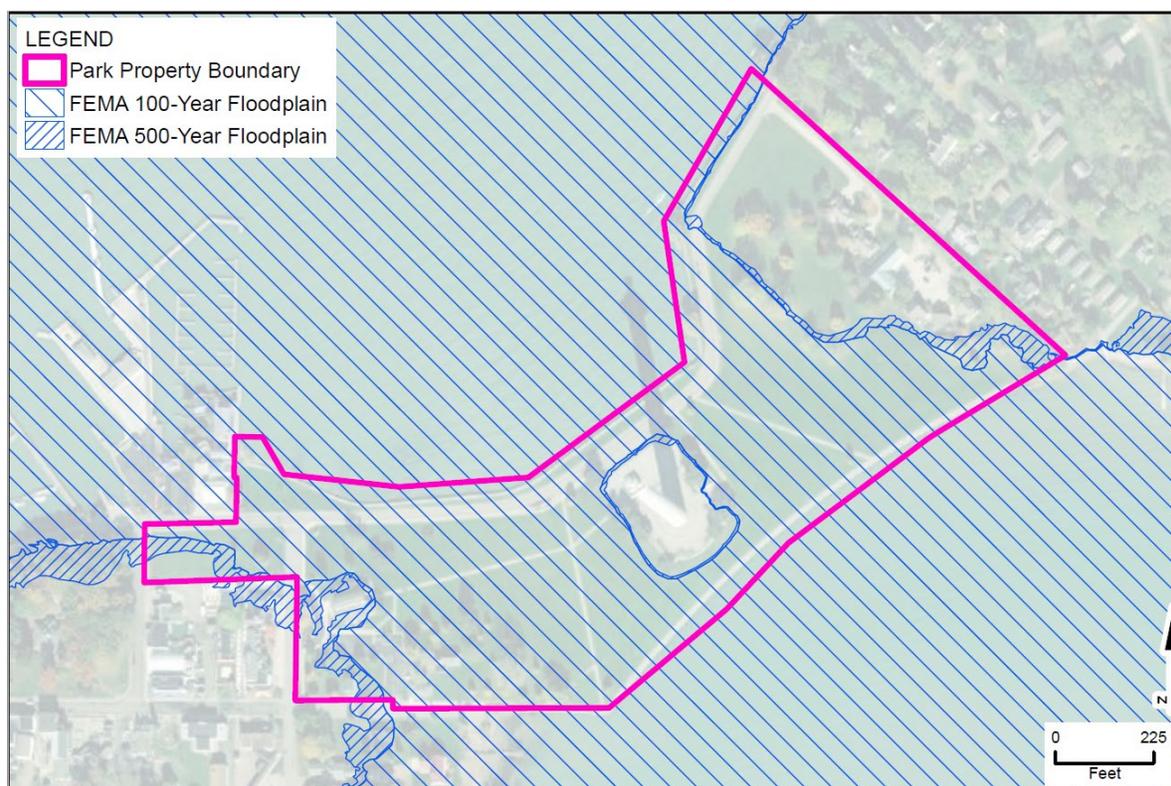
Figure 3-2. FEMA Floodplain

Most of the Park is mapped in the Federal Emergency Management Agency (FEMA) 100-year floodplain (Zone AE – EL 577.4 feet), with small portions of the northeast and southwest ends of the Park in the 500-year floodplain (Zone X) (FEMA 2020) (**Figure 3-2**). Typical floodplain functions such as flood storage, flood conveyance, wildlife habitat, erosion reduction, sediment trapping, and pollutant removal are limited in the Park as a result of constructed features (NPS 2018). These features include significant disturbance by development, layers of fill, and landscaped Park grounds., onsite as a result of wave overtopping and stormwater system deficiencies. 13 inches (Jacobs, 2020). insufficient stormwater infrastructure in place, flooding in the Park regularly occurs during large storm events and when lake levels are elevated.

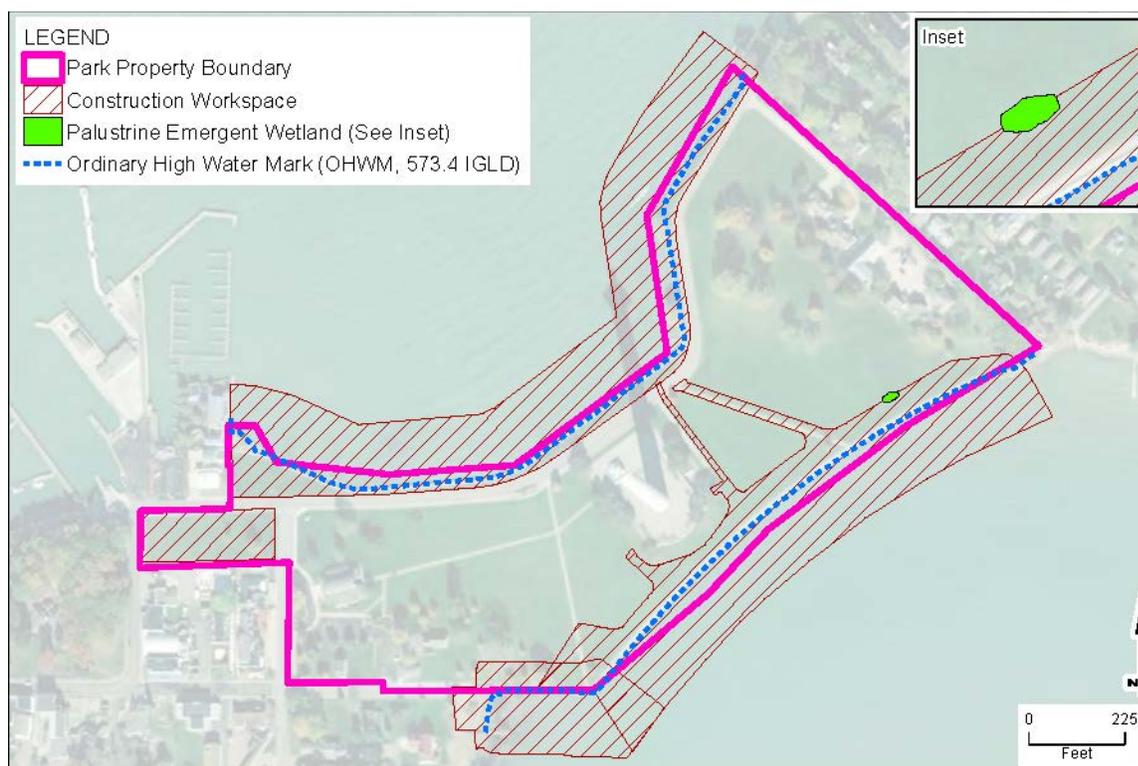
Figure 4-1. Proposed Action Impacts

In each impact category, impacts were assumed to be worst-case, meaning they would occur throughout the construction area shown on **Figure 4-1**. More likely, the entire area would not be an active construction area. For example, an area of temporary barge passage is described as an impact area, although construction, excavation, or other disturbance may not occur.

A VIA was conducted to assess the potential for visual impacts from the proposed changes to the seawalls and to the sidewalks along the seawalls. Six viewsheds were identified in the CLTP as contributing features of the cultural landscape (NPS 2018) (**Table 3-2**) (**Figures 3-2 and 4-1**). Two additional viewsheds, Views 7 and 8, were assessed to evaluate the potential for impacts from the proposed pump station. The VIA confirmed that the proposed changes were either not visible in Views 1, 4, 5, 7, and 8, or would not affect the cultural landscape. Views 2, 3, and 6 had negligible changes, but these changes would not affect important characteristics that contribute to the cultural landscape. Short-term impacts would be limited to temporary obstructions associated with construction machinery but would not obstruct or alter any contributing viewsheds after construction (CH2M 2020f).
