Chattahoochee River National Recreation Area Georgia

Floodplain Statement of Findings

Paces Mill Unit Rehabilitation

September 2022

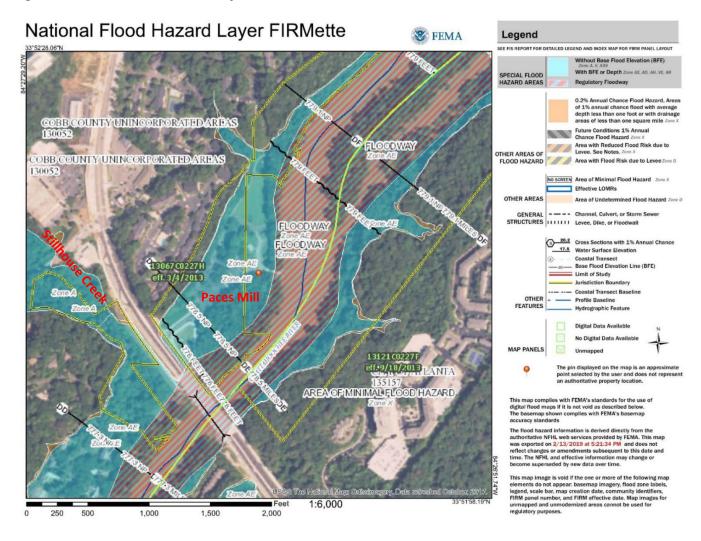
Figure 5. National Flood Hazard Layer FIRMette

Zone A - An area inundated by 1% annual chance flooding, for which no BFEs have been determined. **Zone** AE - An area inundated by 1% annual chance flooding, for which (base flood elevations) have been determined. Paces Mill is primarily in Zone AE with the exception of Stillhouse Creek, which is in Zone A.

Elevations at Paces Mill range from 750 feet at the river to approximately 775 feet across most of the site, which is generally level above the banks of the river. The site is bordered to the west by a palisade (steep uphill slope). Nearly the entire project site is in the 100-year floodplain and Federal Emergency Management Agency (FEMA) Zones AE and A (figure 5). A 100-year floodplain or 100-year flood describes an area or event subject to a 1% probability of a certain size flood occurring in any given year. Zones A and AE are defined by FEMA as the channel of a stream plus any adjacent floodplain areas that must be kept free of encroachment so that the 1% annual chance flood can be carried without substantial increases in flood height. Detailed hydraulic analyses are not conducted for Zone A, but are for Zone AE where base flood elevations are determined and mapped. The base flood elevation (100-year flood) for this site is 778 feet. Impervious surfaces at Paces Mill total approximately 5 acres.
