Mesa Verde National Park

Spruce Tree House Alcove Arch Stabilization

Environmental Assessment

March 2023

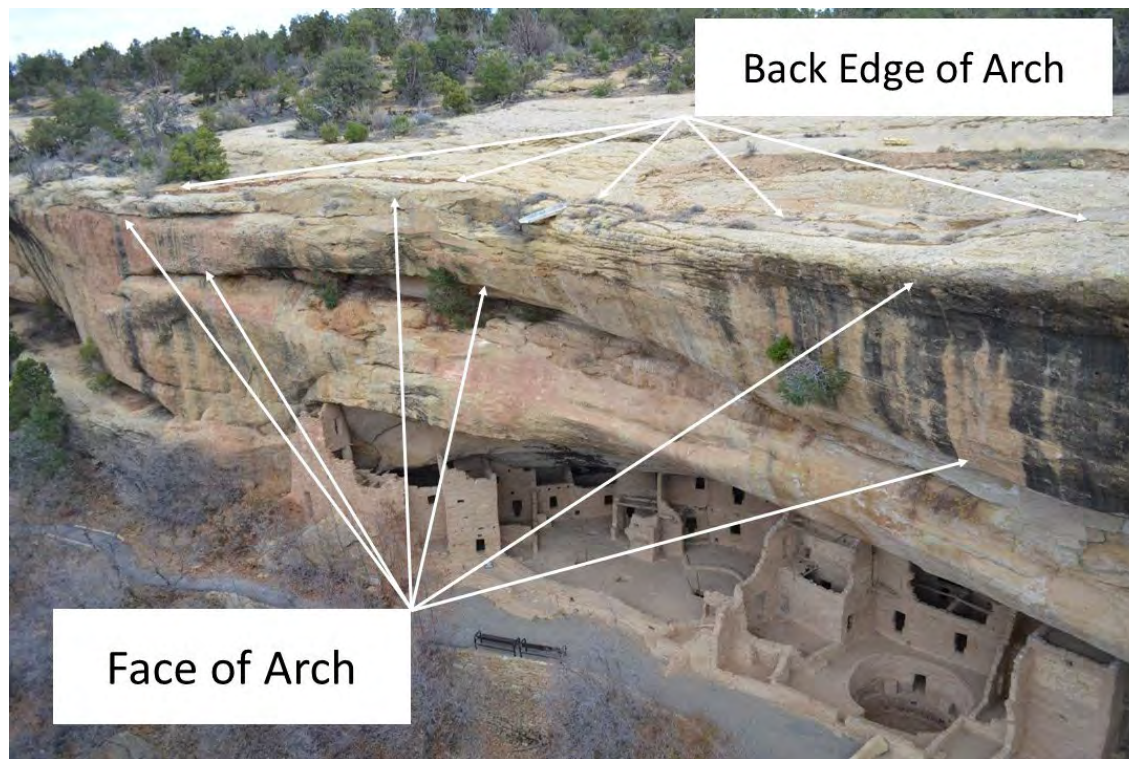
Figure 2-1. The Sandstone Arch Face above the STH Cliff Dwelling
(Photograph source: James A. Mason, PhD, PE, NPS Vanishing Treasures Program 2019)

The proposed stabilization design would remove select loose material via scaling,⁴ install rockbolts,⁵ and install several reinforced concrete supports along the face of the alcove arch (Figure 2-1). Figure 2-2 illustrates the type of rockbolt that is specified for this project.

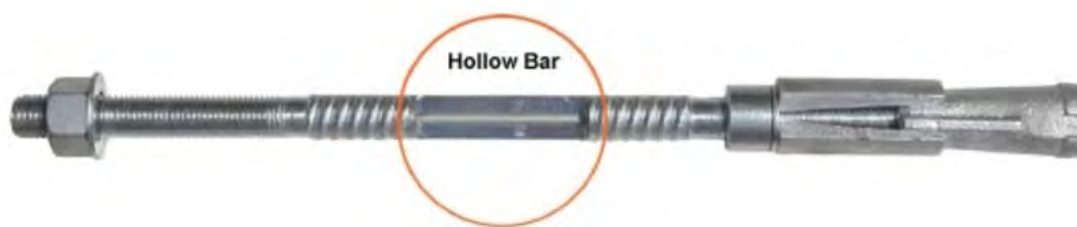
Figure 2-2. Williams Bar Rockbolt

This is an example of the type of rockbolt that is specified for this project. It is hollow for down-hole grouting with a locking head for anchoring the down-hole end (www.williamsform.com).

⁵ Rockbolts are long, threaded bars made of corrosion-resistant steel used to stabilize rock. A hole is drilled with a non-percussive core barrel, the rockbolt is inserted into the rock, the anchor is set, and the rockbolt is tested before being grouted in place. The rockbolt is tensioned to distribute the load evenly onto the surrounding rock by clamping weaker layers together. Passive rockbolts are not tensioned; they increase the local strength of the rock mass due to arching compression and help prevent the rock mass from falling.

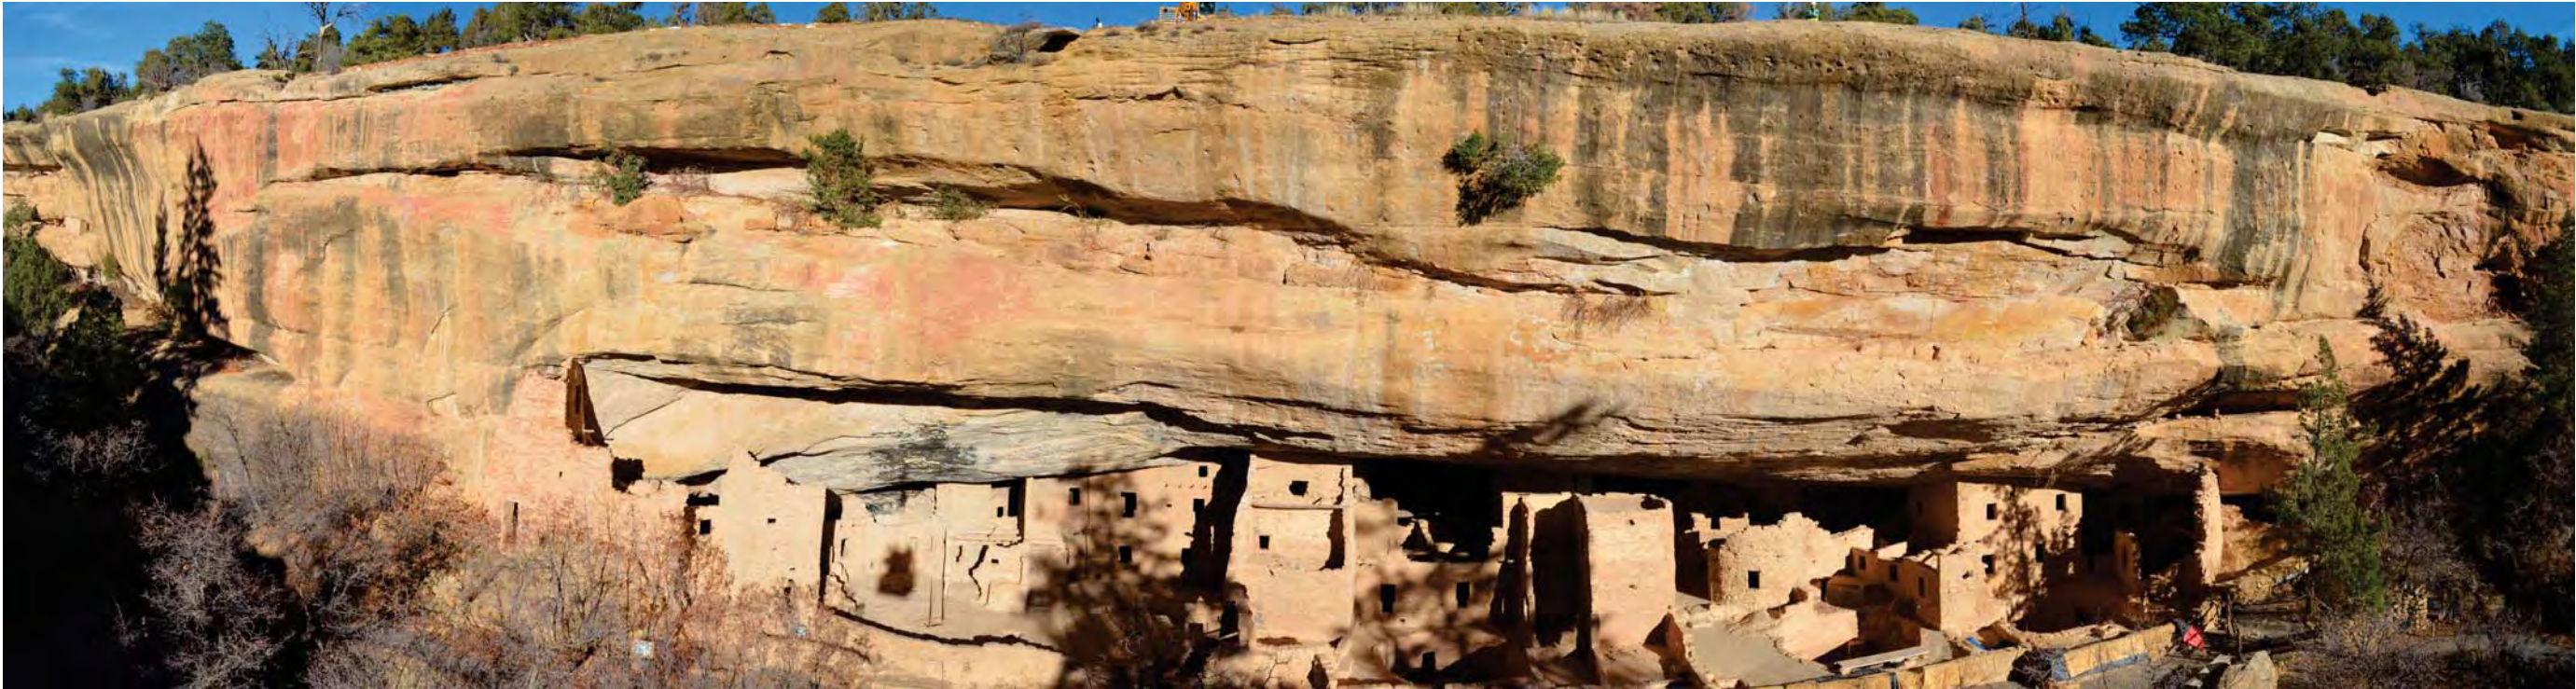
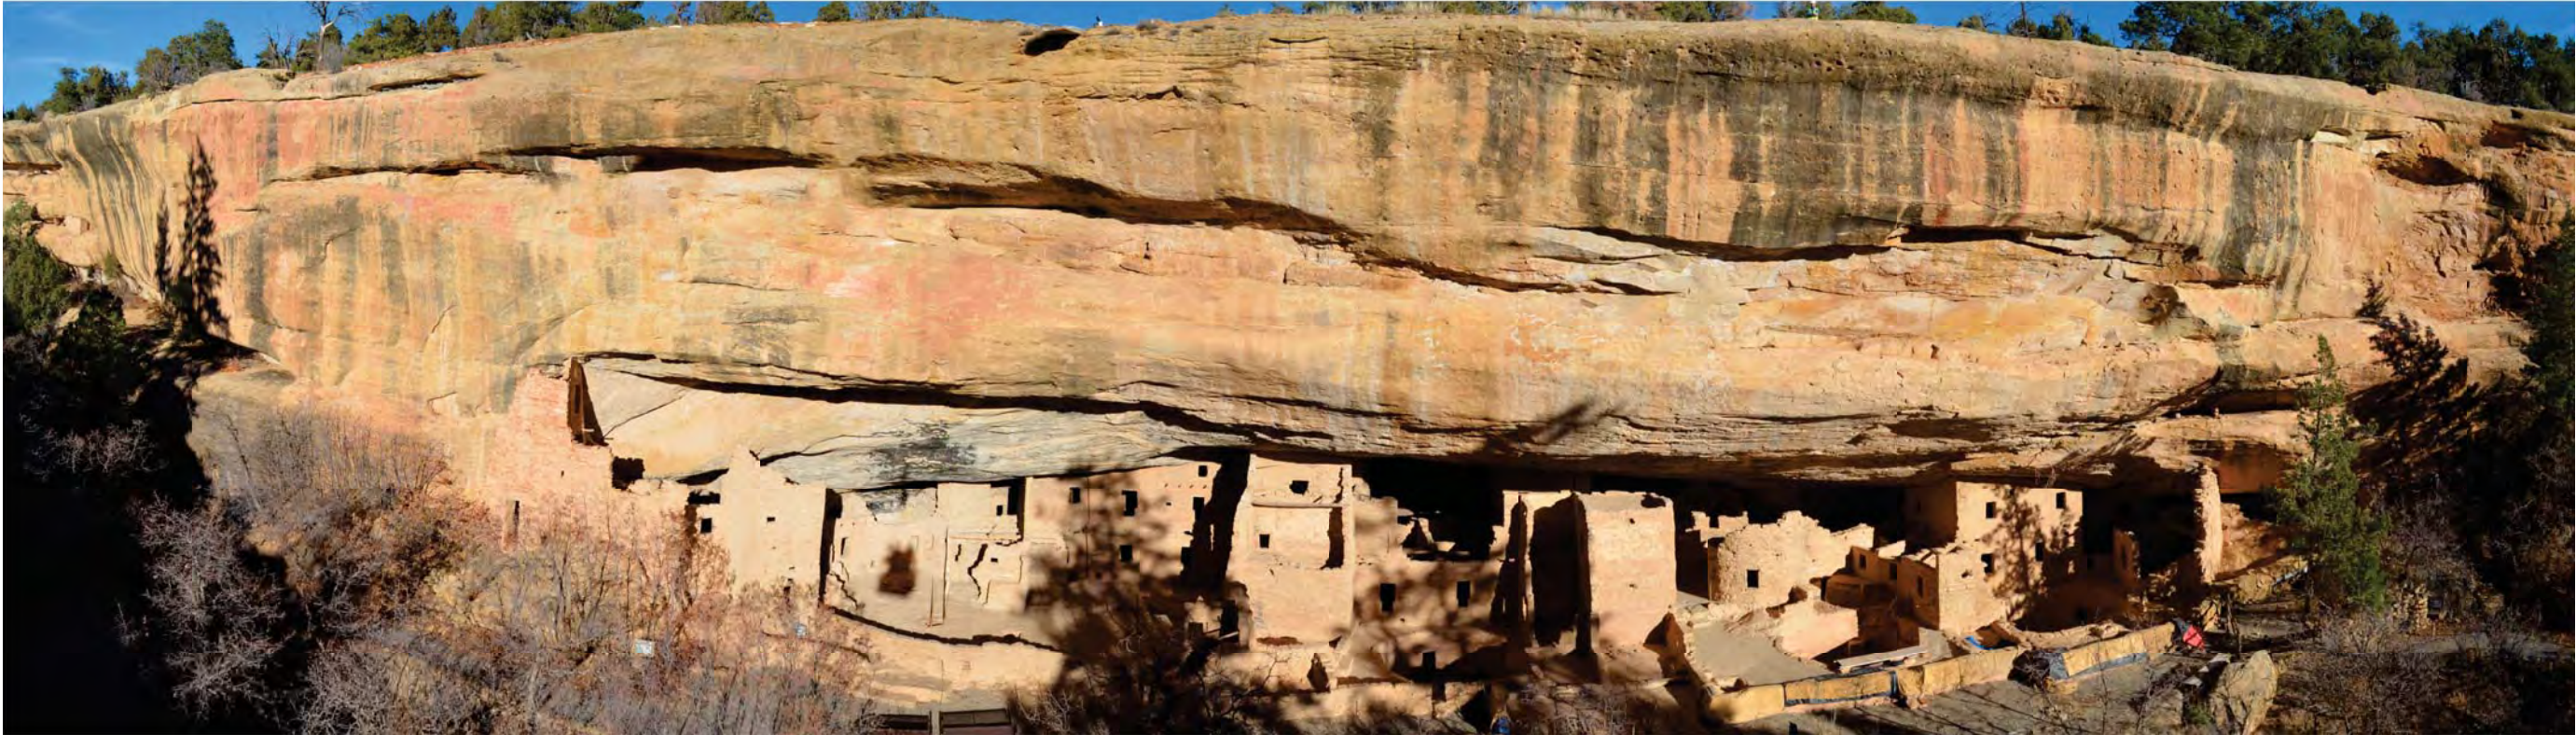
Figure 2-7. Before and After Conditions – Sandstone Arch Face

EXISTING CONDITIONS

CONDITIONS AFTER PROPOSED ROCK SCALING, VEGETATION REMOVAL, AND CONCEALING EXISTING ROCK ANCHORS

Figure 2-7 shows the comparison of existing visual conditions with a simulation of conditions after the proposed rock scaling, vegetation removal, and concealing of the rock anchors.
