# REHABILITATE LINCOLN MEMORIAL REFLECTING POOL AND GROUNDS

CONCEPT SUBMITTAL TO THE U.S. COMMISSION OF FINE ARTS

JULY 16, 2009

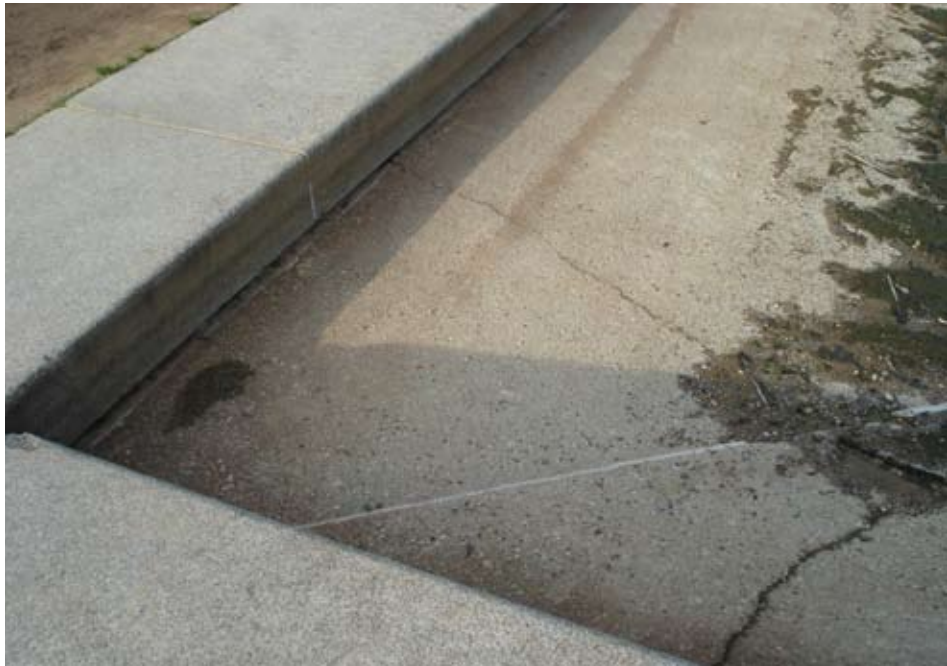
POOL FLOOR HAS SETTLED AND SEPARATED FROM COPING

- Pool bottom has settled; outward leakage of pool water, inward leakage of groundwater, deterioration of the pool bottom

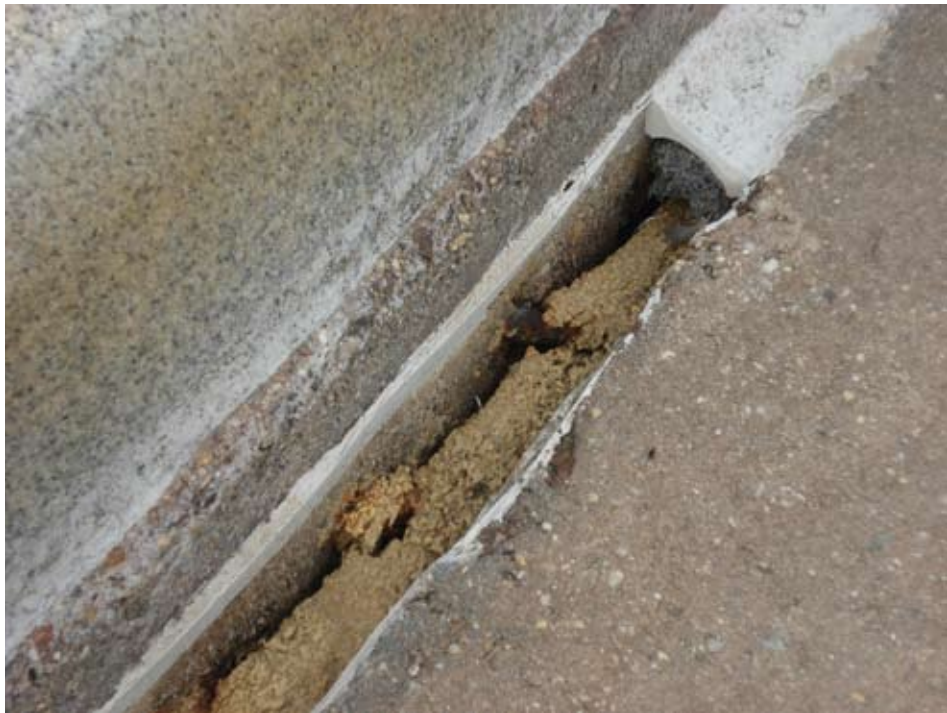
THE BACKER ROD AND SEALANT AT THE POOL FLOOR/COPING JOINT HAVE DETERIORATED

- Damage to the coping stones has allowed water intrusion into the supporting structural elements
- Structural repair will be required; epoxy crack injection, partial demolition and reinforcement replacement, areas of complete grade beam reconstruction.

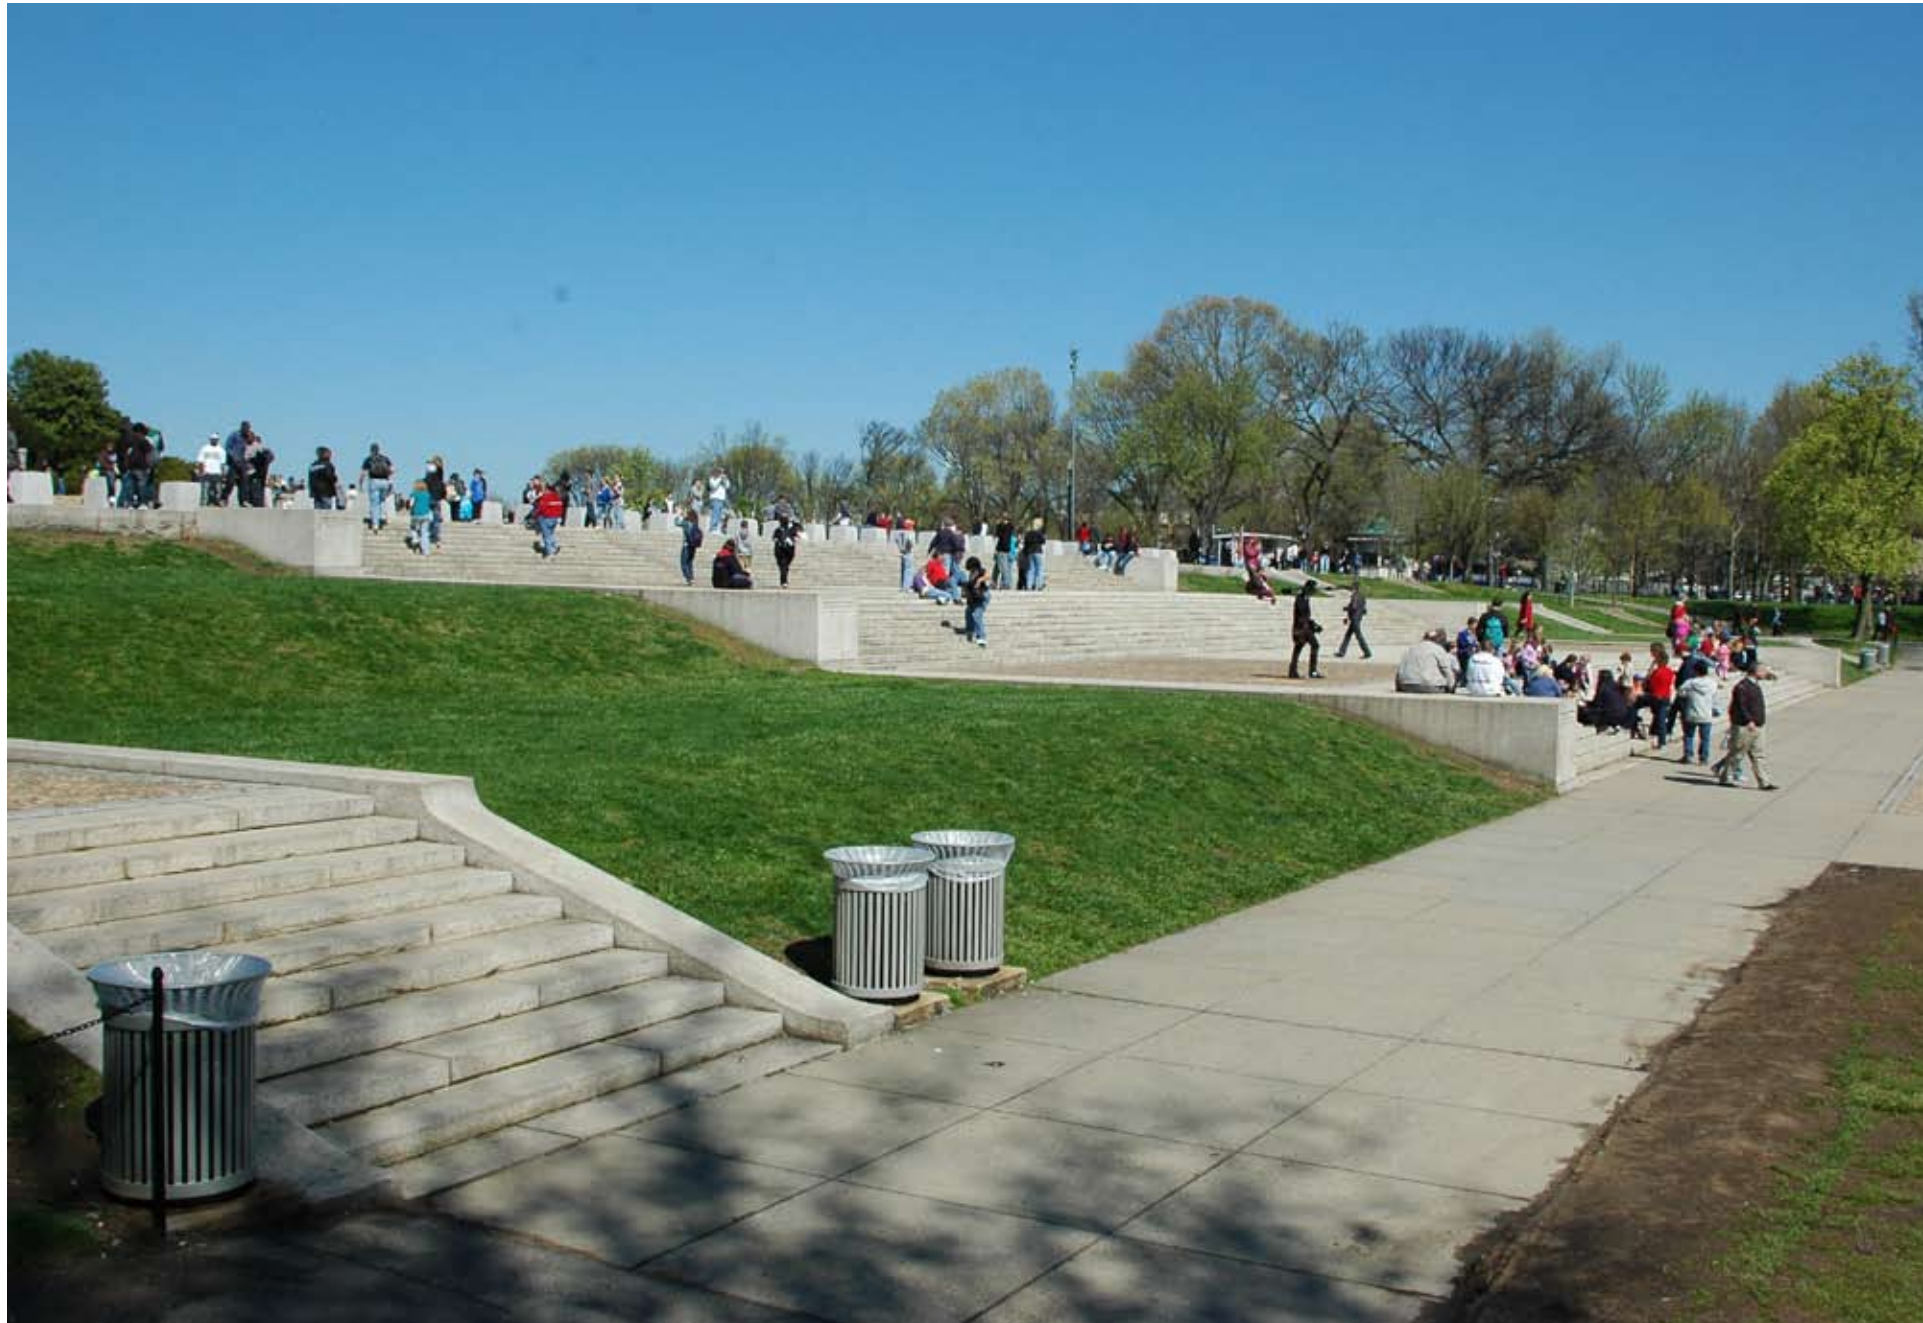
- The historically significant stairways, as currently configured, prohibit handicapped access from the lower Plaza to the upper plaza

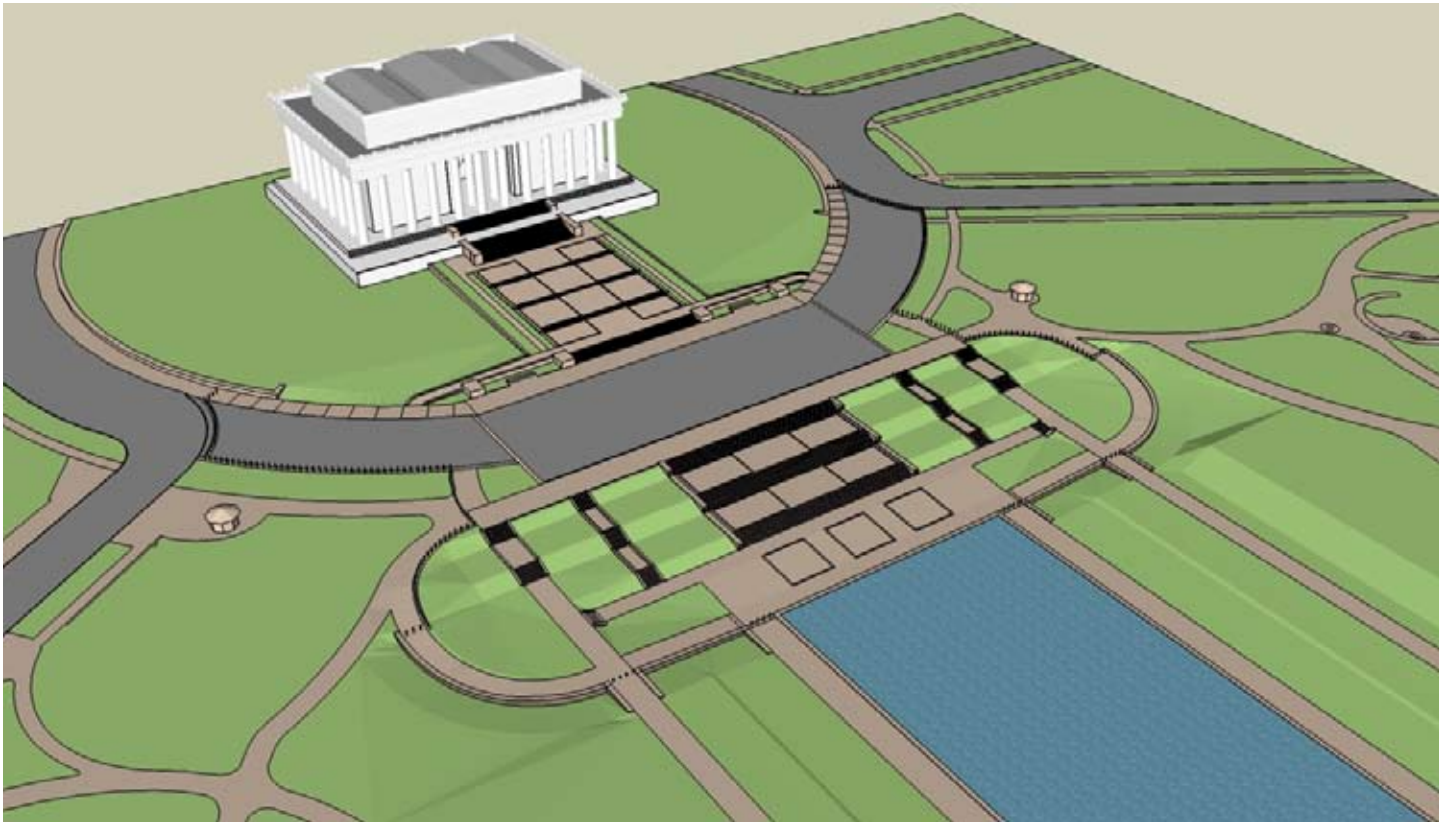
BIRD'S EYE VIEW OF PROPOSED CONCEPT 1

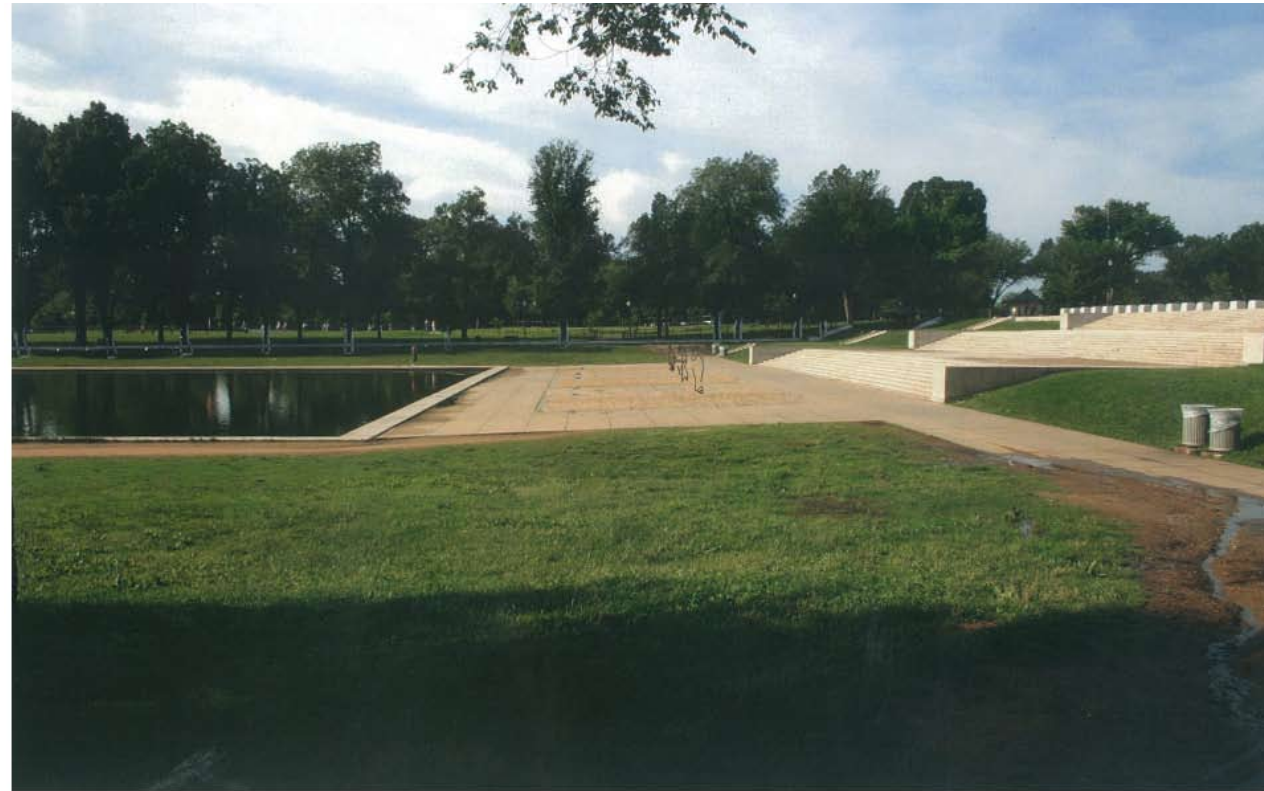
## View Across the Lower Plaza looking South

- Proposed lower grade and walls are located in a transition zone between the reflecting pool topography and terraced landscape leading to the Lincoln Memorial.
- Wall shown at 36" high is divided into a 6" coping, 22" mid-section, and 8" curb.
- The wall may only need to be 30" tall based on security requirements.

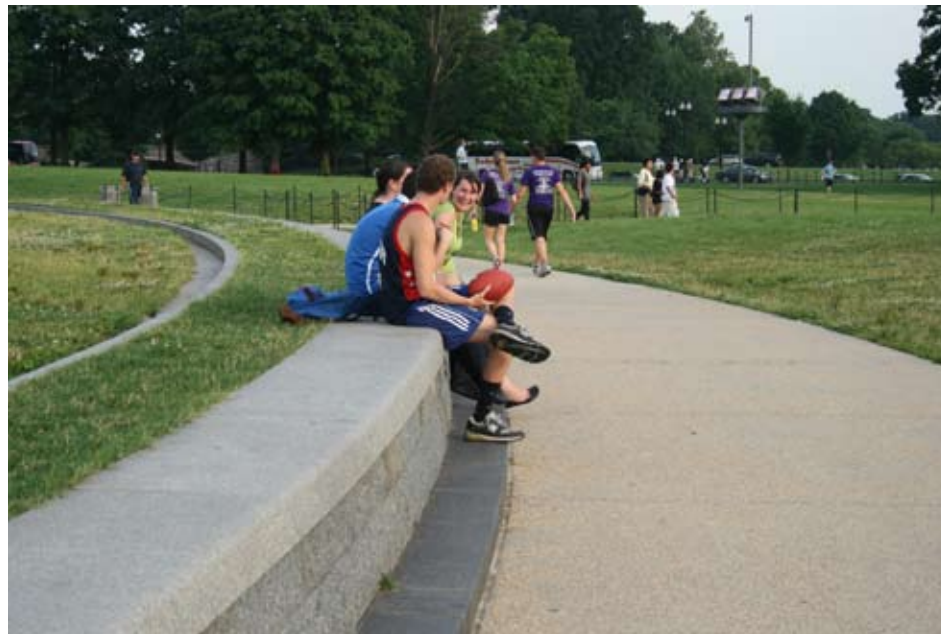
30" WALL AT WASHINGTON MONUMENT

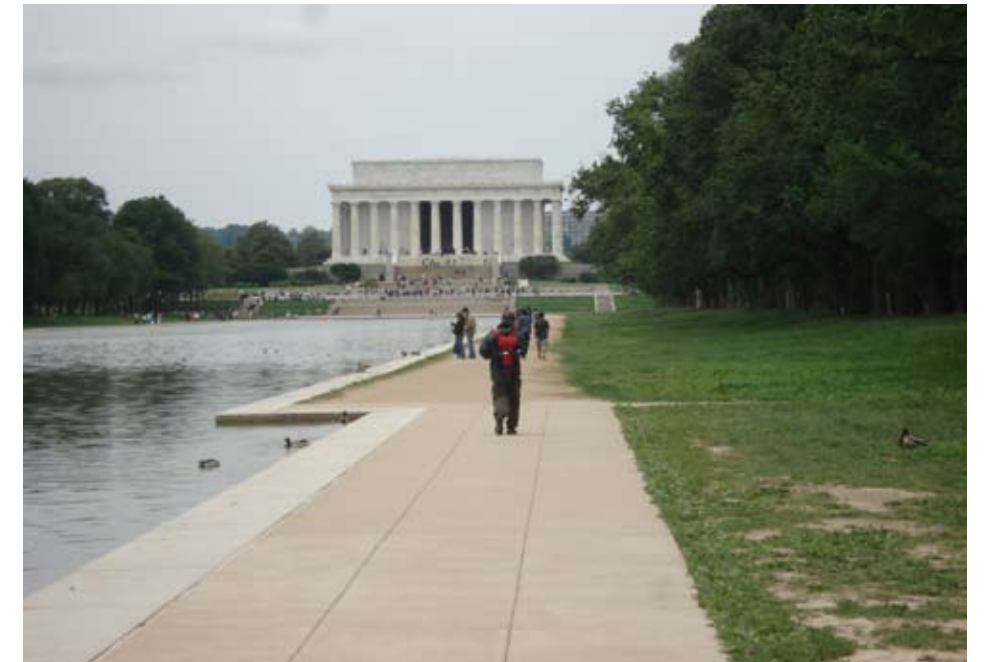
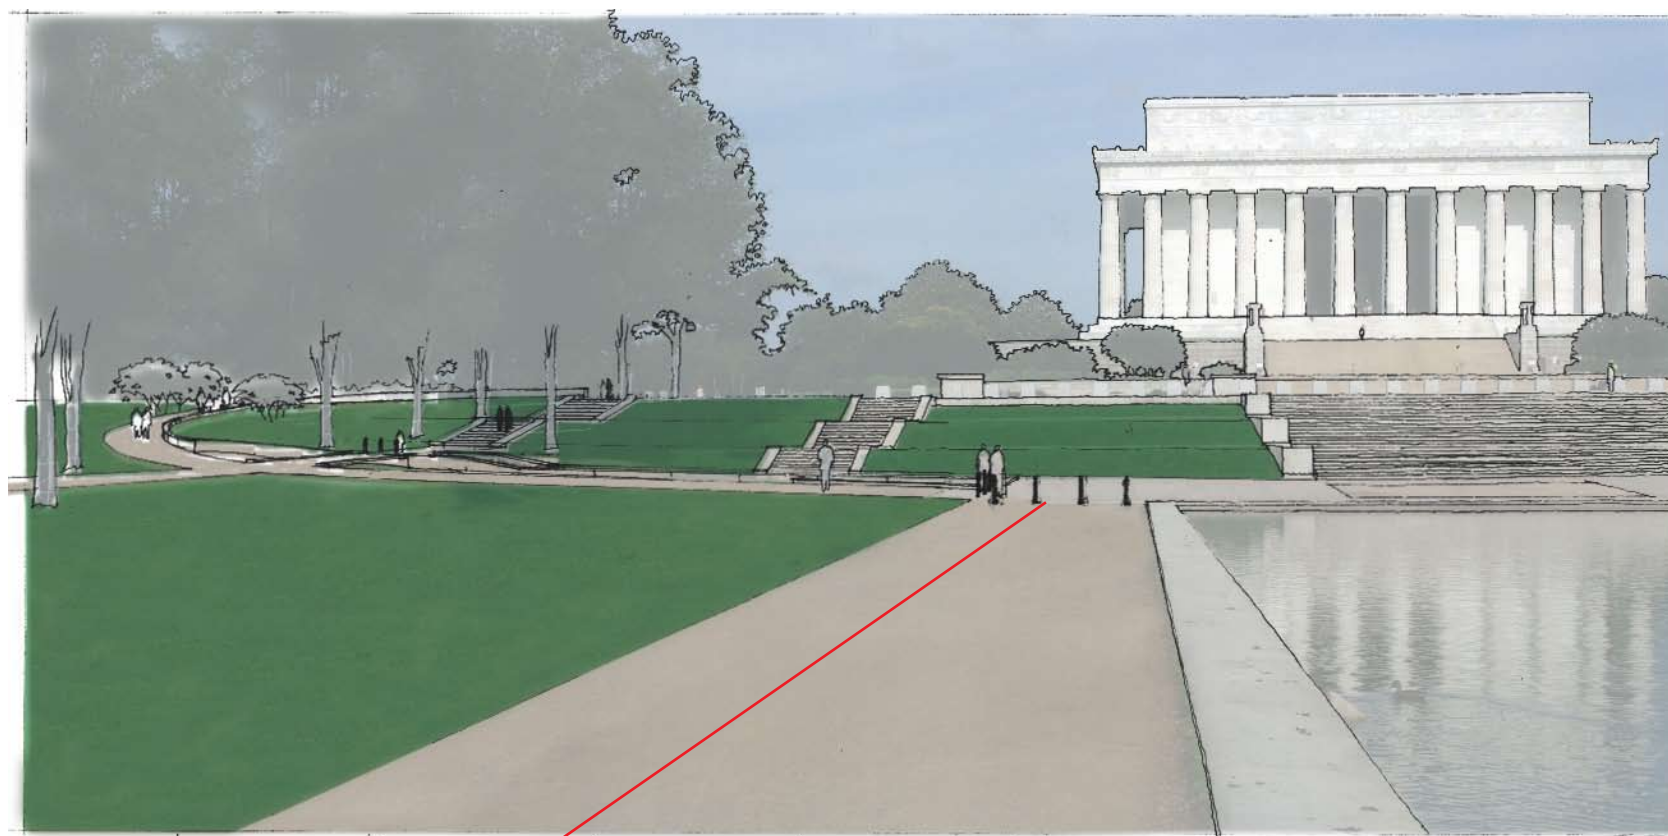
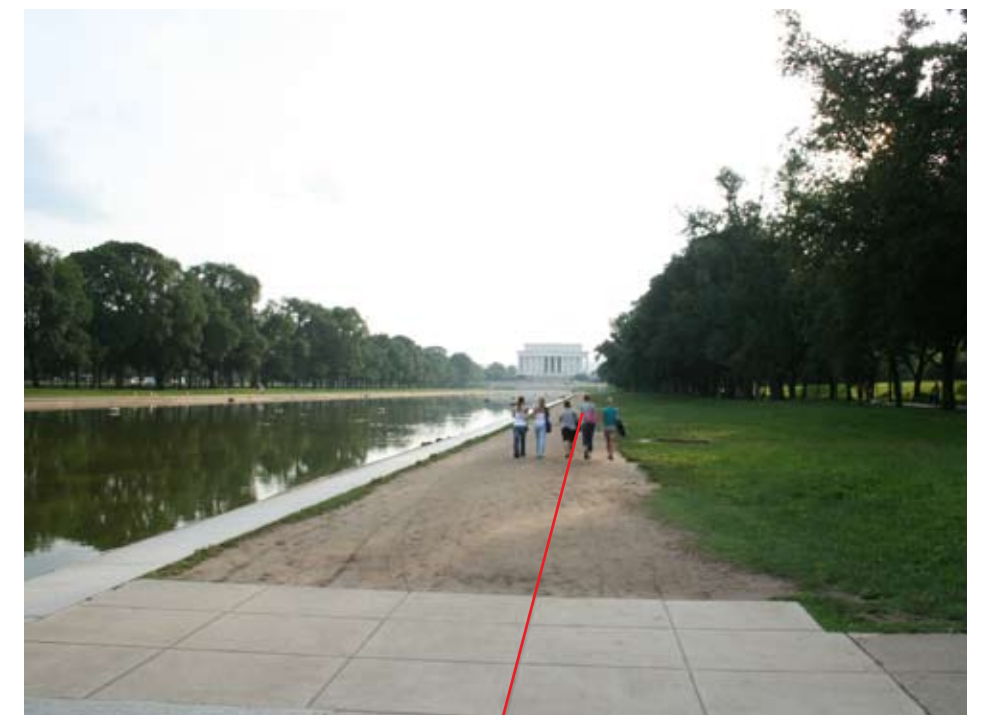
## Proposed Walks Along Edges of the Reflecting Pool at Coping

- The red lines in the sketches below illustrate a proposed 12 foot wide walk along the pool coping.

The long walks parallel to the Reflecting Pool can be located adjacent to the reflecting pool coping.

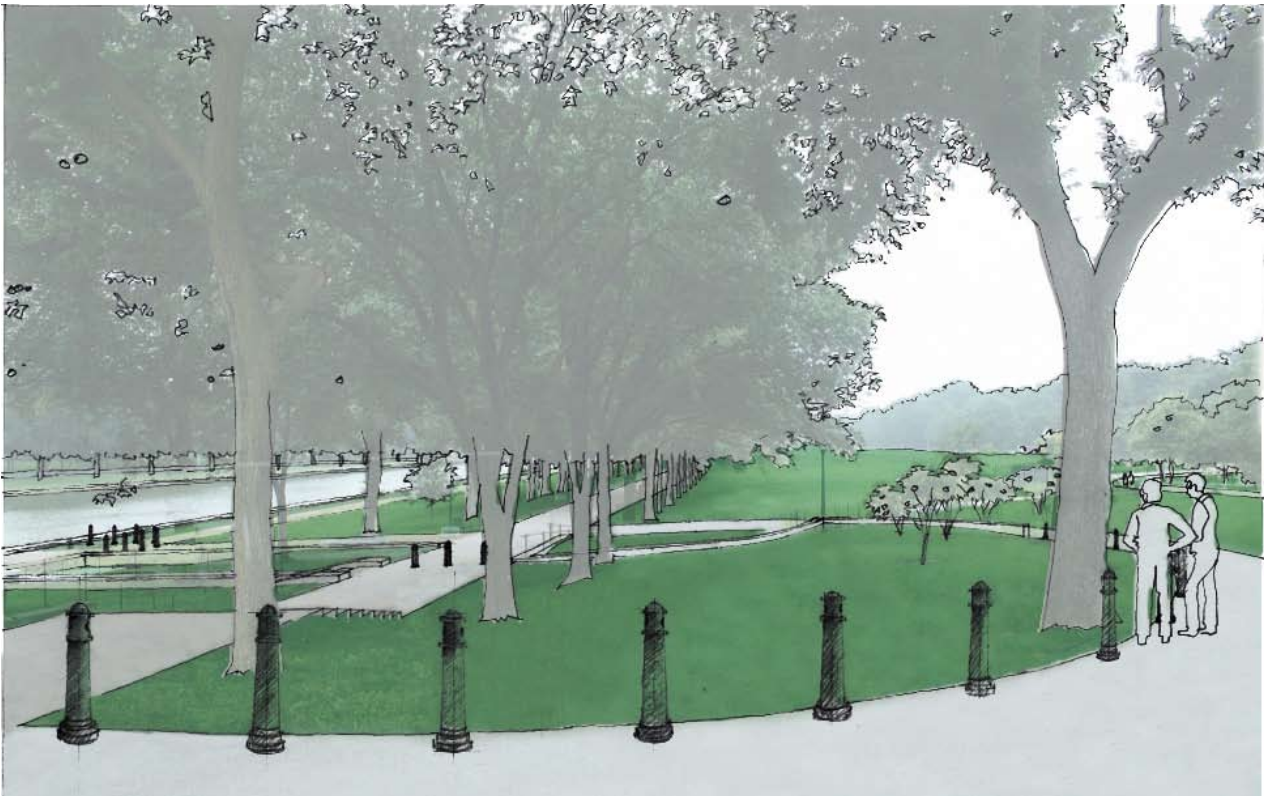
VIEW EAST TOWARD SOUTH ELM WALK - WITH BOLLARDS

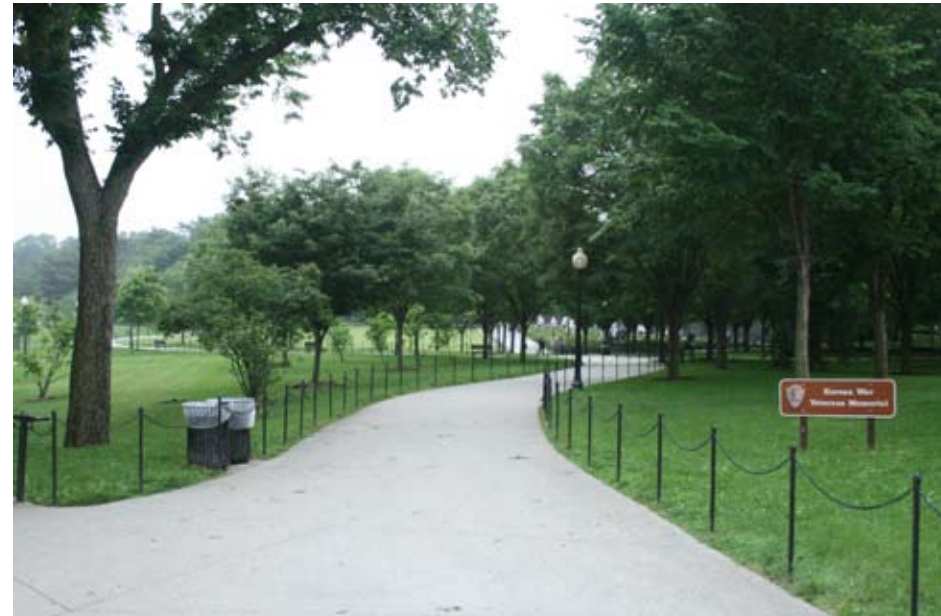
NEW CURVILINEAR PATHS CONNECT WITH EXISTING CURVILINEAR WALKS LEADING TO NEARBY MEMORIALS

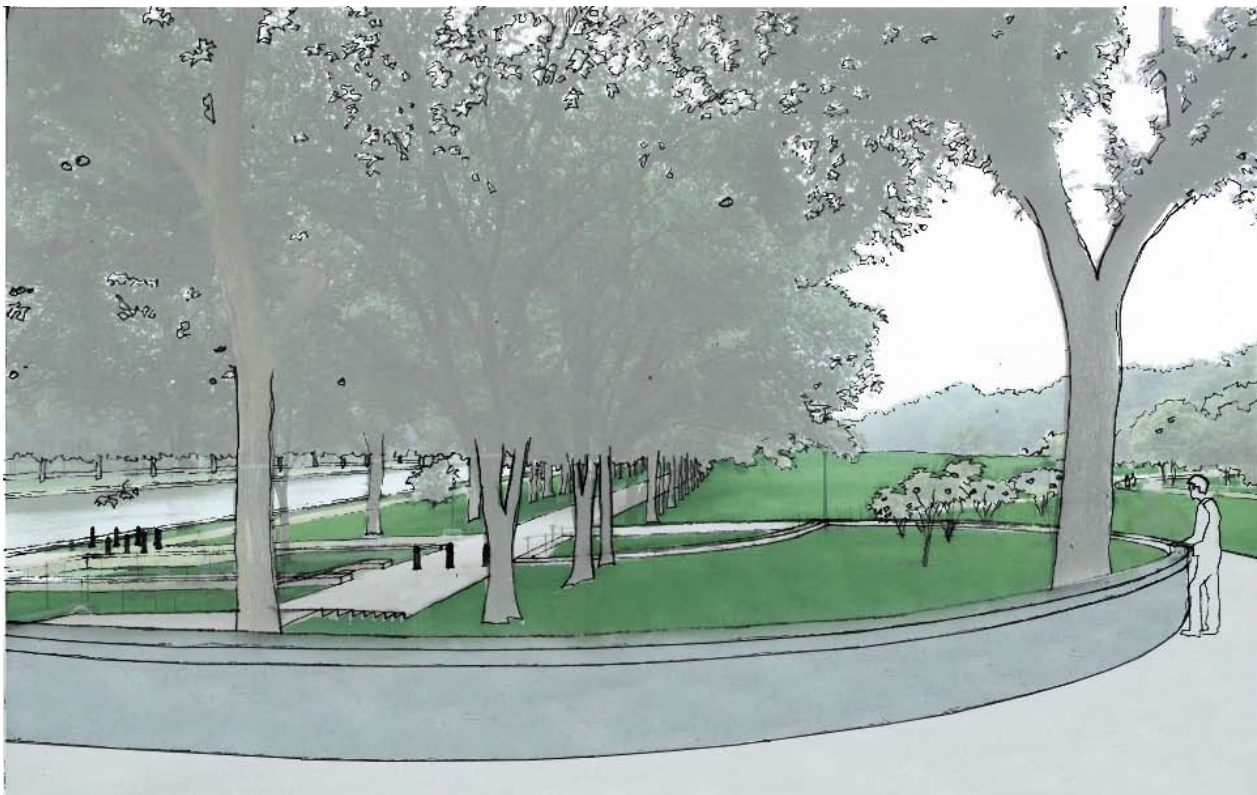
VIEW EAST TOWARD SOUTH ELM WALK - WITH WALL

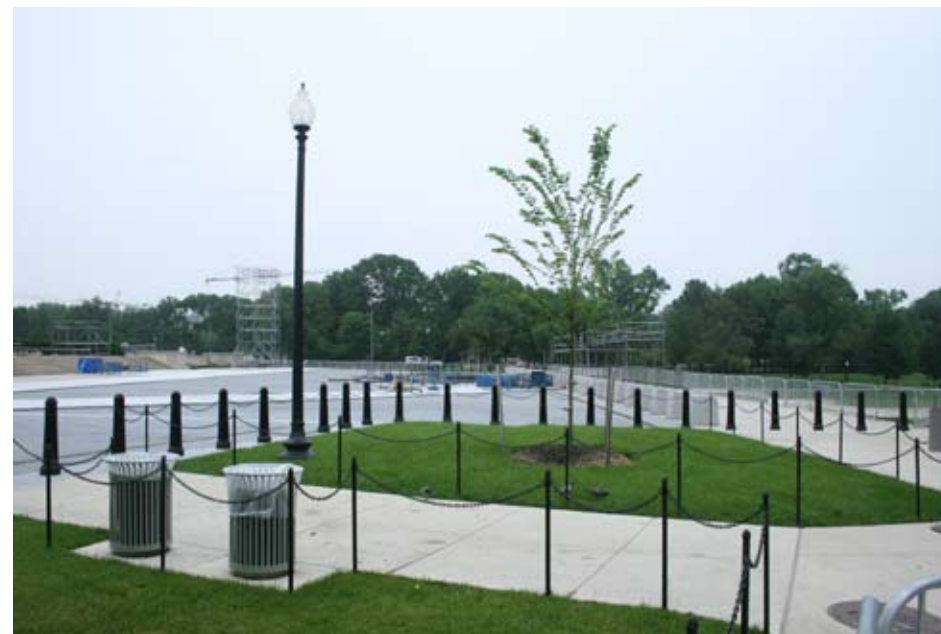
EXISTING BOLLARDS CAN BE REMOVED FROM THIS AREA WITH LINE OF SECURITY MOVED NORTH AND SOUTH

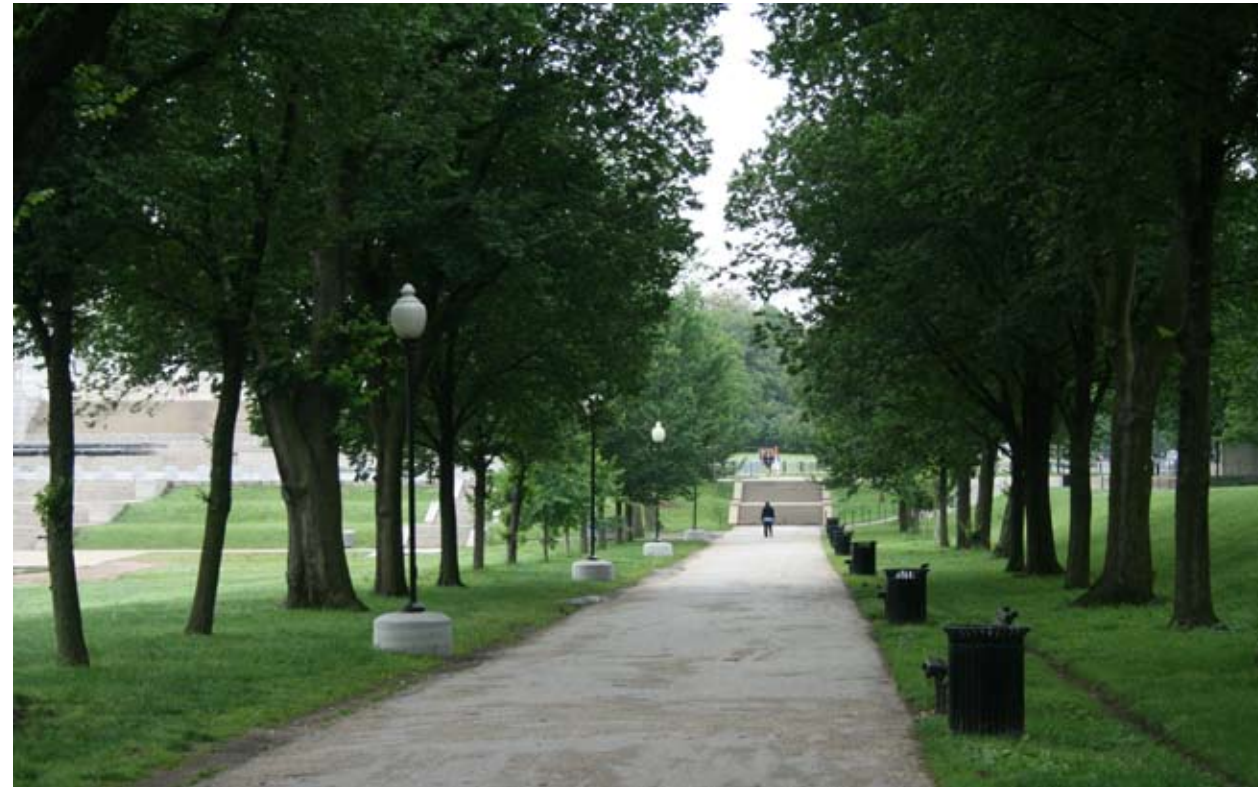
View Along North Elm Walk Toward Lincoln Memorial

- Proposed placement of lights, trash receptacles and benches facing the Reflecting Pool
- Concept for organizing site elements along Elm Walks. Light fixtures shown are conceptual only, further options to be explored.
