REHABILITATE CLARA BARTON NATIONAL HISTORIC SITE CLBA 312325 SCHEMATIC DESIGN ALTERNATIVES

Schematic Design Alternatives
CLBA 312325

Volume 1: SD Integrated Design Narrative

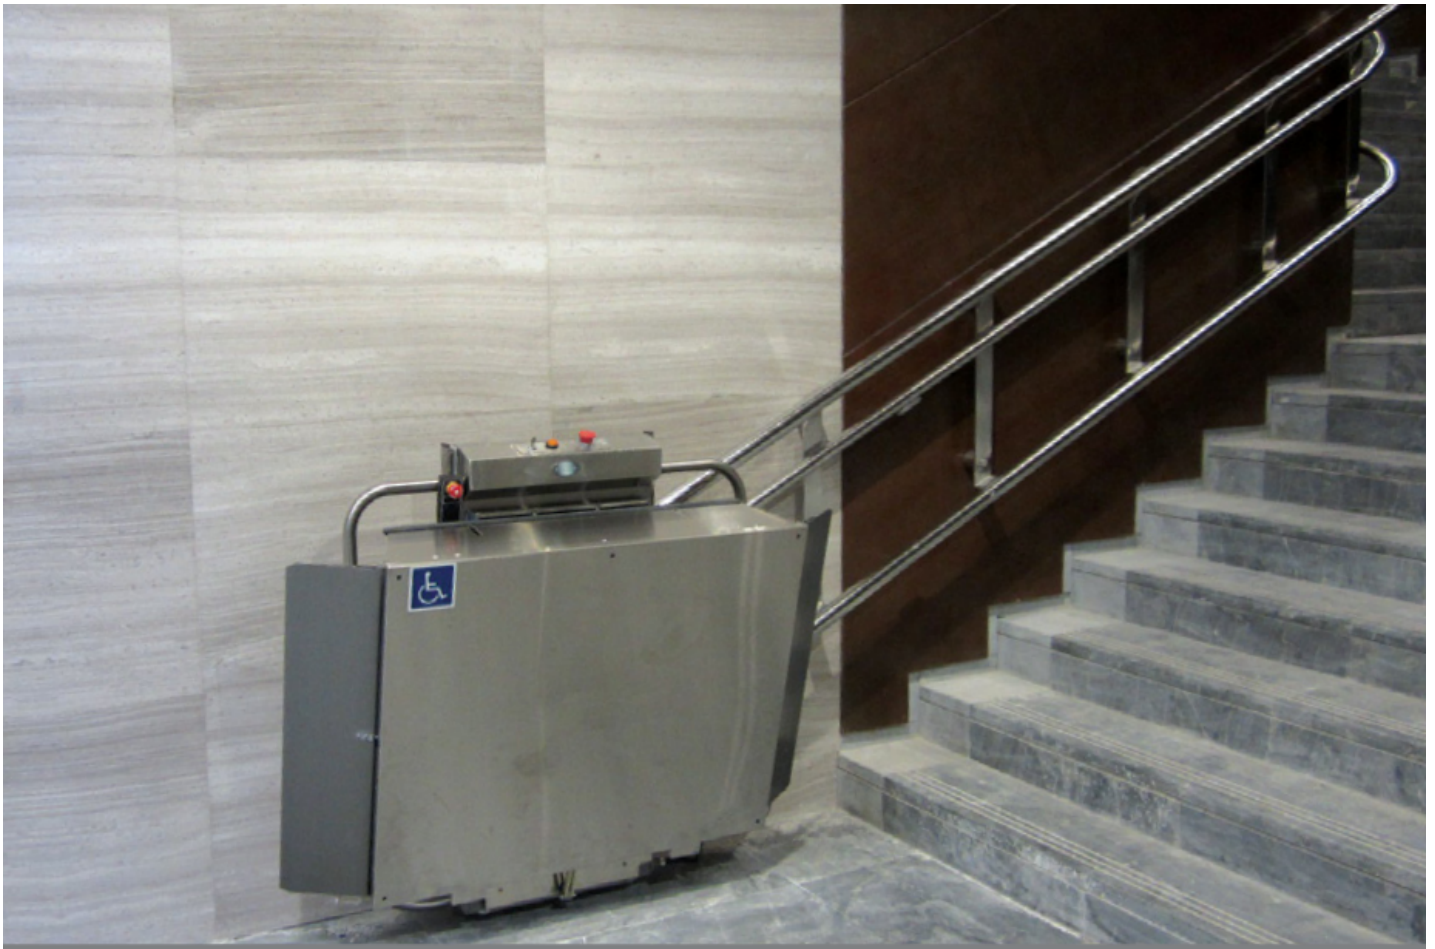
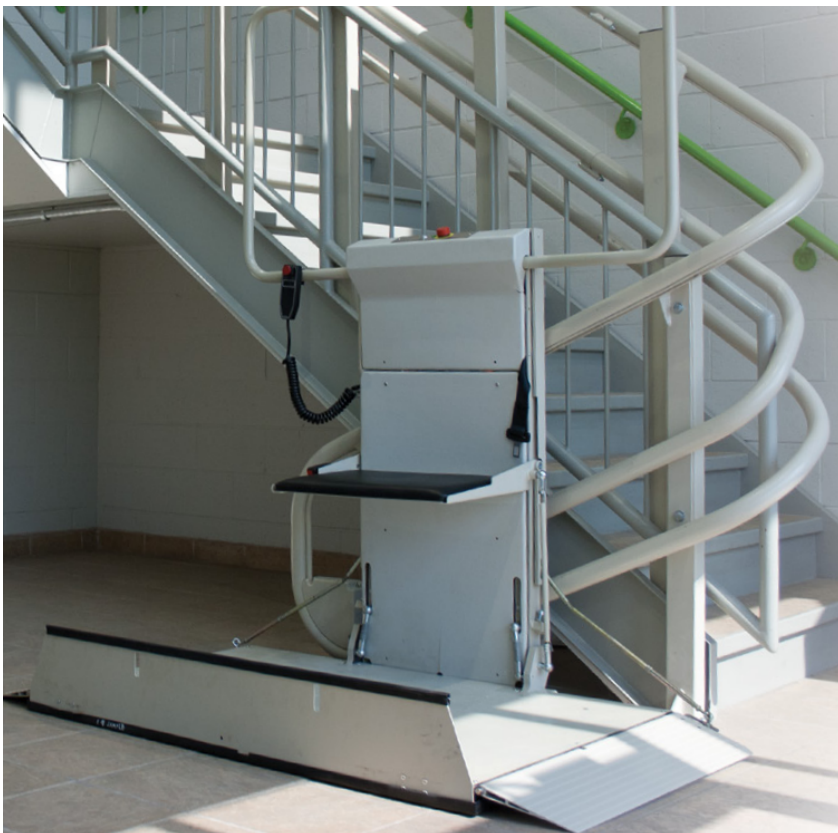
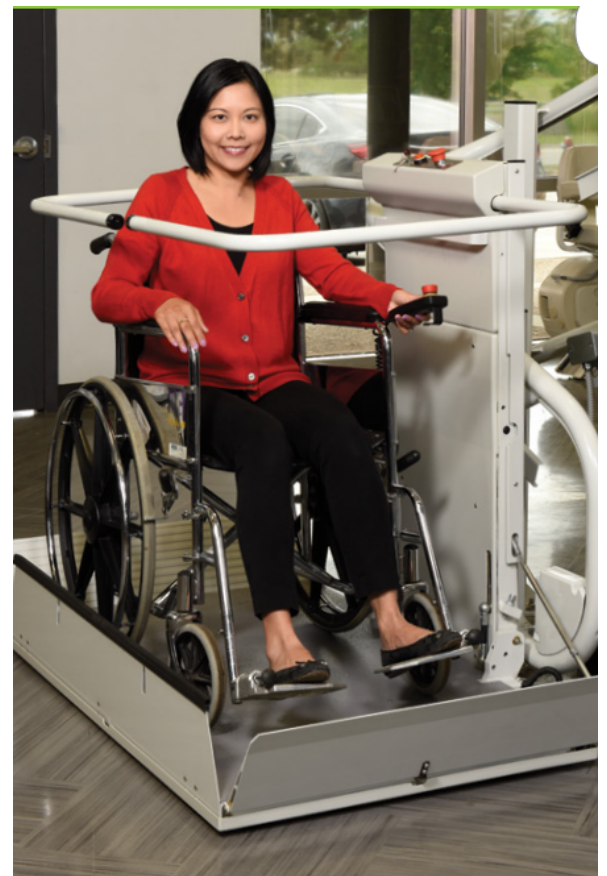
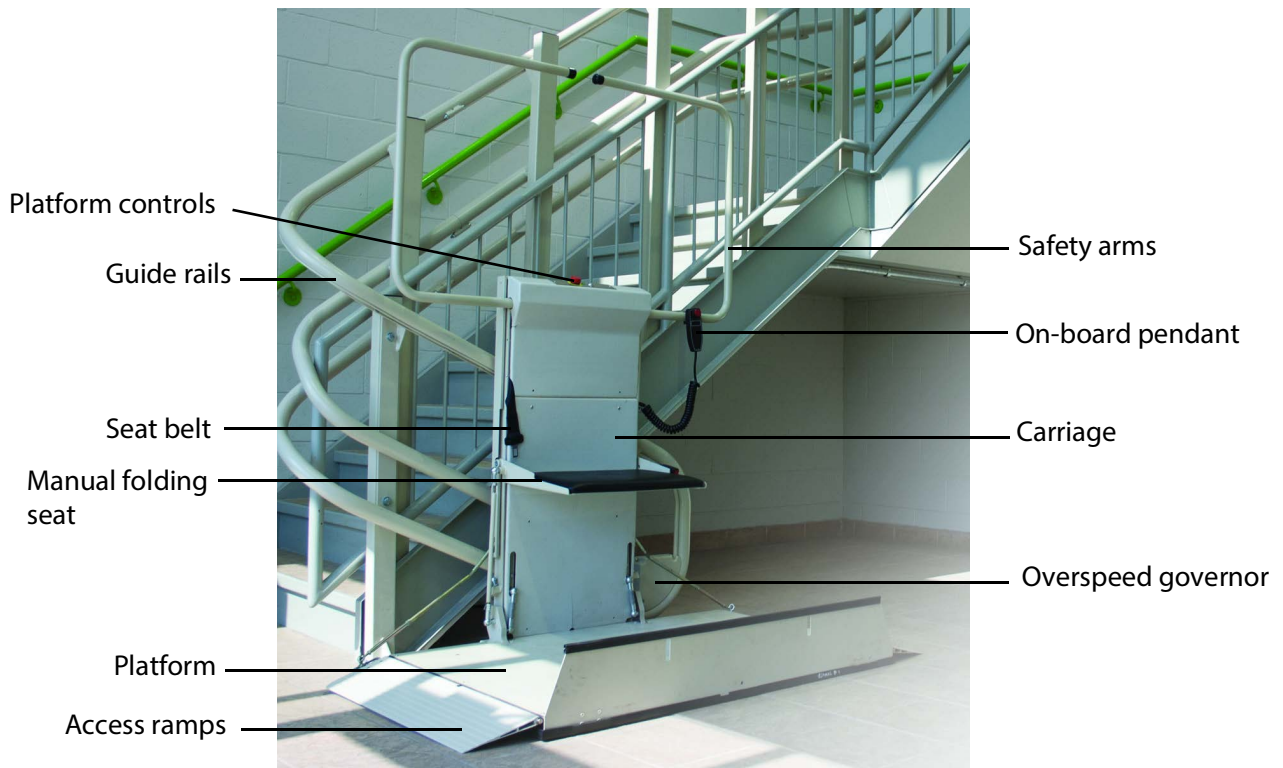
Lift components

A chair lift is not acceptable as part of an accessible route in either new or existing construction per IEBC 306.7.8 "Platform Lifts" - 2021 ed and commentary. For examples of the difference between a chair lift and a platform lift, see the commentary to Section 110.9 of the IBC.
