Mills + Schnoering Architects, LLC

REHABILITATION BASE SCOPE FOR ALL SCHEMATIC DESIGN ALTERNATIVES

REHABILITATE CLARA BARTON NATIONAL HISTORIC SITE

ALTERNATIVE 1: REPAIR AND REHABILITATE

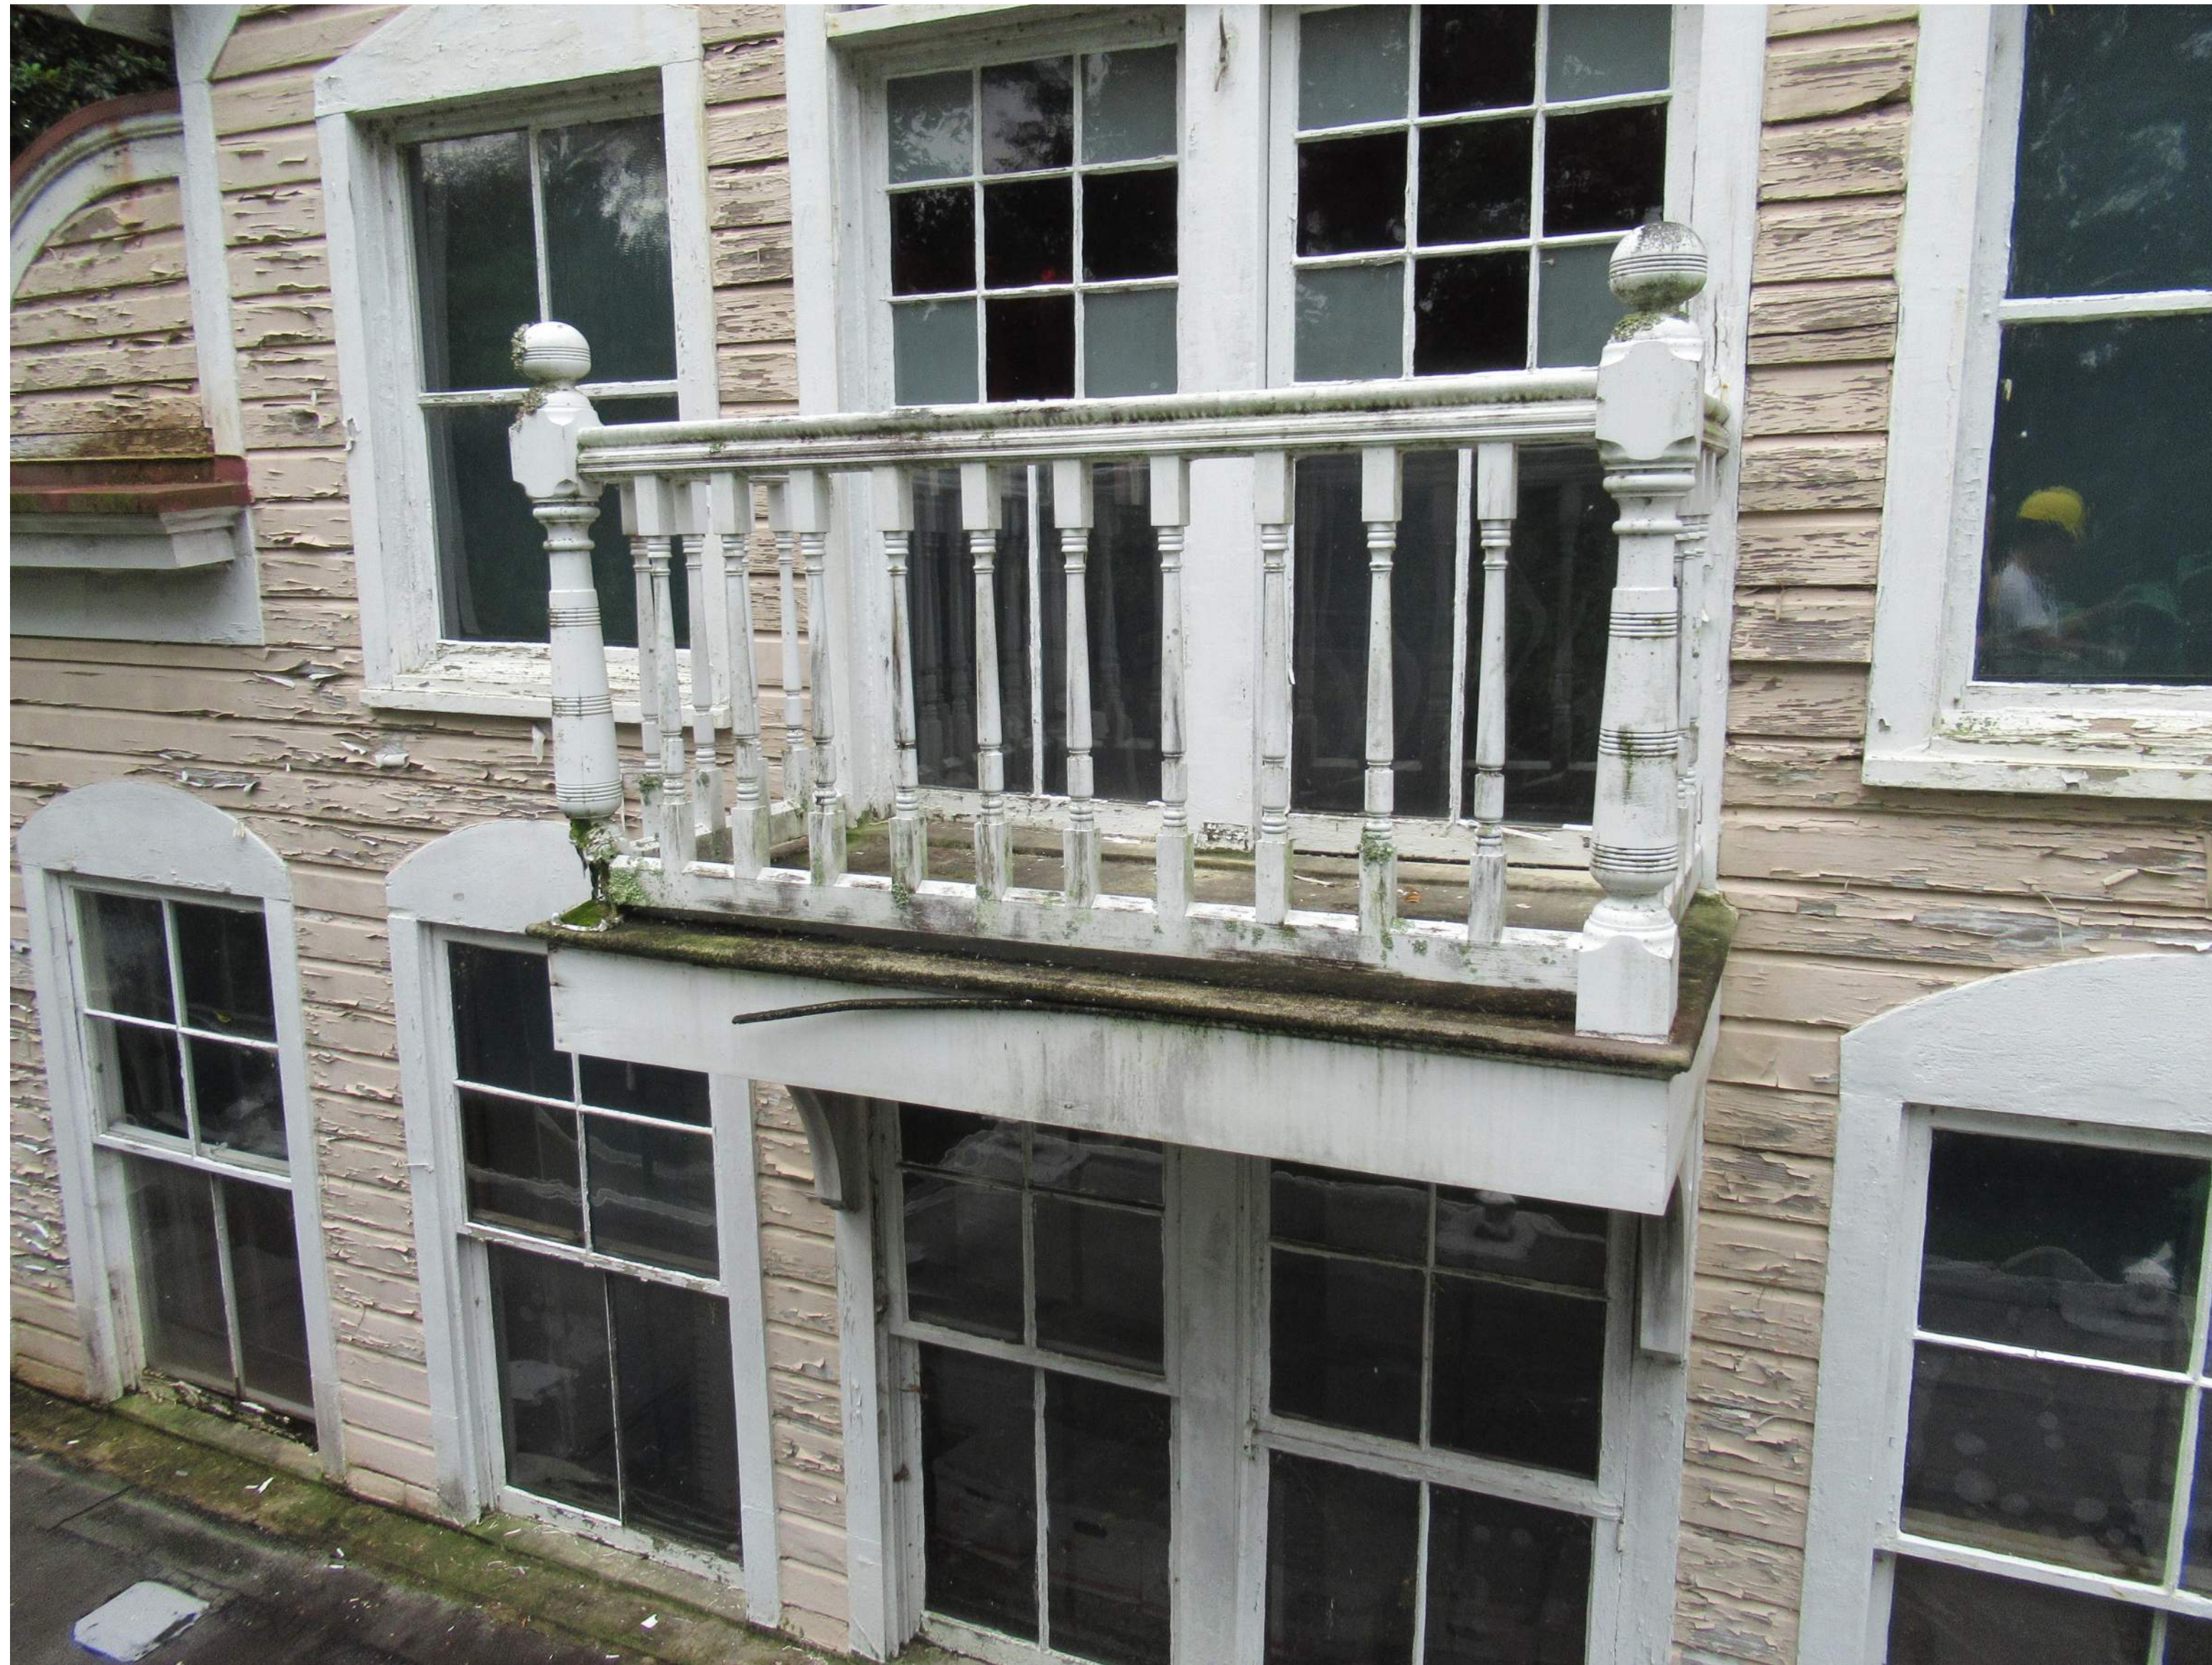
North (front) elevation above porch roof

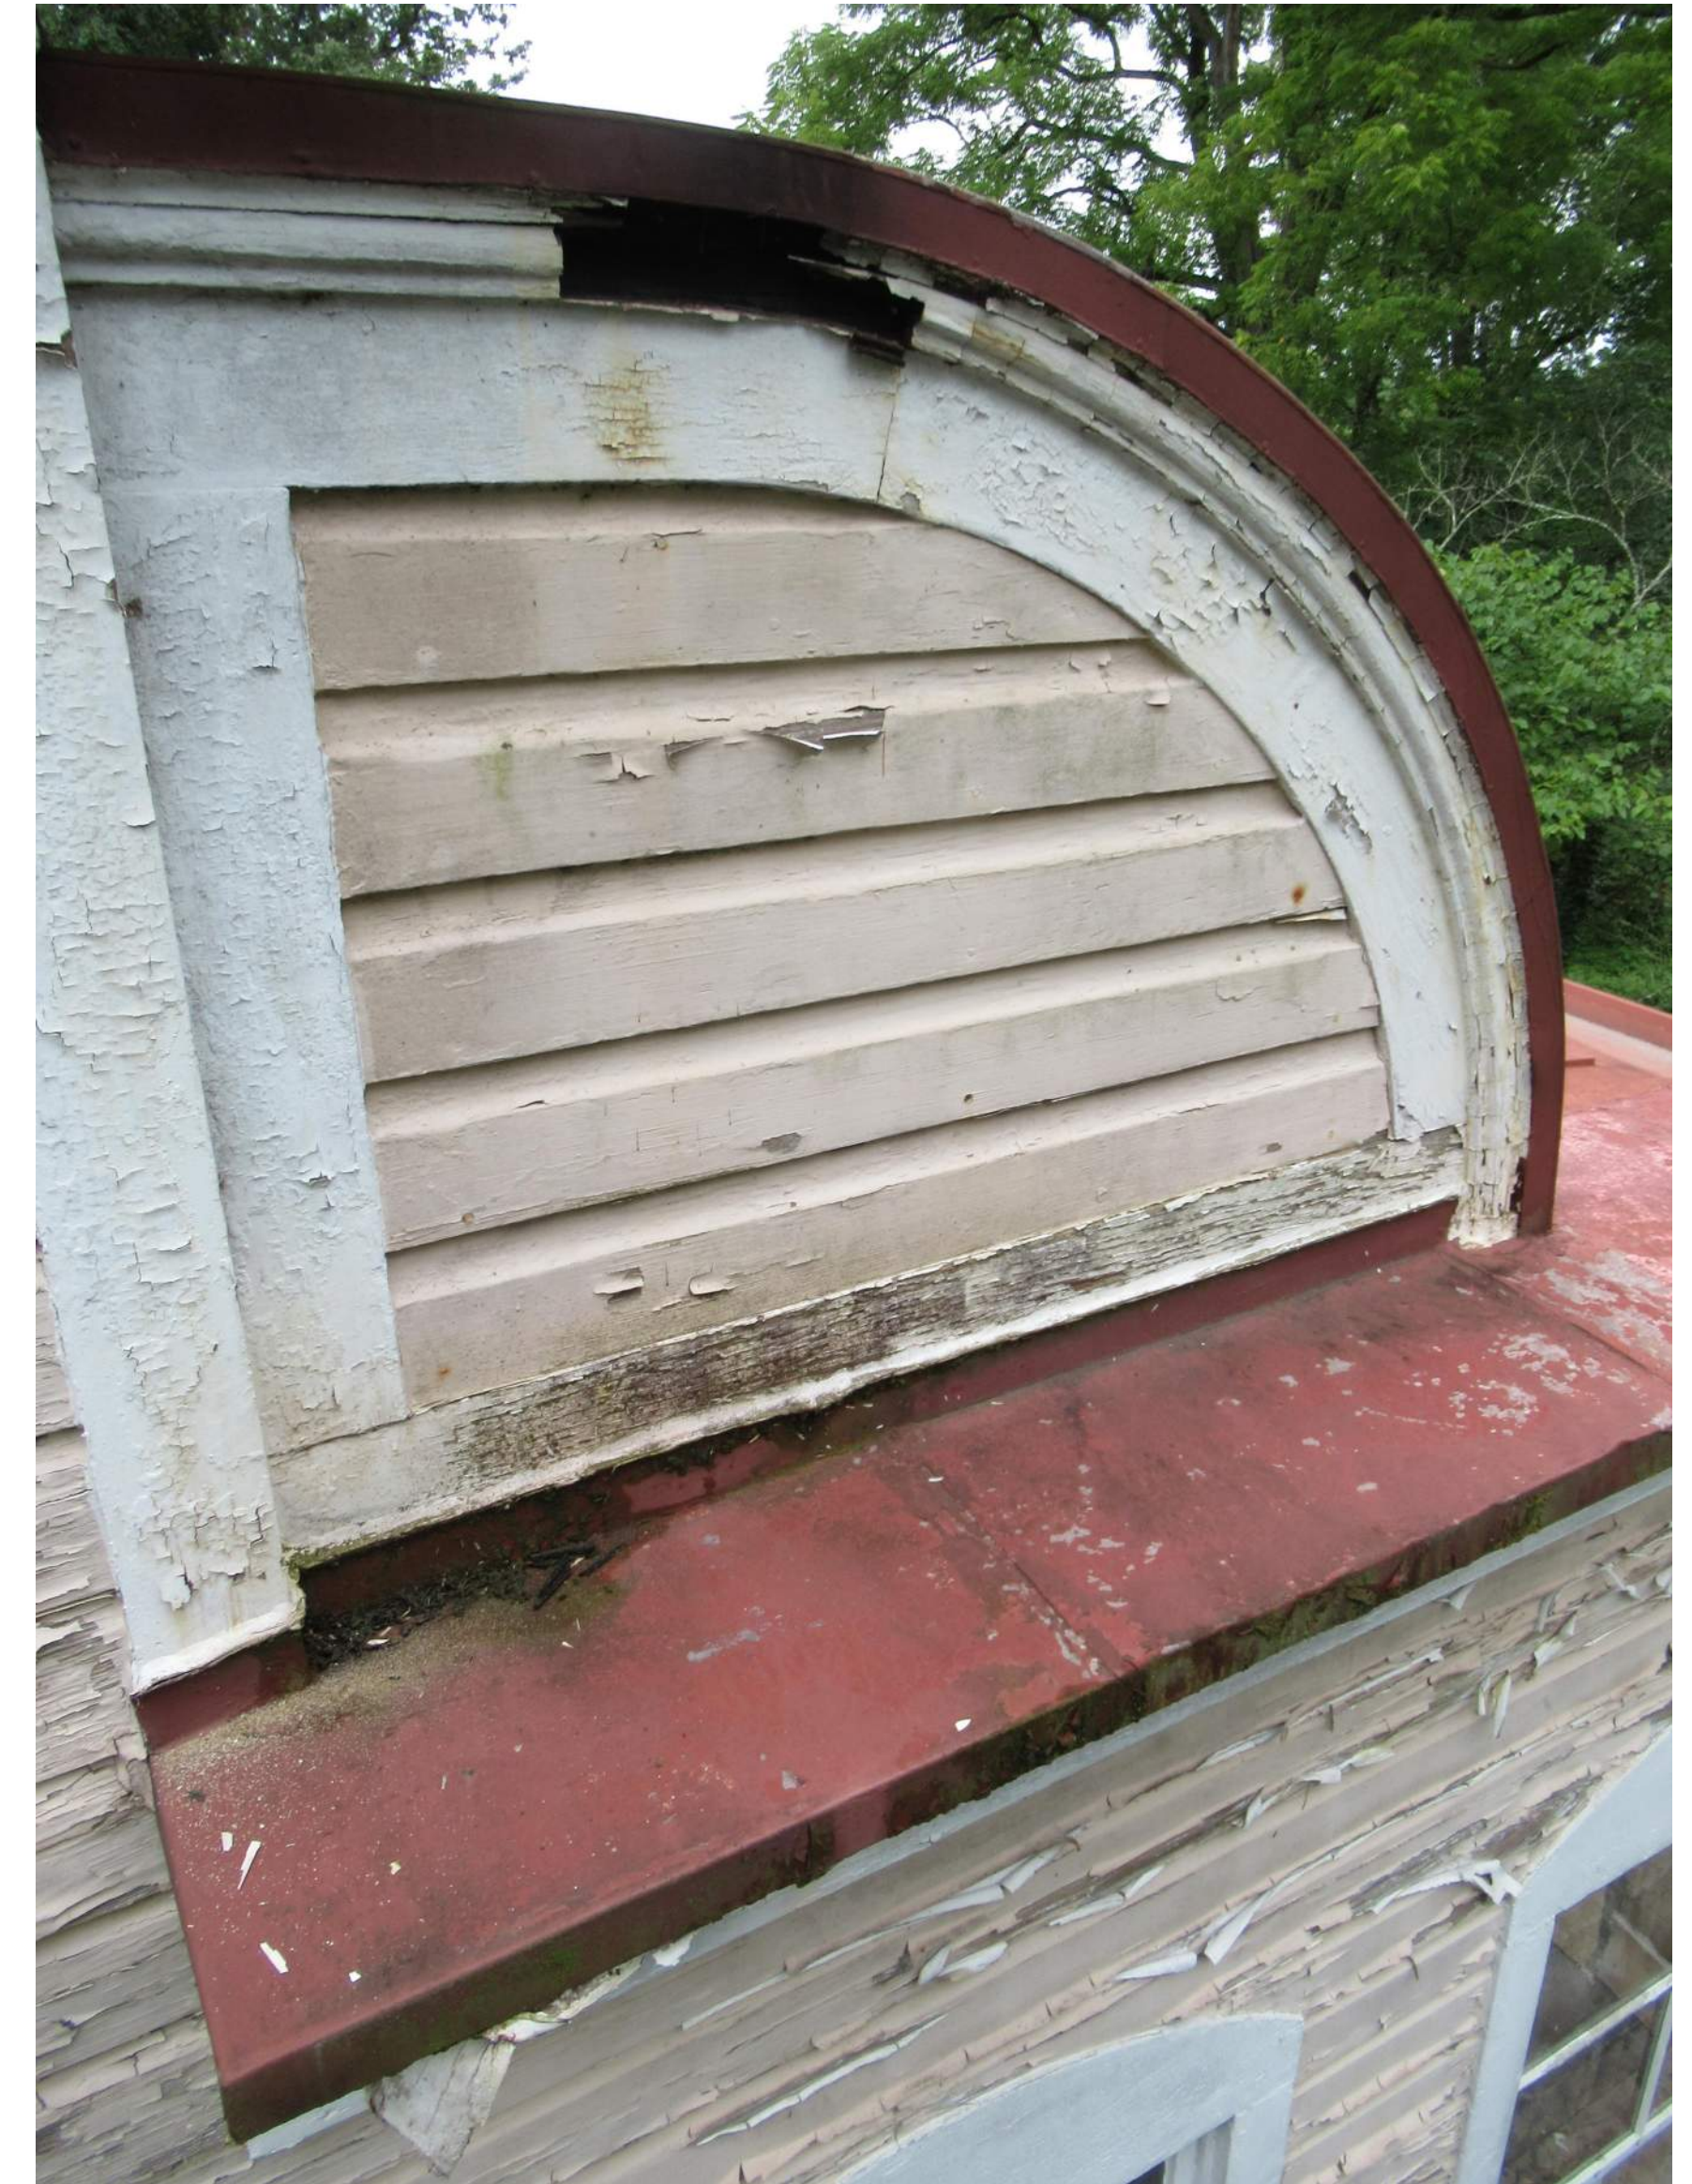
Northwest corner with wood trim and metal roofing

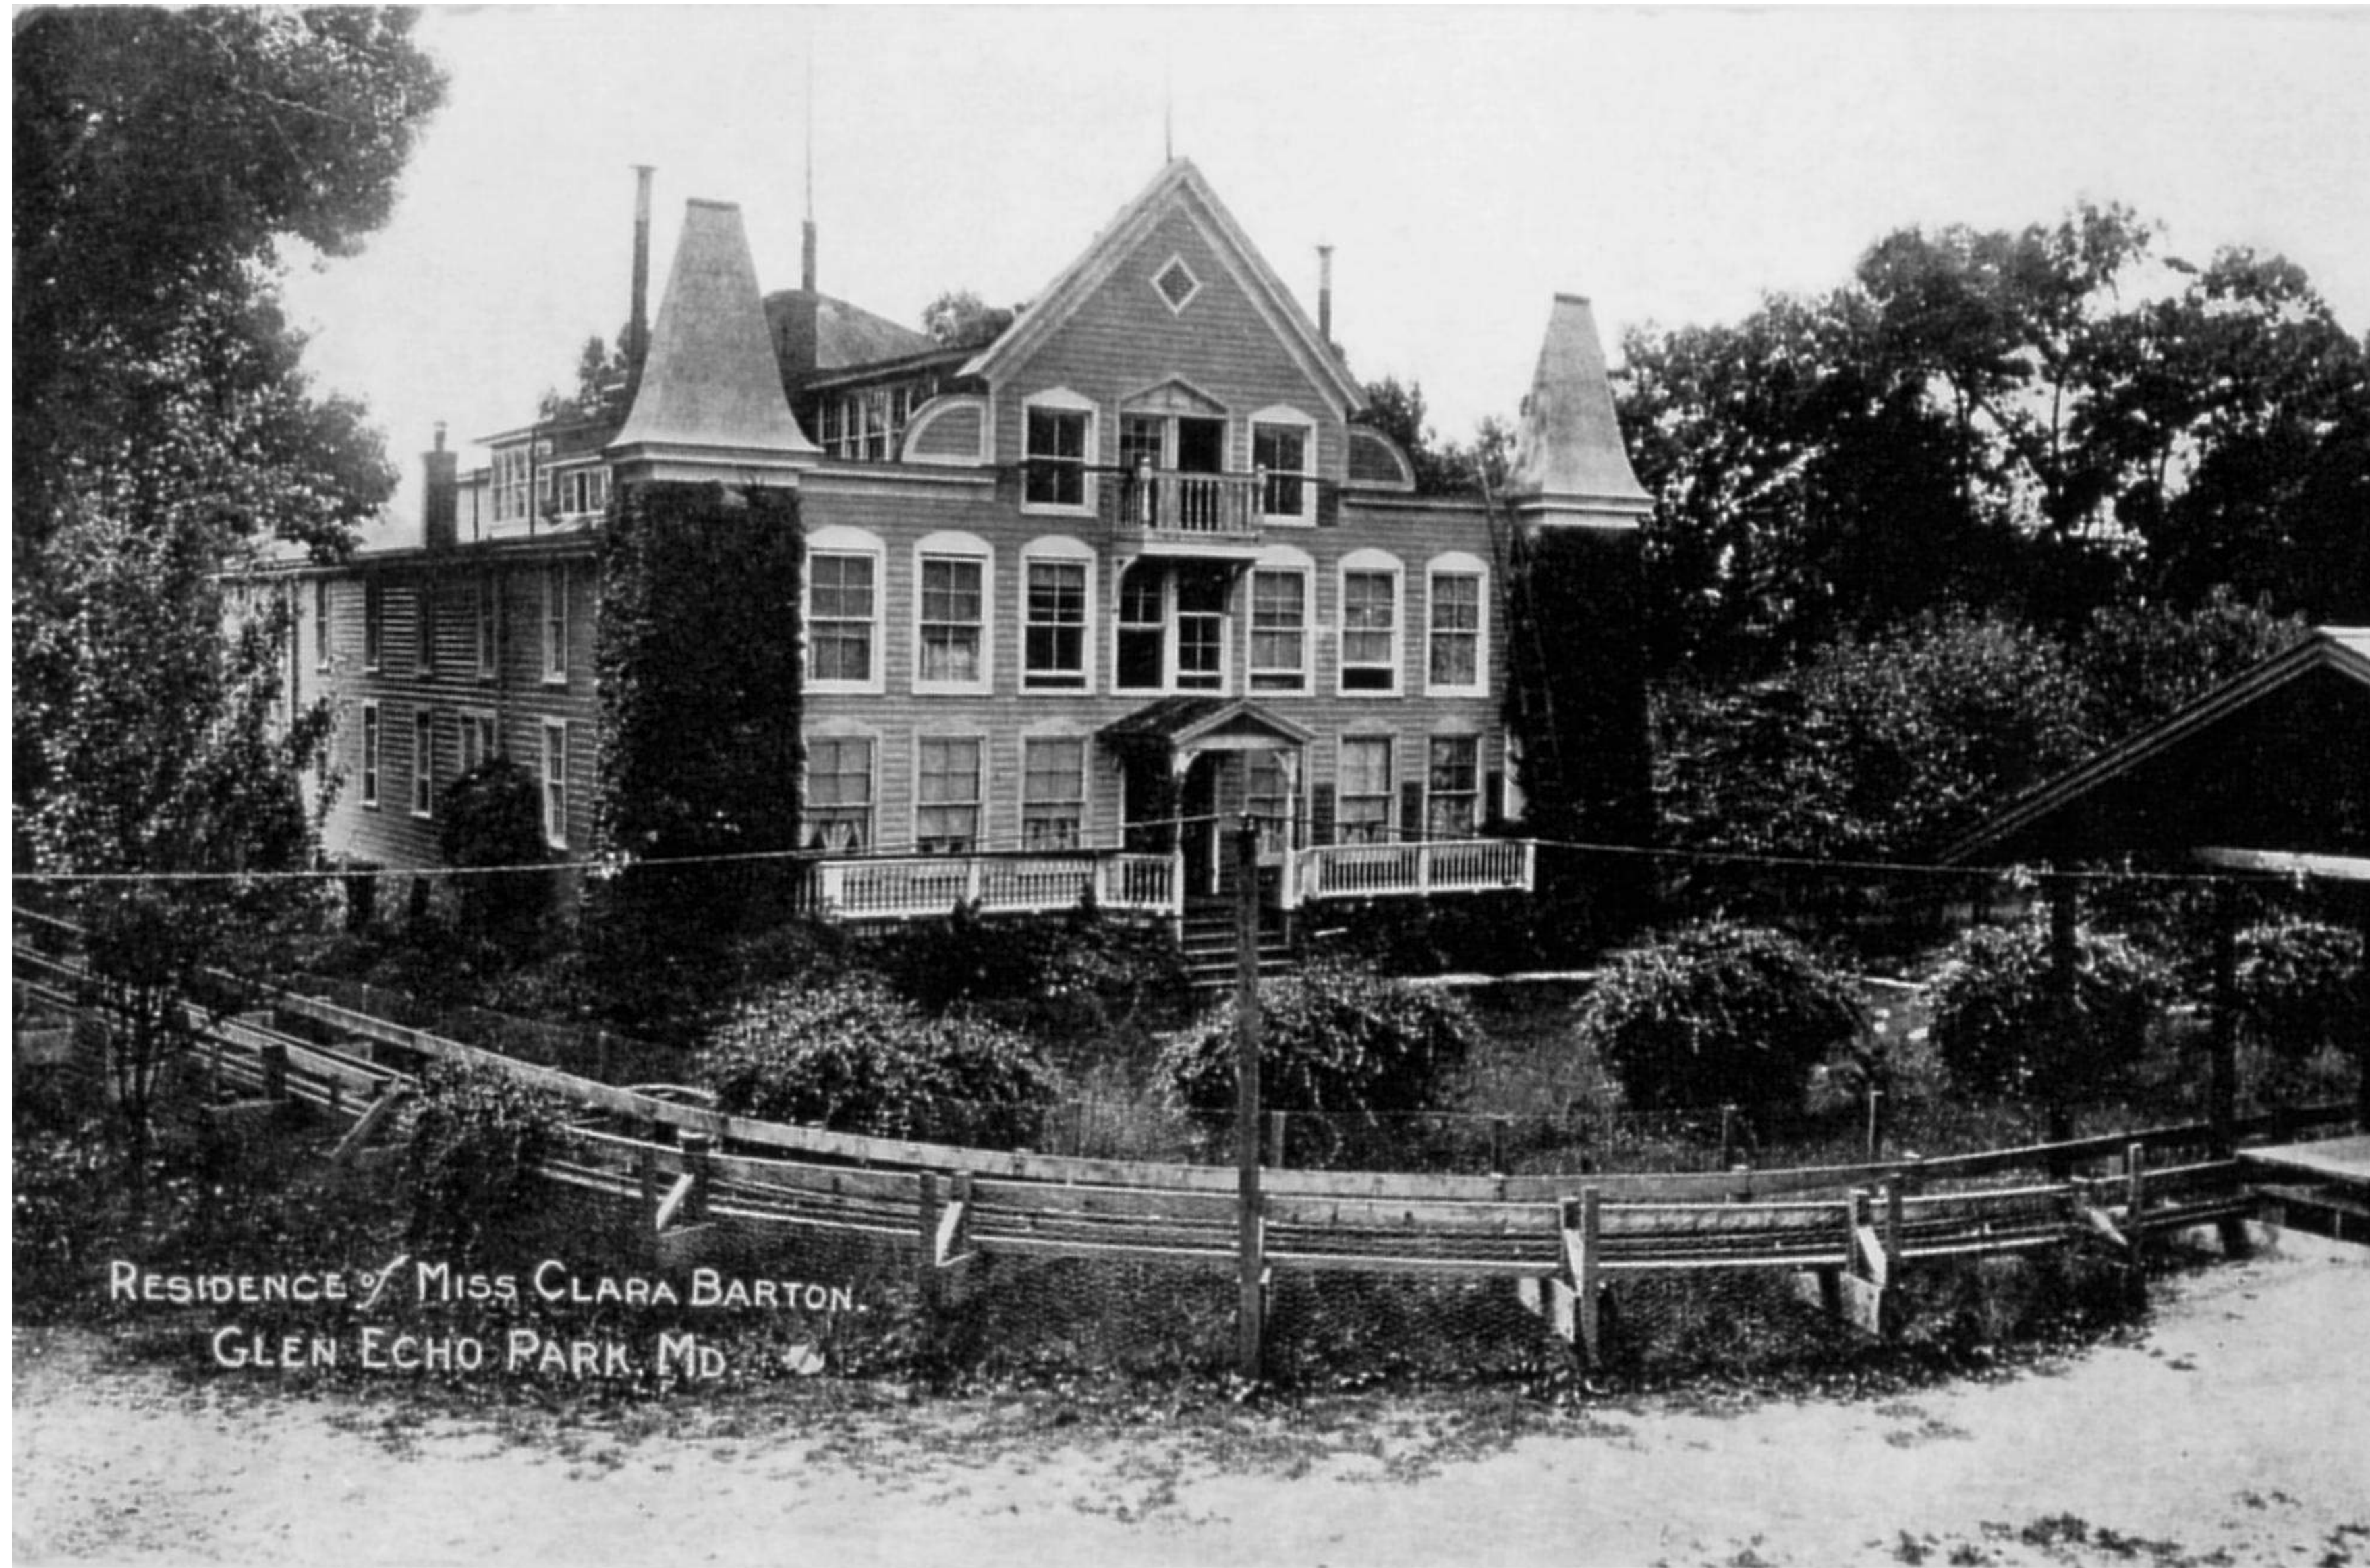
Ca. 1907 postcard showing the front porch and ivy-covered towers

- Porch: Construct new wood front porch with documentation prepared by NPS in 1976-78 to reflect the historic 1897 porch. The wood-deck ramp with stainless steel cable rail infill will be distinguishable in material from the porch itself (wood posts and railings).

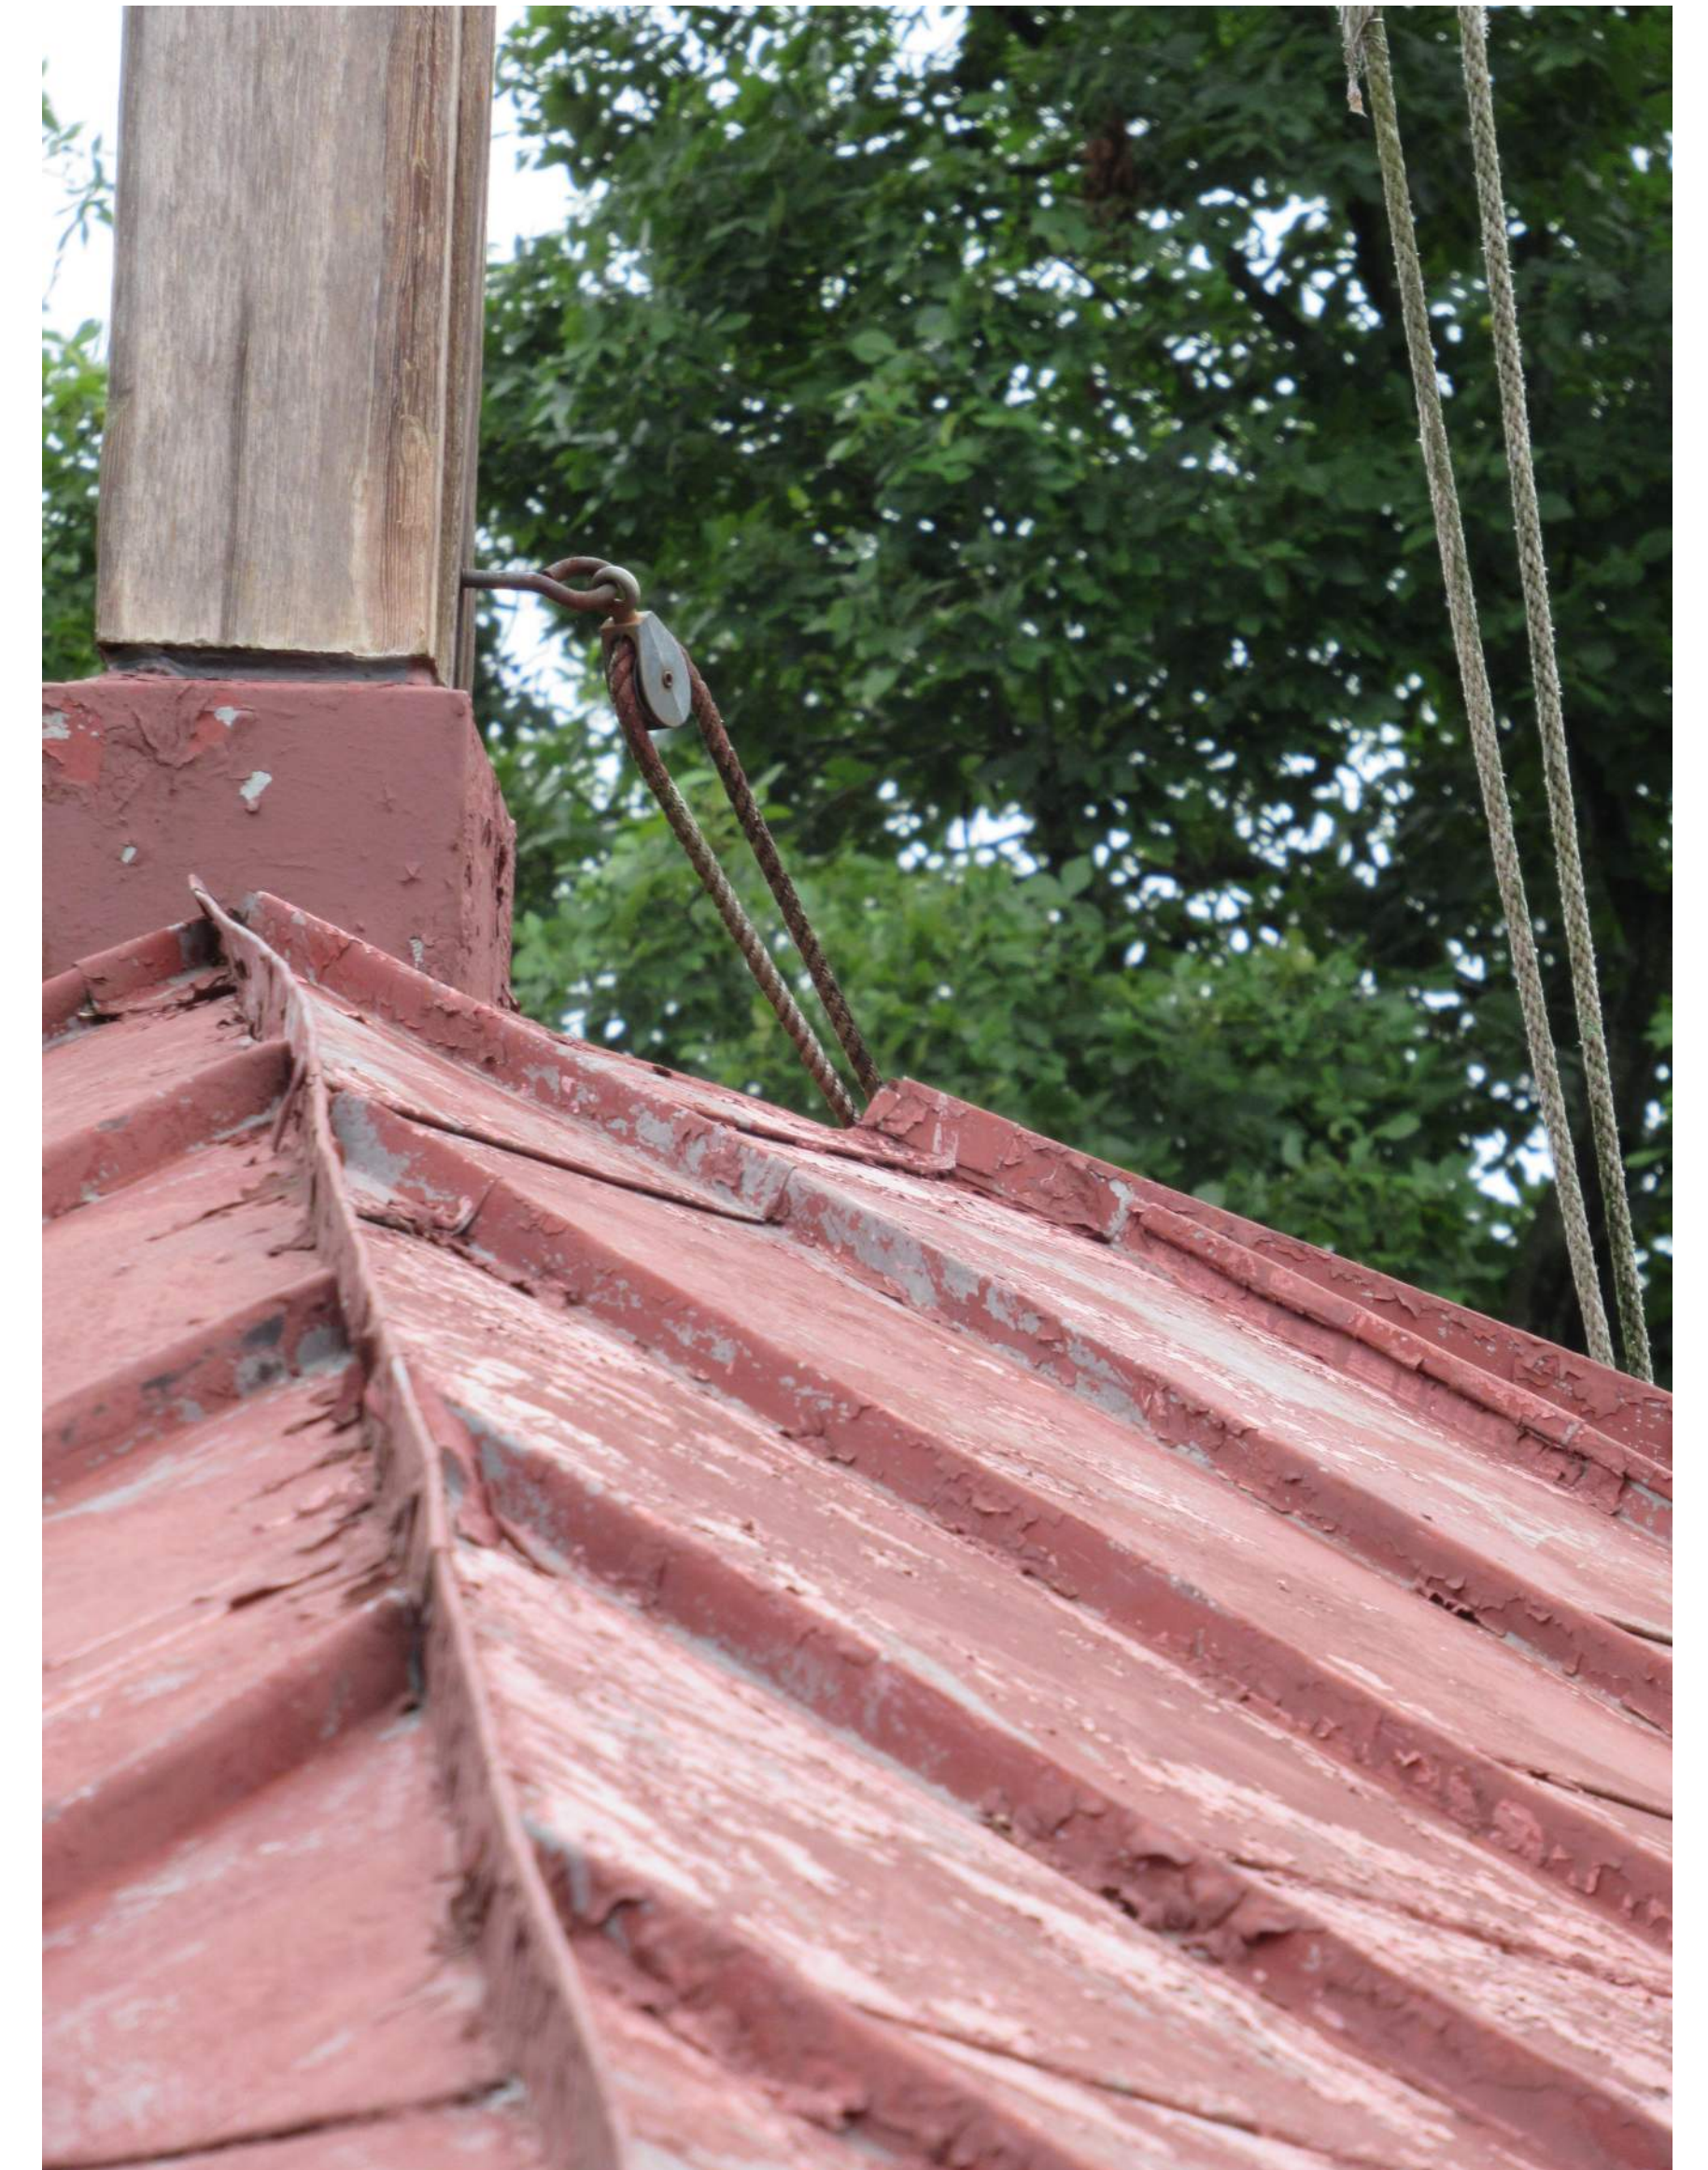
Detail of central flagpole base and roofing conditions

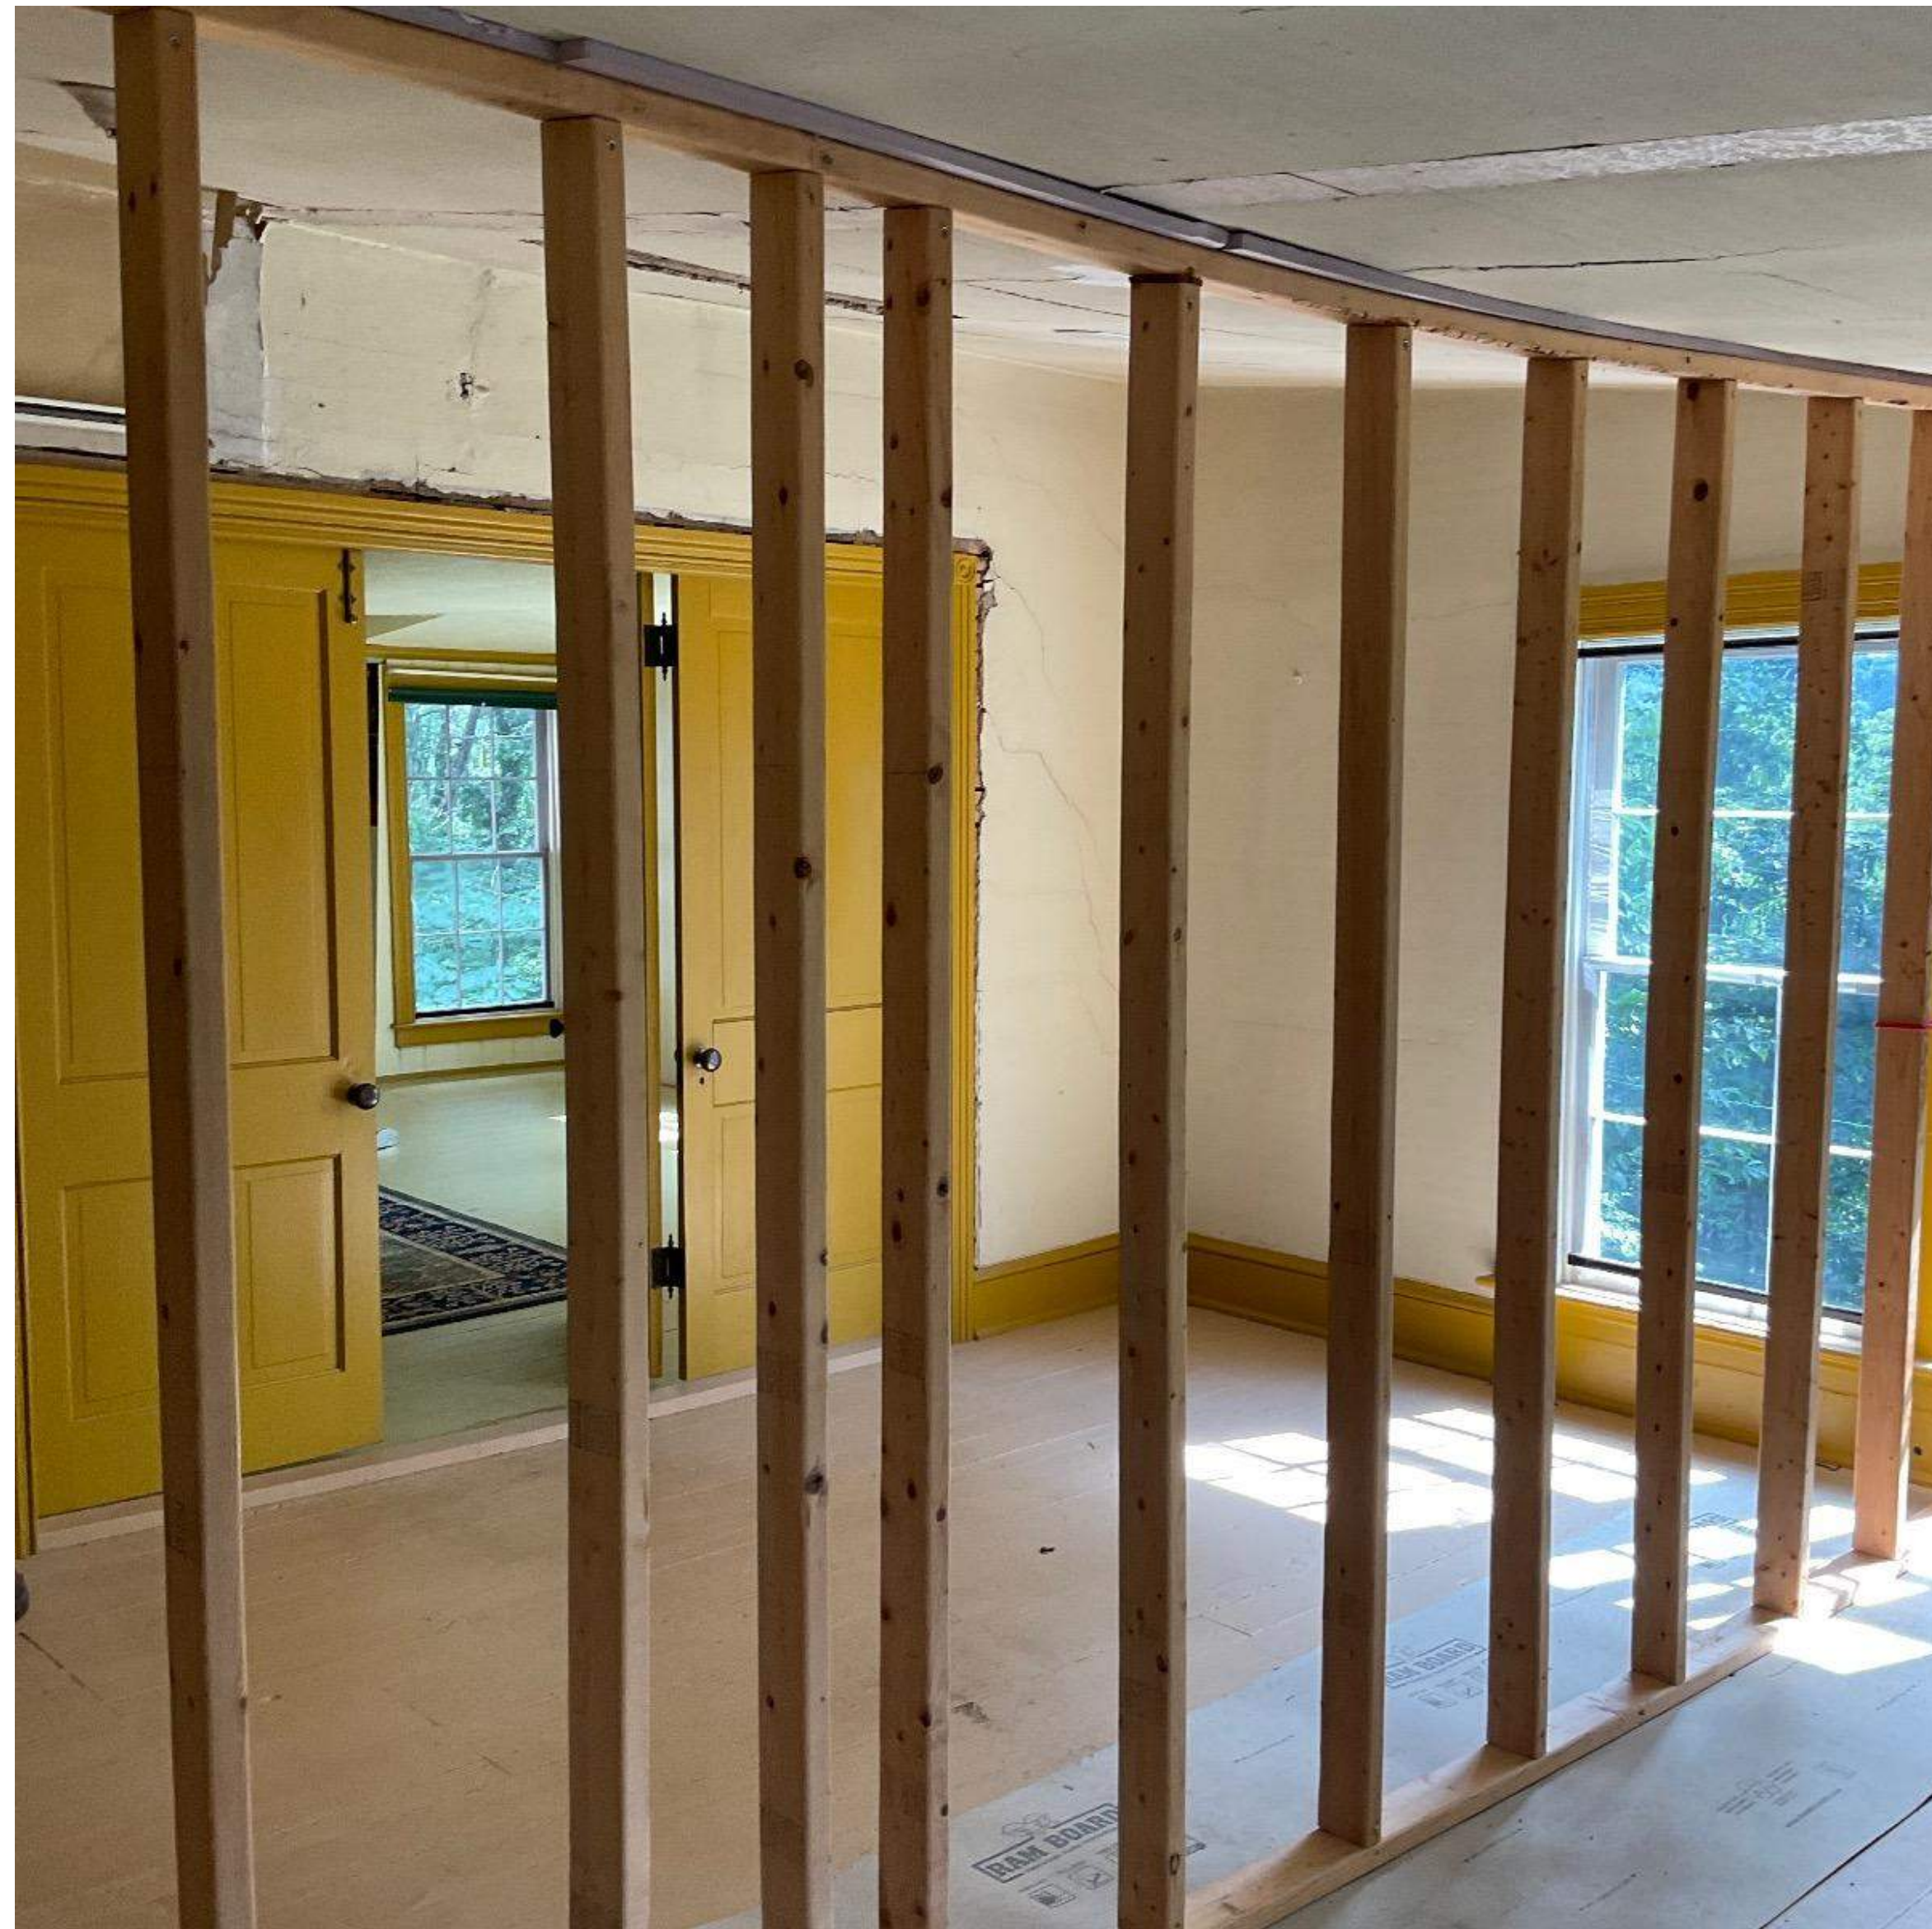
Room 211 - Dr. Hubbell's Bed Chamber; plaster ceiling with roof deflection

- Install new rafters for roof framing at Rooms 211 and 303; sister each hip rafter at the center penthouse and rehang with hold-down anchors.
- Install MPE systems in a manner sensitive to historic fabric, including upgrades for mechanical, plumbing, building electrical distribution, lightning protection, interior lighting, emergency lighting, exterior lighting, telecommunications, security, and fire alarm devices.

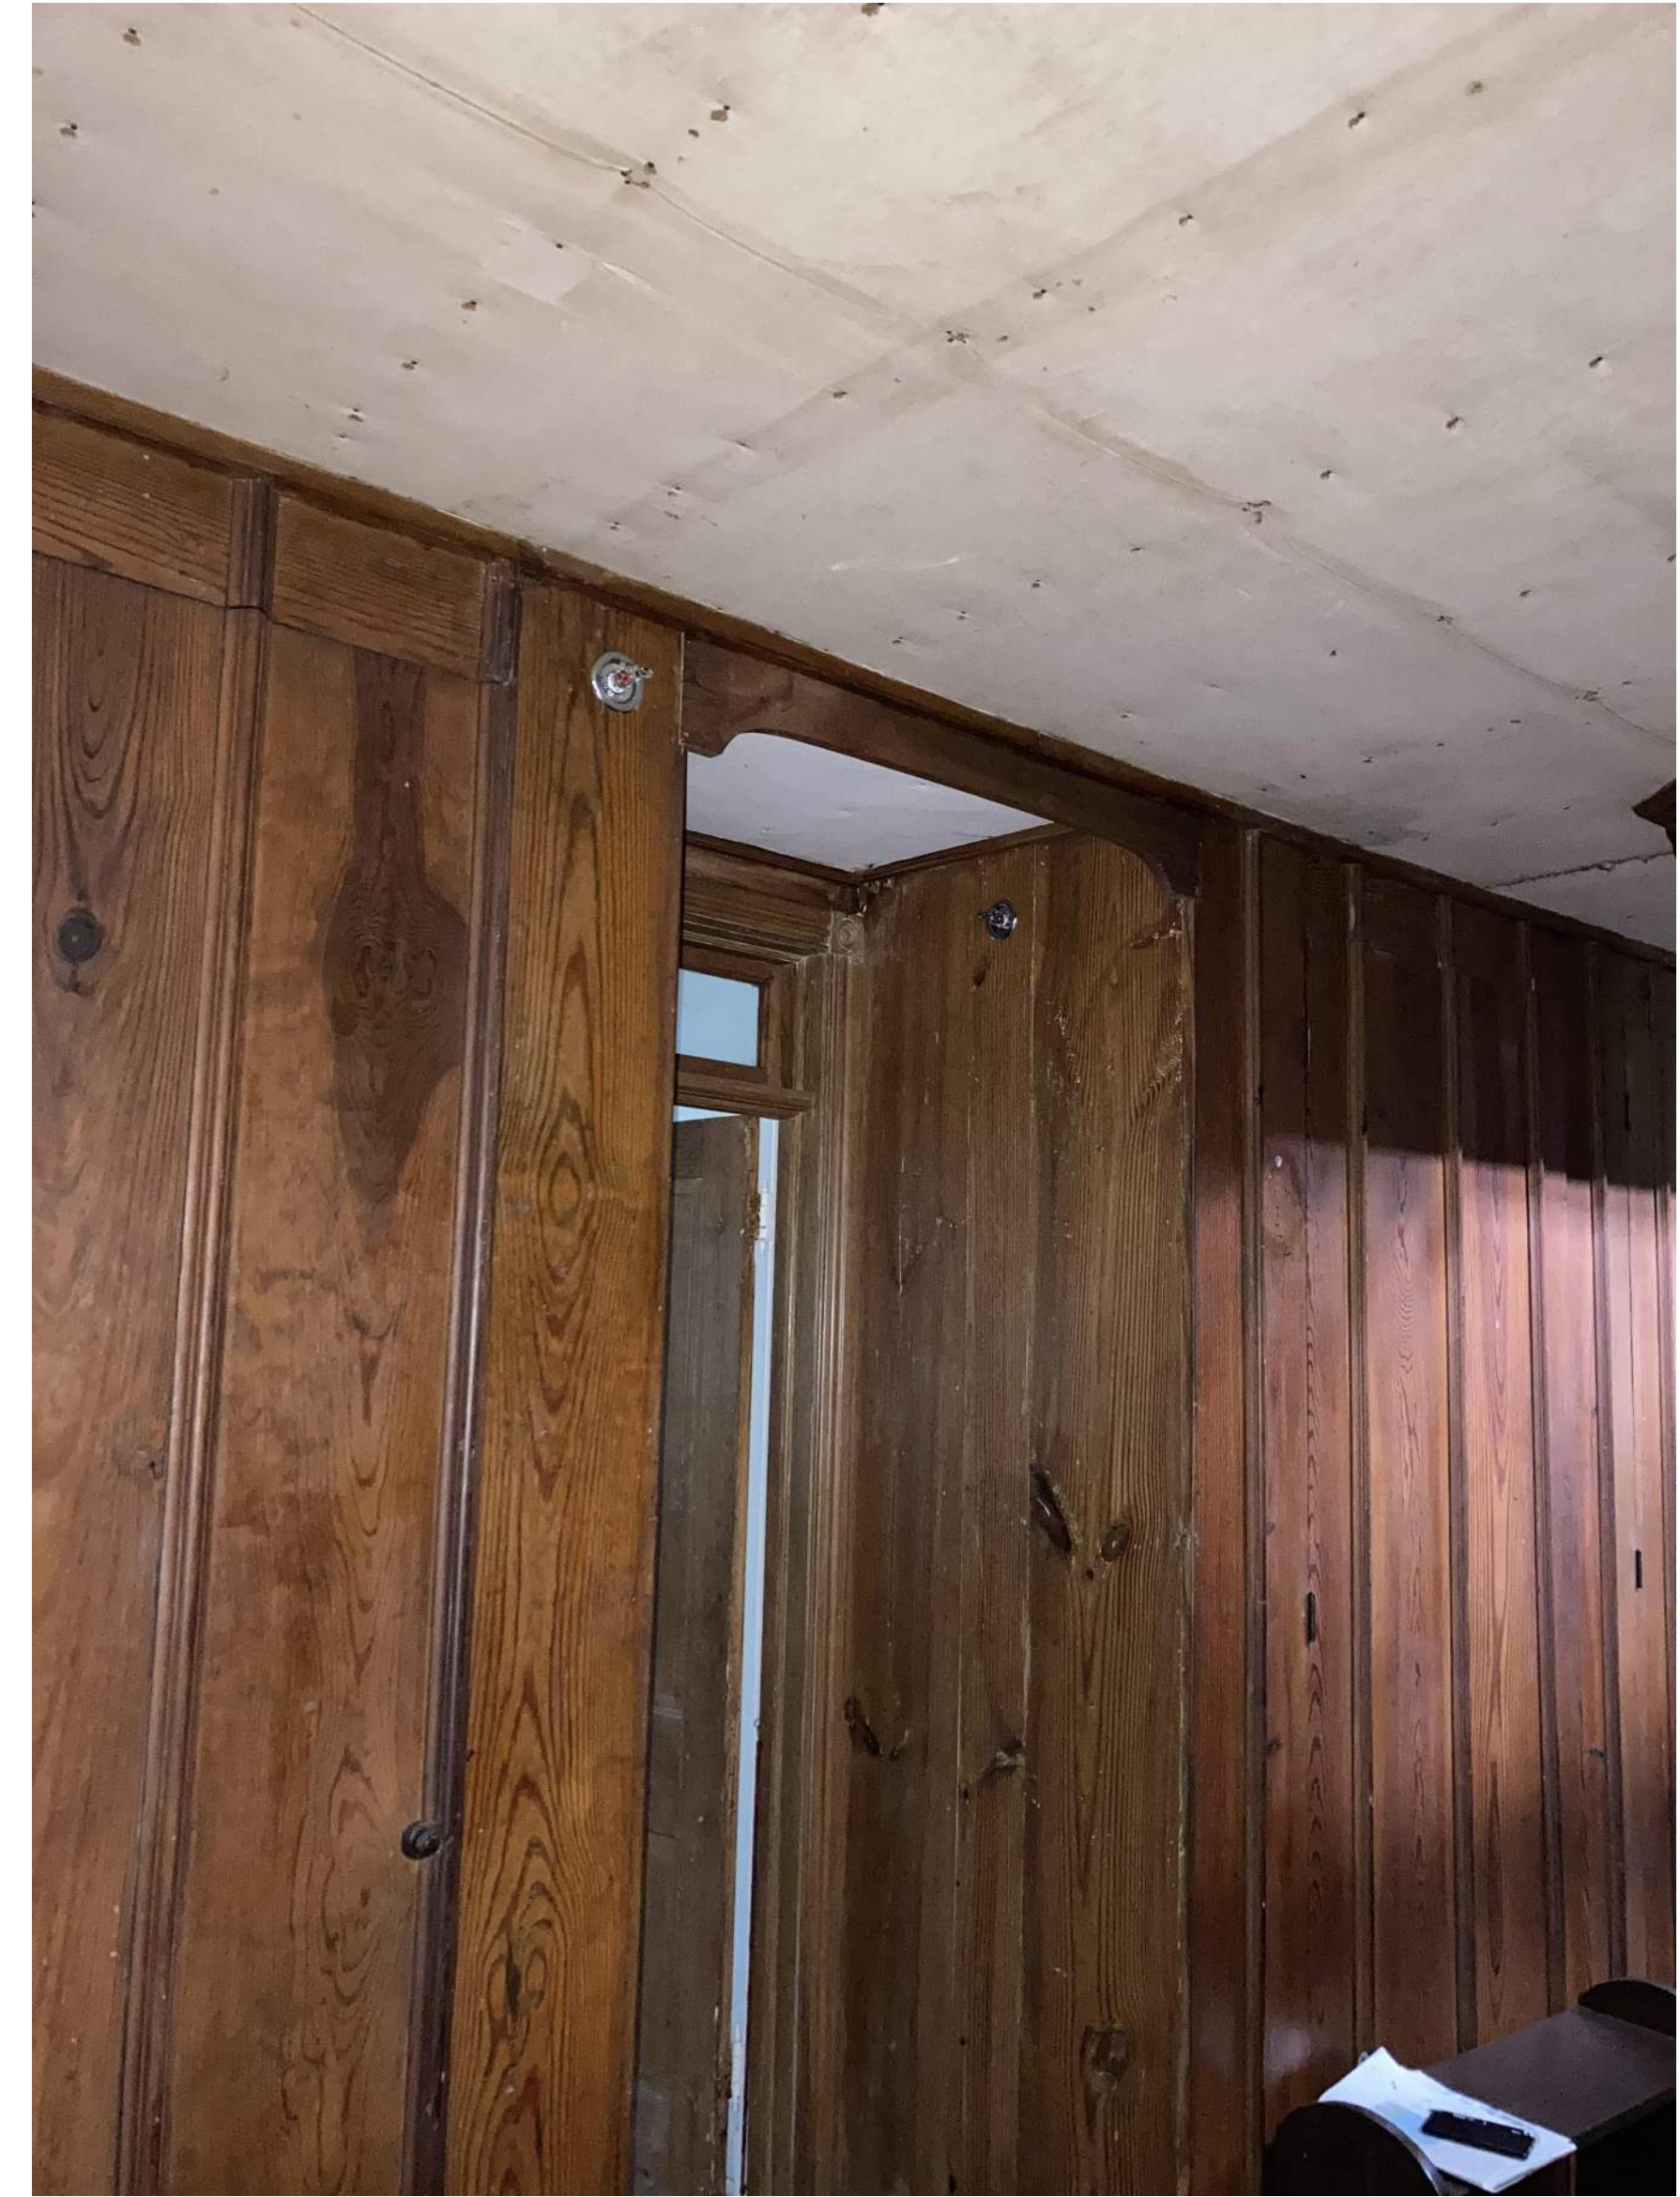
Room 102 - Main Hall; original muslin fabric ceiling

- 1st, 2nd, and 3rd floors:
 - Restore existing wood floors to consistent finish.
 - Repair plaster walls where indicated.
 - Remove muslin ceiling fabric at 1st floor hall and Room 303 and crate for conservation treatment; reinstall on new backing. Install new fire-retardant treated muslin ceilings where indicated in report in place of non-historic ceilings.
