Mills + Schnoering Architects, LLC

REHABILITATION BASE SCOPE FOR ALL SCHEMATIC DESIGN ALTERNATIVES

REHABILITATE CLARA BARTON NATIONAL HISTORIC SITE

ALTERNATIVE 1: REPAIR AND REHABILITATE

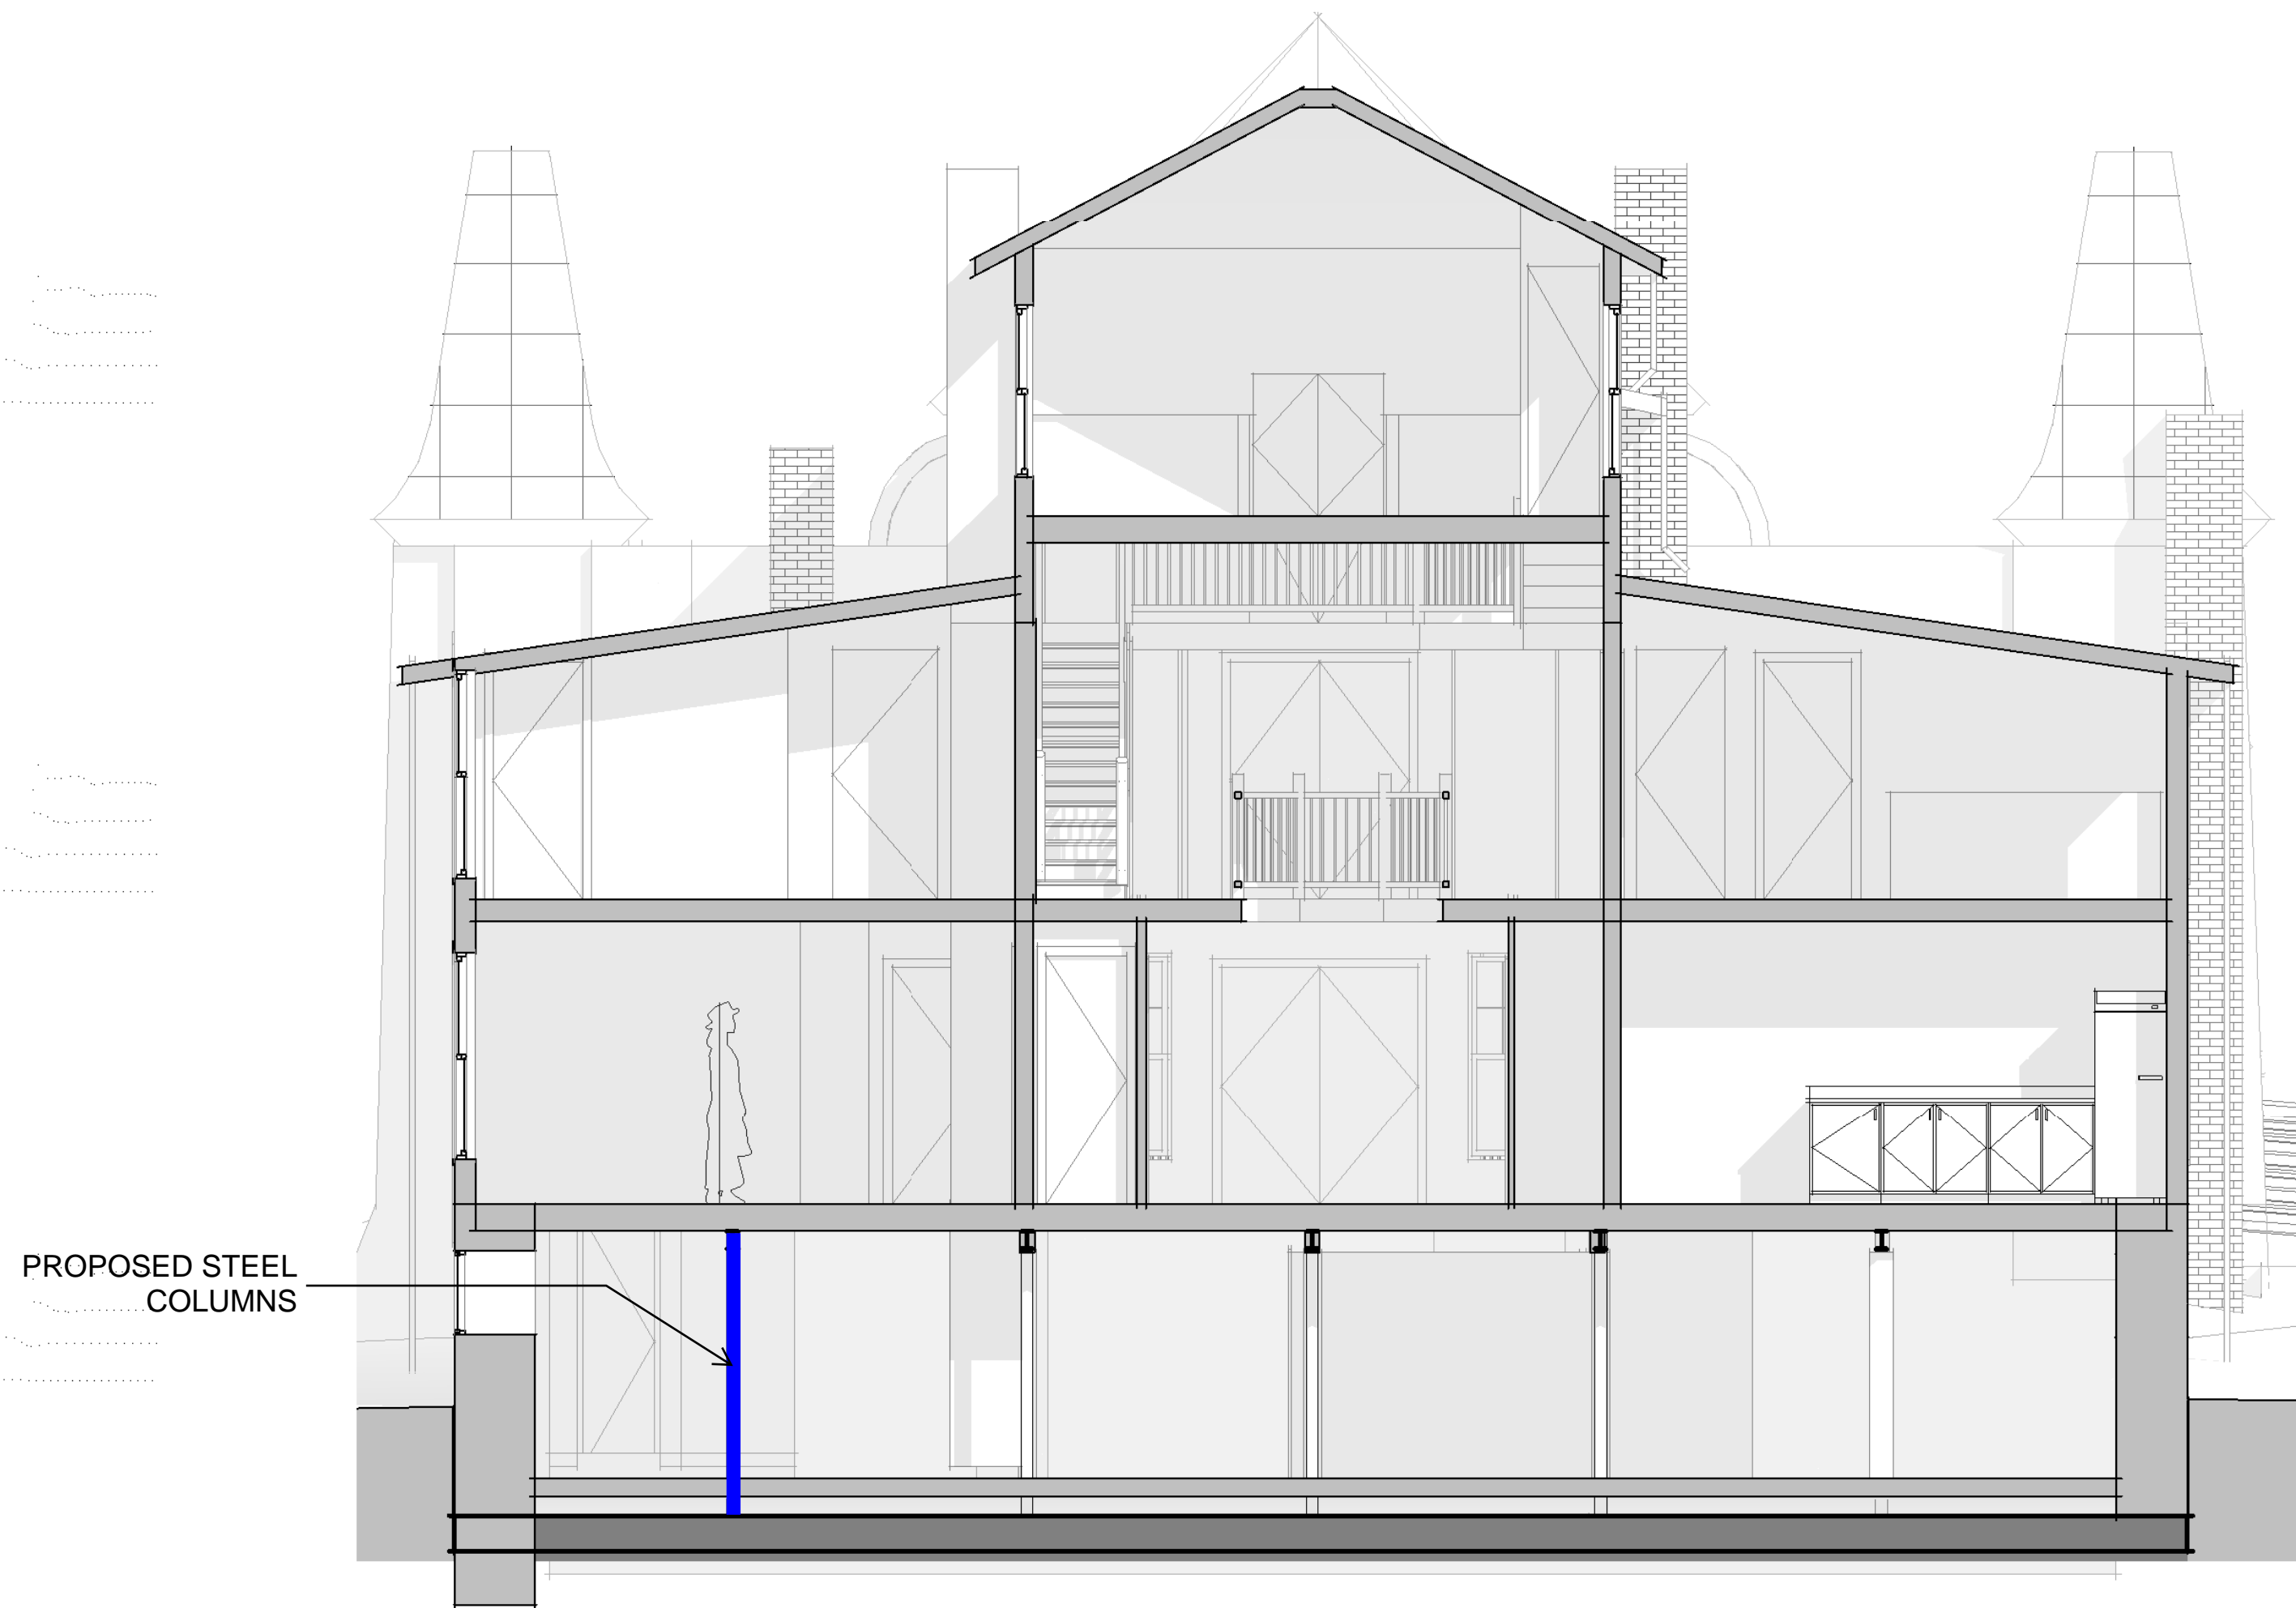
Other than the base scope on Page 3 which includes the reinforcement of the 1st floor framing from the basement (see diagram above), there is no additional structural work in this alternative. No use or visitation will be allowed on the 2nd or 3rd floors due to low live load capacities; rooms will receive restoration treatment but will not be altered or programmed for any use (Photo upper right: existing 2nd floor front room without furnishings).

The structural approach common to all alternatives in the basement is to reinforce the existing 1st floor framing. At portions of the floor structure, new W6 steel beams will be installed below the existing framing near the mid-span of the floor joists. New 4" steel columns will support the beams, thus reducing the spans of the existing joists. This type of reinforcement is already in place in the basement in some locations, installed in 1981 (Photo lower right).

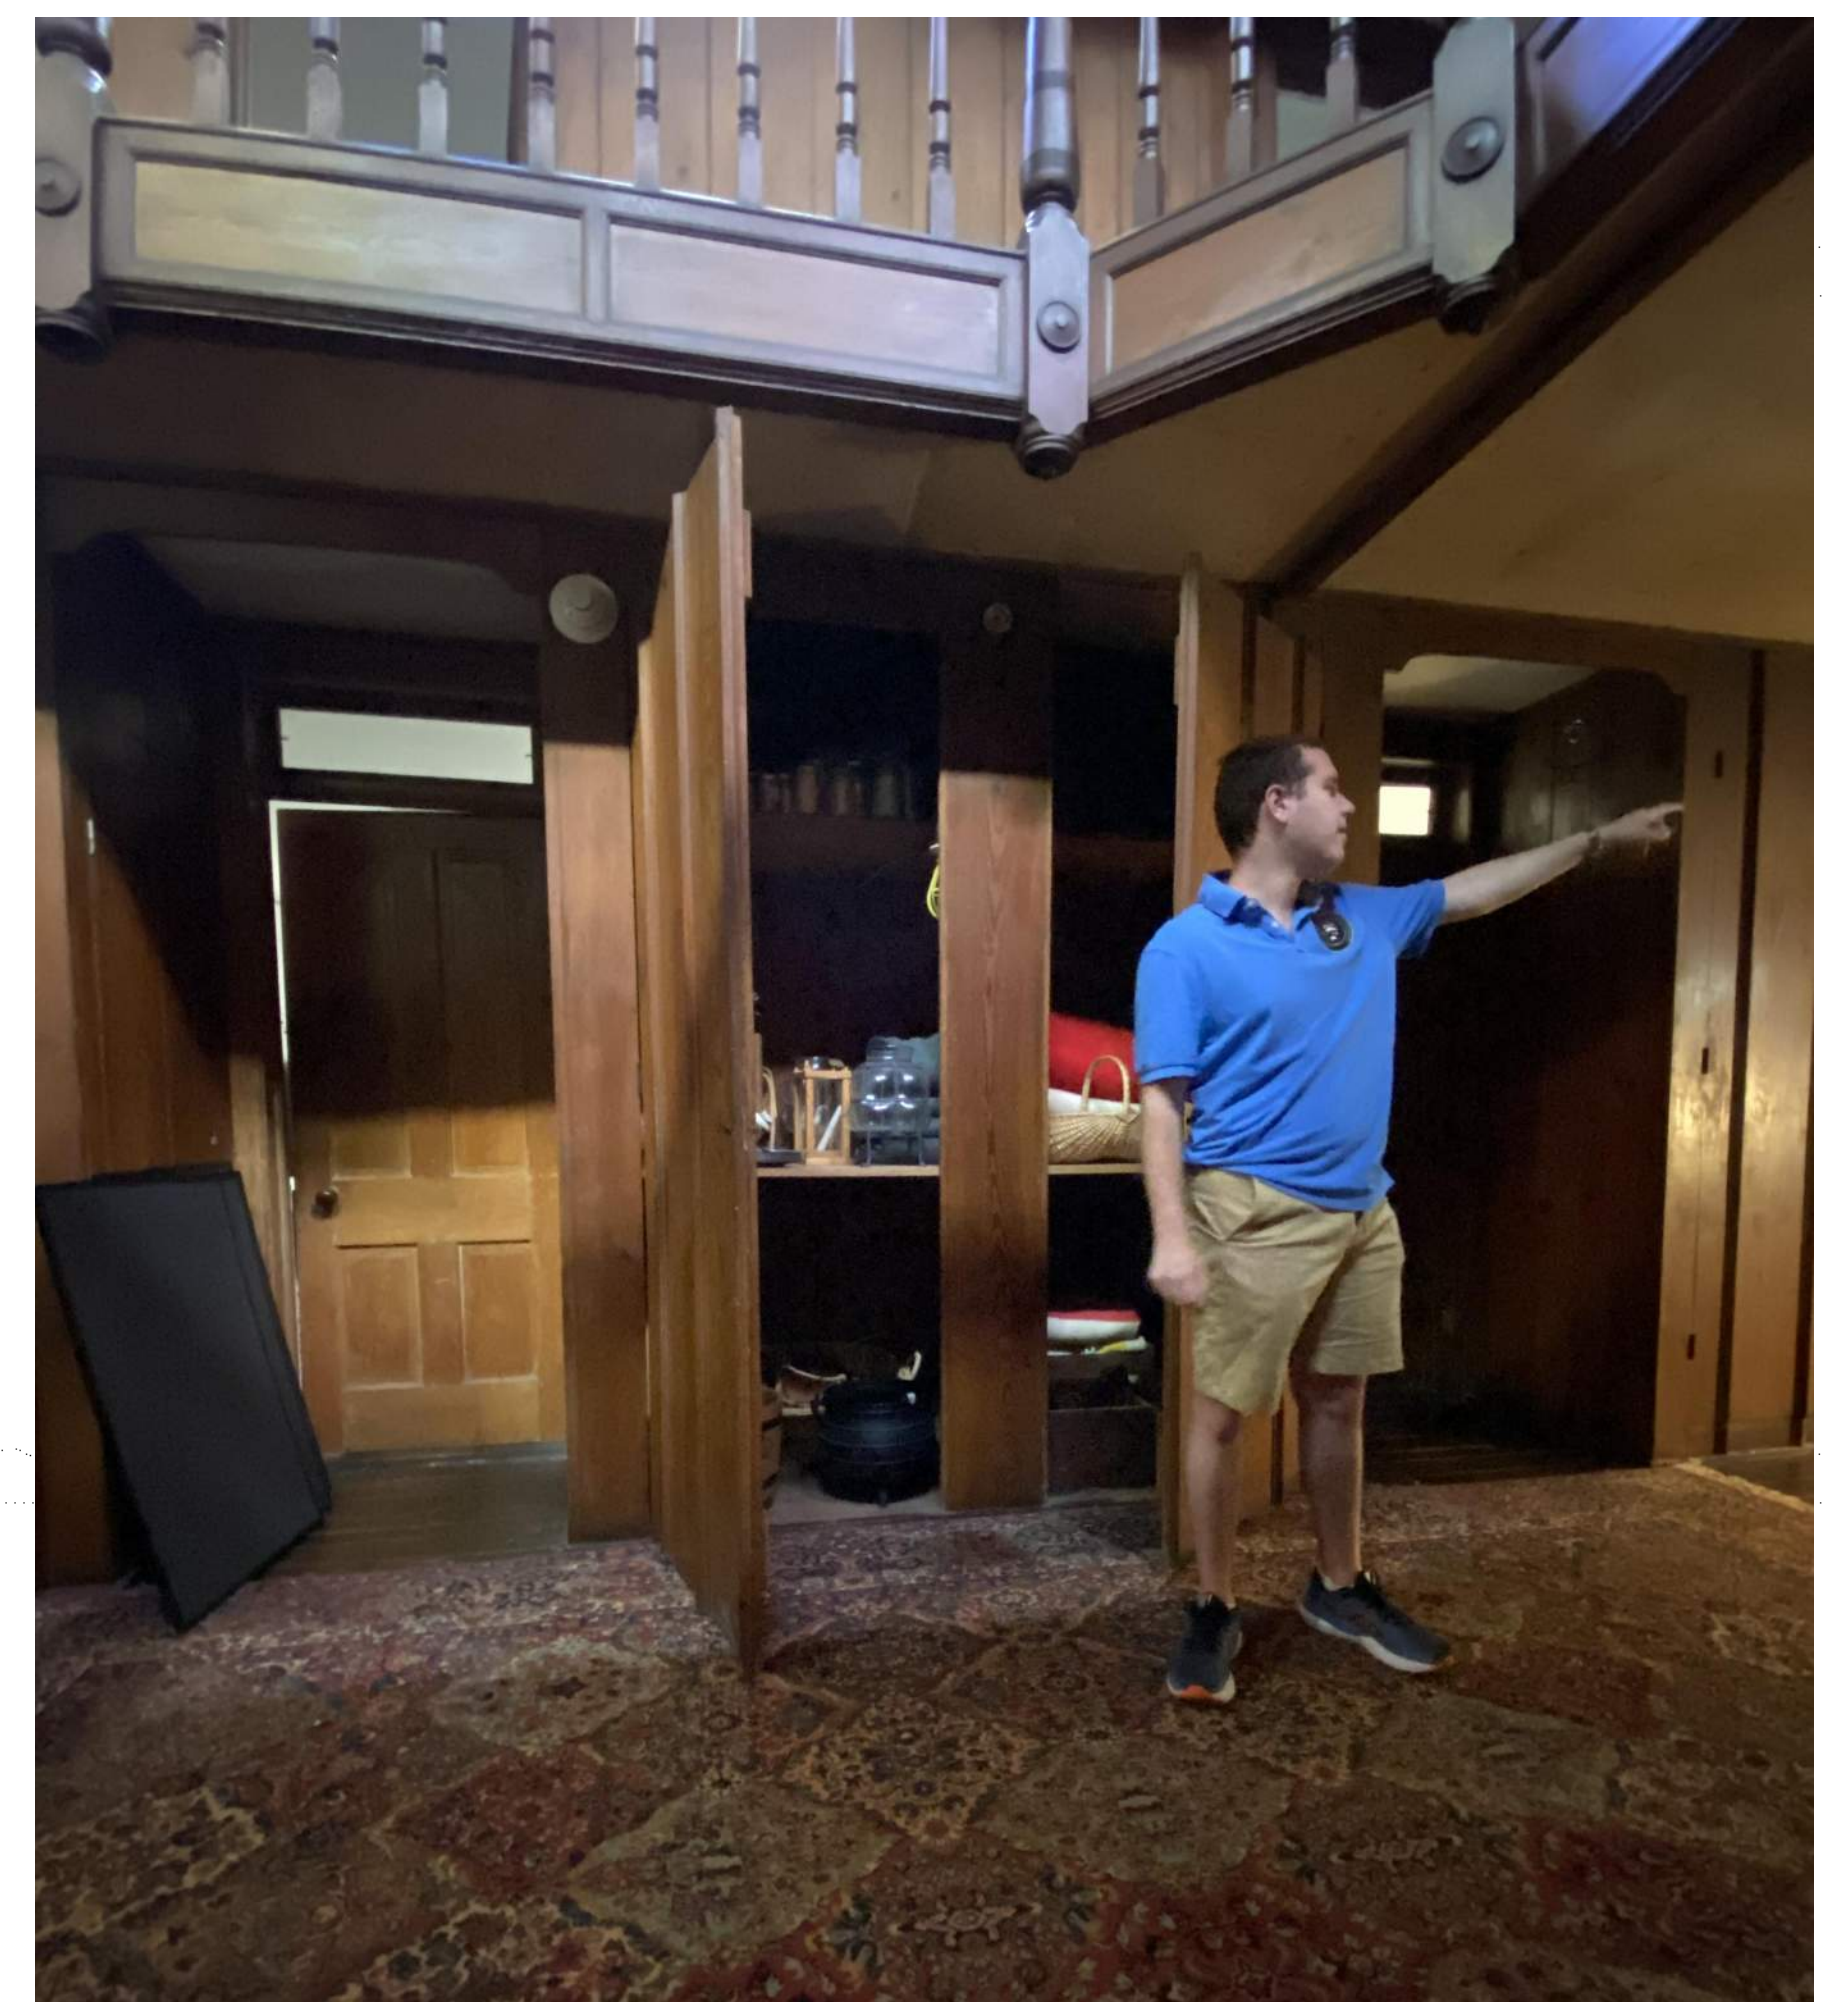
View from 1st floor inside atrium. Interpreted closets will remain free of structural columns in Alternative 2.

All metal framing can be installed from the 1st floor interior rather than through the exterior wall. At the cantilevered atrium floor area, two metal sisters can be lapped to allow smaller members to be used and installed from the rooms below. The upgrade will not be visible to visitors once completed as ceilings will be restored to original appearance - either painted or muslin fabric (Photo lower right).

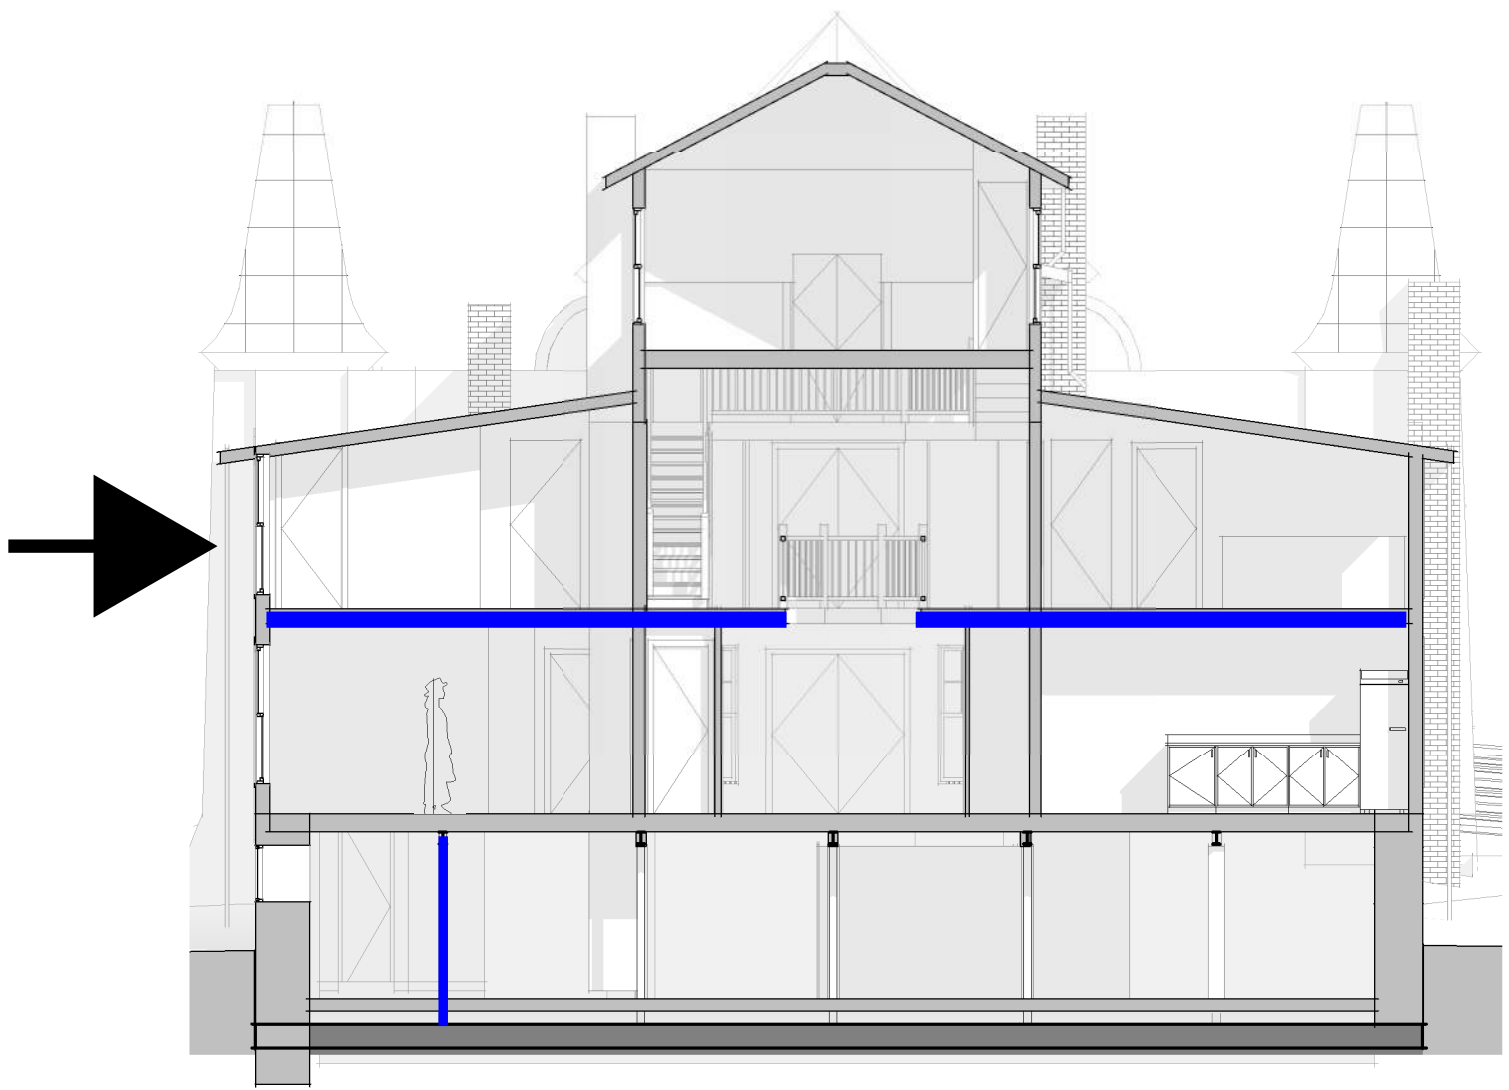
ALTERNATIVE 2 - SECOND FLOOR

ALTERNATIVE 2: MODERATE STRUCTURAL UPGRADE

- Architectural highlights on this floor:
- New restroom
 - New code-required egress stair due to 2nd floor occupancy. Discharges at exterior through the basement.
 - Furnished period rooms with space for interpretation and exhibits with climate-controlled cases.
 - Medium (10 occupants) and Small (5 occupants) Classrooms.
 - Curatorial Workroom, Distance Learning Studio, Reading nook, Temporary Exhibits, Interactive Children's Exhibit - with limited occupancies as shown.
- Mechanical and Electrical highlights:
- Floor-mounted console fan coil units with custom enclosures.
 - New VRF mechanical system to provide heating and air conditioning throughout all rooms.
- Note: Per ADAAG 206.2.3, Exception 7, vertical access to stories above or below the accessible story is not required.

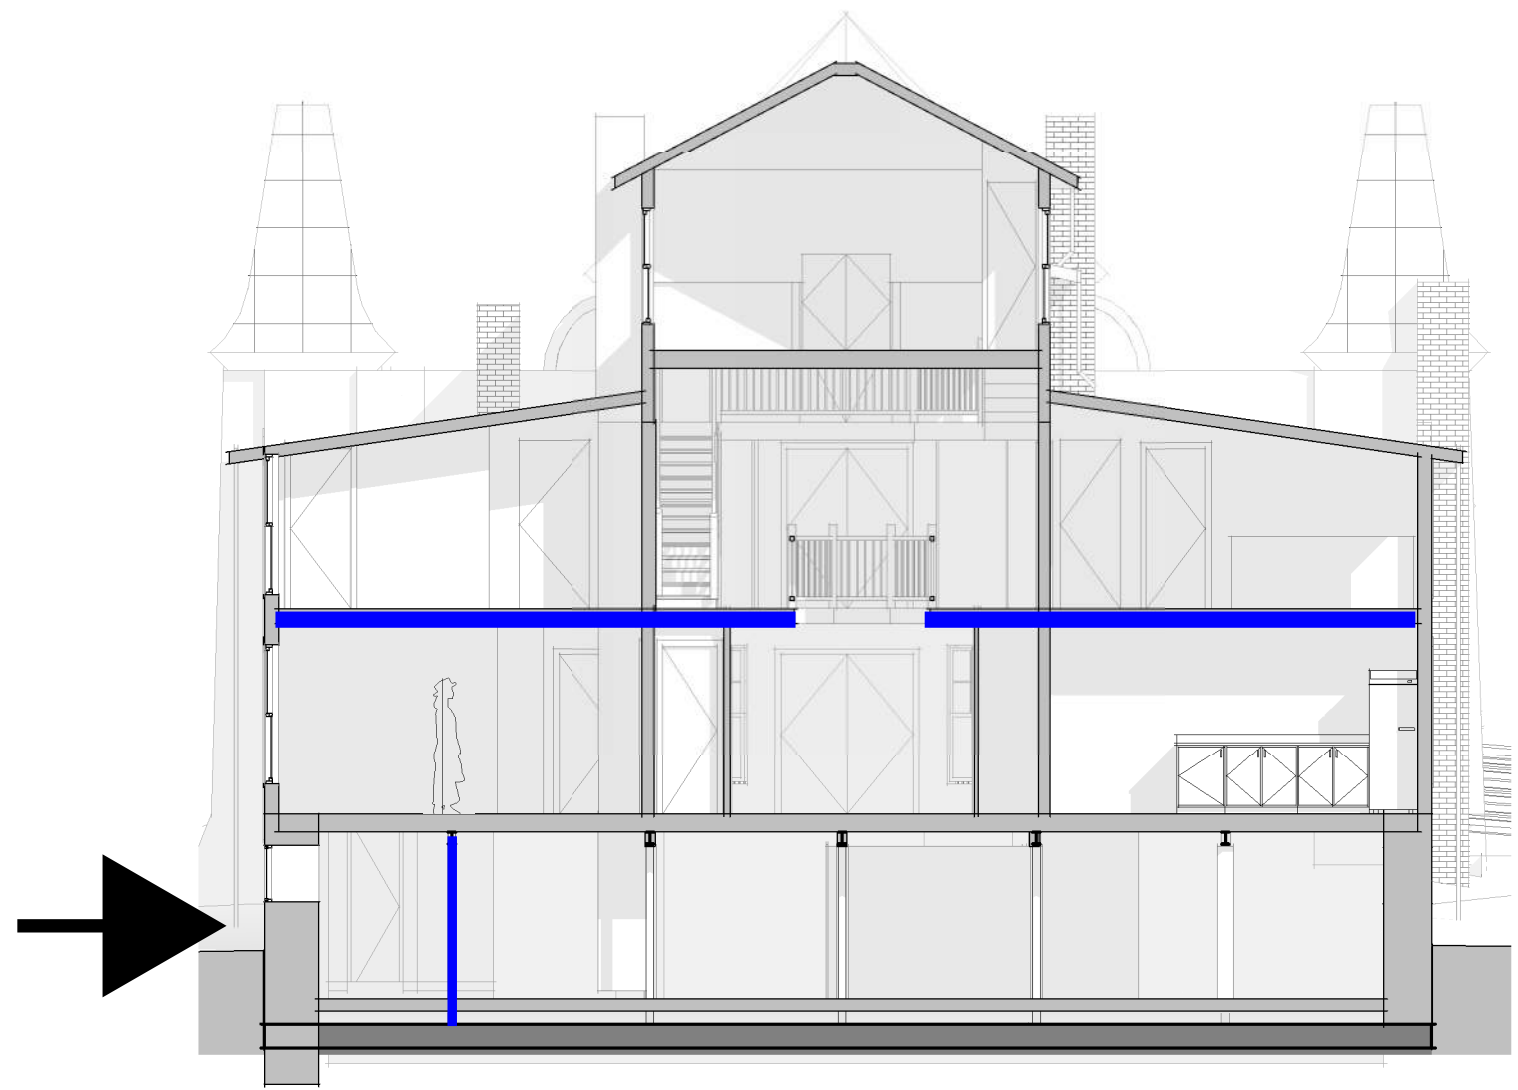
ALTERNATIVE 2 - BASEMENT

ALTERNATIVE 2: MODERATE STRUCTURAL UPGRADE

- Architectural highlights on this floor:
- New code-required egress stair due to 2nd floor occupancy. Discharges at exterior through the basement. Existing wood basement door to be heightened by approximately 12".

- Basement: Remove hazardous materials as indicated in report. Remove floor slab where shown for new concrete footings; install new steel columns and beam at westernmost column line to support first floor above. Install additional columns at the rear basement to support the first floor rear rooms.

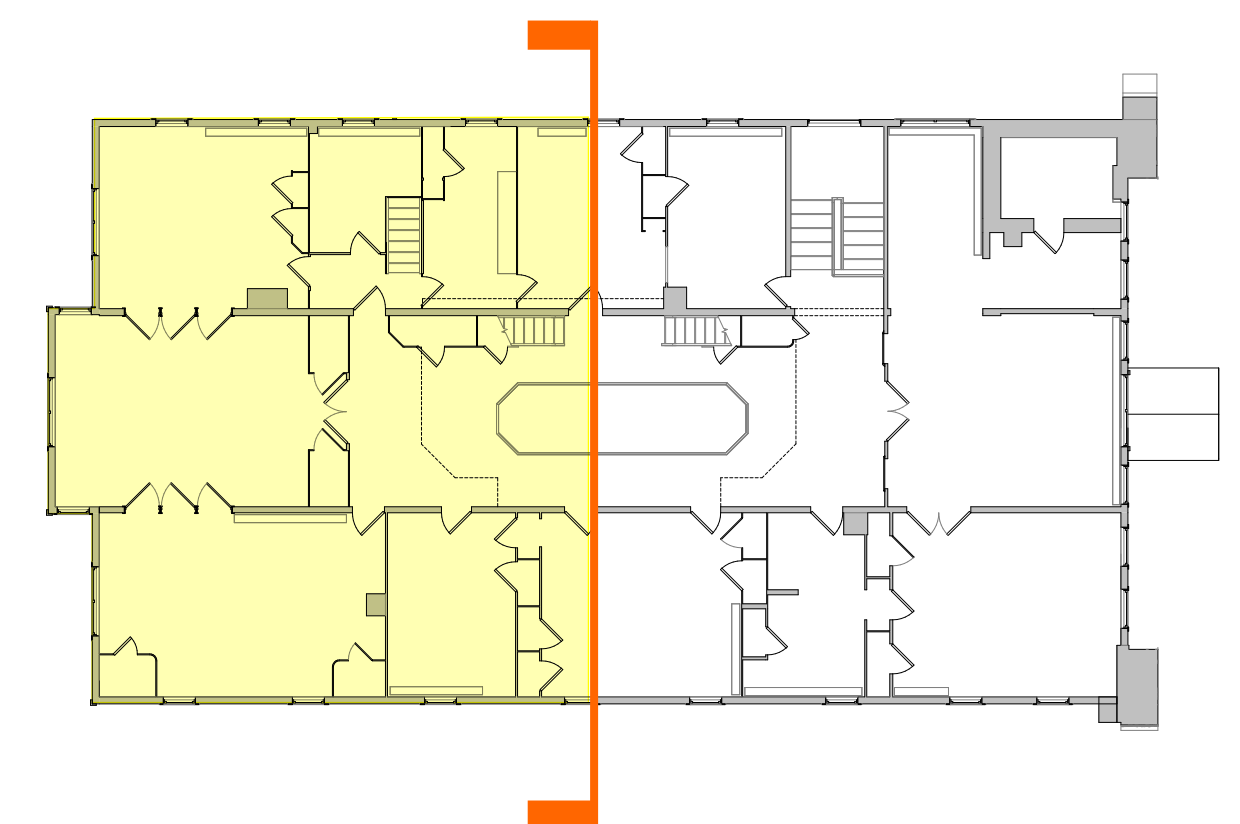
ALTERNATIVE 3A - AXONOMETRIC CUTAWAY VIEW REHABILITATE CLARA BARTON NATIONAL HISTORIC SITE

ALTERNATIVE 3A: EXTENSIVE STRUCTURAL UPGRADE

In addition to the structural base scope on Page 3, an extensive structural upgrade will increase the live load capacity of the 2nd floor and allow for a total of 105 occupants meeting code requirements. New steel columns will be inserted through the floor framing from the basement up to the underside of the 2nd floor to support new steel beams placed within the depth of the 2nd floor framing; these columns will be located in the 1st floor closets and exposed inside certain rooms (Photo upper right: example of similar installation at different building; column is painted to match existing finish). In addition, new wood beams will be inserted mid-span and the existing joists cut and resupported with joist hangers (Photo lower right: example of similar installation at different building). By cutting the existing joists, this installation damages the most historic fabric of the three alternatives. All ceiling finishes at the 1st floor will be removed similar to the work in Alternative 2.

The cantilevered steel beams in the atrium may need to be installed through new openings in the exterior walls, which would require selectively removing the clapboard and threading the new beams through the building joist depth. This is a more difficult field installation than Alternative 2. Once all the ceiling materials are removed, field verifications of all 2nd floor framing will determine how many beams can be installed from the interior and how many require new openings at the exterior walls. The upgrade will not be visible to visitors once completed as ceilings and walls will be restored to original appearance.

Lateral stiffness will be increased with diagonal bracing in the closets in 2 locations from the basement up to the 2nd floor.

KEY PLAN SHOWING SECTION CUT

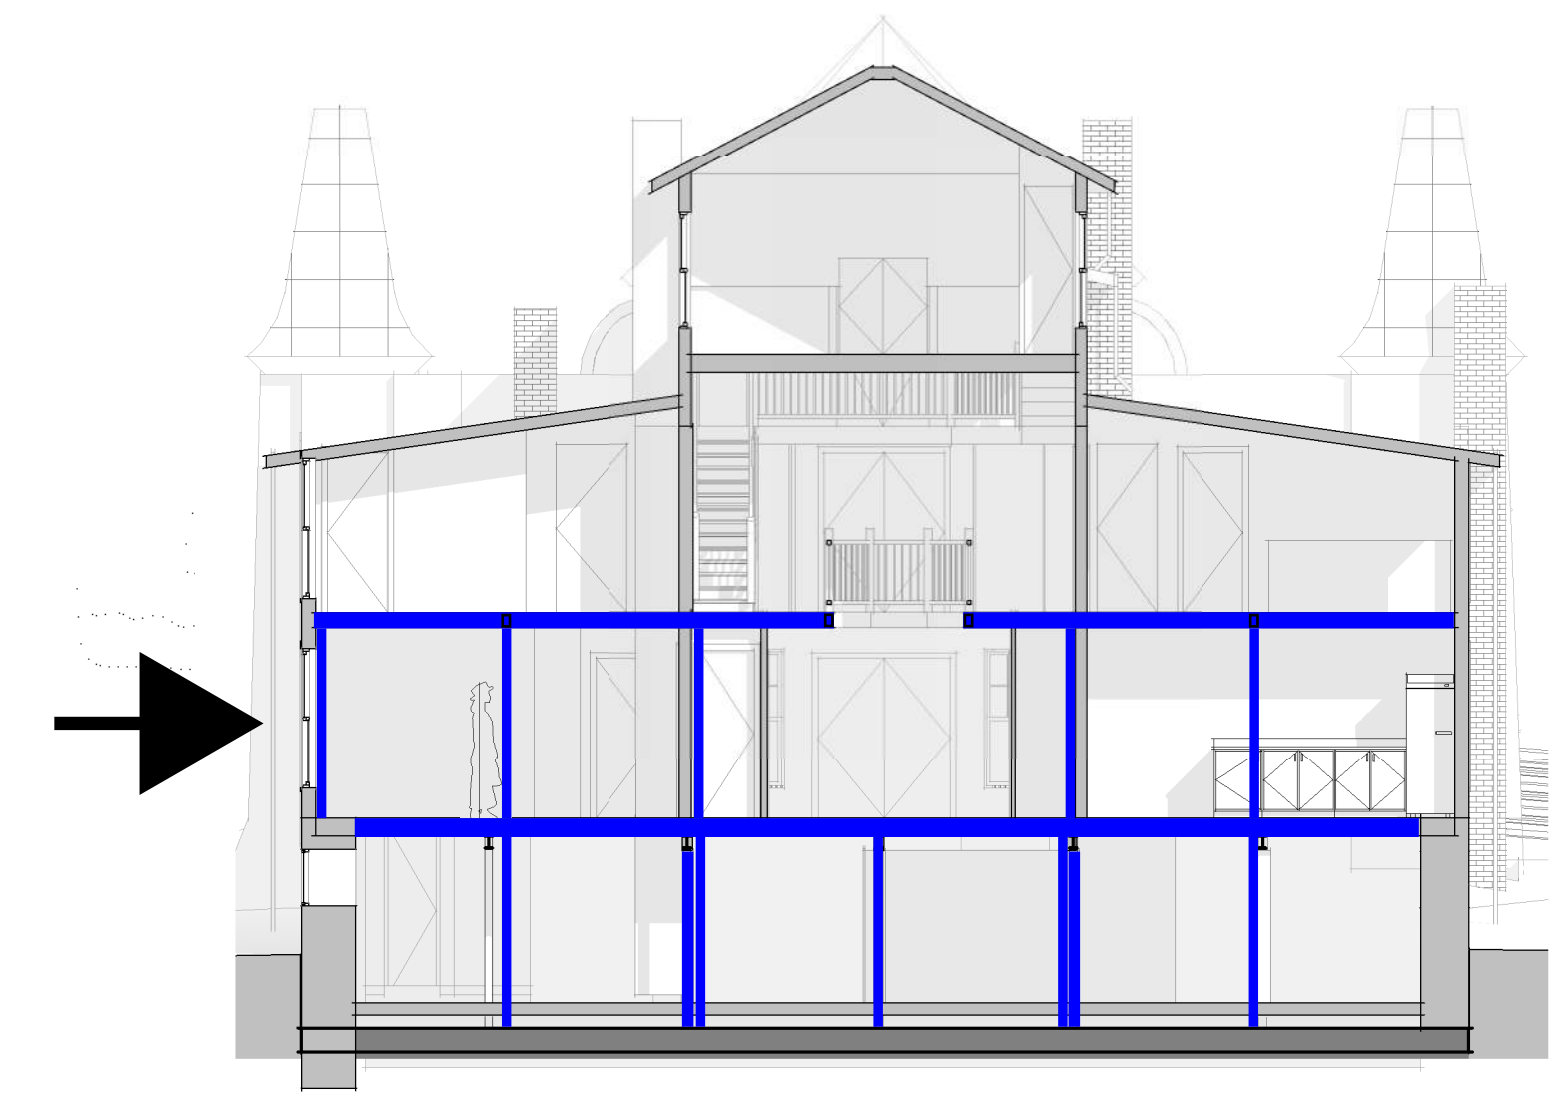
ALTERNATIVE 3A - FIRST FLOOR

ALTERNATIVE 3A: EXTENSIVE STRUCTURAL UPGRADE

- Architectural highlights on this floor:
- Accessible restroom and route to primary spaces.
 - New code-required egress stair due to 2nd floor occupancy. Discharges at exterior through the basement. The stair shaft will be enclosed in new fire-rated walls within the existing space and will remove the existing framing and floor at the 1st level.

- Furnished period rooms with space for interpretation and exhibits with climate-controlled cases
 - Large Classroom for 30 occupants (requires removal of an original partition)

- Bookstore and NPS space
- Mechanical and Electrical highlights:
- Ductwork vertical risers and electrical conduit will be located in closets; pathways to be coordinated with sprinkler pipes currently located in closets.

- New VRF mechanical system to provide heating and air conditioning throughout all rooms.
 - Locate mechanical cooling units and pads at southeast corner further from the house at the exterior.

- Civil and Landscape highlights (shown on Landscape plan):
- Paved walks include the entry path, east and south egress path.
 - Screen planting around mechanical cooling units.

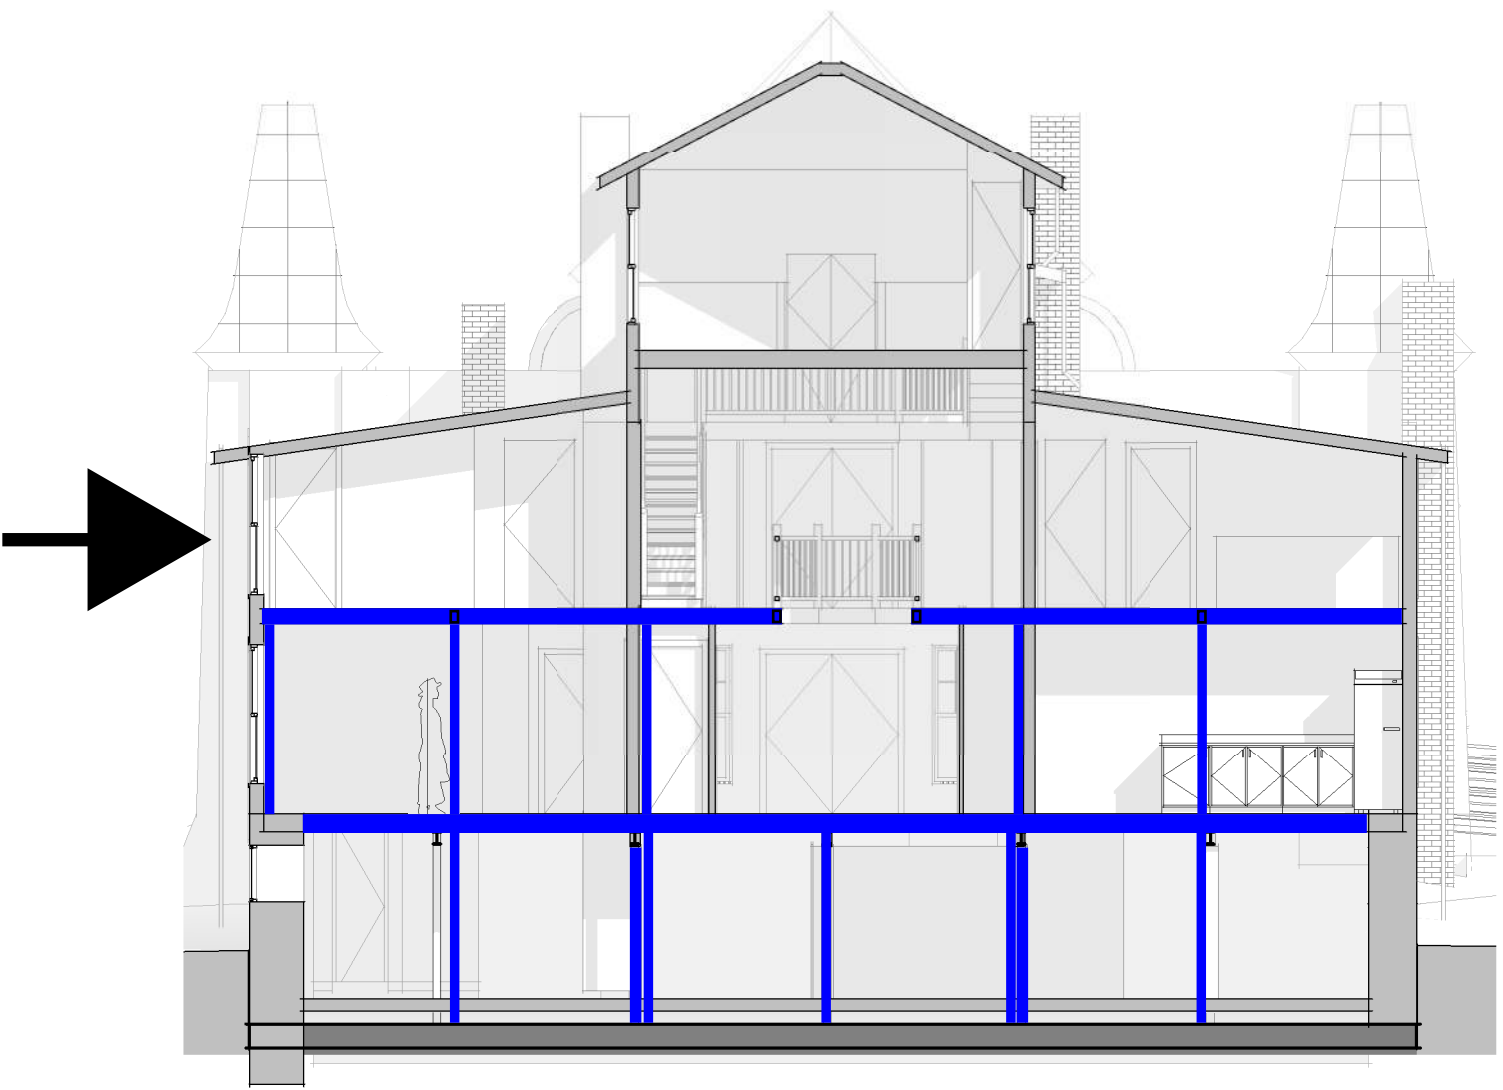
ALTERNATIVE 3A - SECOND FLOOR

ALTERNATIVE 3A: EXTENSIVE STRUCTURAL UPGRADE

Architectural highlights on this floor:

- New restroom
- New code-required egress stair due to 2nd floor occupancy. Discharges at exterior through the basement.
- Furnished period rooms with space for interpretation and exhibits with climate-controlled cases.
- (2) Medium (19 and 20 occupants) Classrooms.
- Curatorial Workroom, Distance Learning Studio, Reading nook, Temporary Exhibits, Interactive Children's Exhibit

Mechanical and Electrical highlights:

- Floor-mounted console fan coil units with custom enclosures.
- New VRF mechanical system to provide heating and air conditioning throughout all rooms.

Note: Per ADAAG 206.2.3, Exception 7, vertical access to stories above or below the accessible story is not required.

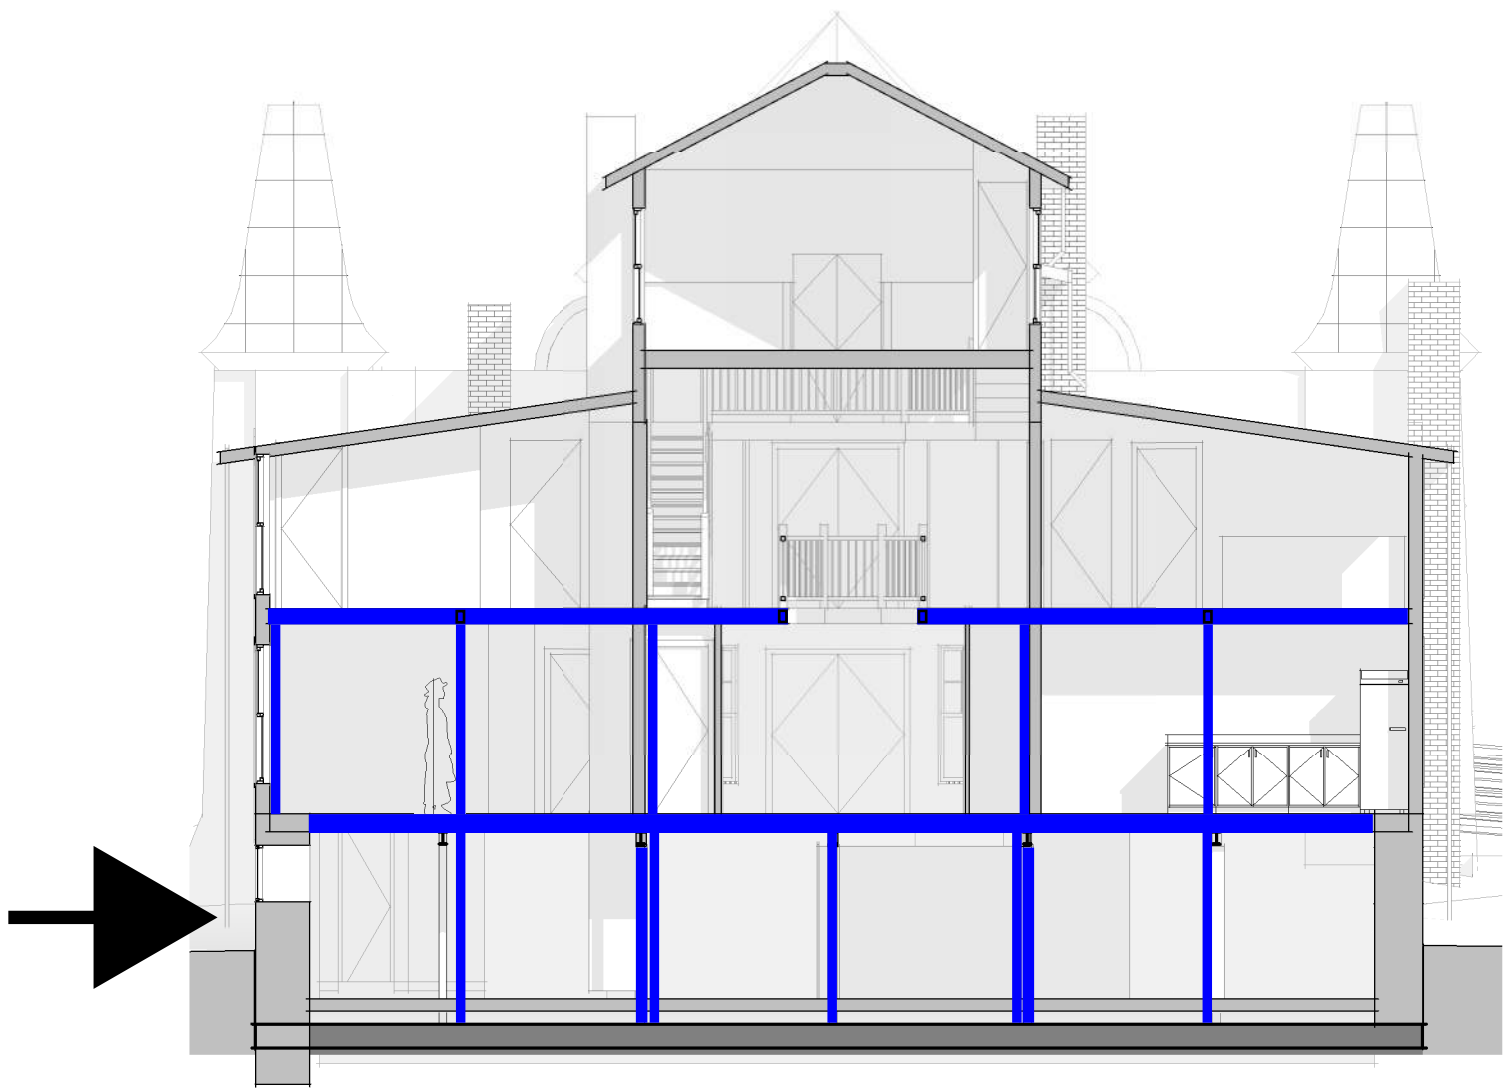
ALTERNATIVE 3A - BASEMENT

ALTERNATIVE 3A: EXTENSIVE STRUCTURAL UPGRADE

- Architectural highlights on this floor:
- New code-required egress stair due to 2nd floor occupancy. Discharges at exterior through the basement. Existing wood basement door to be heightened by approximately 12".

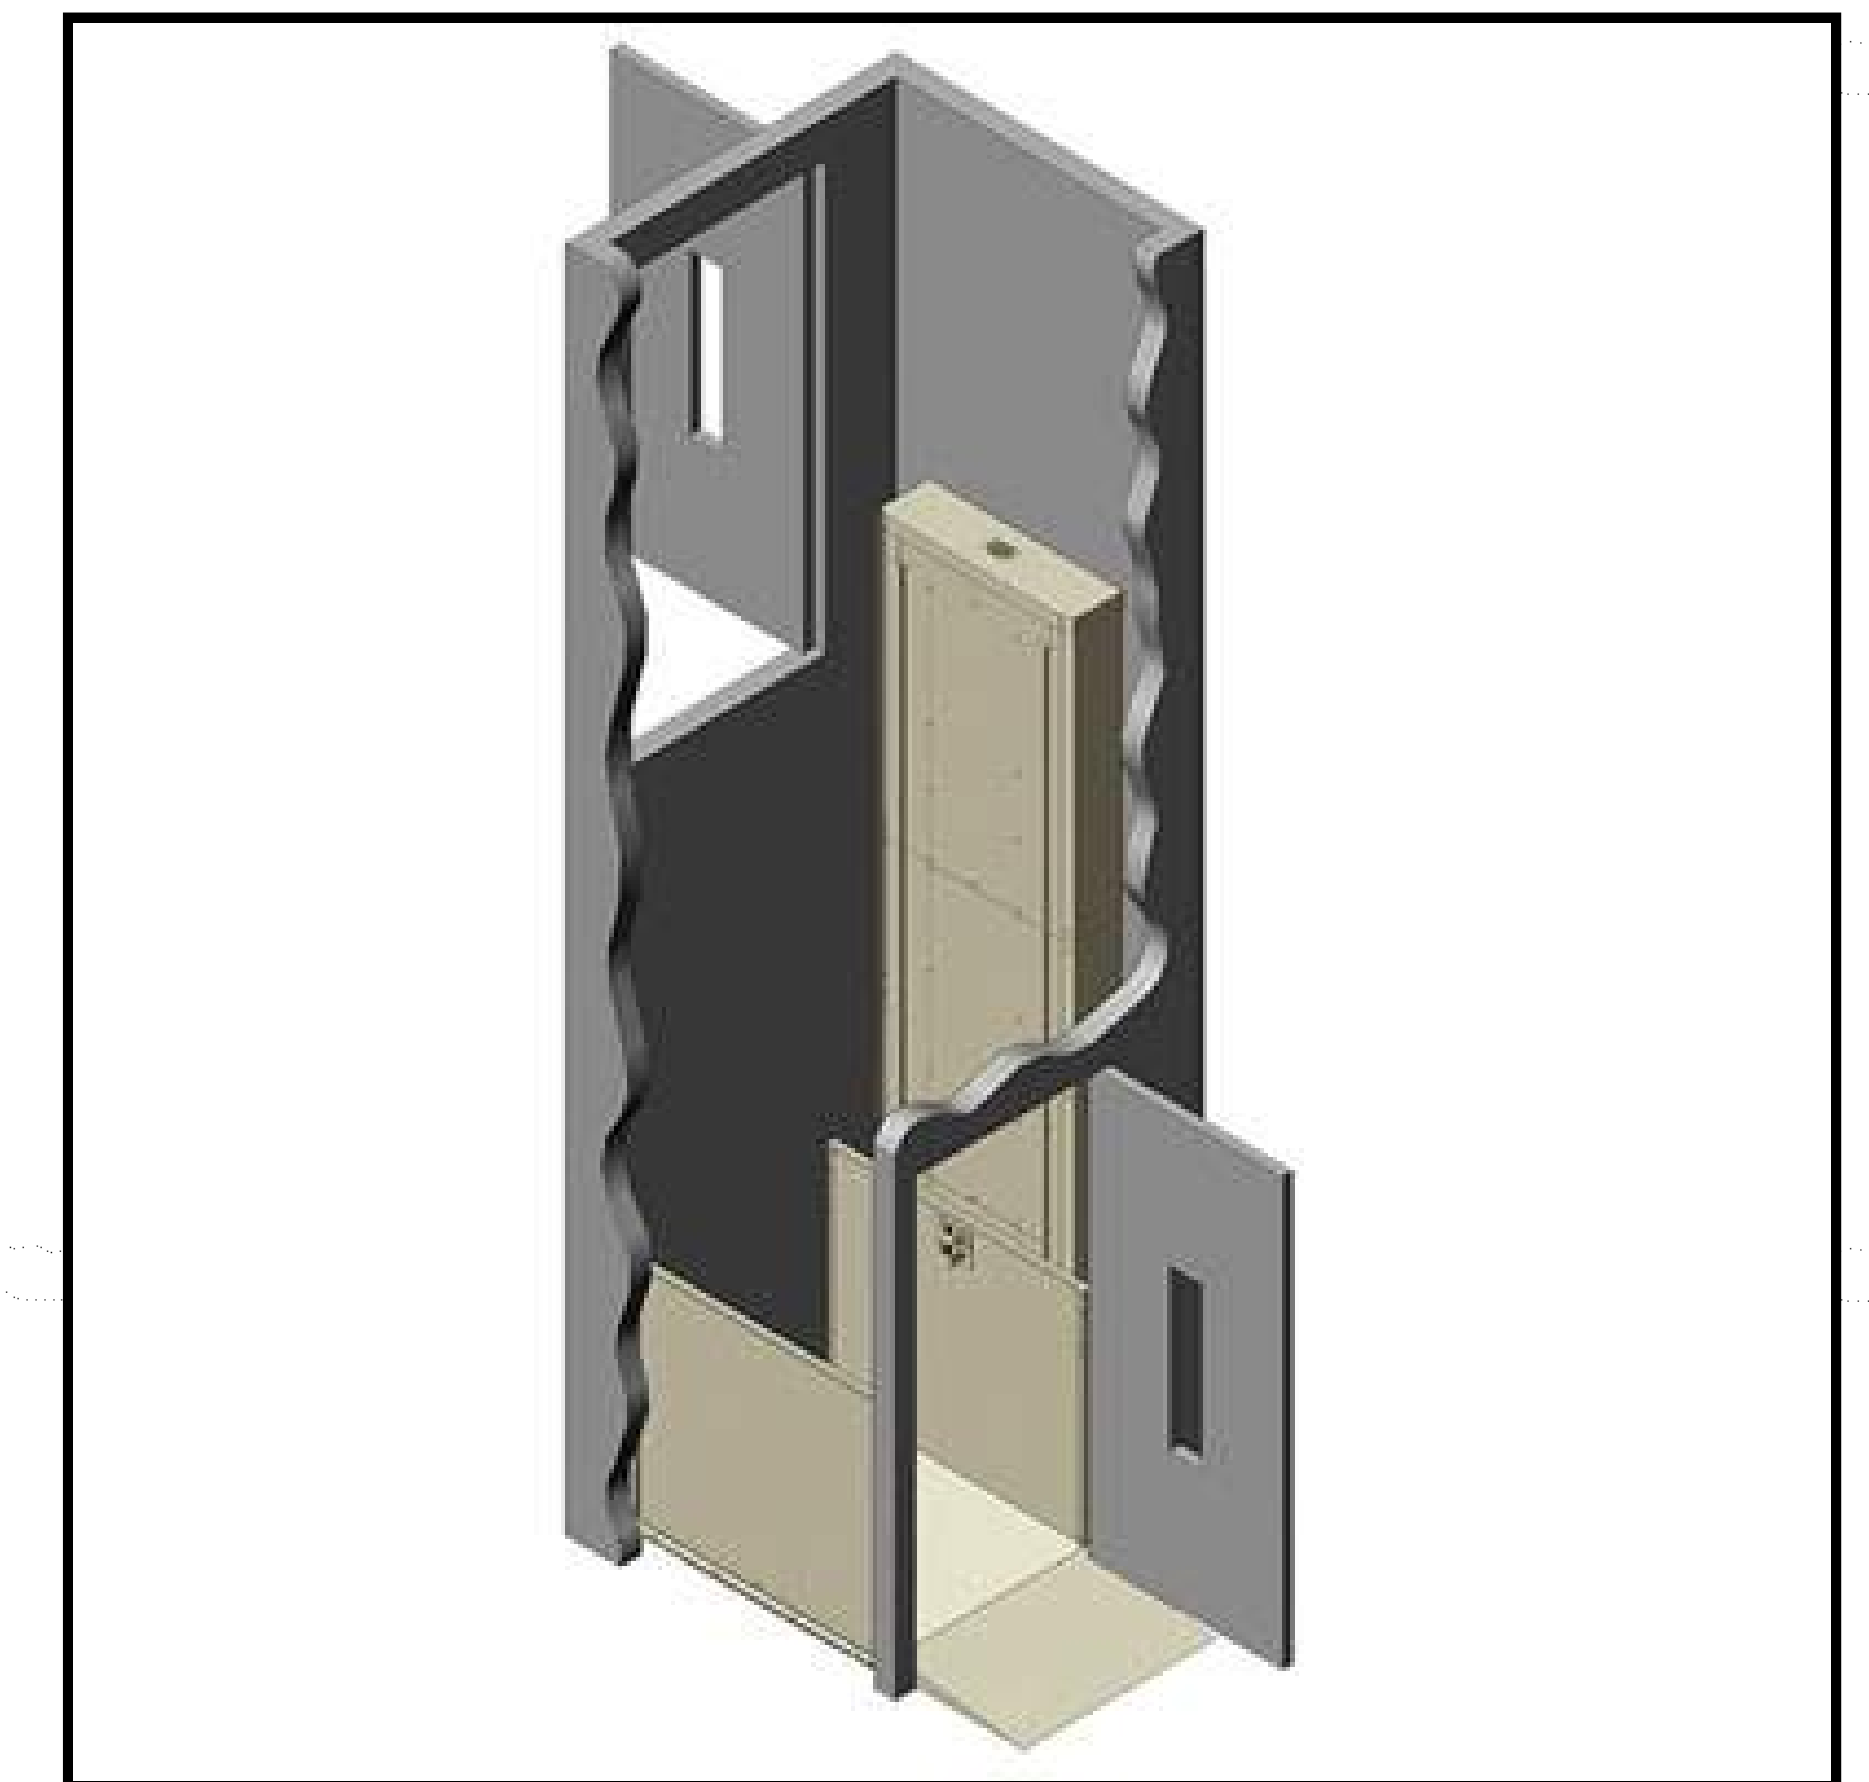
Cut-away diagram of vertical platform lift. The outside walls, or shaft walls, are cut to view inside.
