Mills + Schnoering Architects, LLC

REHABILITATION BASE SCOPE FOR ALL SCHEMATIC DESIGN ALTERNATIVES

REHABILITATE CLARA BARTON NATIONAL HISTORIC SITE

ALTERNATIVE 1: REPAIR AND REHABILITATE

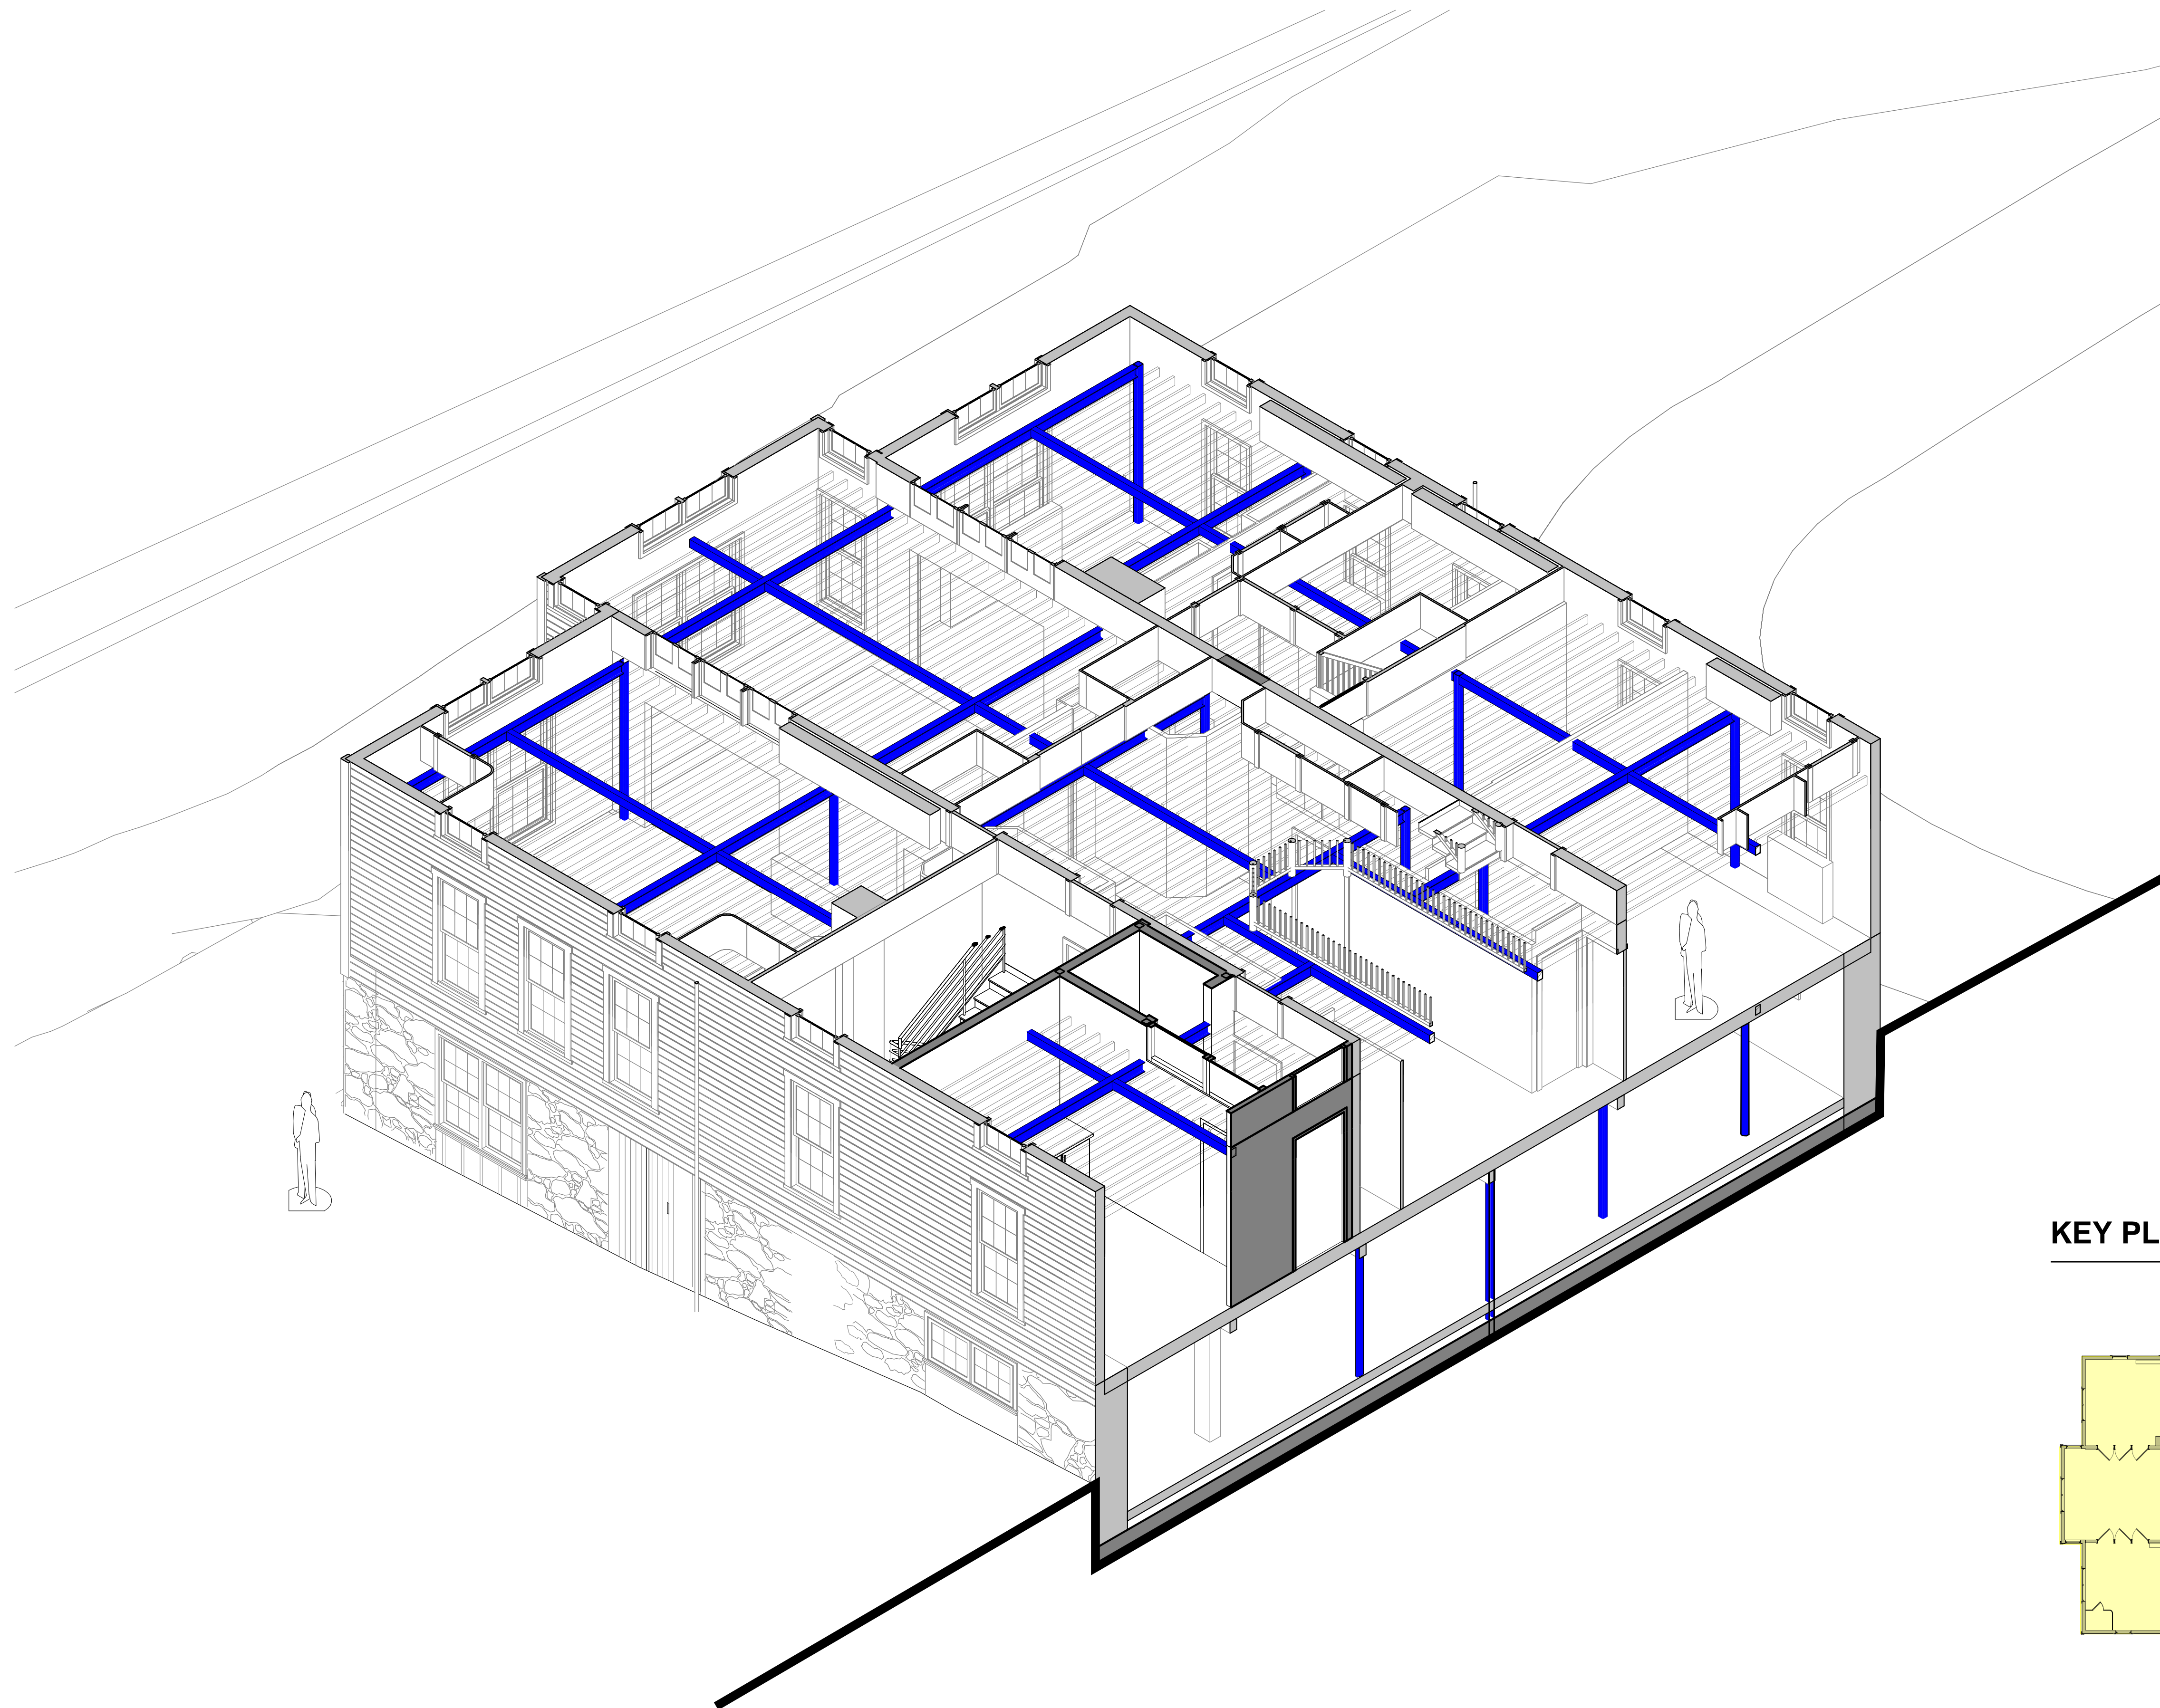
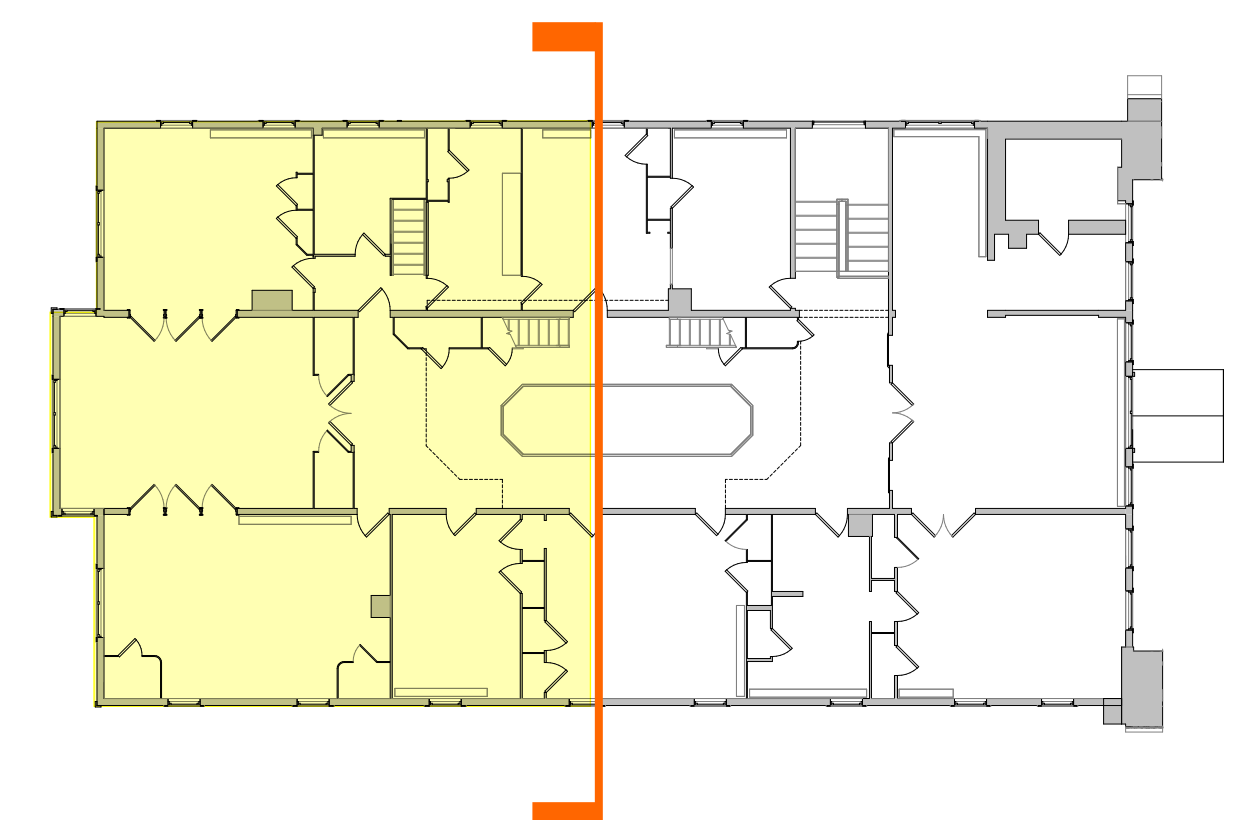
ALTERNATIVE 3B - AXONOMETRIC CUTAWAY VIEW

ALTERNATIVE 3B: EXTENSIVE STRUCTURAL UPGRADE WITH VERTICAL PLATFORM LIFT

Lateral stiffness will be increased with diagonal bracing in the closets in 2 locations from the basement up to the 2nd floor.

KEY PLAN SHOWING SECTION CUT

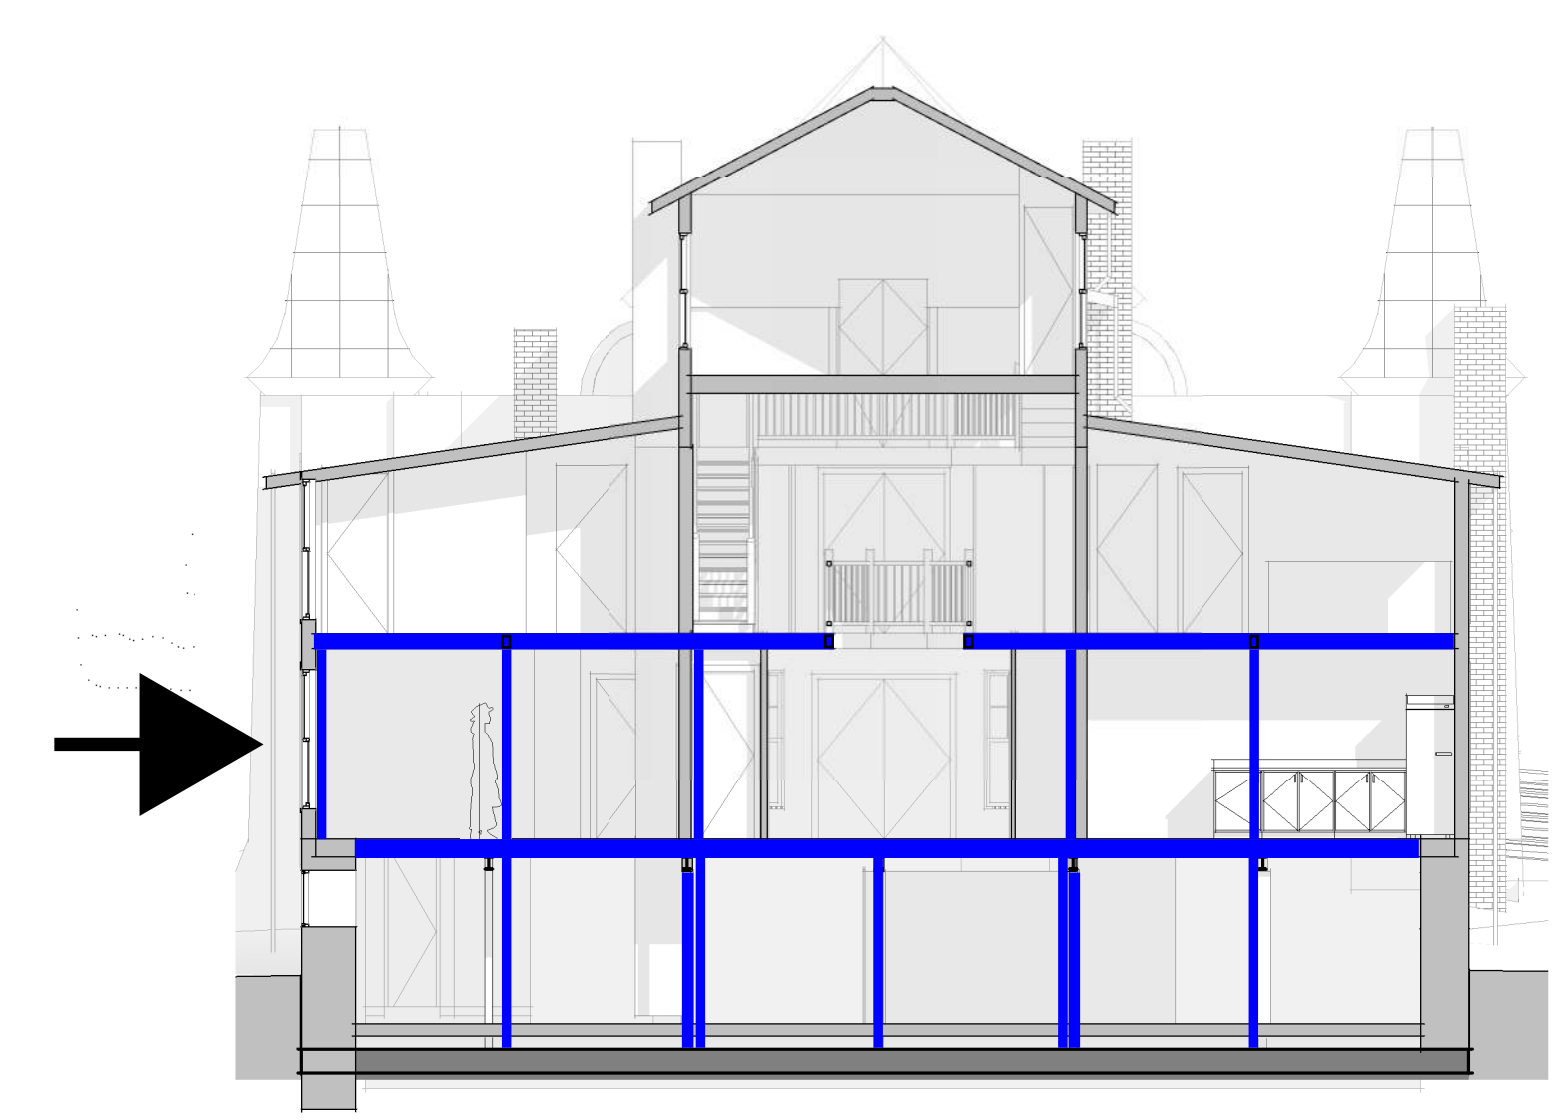
ALTERNATIVE 3B - FIRST FLOOR

ALTERNATIVE 3B: EXTENSIVE STRUCTURAL UPGRADE WITH VERTICAL PLATFORM LIFT

- Architectural highlights on this floor:
- New vertical platform lift enclosed in a fire-rated shaft. The lift will appear similar to a room with a door and will be located in a new small lobby. This requires removal of the partition between Rooms 116 and 117.

- New VRF mechanical system to provide heating and air conditioning throughout all rooms.
 - Locate mechanical cooling units and pads at southeast corner further from the house at the exterior.

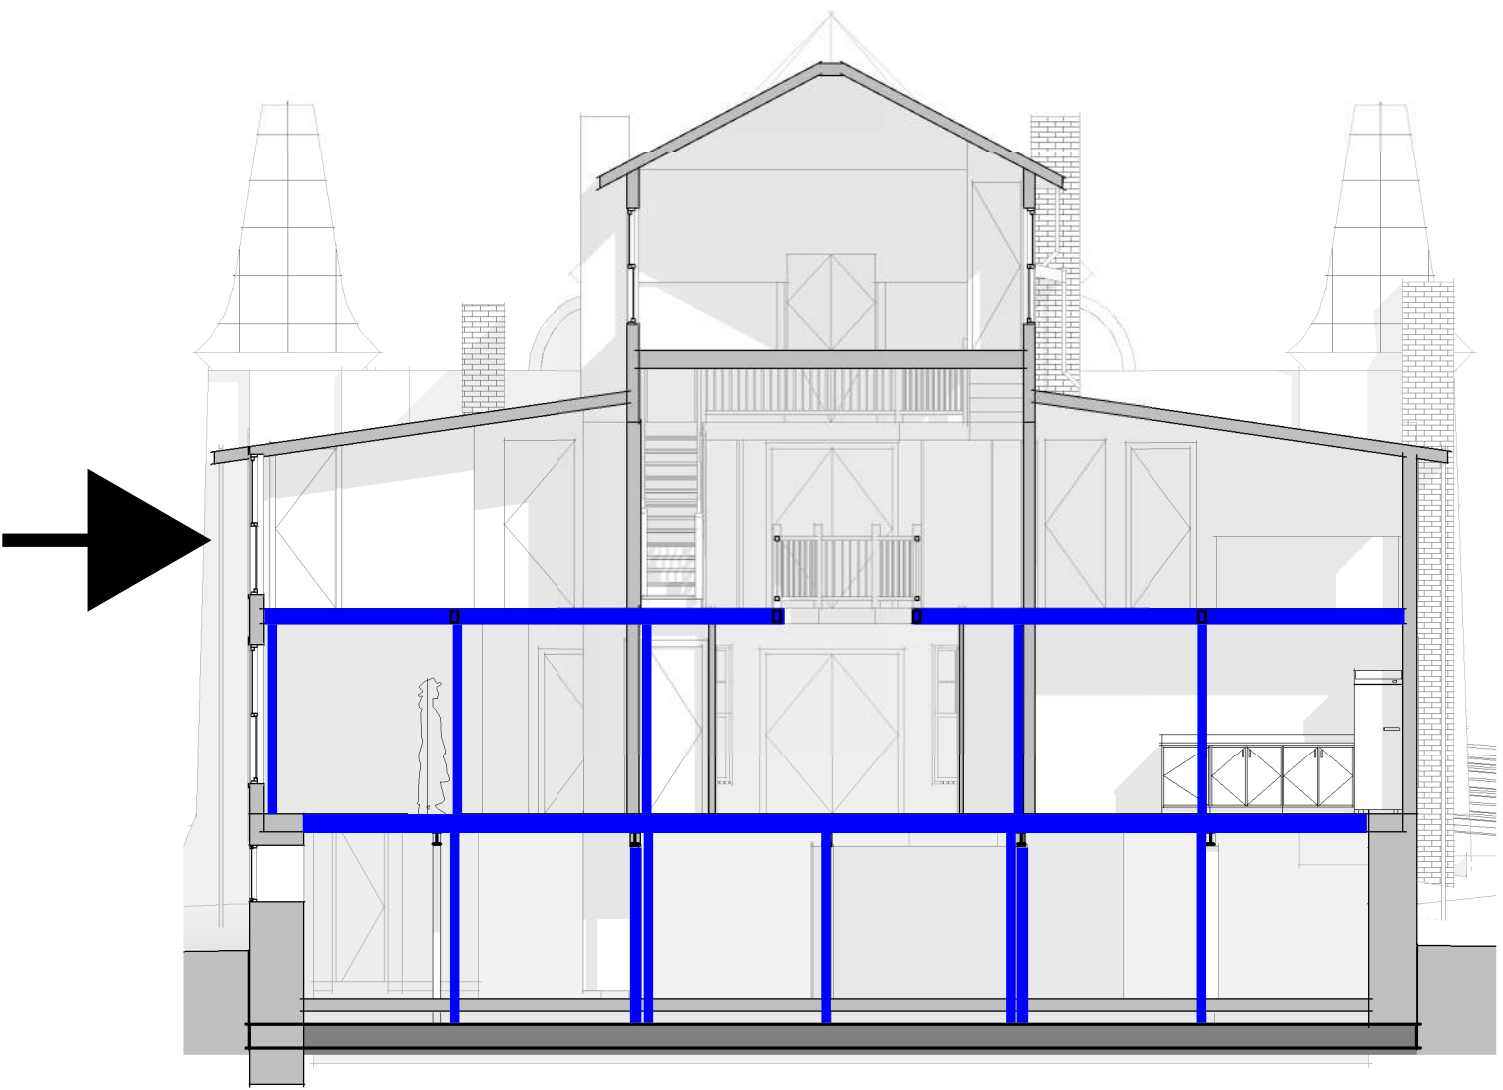
ALTERNATIVE 3B - SECOND FLOOR

ALTERNATIVE 3B: EXTENSIVE STRUCTURAL UPGRADE WITH VERTICAL PLATFORM LIFT

Architectural highlights on this floor:

- Floor-mounted console fan coil units with custom enclosures.
- New VRF mechanical system to provide heating and air conditioning throughout all rooms.

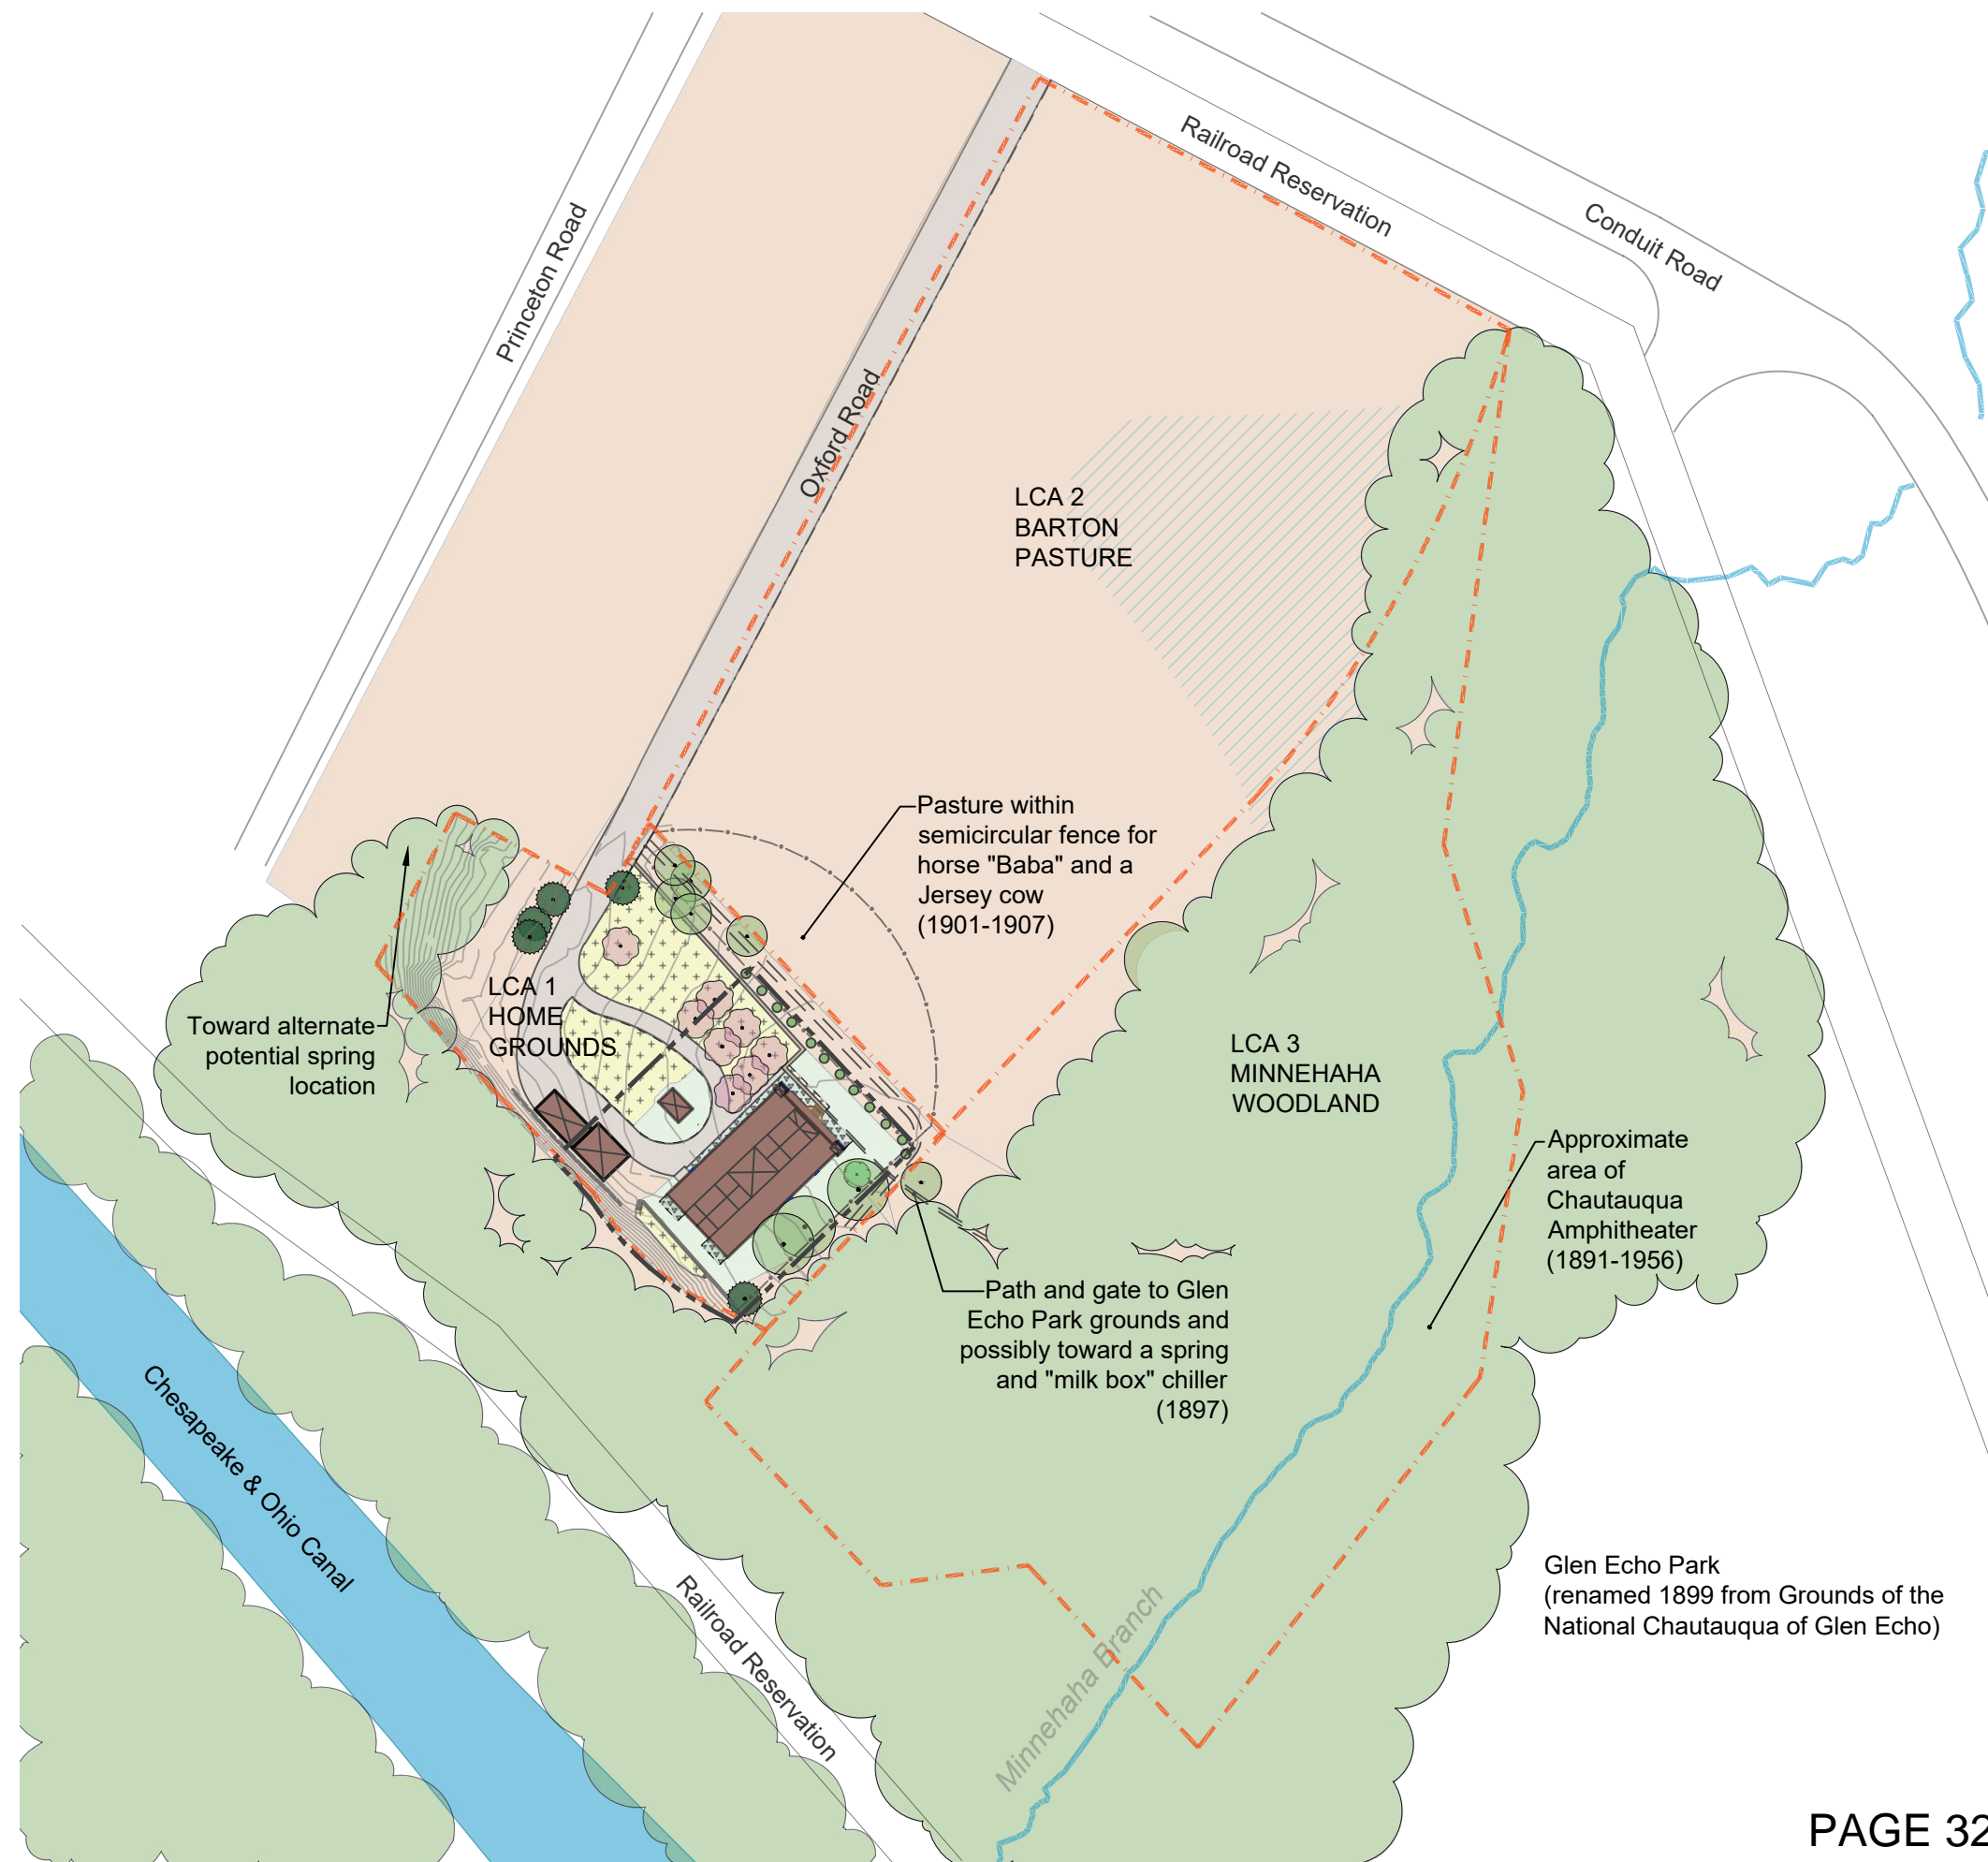
SUB SHEET NO. L2	TITLE OF SHEET CLR PERIOD OF SIGNIFICANCE DRAWINGS OVERALL LANDSCAPE ca.1906	
	CLARA BARTON NATIONAL HISTORIC SITE GEORGE WASHINGTON MEMORIAL PARKWAY GLEN ECHO MARYLAND	
	NPS NO. GWMP 850-18-7591	PMIS/PKG NO. 312325
	DATE 07/24/2023

The property line depicts the 0.47 acre that Clara Barton owned around 1906. Her use of the land did not directly coincide with changes to the property boundary over time. Features shown in approximate locations.
