Apostle Islands National Lakeshore
Ashland County, Wisconsin

**STATEMENT OF FINDINGS
FOR
EXECUTIVE ORDER 11900 (PROTECTION OF WETLANDS)**

**Replace Devils Island Docks Waterfront and
Reconstruct Historic Boathouse**

Rehabilitate Waterfront at Devils Island and Boat House
Apostle Islands National Lakeshore, Ashland County, WI
Wetland Statement of Findings, PMIS 270691

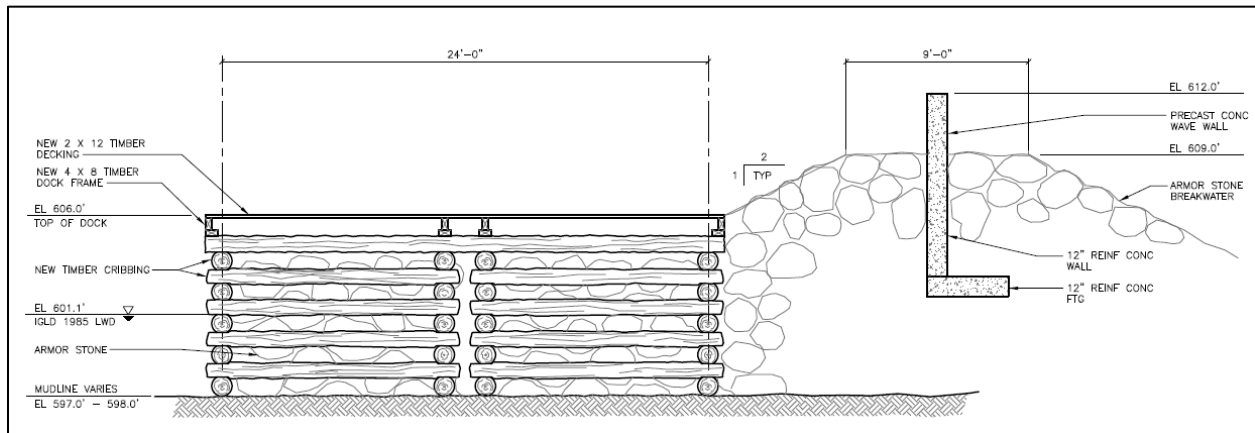
Figure 3: Cross-Sectional View of Alternative Option 1

Alternative option 1 consisted of replacing the existing dock structures in-kind and providing an armor stone breakwater with a concrete wave wall. The breakwater and wave wall would be necessary to minimize the damage to the proposed docks and to reduce the amount of wave overtopping experienced in the harbor. With this design, the significant waves inside the harbor would range from 6 inches to 1 foot 9 inches at the locations where boats would be moored. This meets the American Society of Civil Engineers (ASCE) design standard for a 50-year storm event for a small craft harbor.

The existing conditions have a wave overtopping volume of about 439 liters per second (L/s) per meter. Wave overtopping volumes greater than 10 L/s per meter is an upper threshold for small craft harbor design. Overtopping rates exceeding 10 L/s per meter are capable of sinking small craft. To reduce the wave overtopping, an armor stone breakwater with a concrete wave wall was proposed. The armor stone breakwater would require a crest width of about 10 feet and a crest elevation of 609 feet. The wave wall would extend beyond the breakwater crest up to an elevation of 612 feet and would reduce the wave overtopping to around 9 L/s per meter during storm events.

Alternative option 1 is the most expensive option considered and also provides the least resiliency in design. The concrete wave return wall was deemed detrimental to the cultural landscape of the island, and also very difficult to construct. Because of these reasons, this option was dismissed. The cross section and rendering for this option can be seen in figures 3 and 4.

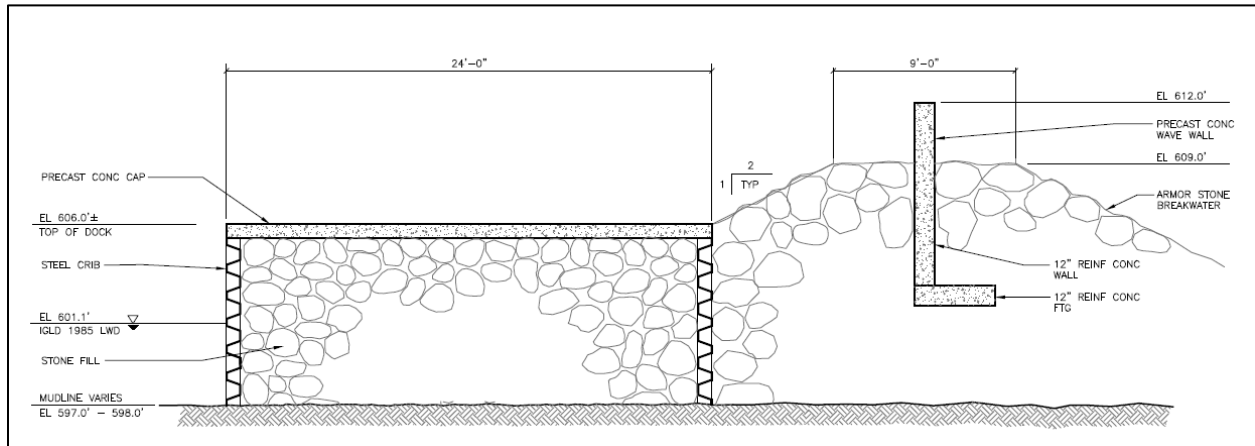
Figure 5: Cross-Sectional View of Alternative Option 2

Alternative option 2 consisted of replacing the existing dock structures with a steel crib dock structure and providing an armor stone breakwater with a concrete wave wall. The breakwater and wave walls would be necessary to minimize the damage to the proposed docks and to reduce the amount of wave overtopping experienced in the harbor. With this design, the significant waves inside the harbor would range from 6 inches to 1 foot 9 inches at the locations where boats would be moored. This meets the ASCE design standard for a 50-year storm event for a small craft harbor.

The wave analysis performed for this option yielded the same design wave conditions as the analysis performed for the alternative option 1 described above. The overtopping conditions did not change as a result of the dock structure change between options 1 and 2.

Alternative option 2 provides a higher resiliency in design; however, it is important to note that this option does not match the historic nature of the Devils Island docks. The concrete wave return wall was deemed detrimental to the cultural landscape of the island, and also very difficult to construct. Because of these reasons, this option was dismissed. The cross section and rendering for this option can be seen in figures 5 and 6.

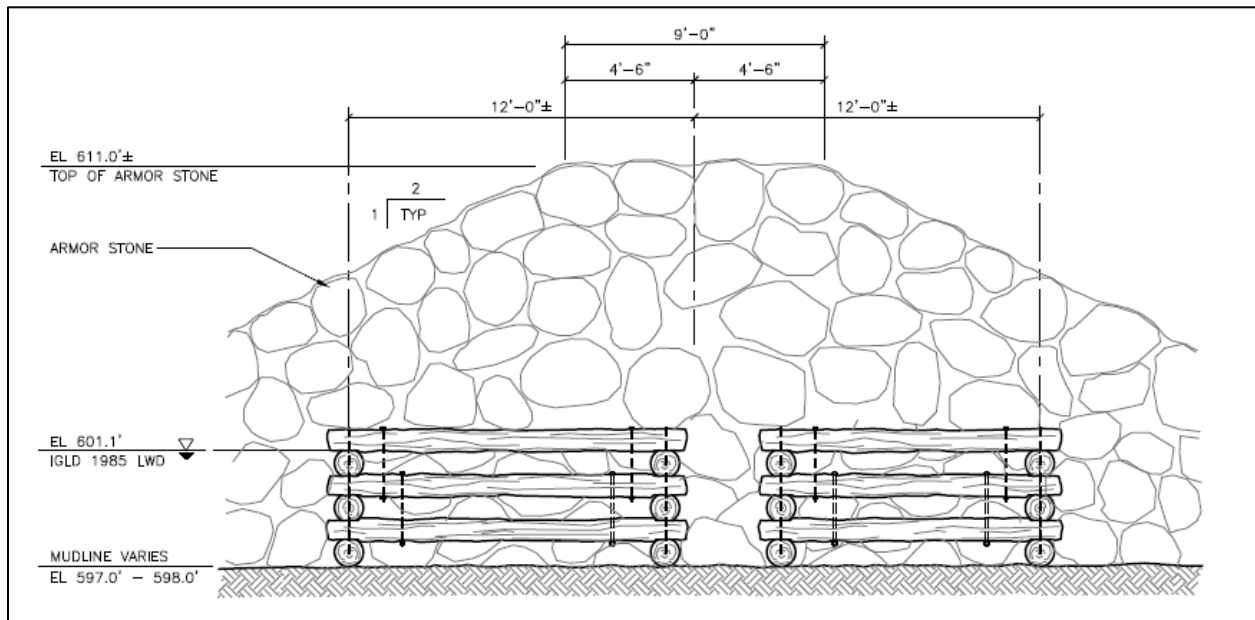
Figure 7: Cross-Sectional View of Alternative Option 3.

The existing conditions have wave overtopping amounts of about 439 L/s per meter. Because design option 3 does not have a dock structure immediately behind it, the threshold for the wave overtopping

discharges was increased to 50 L/s per meter. To be within this limit, the crest of the armor stone was set at elevation of 611 feet, which resulted in an overtopping rate of about 43 L/s per meter. Note that a wave wall was not required for this design option.

Alternative option 3 is a lower cost alternative and also provides the highest resiliency in design compared to the other alternative options. This option also most closely matches the historic and cultural landscape of the infrastructure at the site. This option was considered, but there were additional opportunities to reduce the impacts to the lake-bottom and natural resources; therefore, it was dismissed. The cross section and rendering for this option can be seen in figures 7 and 8.

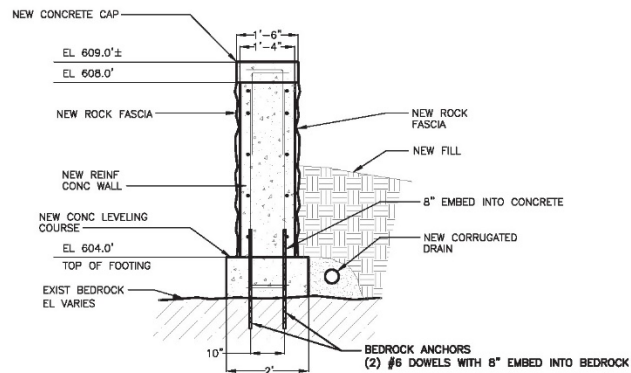
1 CONCRETE RETAINING WALL
SCALE: 3/4" = 1'

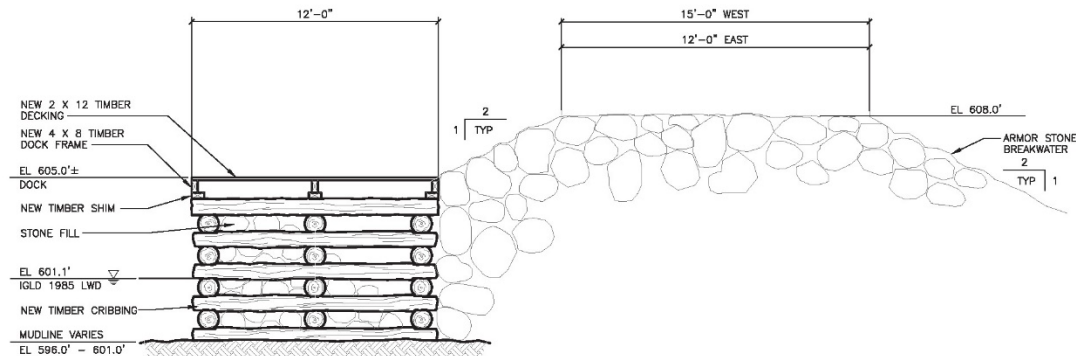
3 DOCK REHABILITATION
SCALE: 3/8" = 1'-0"

Debris in the water from the failing docks and breakwaters would be removed before construction. Portions of the existing timber crib structure would remain in place and be expanded to repair the docks. The new crib structure would be tied into the existing crib structure and pinned to the bedrock. The voids of the timber crib structure would be filled with stone. A new wooden dock structure would be built on top of the timber crib structure. The existing damaged rock retaining wall to the west of the dock would be repaired in a way that mimics the current aesthetic of the existing rock wall. The rock wall would aid in the protection of the docks and shoreline from damage.

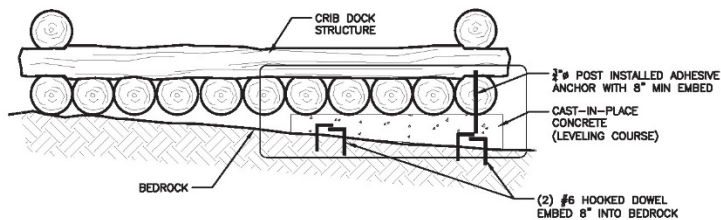
2 CRIB DOCK LEVELING FOUNDATION
SCALE: 3/4" = 1'

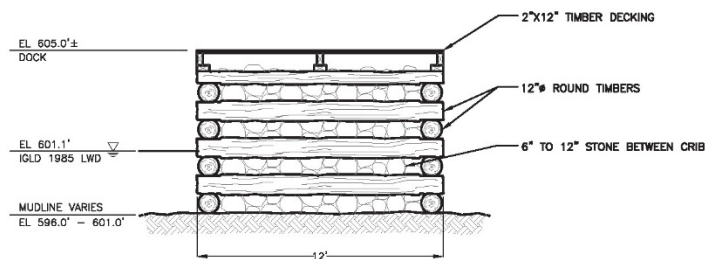
4 TYPICAL CRIB DOCK SECTION VIEW
SCALE: 3/8" = 1'
