National Park Service
U.S. Department of the Interior

WETLAND STATEMENT OF FINDINGS FOR
EXECUTIVE ORDER 11990 WETLAND PROTECTION

Stabilize Riverbank at CVSR 59.3 along the Cuyahoga River
Cuyahoga Valley National Park Peninsula, Ohio

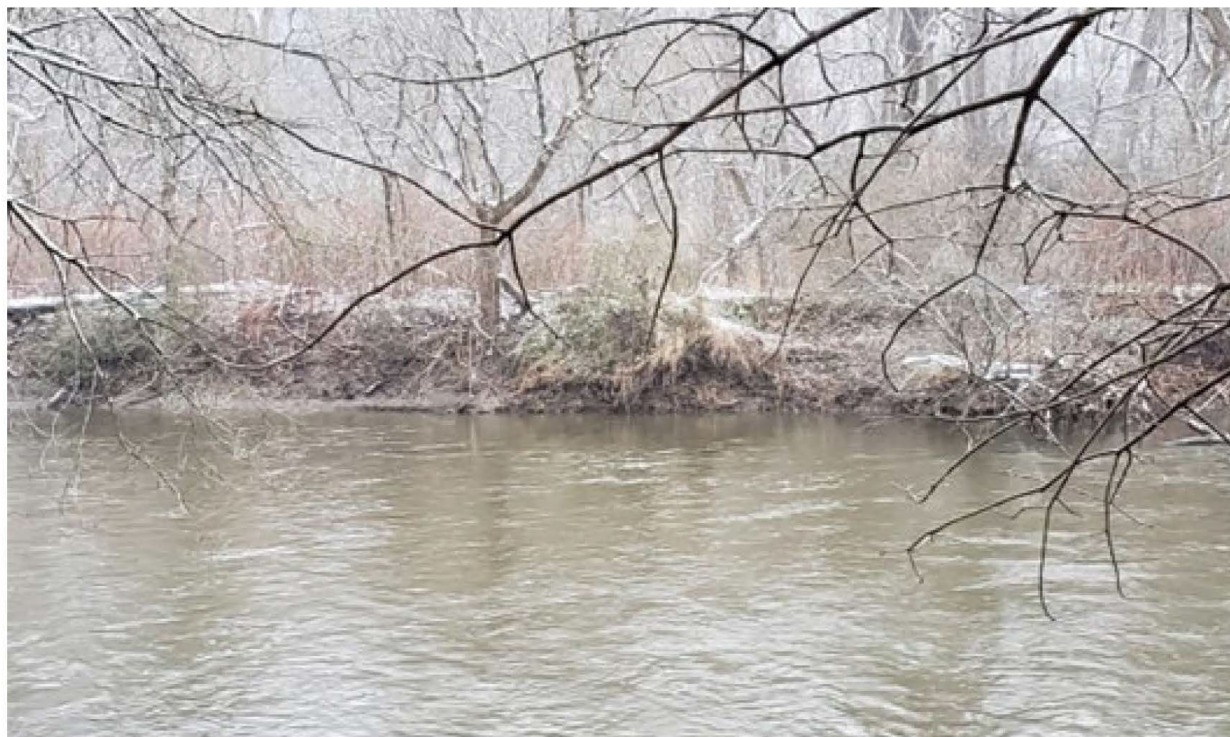
Figure 2. Shoreline of the project site at 59.3 with the CVSR feet from the riverbank.
