## REHABILITATE CLARA BARTON NATIONAL HISTORIC SITE CLBA 312325 SCHEMATIC DESIGN APPENDICES

REHABILITATE CLARA BARTON  
NATIONAL HISTORIC SITE  
CLBA 312325

SCHEMATIC FINAL SUBMISSION  
DECEMBER 8TH, 2023

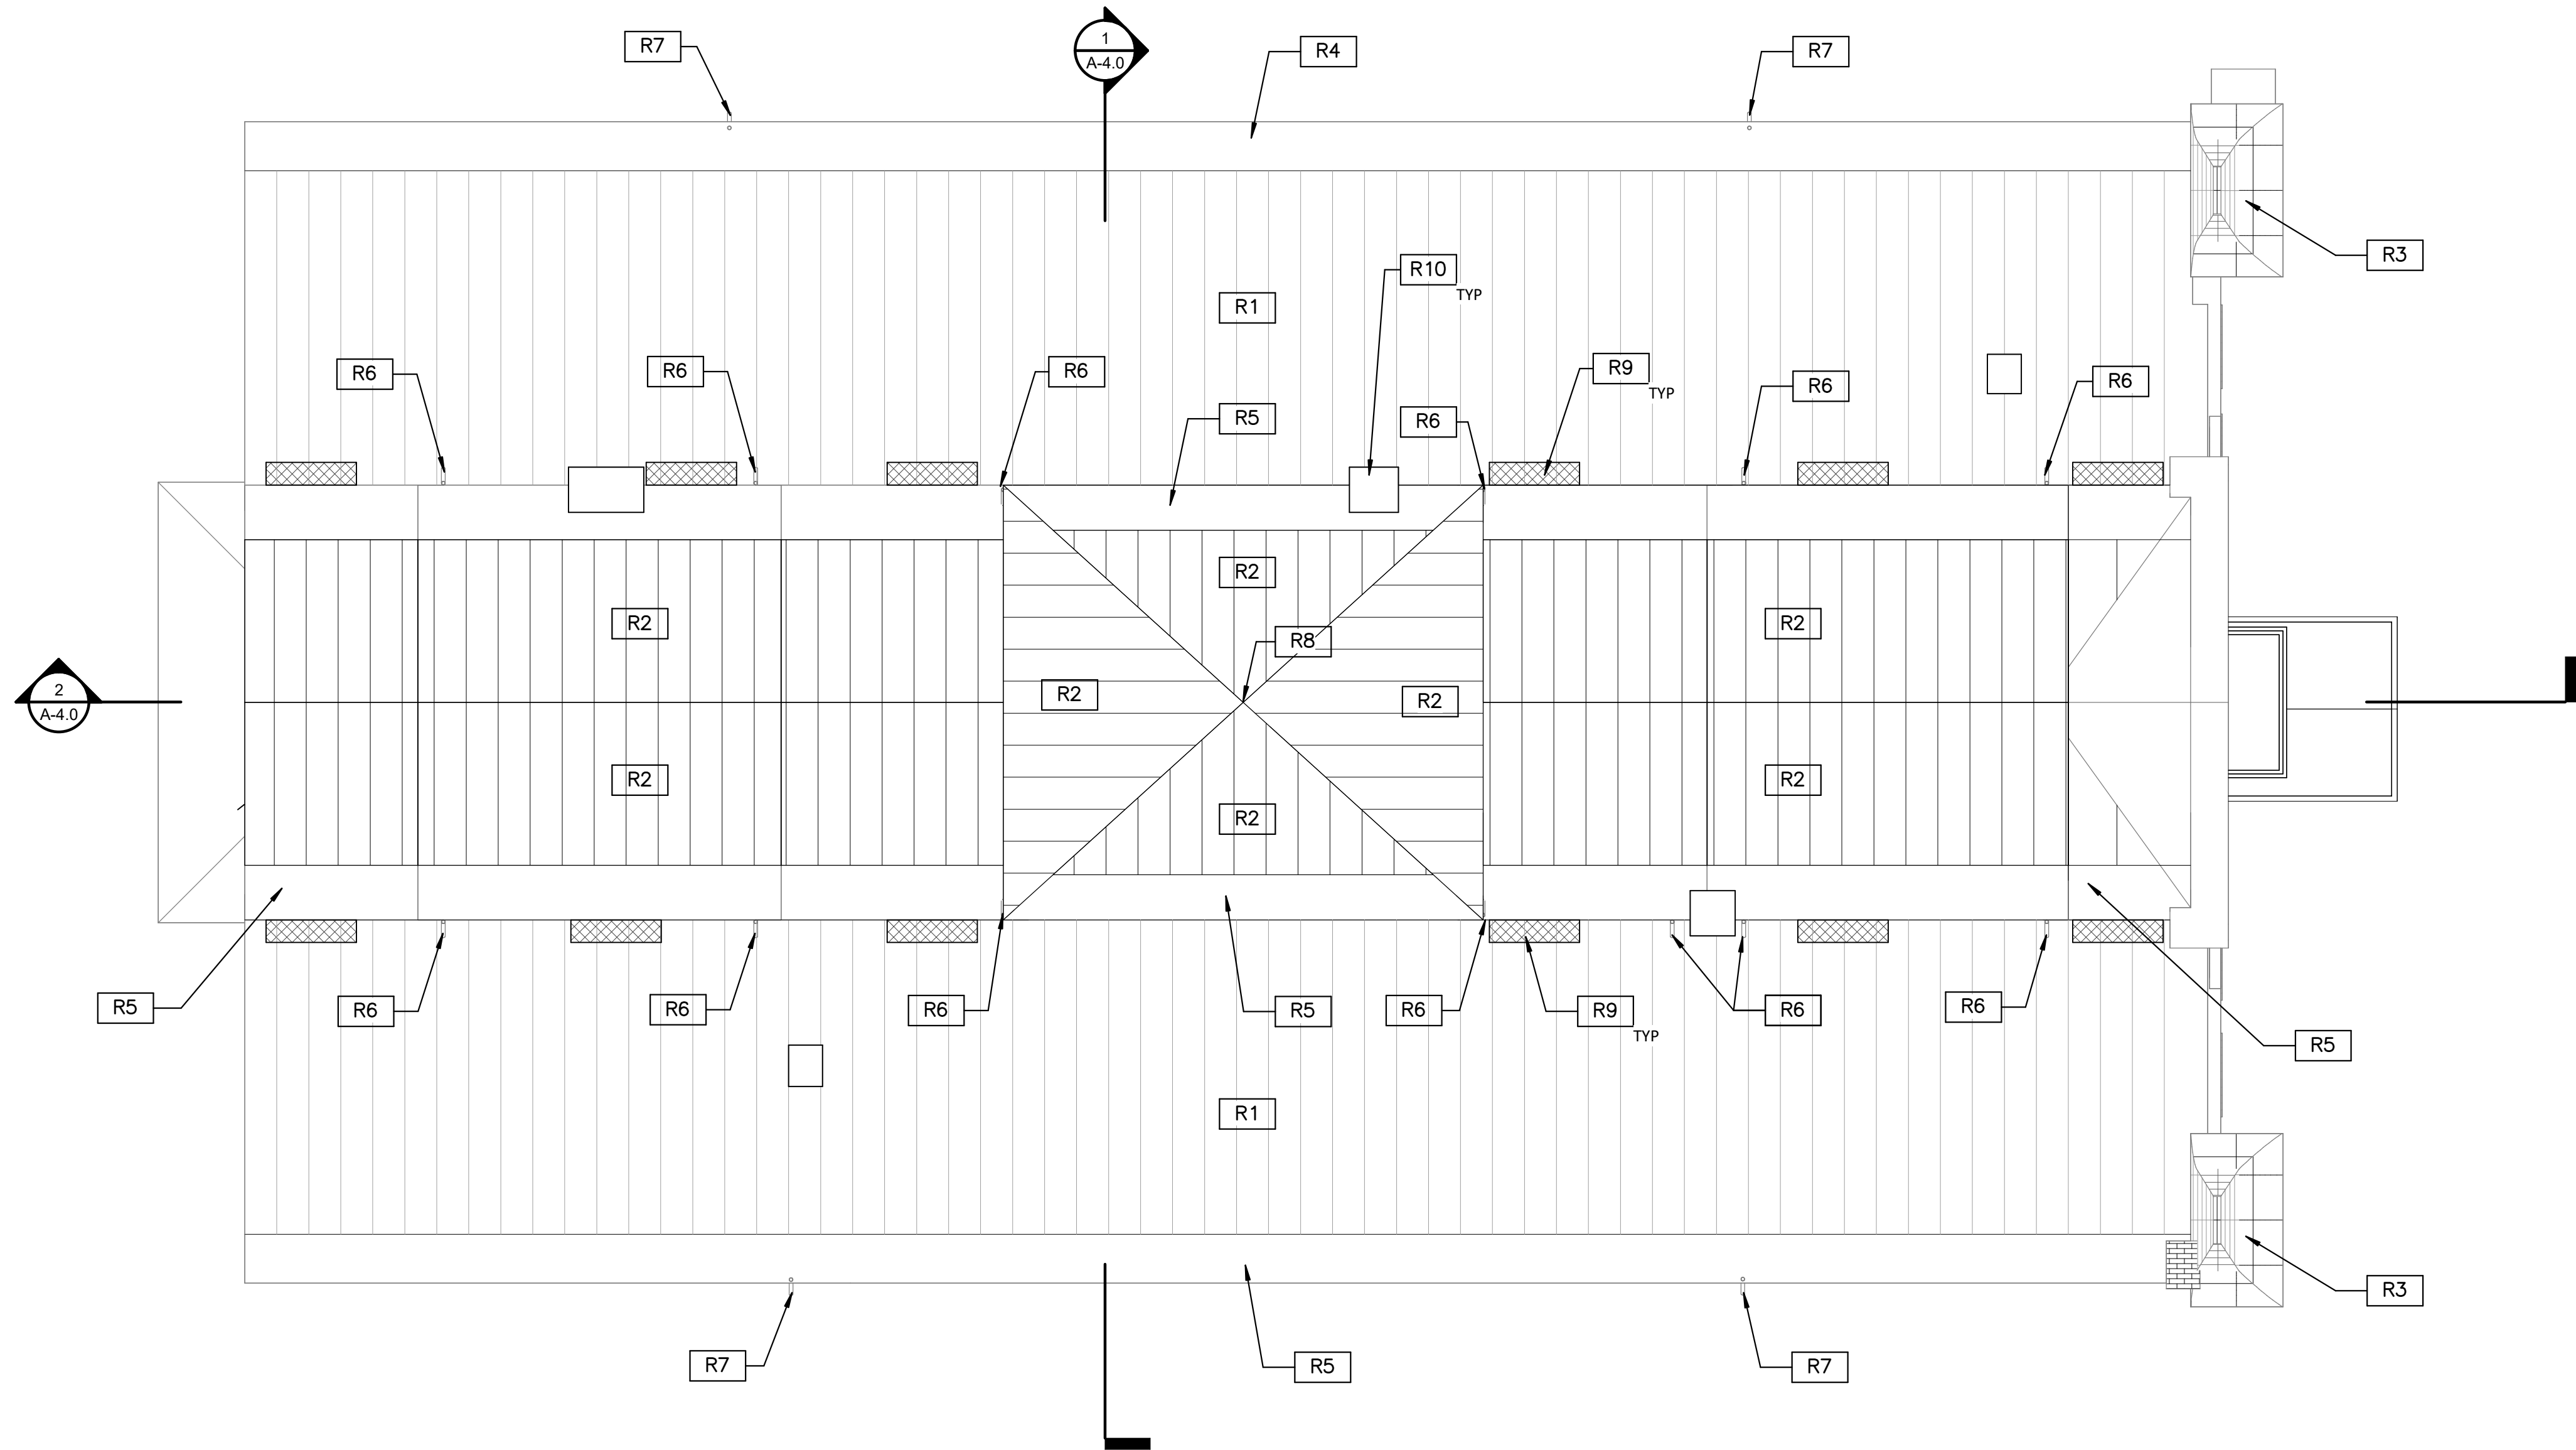
1  
A-1.4  
PROPOSED ROOF PLAN  
SCALE A

R1	REPAINT EXISTING COPPER STANDING SEAM ROOF.
R2	REPLACE ROOF WITH NEW PTD STANDING SEAM COPPER TO MATCH EXISTING.
R3	REPLACE EXISTING FLAT SEAM SHEET METAL WITH COPPER TO MATCH EXISTING.
R4	REPAIR EXISTING COPPER POLE GUTTER AND REPAINT.
R5	REPLACE EXISTING COPPER POLE GUTTER AND REPAINT.
R6	RETAIN EXISTING COPPER DOWNSPOUT FOR REUSE.
R7	INSTALL NEW COPPER DOWNSPOUT.
R8	INSTALL NEW COPPER FLASHING AT FLAGPOLE.
R9	REMOVE/MODIFY STANDING SEAM METAL ROOF OR FLASHING TO ACCOMODATE FALL PROTECTION ANCHORS.
R10	EXISTING CHIMNEY TO REMAIN. REFER TO REPAIR ELEVATION FOR BRICK REPOINTING SCOPE.

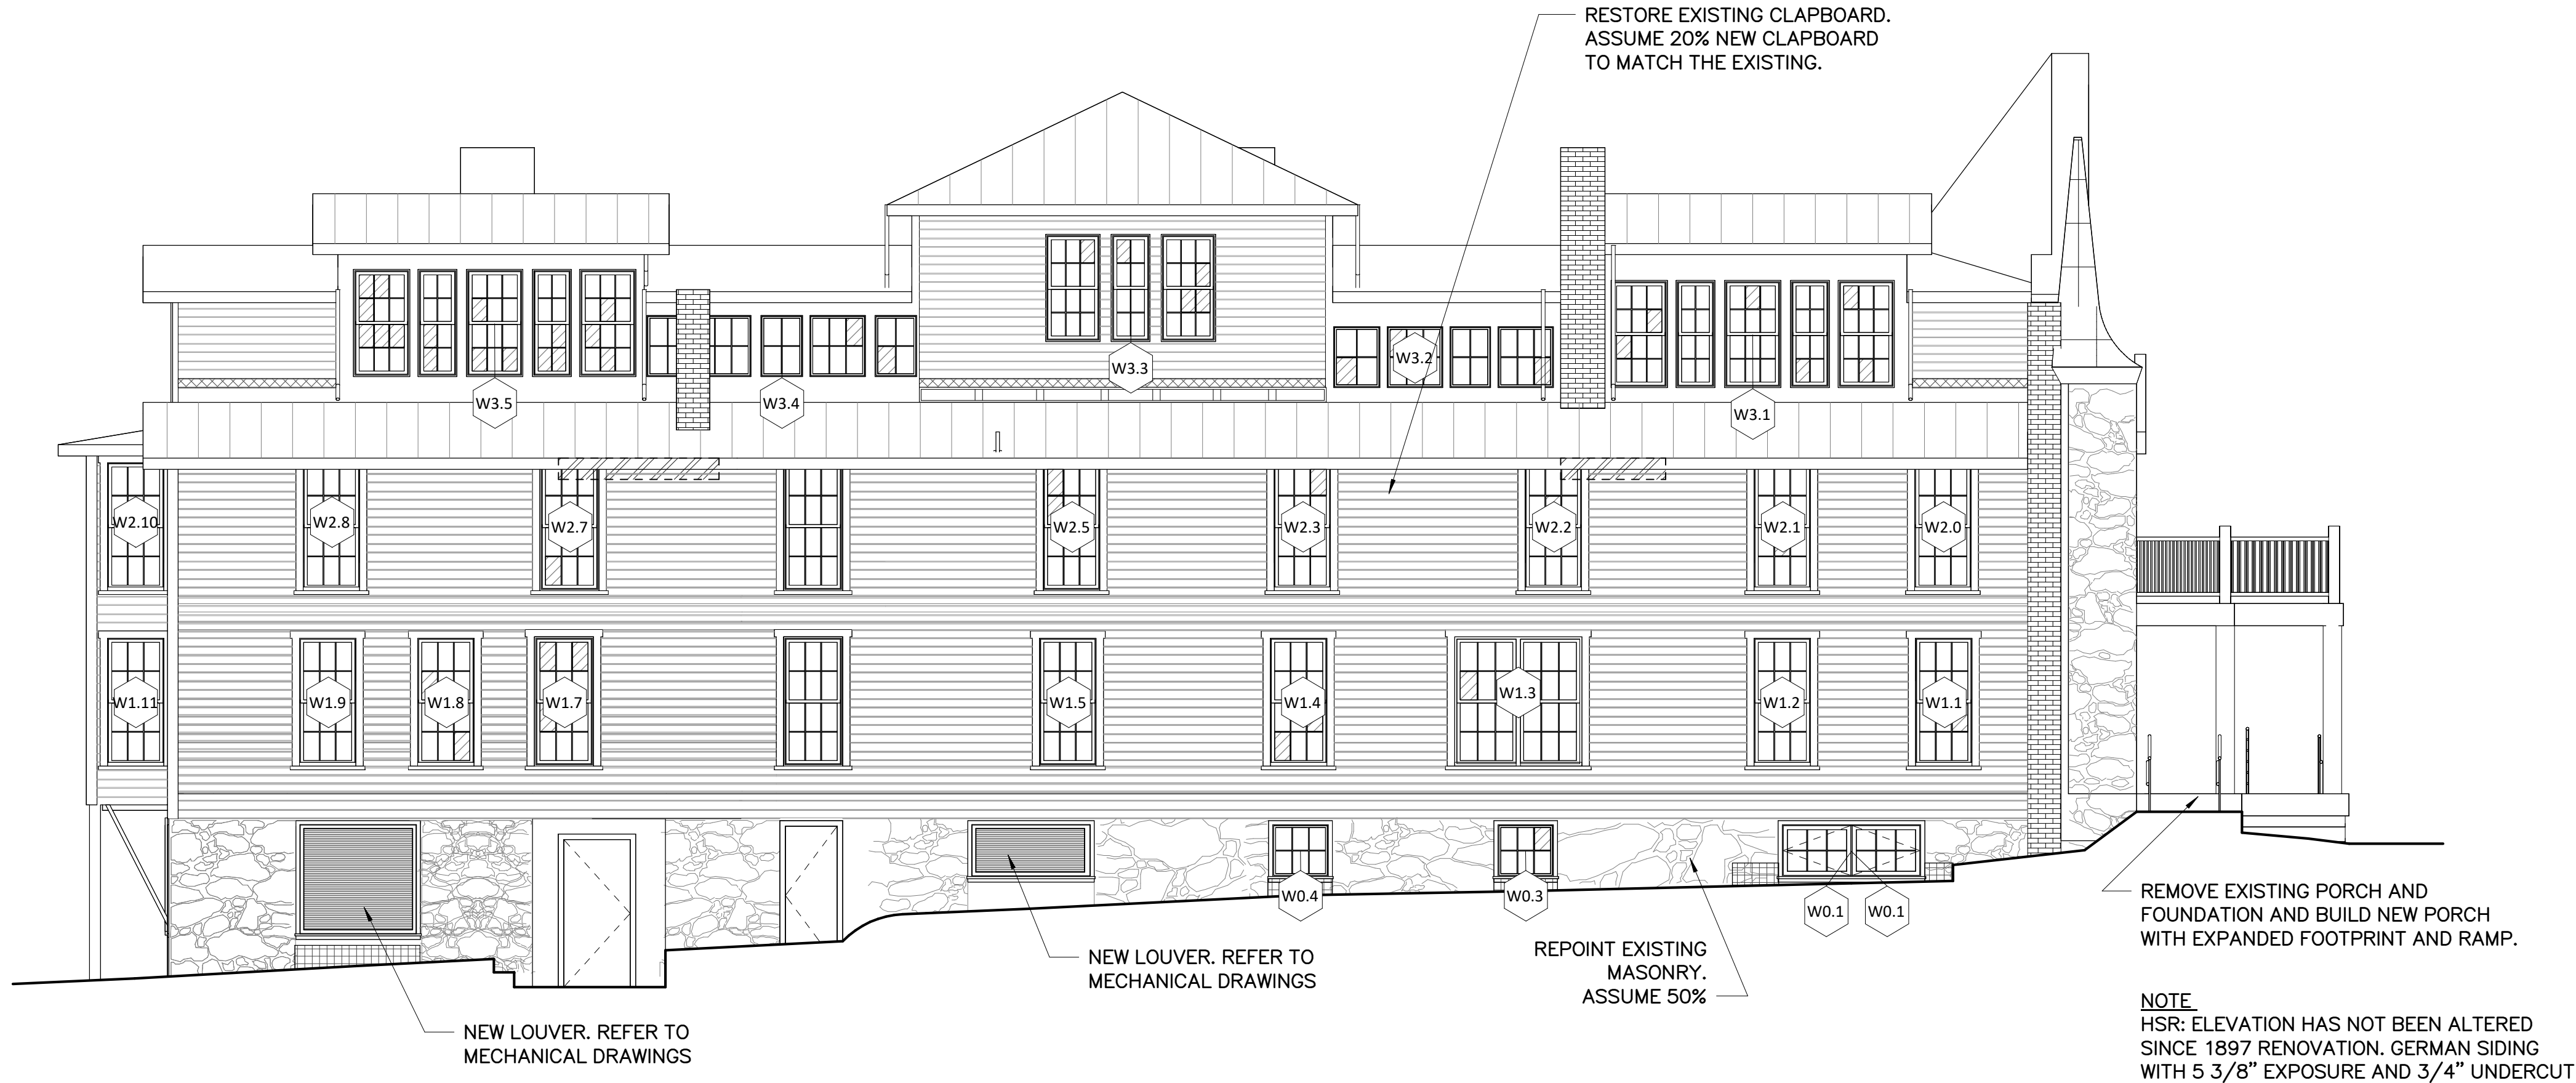
1 REPAIR WORK – EAST ELEVATION  
A-3.2 SCALE (A)

- INSTALL NEW GLAZING PUTTY WHERE DETERIORATED.
  - REPLACE GLAZING TO MATCH EXISTING WHERE CRACKED OR BROKEN.
  - SAND, PRIME, AND PAINT ALL EXTERIOR PORTIONS. PROVIDE (1) INTERIOR COLOR TO MATCH EXISTING.

- REINSTALL WINDOW SASH, TRIM, WINDOW STOPS OR BEADS, AND FINAL PAINT AS REQUIRED.

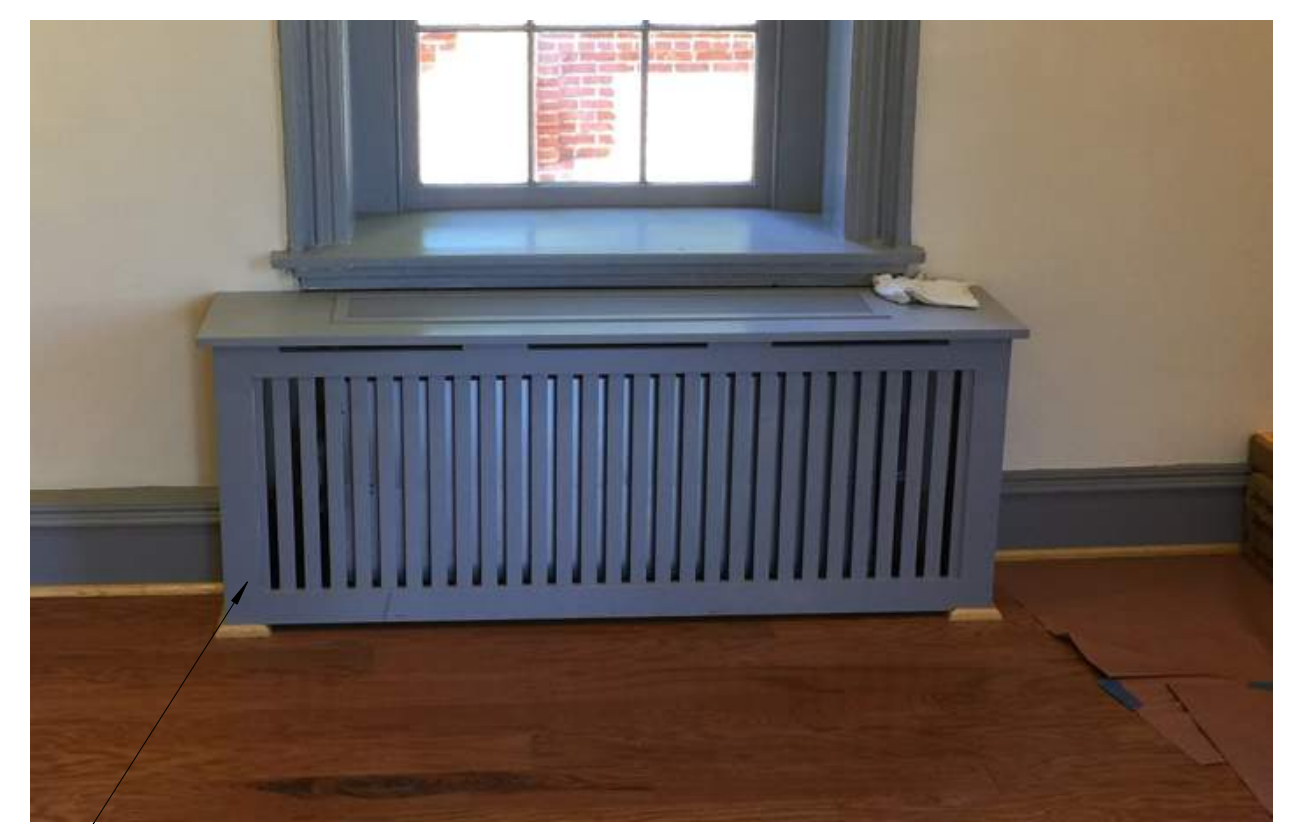
4 CUSTOM ENCLOSURE EXAMPLE FOR FCU  
A-4.0

THIS EXAMPLE DEMONSTRATES A CUSTOM ENCLOSURE FOR A FAN COIL UNIT. THE DESIGN INTENT IS TO BE COMPATIBLE WITH EXISTING HISTORIC ROOM FINISHES. SIZE AND LOCATION TO BE COORDINATED WITH FURNISHING AND EXHIBIT LAYOUT IN NEXT DESIGN PHASE.

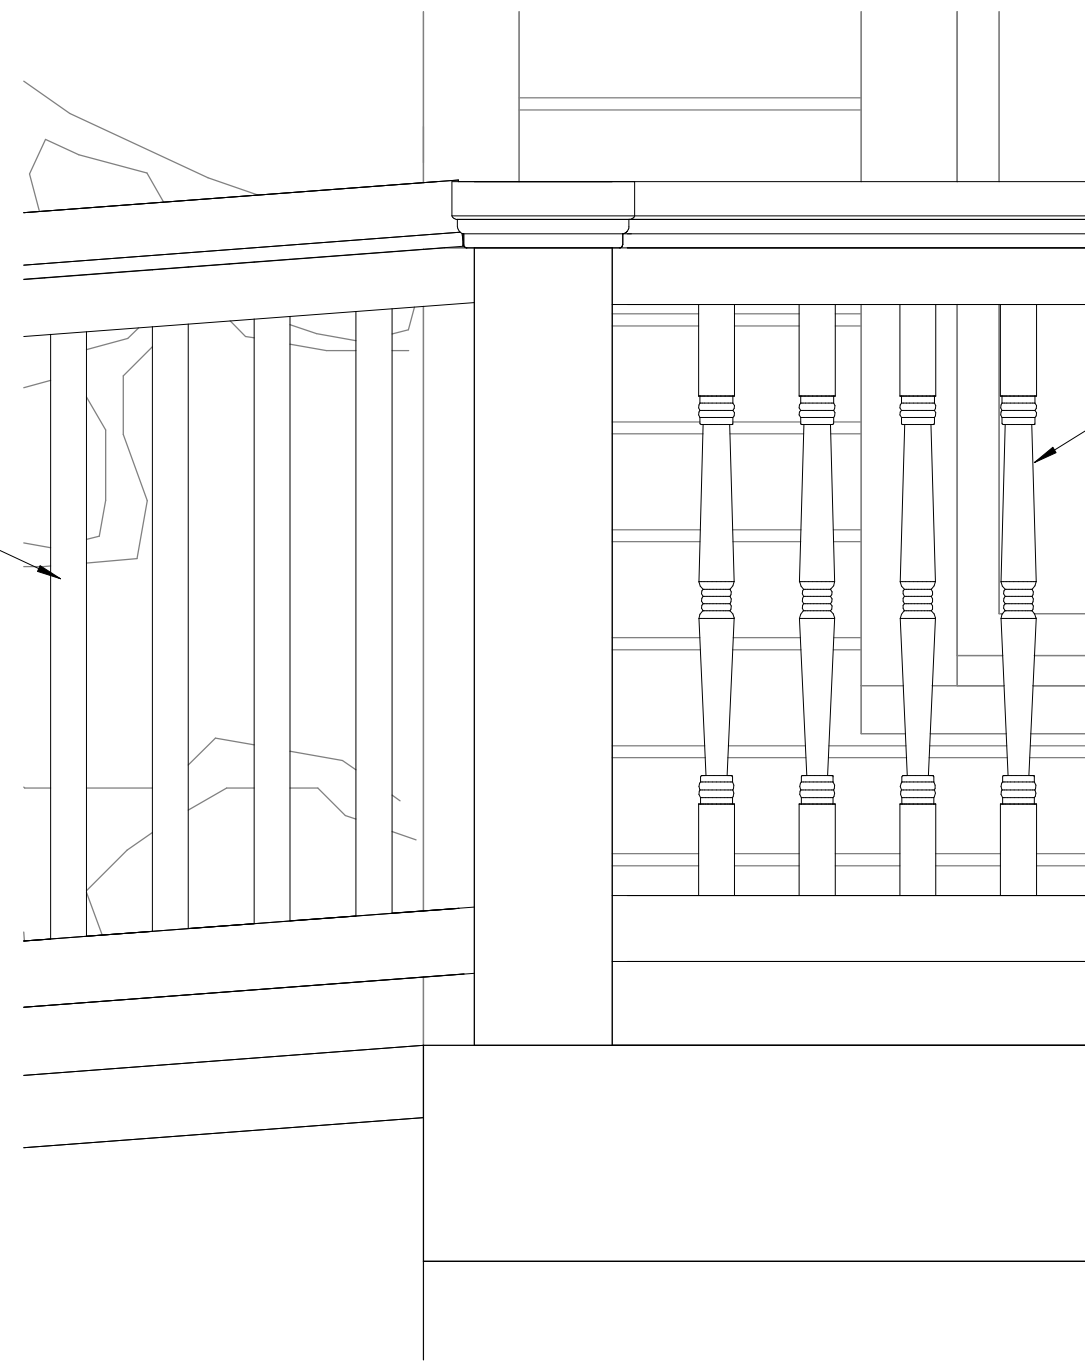
3 ENLARGED RAILING ELEVATION AT RAMP AND PORCH RAIL  
A-5.0 SCALE (A)

NEW DECORATIVE WD HANDRAIL AT NEW PORCH. DESIGN INTENT IS TO ALLUDE TO THE HISTORIC FRONT PORCH DESIGN.

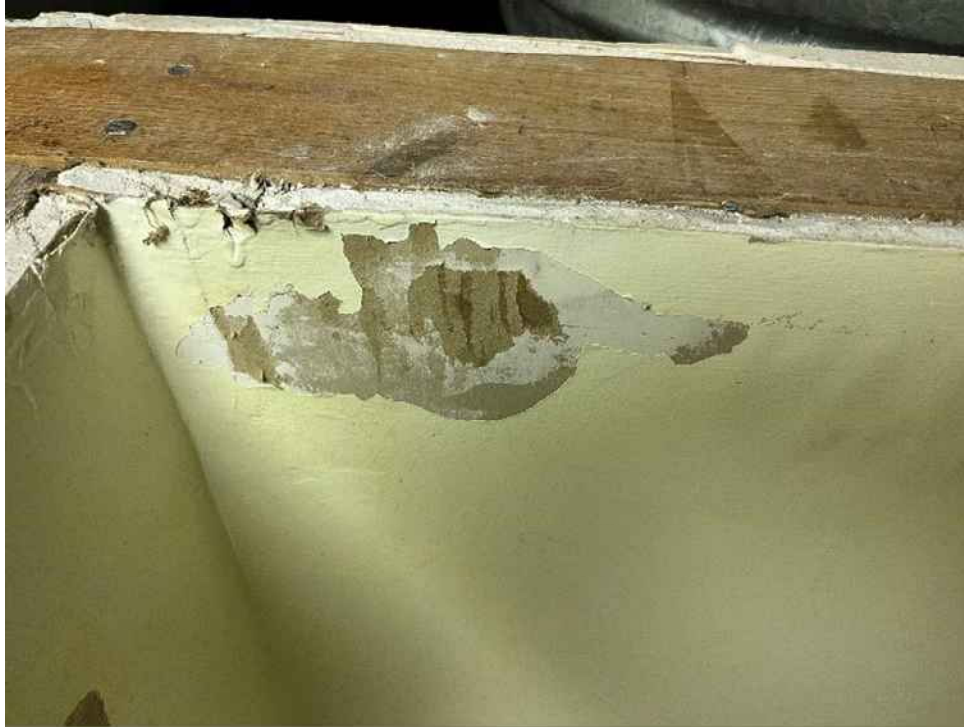
**Photograph: 1**

HA-1: White Joint  
Compound  
HA-2: White Drywall

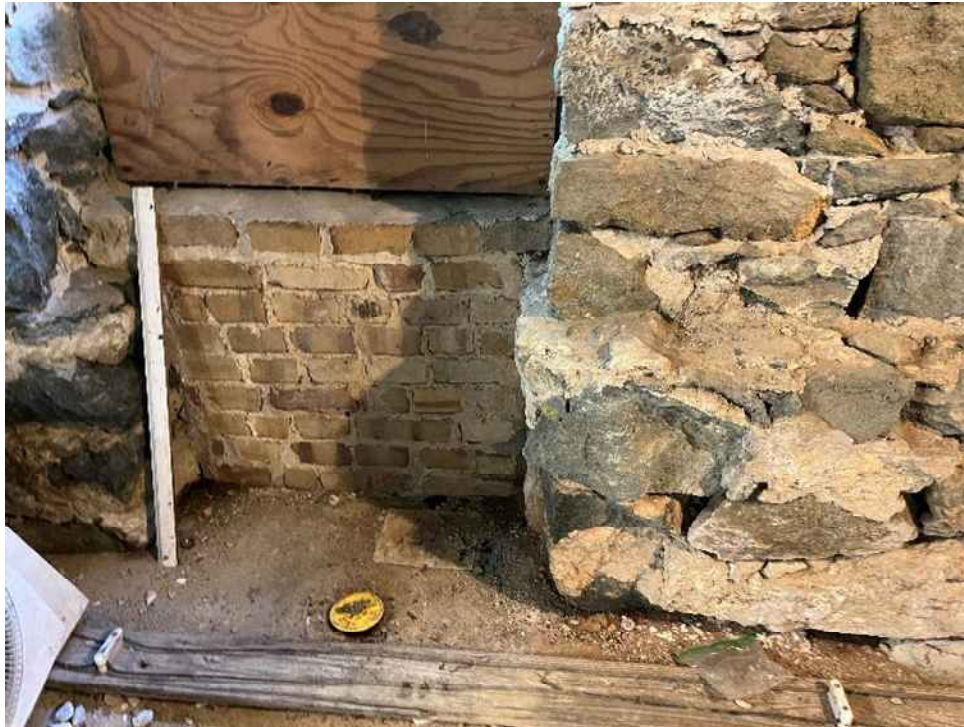
**Photograph: 3**

HA-4: Gray Stone/Brick  
Mortar

PCB-1: Gray stone/brick  
mortar

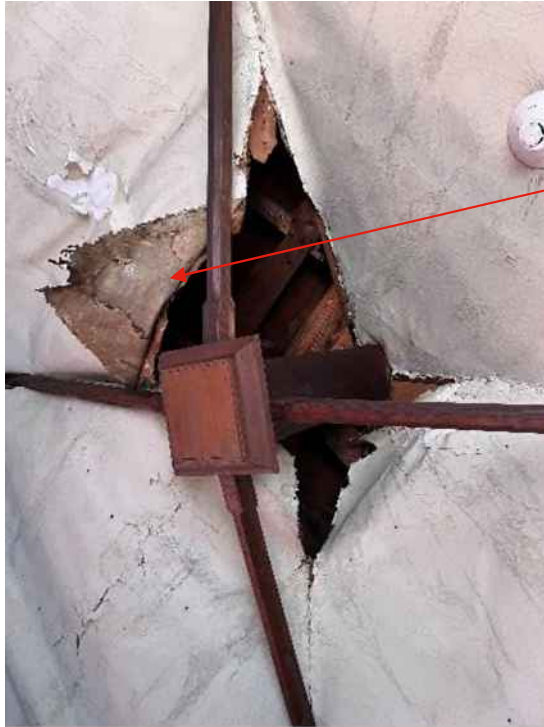
**Photograph: 5**

HA-6: Brown Paper  
Backing

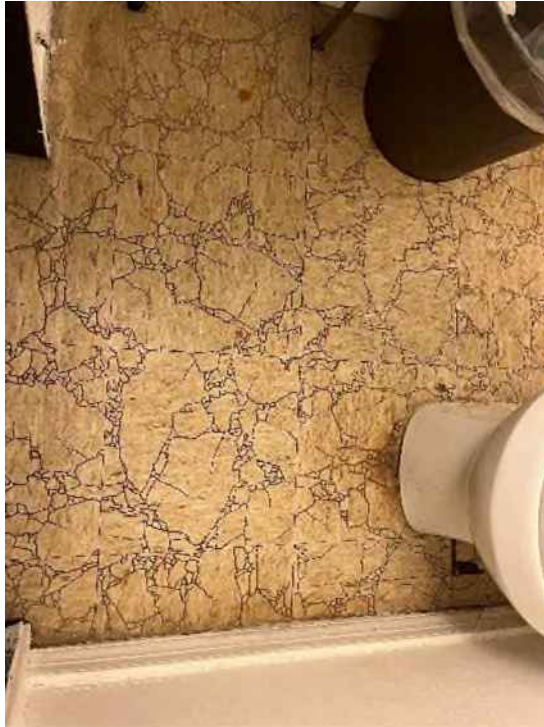
**Photograph: 7**

HA-9: Brown 12"x12"  
Vinyl Floor Tile (VFT)  
and associated mastic

Sample	Description	Appearance	Non-Asbestos		Asbestos
			% Fibrous	% Non-Fibrous	% Type
7C 042216789-0027	2nd Floor - 207 - Drywall - Gray	Gray Non-Fibrous Homogeneous	3% Hair  HA: 7	97% Non-fibrous (Other)	None Detected
8A 042216789-0028	1st Floor - 110 Closet - Joint Compound - White	White Non-Fibrous Homogeneous	  HA: 8	100% Non-fibrous (Other)	None Detected
8B 042216789-0029	1st Floor - 117 - Joint Compound - White	White Non-Fibrous Homogeneous	  HA: 8	100% Non-fibrous (Other)	None Detected
8C 042216789-0030	2nd Floor - 207 - Joint Compound - White	White Non-Fibrous Homogeneous	  HA: 8	100% Non-fibrous (Other)	None Detected
9A-VFT 042216789-0031	1st Floor - 106 - 12" x 12" Speckled VFT - Brown	Brown Non-Fibrous Homogeneous	  HA: 9	98% Non-fibrous (Other)	2% Chrysotile
9A-Mastic 042216789-0031A	1st Floor - 106 - Mastic	Yellow Non-Fibrous Homogeneous	  HA: 9	100% Non-fibrous (Other)	None Detected

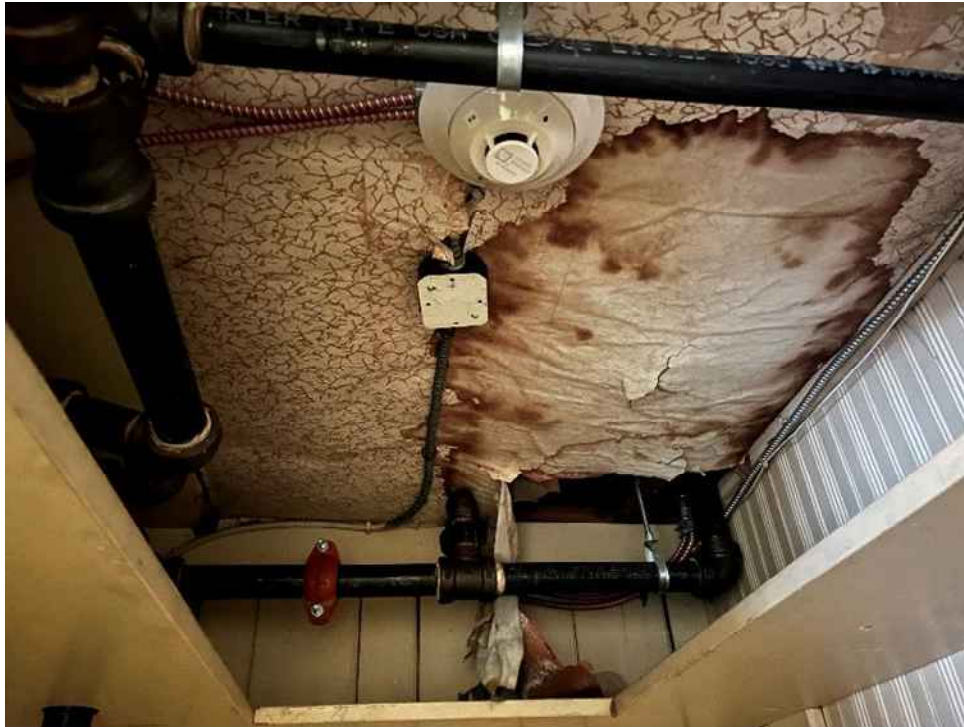
**Photograph: 9**

HA-12: White Paper  
Backing  
Note water staining  
from formerly leaking  
pipe

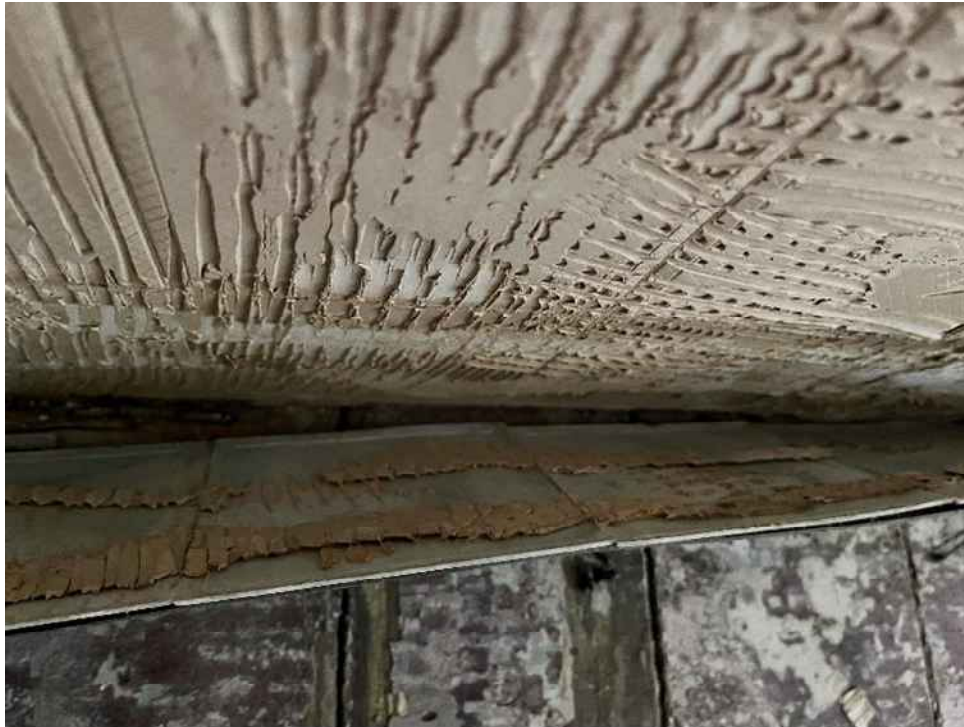
**Photograph: 11**

HA-14: Tan Tile Mastic;  
HA-15: Tan Cove Base  
Mastic

Sample	Description	Appearance	Non-Asbestos		Asbestos
			% Fibrous	% Non-Fibrous	% Type
14C 042216789-0048	2nd Floor - 203A - Tile Mastic - Tan	Tan Non-Fibrous Homogeneous	HA: 14	100% Non-fibrous (Other)	None Detected
15A 042216789-0049	2nd Floor - 217 - Cove Base Mastic - Tan	Tan Non-Fibrous Homogeneous	HA: 15	97% Non-fibrous (Other)	3% Chrysotile
15B 042216789-0050	2nd Floor - 217 - Cove Base Mastic - Tan		HA: 15		Positive Stop (Not Analyzed)
16A 042216789-0051	3rd Floor - Closet - Insulation - Tan	Gray/Yellow Fibrous Homogeneous	HA: 16	96% Min. Wool 4% Non-fibrous (Other)	None Detected
16B 042216789-0052	3rd Floor - Closet - Insulation - Tan	Gray/Yellow Fibrous Homogeneous	HA: 16	96% Min. Wool 4% Non-fibrous (Other)	None Detected
16C 042216789-0053	3rd Floor - Closet - Insulation - Tan	Gray/Yellow Fibrous Homogeneous	HA: 16	96% Min. Wool 4% Non-fibrous (Other)	None Detected
17A 042216789-0054	1st Floor - SE Window - Window Glazing - White	White Non-Fibrous Homogeneous	HA: 17	100% Non-fibrous (Other)	None Detected

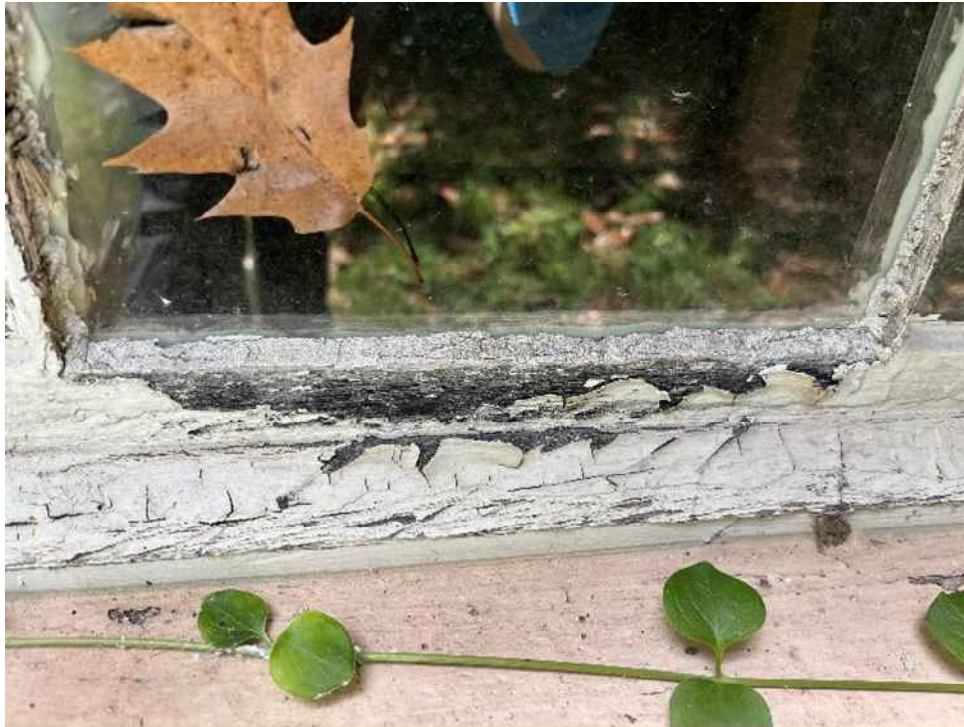
**Photograph: 13**

HA-17/PCB-3: Gray  
Exterior Window  
Glazing;  
Pb-8: White paint on  
exterior window sill

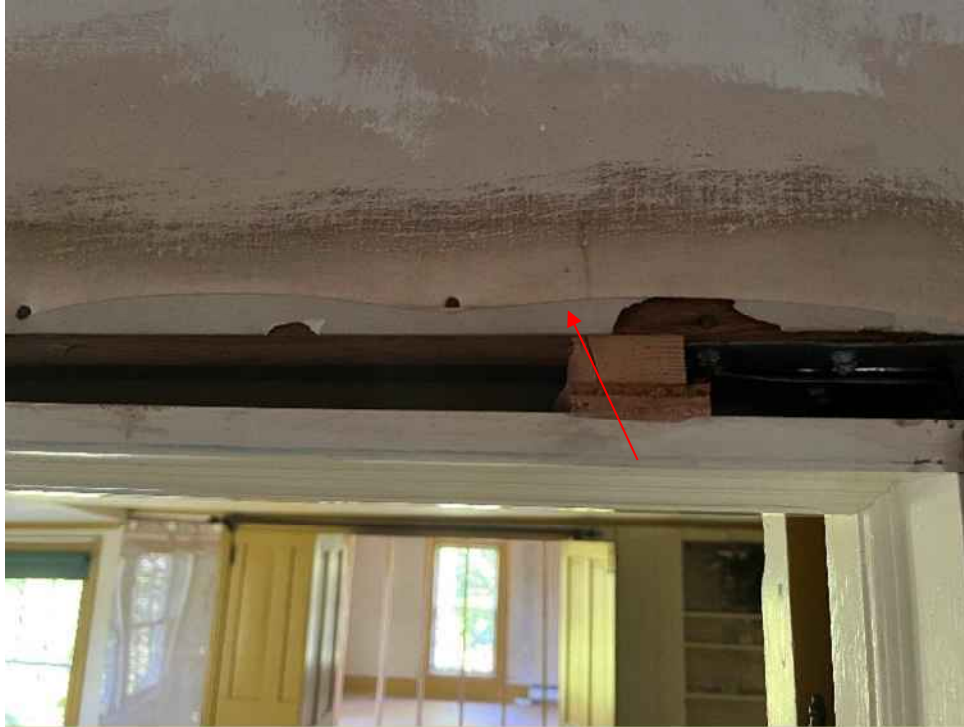
**Photograph: 15**

HA-19: Gray Paper  
Backing

Sample	Description	Appearance	Non-Asbestos		Asbestos
			% Fibrous	% Non-Fibrous	% Type
19A 042219613-0001	Room 213 - Paper Backing - Gray	Gray Non-Fibrous Homogeneous		65% Non-fibrous (Other)	35% Chrysotile
19B 042219613-0002	Room 213 - Paper Backing - Gray				Positive Stop (Not Analyzed)
19C 042219613-0003	Room 212 - Paper Backing - Gray				Positive Stop (Not Analyzed)
20A 042219613-0004	Basement - Foyer - Paper Flooring - White	White Fibrous Homogeneous	20% Cellulose 5% Glass	75% Non-fibrous (Other)	None Detected
20B 042219613-0005	Basement - Foyer - Paper Flooring - White	White Fibrous Homogeneous	20% Cellulose 5% Glass	75% Non-fibrous (Other)	None Detected
20C 042219613-0006	Basement - Bathroom - Paper Flooring - White	White Fibrous Homogeneous	20% Cellulose 8% Glass	72% Non-fibrous (Other)	None Detected
21A-Paper Flooring 042219613-0007	2nd Floor - Kitchen - Paper Flooring - White	White Fibrous Homogeneous	15% Cellulose 2% Glass	83% Non-fibrous (Other)	None Detected

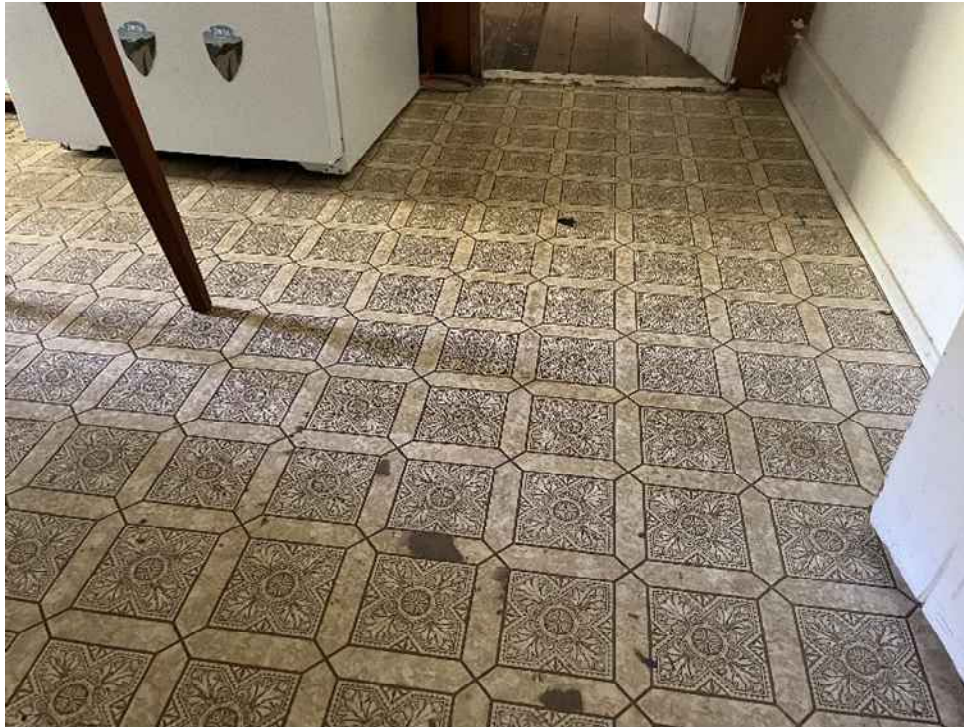
**Photograph: 17**

HA-21: Tan Paper  
Flooring

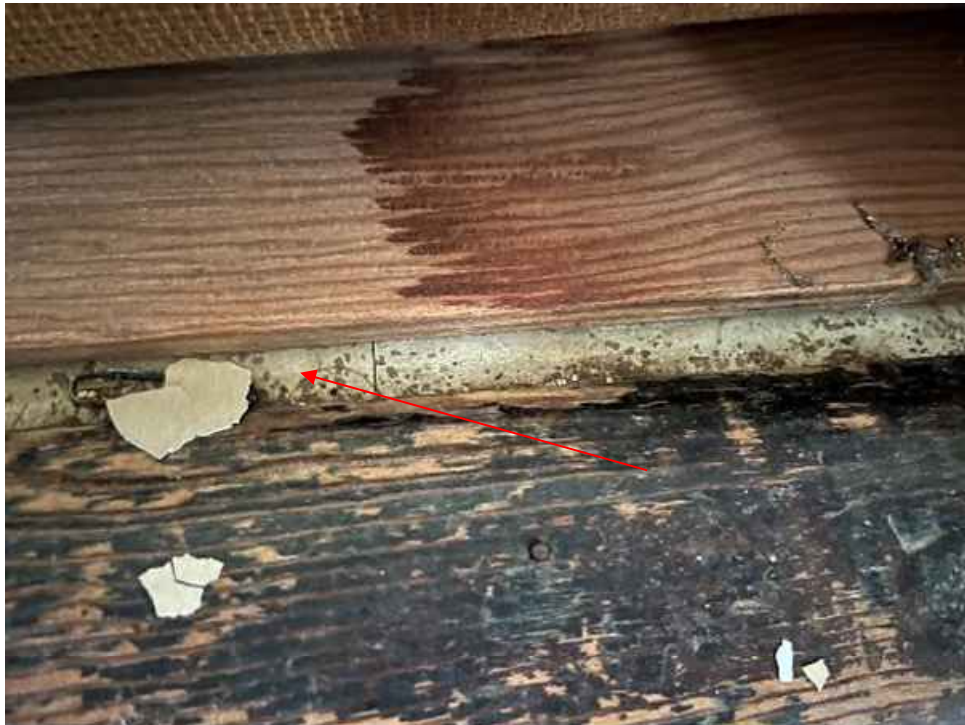
**Photograph: 19**

HA-25: White 12"x12"  
Vinyl Floor Tile under  
wood flooring –  
assumed ACM;  
HA-26: Floor Tile  
Mastic associated with  
HA-25 – assumed ACM

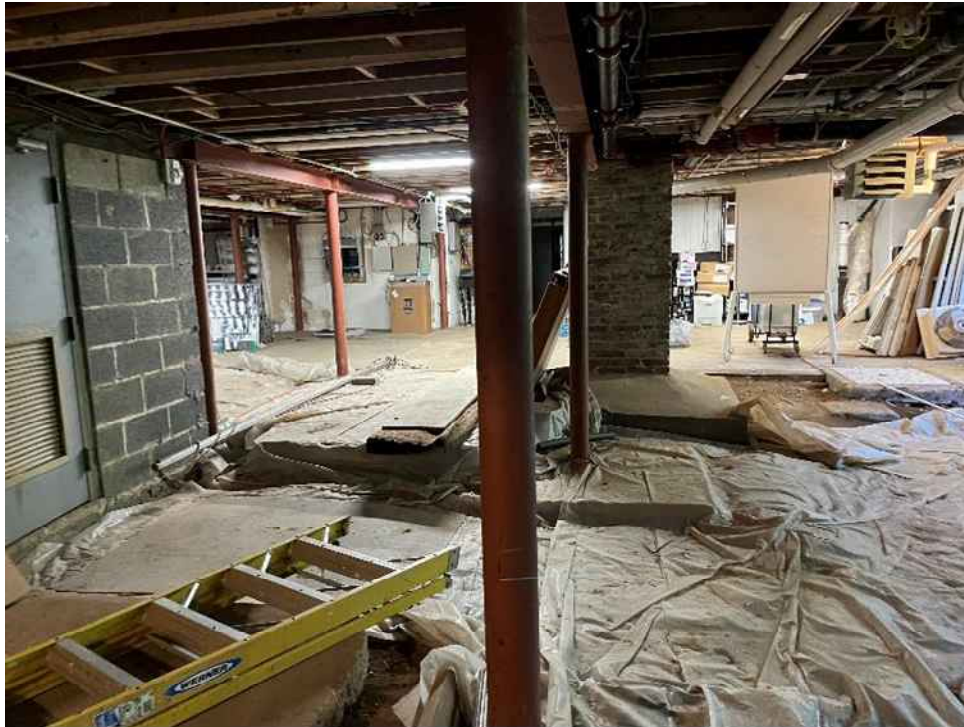
**Photograph: 21**

Pb-3: Brown paint on  
basement metal  
support beam

Sample #	Component	Substrate	Color	Floor	Testing Location	Condition	Result Total Lead (%)	Comments
Pb-1	Wall	Wood	White	Basement	B-3	Poor	<0.0080	---
Pb-2	Wall	Drywall	White	Basement	B-5 - kitchen	Good	<0.0080	---
<b>Pb-3</b>	<b>Support beam</b>	<b>Metal</b>	<b>Brown</b>	<b>Basement</b>	<b>Basement</b>	<b>Good</b>	<b>37</b>	<b>Lead-Containing Paint</b>
<b>Pb-4</b>	<b>Ceiling</b>	<b>Drywall</b>	<b>White</b>	<b>1</b>	<b>110 - closet</b>	<b>Good</b>	<b>1.9</b>	<b>Lead-Containing Paint</b>
<b>Pb-5</b>	<b>Wall</b>	<b>Wood</b>	<b>White</b>	<b>1</b>	<b>111</b>	<b>Poor</b>	<b>5.7</b>	<b>Lead-Containing Paint</b>
<b>Pb-6</b>	<b>Wall</b>	<b>Stone</b>	<b>White</b>	<b>1</b>	<b>110</b>	<b>Poor</b>	<b>9.7</b>	<b>Lead-Containing Paint</b>
<b>Pb-7</b>	<b>Door</b>	<b>Wood</b>	<b>White</b>	<b>1</b>	<b>Hall</b>	<b>Poor</b>	<b>1.0</b>	<b>Lead-Containing Paint</b>
<b>Pb-8</b>	<b>Window sill</b>	<b>Wood</b>	<b>White</b>	<b>2</b>	<b>Exterior window</b>	<b>Poor</b>	<b>0.12</b>	<b>Lead-Containing Paint</b>

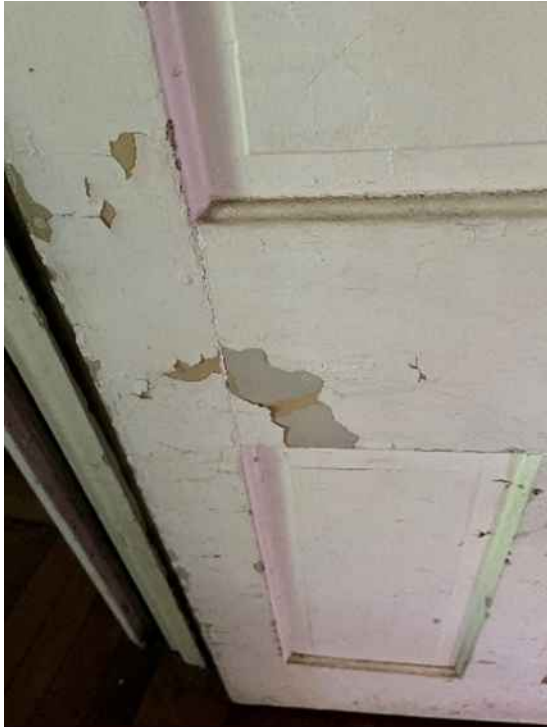
**Photograph: 23**

Pb-7: White paint on  
wood door

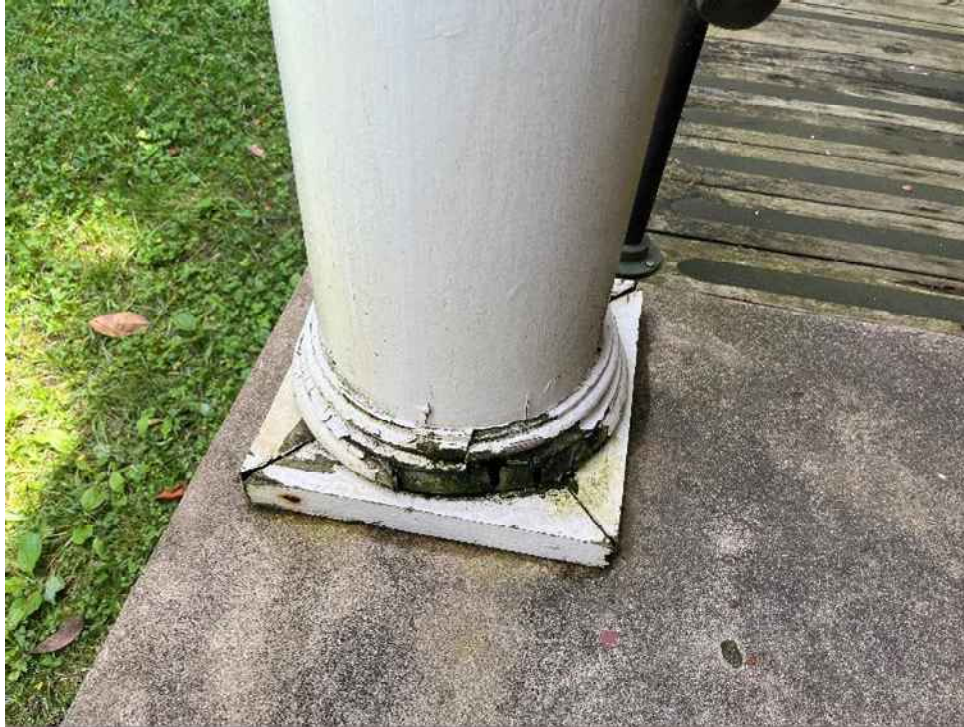
**Photograph: 25**

Pb-13: White paint on  
wood column
