**WETLAND STATEMENT OF FINDINGS**  
**For**  
**EXECUTIVE ORDER 11990**  
**And**  
**NATIONAL PARK SERVICE DIRECTOR'S ORDER 77-1:**  
**WETLAND PROTECTION**

**Stabilize Riverbank at Towpath Station Road South along the Cuyahoga River  
(PEPC # 116064)**

Prepared by  
Cuyahoga Valley National Park – Brecksville, Ohio  
The Denver Service Center – Lakewood, Colorado

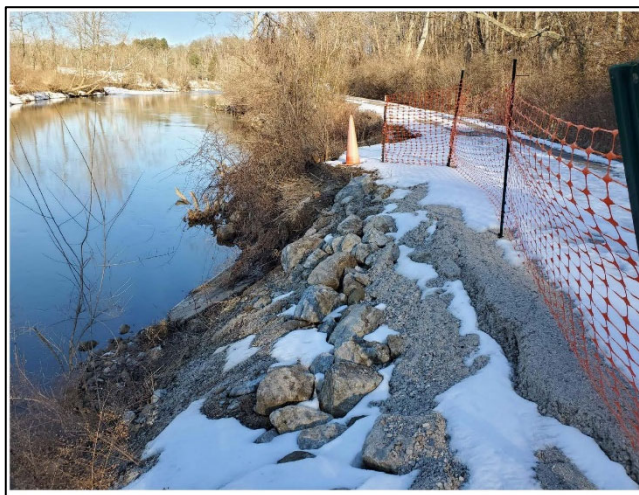
Figure 2. Station Road South project site viewed from the south.

The project site is located about two miles east-southeast of downtown Brecksville and about one-third mile south of the Station Road Parking Lot (Figures 1, 2, and 3). The site is located on NPS property immediately east of the Cuyahoga River about 300-feet south of the confluence of Chippewa Creek with the river.

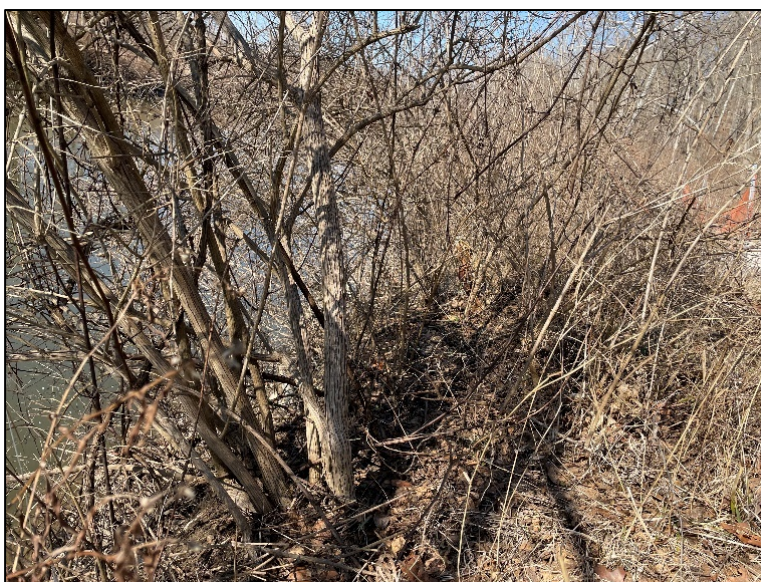
Figure 10: Typical condition of riverbank in the project area indicating extensive presence of woody vegetation.

This section of riverbank riparian habitat is vegetated which provides canopy structure for wildlife and some bank stabilization, but the plant species composition suggests that the overall wildlife functions of the riparian edge appear to be in poor condition. The riparian edge in the project area is dominated by woody vegetation including non-native bush honeysuckle (*Lonicera mackii*) and mugwort (*Artemisia vulgaris*) (Figures 10 and 11).

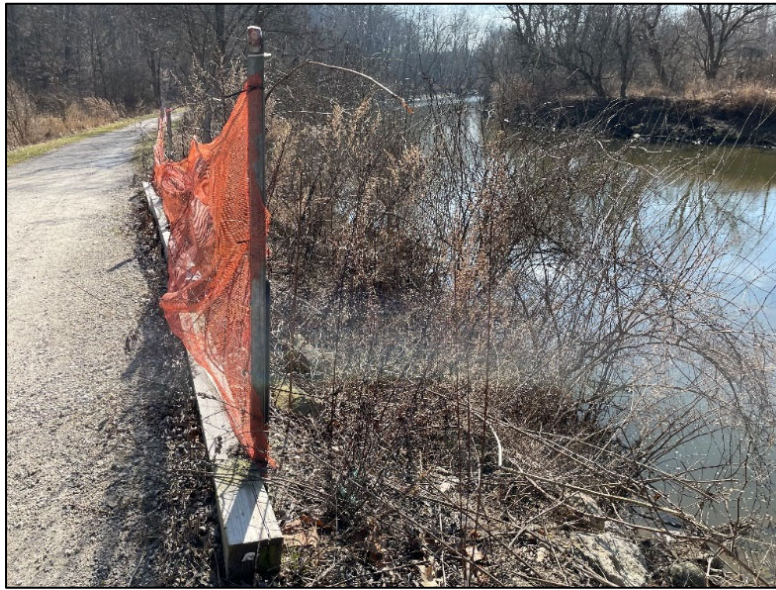
Figure 11: Typical condition of riverbank in the project area indicating extensive presence of mugwort and other woody vegetation with sandstone riprap towards bottom of the slope.

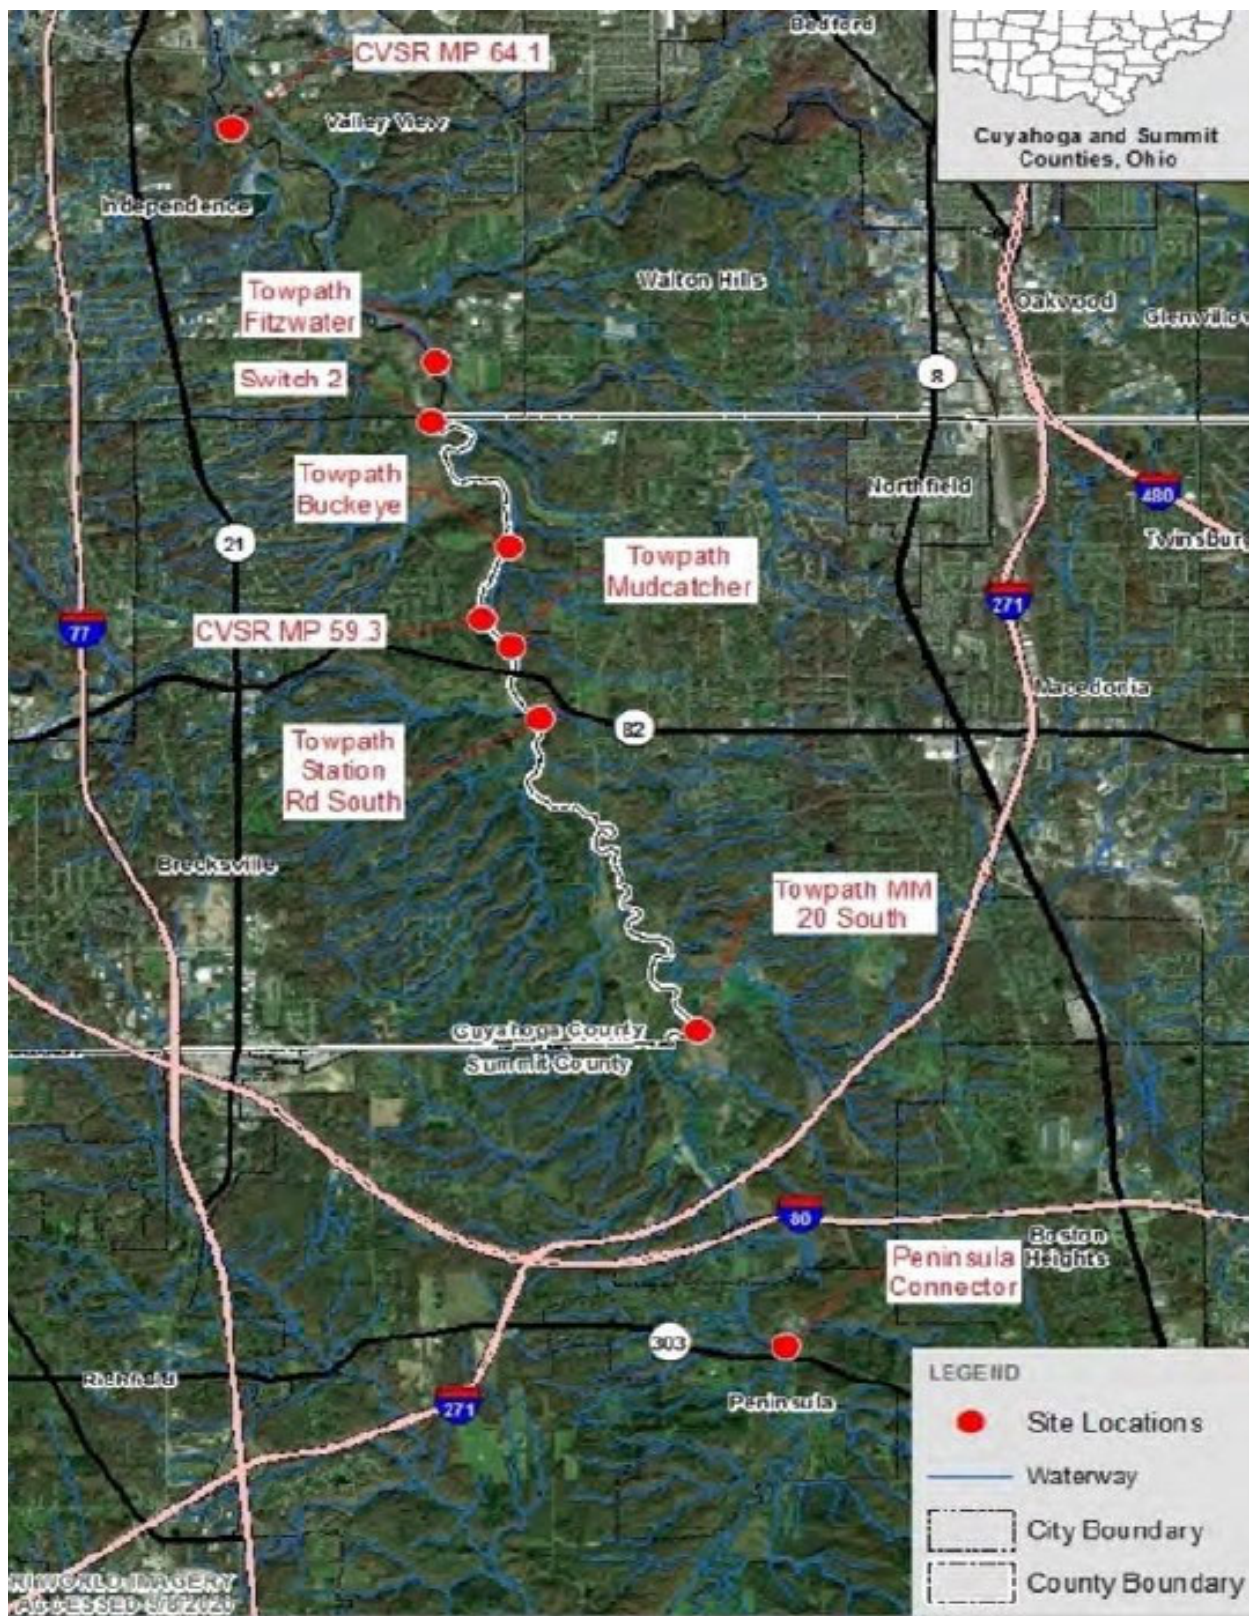
Figure 12. All nine shoreline project locations along the Cuyahoga River including the Station Road South armoring.

According to the Programmatic Environmental Assessment for Riverbank Management of the Cuyahoga River (NPS 2004, Table 4-8), prior to 2004 a total of 2.7 miles of shoreline had been armored within the park. By 2017, more than 6.5 miles of riverbank at the park were armored with riprap or other material, an increase of nearly 250 percent since 2004 (NPS 2017). Over time, the existing armoring and the Towpath Station Road South project will be joined by eight more shoreline armoring structures. It is estimated that the nine projects will armor an additional 9,000 feet (1.7 miles) of the riverbank in the 25-mile reach of the Cuyahoga River within the park (please see Figure 12). Some of the new armoring will replace old armoring.

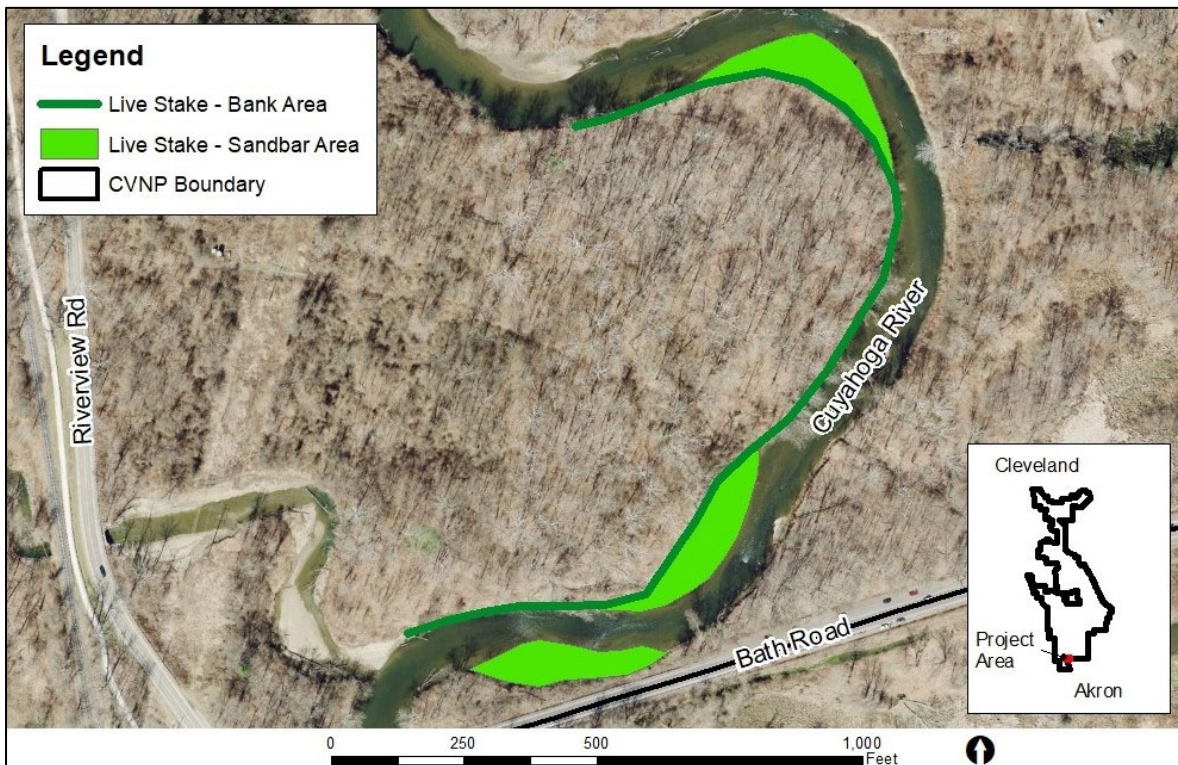
Figure 13: Proposed compensation area and plan to offset project impacts to 0.7 acre of riverine wetland.

In accordance with NPS guidelines to compensate for wetland impacts, the NPS will create approximately 2.1 acres of forested riverine wetland adjacent to and within the ordinary high-water mark of the Cuyahoga River on NPS property (Figures 13 and 14). This work will result in a compensation ratio of 3:1, creating three acres of habitat for each acre of wetland impact. The compensation area will be located near the southern boundary of the park immediately north of Bath Road and between Riverview Road and Akron-Peninsula Road.

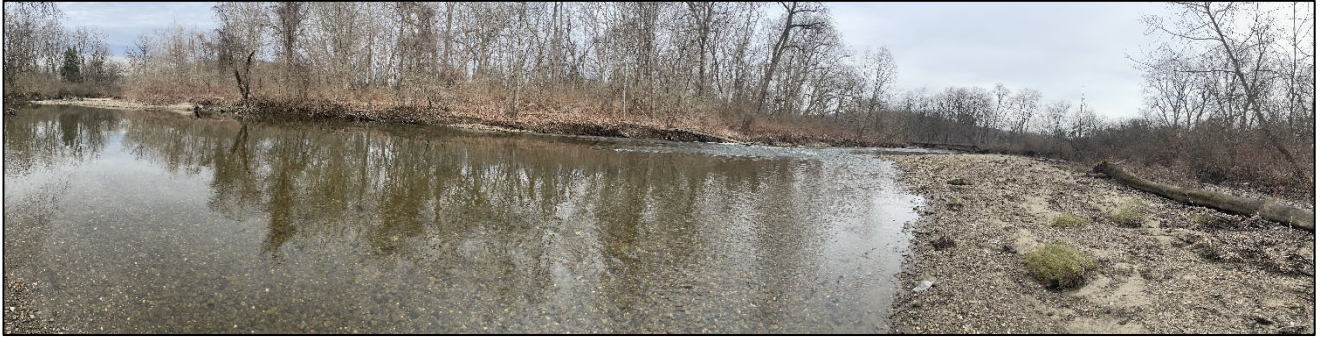
Figure 14: Typical bank and river conditions in the compensation area.

Compensation will focus on reforestation of approximately 2,000-linear feet of riverbank and 1.6 acres of sandbar. Existing riverbank conditions in the compensation area are similar to conditions in the project area with poorly vegetated banks dominated by non-native, invasive plants. Plants of particular concern in the compensation area are bush honeysuckle and Japanese knotweed (*Reynoutria japonica*).
