**FINAL**  
**Vegetation Monitoring Plan**  
**Arches Anomaly Repair**

**March 2010**

**Prepared for:**  
**Williams Gas Pipelines**

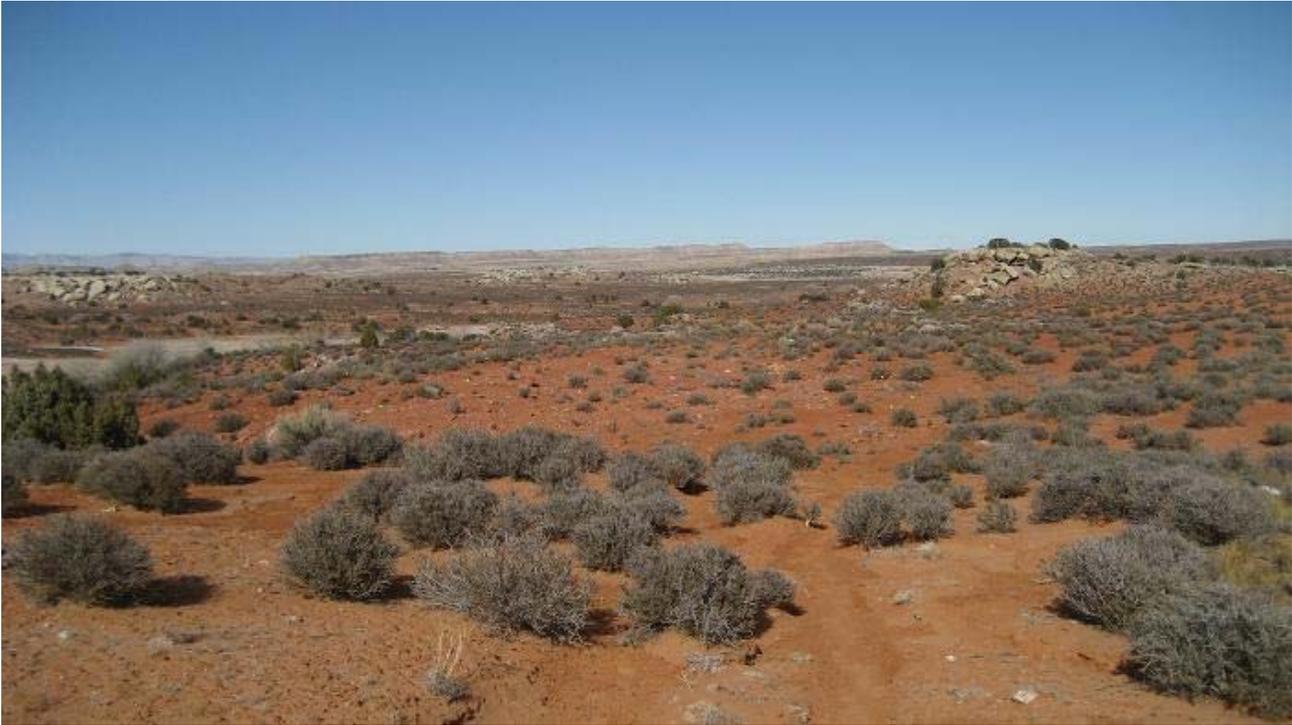
Anomaly photo 1- taken from next to rock on trail toward sand dune arch, from southwest of anomaly site, looking northeast (30°). Green flags indicate perimeter of planting area. Photo taken 2-27-09.

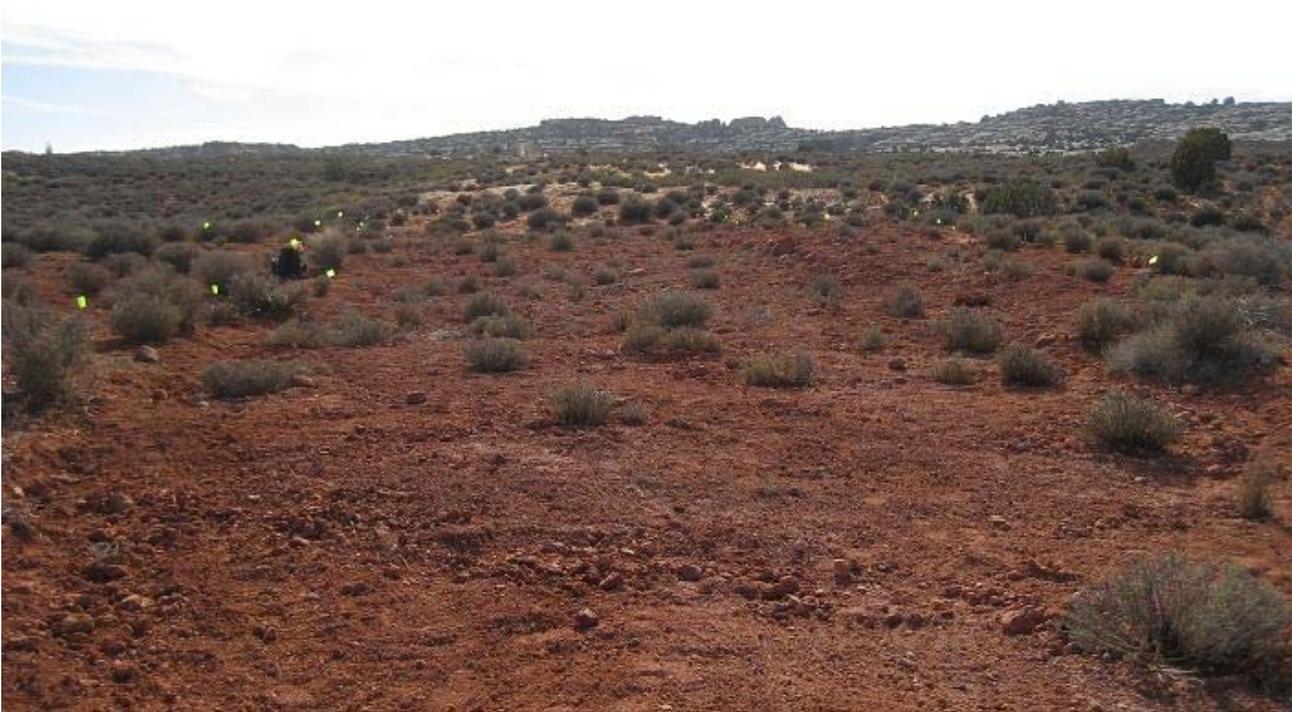
Anomaly photo 2- taken from access route looking south (200°). Green flags indicate perimeter of planting area. Photo taken 2-27-09.

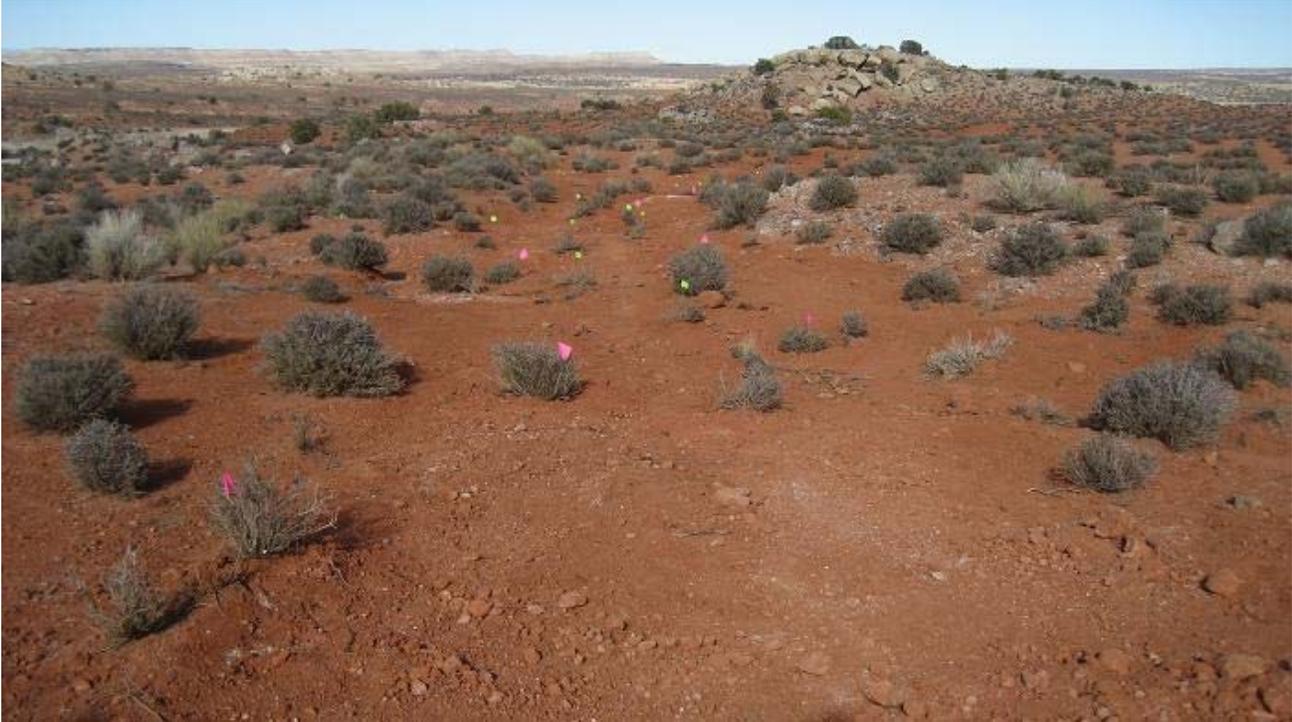
Beginning of section 1- looking northeast (40°). Pink flags mark blackbrush transplants, green flags mark tracked blackbrush individuals. Avoided blackbrush individuals are not flagged. Photo taken 2-27-09.

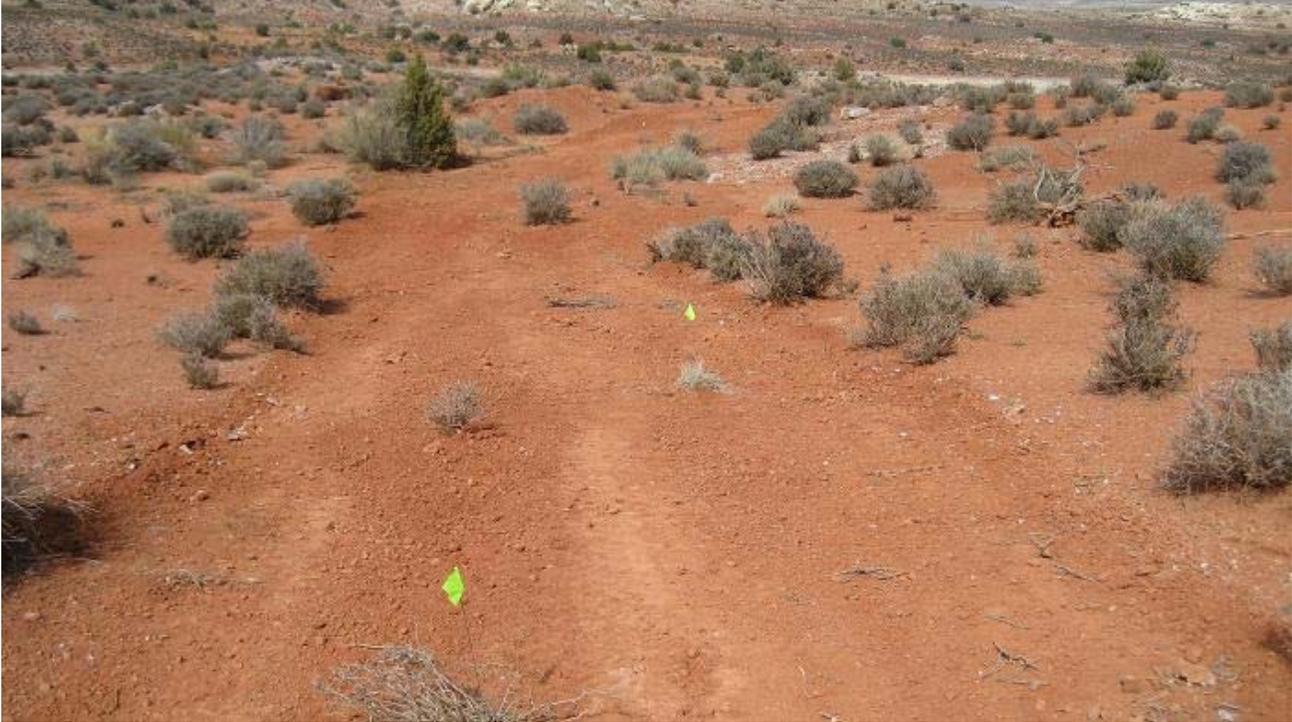
Beginning of section 2- looking north (340°). Pink flags mark blackbrush transplants, green flags mark tracked blackbrush individuals. Avoided blackbrush individuals are not flagged.

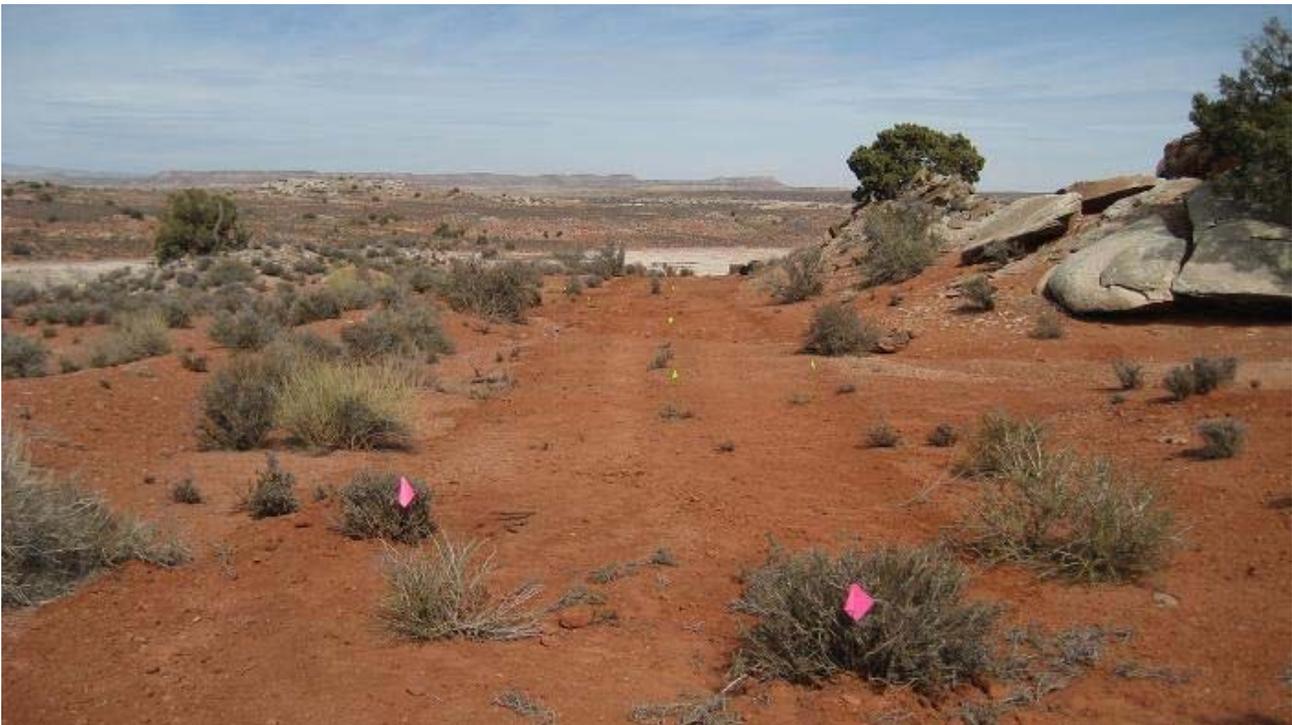
Section 2 midway photo a- looking northeast (40°). Pink flags mark blackbrush transplants, green flags mark tracked blackbrush individuals. Avoided blackbrush individuals are not flagged.

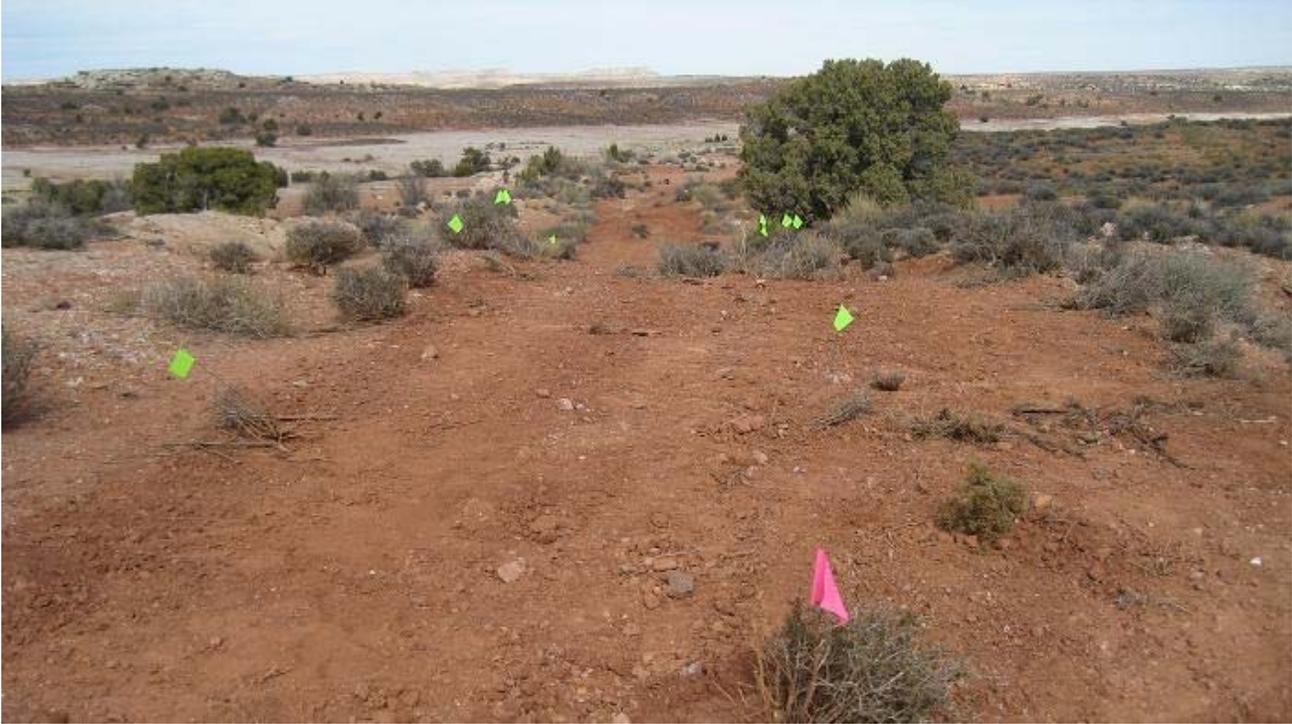
Section 2 midway photo b- looking northeast (30°). Pink flags mark blackbrush transplants, green flags mark tracked blackbrush individuals. Avoided blackbrush individuals are not flagged.

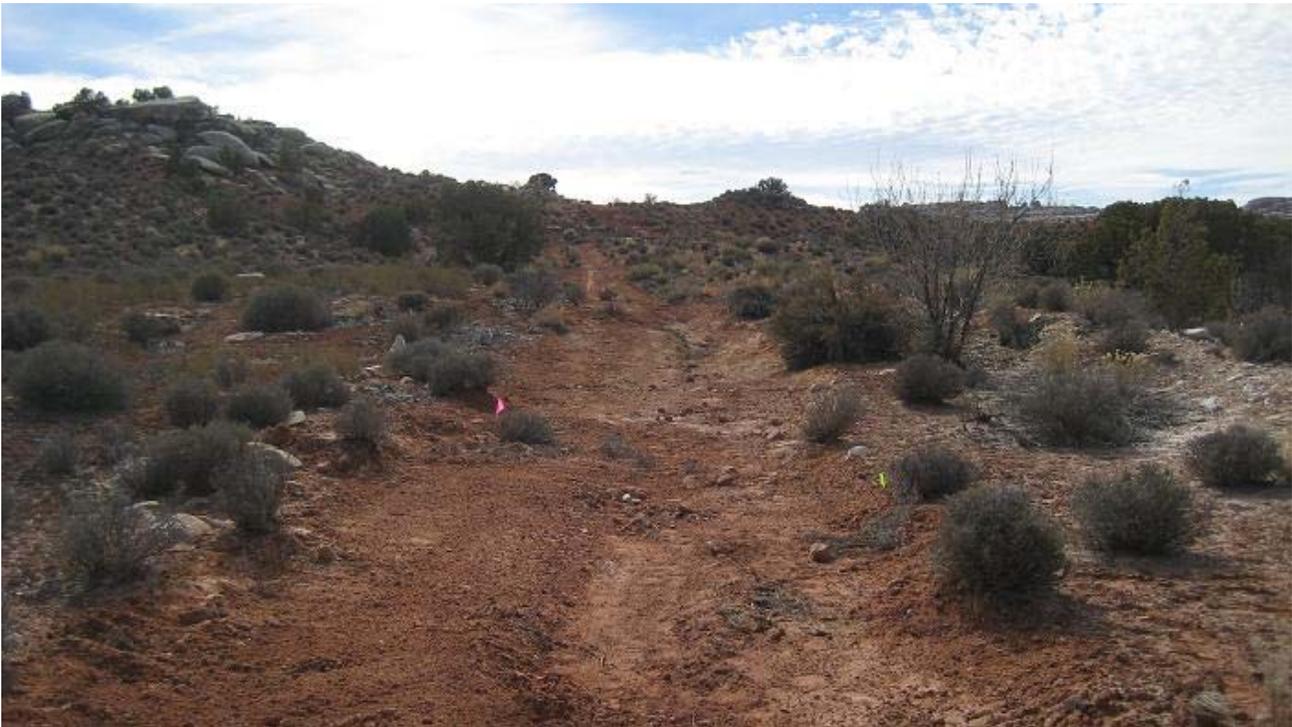
End of section 2- looking southwest (220°) from near pipe crossing. Pink flags mark blackbrush transplants, green flags mark tracked blackbrush individuals. Avoided blackbrush individuals are not flagged.

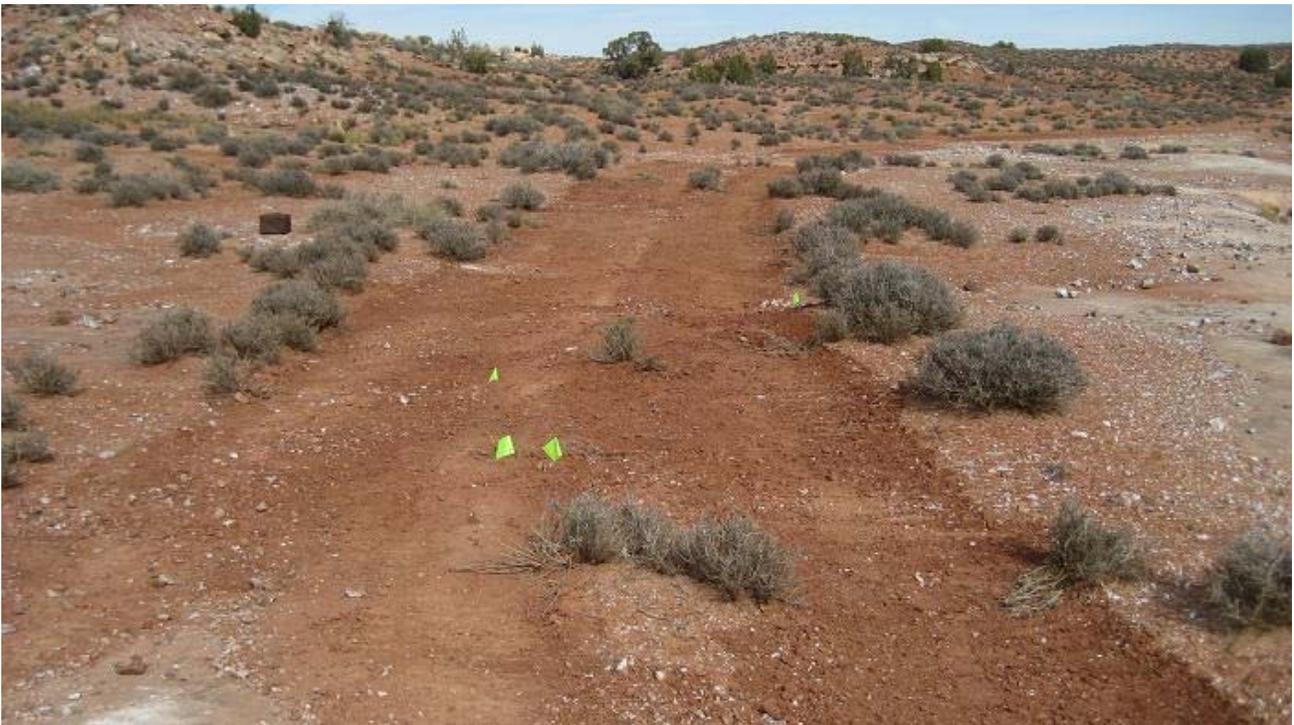
Section 5 midway photo- looking northeast (50°). Pink flags mark blackbrush transplants, green flags mark tracked blackbrush individuals. Avoided blackbrush individuals are not flagged.

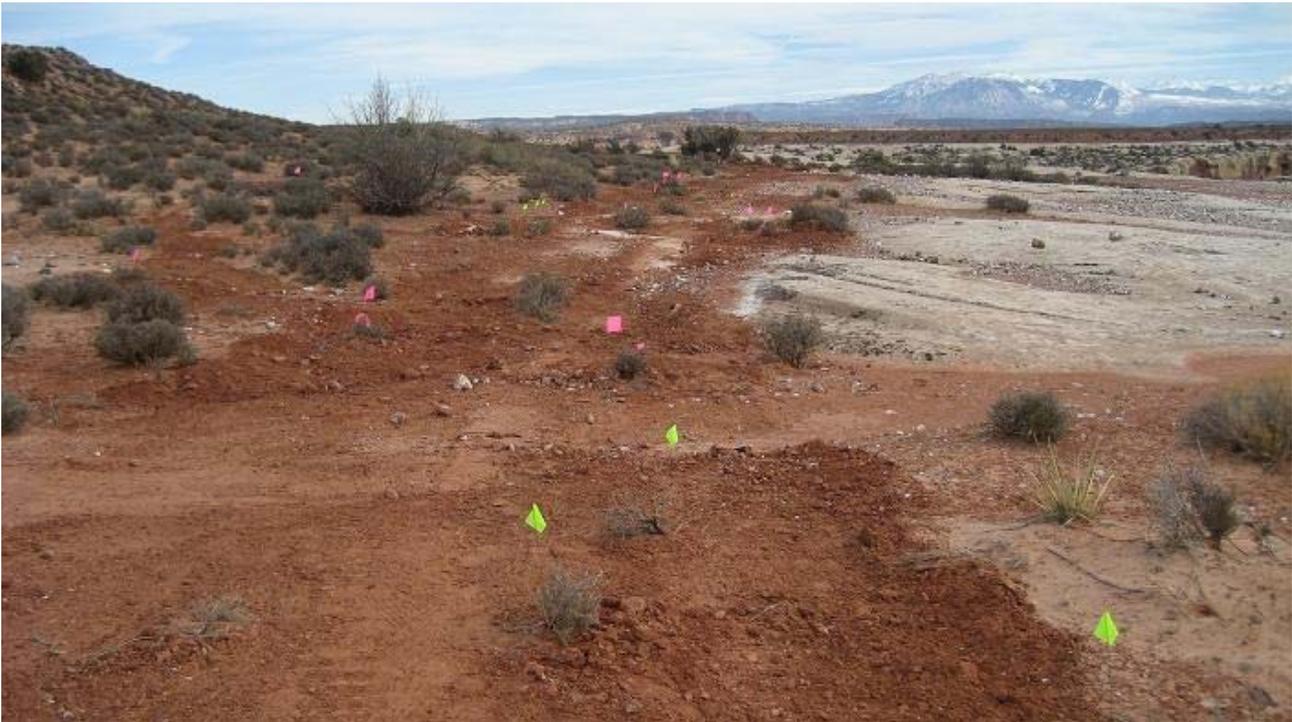
Beginning of section 6- Taken from bend in road, looking southeast (110°). Pink flags mark blackbrush transplants, green flags mark tracked blackbrush individuals. Avoided blackbrush individuals are not flagged.

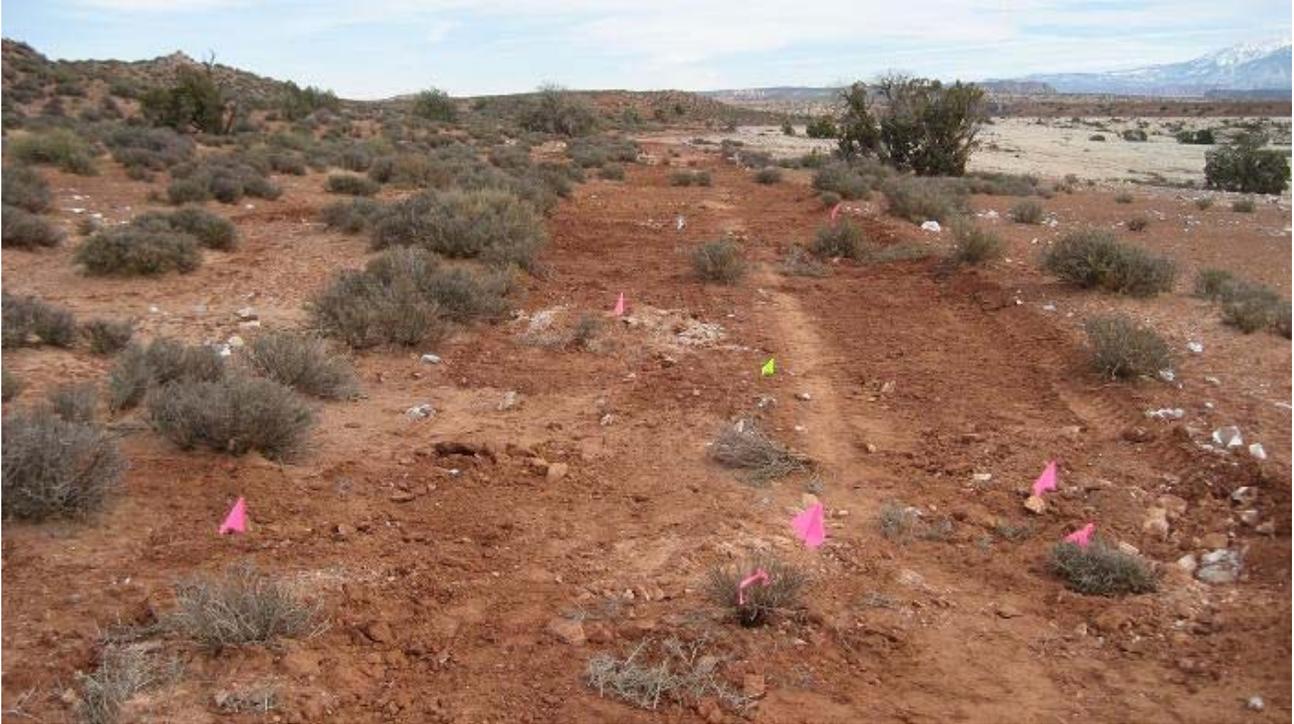
Section 6 midway photo- looking east (110°). Pink flags mark blackbrush transplants, green flags mark tracked blackbrush individuals. Avoided blackbrush individuals are not flagged.

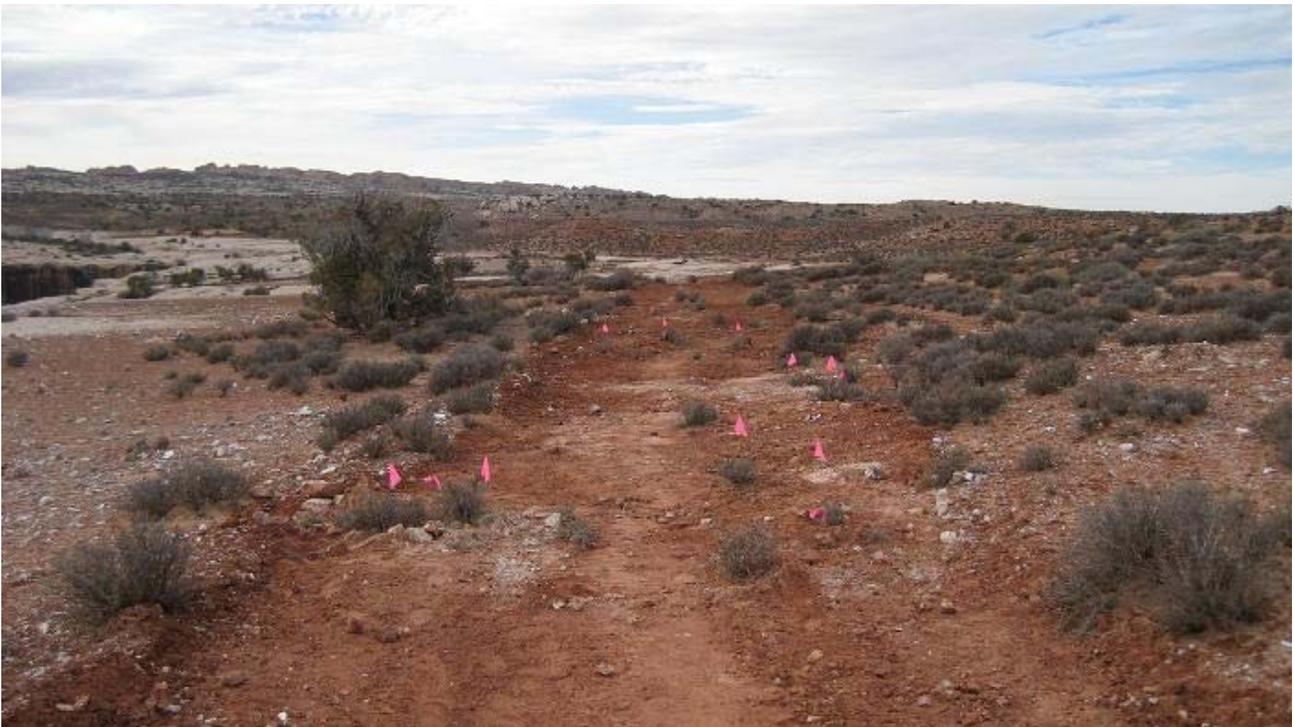
End of section 6- Taken from next to large juniper tree adjacent to road, looking west (270°). Pink flags mark blackbrush transplants, green flags mark tracked blackbrush individuals. Avoided blackbrush individuals are not flagged.

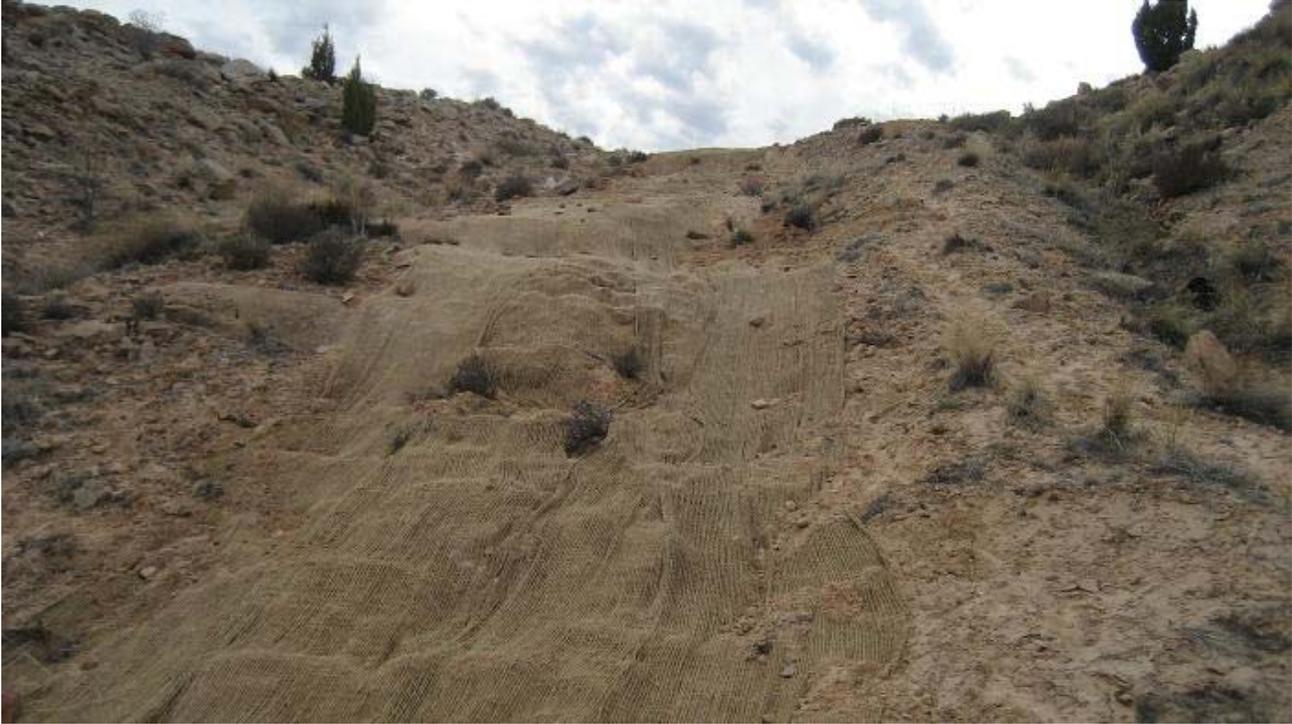
Section 8 midway photo taken from top of middle water bar, looking uphill, south (200°).

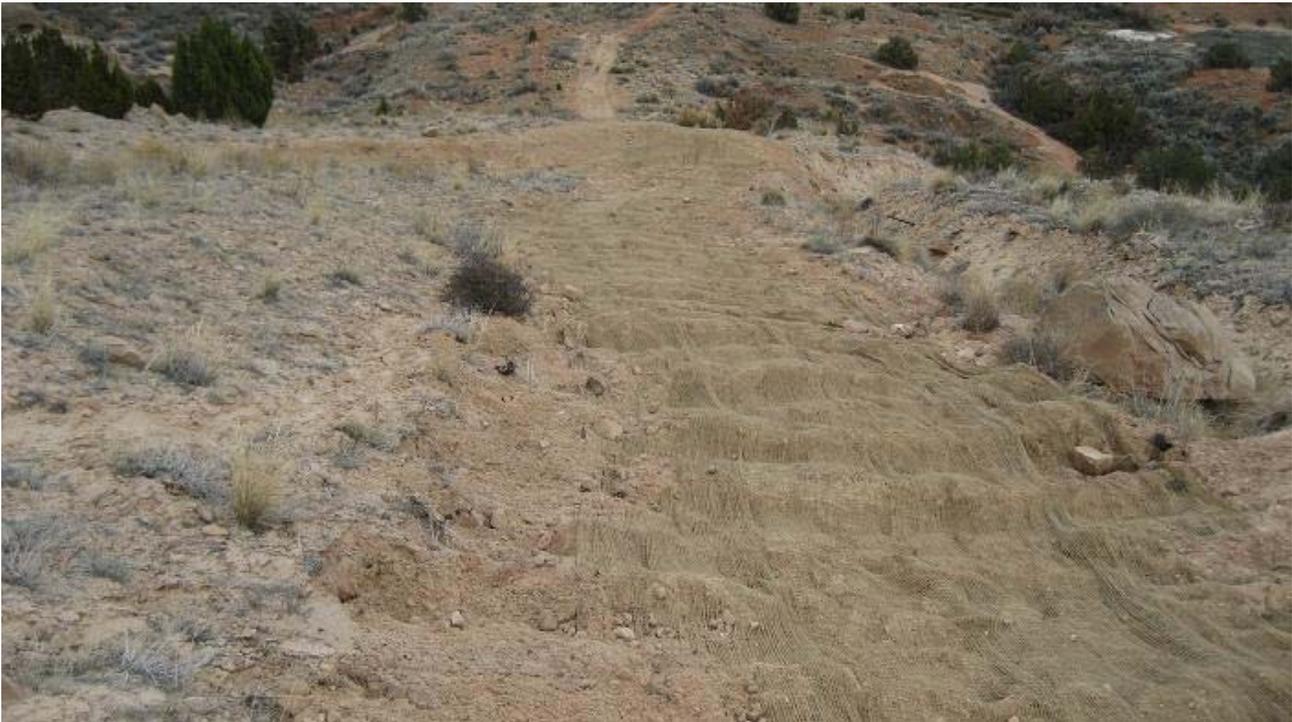
Section 8 midway photo taken from top of middle water bar, looking downhill, northeast (45°).

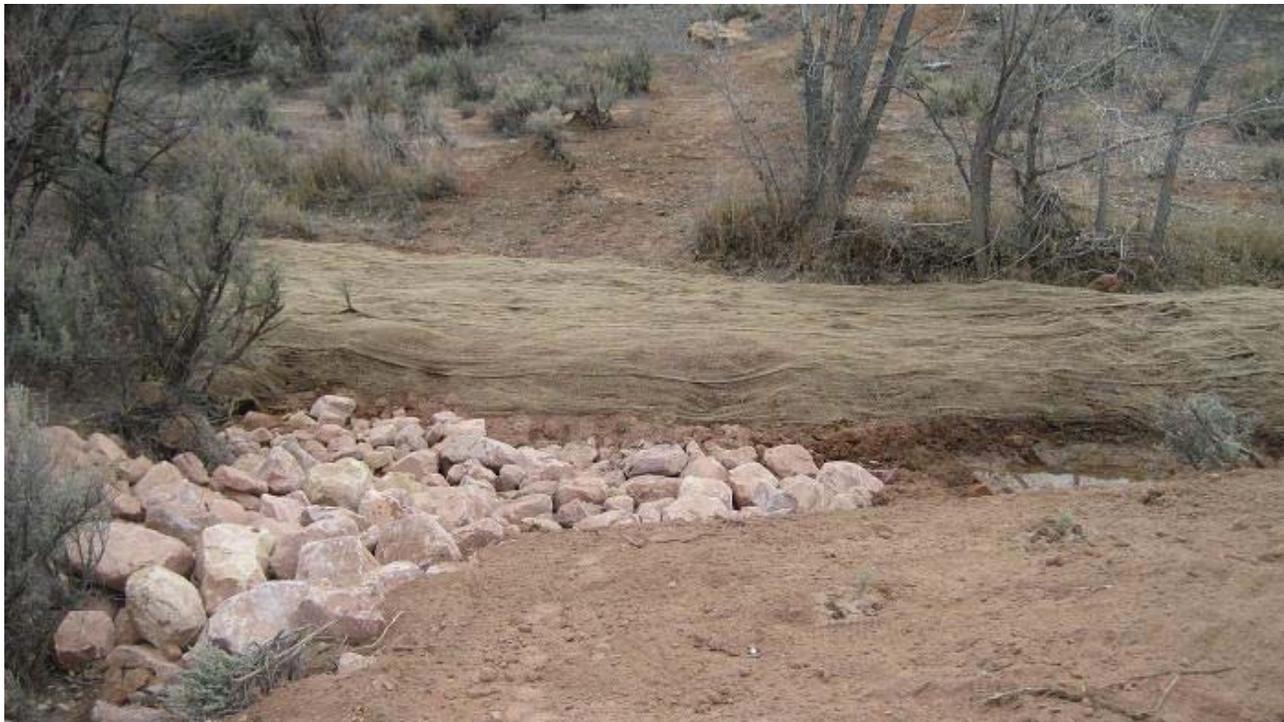
Section 9- Photo of rock check dam structure in salt wash.

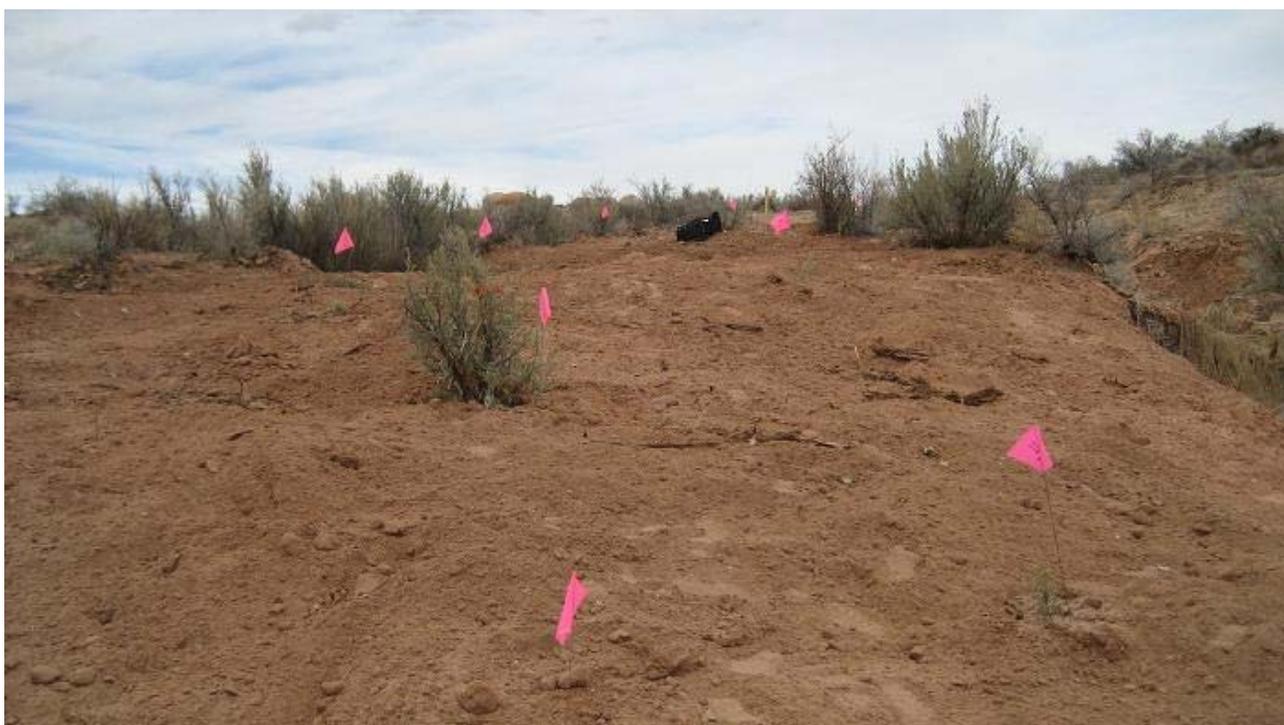
Section 9- Photo of sagebrush transplants just north of salt creek. Pink flags show locations of transplants.

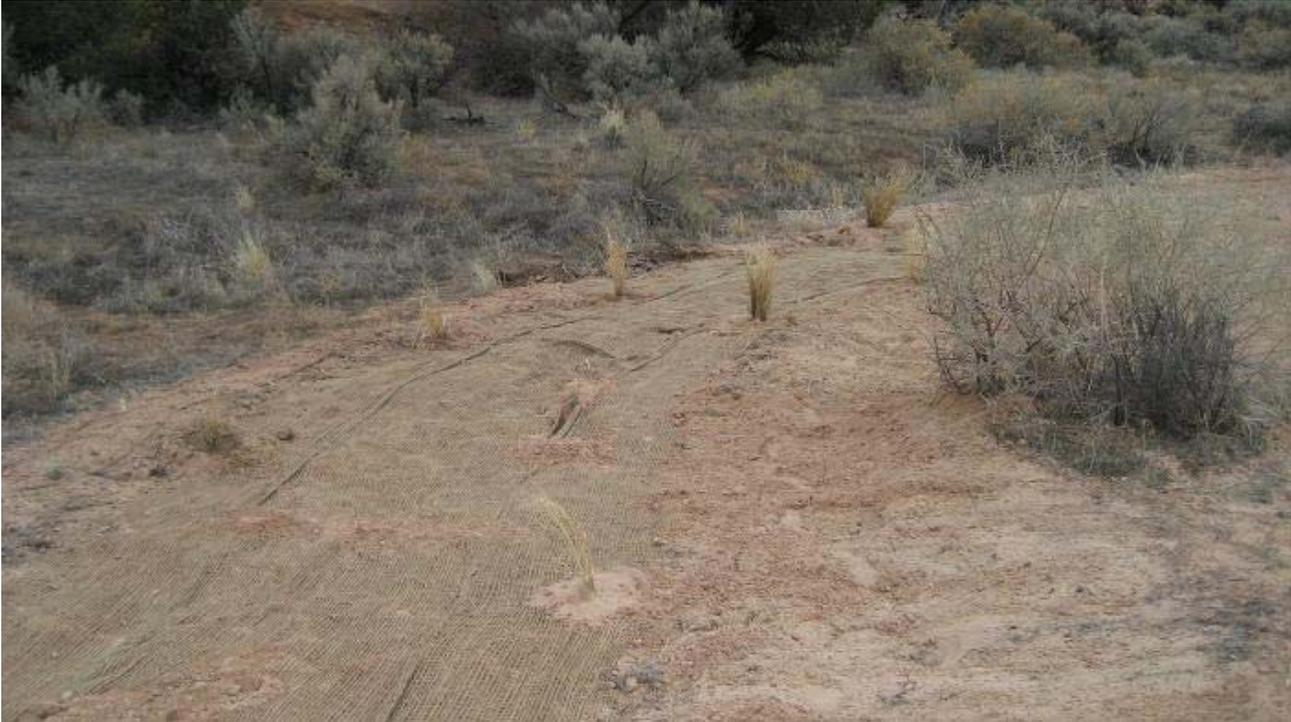
Photo of grass transplants at end of section 12, from same location as above.

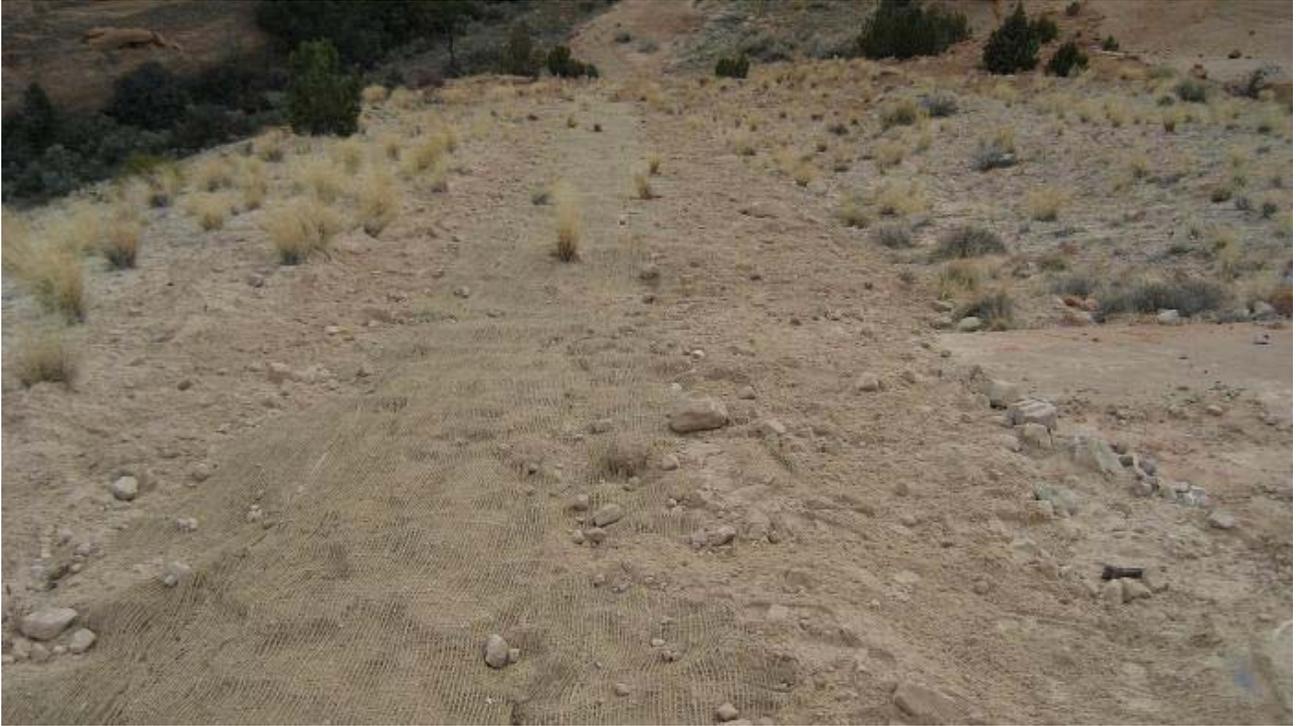
Section 13- Photos taken from atop water bar looking downhill, southwest (220°).

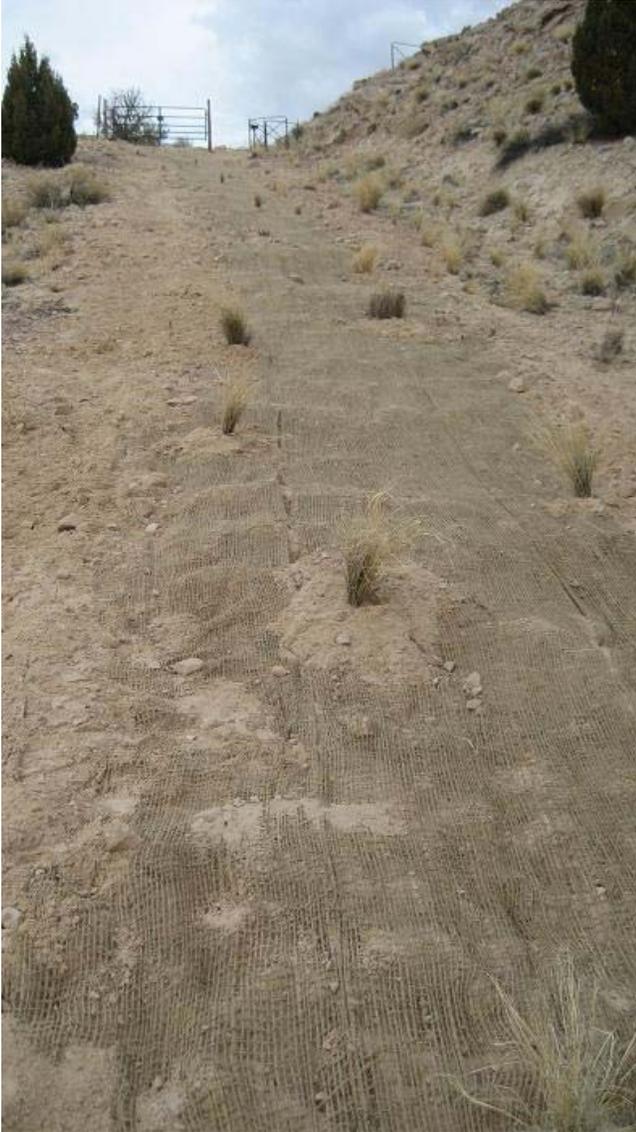
Section 13- Photos taken from atop water bar looking uphill, northeast (40°).

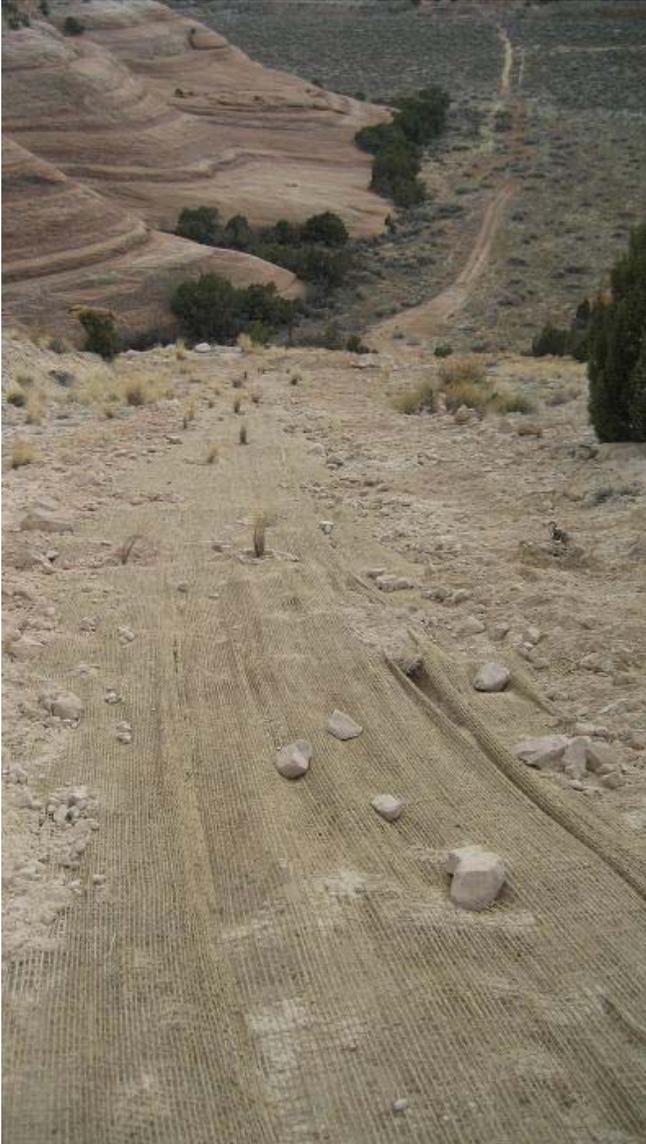
End of section 13 looking downhill, southwest (220°).

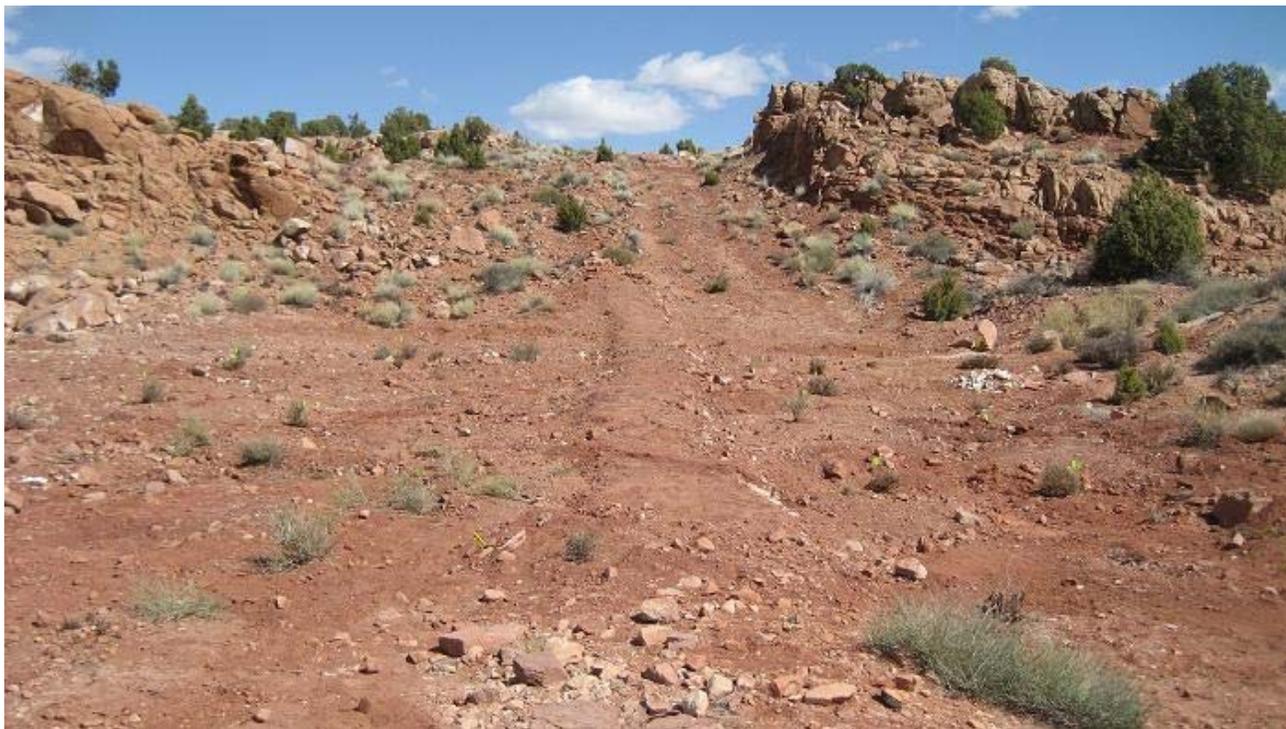
Photo 1- Anomaly site from atop pipeline mound, looking north (20°).

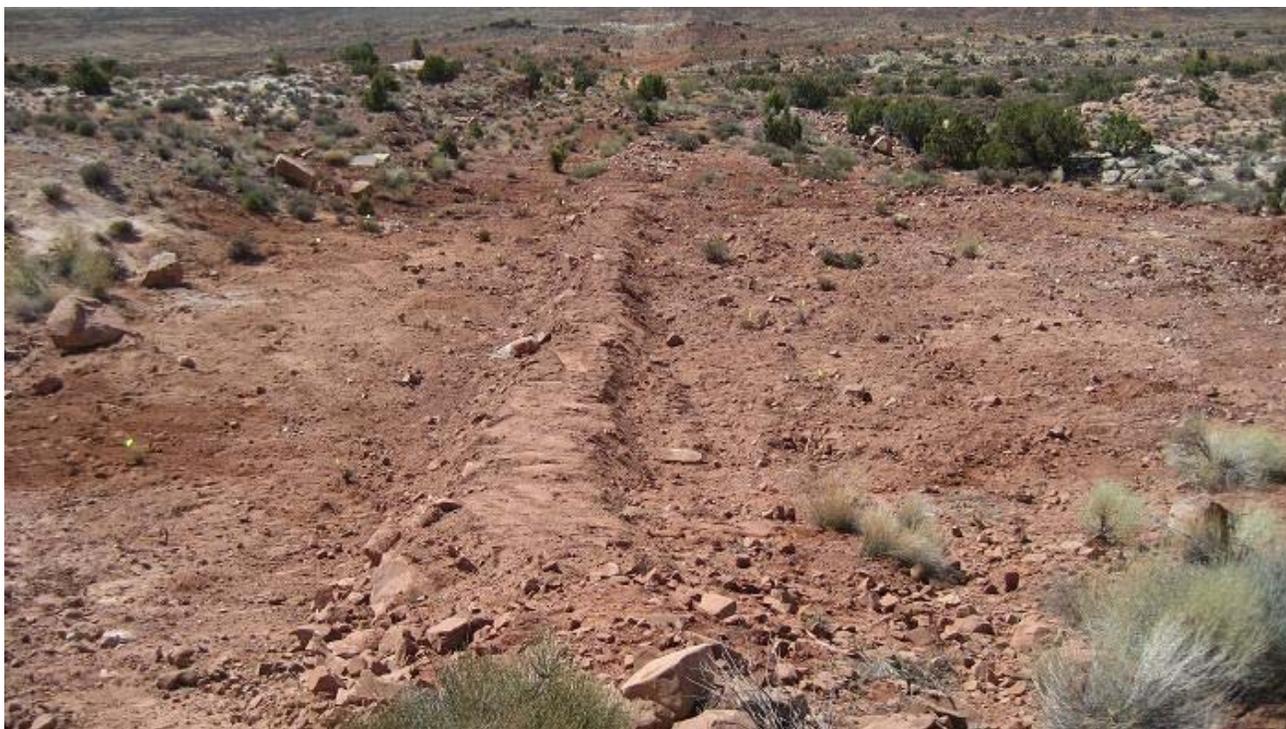
Photo 2- Anomaly site from atop pipeline mound, looking south (200°).

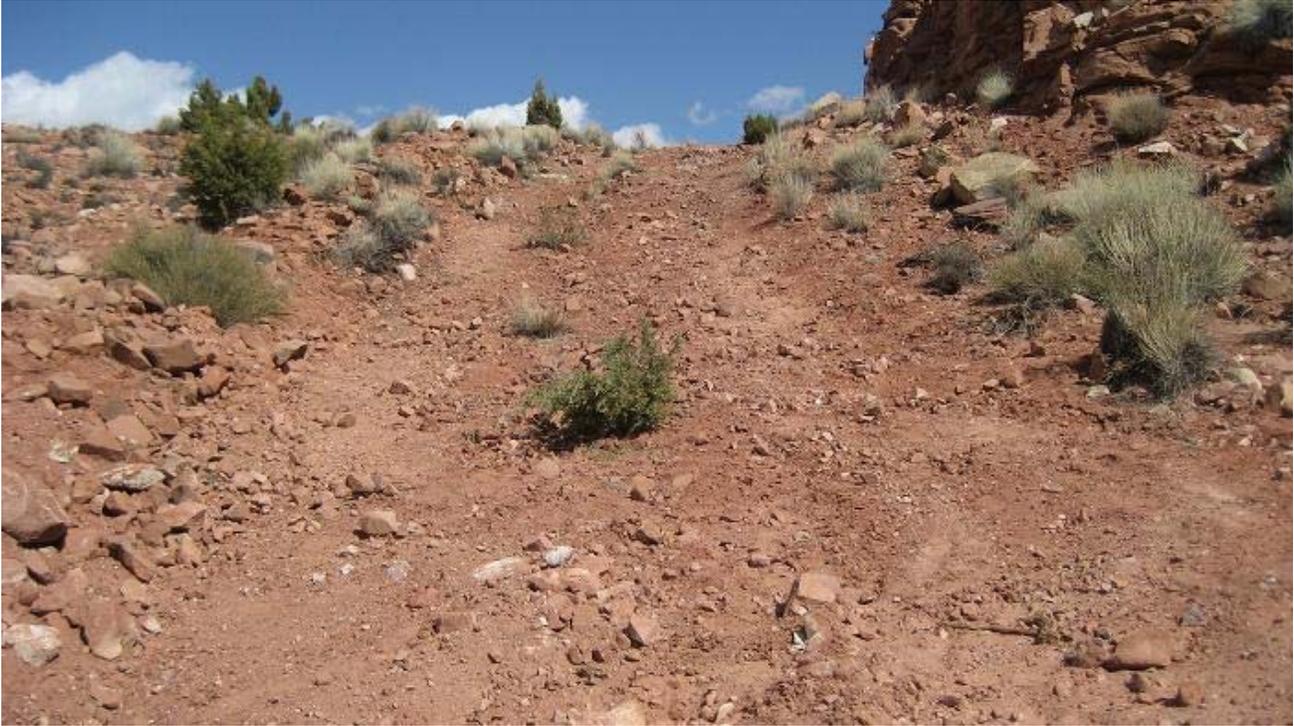
Photo 3- Beginning of access route section A, looking north (10°).

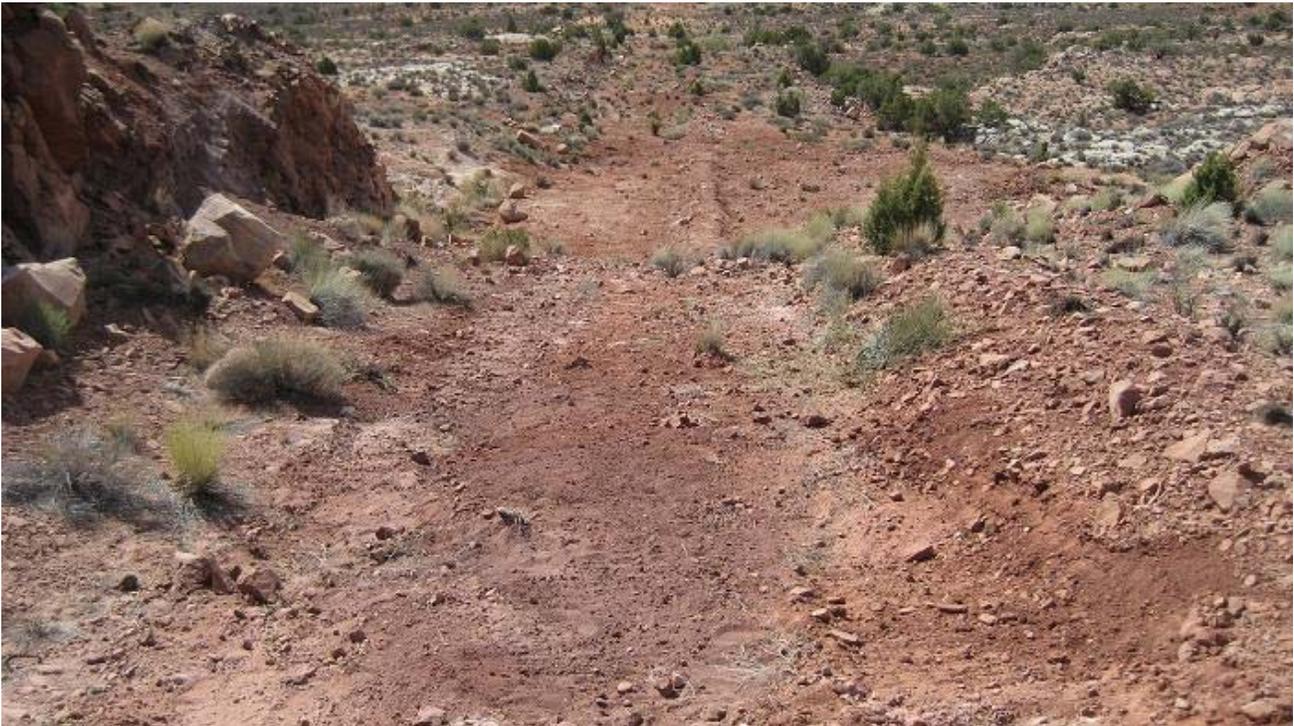
Photo 4- Access route section A, taken from atop water bar looking southwest (220°).

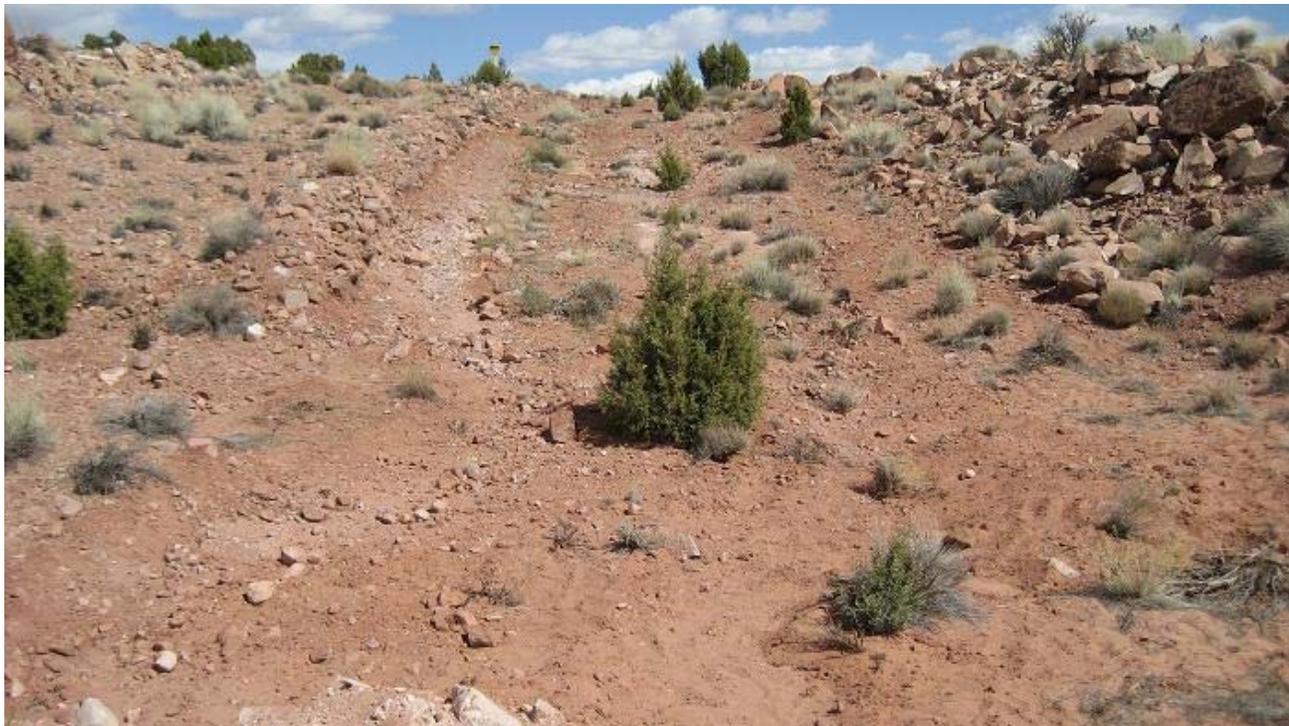
Photo 5- Access route section A, taken from atop water bar looking north (20°)
