**FINAL**  
**Vegetation Monitoring Plan**  
**Arches Anomaly Repair**

**March 2010**

**Prepared for:**  
**Williams Gas Pipelines**

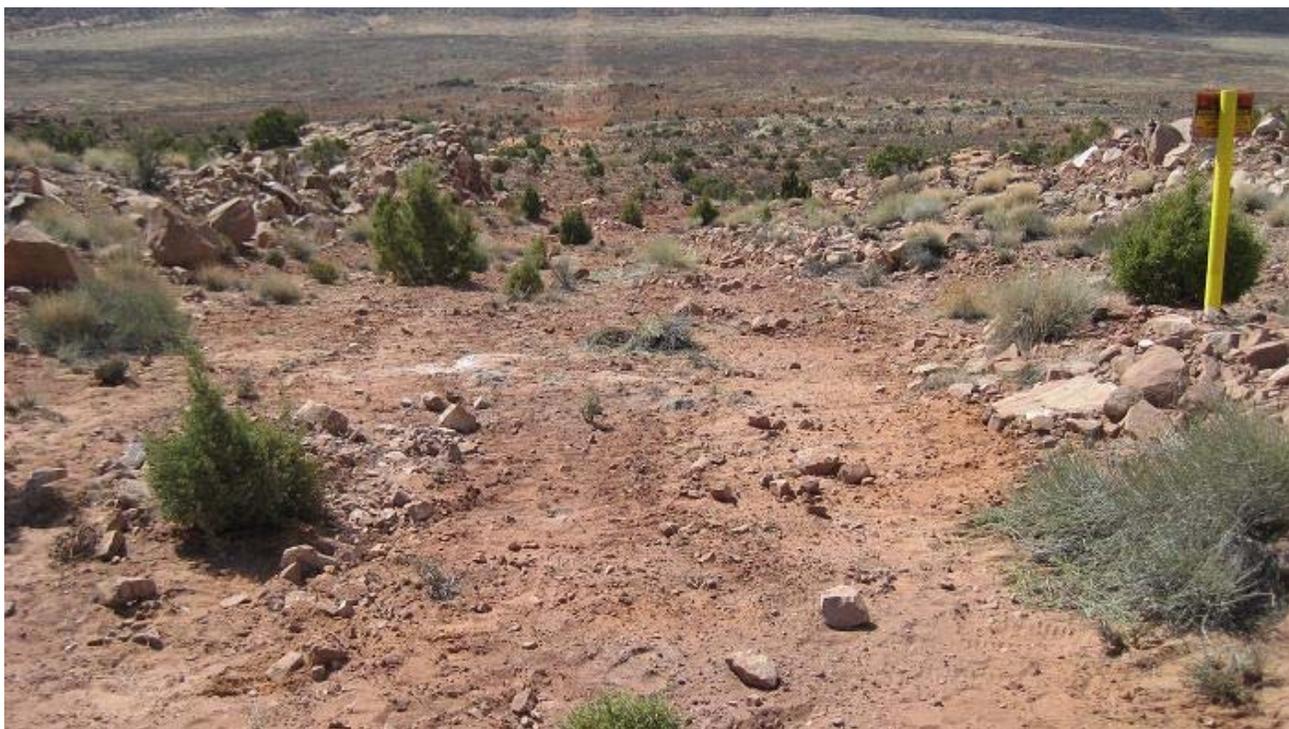
Photo 6- Access route section A, taken from atop water bar looking southwest (220°).

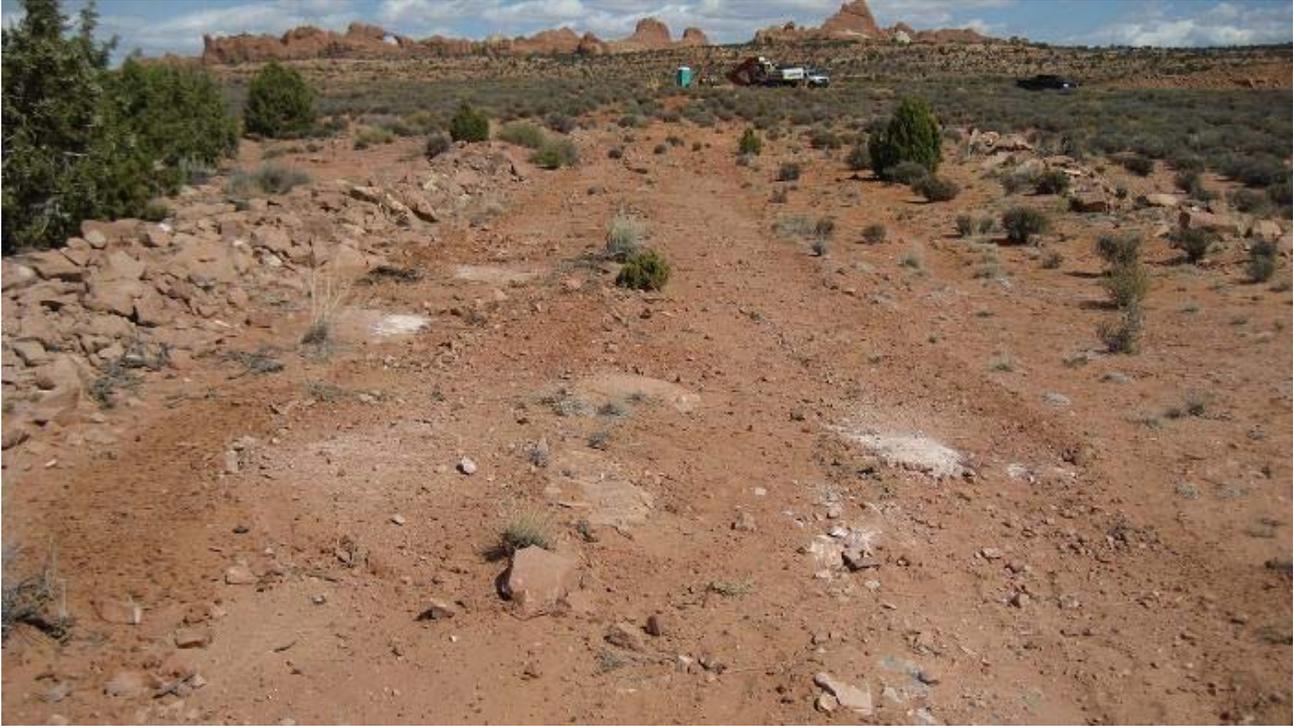
Photo 7- Access route section A, taken from atop water bar looking north (20°).

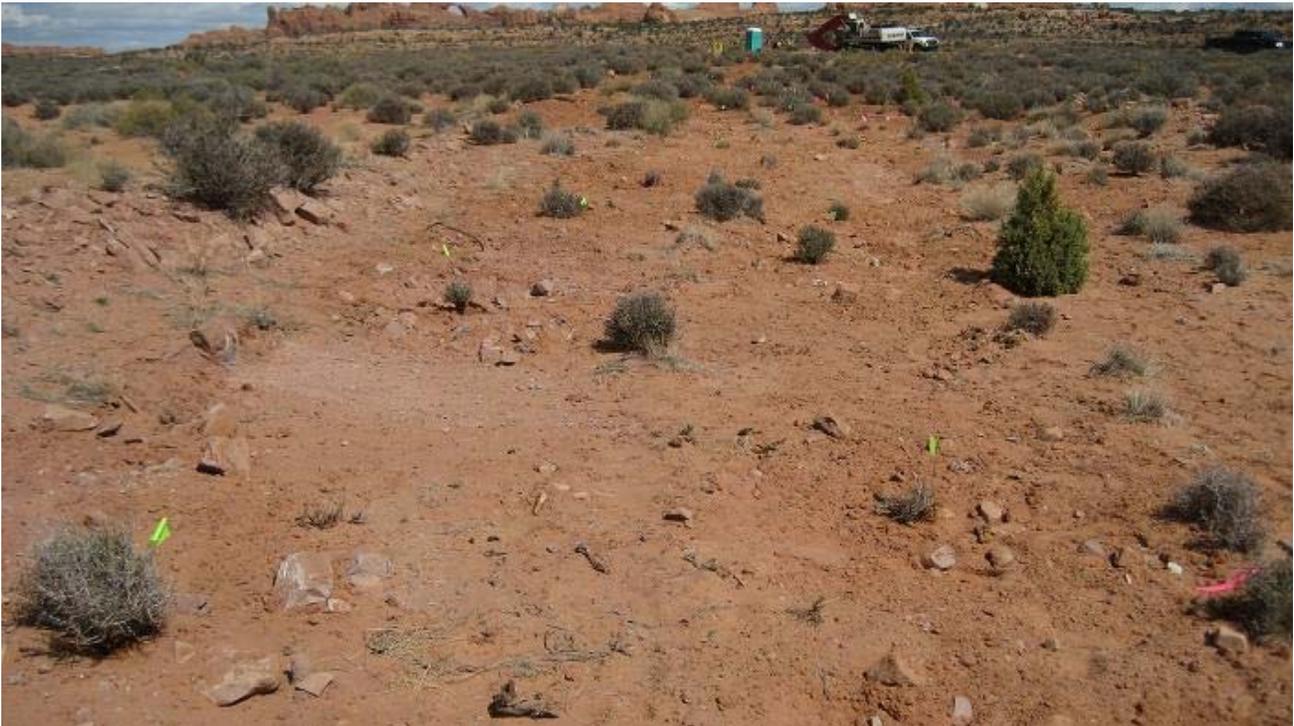
Photo 8- Beginning of access route section B, looking north (20°) Transplants are flagged, colors are meaningless.

**Access Route Sections A & B:** 80% survival of transplanted and/or tracked blackbrush shrubs and four junipers that were transplanted along section A. There should be no evidence of excessive erosion in the area related to anomaly repair activities.

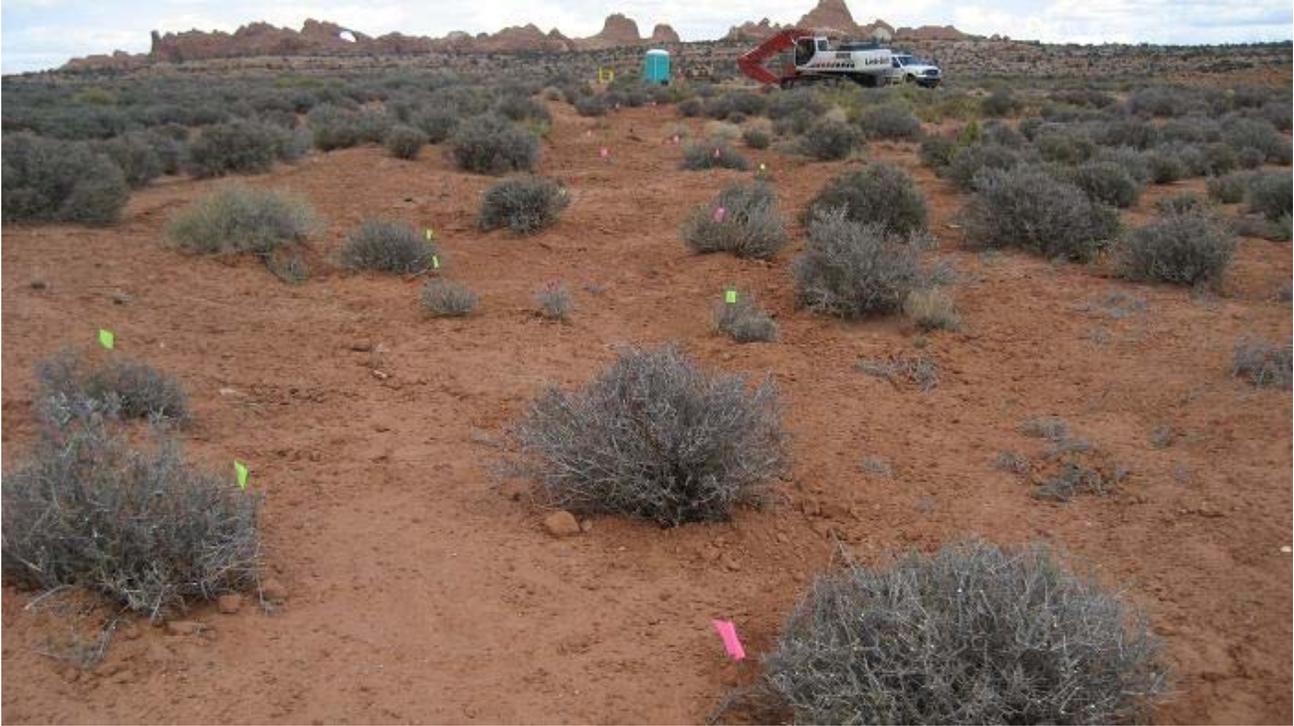
Photo 9- Access route section B, looking northeast (30°). Transplants are flagged, colors are meaningless.

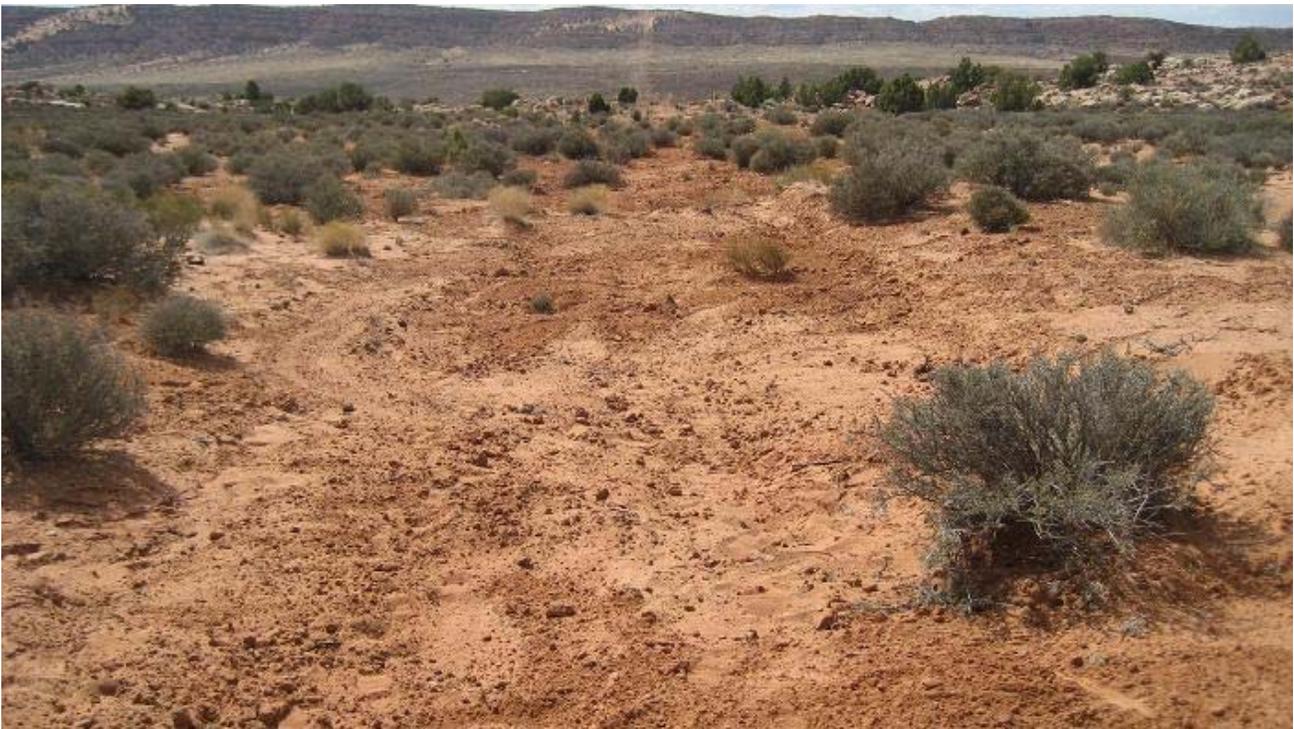
Photo 10- Access route section B, looking southwest (220°).

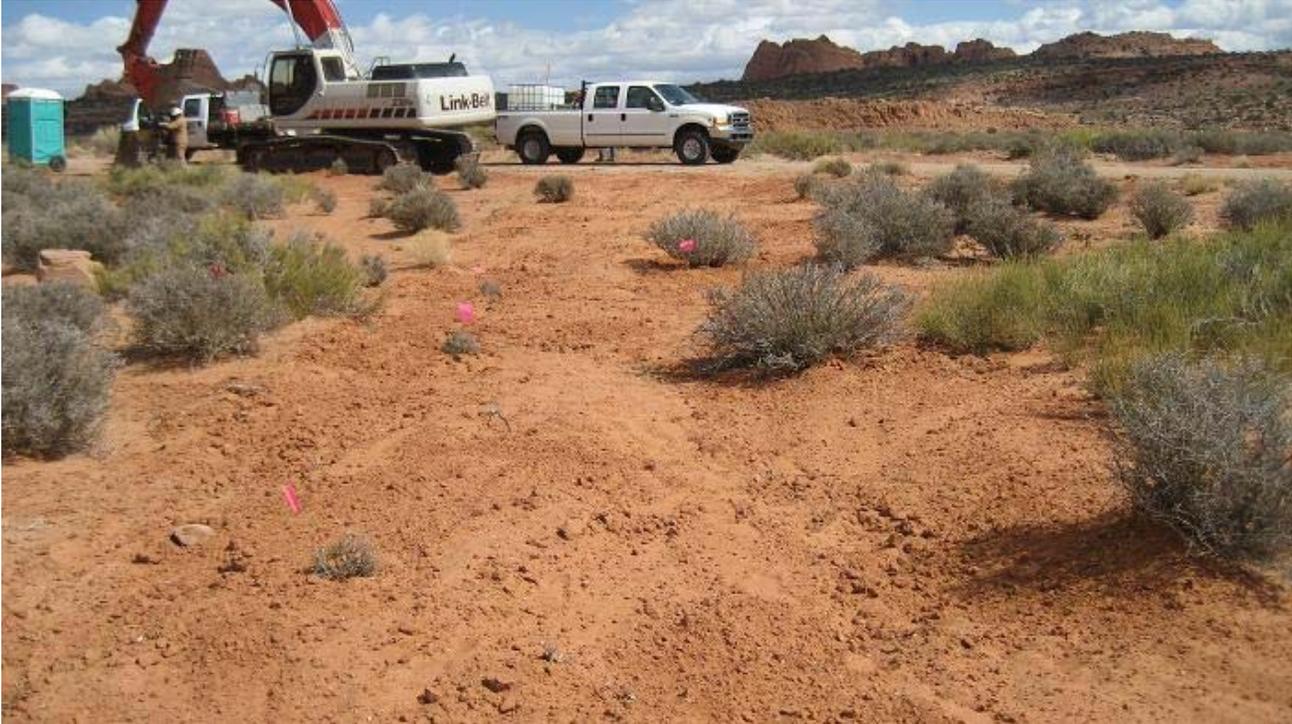
Photo 11- Access route section B, looking northeast (50°). Transplants are flagged, colors are meaningless.

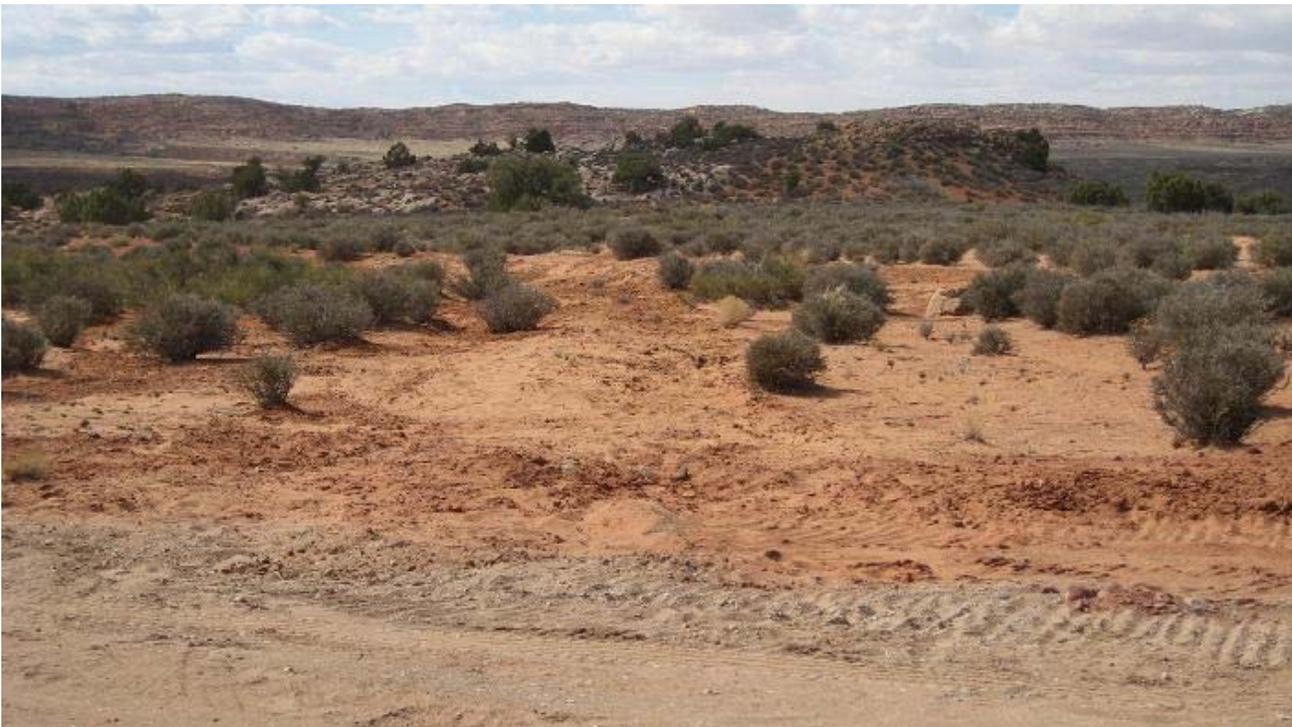
Photo 12- End of access route section B, from across road, looking west (260°).

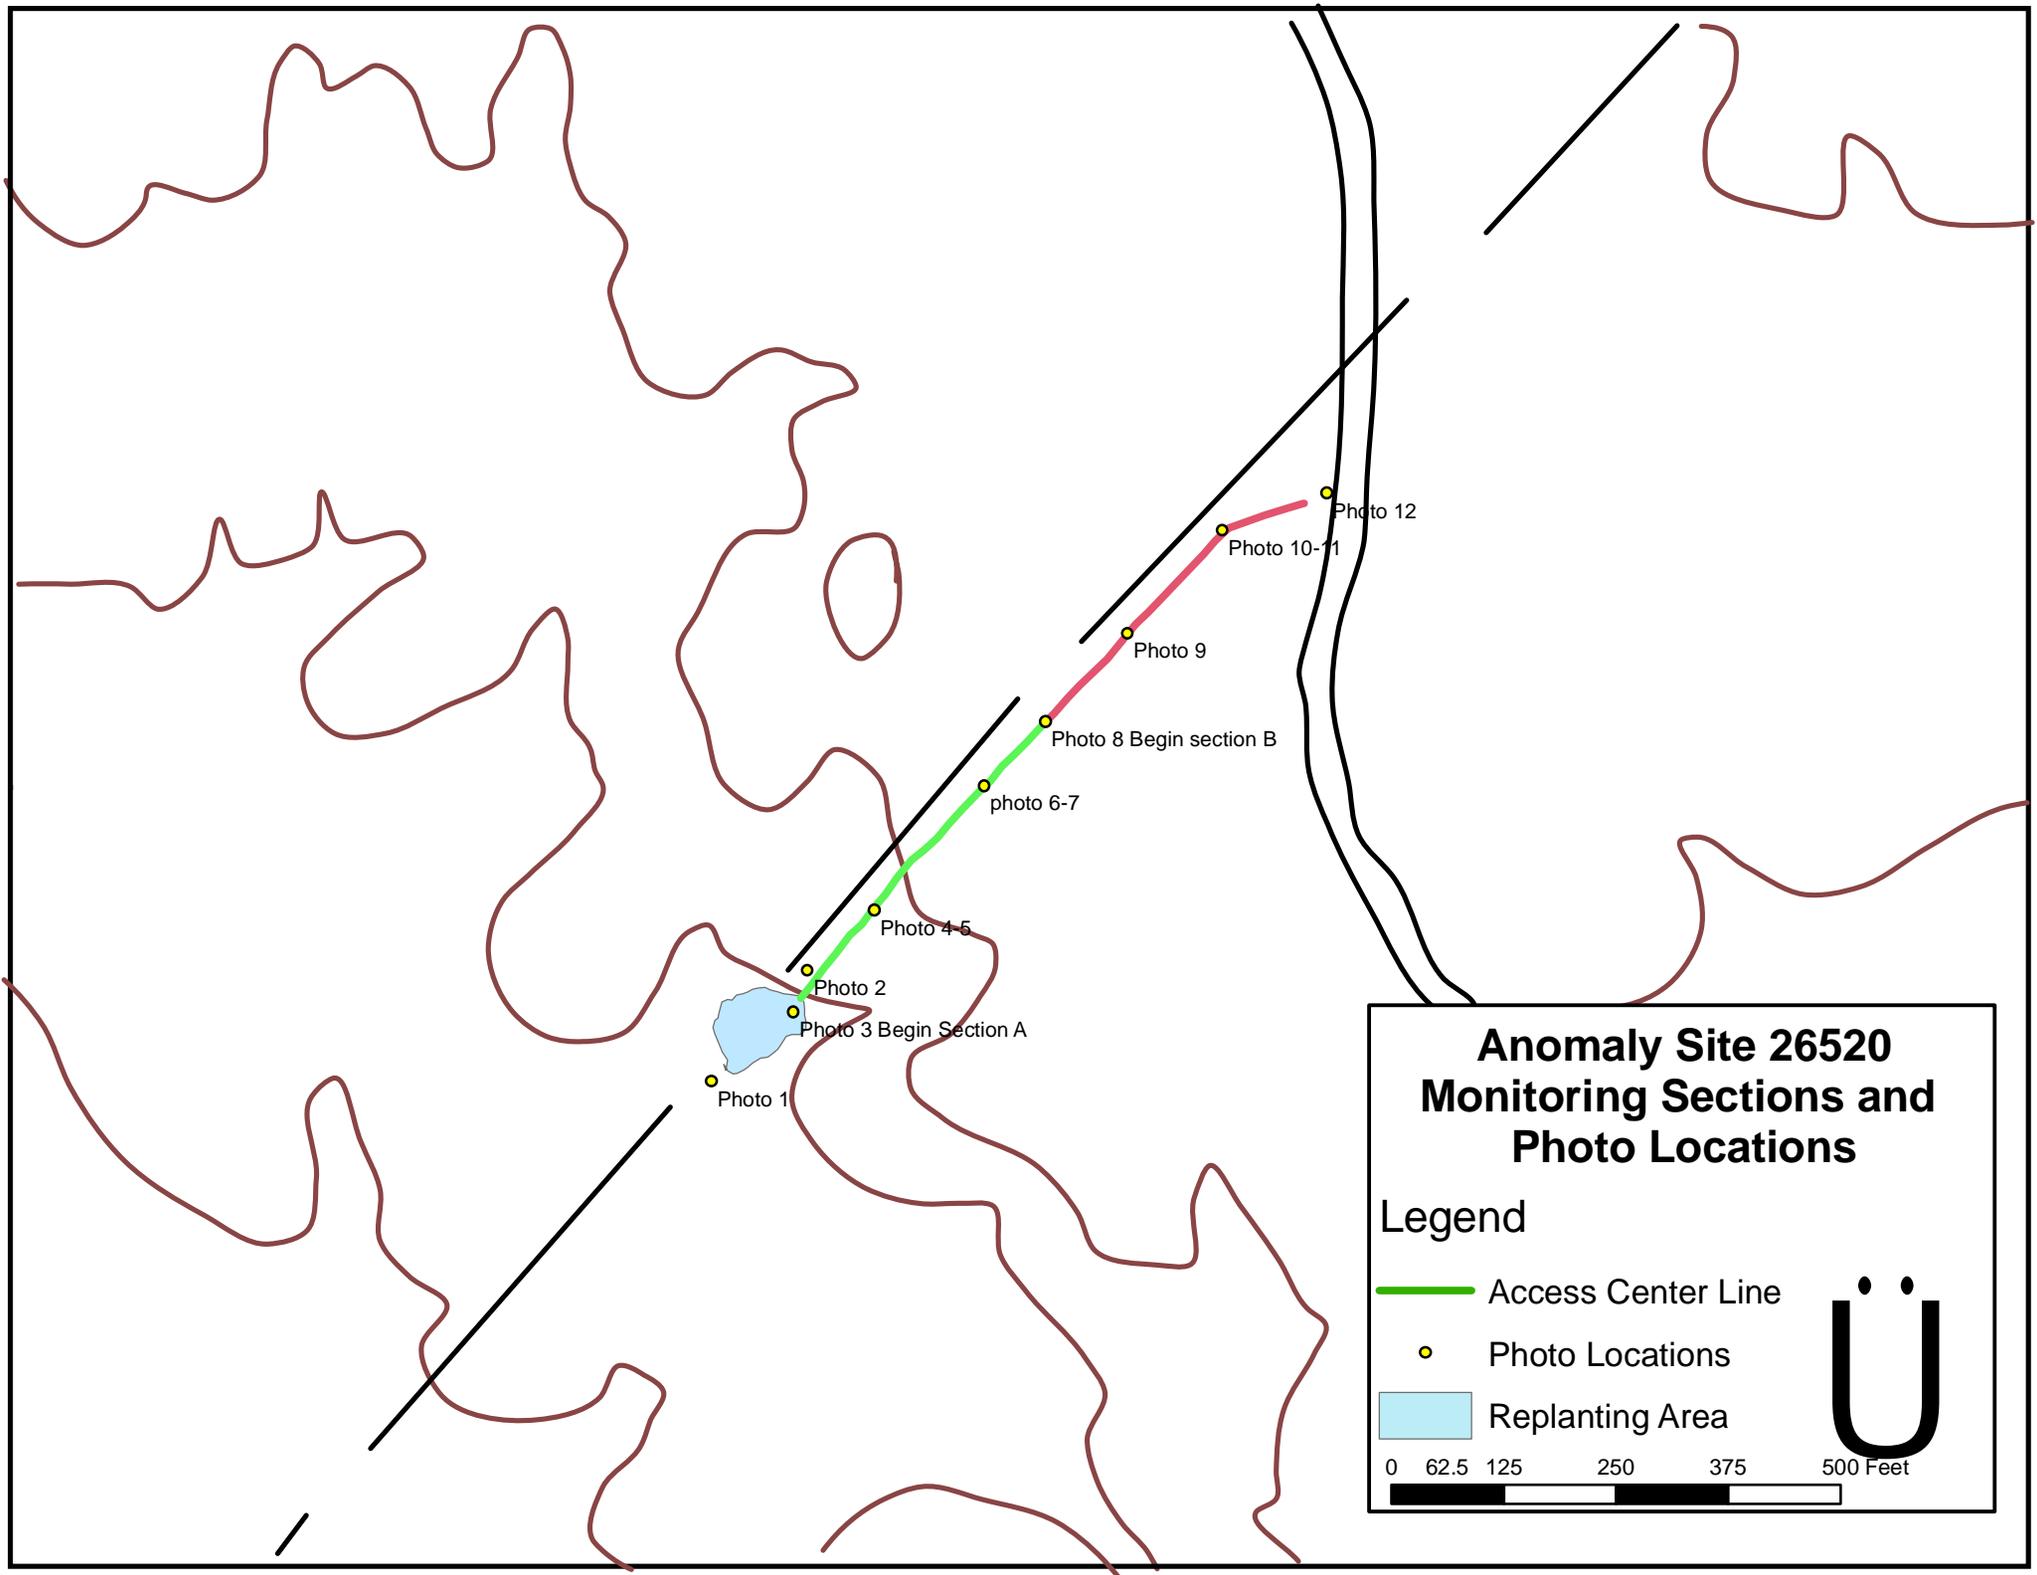
# Anomaly Site 26520 Monitoring Sections and Photo Locations

26520	photo 6-7	621472.415030	621472.415030	220 & 20
26520	Photo 8 Begin section B	621493.082986	621493.082986	20
26520	Photo 9	621521.041516	621521.041516	30
26520	Photo 10-11	621553.234924	621553.234924	220 & 50
26520	Photo 12	621588.574738	621588.574738	260
