Petersen House
Section 106
Consulting Parties
Meeting
June 16, 2010

Petersen House

House Where Lincoln Died (April 15, 1865)

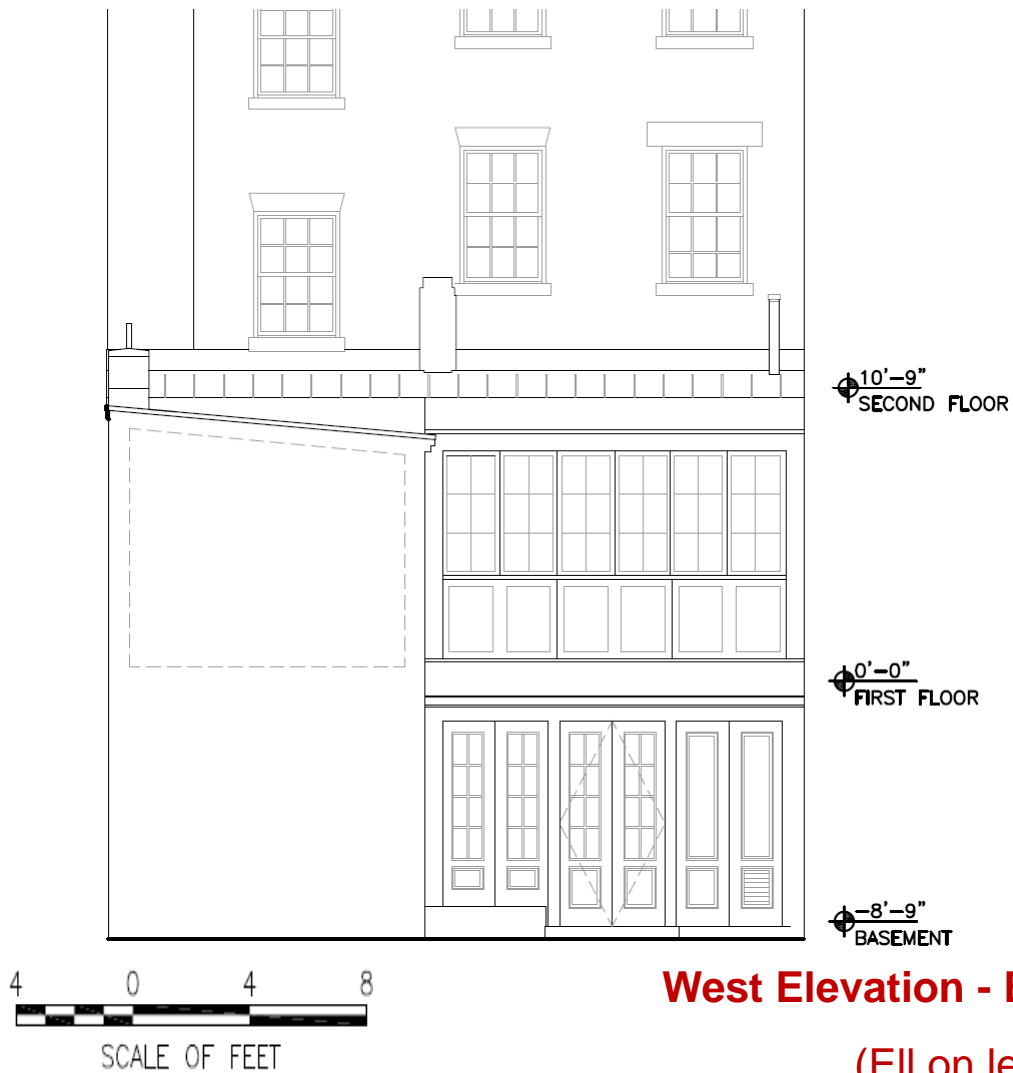
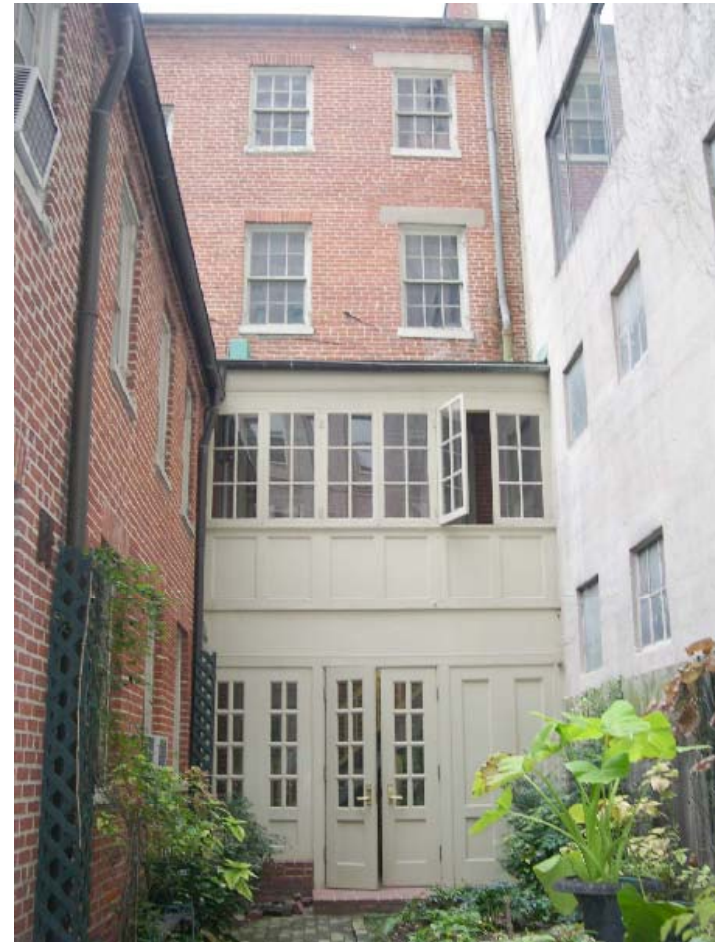
West Elevation - Existing View

(Ell on left, House in center, CEL Bldg on right)

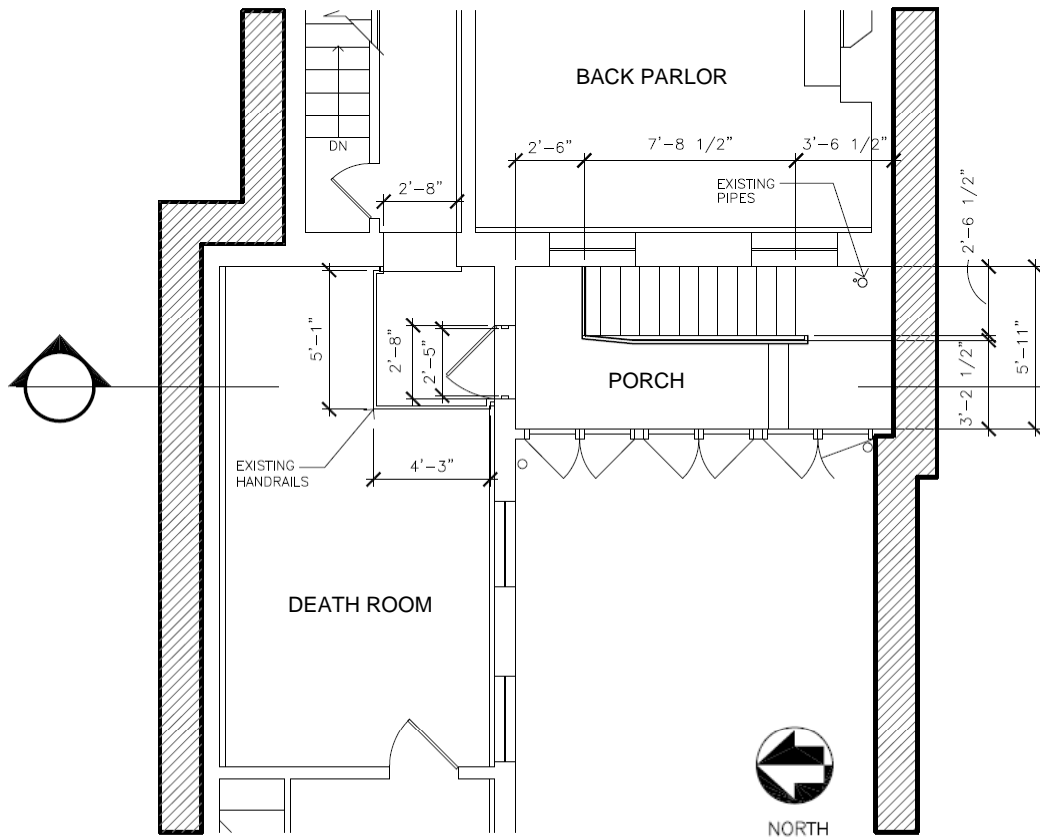
Existing Floor Plan

- The current porch is 5'-11" wide with a switch-back configuration of stairs that are 2'-6" wide with an 8" rise and 8-1/2" run.

- Fails to meet basic compliance with accessibility or building code
- The view to the back parlor through the historic windows is obscured.
- Two existing pipes in the SE corner of the porch obstruct circulation
- The rough openings of the doorways into the Death Room are 2'-8" (32"); the clearance between the door jamb is 2'-5" (29").

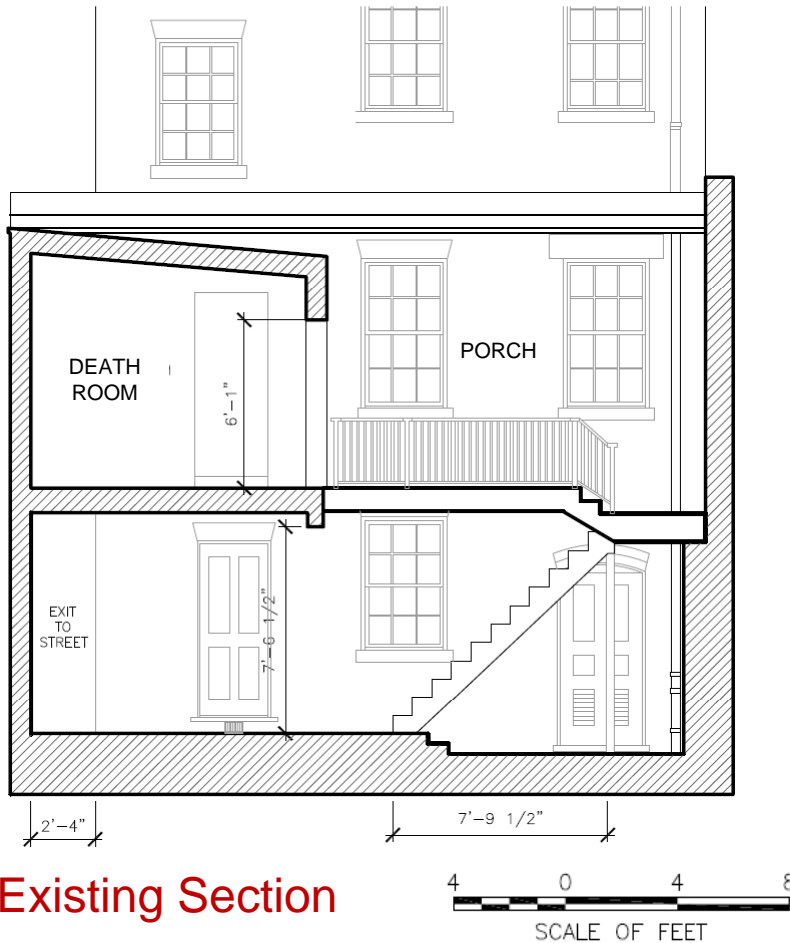
Existing Section

- The porch structure also abuts the existing exterior wall of the CEL.

- The height of the doorway to the death room is only 6'-1".
- The slope of the porch stairwell exceeds code requirements.
- The exit and alley to 10th Street NW is only 2'-4" wide.

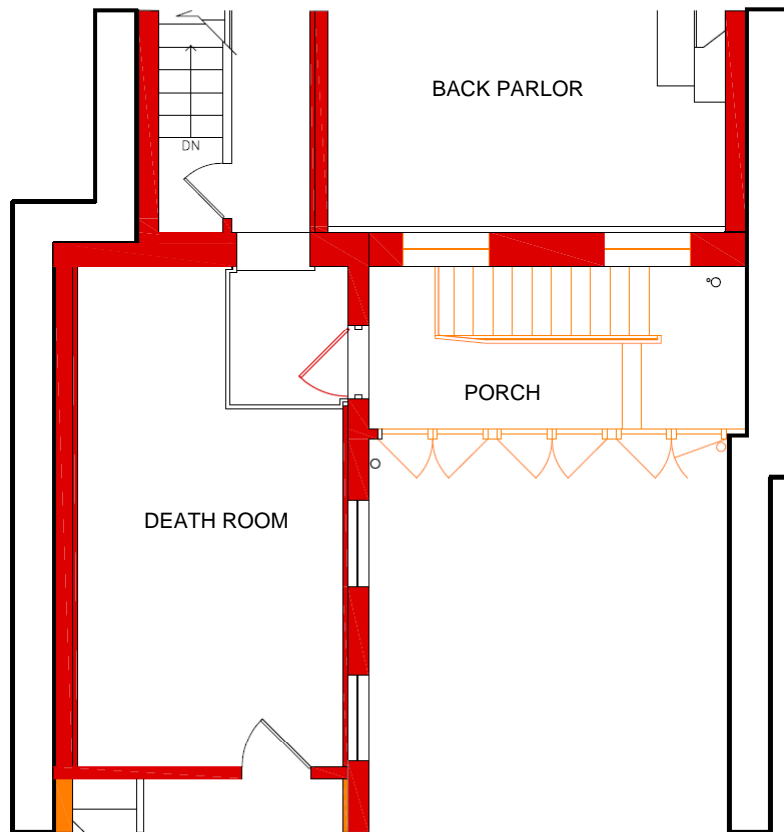
Existing Floor Plan

- First Floor level rooms
- First Floor of Rear Ell, “Death Room”

- First Floor room of Rear Ell behind “Death Room”
- Back porch

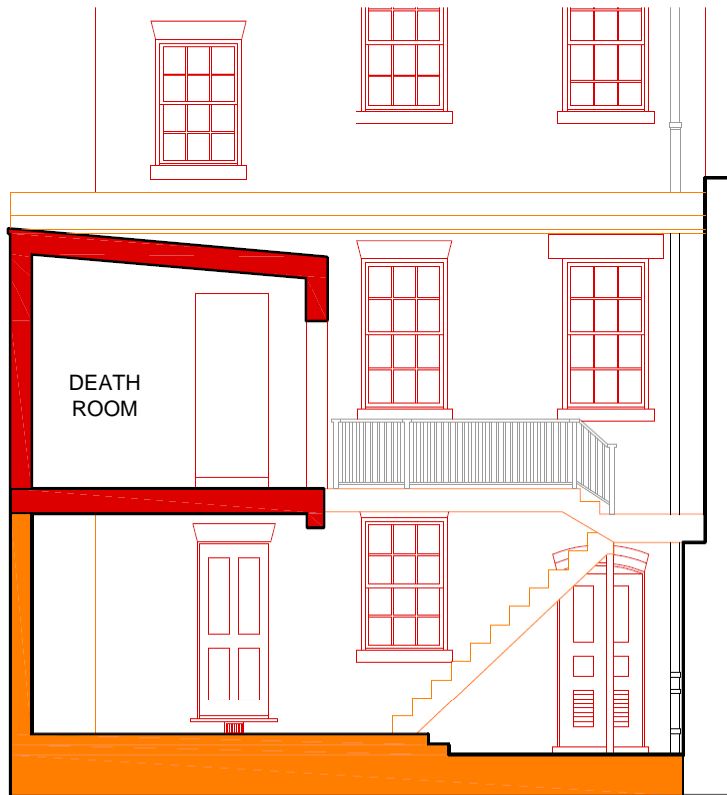
Existing Section

- Front Elevation (not shown)
- Rear Elevation of House
- First Floor level rooms
- First Floor of Rear Ell, "Death Room"

- Basement level rooms
- First Floor room of Rear Ell behind "Death Room"
- Roof of Main House and Rear Ell
- Alley Easement to north

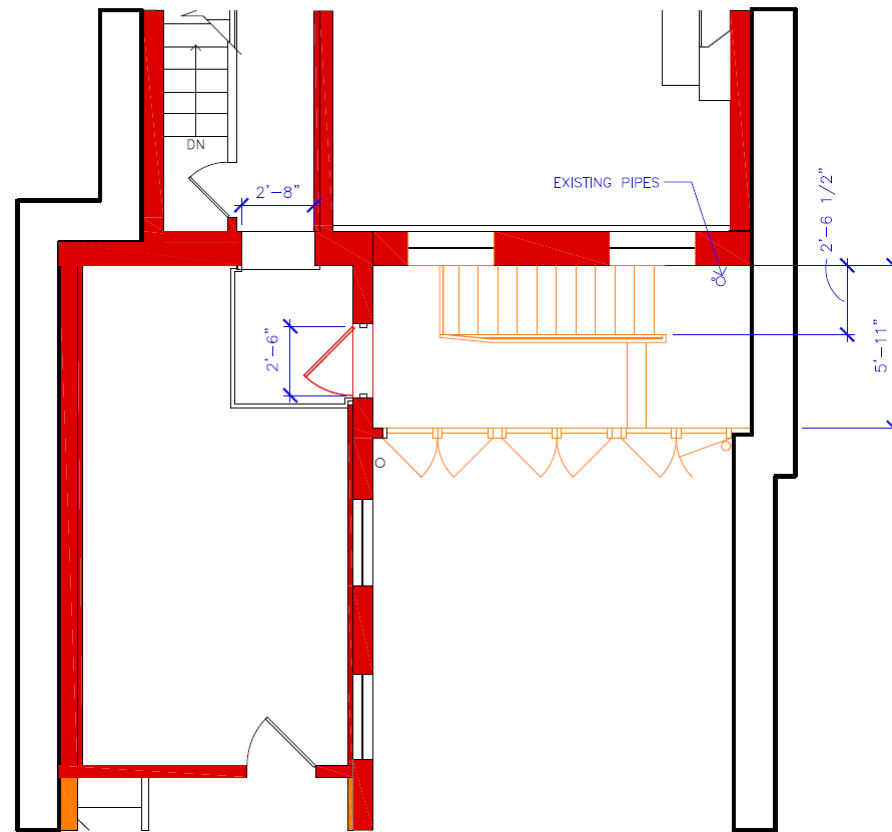
Existing Floor Plan

- The existing stair is only 2'-6" wide
- The existing width of the porch (5'-11") precludes a 3'-0" wide stair and 3'-0" hallway
- The existing pipes in SE corner of porch obstruct access to stairs
- The rough openings of the doorways into the Death Room are 2'-8" (32"); the clearance between the door jamb is 2'-5" (29").

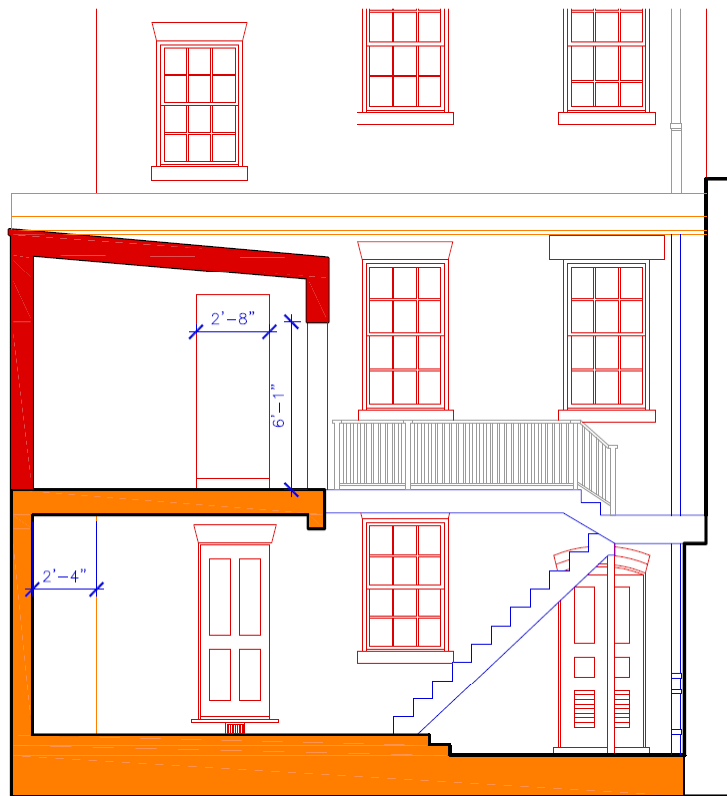
Existing Section

- The existing stairs are 8-1/2" deep and 8" high
- The existing height of doorway to death room is 6'-1"
- Two existing pipes are located in the SE corner of the porch
- The alley to 10th Street is only 2'-4" wide

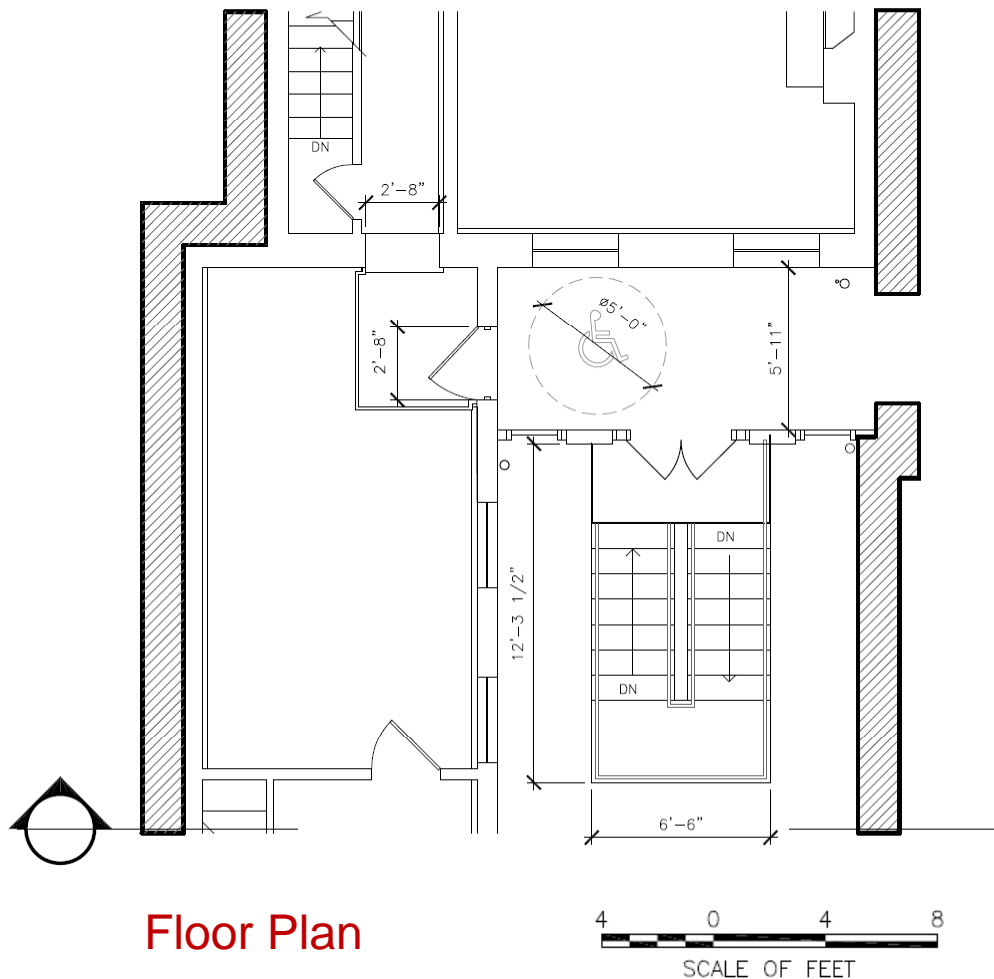
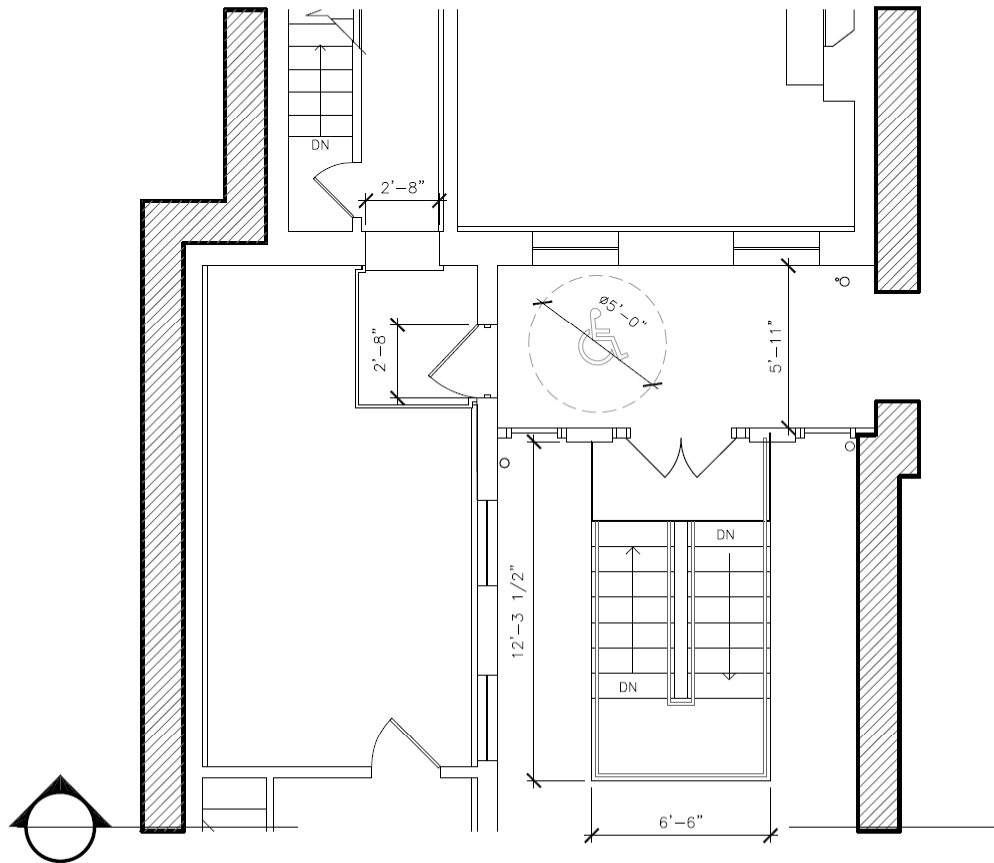
Floor Plan

Alt 1A — ADD NEW EXTERIOR STAIR

The floor of the porch is demolished and replaced with new flooring set at the elevation of the death room. The egress stair is placed outside the porch requiring modification of center panel of the upper level of the west façade of the porch.

- Minimal damage to historic fabric
- A 180 degree turn is provided
- Visual access through historic windows to parlor is provided
- No modification to the basement is required
- Existing pipes in SE corner of the porch remain

- Egress stair is not enclosed

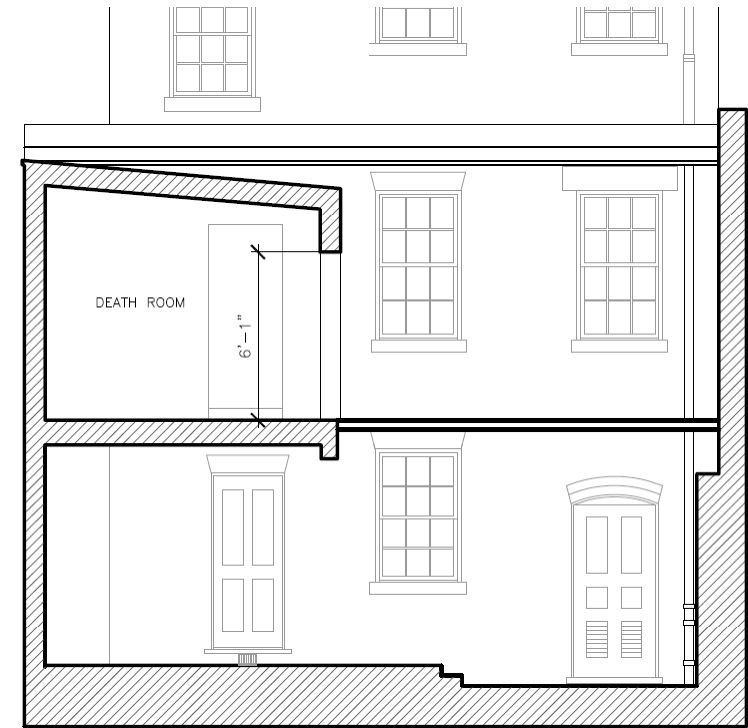
Section

Alt 1A — ADD NEW EXTERIOR STAIR

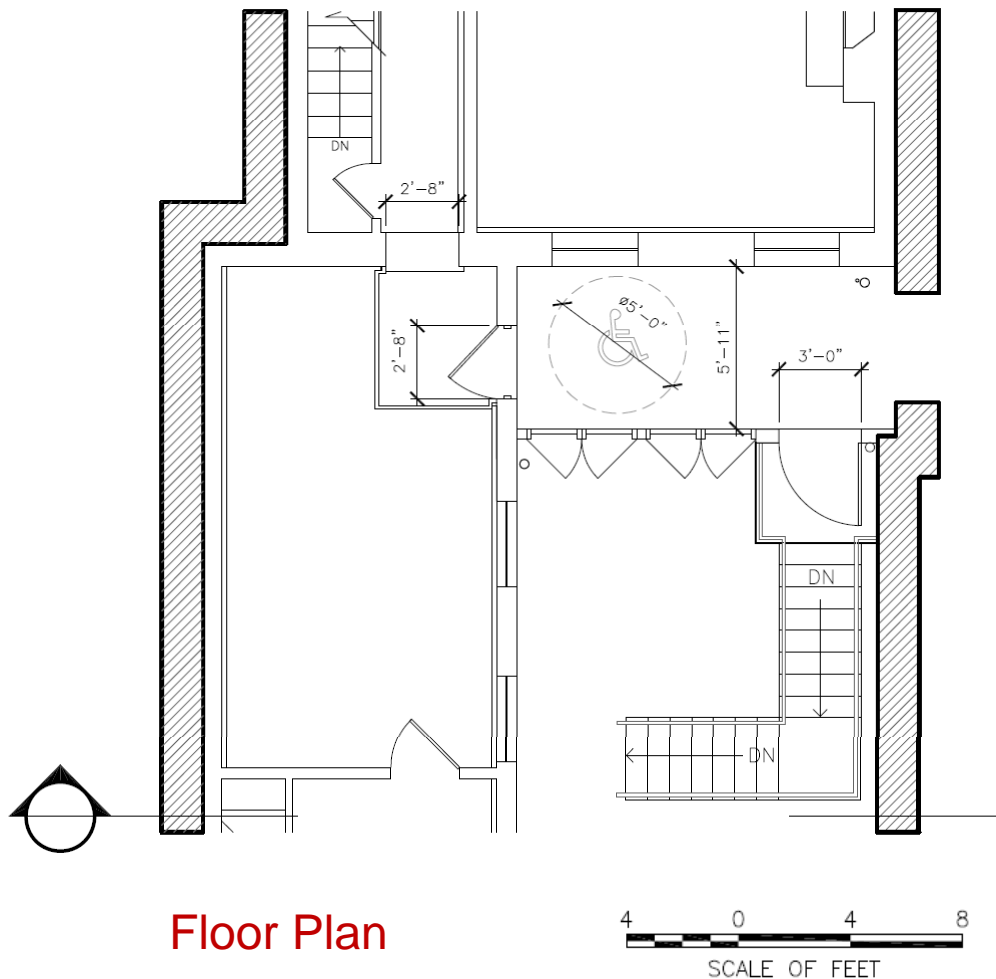
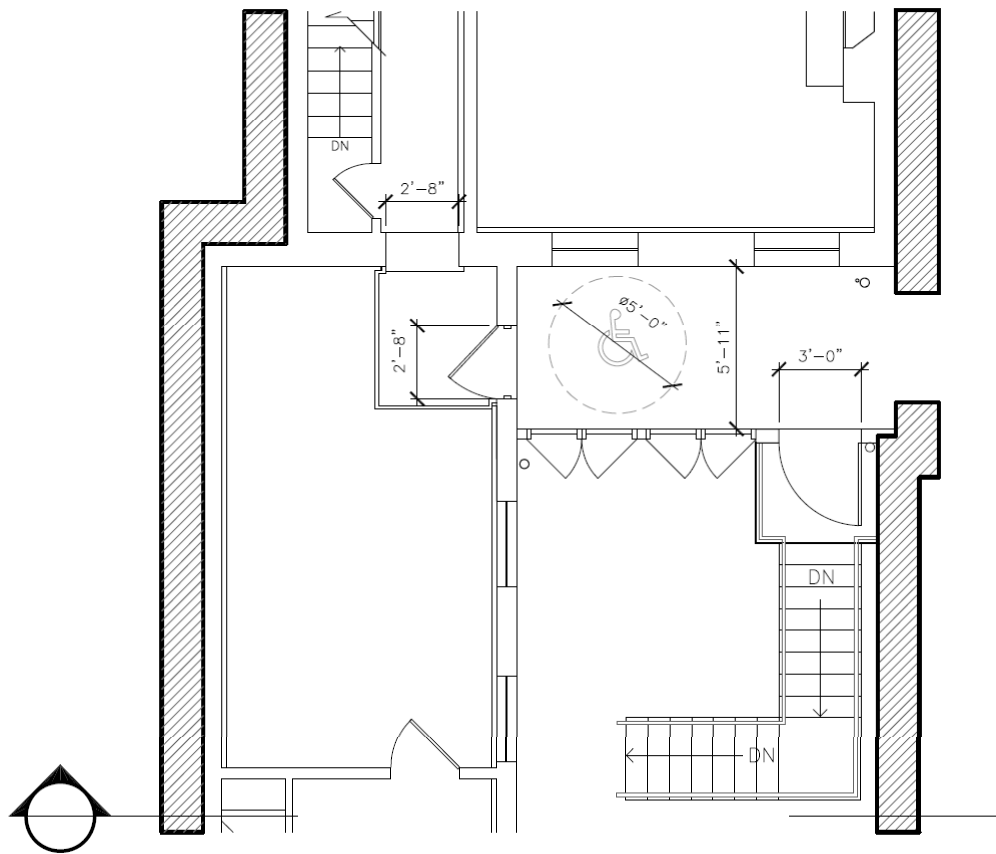
Floor Plan

Alt 1B — ADD NEW EXTERIOR STAIR

The floor of the porch is demolished and replaced with new flooring set at the elevation of the death room. The egress stair is placed outside the porch requiring modification of right panel of the upper level of the west façade of the porch.

- Minimal damage to historic fabric
- A 180 degree turn is provided
- Visual access through historic windows to parlor is provided
- No modification to the basement is required
- Existing pipes in SE corner of the porch remain

- Egress stair is not enclosed

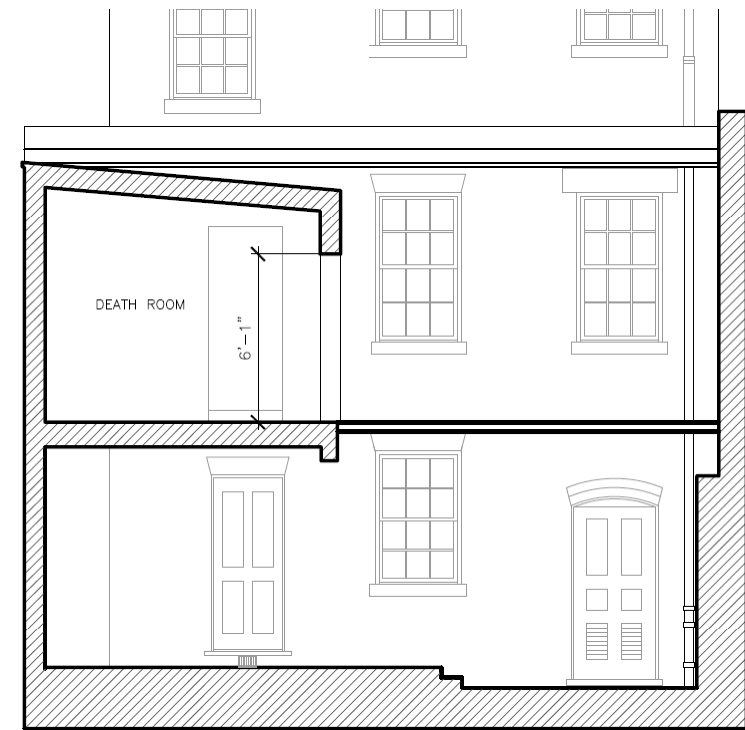
Section

Alt 1B — ADD NEW EXTERIOR STAIR

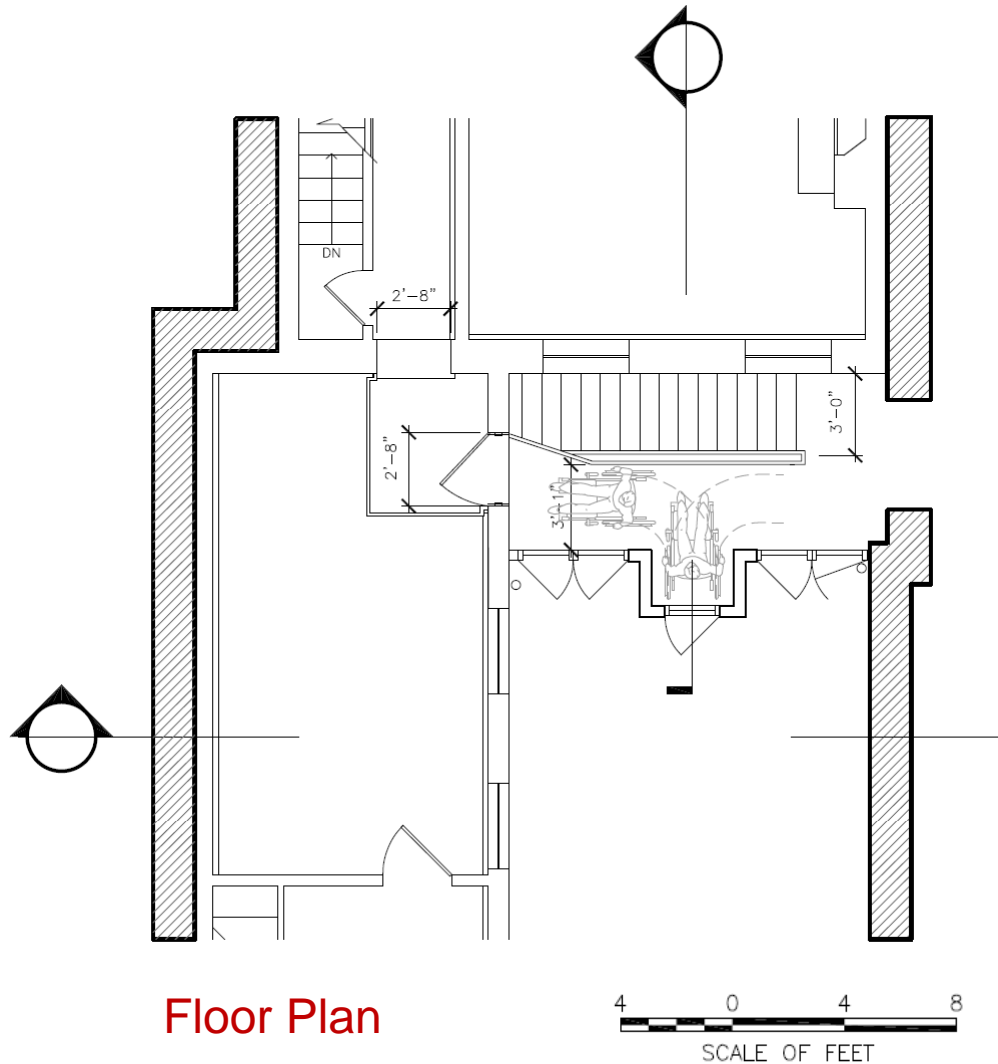
Alt 2A — RECONFIGURE UPPER PORCH

The floor of the porch is demolished and replaced with new flooring set at the elevation of the death room. The upper level of the porch is widened by 6" to accommodate a wider hallway, and the center panel of the porch is bumped out for universal accessibility.

- A "T" shaped turning space is provided for accessibility
- Egress Stair is enclosed
- Basement level is unchanged

- Requires complete replacement of the upper west façade of the porch . Existing windows could be reused.
- Minor modification to the structural support below the death room
- Existing pipes in SE corner of the porch are removed

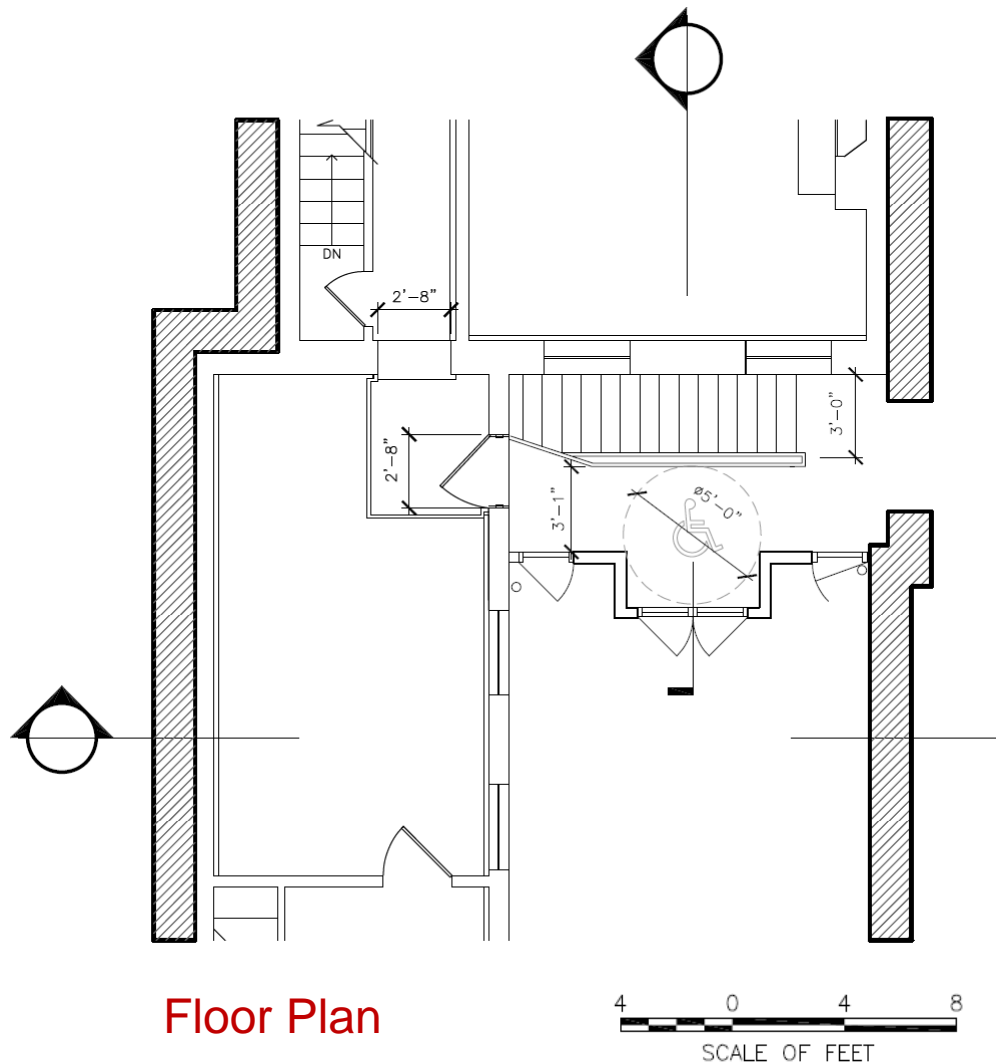
Alt 2A – RECONFIGURE UPPER PORCH

The floor of the porch is demolished and replaced with new flooring set at the elevation of the death room. The upper level of the porch is widened by 6" to accommodate a wider hallway, and the center panel of the porch is bumped out for universal accessibility.

- A 180 degree full turn is provided
- Egress Stair is enclosed
- Basement level is unchanged

- Requires complete replacement of the upper west façade of the porch . Existing windows could be reused.
- Existing pipes in SE corner of the porch are removed
- Obstructions to headroom on stair

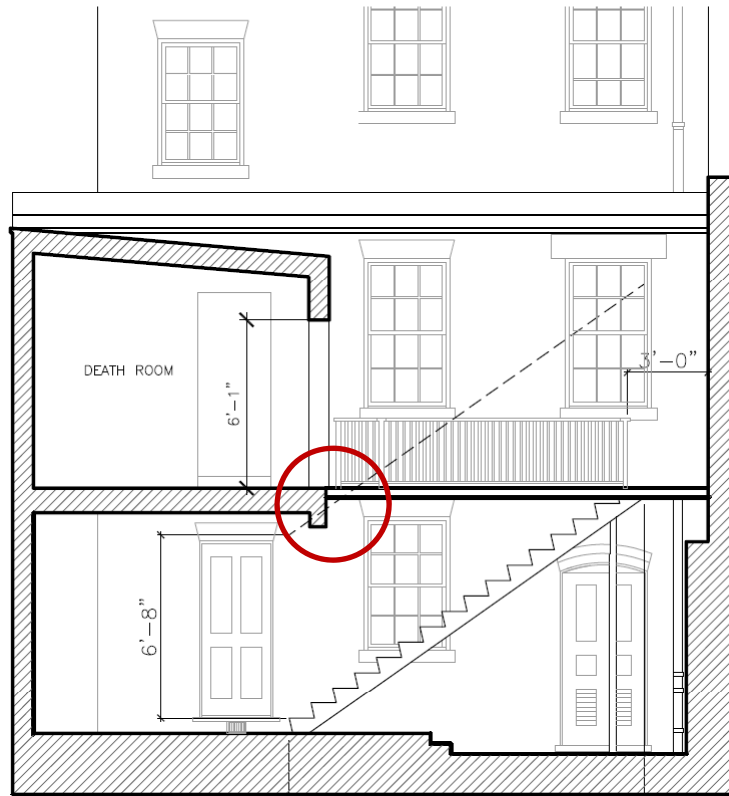
Section looking east

*Handrails not shown on stair for clarity

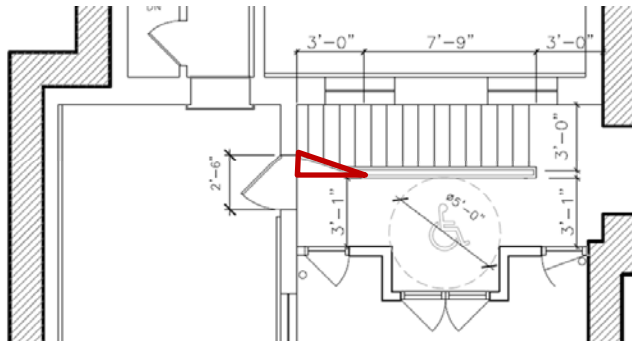
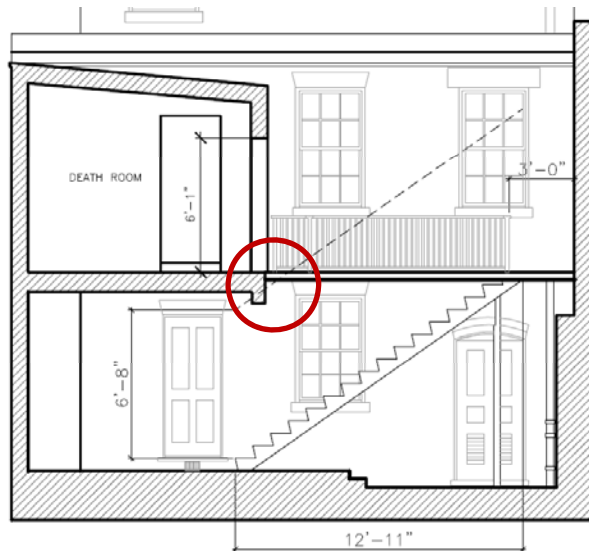
Alt 2A & 2B – RECONFIGURE UPPER PORCH

There are obstructions to achieving 80" headroom on the stair due to the angled exit at the death room and the structural beam supporting the death room.

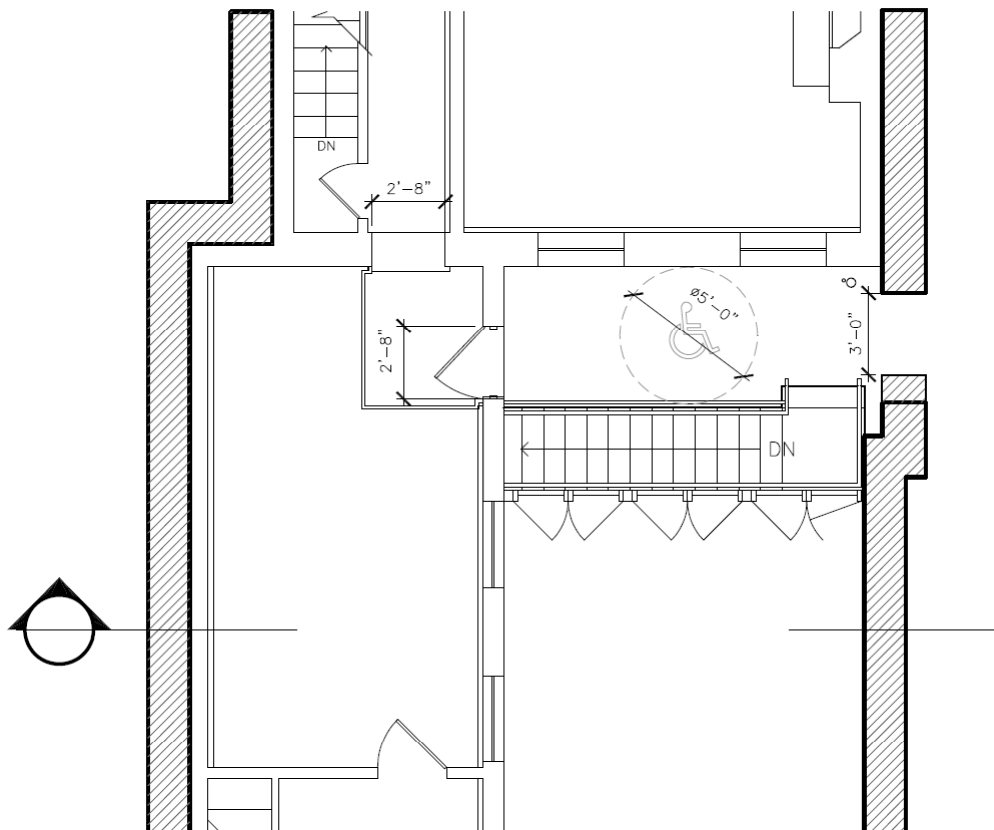
Floor Plan

Alternative 03 — EXPAND PORCH

The porch would be expanded 2'-3" west and the floor would be demolished and replaced with new flooring set at the elevation of the death room. This option would require a reduction in width of the CEL penetration.

- A 180 degree turn is provided
- Visual access through historic windows to parlor is provided
- Egress stair is enclosed
- Existing pipes could remain

- Major modification to porch and basement is required
- This option would require the removal of portions of historic fabric

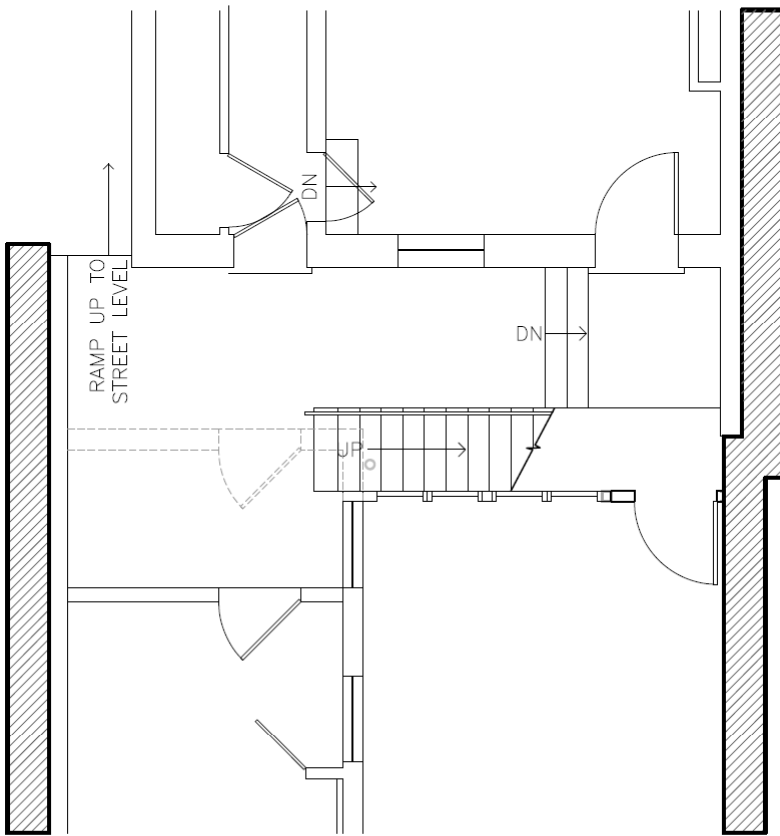
Basement Plan

- A new doorway to courtyard is required
- Demolition of portions of the former kitchen is required
- Header below death room needs to be modified

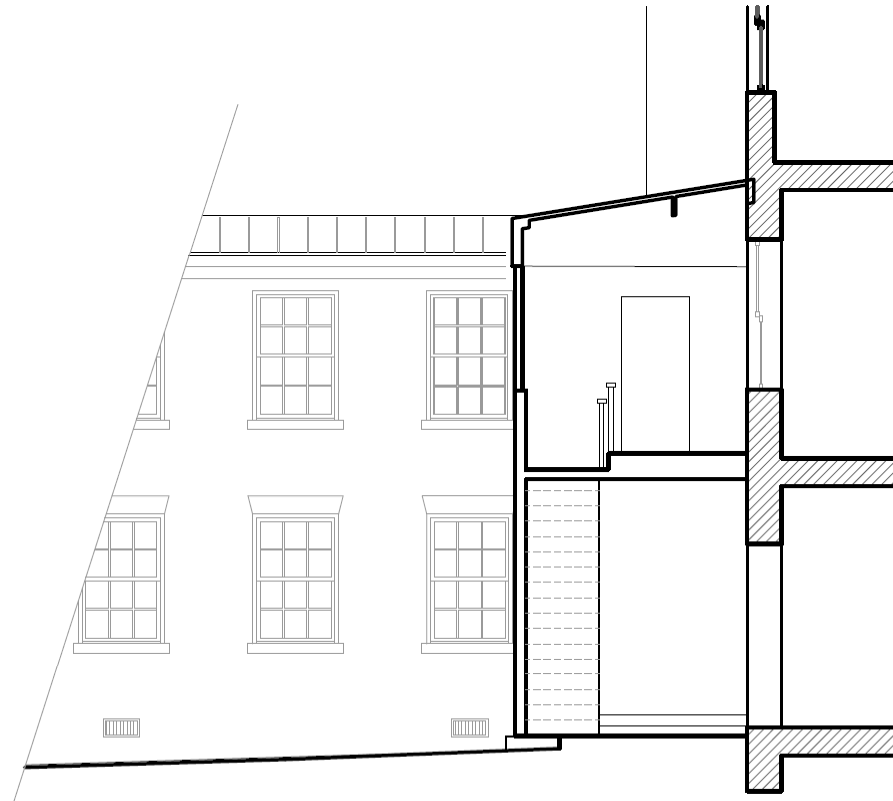
Section looking north

Alternative 03 — EXPAND PORCH

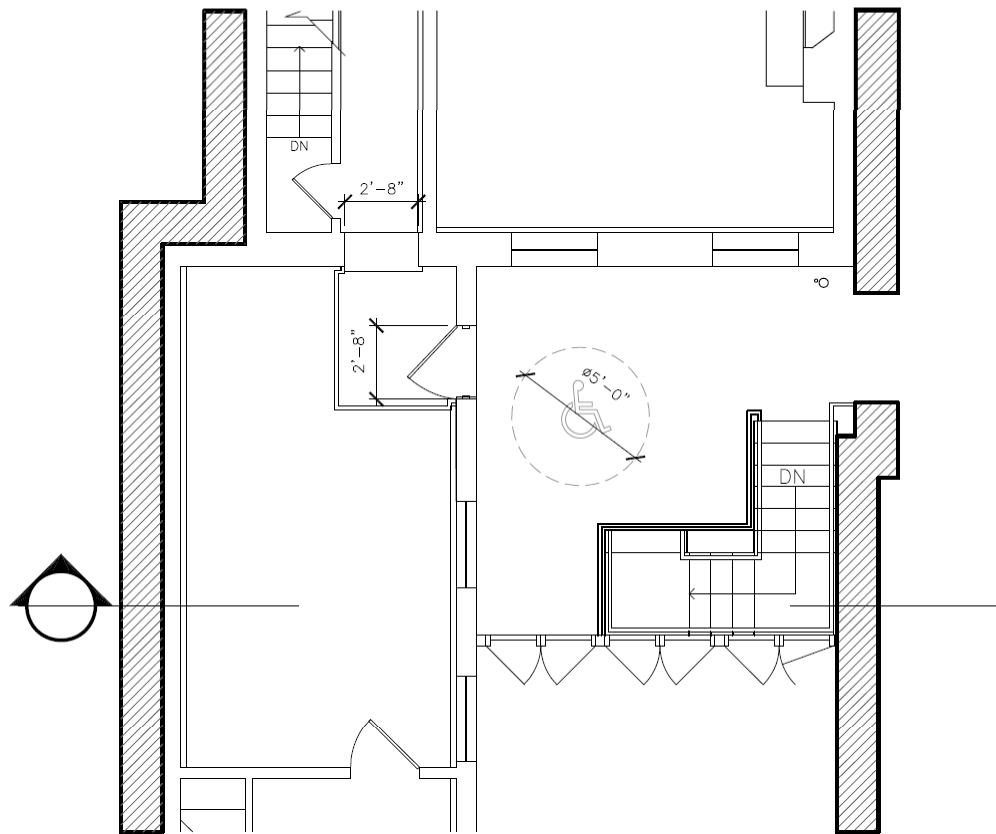
Floor Plan

The porch would be expanded approximately 7' west and the floor would be demolished and replaced with a new flooring set at the elevation of the death room. The porch would enclose two existing exterior windows on the south façade.

- A 180 degree turn is provided
- Visual access through historic windows to parlor is provided
- Egress stair is enclosed
- Historic fabric is affected but not damaged
- Existing pipes could remain

- Porch now encloses some exterior windows

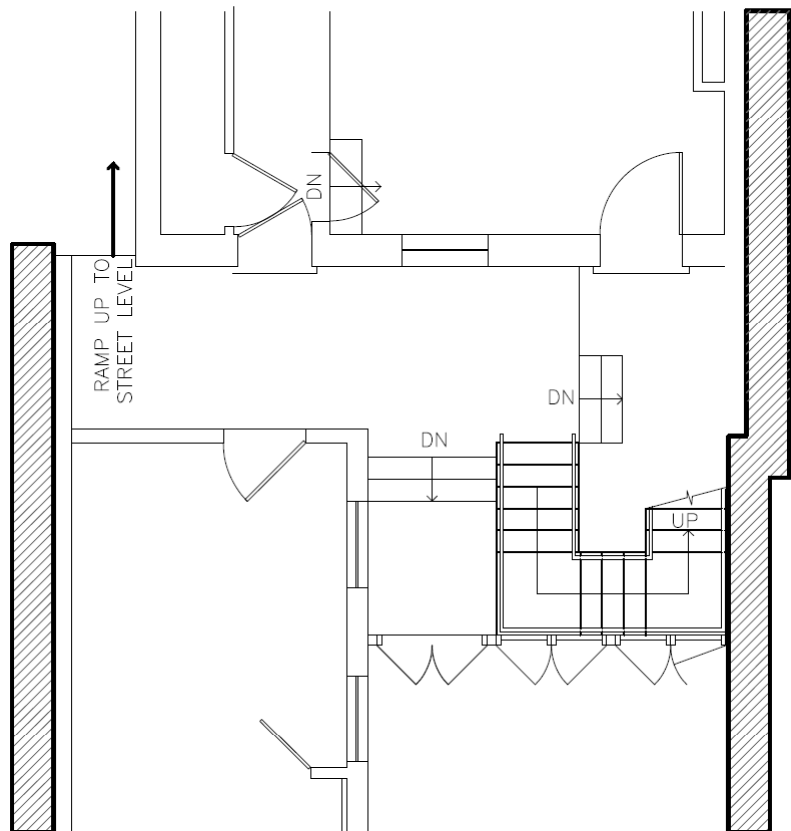
Basement Plan

- Historic fabric is not damaged

- The basement level would be reconfigured
- A new doorway to the courtyard would be required

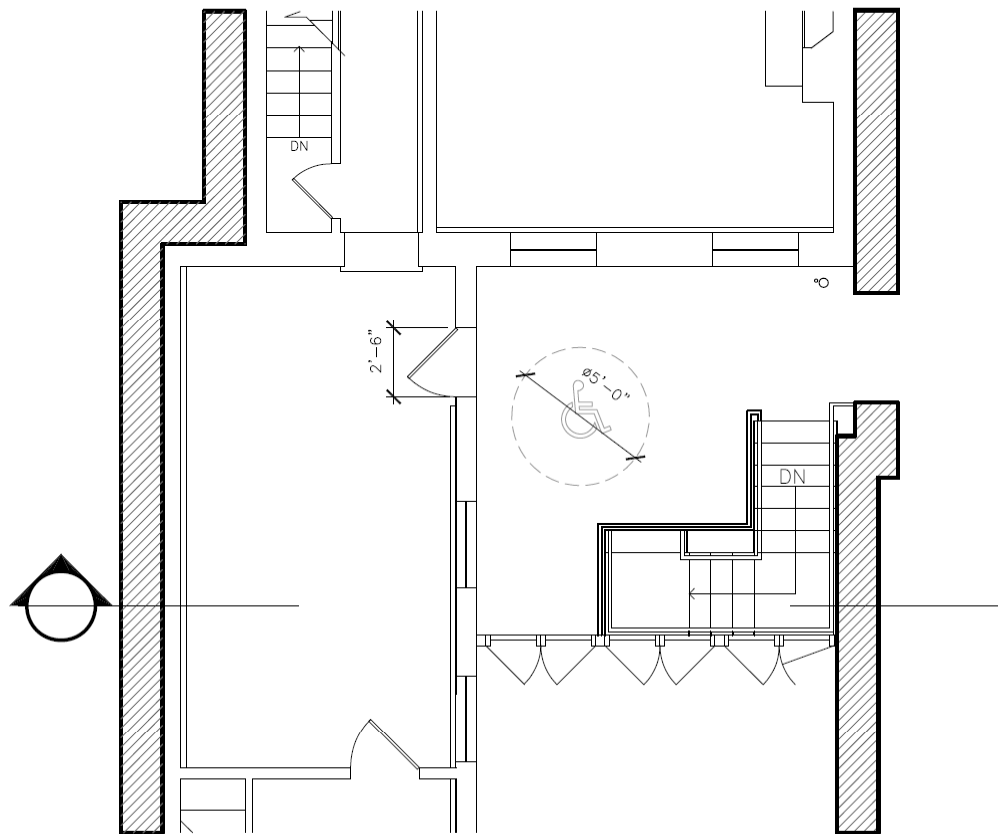
Floor Plan

Alternative 04 — RENOVATE ENTIRE PORCH

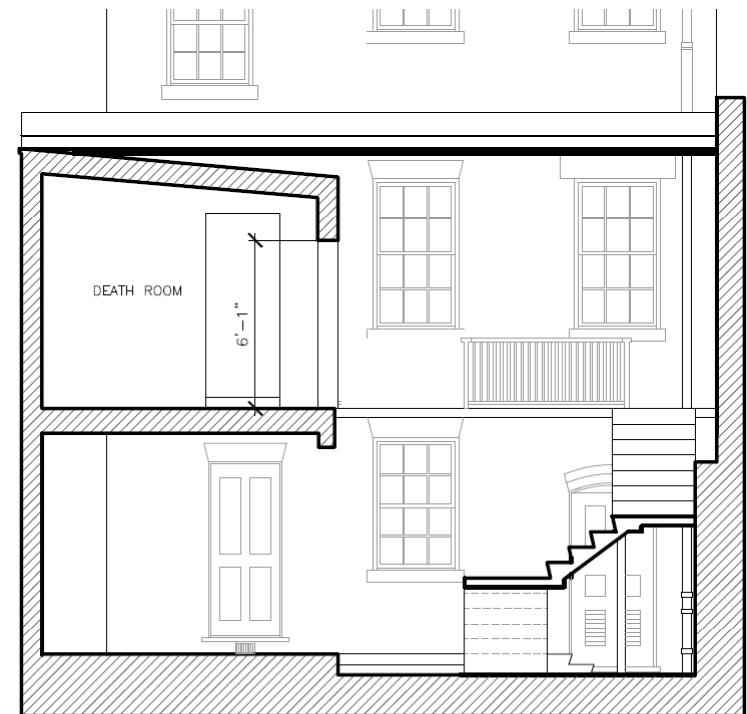
Section

*Handrails not shown on stair for clarity

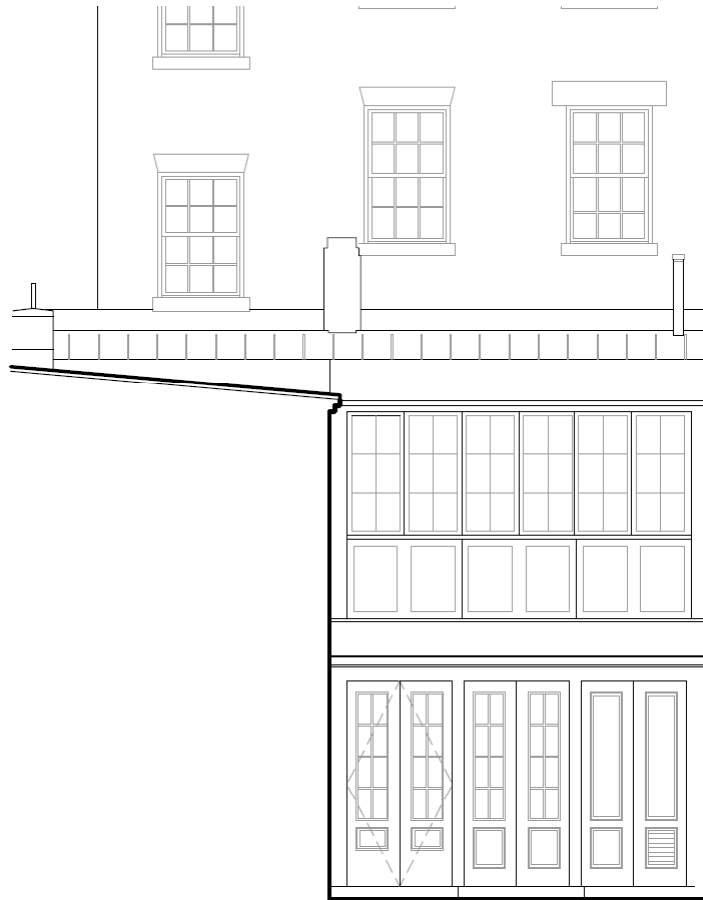
West Elevation

Alternative 04 — RENOVATE ENTIRE PORCH

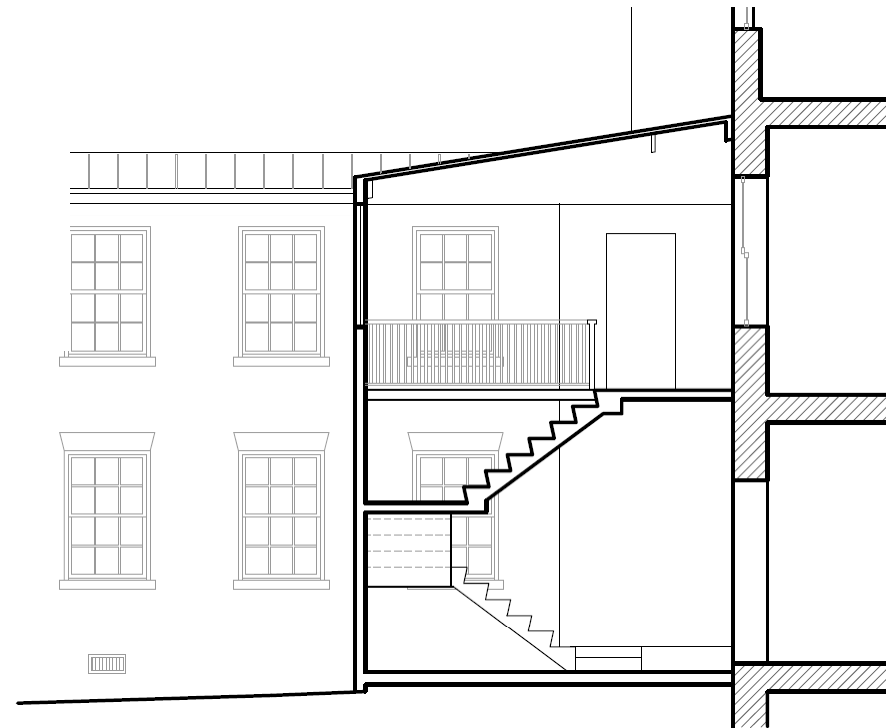
Section looking north

*Handrails not shown on stair for clarity

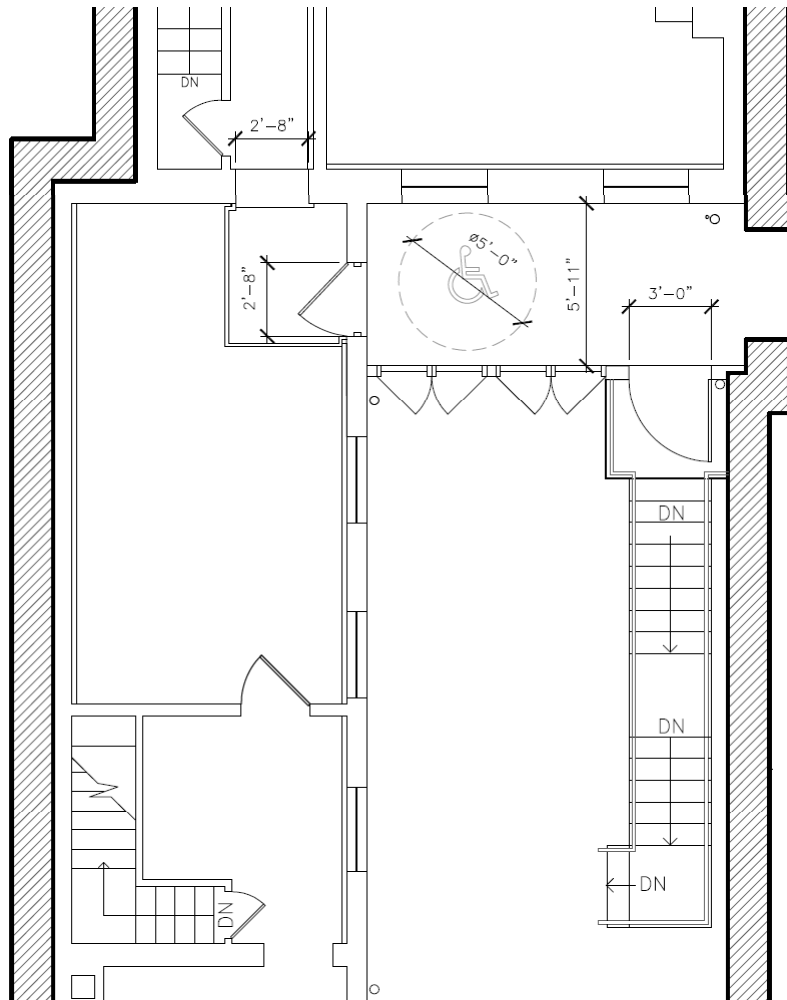
Floor Plan

Preferred Alternative

Alt 1B Revised – ADD NEW EXTERIOR
STAIR
