Petersen House
Section 106
Consulting Parties
Meeting
June 16, 2010

Petersen House

House Where Lincoln Died (April 15, 1865)

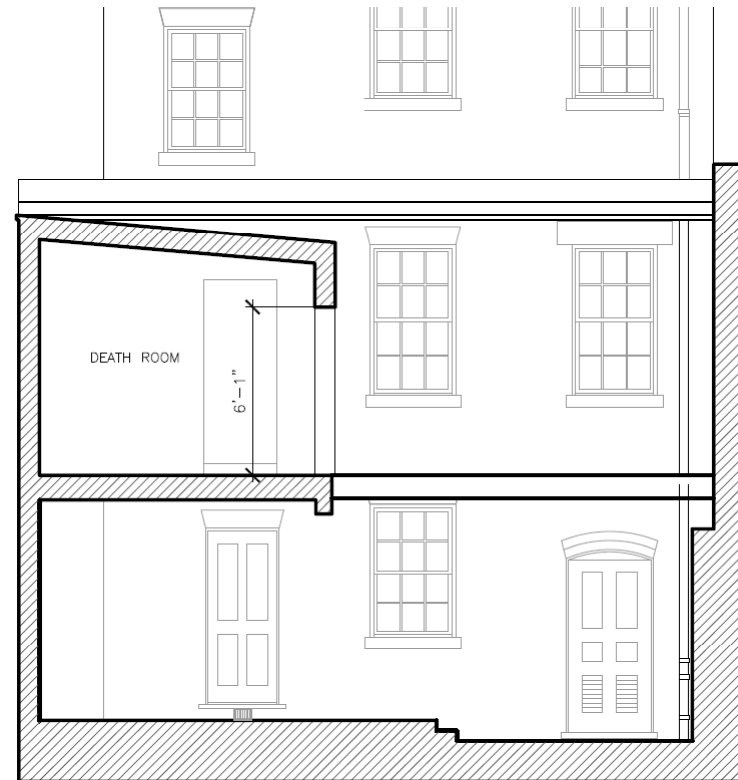
Section

Alt 1B Revised – ADD NEW EXTERIOR
STAIR

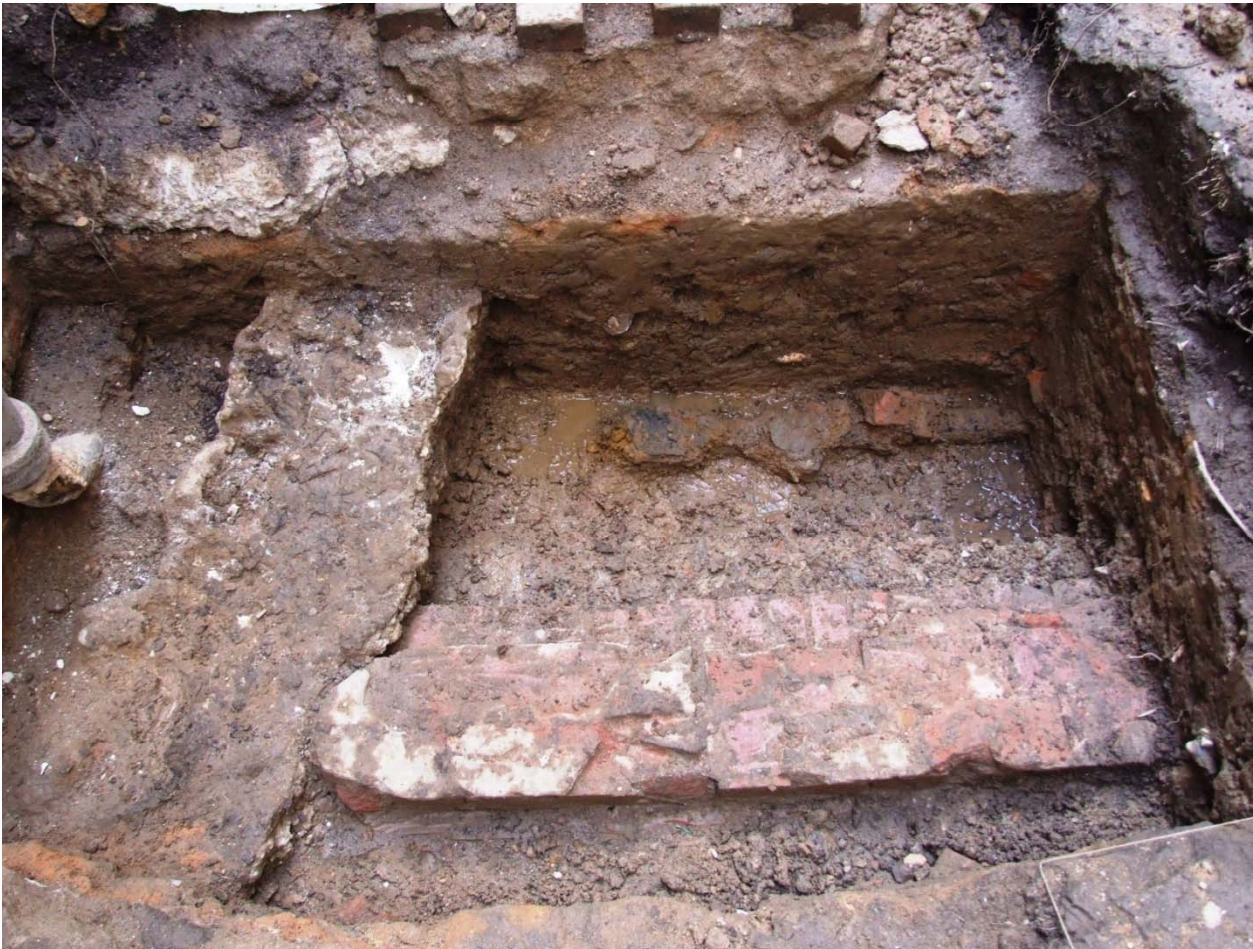
- Rear yard could be affected by ground disturbance associated w/proposed project
- Investigation concluded Spring 2010
- Monitoring to take place during construction

Unit 2, features 10 and 11 (Site 51NW65)

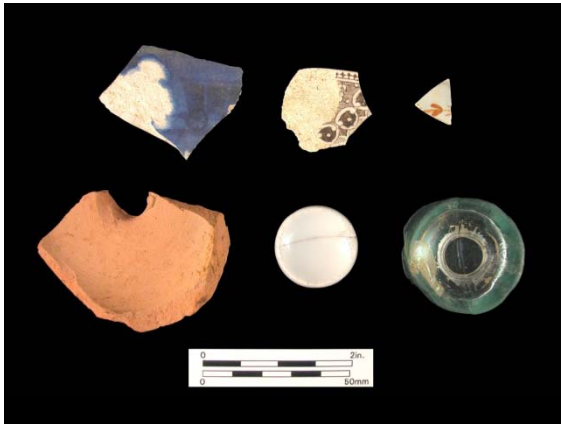
Unit 1, Stratum D, 1820's-1830's,
Redeposited trash from adjacent lot.

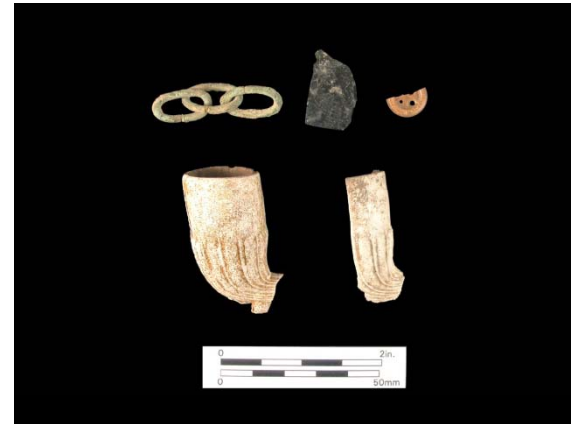
Unit 3, Stratum D, Artifacts from Petersen
family occupation.

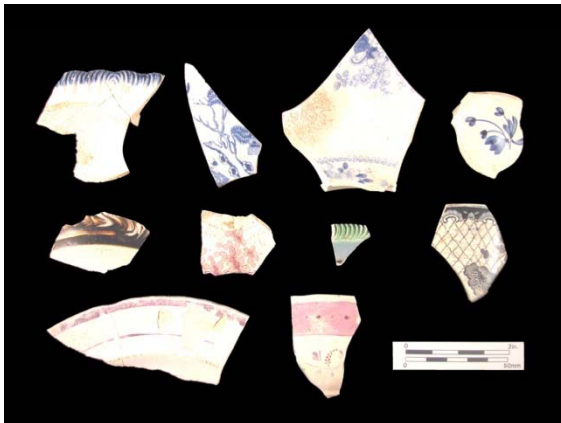
Unit 7, Stratum E, 1850's Petersen family
occupation.

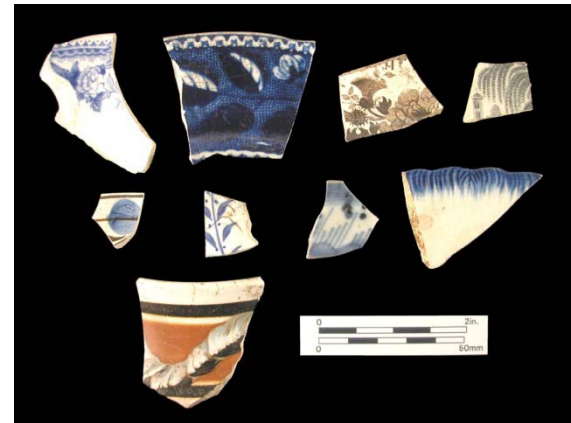
Unit 8, Stratum F, 1850's, Petersen family
occupation.
