Appendix C

STATEMENT OF FINDING FOR FLOOD PLAIN ANALYSIS
FOR IMPROVEMENTS TO VISITOR FACILITIES PROJECTS

August 28, 2010

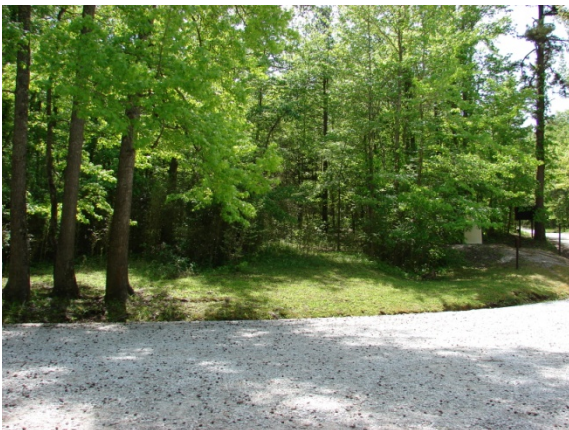
Current Cabana Style Restroom

The current cabana style restroom is located within the 100-year flood plain. It consists of a plastic building and unlined concrete vault that is not designed to withstand wind or rising water. It also is not of sufficient size for the expected visitor use and the unlined vault is subject to stress cracks, which may allow human waste to leach into the ground water. It also does not use the latest Sweet Smelling technology and therefore is a source of odor most of the year.

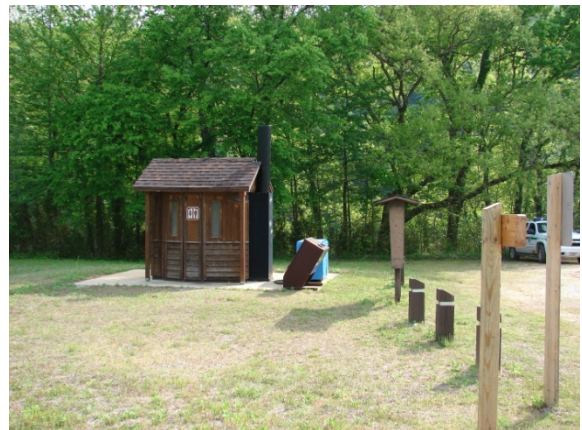
Proposed Restroom would be Similar Those at Other Launch Sites.

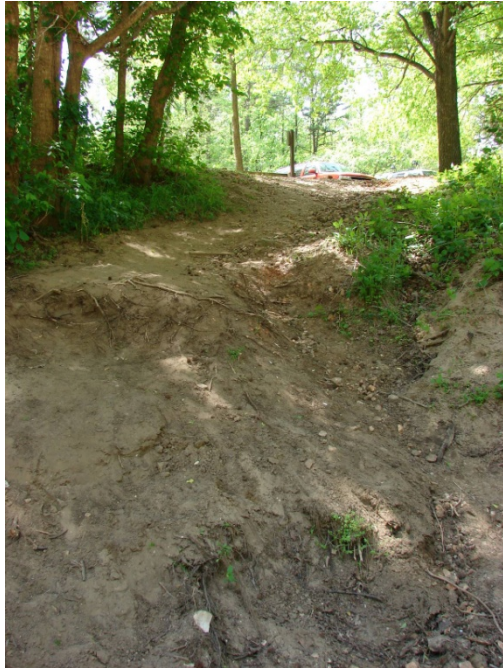
Social Trailing and Location
of Proposed Canoe Walkway

A new canoe walkway would be constructed directly from the parking lot to the gravel bar, where excessive social trailing is causing deep bank erosion and destabilization. Additionally, the existing walkway at the downstream end of the parking area would be stabilized and barriers would be installed to prevent the use of existing social trails as well as prevent the development of new social trails. Area of social trails would be restored by revegetating them. Various devices like large rocks and fence railing would be installed to direct foot traffic down canoe walkway.

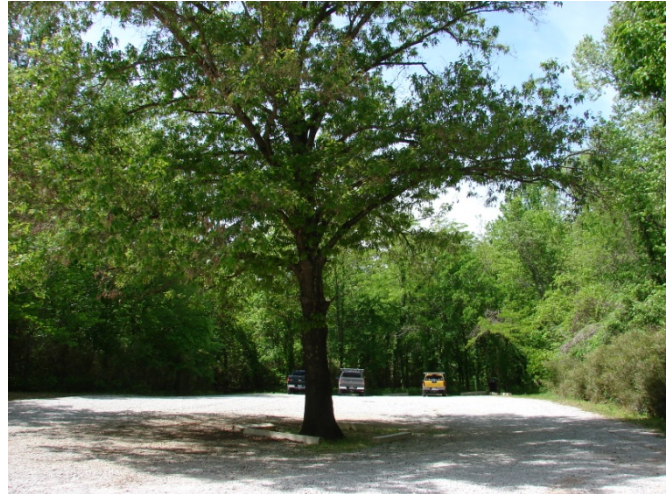
One of the Trees Impeding Traffic
Flow In Parking Lot

Two large trees in the parking area would be removed to improve vehicle maneuvering and increase parking space. The parking area would be slightly expanded by squaring off the corners and re-graded to improve control of stormwater runoff.

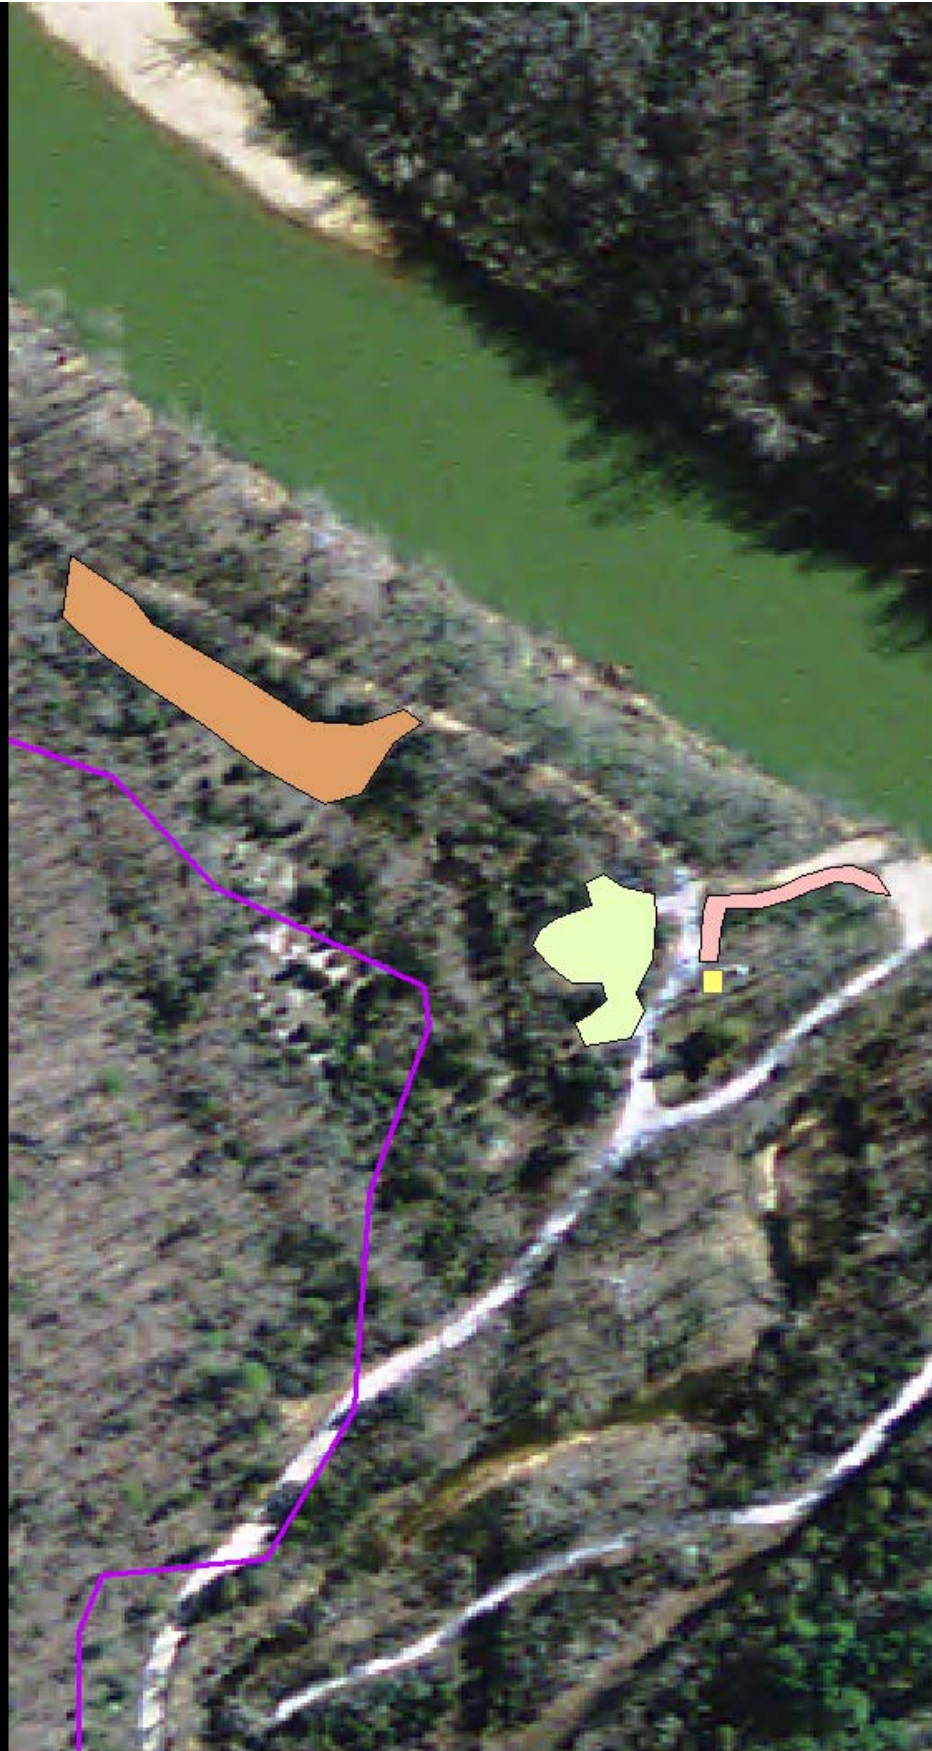
Rush Launch Area Flood Prone Zone

- Flood Prone Zone
- Proposed parking lot Improvements
- Proposed Restroom Locations
- Proposed Canoe Walkway
- Proposed Tree Clearance Area for Restroom
- Gravel Bar

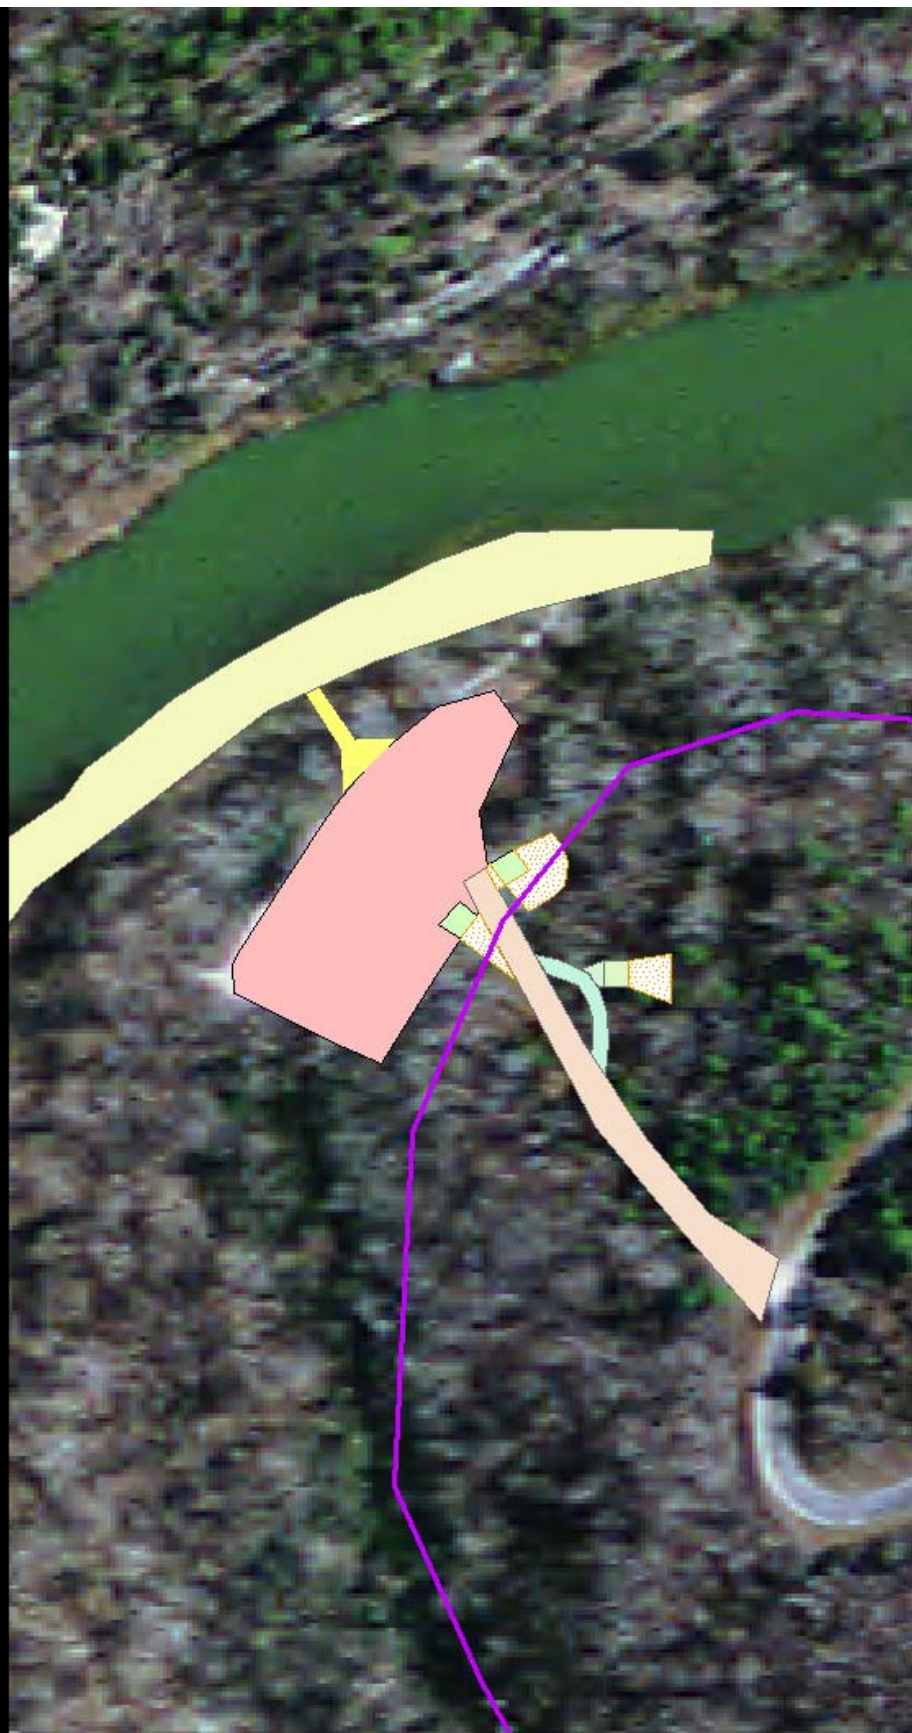
Hasty Launch Area Flood Prone Zone

- Flood Prone Zone
- Proposed parking lot Improvements
- Proposed Restroom Locations
- Proposed Canoe Walkway
- Proposed Tree Clearance Area for Restroom
- Gravel Bar
