STATEMENT OF FINDING FOR FLOOD PLAIN ANALYSIS
FOR IMPROVEMENTS TO VISITOR FACILITIES PROJECTS

August 28, 2010

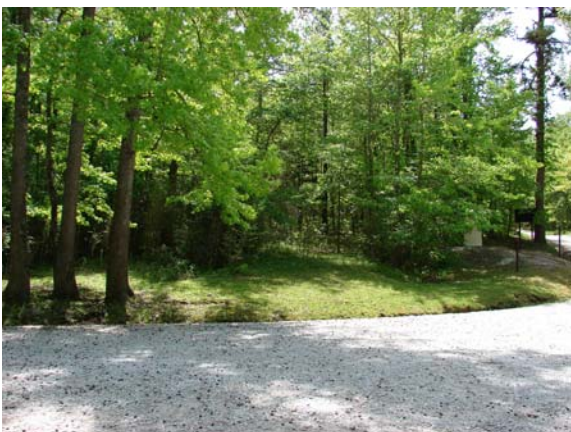
Current Cabana Style Restroom

The current cabana style restroom is located within the 100-year flood plain. It consists of a plastic building and unlined concrete vault that is not designed to withstand wind or rising water. It also is not of sufficient size for the expected visitor use and the unlined vault is subject to stress cracks, which may allow human waste to leach into the ground water. It also does not use the latest Sweet Smelling technology and therefore is a source of odor most of the year.

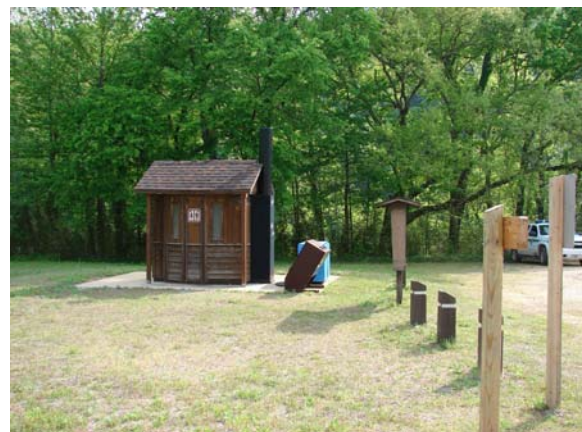
Proposed Restroom would be Similar Those at Other Launch Sites.

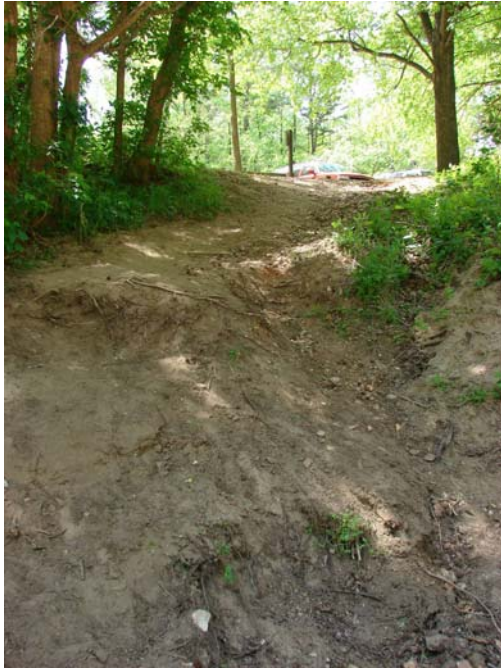
Social Trailing and
Location of Proposed
Canoe Walkway

A new canoe walkway would be constructed directly from the parking lot to the gravel bar, where excessive social trailing is causing deep bank erosion and destabilization. Additionally, the existing walkway at the downstream end of the parking area would be stabilized and barriers would be installed to prevent the use of existing social trails as well as prevent the development of new social trails. Area of social trails would be restored by revegetating them. Various devices like large rocks and fence railing would be installed to direct foot traffic down canoe walkway.

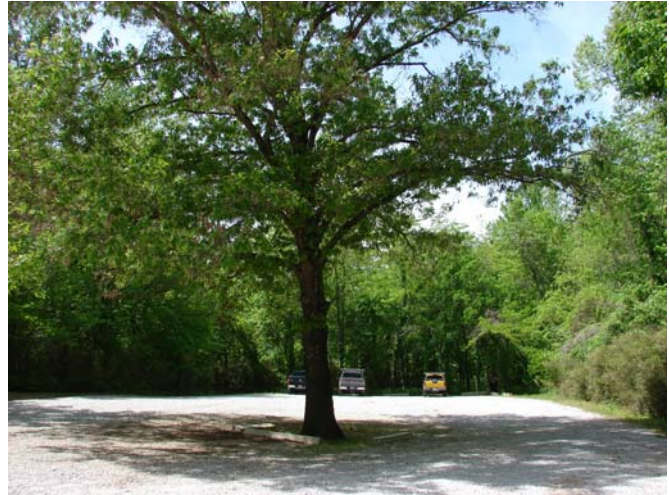
One of the Trees Impeding
Traffic Flow In Parking Lot

Two large trees in the parking area would be removed to improve vehicle maneuvering and increase parking space. The parking area would be slightly expanded by squaring off the corners and re-graded to improve control of stormwater runoff.

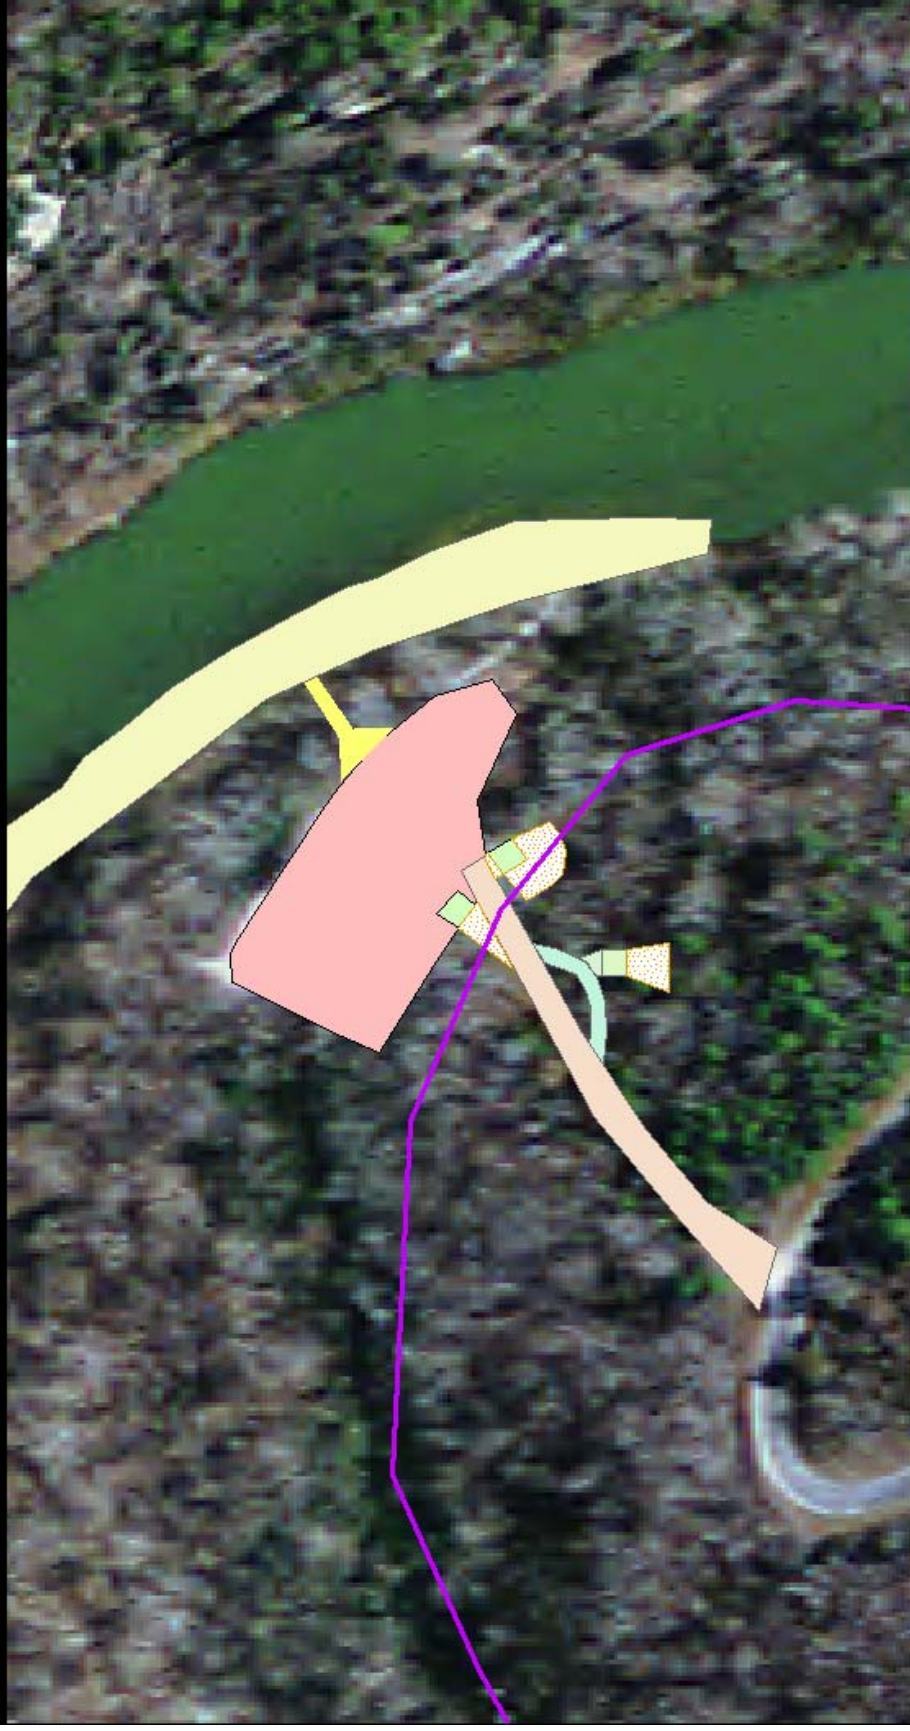
- Flood Prone Zone
- Proposed parking lot Improvements
- Proposed Restroom Locations
- Proposed Canoe Walkway
- Proposed Tree Clearance Area for Restroom
- Gravel Bar

Figure 1 - Hasty Launch Area Flood Prone Zone identifies that the canoe walkway, the parking lot improvements and all of Restroom Site A and a portion of Restroom Site B will all be located within the 100-year floodplain.
