Delaware Water Gap National Recreation Area New Jersey, Pennsylvania U.S. Department of the Interior National Park Service

WATERGATE WETLANDS RESTORATION PROJECT

Environmental Assessment

June 2020

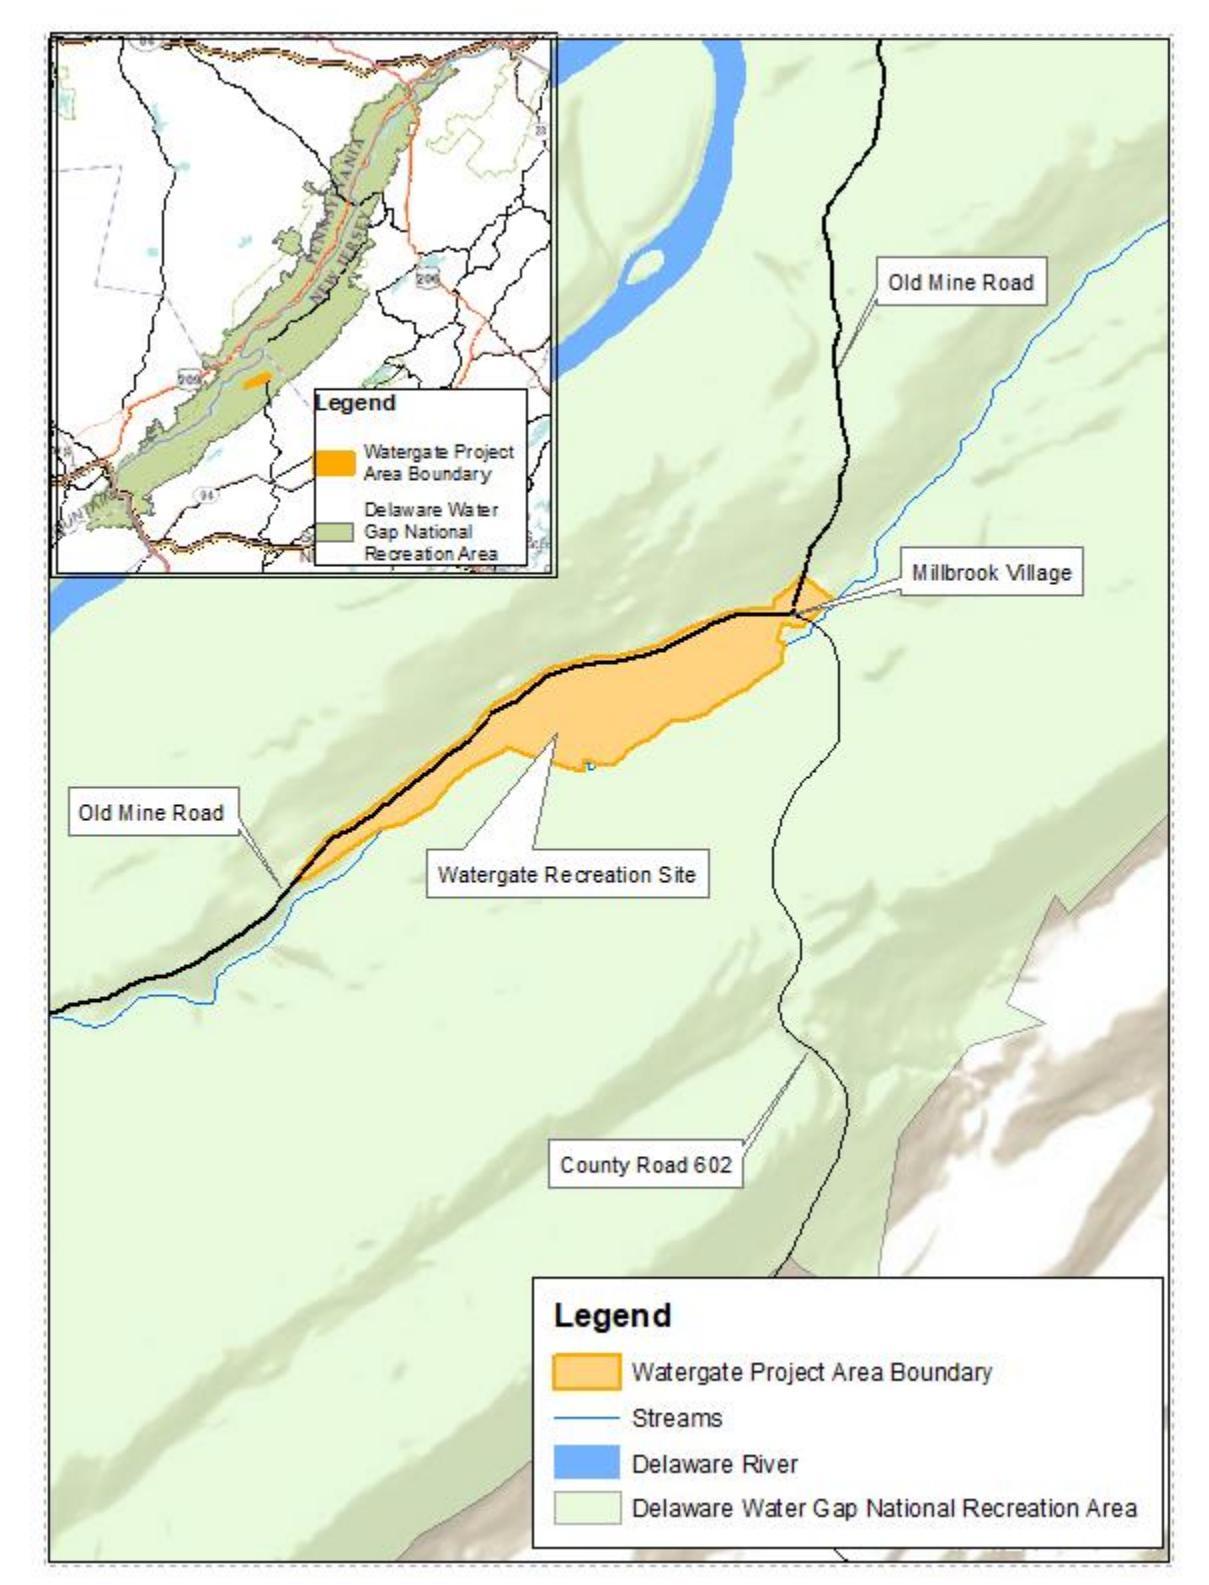
Figure 1: Project Location Map

The project area is located within the Van Campens Brook watershed in Warren County, New Jersey (Figure 1). The bulk of the work associated with the proposed project would occur within the Watergate Recreation Site, which features a large mowed lawn and rustic picnic area and several ponds (Figure 2). The natural conditions and overall hydrology of the project site have been significantly altered by the draining of wetlands; the creation of numerous man-made dams, ponds, and levees; and the construction of a road next to the stream. See Appendix B: Photos for photos of existing conditions.

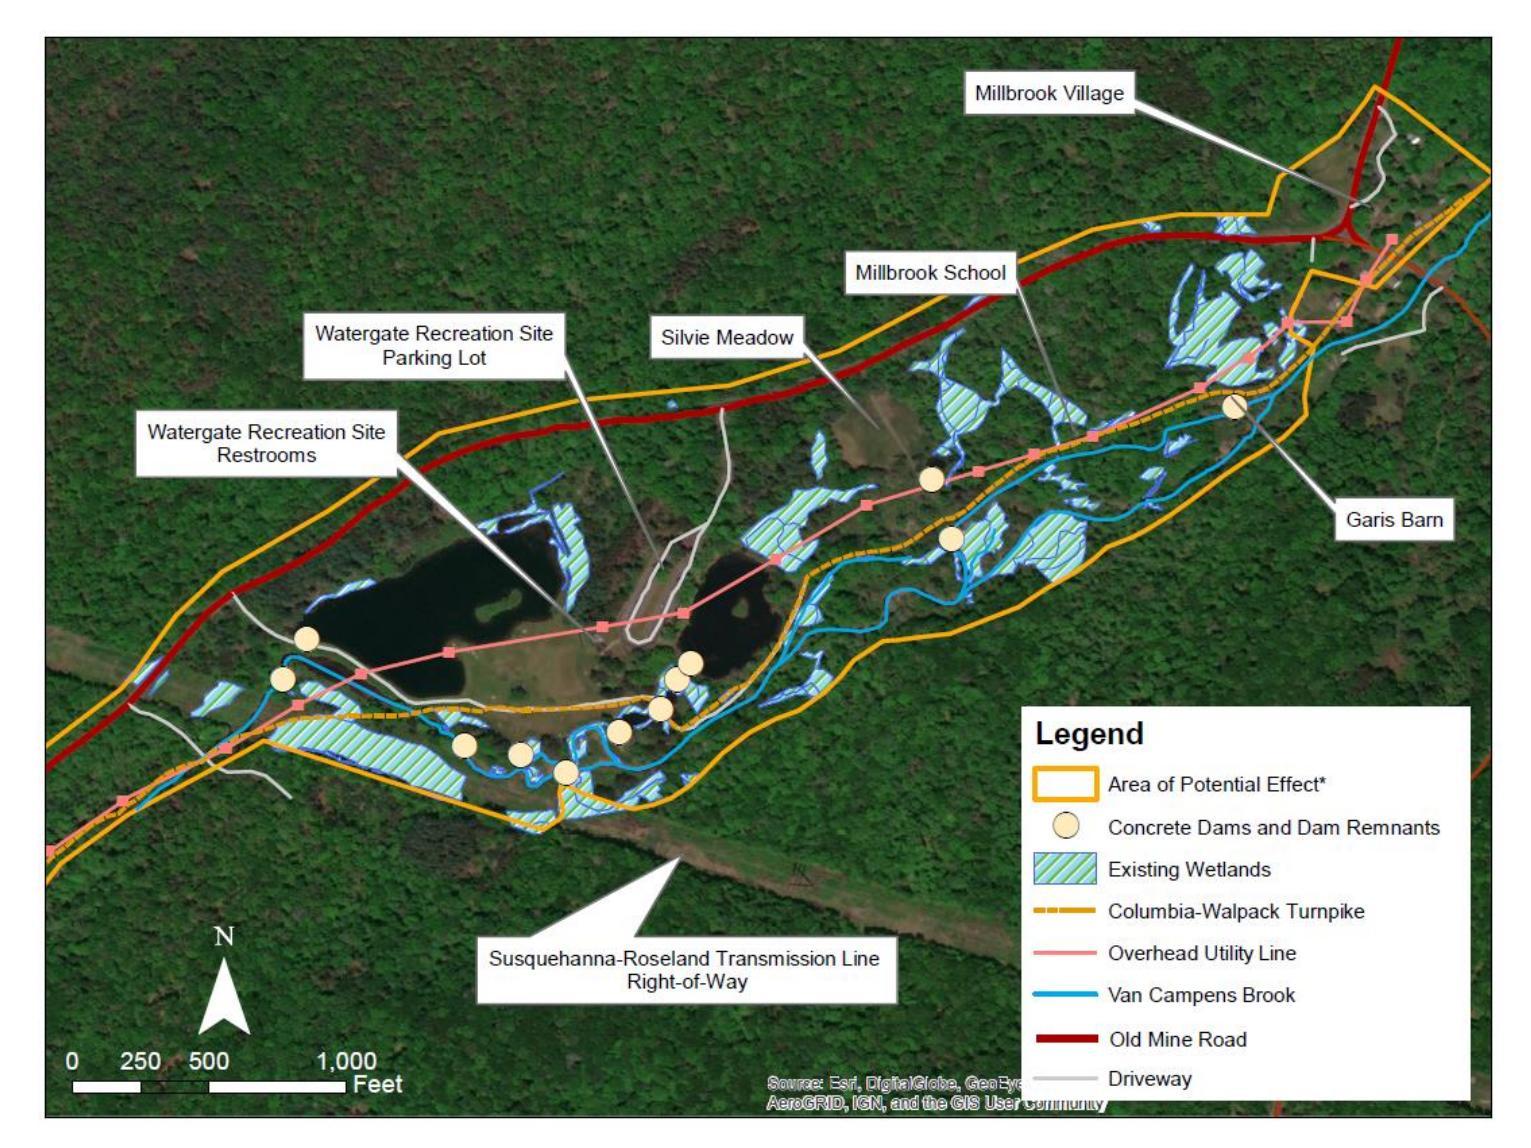
Figure 2: Current conditions and existing features at the project site

The Watergate Recreation Site was created by the NPS in the 1980s. It capitalized on the ponds and upland area created by the previous landowner to form a picnic area and open-water fishing opportunities. Over the last decade, on average the site receives only 1-6% of the visitors of the six comparable recreation sites within the park. The recreation quality at the site is low—the picnic area is mostly unshaded, geese frequently inhabit the lawn area, the open-water fishing is poor quality due to the warm, shallow ponds, and the 200'-tall towers and wires of the Susquehanna-Roseland Transmission Line compromise the vista. In addition to those recreational opportunities, the Van Campens Glen Trail, which was co-located on the Columbia-Walpack Turnpike, was heavily damaged during flood events from 2004-2011 and is impassable by vehicles and to most park visitors.

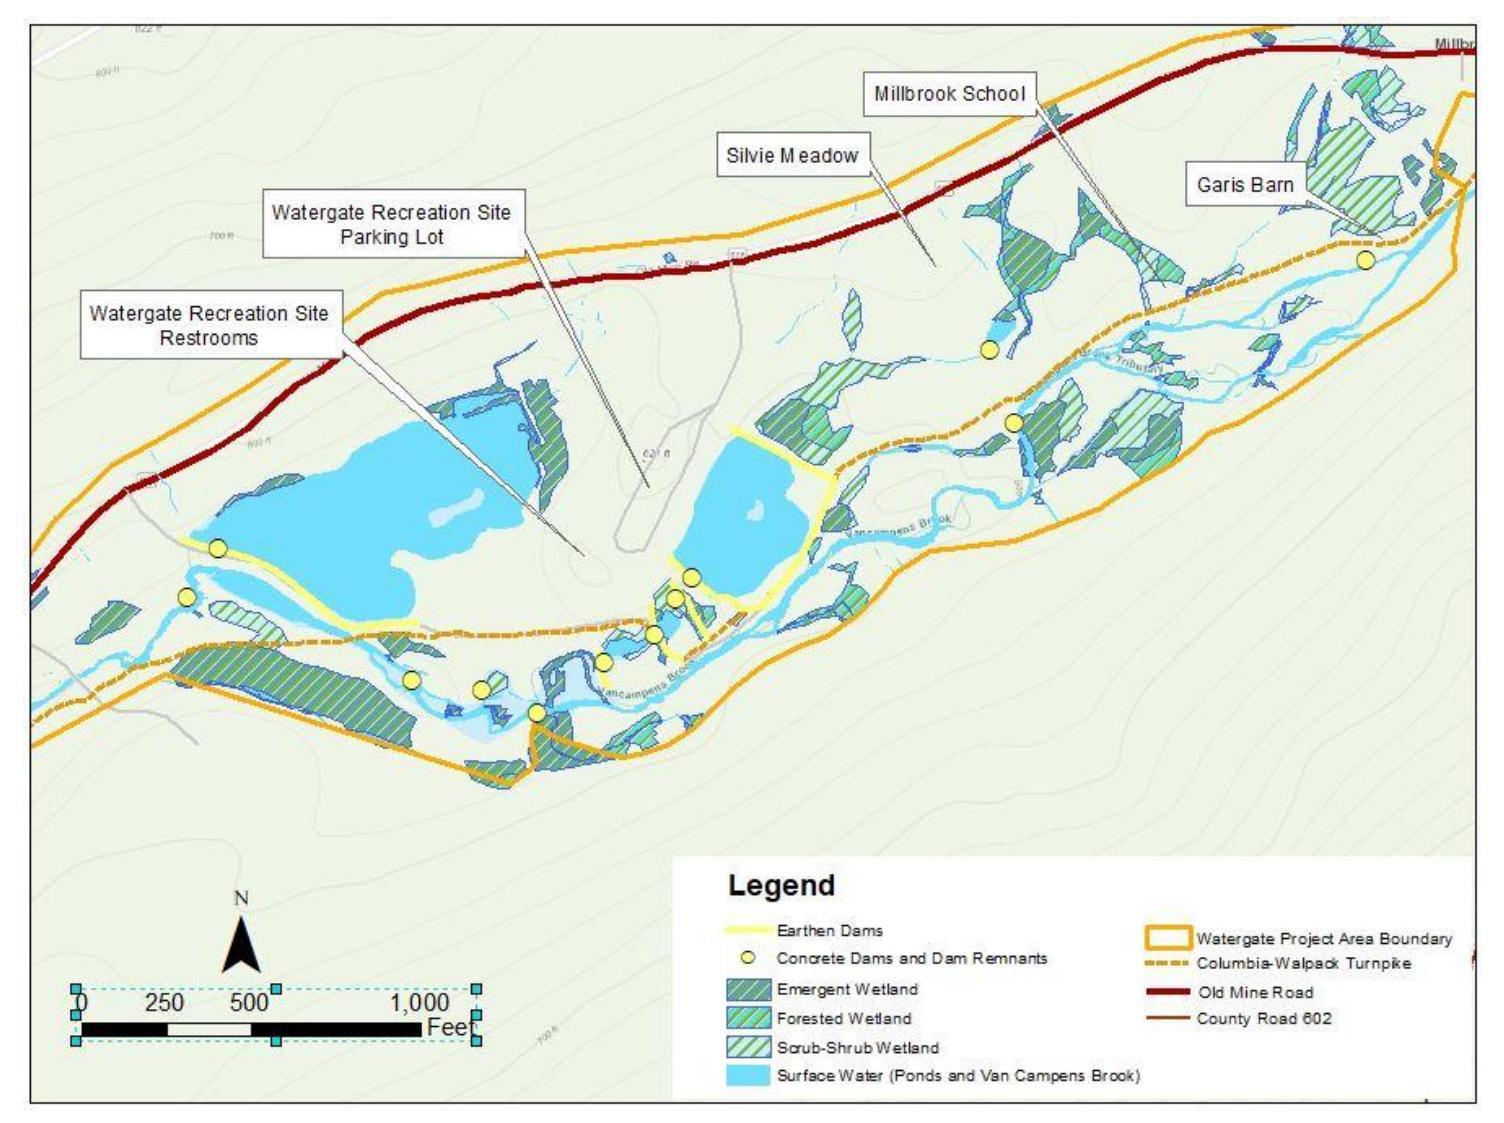
Appendix A, Figure 1: Existing wetlands within the project area

There are three types of wetlands present onsite, but all are poor- to medium-quality. This project would restore 20 acres of medium- to highquality wetlands.

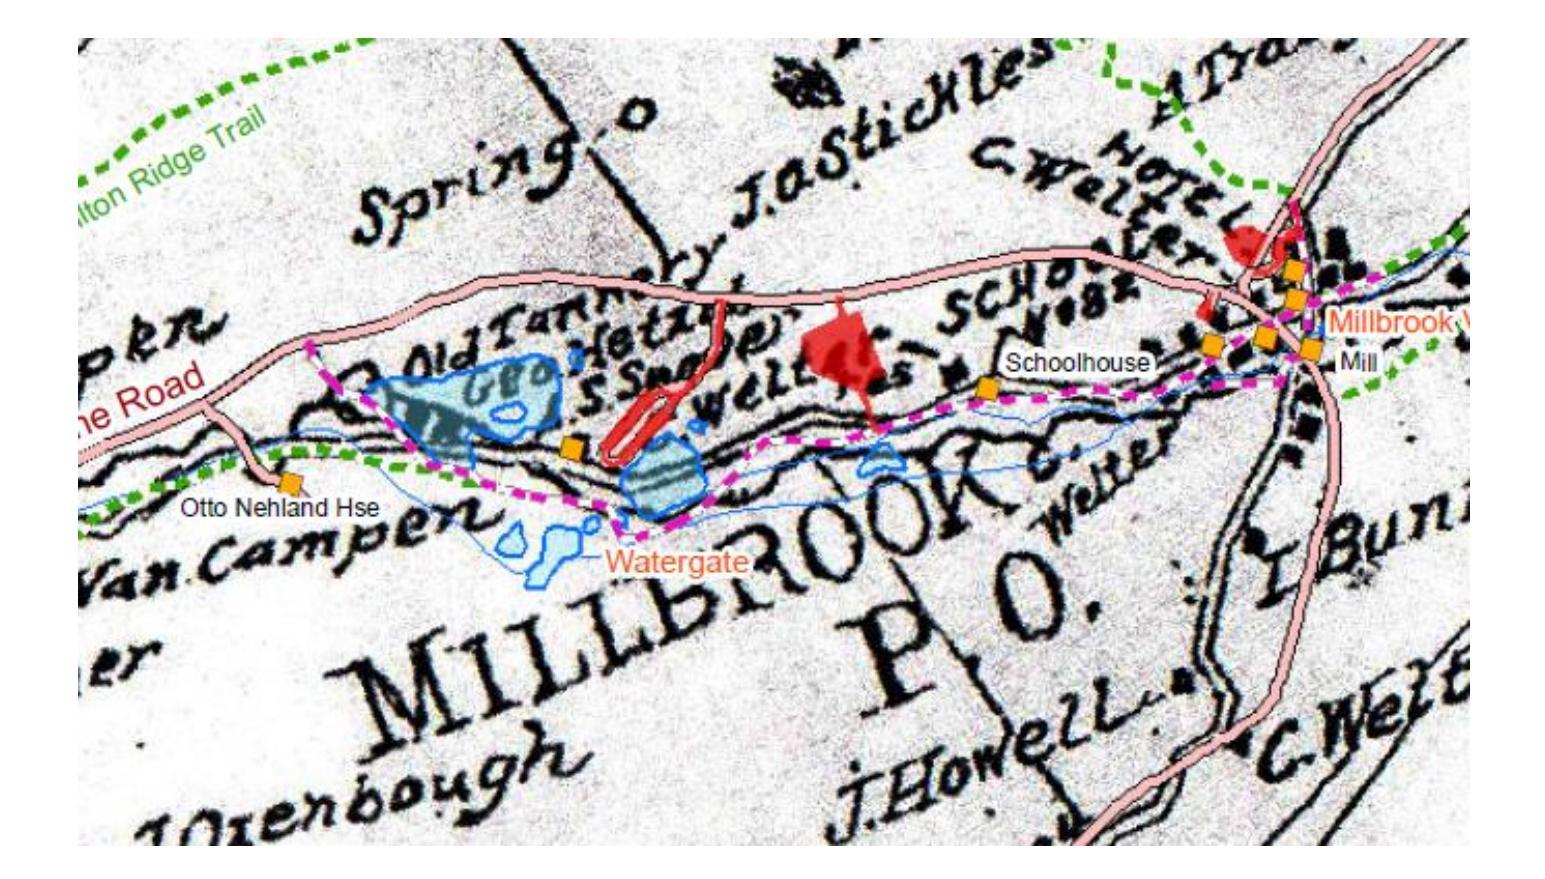
Appendix A, Figure 2: 1874 map, with an overlay of current features in the project area.

The black-and-white map was produced in 1874. It shows the previous location of Van Campens Brook (single black line), the location of the Columbia-Walpack Turnpike (double black line), and only one pond within the project area, which was associated with the "old Tannery." The current features are overlaid in color, including paved roads (peach color) ponds and streams (in blue), current location of the Columbia-Walpack Turnpike (white-and-pink) line, and buildings (orange squares). Old Mine Road was in a different location at the time, to the west of the area shown on this map. Note that Van Campens Brook used to pass through the area where the largest pond now is. Its current alignment is to the south of its original alignment.

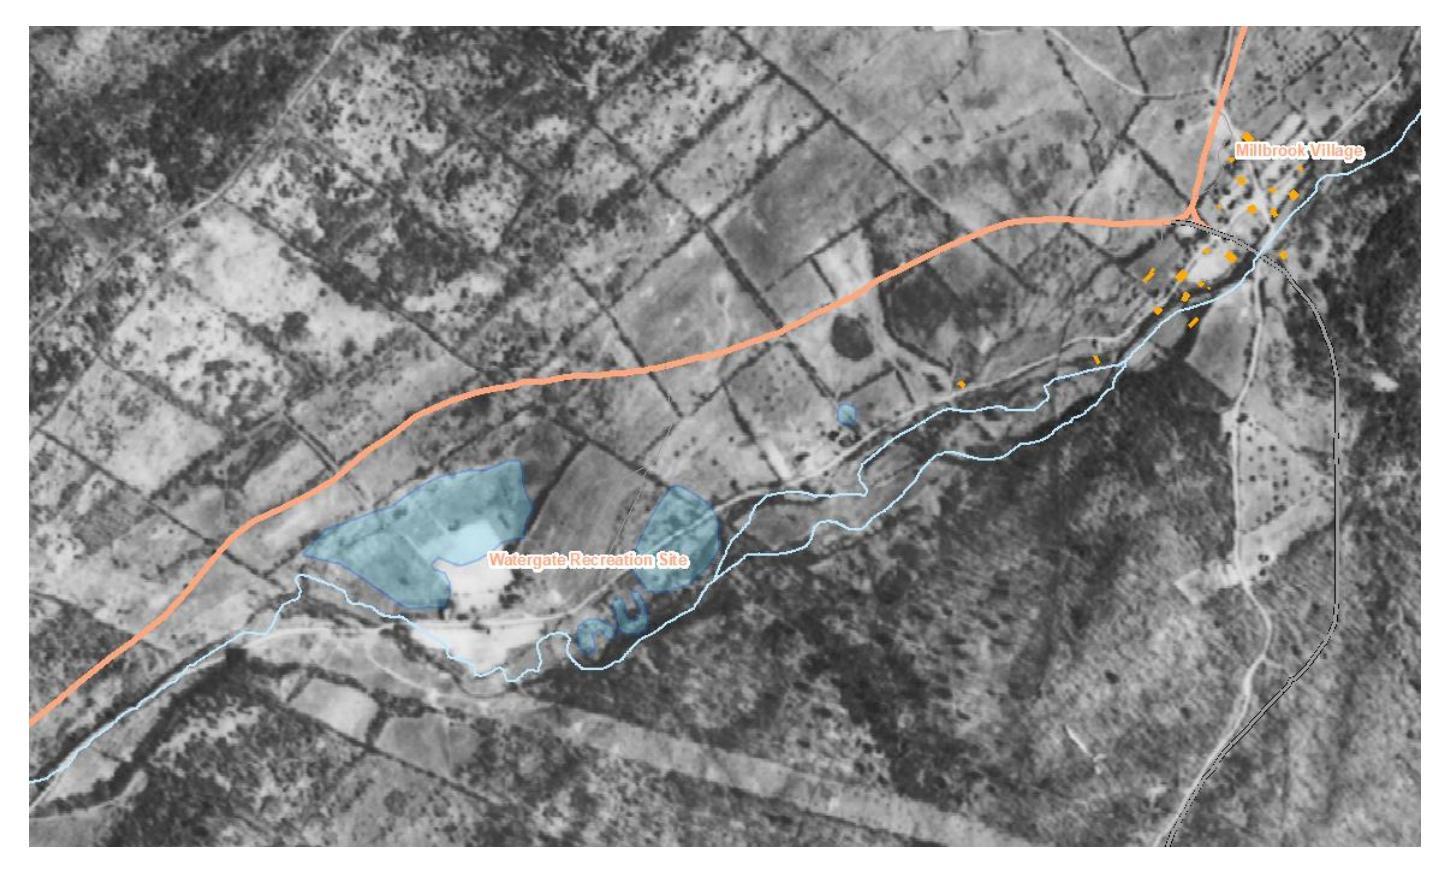
Appendix A, Figure 3: Aerial photo from 1930, with an overlay of current features in the project area.

This aerial photo from 1930 highlights the use of the project area as agricultural land. Van Campens Brook, which in the Figure 2 map had been running through where the largest pond now is, has been moved to its current position (south of where it was previously). The Susquehanna-Roseland Transmission Line right-of-way, constructed in 1929, is evident as the cleared area running diagonally across the lower left of the photo. The Columbia-Walpack Turnpike is the sinuous lighter-colored line that runs diagonally through the photo from lower left to upper right. Old Mine Road had not been built in its current alignment yet, but was constructed later in the 1930s. The current features are overlaid in color, including Old Mine Road (peach color) ponds and streams (in blue), and buildings (in orange).

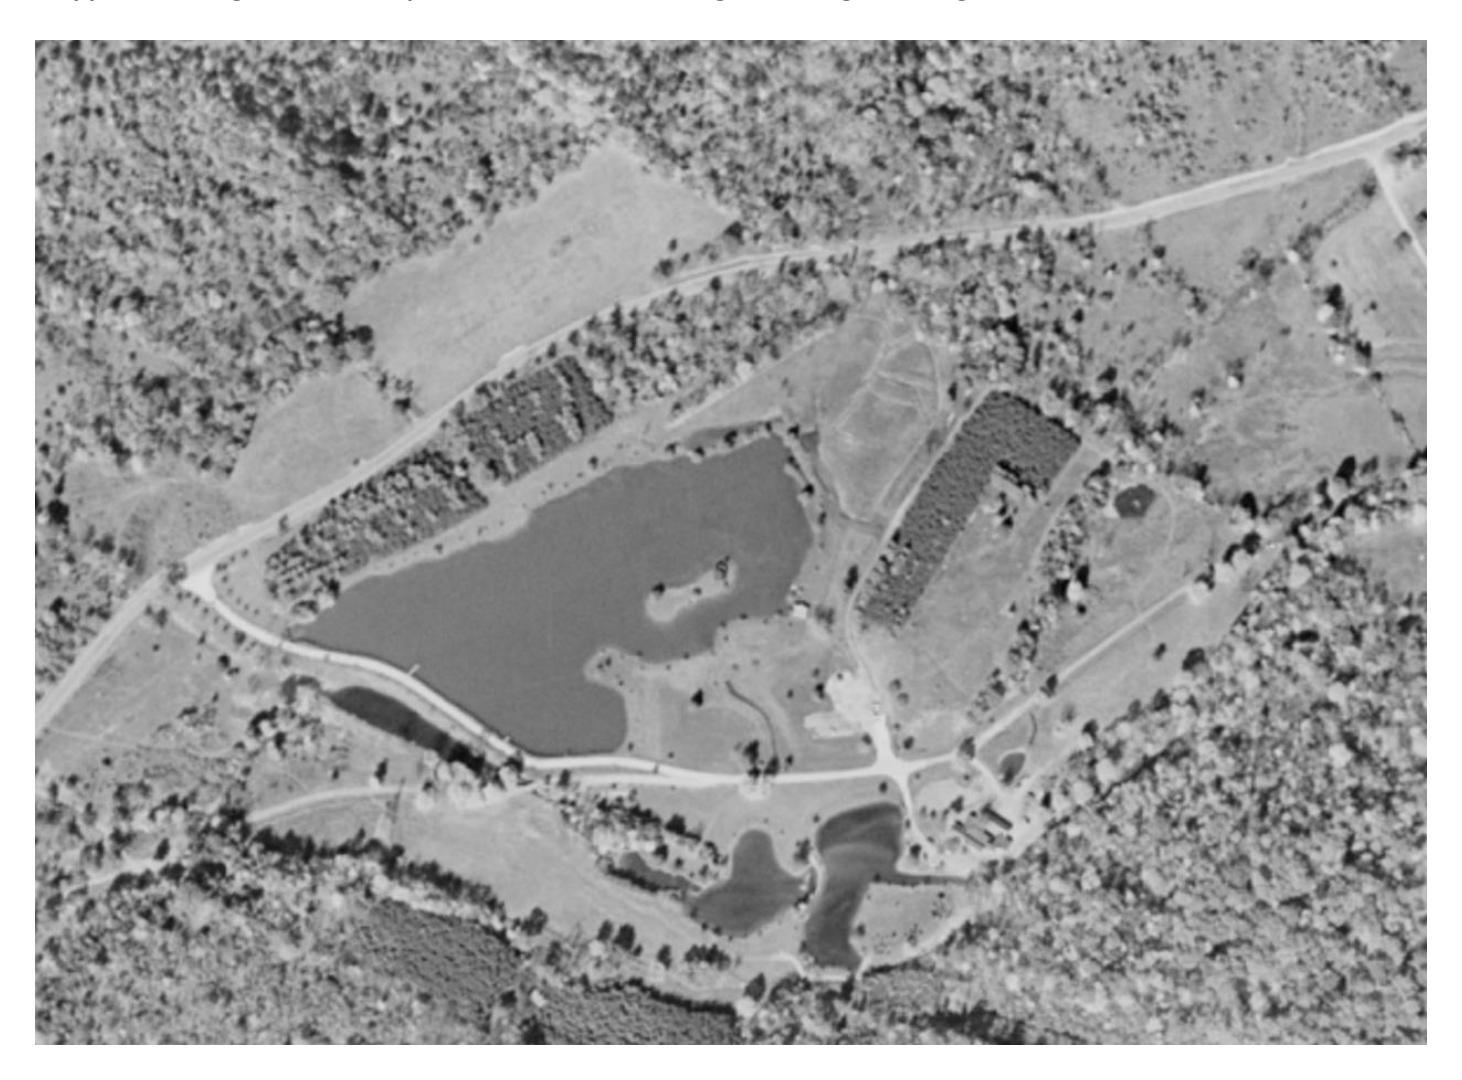
Appendix A, Figure 4: Aerial photo from 1970, showing the change from agricultural use to recreational use.

This aerial photo from 1970 shows that a transition in land use has occurred from agricultural to recreational (vacation homes and properties). The agricultural fields are mostly gone, and the property owners have excavated the largest pond, dammed Van Campens Brook to create smaller ponds, and created a large mowed/maintained landscape. The Susquehanna-Roseland Transmission Line right-of-way is evident as the cleared area running diagonally across the lower third of the photo. The Columbia-Walpack Turnpike is still present, shown in the middle of the photo, but its alignment and characteristics have changed—it is no longer the main travel route through the valley, because Old Mine Road (top third of photo) has been built in its current alignment.

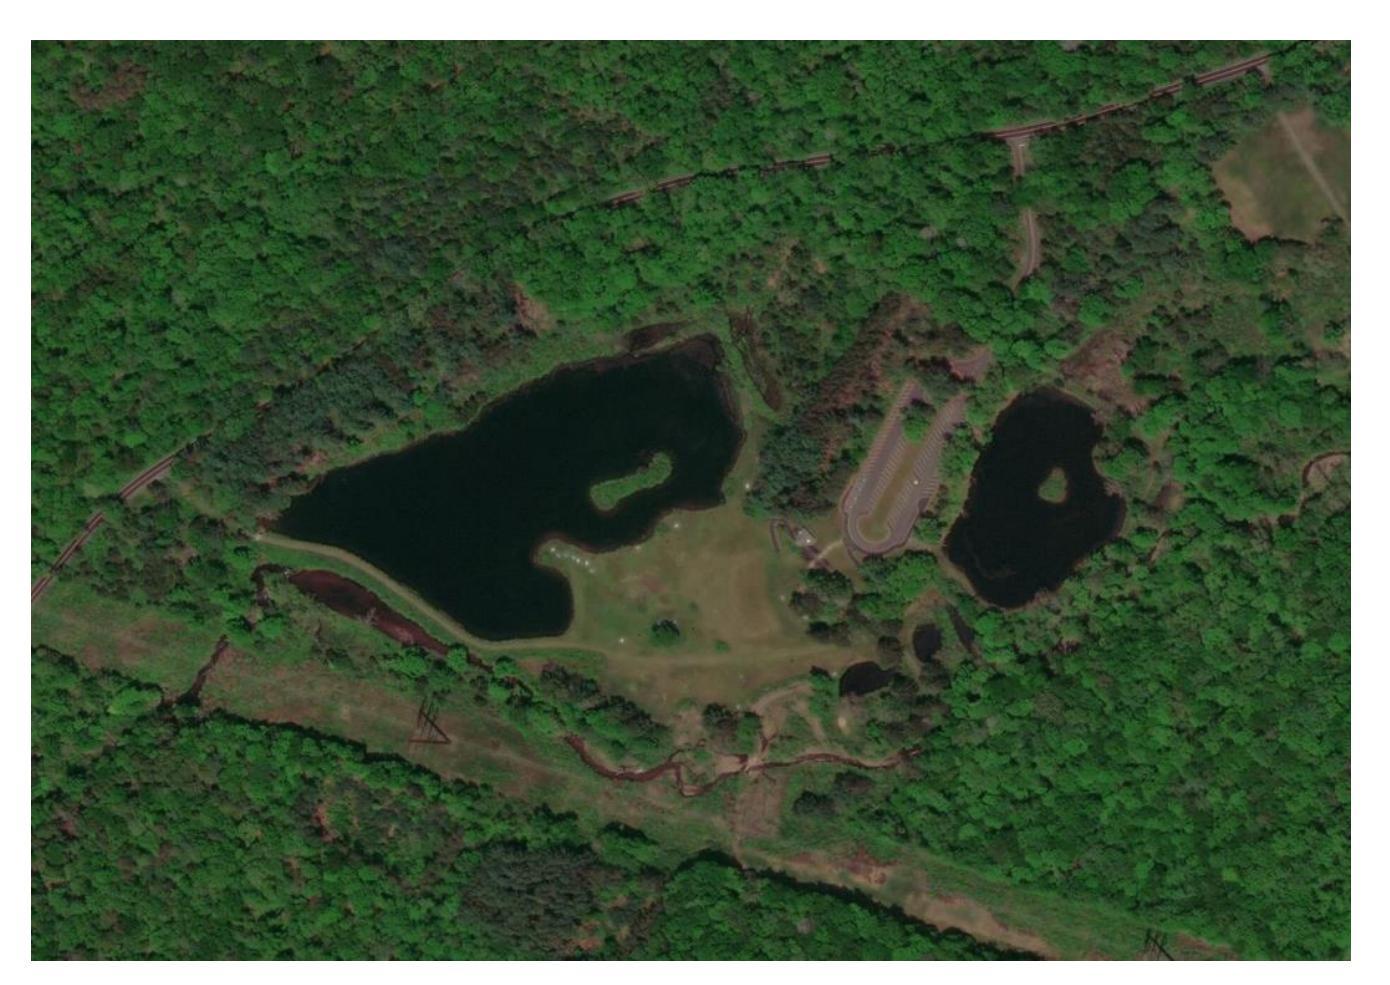
Appendix A, Figure 5: Watergate Recreation Site, present-day aerial photo

This 2019 aerial photograph shows conditions at the present-day Watergate Recreation Site. Some of the smaller ponds on Van Campens Brook have been lost to flooding. Some of the mowed/maintained landscape seen in the 1970 photo continued to be maintained as such since federal acquisition of the property around 1980, and is currently used as a picnic area. The houses and driveways were removed, and a parking lot and restroom building were added.

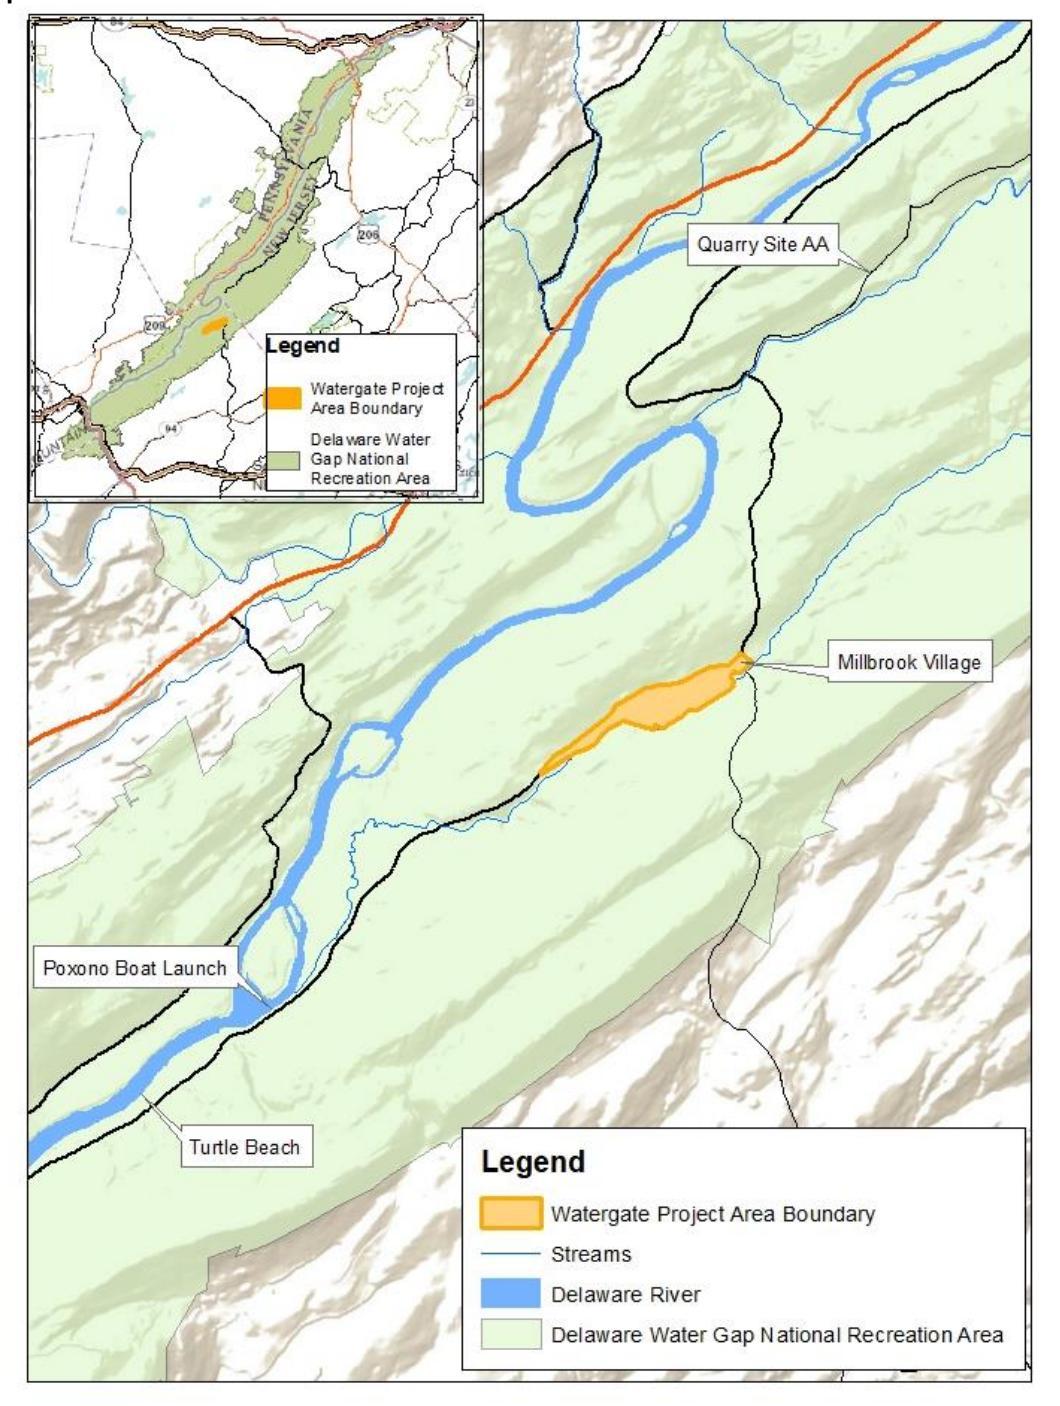
Appendix A, Figure 6: Map of locations where soil/rock spoils and salvaged fish would be placed.

Excess soil and rock (spoils) from the project would be trucked 2 miles to the north and used to fill in an abandoned quarry (Quarry Site AA). Salvaged fish would be trucked to the nearest location within the watershed that would not adversely affect native aquatic fauna—most likely, Poxono Boat Launch on the Delaware River, 3.5 miles south of the project area.

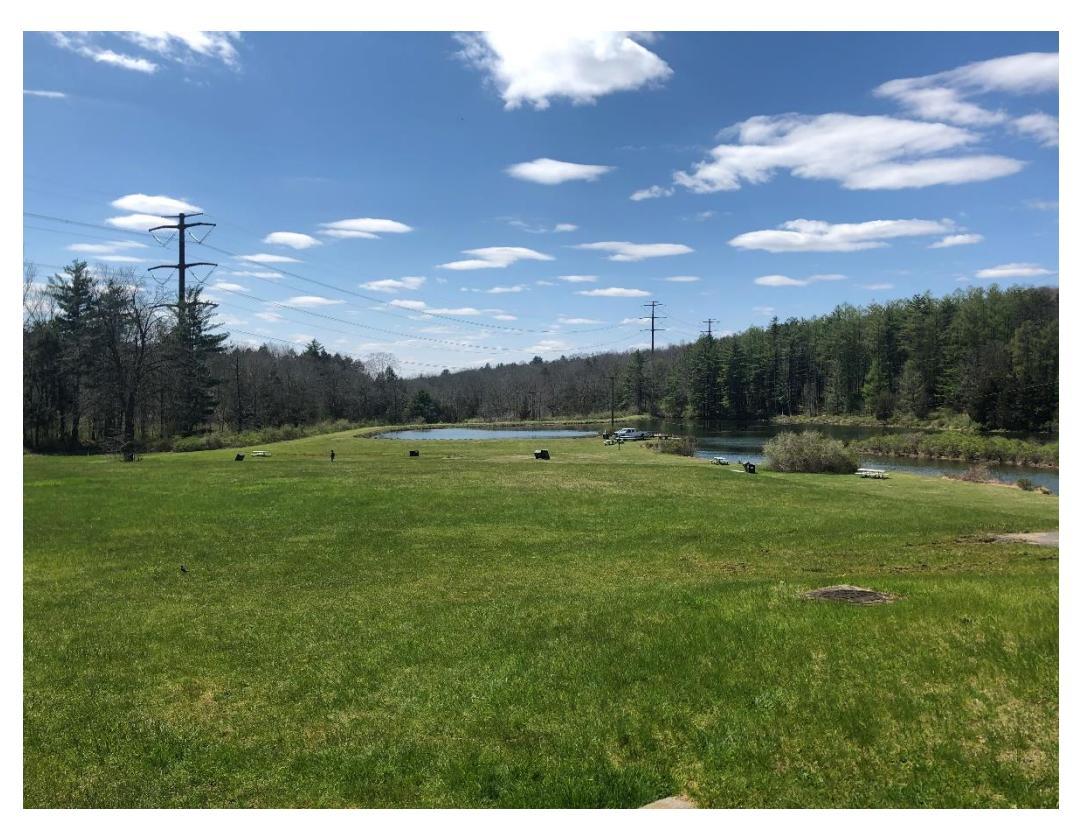
Photo 1: Overview of main area of Watergate Recreation Site. Photo taken from septic mound. Note picnic tables, large mowed lawn, and pond. The Susquehanna-Roseland Transmission Line is in the background.

The lawn and pond would be converted into wetlands.

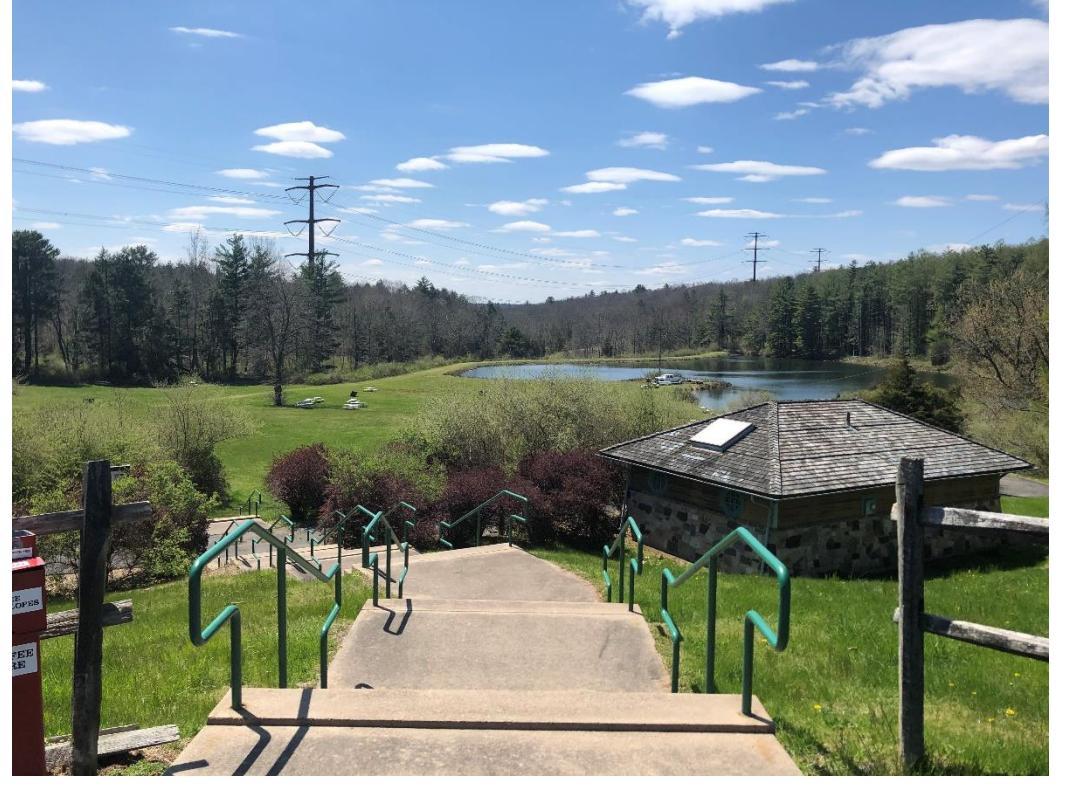
Photo 2: The restroom building and one of the concrete staircases, just below the parking lot.

These features would remain unchanged.

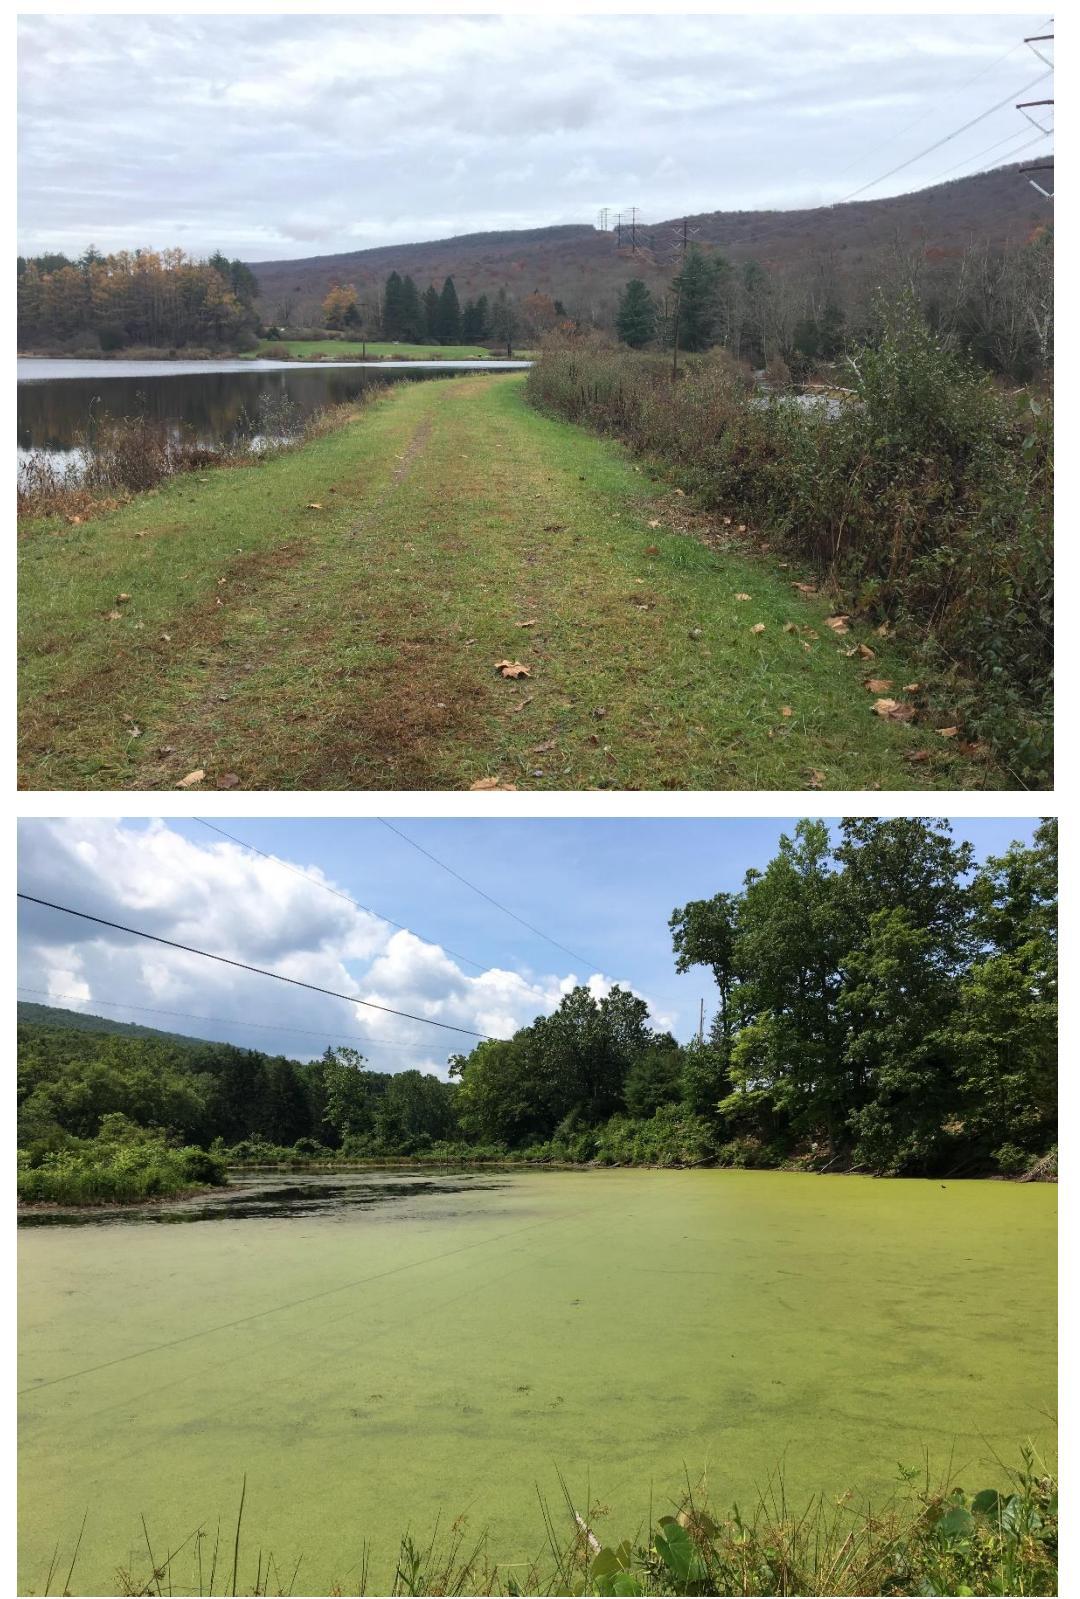
Photo 3: Looking back towards the Watergate Recreation Site (center left of photo), standing on earthen dam of largest pond. Van Campens Brook is to the right of the dam.

The pond would be dewatered prior to removal of the dam. The pond and dam would be converted to wetlands, and would be at the same elevation as Van Campens Brook in order to restore the floodplain.

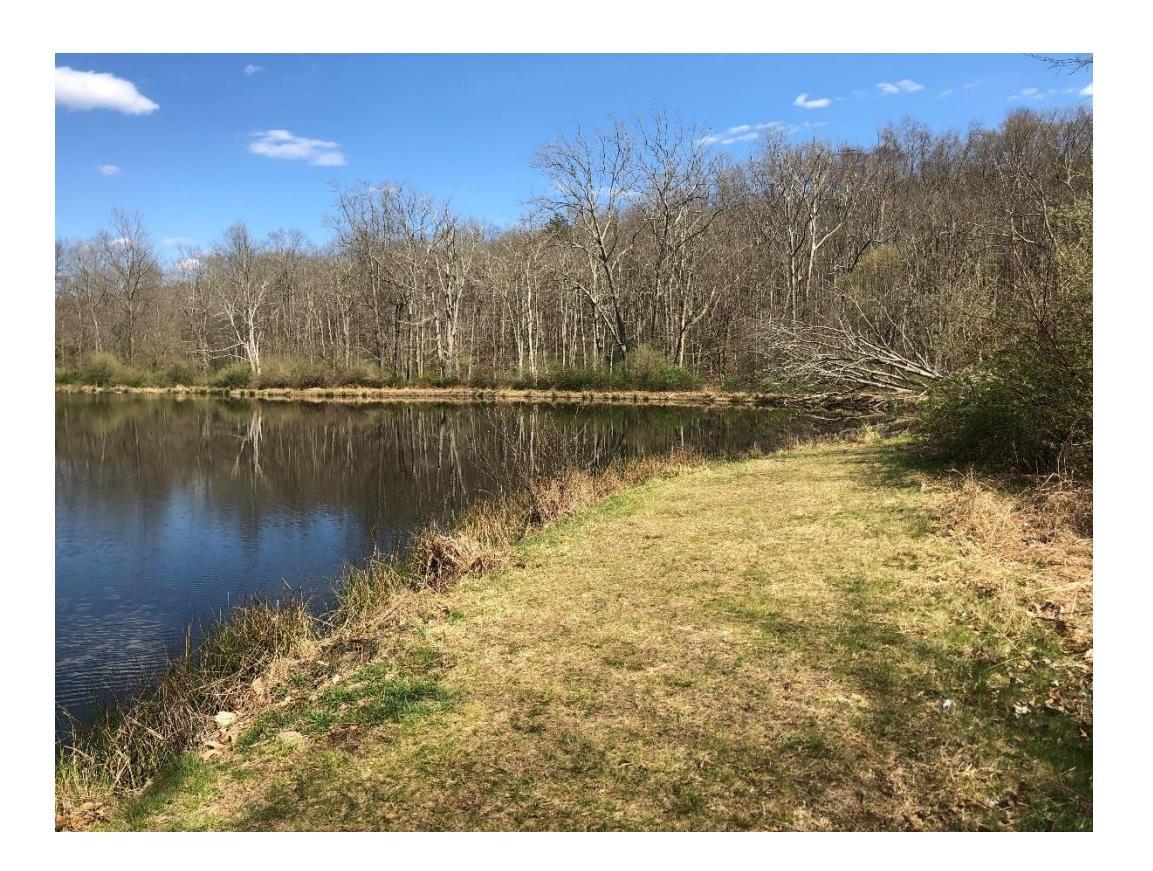
Photo 5: The low, earthen dam that forms the second-largest pond.

This would be removed and the area restored as wetlands.

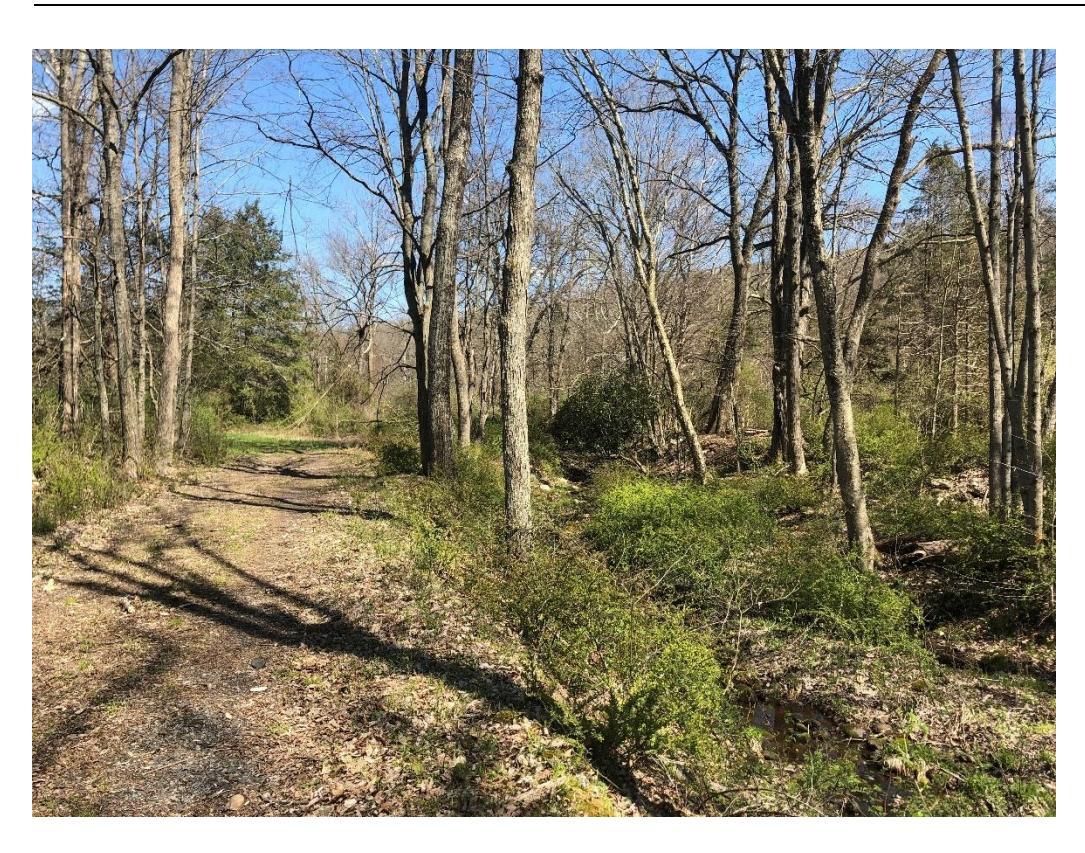
Photo 7: The Columbia-Walpack Turnpike. A channel of Van Campens Brook is just to the right of the road, and a wetland is just to the left of the road.

The road acts as a levee. Removing it and restoring natural grades would reconnect Van Campens Brook with its floodplain (including the wetland).

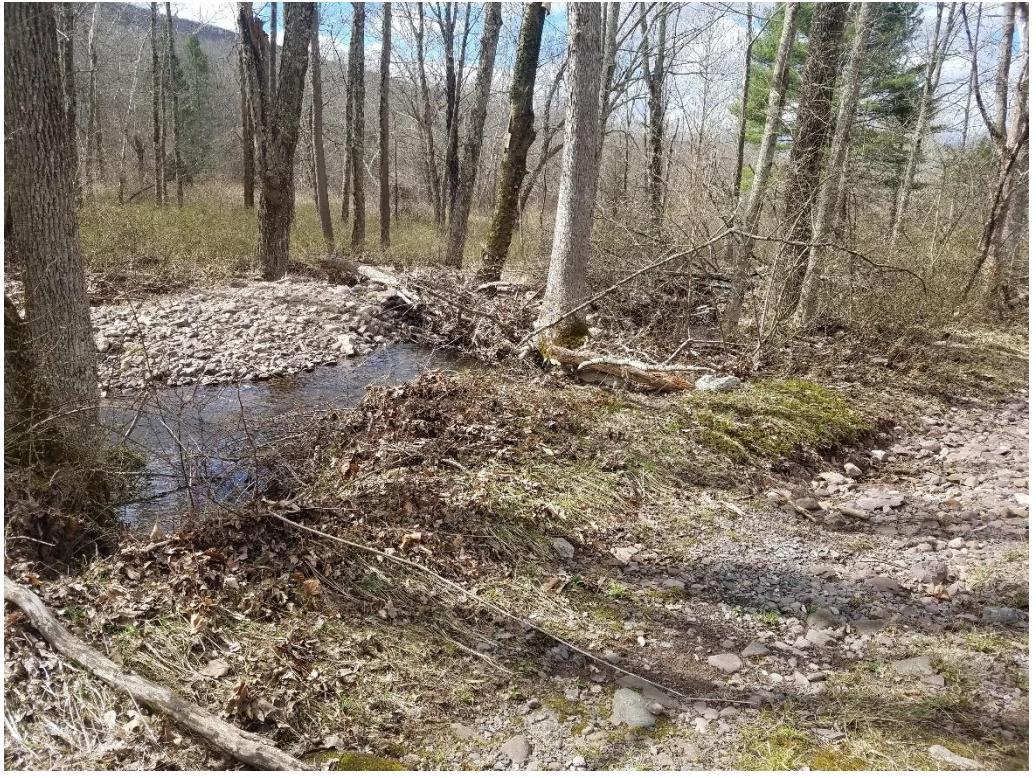
Photo 8: The Columbia-Walpack Turnpike on the right, and Van Campens Brook on the left. The stream frequently avulses (jumps its banks) after rainfall in this section, eroding the roadbed.

> This section of road would be removed. Doing so would allow the stream to function properly; it would be reconnected with its floodplain and the energy of flood flows would be able to dissipate more than at present.

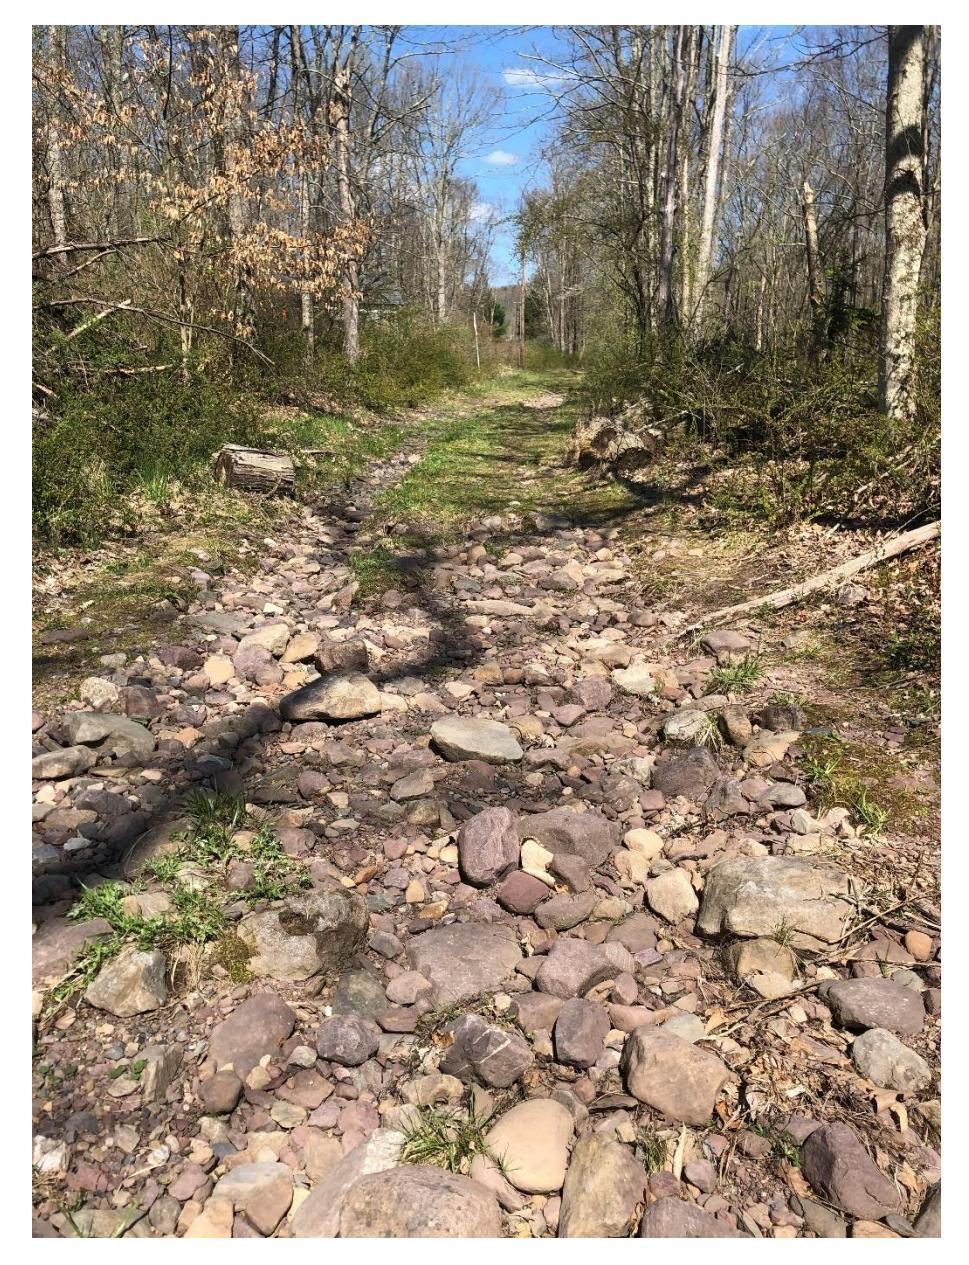
Photo 9: The Columbia-Walpack Turnpike. Van Campens Brook is to the right and behind the nonnative shrubs. The stream frequently avulses (jumps its banks) after rainfall in this section, eroding the roadbed and leaving behind cobble.

This section of road would be removed. Doing so would allow the stream to function properly; it would be reconnected with its floodplain and the energy of flood flows would be able to dissipate more than at present.

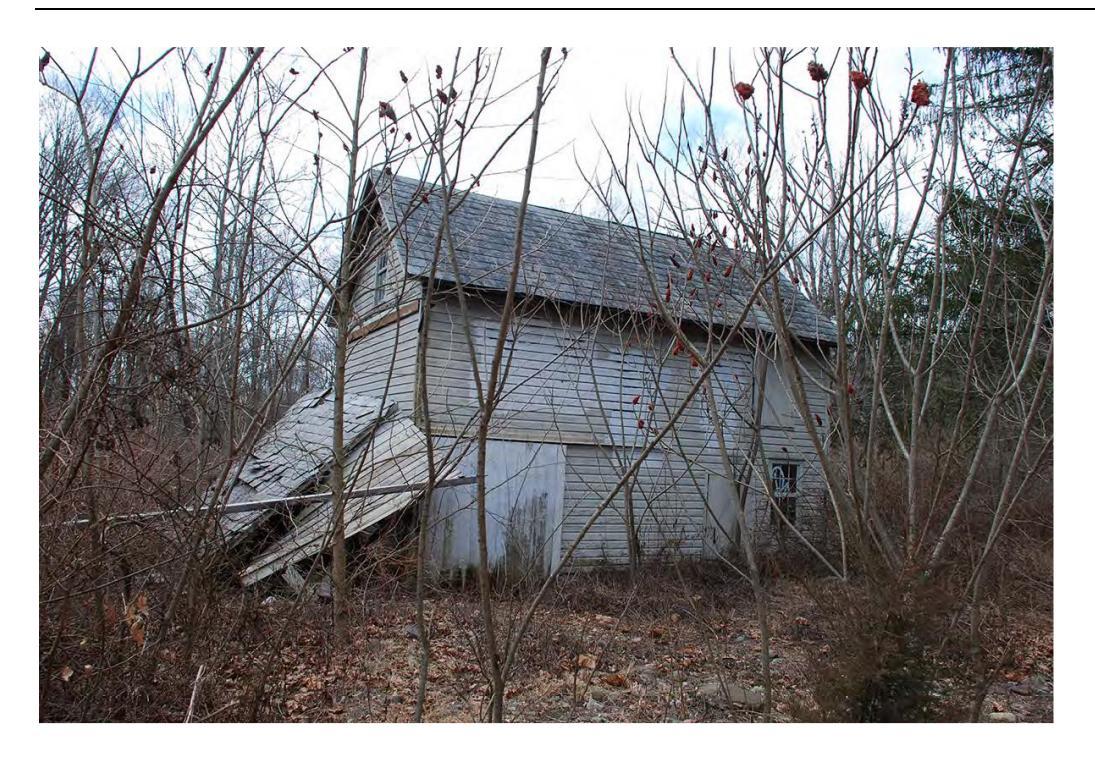
Photo 14: Garis Barn, north façade. Note collapsed (modern) lean-to. The barn is in the Van Campens Brook floodplain. Removing the firstfloor exterior clapboard siding would allow floodwaters to flow through the building, rather than against it. This will allow for the long-term preservation of the building in its current location.
