Delaware Water Gap National Recreation Area New Jersey, Pennsylvania U.S. Department of the Interior National Park Service

WATERGATE WETLANDS RESTORATION PROJECT

Environmental Assessment

June 2020

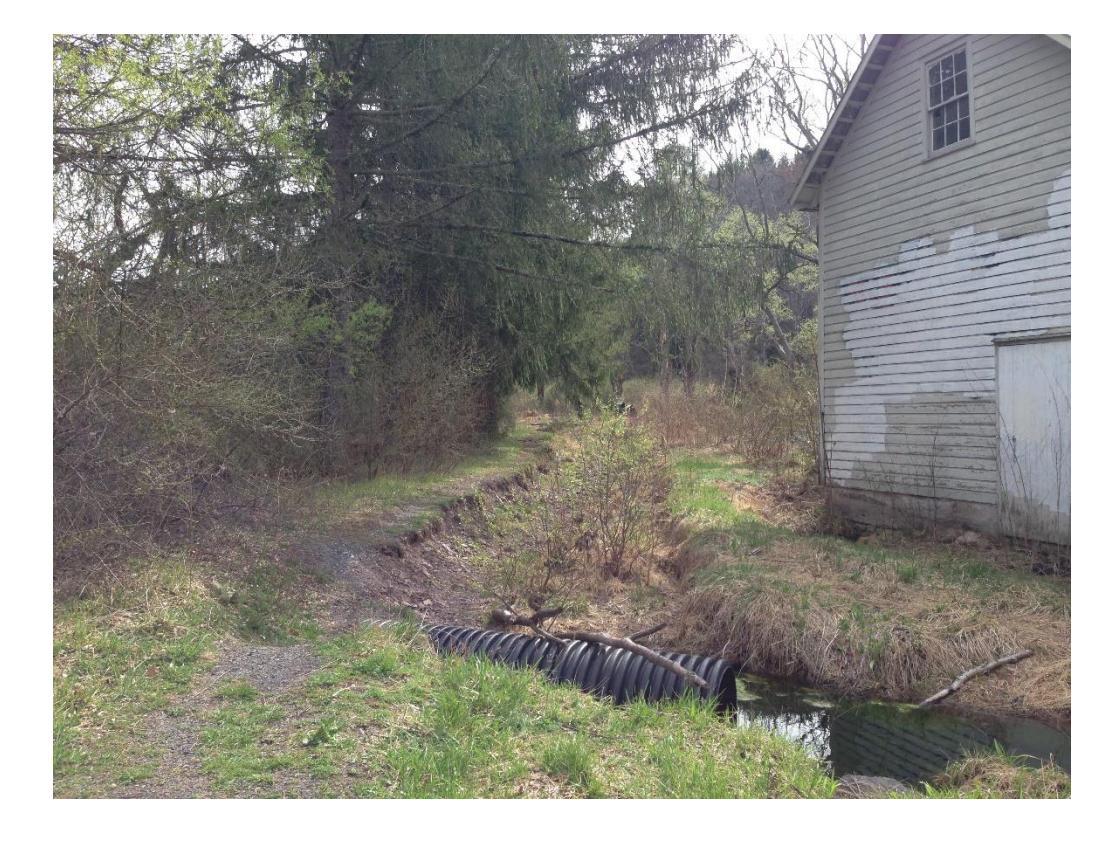
Photo 15: The Columbia-Walpack Turnpike near Garis Barn. It was damaged during flood events from 2004-2011 and has become impassable to most park visitors. As in the photo above, the road is between Van Campens Brook and a wetland.

Removing this section of road would reconnect Van Campens Brook with its floodplain (including the wetland).

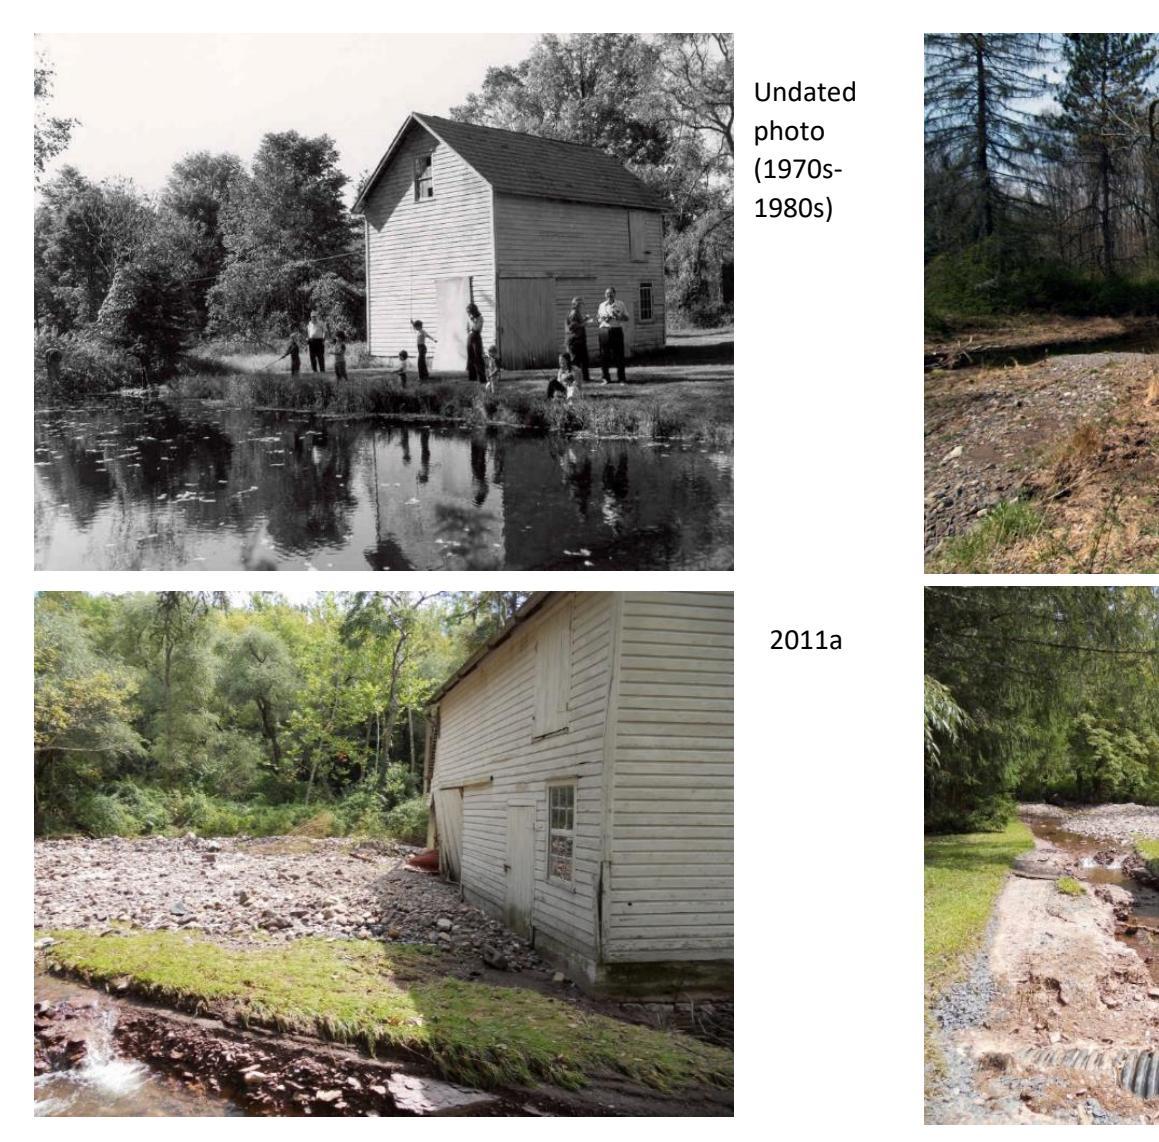
Photo 16 (series of 4 photos): Original condition of barn (note lack of lean-to and pond) and damage following two flood events. In the photo labeled 2011a, note cobble piled up against the north façade of the barn from the flood event in Van Campens Brook.

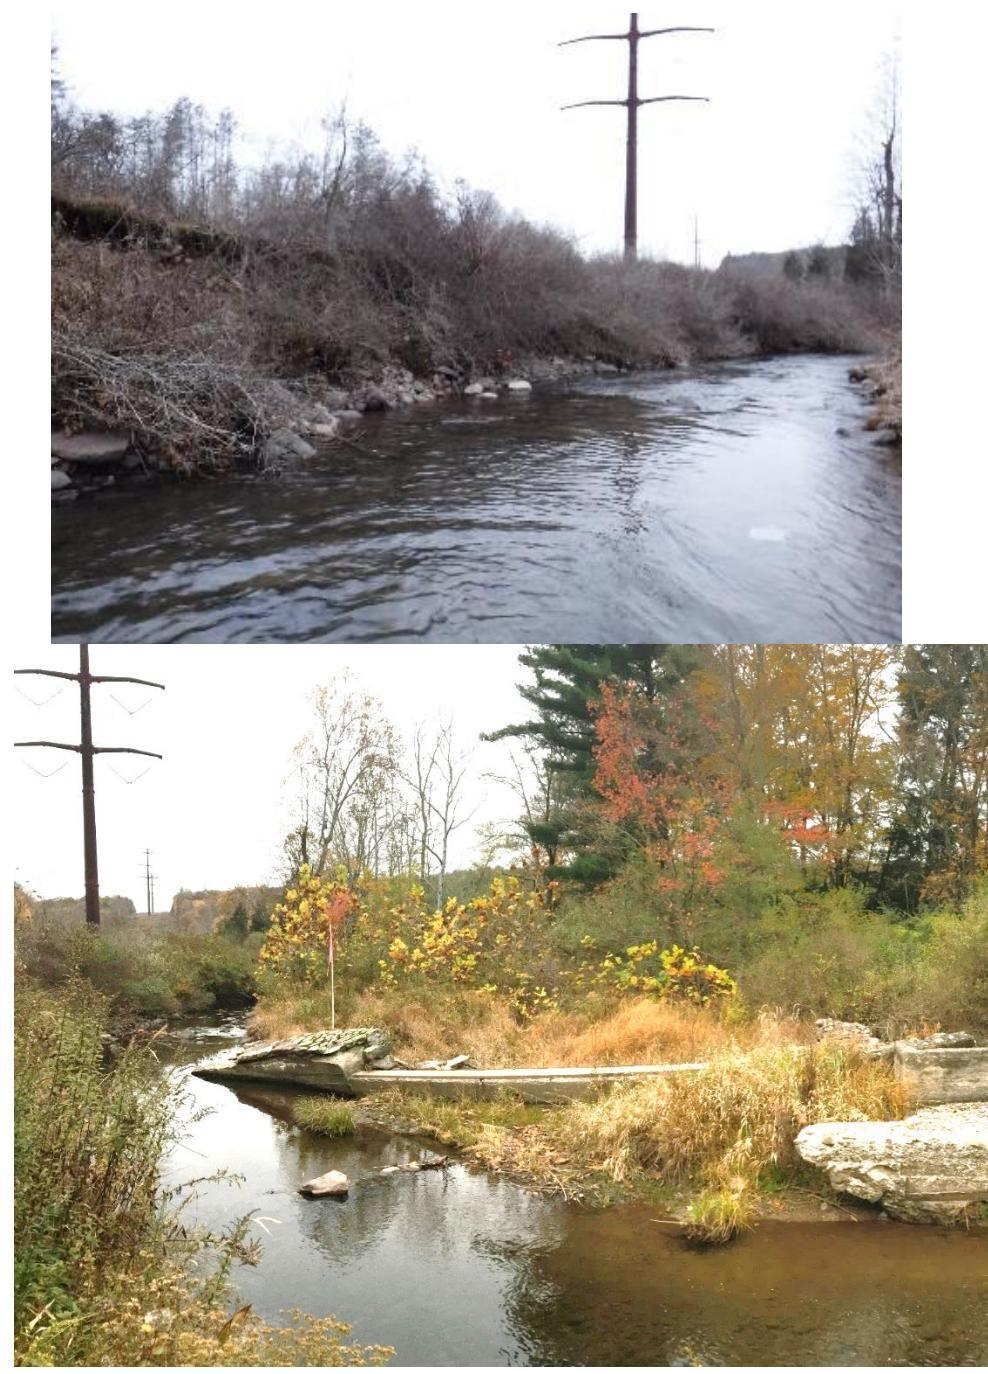
Photo 17: Mass wasting of a bank on Van Campens Brook within the Susquehanna-Roseland Transmission Line right-of-way.

This bank would be armored (stabilized) to prevent the stream from cutting further into the right-of-way, which would reduce erosion, prevent habitat loss for state-listed species, and allow vegetation to re-grow which would provide shade over the stream and reduce its temperature.

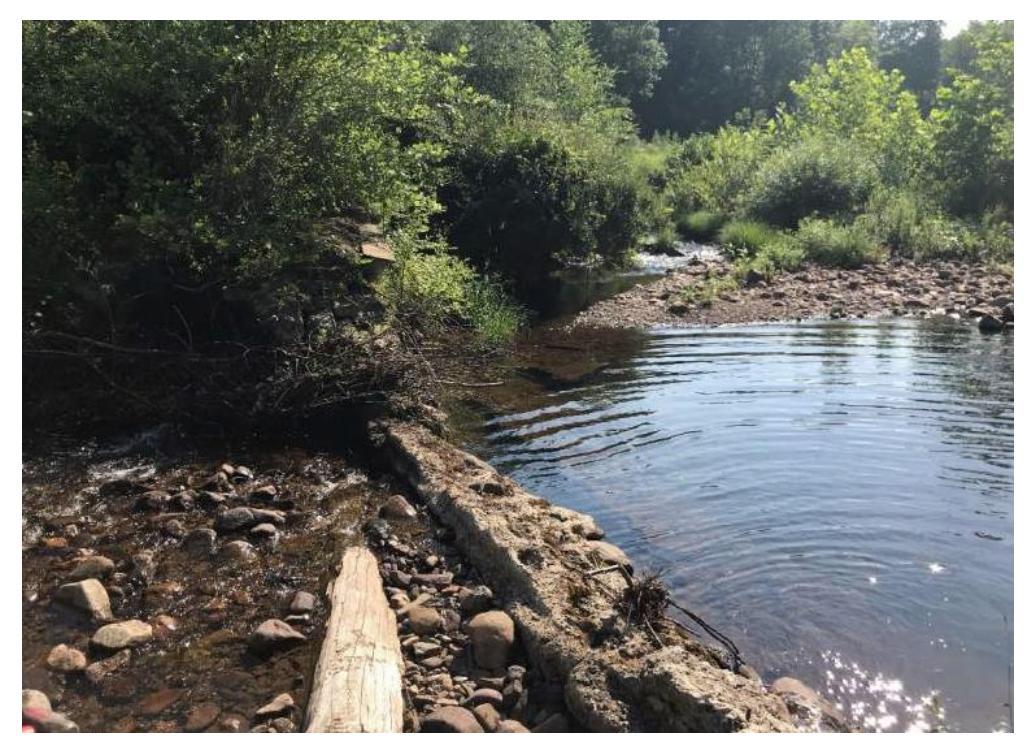
> Photo 18: Remnants of a dam in Van Campens Brook. The dam still constrains the brook, preventing the stream's hydraulics from functioning naturally.

This concrete dam remnant would be removed.

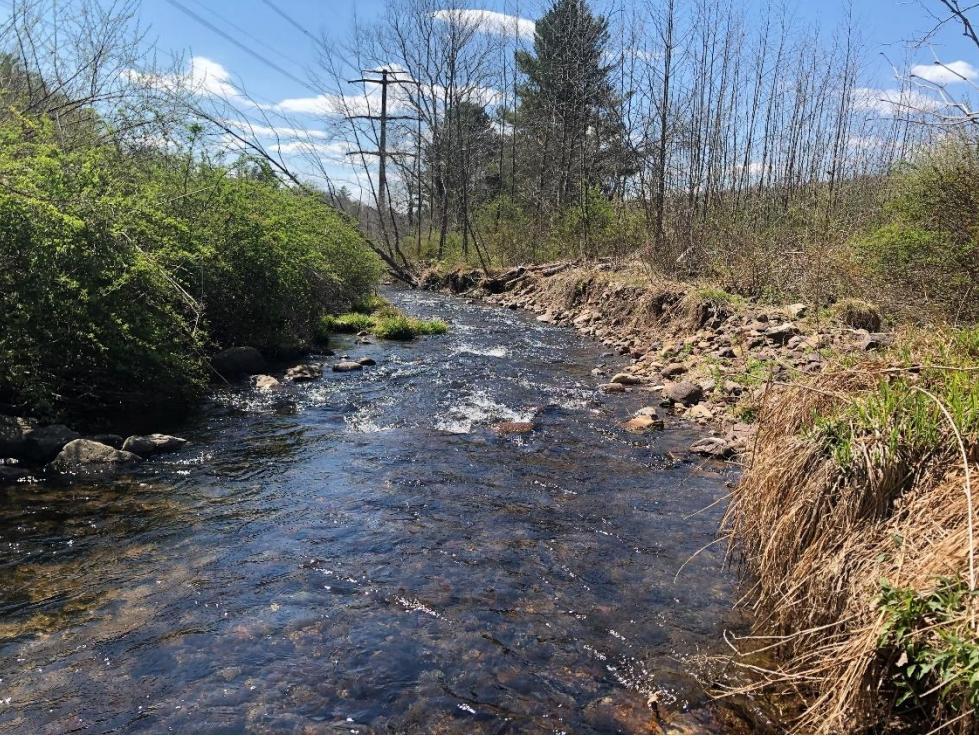
Photo 19: Another example of remnants of a concrete dam in Van Campens Brook. The dam still constrains the brook, preventing the stream's hydraulics from functioning naturally.

This concrete dam remnant would be removed.
