Biological Survey Report

Asan Springs Water Supply Facility

GUAM WATERWORKS AUTHORITY

June 2021

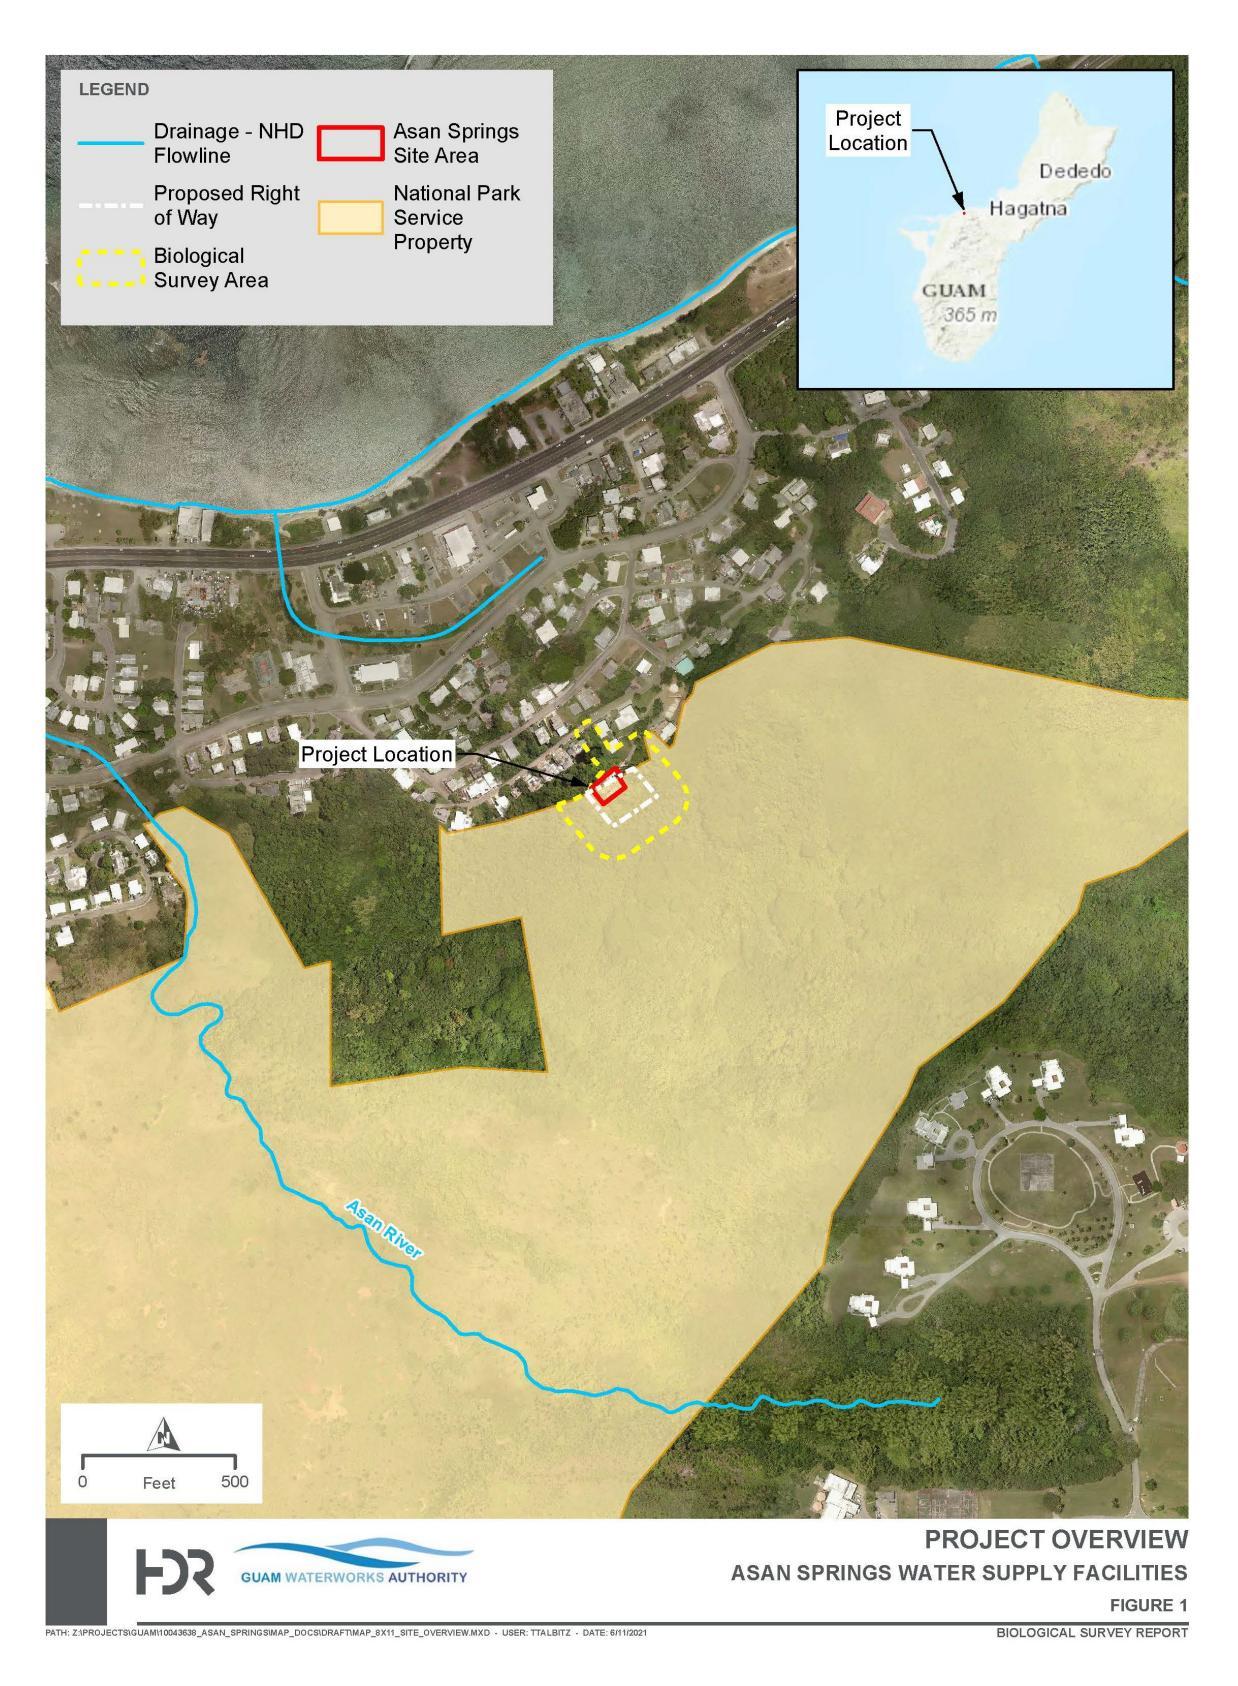
Figure 1. Proposed Asan Springs Water Supply Facility Project Overview

The Asan Springs Site Area and National Park Service Proposed Right-of-Way (Project Area) is located on a steep slope between the Asan village and Nimitz Hill and is partially within the Asan Inland Unit, which is run by the National Park Service (**see Figure 1**). The Project Area is 1.08 acres and the property is owned by the Guam Waterworks Authority and the National Park Service.

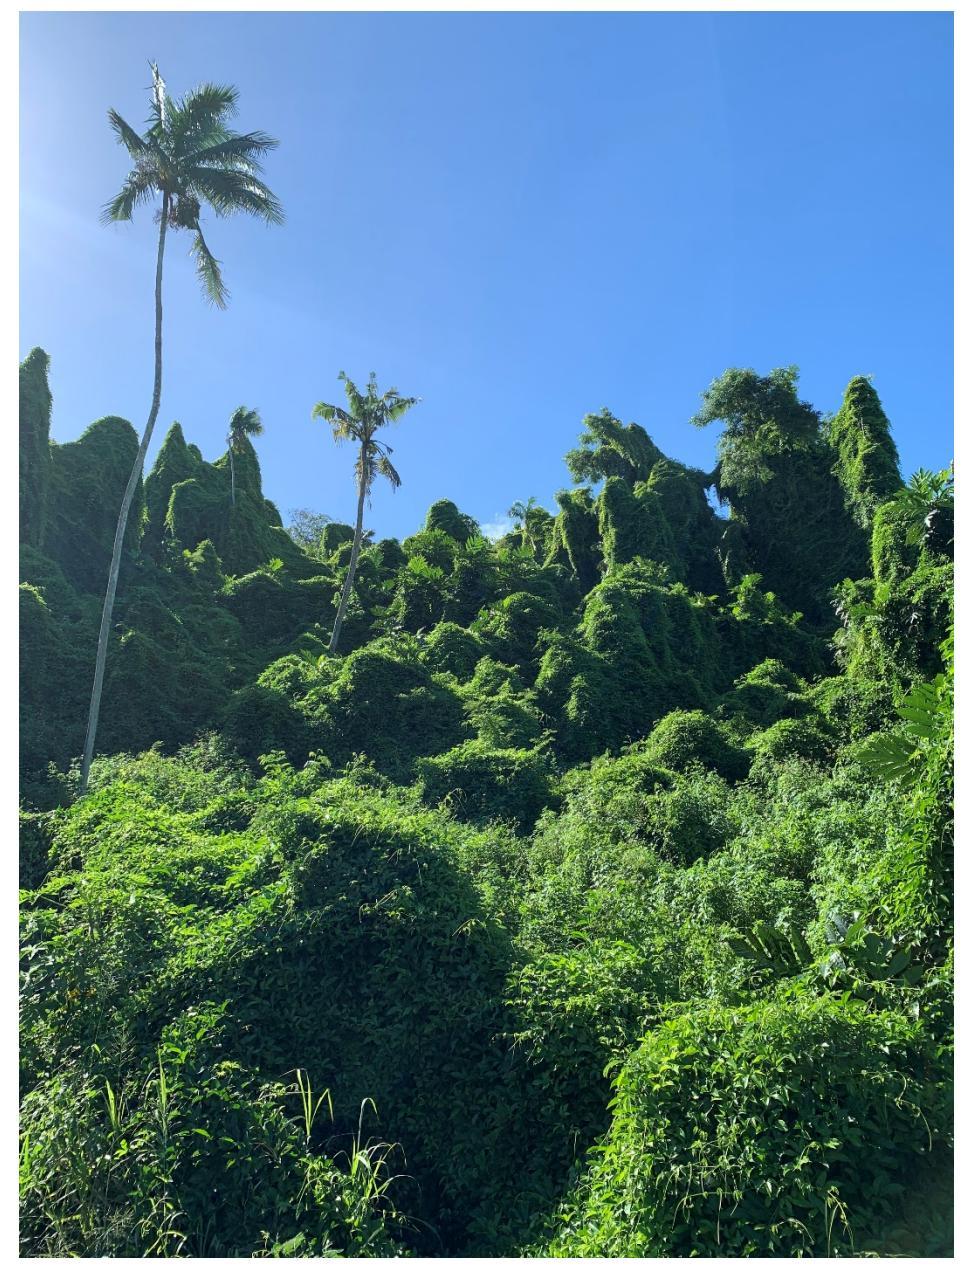
Photo 1. Tetrastigma pubinerve vines at Proposed Asan Springs Water Supply Facility

The Project Area is a mixed, mesophytic evergreen forest of elevated limestone slopes characterized with native and non-native plant species and, consequently, more abundant undergrowth (Fosberg 1960). Climbing vines, including *Tetrastigma pubinerve* and *Antigonon leptopus*, grow primarily on existing vegetation and dominate the area (**see Photo 1**). During field surveys, a total of 21 plant species were observed (**see Appendix A Table 1**).

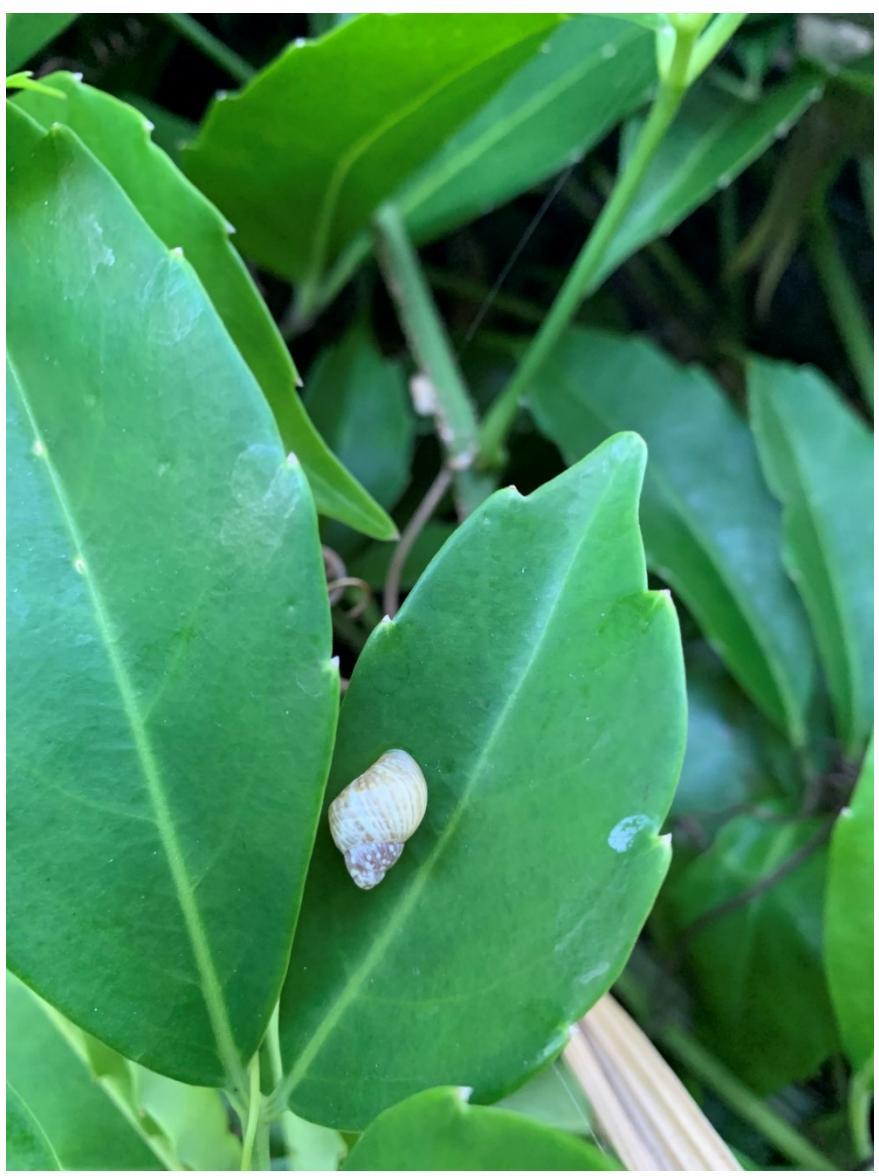
Photo 2. Partula radiolata juvenile snail

P. radiolata is one of three species of Partulid snails known to occur in Guam today, the other two being *P. gibba* and *S. fragilis. P. radiolata* are endemic to the island and are tropical, arboreal snails described to have a pale colored shell with darker axial rays and faint brown lines (**see Photo 2**). They are found throughout Guam in dense bushes on the undersides of leaves (Kerr 2013). Though *P. radiolata* are still present throughout diverse forests, populations

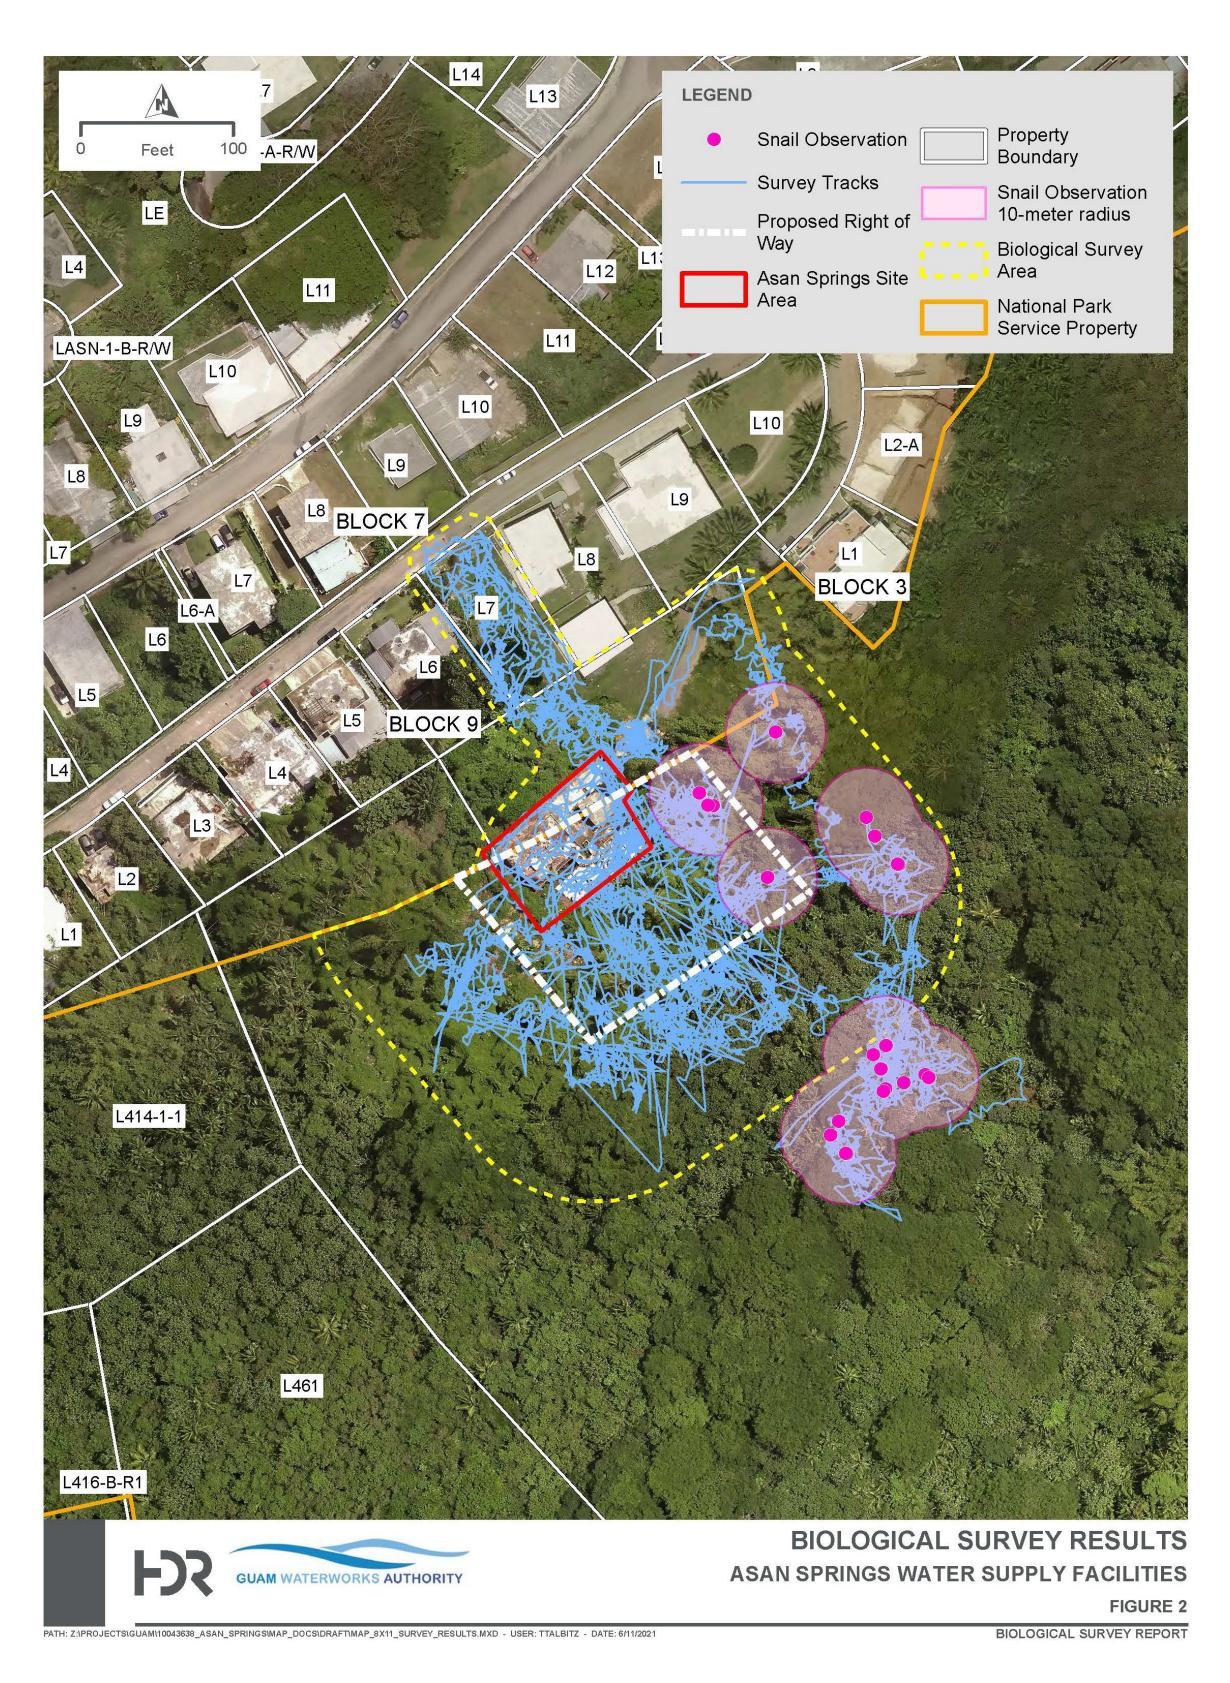
Figure 2 includes the meandering tracklogs and points recorded during the biological survey.

Small populations of the federally endangered *P. radiolata* were observed during field surveys. These populations were located within the northeast area of the proposed right-of-way and the 30-meter survey buffer area (**see Figure 2**). The *P. radiolata* snails were observed on *T. pubinerve* vines, which may aid in movement to suitable host plant species. The vegetation in the Project Area has the potential to support other federally listed snail species, such as *P. gibba* and *S. fragilis*.
