**U.S. Department of the Interior  
NATIONAL PARK SERVICE  
Virgin Islands National Park**

**Various Tracts  
Caneel Bay Resort**

**Level I  
Pre-Acquisition  
Environmental Site Assessment  
Survey**

**September 4, 2012**

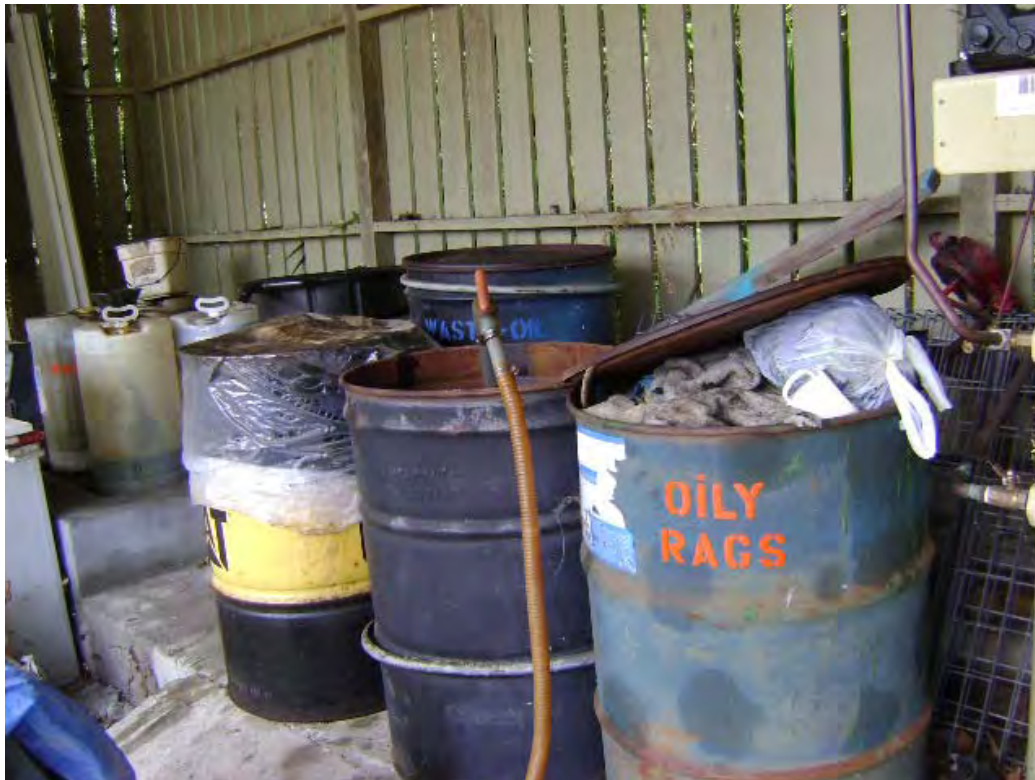
- Approximately 20 buildings are located in the engineering and maintenance area, which is in the southeast part of the property. The area appears to be used for the repair and maintenance of buildings, vehicles, golf carts, and landscape maintenance equipment, and for charging vehicular batteries. Numerous open and closed containers of waste motor oil, and oil filters were present in this area. Automotive batteries were observed on the concrete floors; the floors were stained from battery leakage. Several areas of oil stains on the work tables, concrete floors and on the soil outside the buildings were observed in this area. Numerous storm water drains are present near buildings with oil stained floors. The storm water drains and the surface drainage in the area appear to flow east and north to a small drainage ditch north of the engineering area. The stained tables, floors and soil are considered to be a recognized environmental condition (REC).

**Waste Oil Storage Area in Engineering & Maintenance Area**

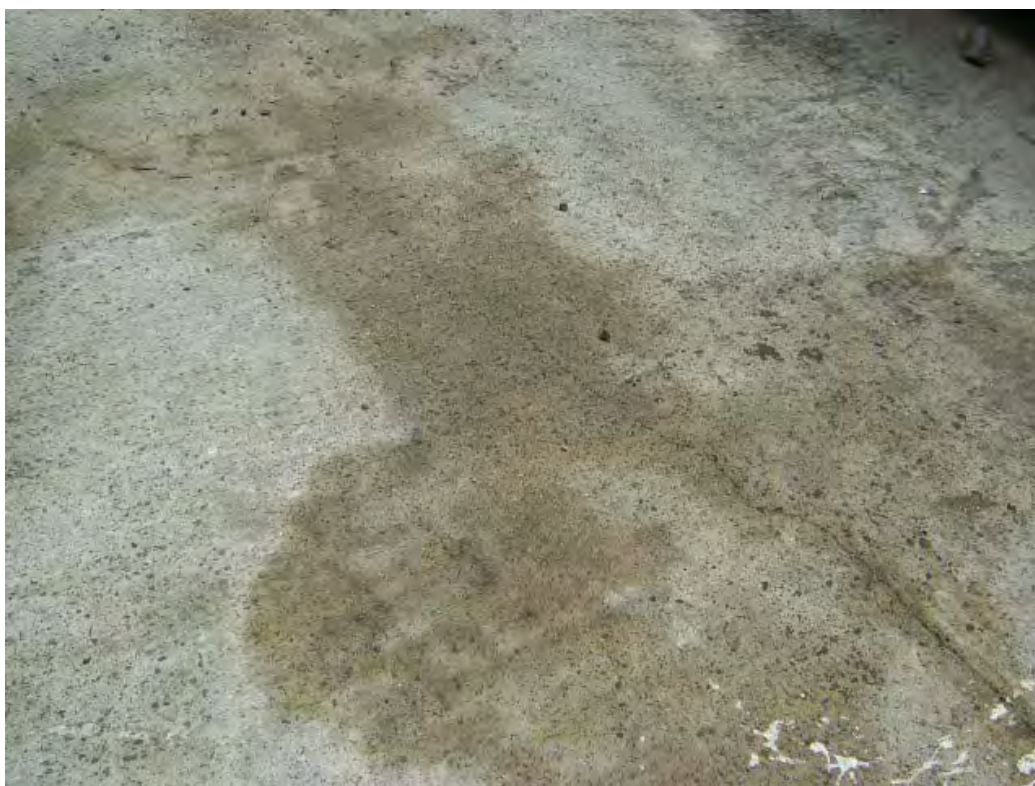
**Oil Stained Concrete Floor in Engineering & Maintenance Area**

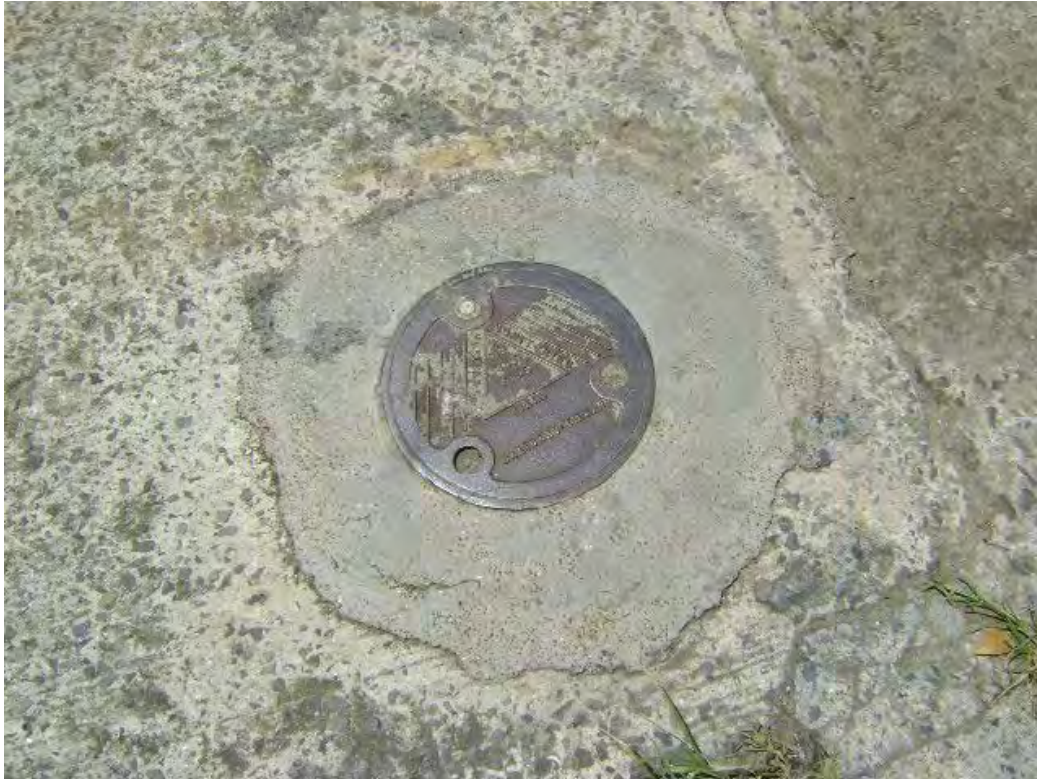
- A flush-mounted monitoring well manhole was observed in the concrete pavement just south of the diving storage building. Alvin Nazario with the Caneel Bay Resort indicated that the well was put in to monitor underground fuel storage tanks (USTs) that were removed from that area in the 1990s; Mr. Nazario stated that no contamination was detected in the well. The former USTs and monitoring well are considered to be a REC.

**Monitoring Well in Pavement Near Diving Storage Building in Engineering & Maintenance Area**

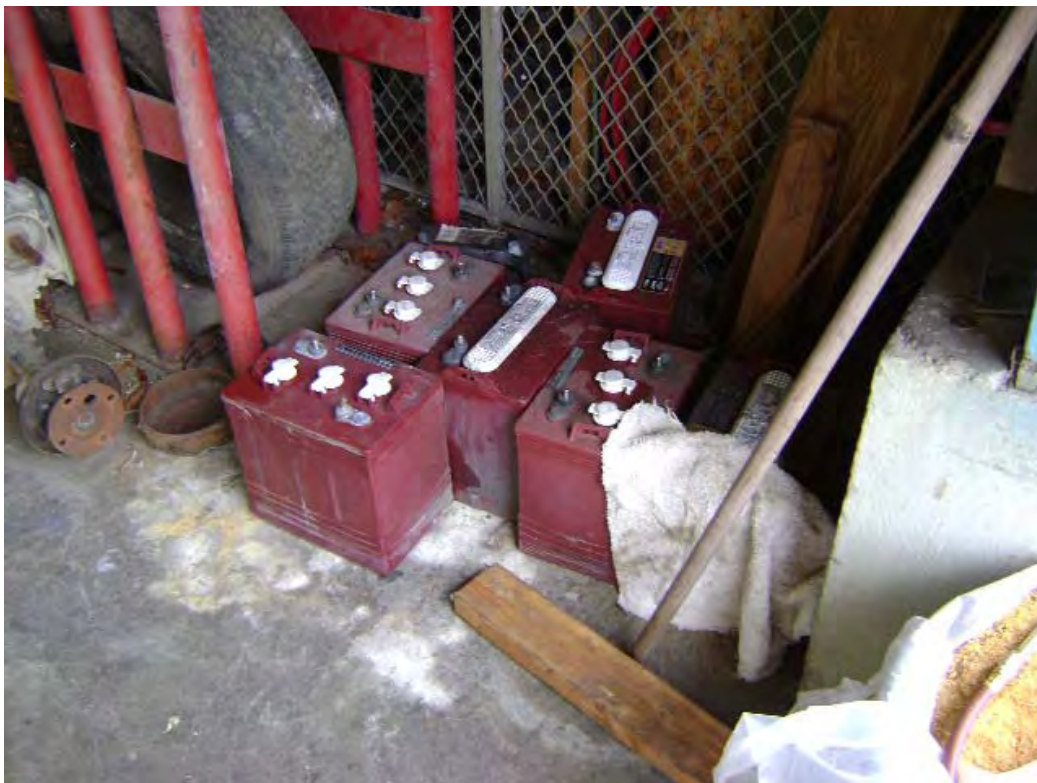
**Automotive Batteries & Stained Concrete Floor in Engineering & Maintenance Area**

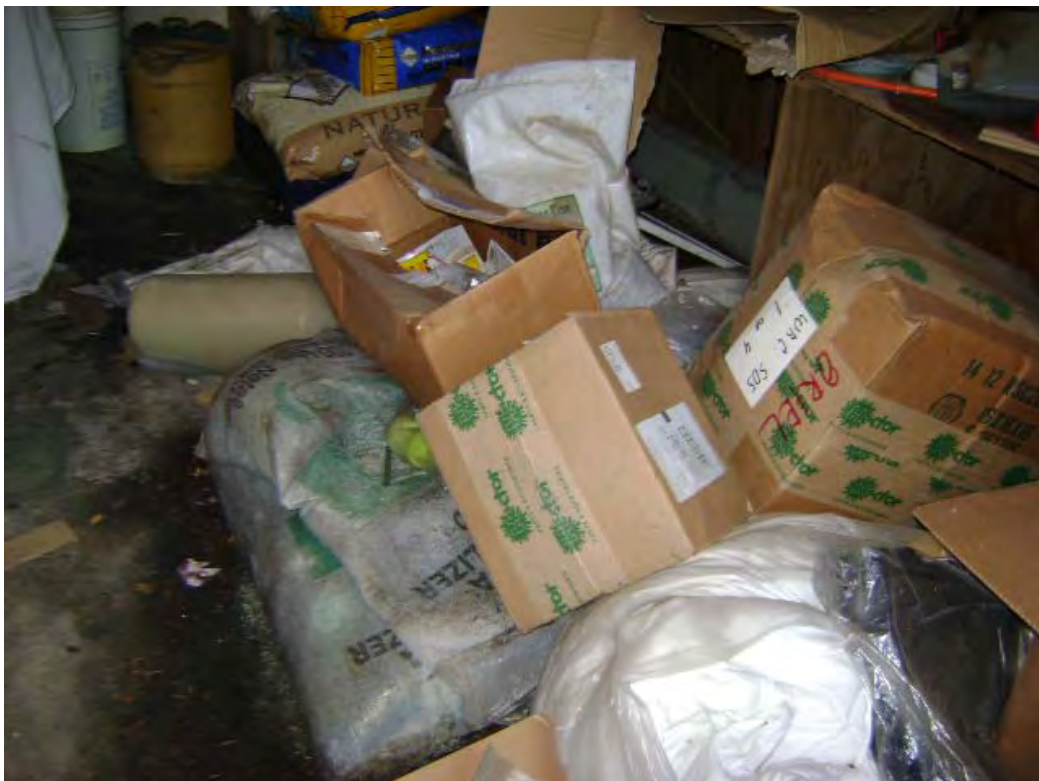
- Approximately six buildings are located in this area, which is just west of engineering. The area appears to be used for growing plants, landscape equipment repairs, and storage of lawn and garden chemicals and supplies. Several storage buildings were observed with bags and containers of various pesticides, herbicides and fertilizers; these materials were observed to have leaked or spilled onto the unpaved floors of the sheds. These leaked or spilled materials are considered to be a REC.
- An open-sided equipment maintenance building was observed to have numerous pieces of oily equipment, oil stained tables, oil-stained concrete floors, an open container of used motor oil, and numerous cans of gasoline and oil. An oily odor was present in this area. The oil-stained tables and floors are considered to be a REC.

**Fertilizer Spilled on Ground in Storage Shed in Grounds & Landscaping Area**

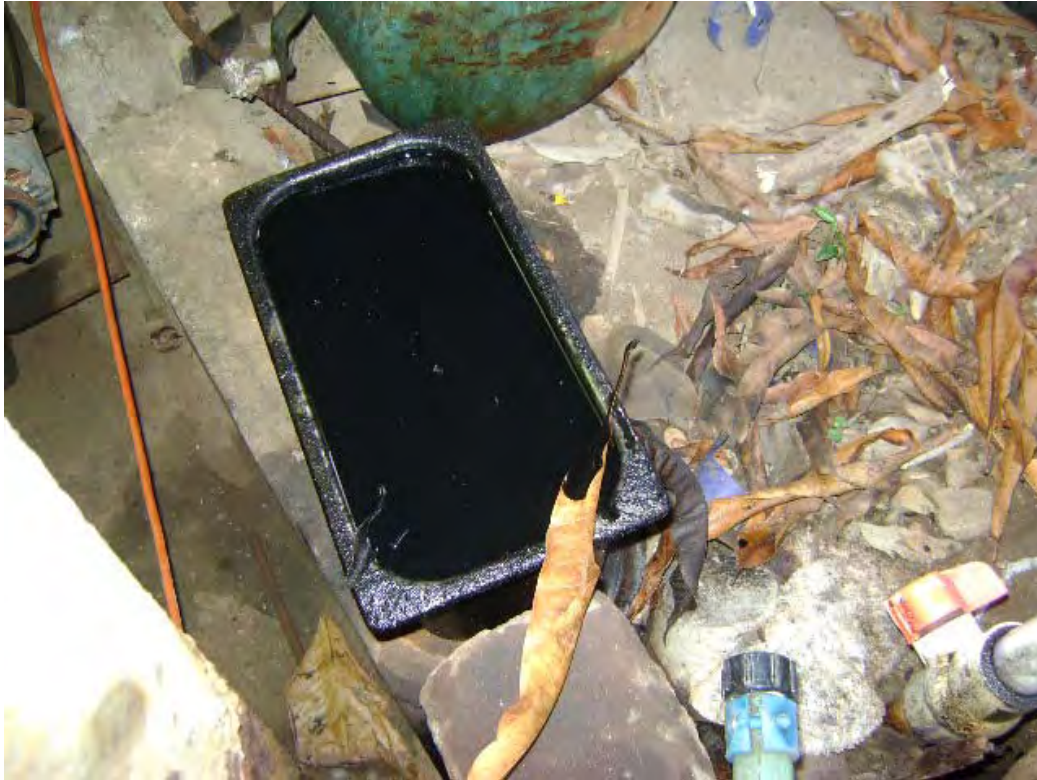
**Open Container of Waste Oil in Building in Grounds & Landscaping Area**

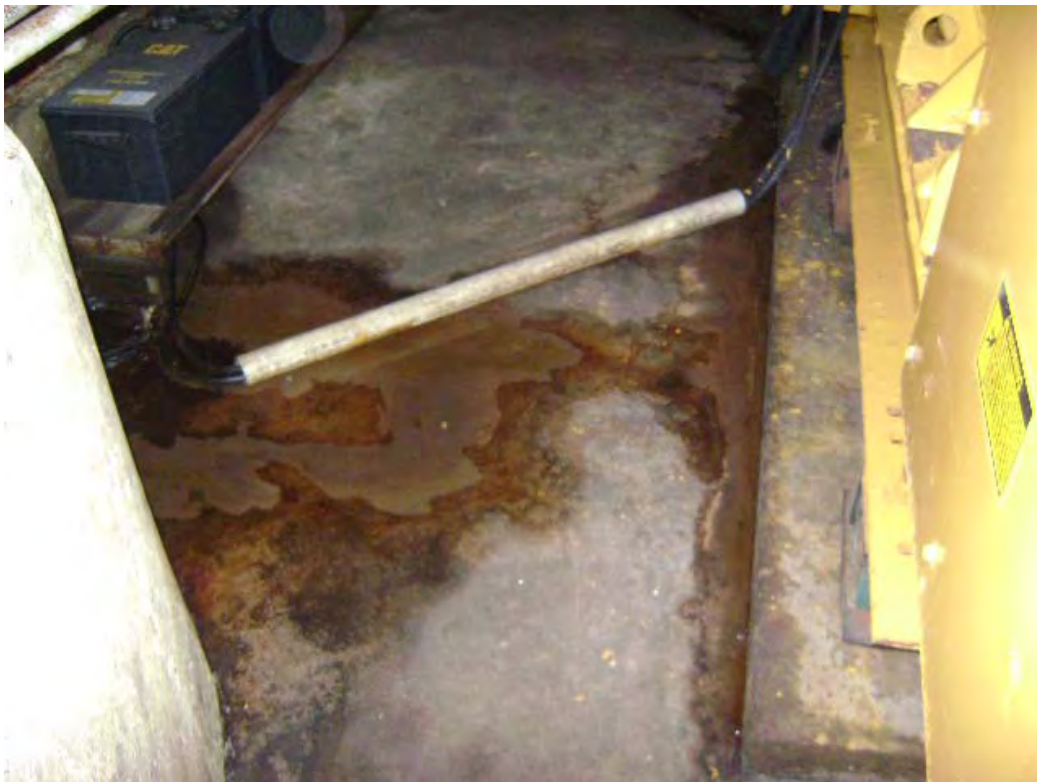
- This building is west of engineering and houses two large diesel-powered emergency electric generators. A strong oily odor was present in the building. The concrete floor beneath the generators was oil stained. Several large lead-acid batteries were present on the floor of the building. Two shallow floor gutters in the building appear to discharge oil or other liquid leaks from the generators to the soil outside on the east side of the building; two areas of oil-stained soil were present on the ground beneath these two

**Oil & Batteries on Concrete Floor of Emergency Generator Building**

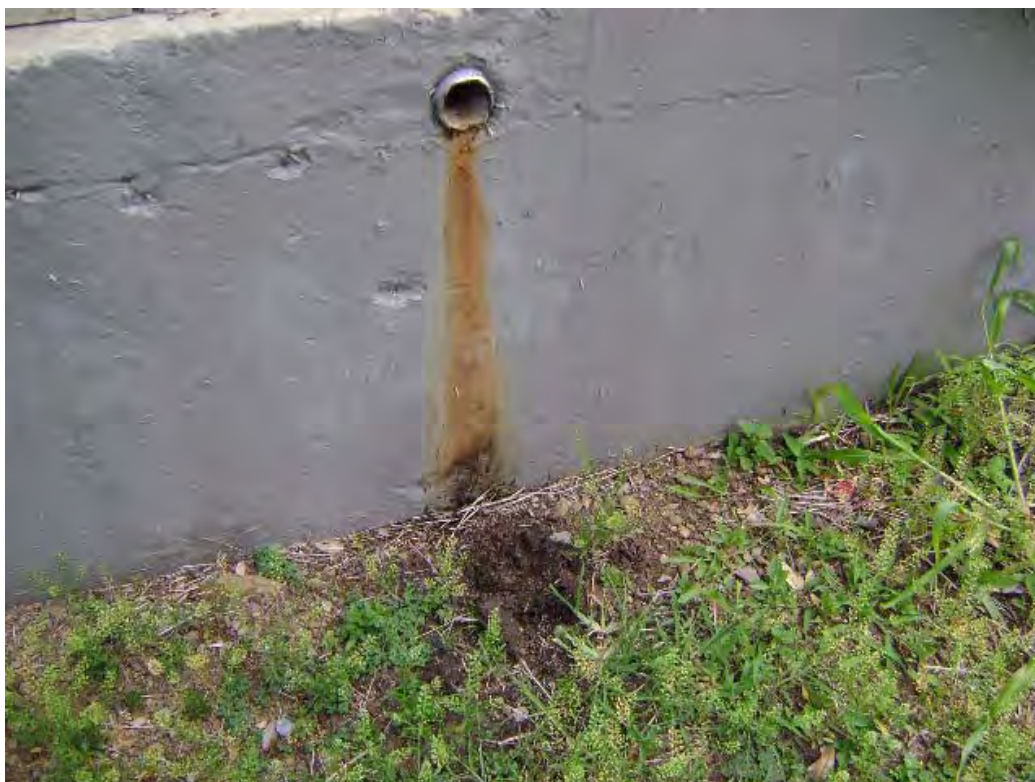
discharge points. The oil-stained floors and soil are considered to be a REC.

**Oil Discharge From Floor of Emergency Generator Building to Soil Outside Building**

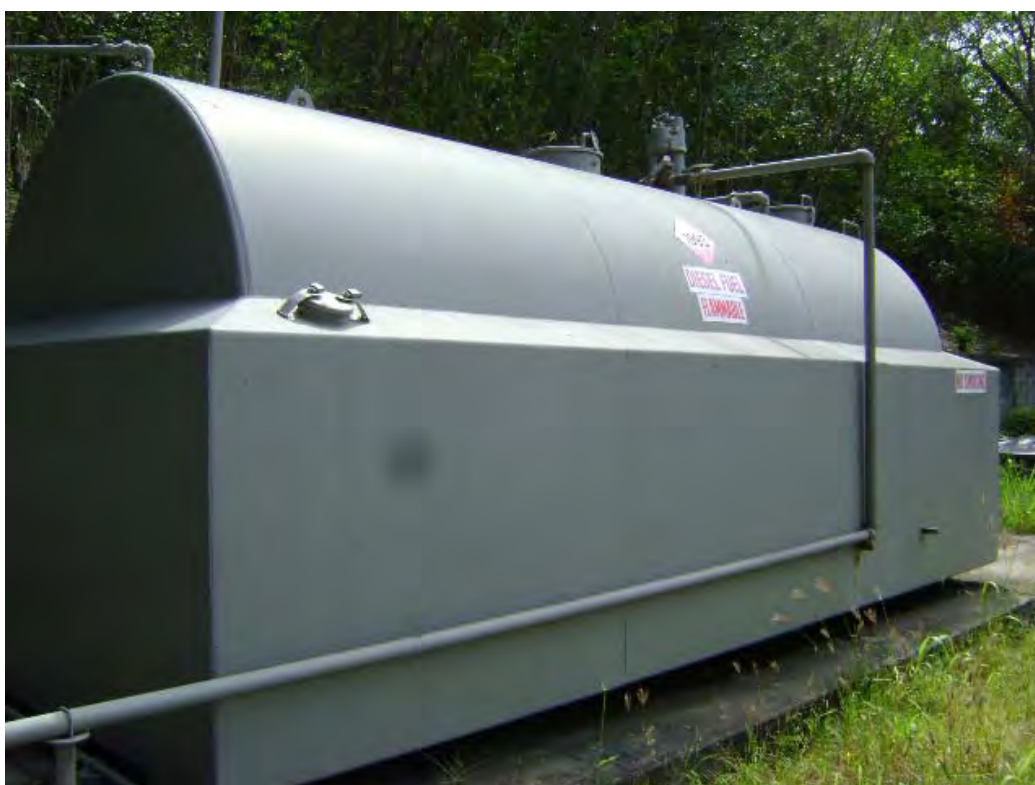
- Three above ground storage tanks (ASTs) are present just north of the generator building. One AST is approximately 20,000 gallons in capacity and appears to hold diesel fuel for the emergency generators. One AST is approximately 10,000 gallons and appears to hold gasoline. One AST is approximately 500 gallons and appears to hold gasoline. A diesel and gasoline fuel dispenser was present in the area. A diesel fuel leak is reported to have occurred two years ago; the fuel-impacted soil is reported to have been excavated, covered with a tarp and placed on a concrete pad near the ASTs. A covered area of stockpiled soil (approximately 15' by 40') was observed in this area; however, the exact area from which the soil was excavated was not determined.

**Above Ground Diesel Fuel Storage Tank for Emergency Generator**

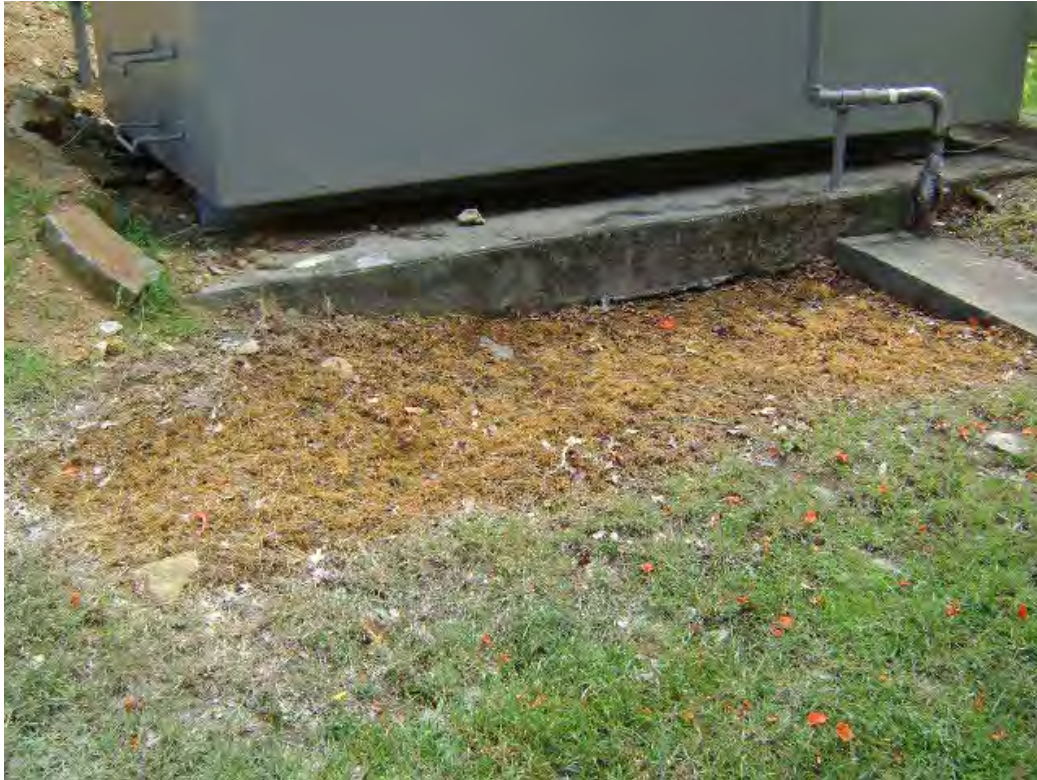
- An approximately 5' by 12' area of distressed vegetation and fuel-stained soil was observed just east of the 10,000-gallon gasoline AST; the leaked fuel appeared to be gasoline. The depth of the fuel-impacted soil was more than 6 inches.

- The past and current fuel leaks and fuel-impacted soils in this area are considered to be RECs.

**Distressed Vegetation & Fuel Impacted Soil Near Gasoline Fuel Tank North of Generator Building**

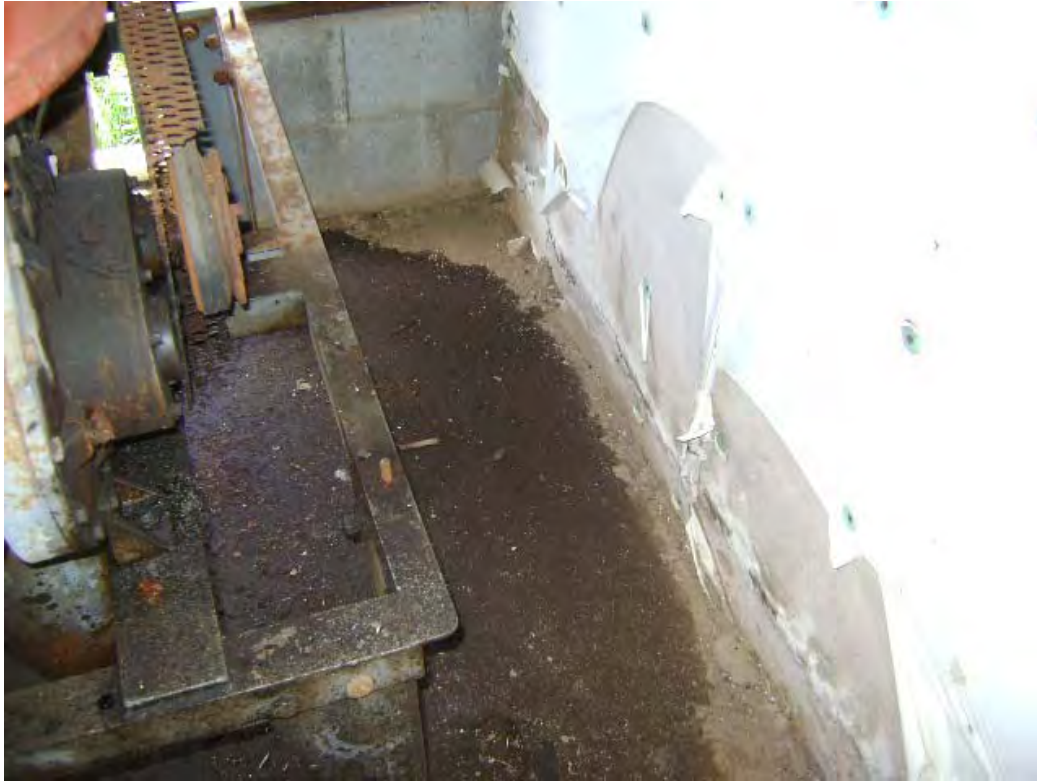
- An approximately 5' diameter oil stain was observed on the concrete floor of a small pump building for the plant.
- An approximately 2' diameter oil stain was observed on the ground near the treatment plant buildings. The stain appeared to be oil that leaked from a vehicle or other equipment previously parked at that location.
- The oil-stained floor and soil are considered to be RECs.

**Oil Stained Floor Near Pump in Building at Wastewater Treatment Plant**

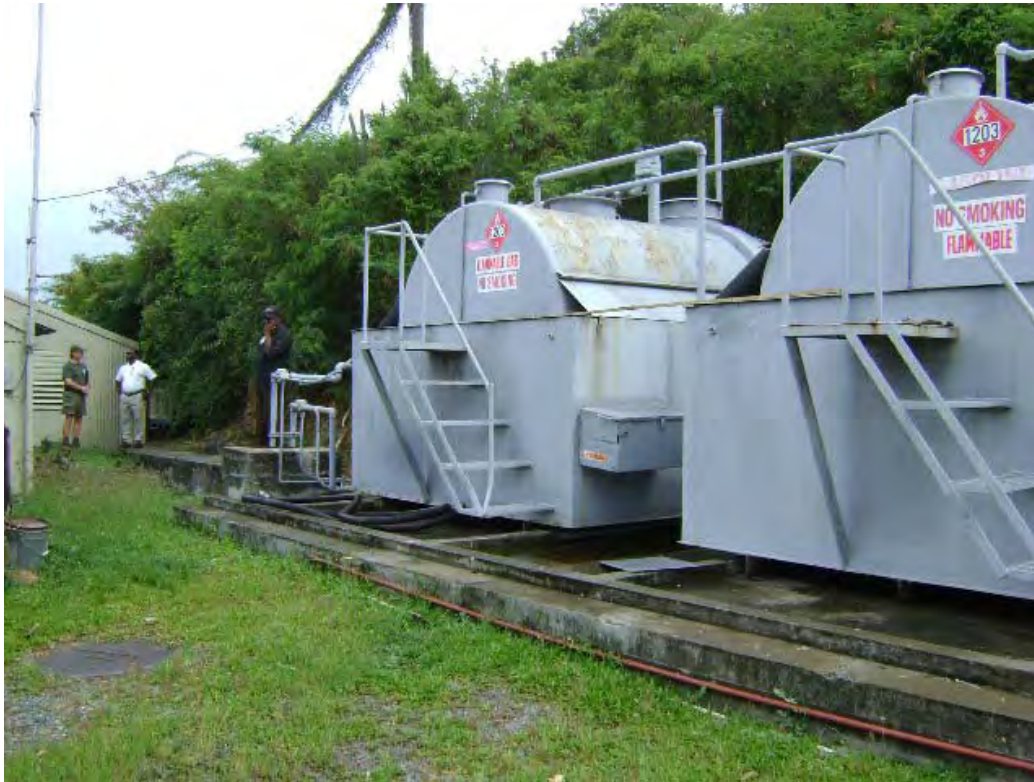
- The past and current operation of the marina, the fueling station, the fuel and waste oil ASTs, the fuel pipeline and boat repair facility (since the 1960s) are considered to be a REC for this tract.

**Above Ground Fuel Storage Tanks at Marina Facility**

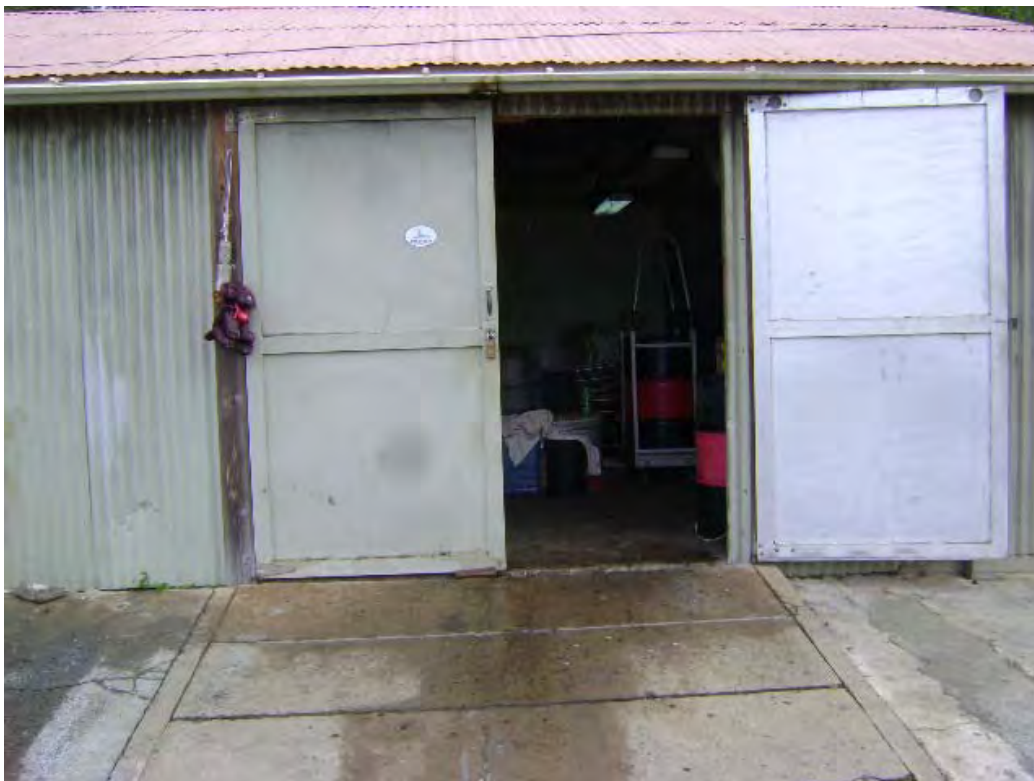
- Oil-stained concrete floors and an oily odor were present in the west building near open and closed containers of waste oil. Approximately ten lead-acid batteries were observed to be stored on the concrete floor; the floor near the batteries was stained. Numerous containers of paints, oils and cleaners were present in the west building. Outboard motors, fuel cans, air compressors and electric generators were also present in the building.

**Oil Stained Pavement Near West Building of Marina Facility**

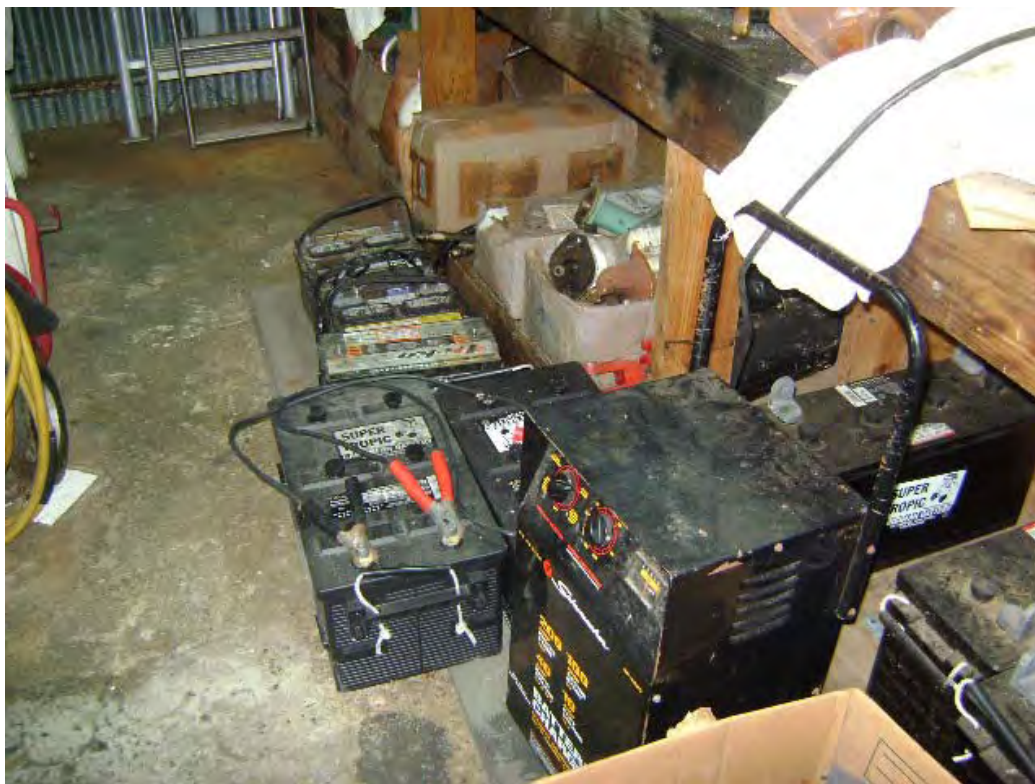
**Batteries & Stains on Floor of West Building of Marina Facility**

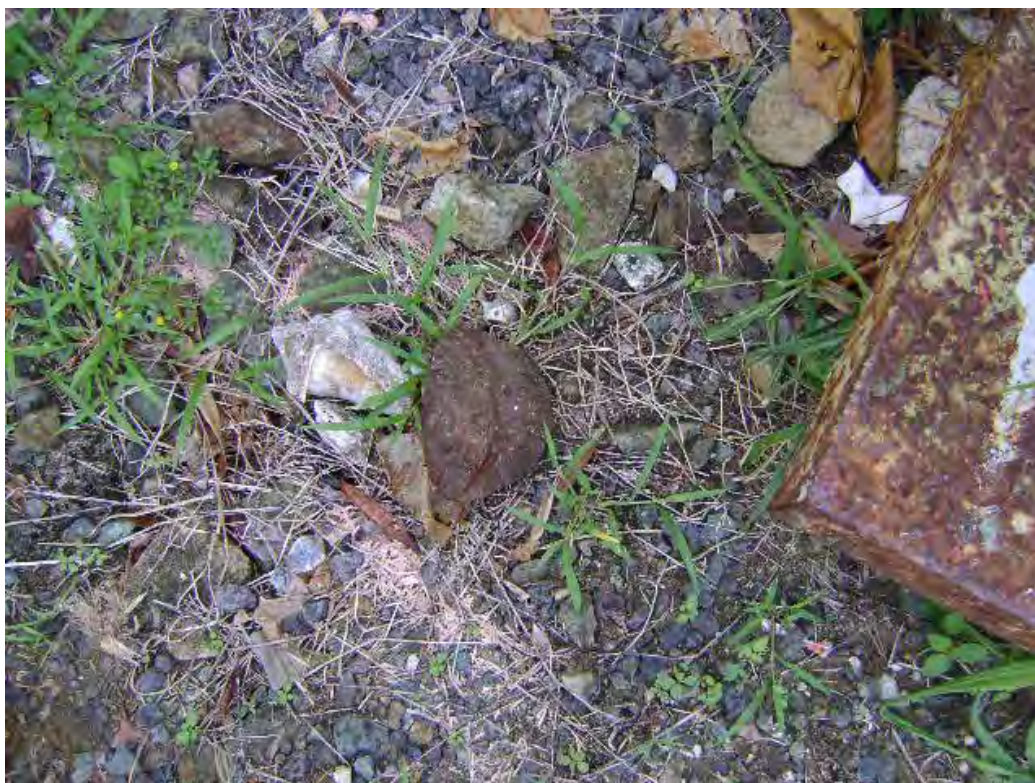
**Polyurethane Resin on Ground at Marina Facility**

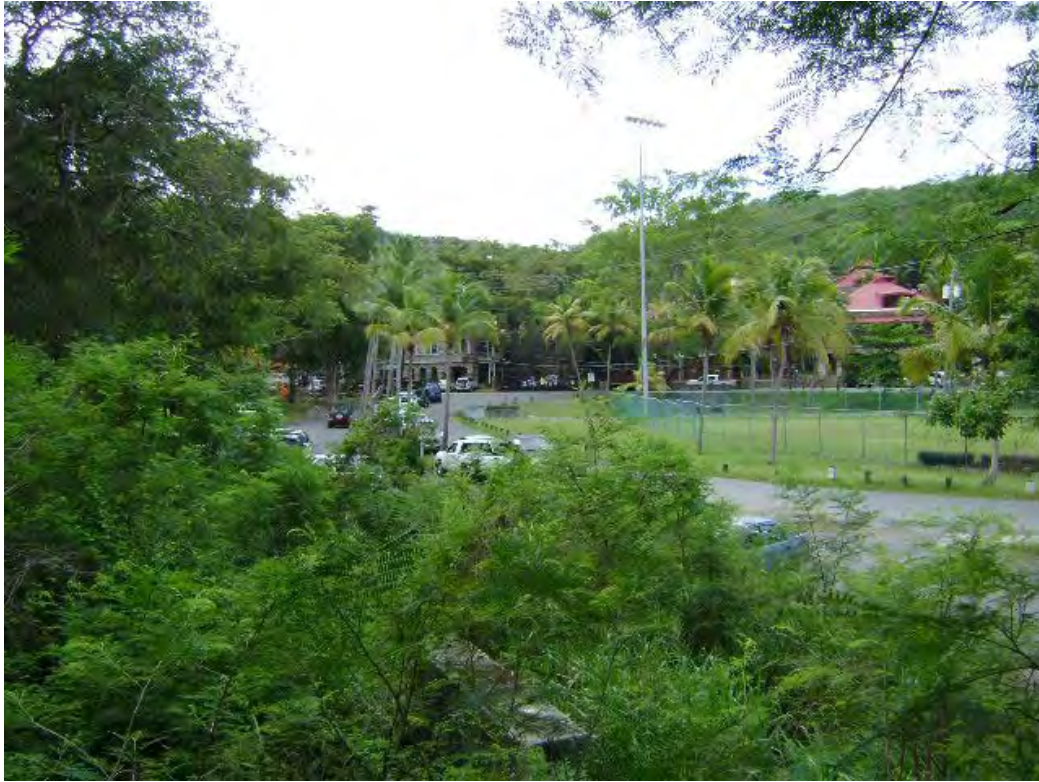
- The former location of the fuel ASTs is an overgrown area with two concrete tank support structures. No direct evidence of fuel spills or releases was observed in this area. However, the past operation of the fuel ASTs and underground pipeline is considered to be a REC for this tract.

**Area of Former Above Ground Fuel Storage Tanks on Tract 04-104 (in foreground)**

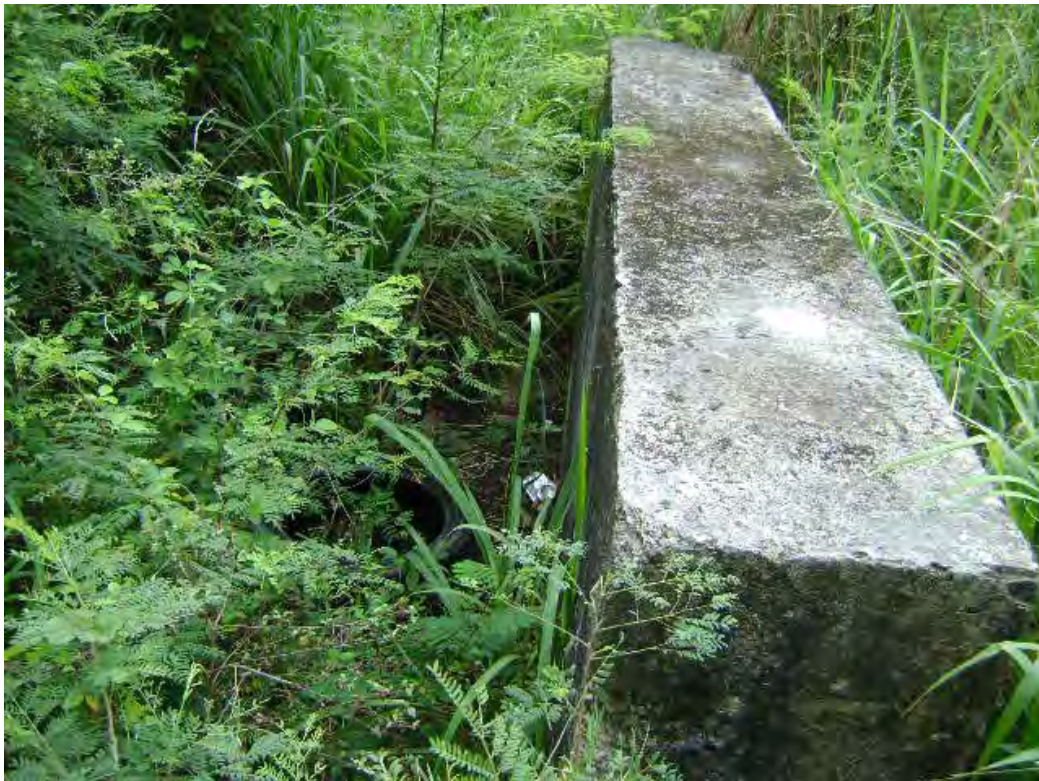
**Concrete Structure in Area of Former Above Ground Fuel Storage Tanks on Tract 04-104**

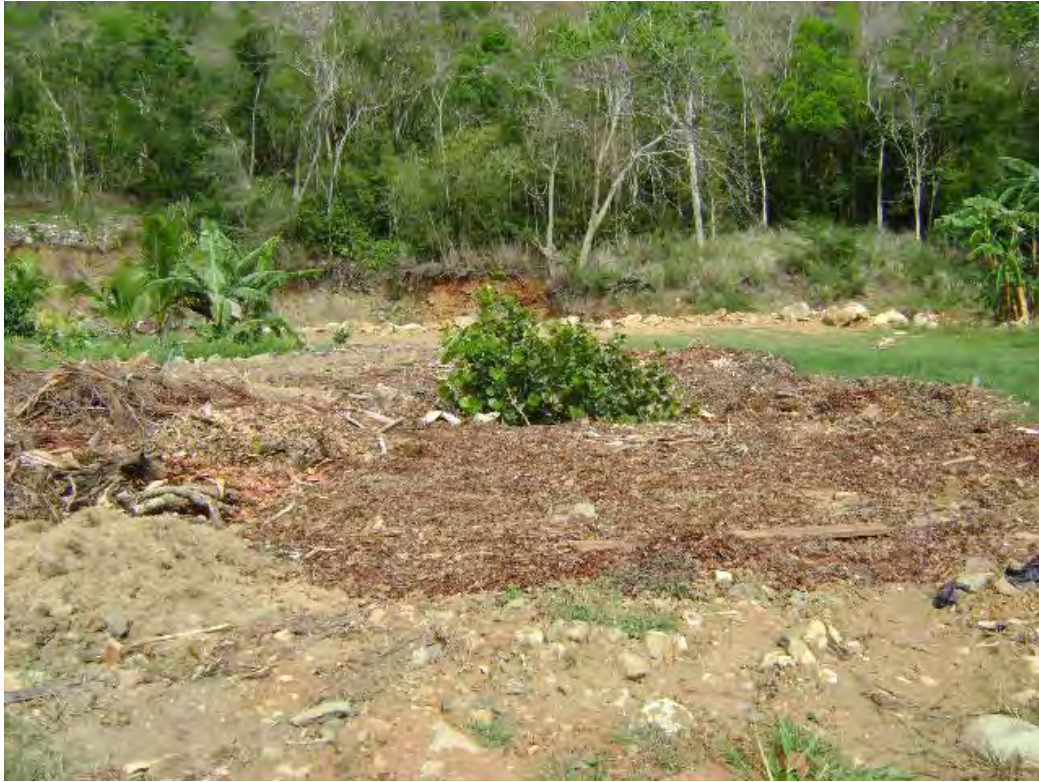
**Debris Landfill Near Honeymoon Beach**
