SUBJECT: Soil Testing Reports

# LETTER OF TRANSMITTAL

RE: **East Wing Modernization Environmental Support**  
 ECS Job # **47:22487**  
 Permits:  
 Location: **1600 Pennsylvania Ave  
 Washington, DC 20500**

## FIELD REPORT

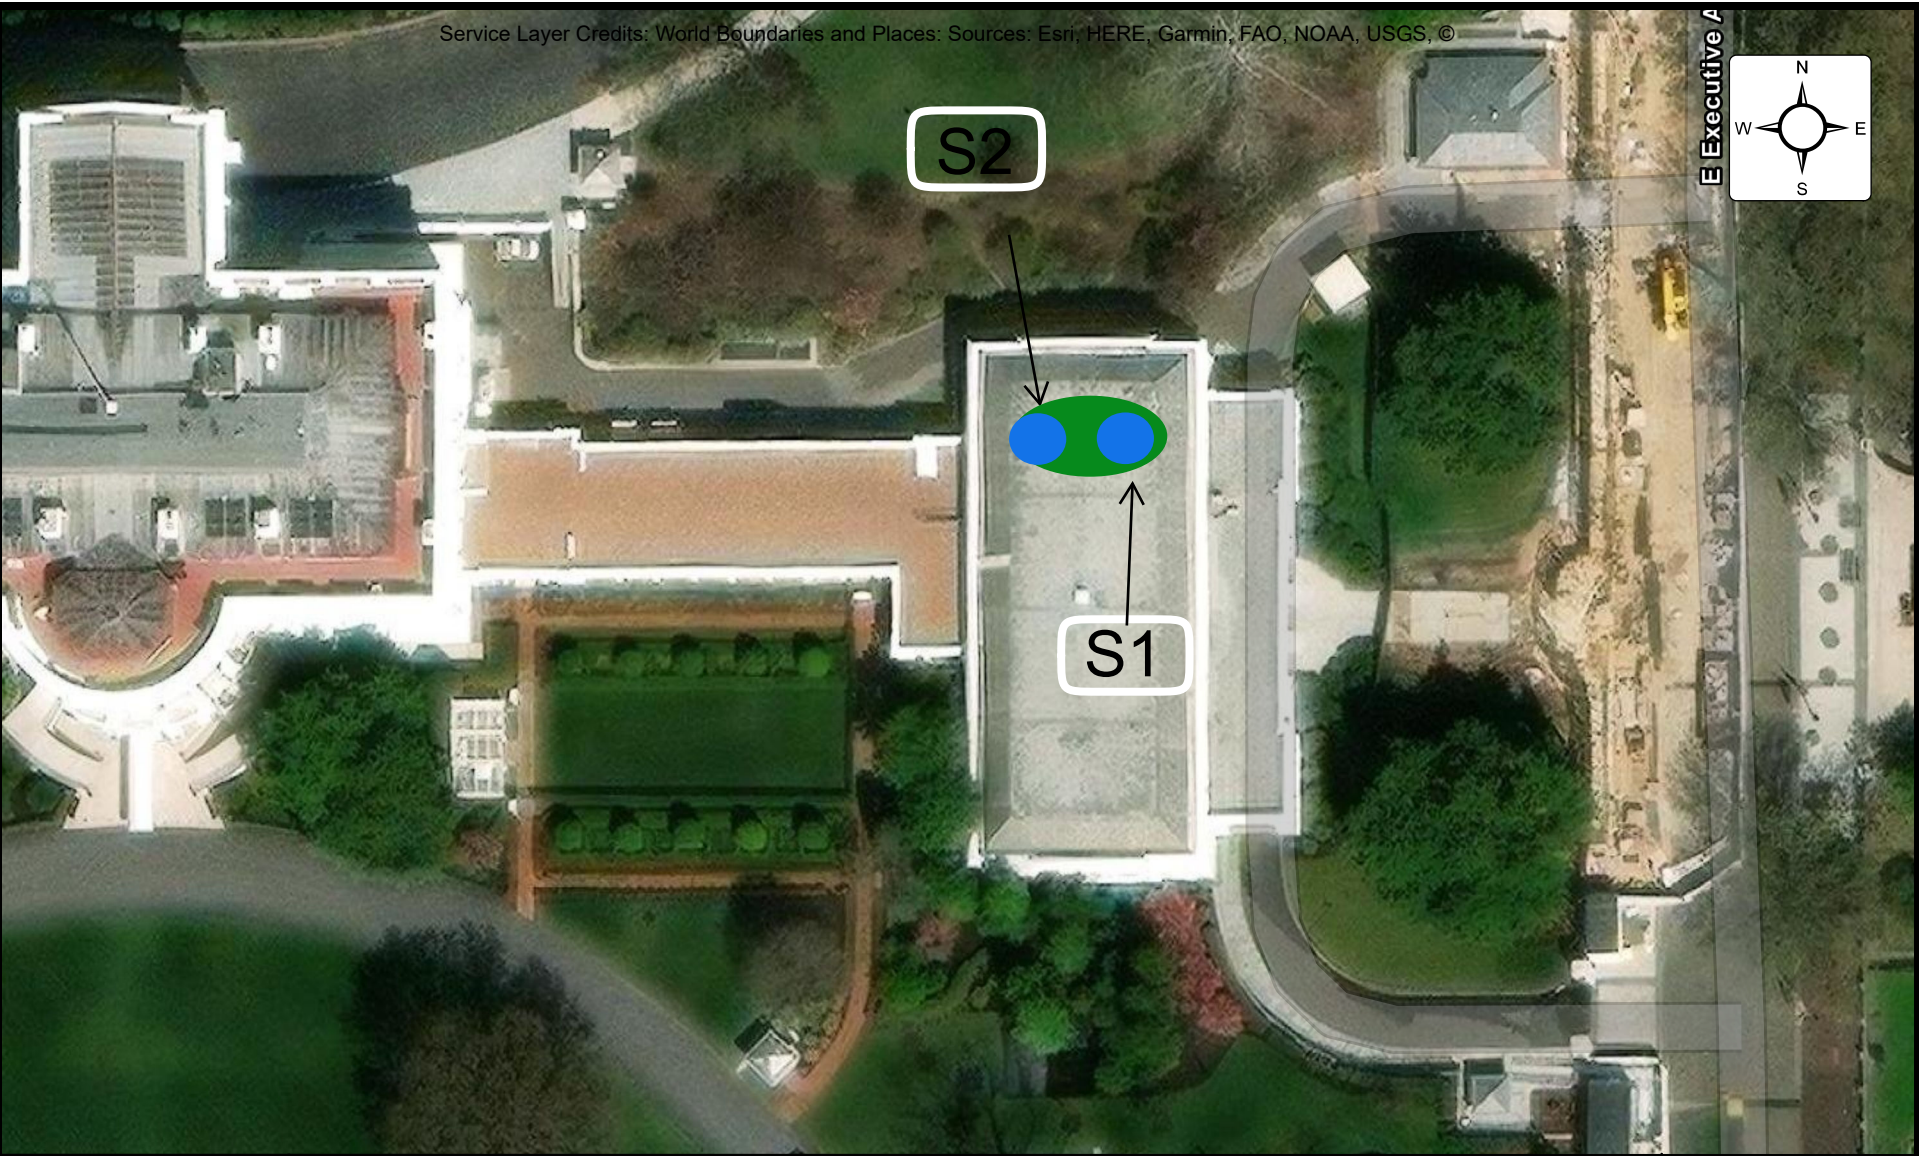
# SITE LOCATION DIAGRAM

On this date, Strittmatter was observed hauling off the stockpile of previously classified nonpetroleum-impacted material on the northern portion of the former East Wing. The stockpiled material was previously excavated from depths ranging between approximately 10 to 15 feet below ground surface (bgs).

Material field screened on this date was generally comprised of dark brown silt and sand. Field screening did not indicate evidence of petroleum impact in the samples screened, and staining and suspect odors were not observed/detected in the excavated material.

A total of 56 truckloads of nonpetroleum-impacted soil were hauled offsite on this date.

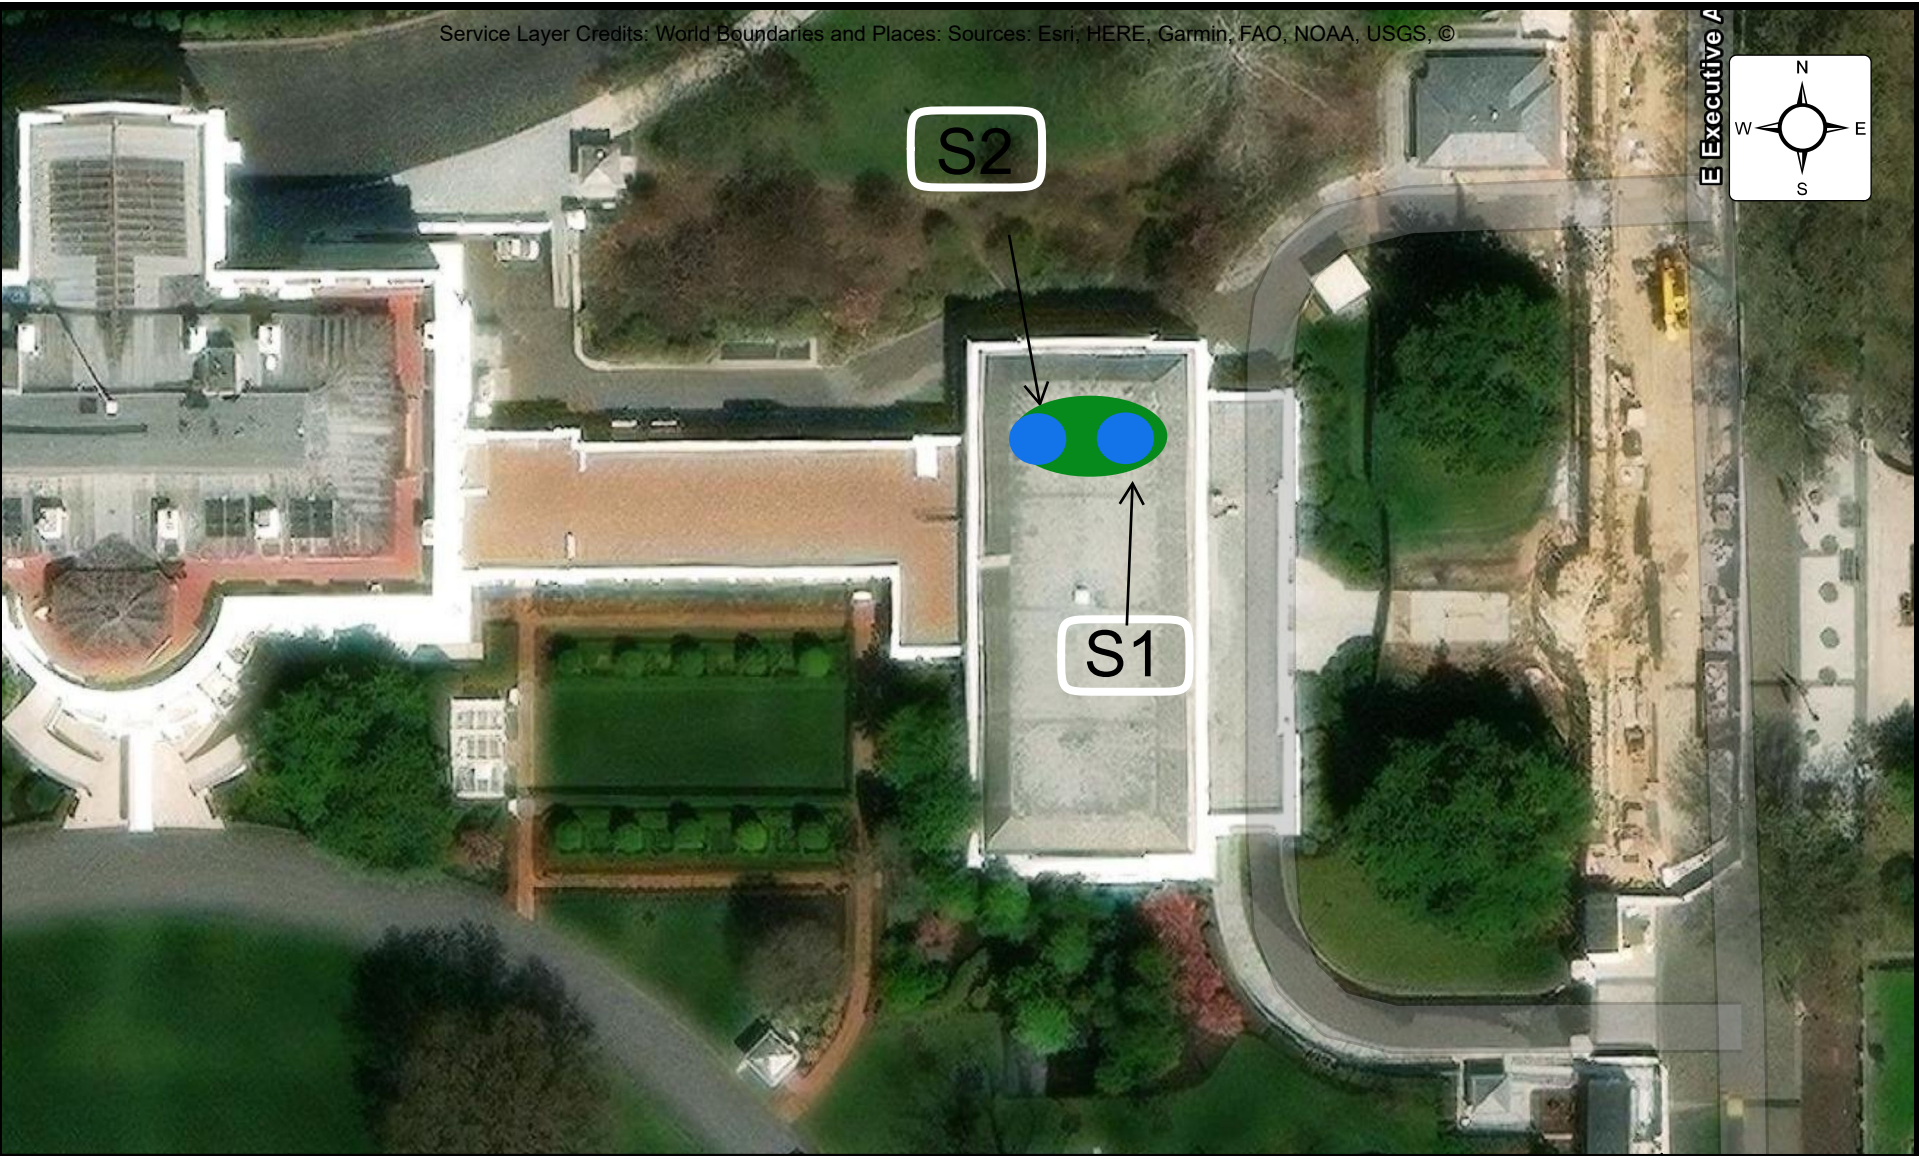
# SITE LOCATION DIAGRAM

On this date, Strittmatter was observed hauling off the stockpile of previously classified nonpetroleum-impacted material on the northern portion of the former East Wing. The stockpiled material was previously excavated from depths ranging between approximately 10 to 15 feet below ground surface (bgs).

Material field screened on this date was generally comprised of dark brown silt and sand. Field screening did not indicate evidence of petroleum impact in the samples screened, and staining and suspect odors were not observed/detected in the excavated material.

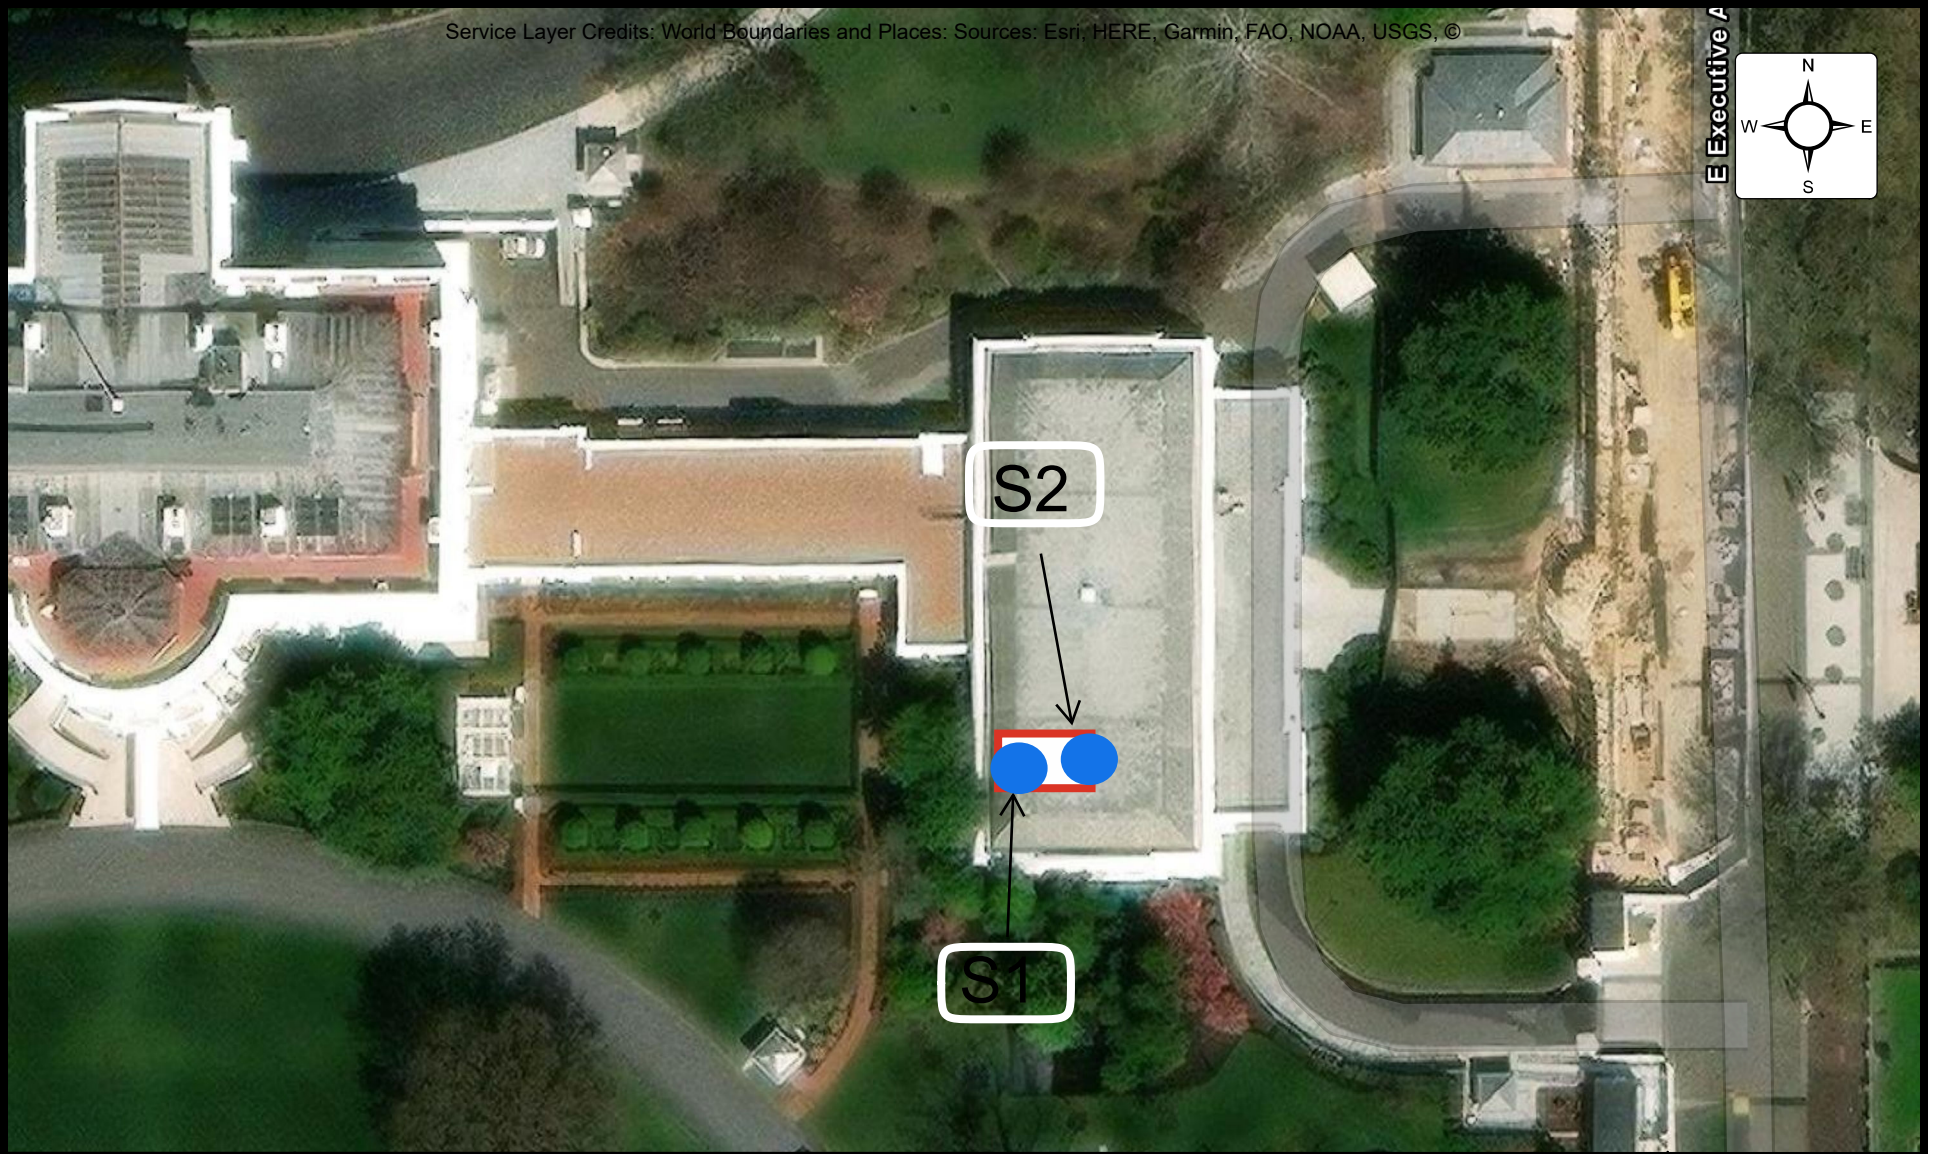
# SITE LOCATION DIAGRAM

On this date, Strittmatter was observed excavating against the wall on the southern portion of the former East Wing. Material was excavated to a depth of approximately 5 to 10 feet below ground surface (bgs).

Material field screened on this date was generally comprised of dark orangish brown silt and sand. Field screening did not indicate evidence of petroleum impact in the samples screened, and staining and suspect odors were not observed/detected in the excavated material.

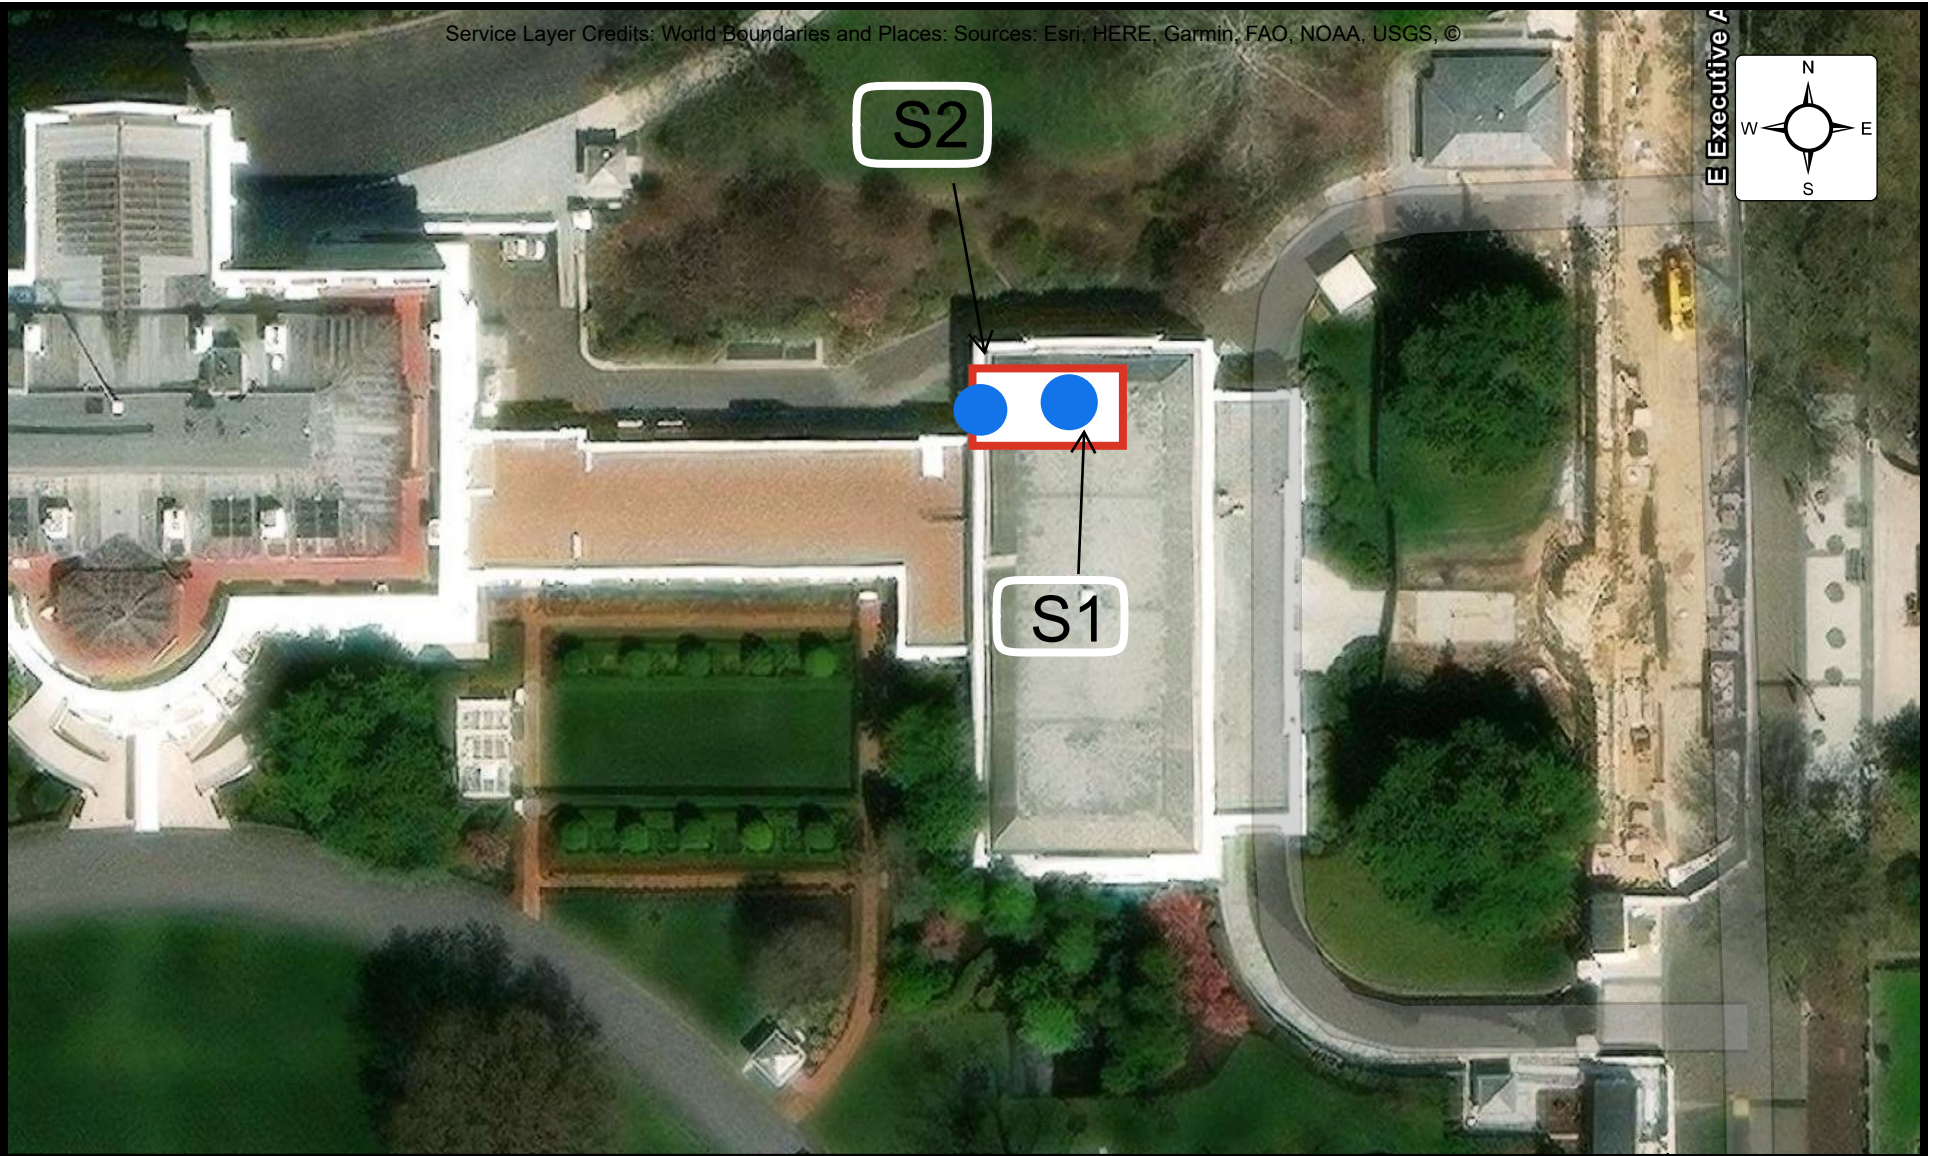
# SITE LOCATION DIAGRAM

On this date, Strittmatter was observed excavating on the northwest portion of the former East Wing. Material was excavated at a depth of approximately 15 feet below ground surface (bgs).

Material field screened on this date was generally comprised of dark brown silt and sand. Field screening did not indicate evidence of petroleum impact in the samples screened, and staining and suspect odors were not observed/detected in the excavated material.

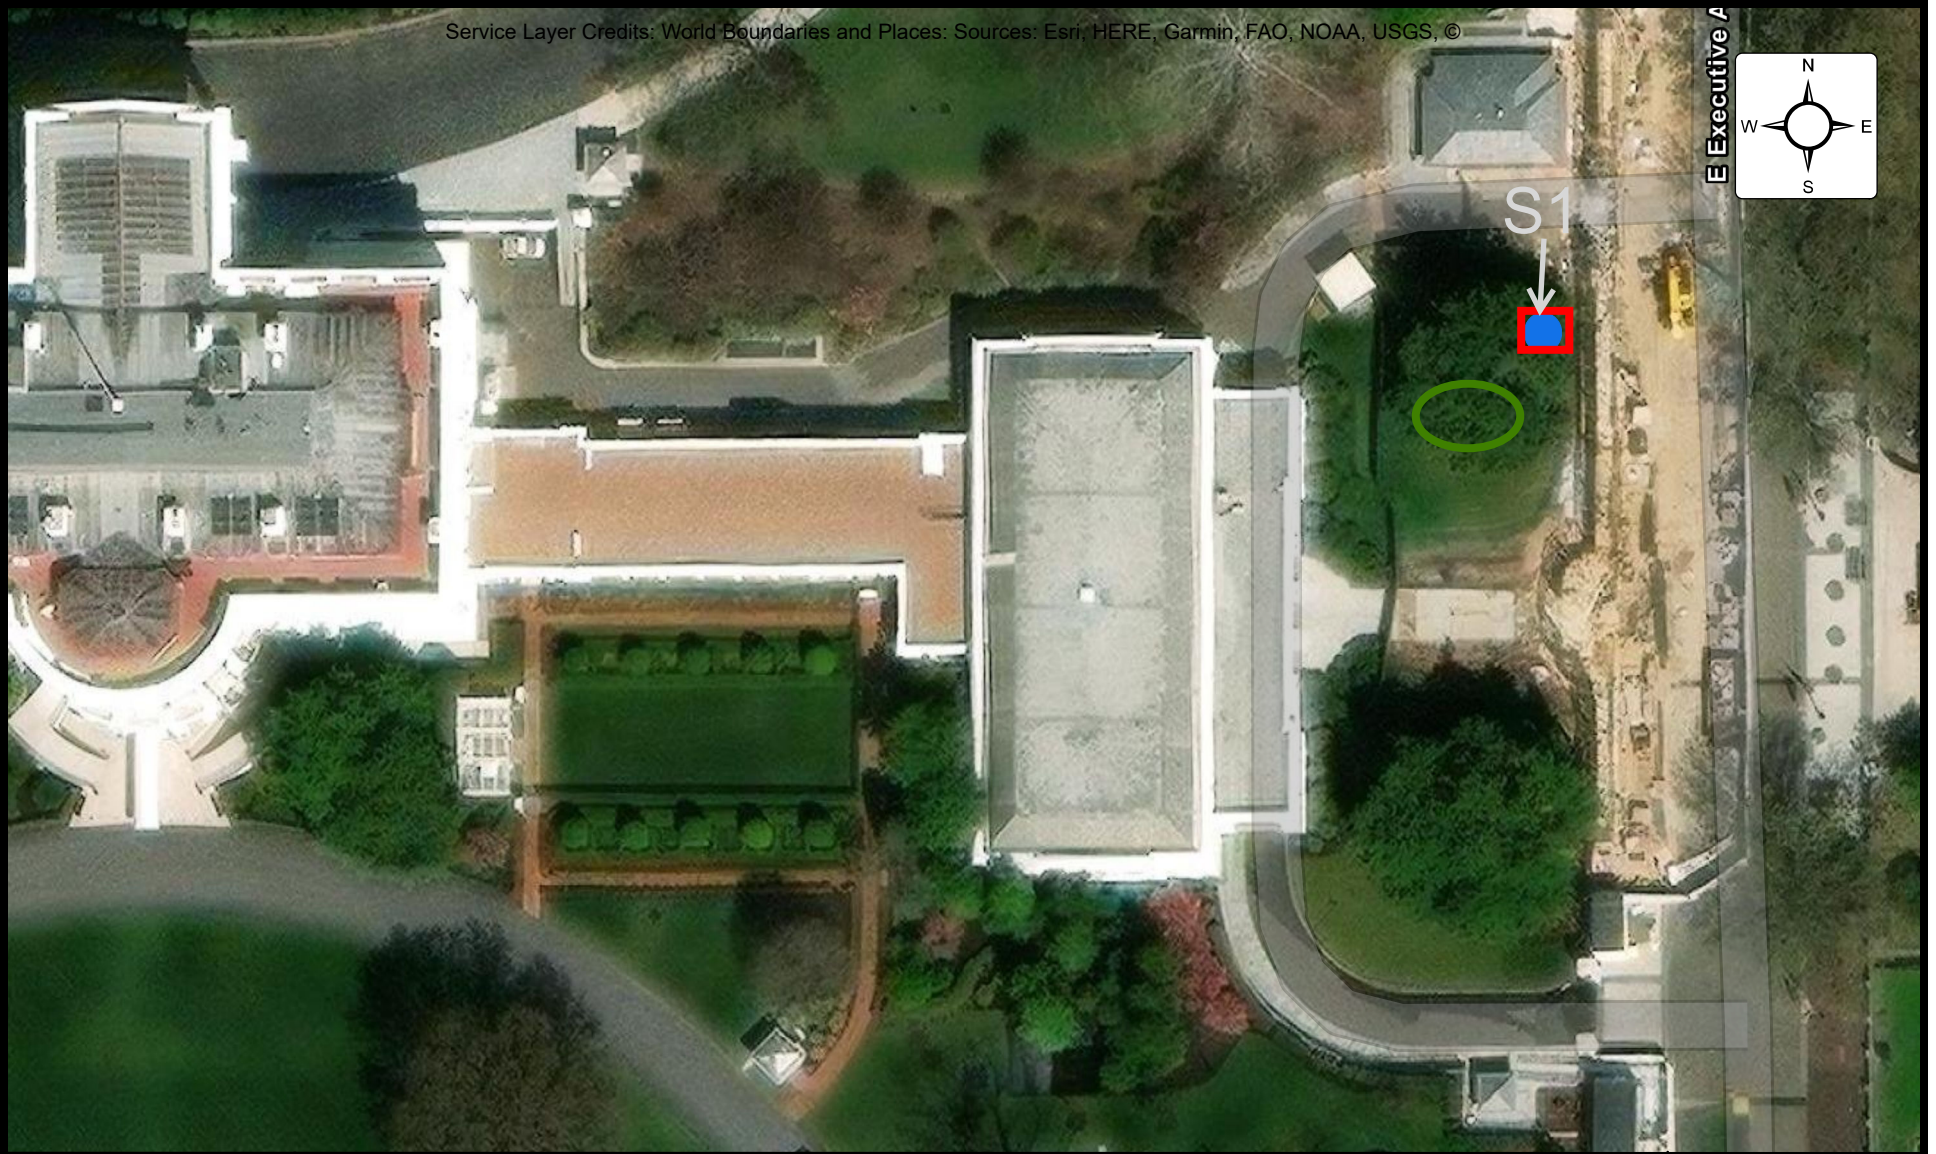
# SITE LOCATION DIAGRAM

On this date, Strittmatter was observed excavating on the northern portion of the site to a depth of approximately 20 feet below ground surface (bgs).

Material field screened on this date was generally comprised of brown silt and fine sand. Field screening did not indicate evidence of petroleum impact in the samples screened, and staining and suspect odors were not observed/detected in the excavated material. Material was stockpiled near the northern excavation area.
