OPPORTUNITIES MAP - PICNIC AREA OVERALL

Picnic Area Overall Opportunities Map

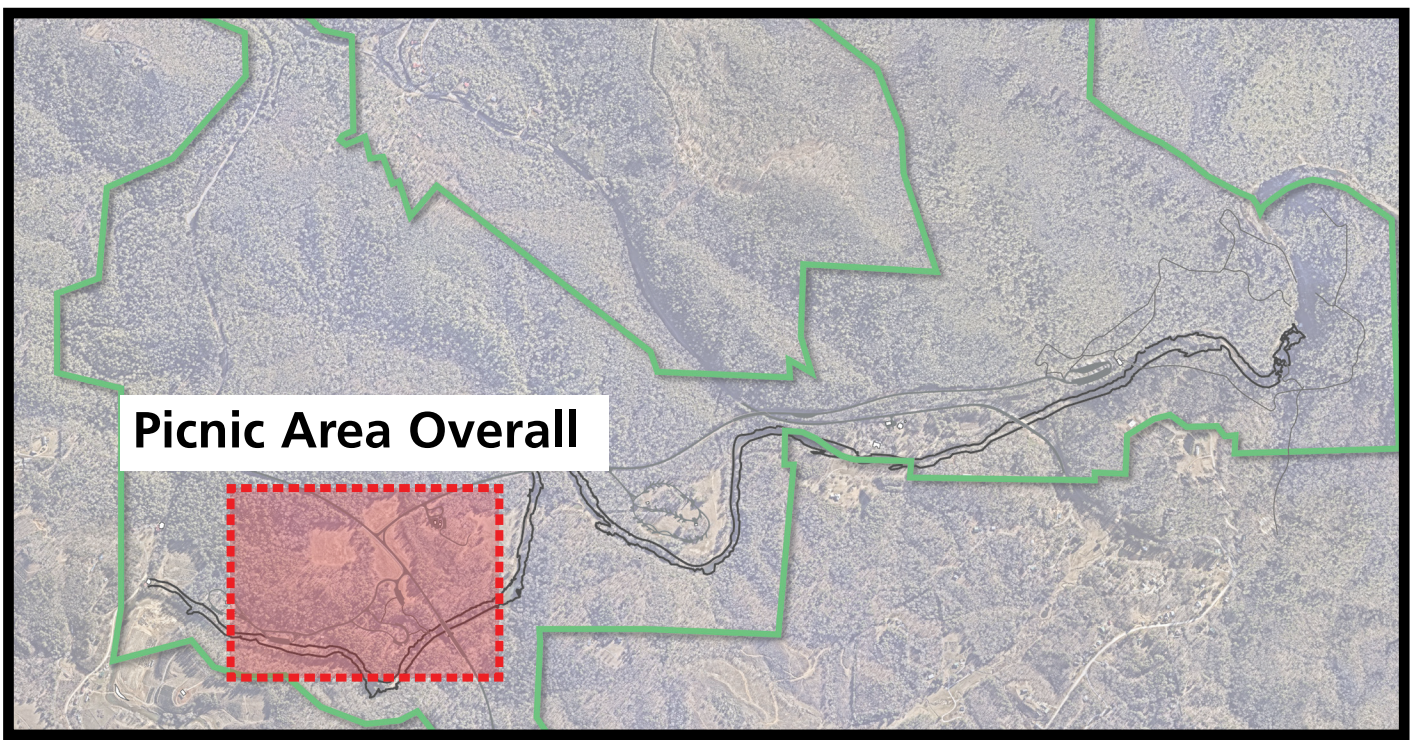
- 1 Construct a new picnic shelter outside the floodplain.
- 2 Construct a new toilet facility outside the floodplain.
- 3 Improve the existing pedestrian trail from the elevated parking area to the picnic area.
- 4 Restore wetland and floodplain areas along the Linville River shoreline.

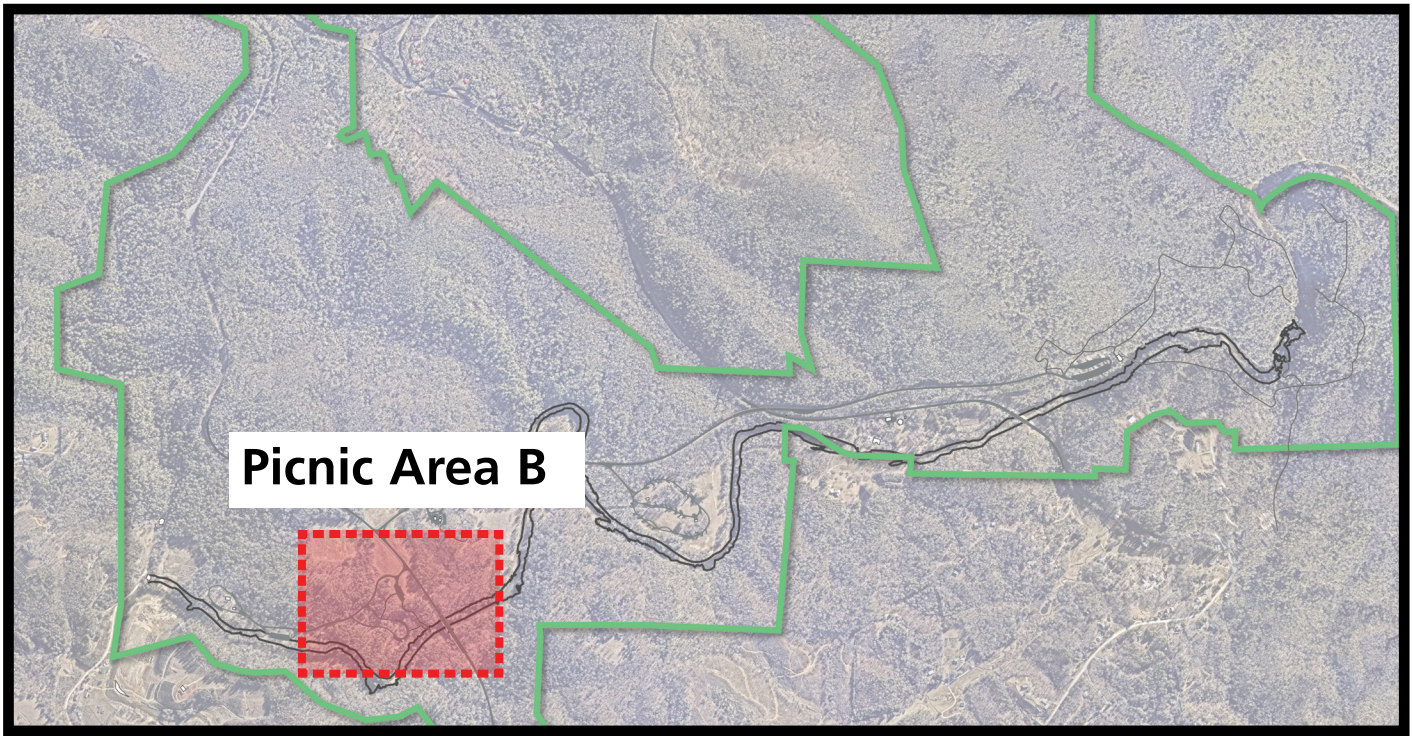
Picnic Area B Opportunities Map

OPPORTUNITIES MAP - PICNIC AREA B ENLARGED

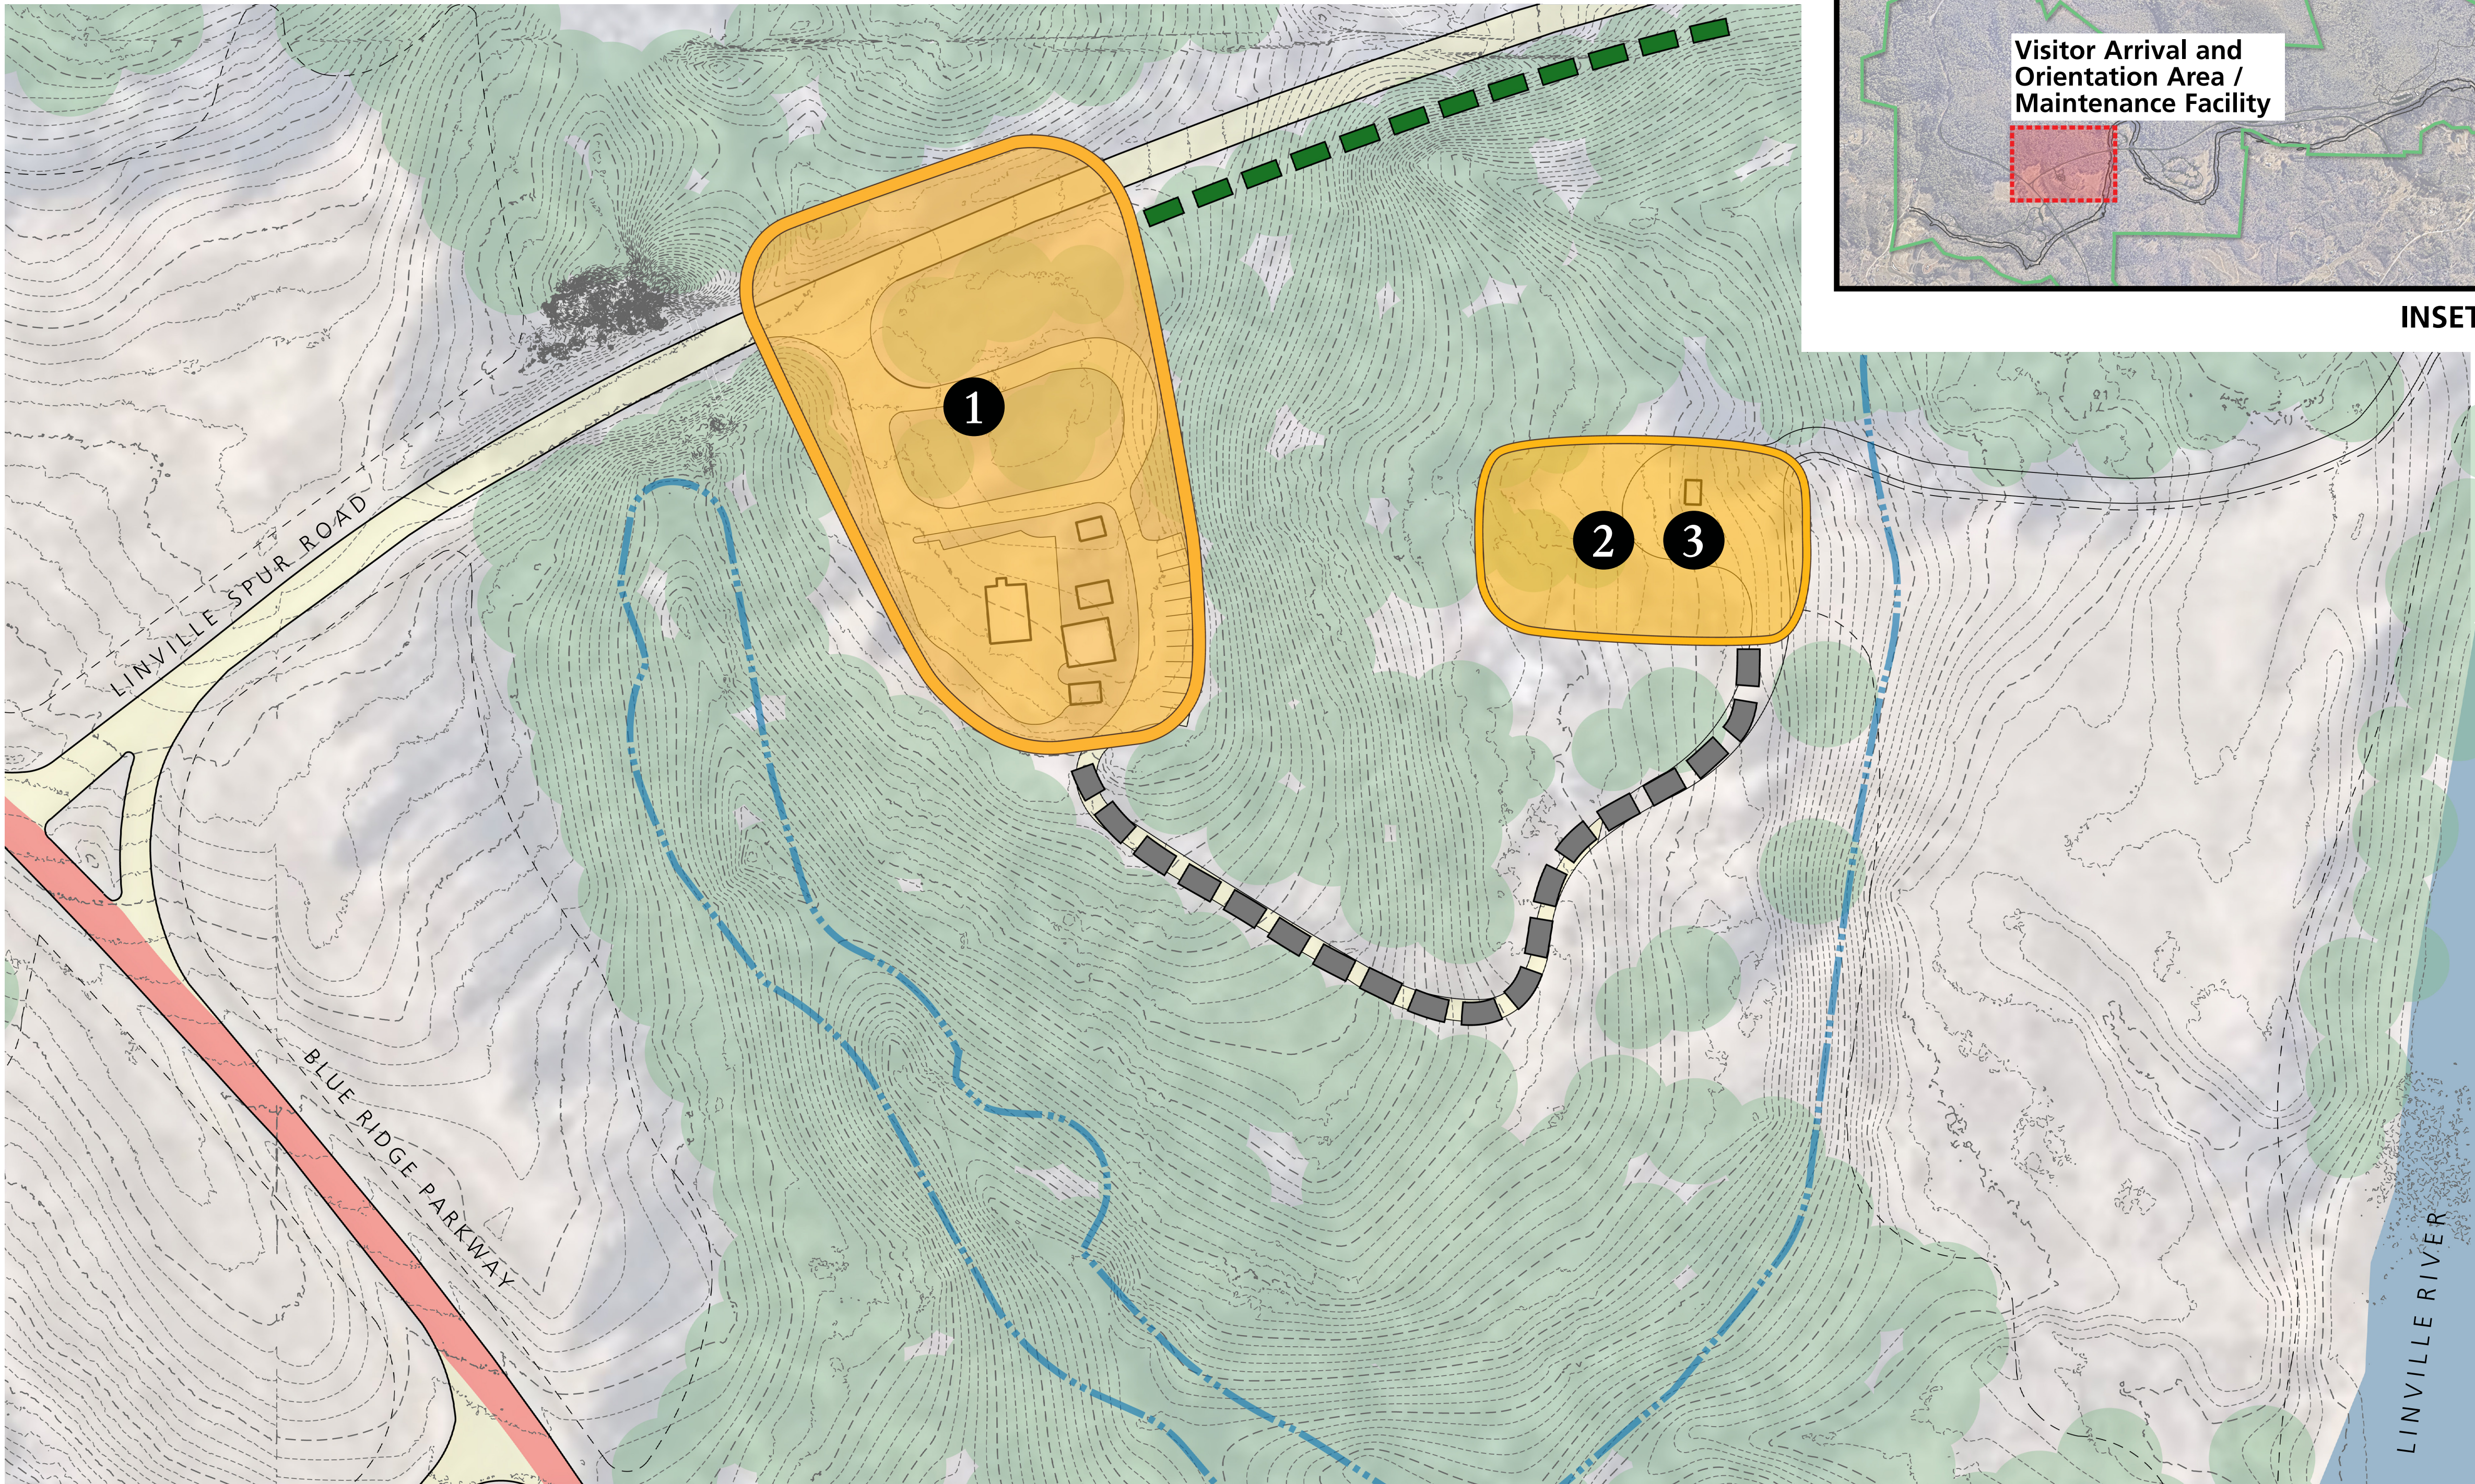
Visitor Arrival and Orientation Area / Maintenance Facility Opportunities Map

OPPORTUNITIES MAP - VISITOR ARRIVAL AND ORIENTATION AREA / MAINTENANCE FACILITY

- 1 Develop a new Visitor Center at the site of the existing maintenance facility to serve as the primary arrival and orientation hub for the area
- 2 Construct a new maintenance complex with National Park Service offices and emergency equipment
- 3 Establish RV Pads for volunteers

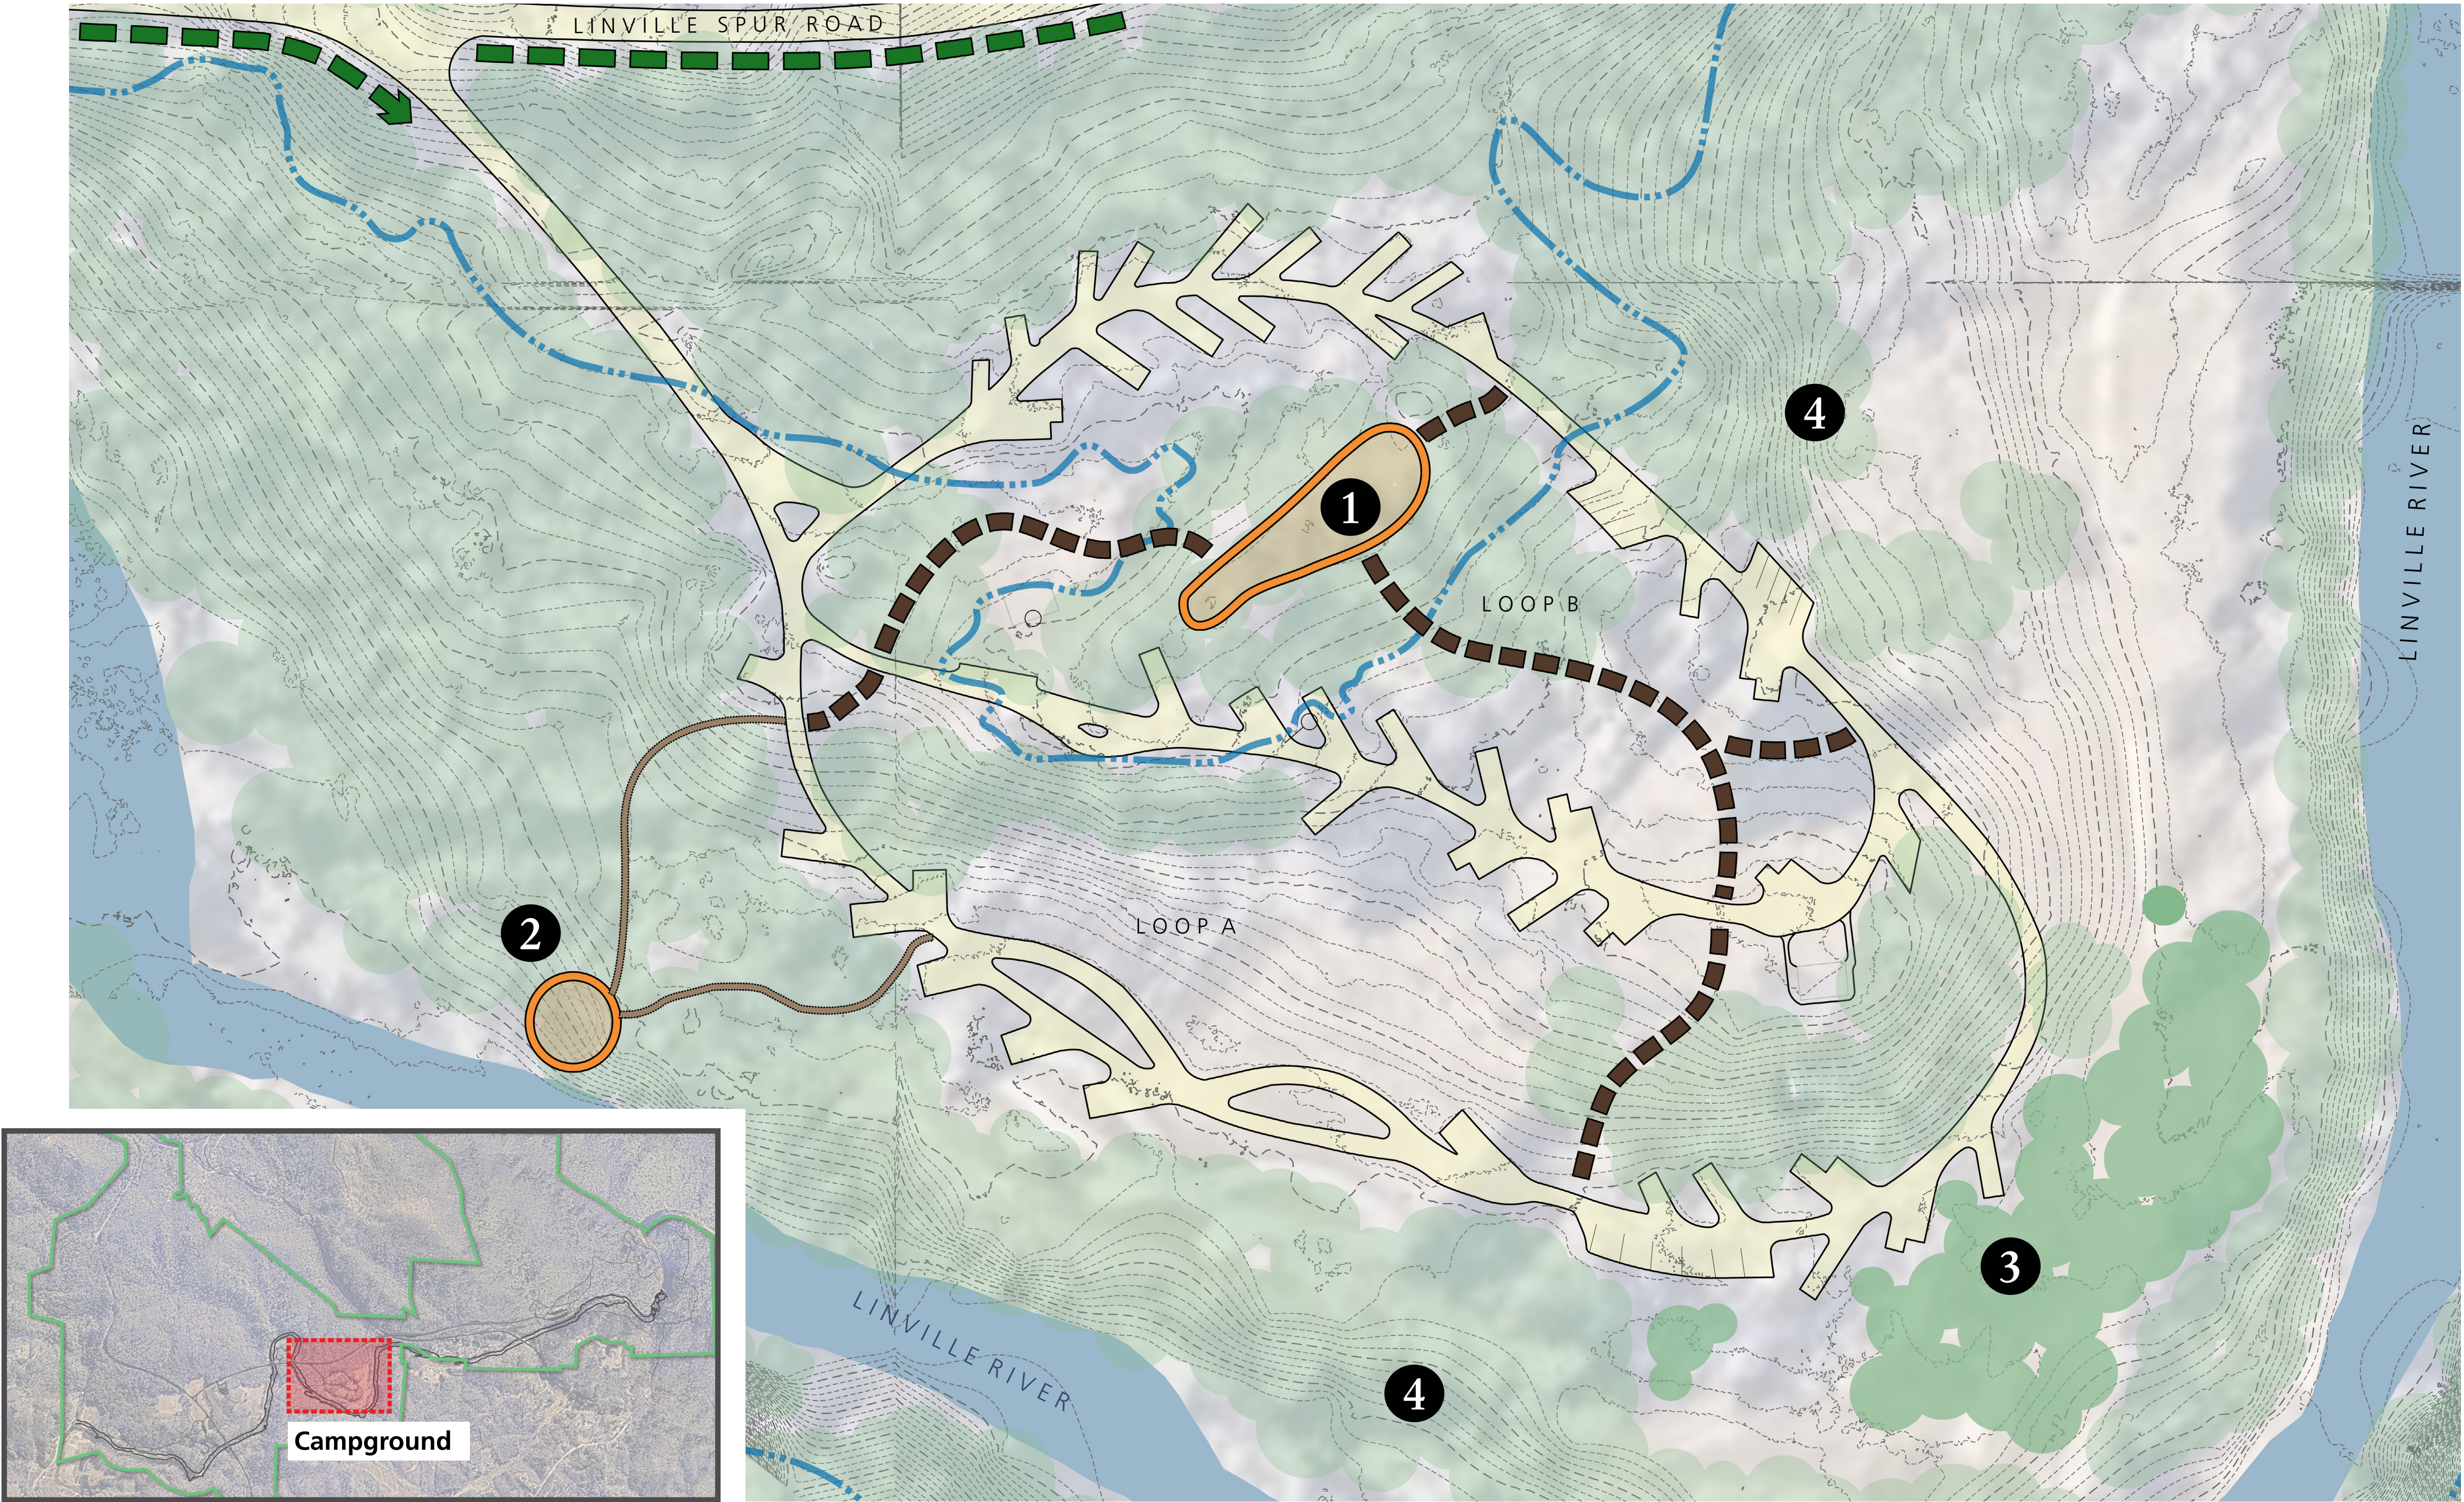
Campground Loops A & B Opportunities Map

OPPORTUNITIES MAP - CAMPGROUND LOOPS A & B

- 1

Enhance amenities to support a more fully serviced campground experience
- 2

Reconstruct Campfire Circle in previous footprint
- 3

Habitat improvements
- 4

Maintain primitive park-and-walk and hike-in campsites

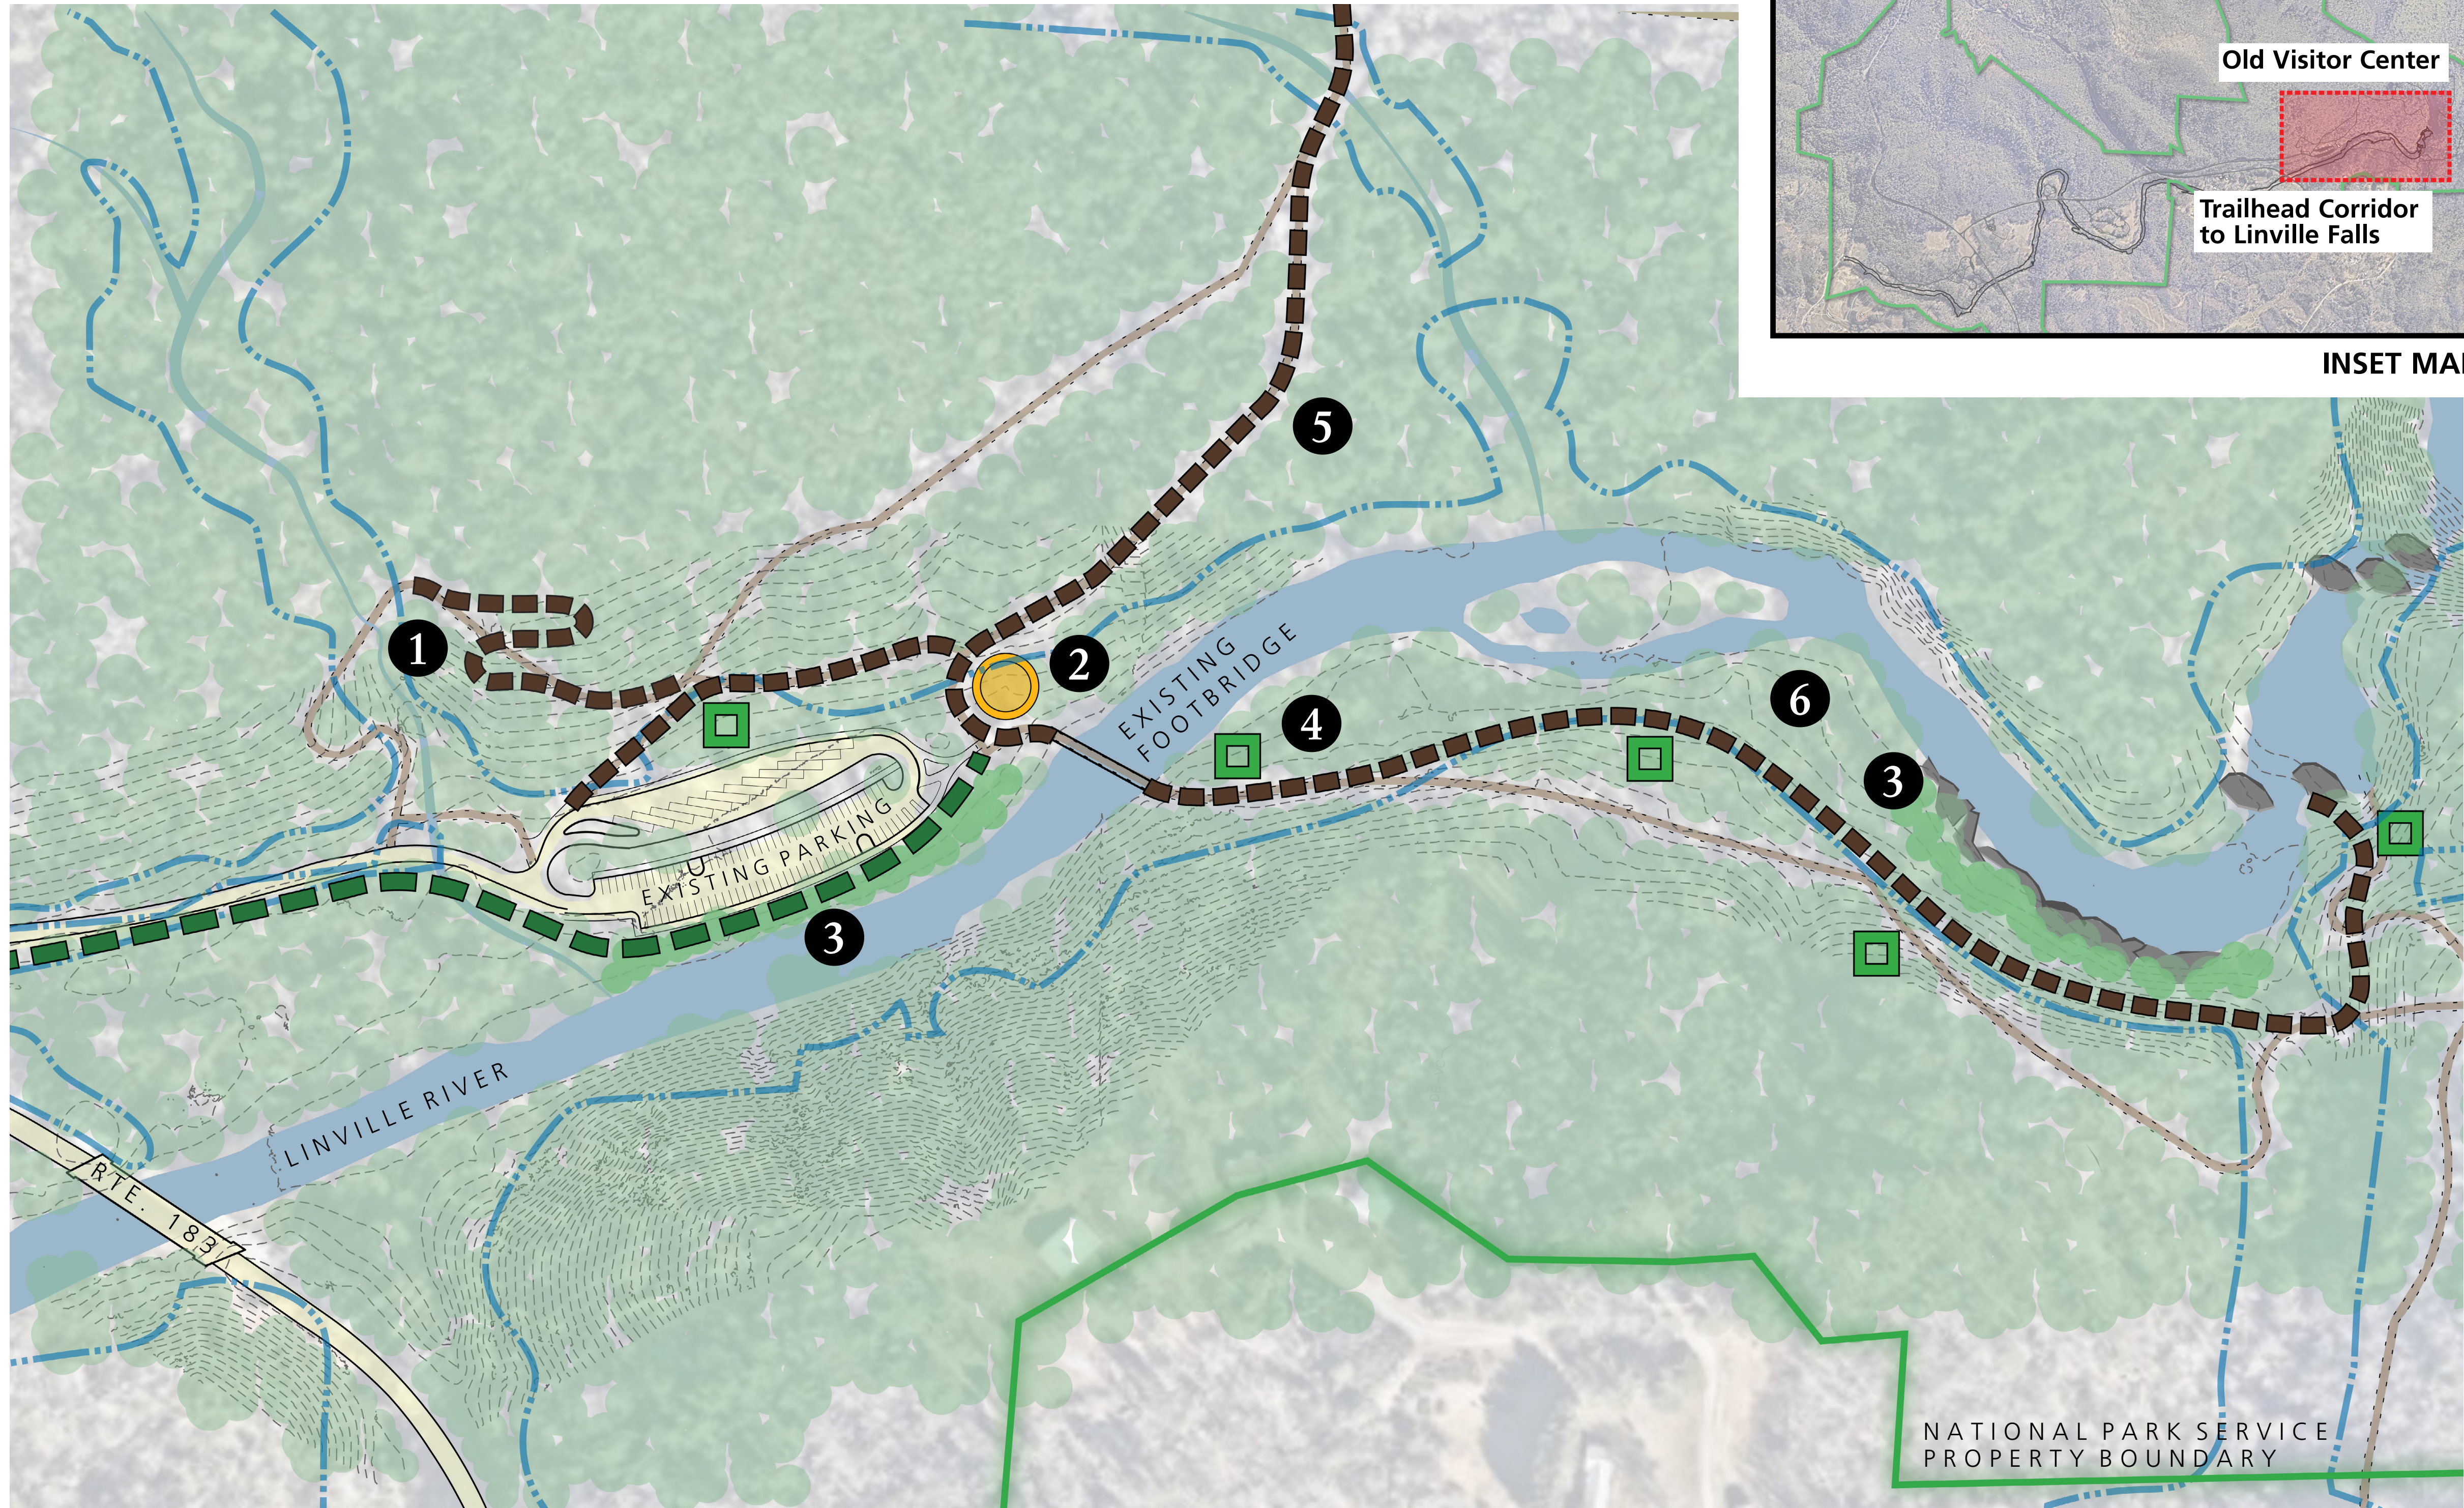
Trailhead Area & Trail Corridor to Linville Falls

OPPORTUNITIES MAP - TRAILHEAD AREA & TRAIL CORRIDOR TO LINVILLE FALLS

- 1 Improve Duggers Creek Trail to provide accessible opportunities to view the falls
- 2 Replace former visitor center with a trailhead shade structure containing orientation maps, interpretive panels, benches, and an enclosed storage area for emergency supplies
- 3 Reestablish buffer and stabilize vegetation
- 4 Add / improve wayfinding and interpretive signage along trails
- 5 Designated primary use trail to Linville Falls loop
- 6 Improve the existing trail on the western side of Linville River to provide accessible opportunities to view the upper falls
