National Park Service
U.S. Department of the Interior
Yellowstone National Park

Fiber Optic Cable Installation, Yellowstone National Park
Environmental Assessment
March 2021

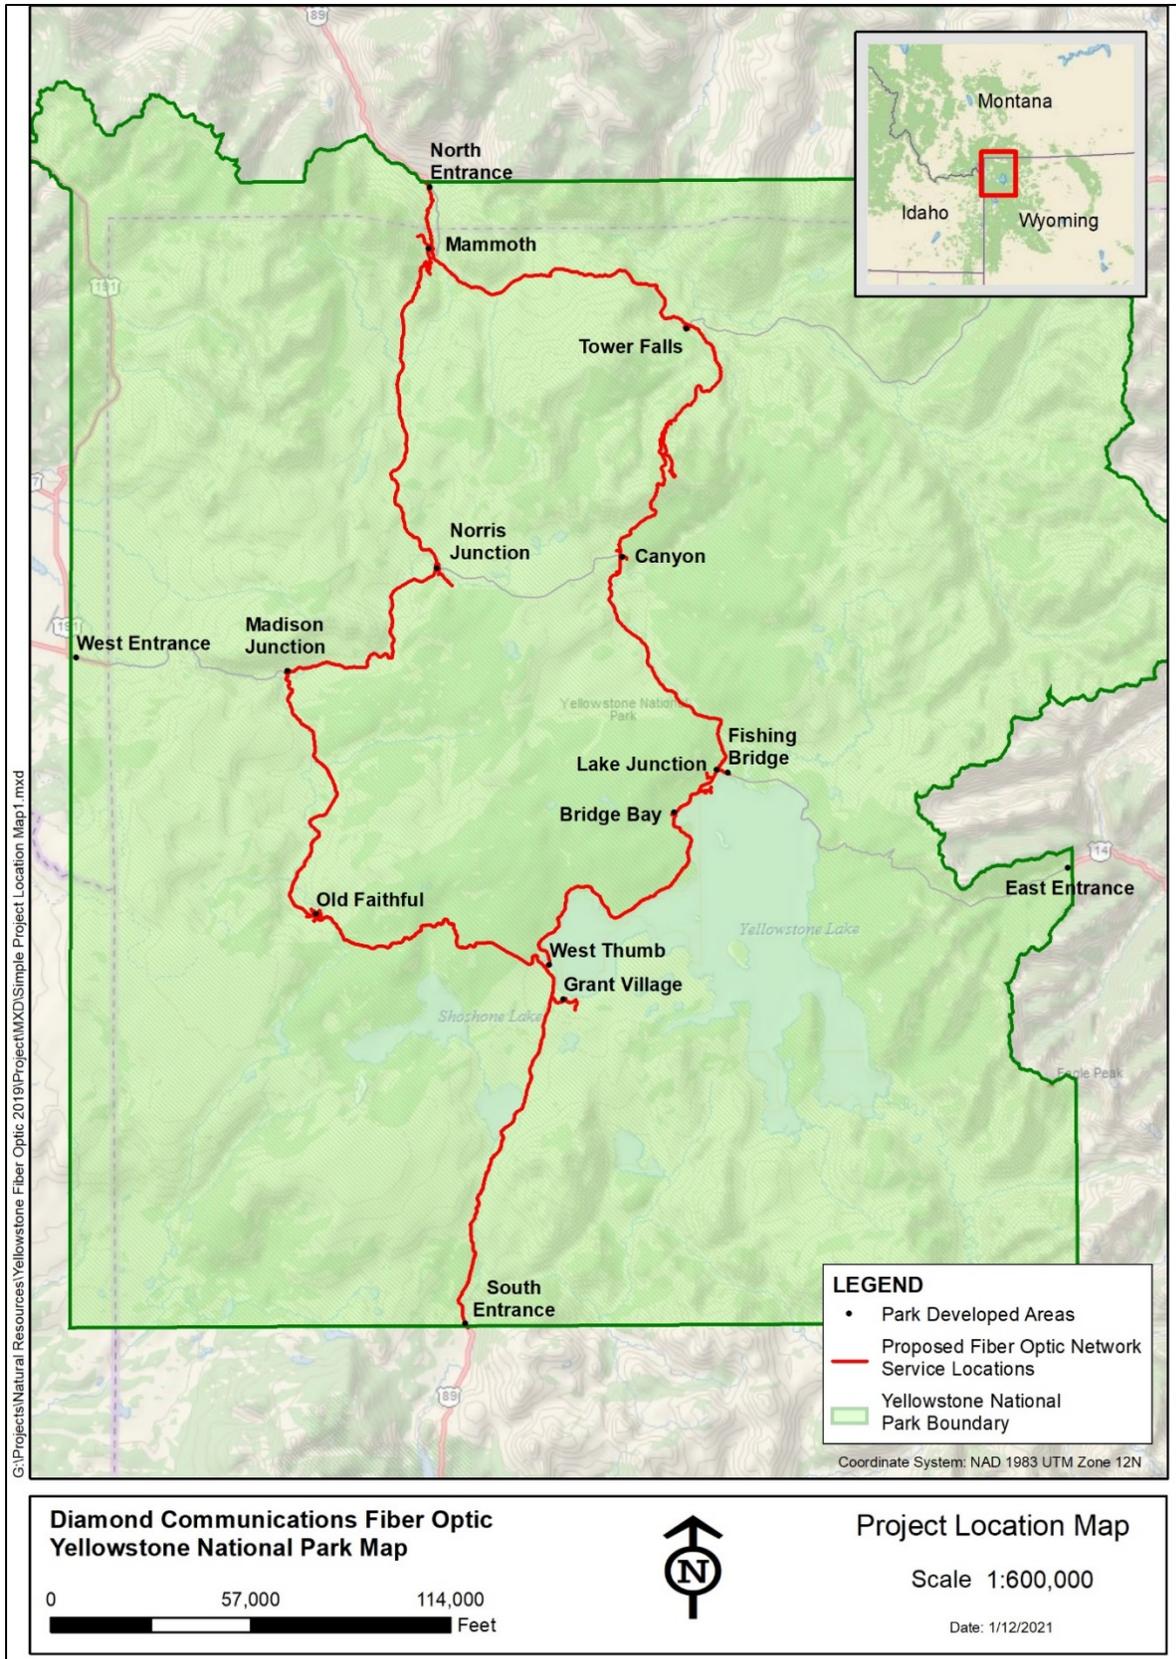
Figure 1. Fiber Optic Line Project Location.

The project area is 187-miles in length, following the park's Grand Loop Road with spurs or lateral lines branching off into multiple developed and administrative areas (Figure 1). The following segments are included: Madison Junction to Norris Junction, Norris Junction to Mammoth Hot Springs, Mammoth Hot Springs to Tower Junction, Tower Junction to Canyon Junction, Canyon Junction to Fishing Bridge Junction, Fishing Bridge Junction to West Thumb, Madison Junction to Old Faithful Interchange, Old Faithful Interchange to West Thumb, Old Gardiner Road, and West Thumb to South Entrance. The Elk Plaza Service Road and Chittenden Road to Mount Washburn are also included. Lateral lines are proposed into the following developed areas: Mammoth, Tower Junction, Mount Washburn, Canyon Village, Lake Village, Grant Village, South Entrance, Norris, Madison, and Old Faithful.

This proposal would not expand existing cell phone coverage areas as defined in the 2008 Wireless Communications Services Plan / Environmental Assessment (NPS 2008), and does not include additional above-ground telecommunications infrastructure. The increased data bandwidth would provide faster broadband speeds and would support more users within the existing coverage areas. Figure 1 shows an overview of the proposed route.

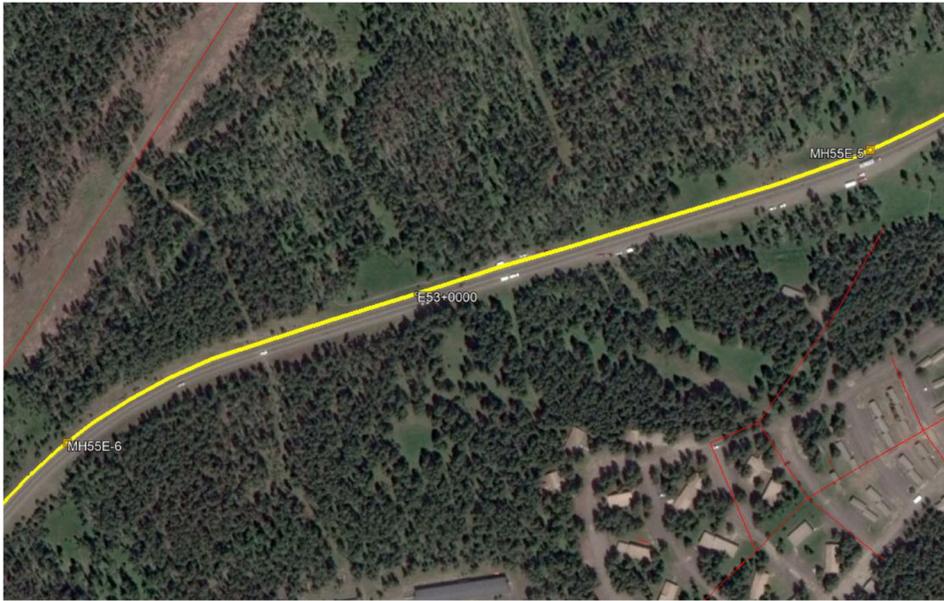
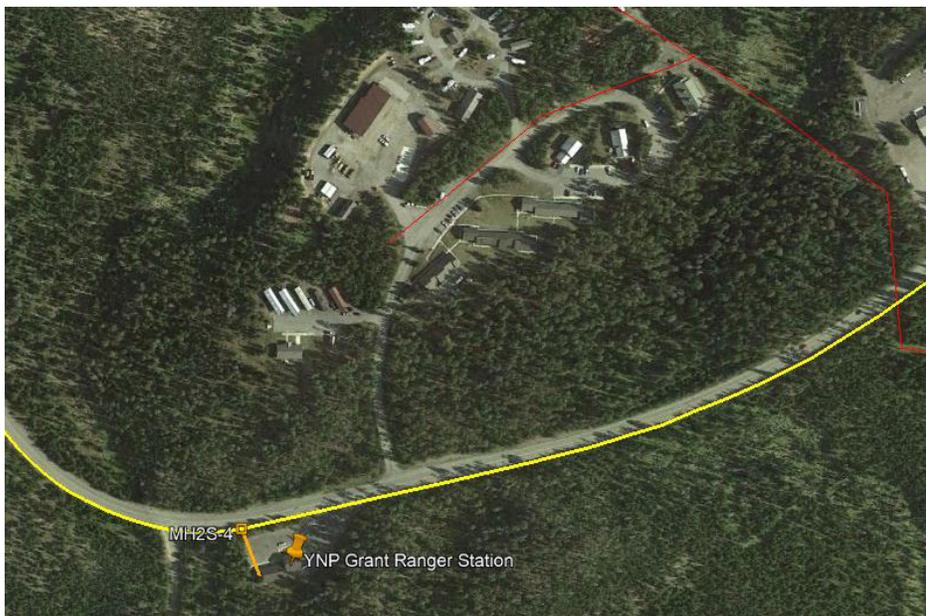
Figure 2. Fiber Optic Cable Illustrations.

Typical Alignment of Fiber Optic Cable along Park Roadways

Example Fiber Optic Lateral Cable Shown in Gold Going into the Grant Ranger Station

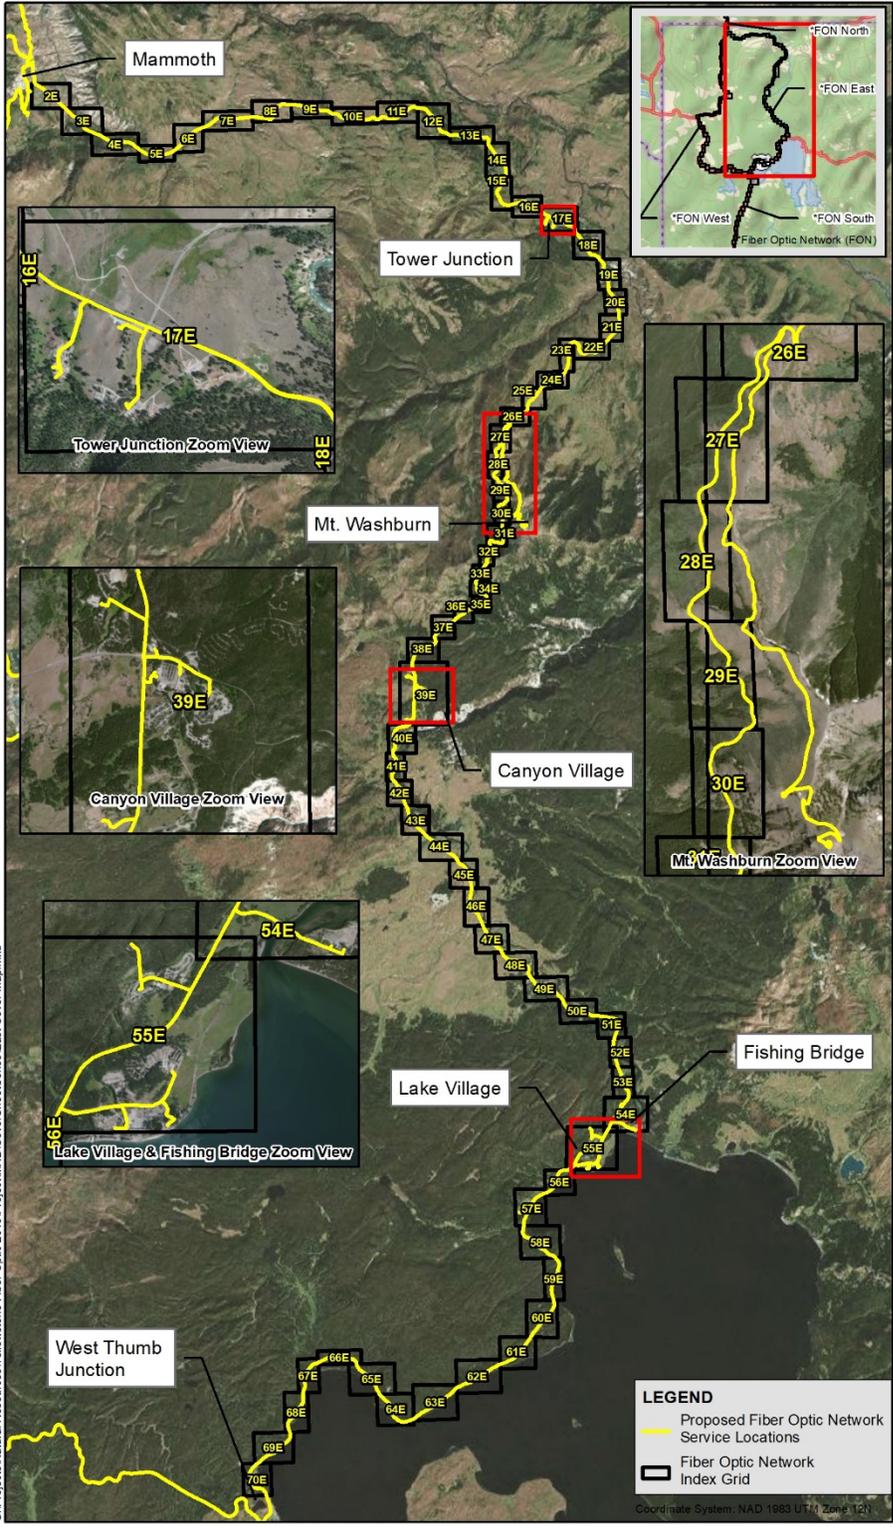
Figure 4. Proposed Action – East Section Detail.

Cover Sheet, Fiber Optic Network (FON) East
Scale 1:230,000
Date: 1/12/2021

The proposal would include a 288 single-mode fiber optic cable with a theoretical maximum capacity of up to 72 million Mbps of data, high-density polyethylene (HDPE) conduit, ducts, concrete and concrete polymer maintenance holes, splice cases, fiber optic line marker tape, and bridge attachments, as required. HDPE conduit is known to exhibit permanent flexibility and bends and flexes without breakage over a wide range of temperatures, even with ground shifts or heaves (PPI 2018). There are a few areas in the park that are prone to slumping ground. HDPE can tolerate movement and the conduit is expected to stretch and move with the ground if slumping or sliding occurs after installation. If large-scale sliding occurs such that the road is damaged, the conduit would be inspected and repaired along with the road, if necessary. The total path length of the cable is approximately 187 miles including the main trunk cable running north and south on the Grand Loop Road and the Old Gardiner Road from Mammoth to the NPS offices in Gardiner. Installation would occur within existing roadways as shown in Figure 2 (top illustration). Construction would include placement of maintenance holes, multiple HDPE conduits, and fiber optic cable. Lateral lines would be installed to provide fiber optic connectivity to developed areas off the main roadways. These lateral lines branching off the main route would comprise approximately 21 linear miles of the total project. An example of a lateral line is shown in Figure 2 (bottom illustration); Figures 3 through 6 show greater detail of the lateral line locations in the north, east, south, and west sections of the project area.

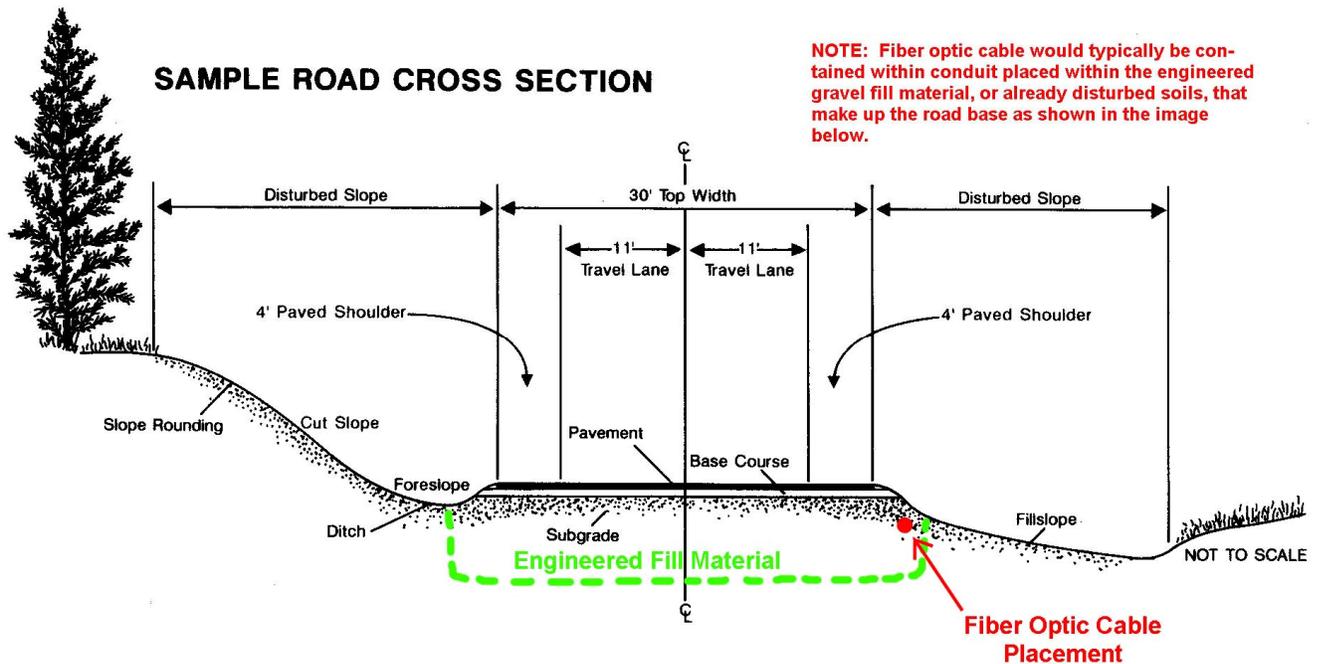
Figure 7. Road Cross-Section.

Conduit and cable would be installed in the engineered road base (engineered fill material), meaning within the fill that has been placed to create the roadbed surface, as shown in Figure 7. This would help to mitigate potential impacts in thermal zones because the conduit would be installed in existing roads that typically are already elevated to address concerns related to higher ground temperatures. In thermal zones, the conduit would be installed at shallower depths within this engineered road base to ensure no new impacts to thermal areas (Figure 8). No installation would occur in previously undisturbed areas and there would not be any direct impacts to surface thermal features.

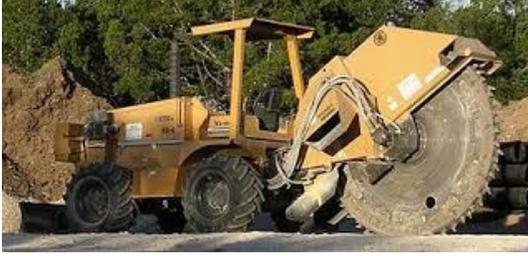
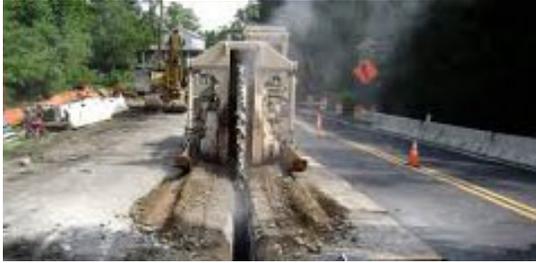
<p>Rock saw for road and rock cutting/trenching</p>	<p>Rock saw disturbance in road</p>

Fiber optic installation would be accomplished using standard construction equipment such as vibrating plows, rock saws, small backhoes/excavators, skid steers, trenchers, directional drilling equipment, trucks and trailers hauling materials, and fuel trucks (no fuel tanks would be stored along the route or at existing equipment staging areas). Walk-behind and tractor-mounted trenching equipment would make a cut in the ground 4 to 8 inches wide to a depth of 10 to 20 inches. In most cases, an offset plow tooth would be used to place the conduit in the existing road prism as near to the paved road shoulder as possible, minimizing environmental impacts and off-road travel (Figure 7). The road prism is the area within the ROW that supports the paved roadway between the bottom of the ditch and the toe of slope. It includes the subgrade, base courses, surfacing courses, pavement, and roadway fill-slopes. Typical equipment and disturbance are shown in the images in Table 1.

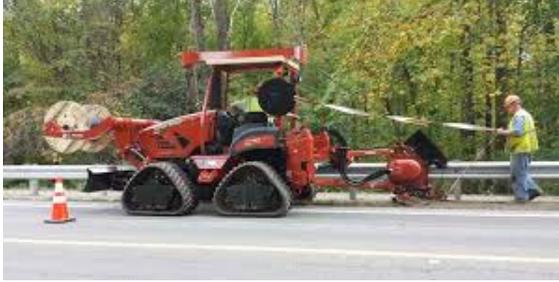
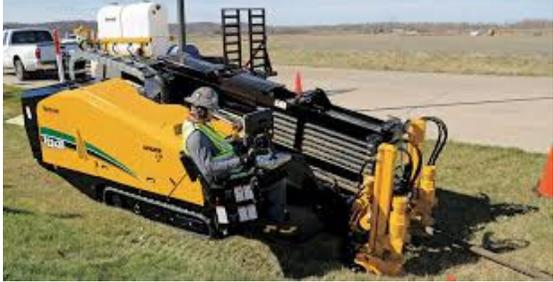
<p>Rubber track fiber plow</p>	<p>Directional drilling equipment</p>

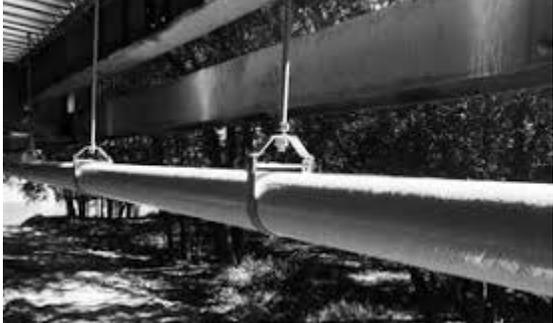
<p>Maintenance hole</p>	<p>Bridge attachment</p>

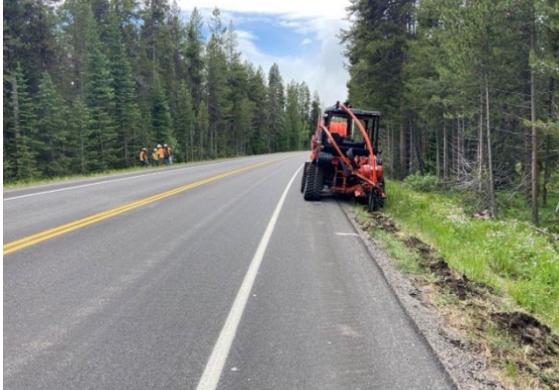
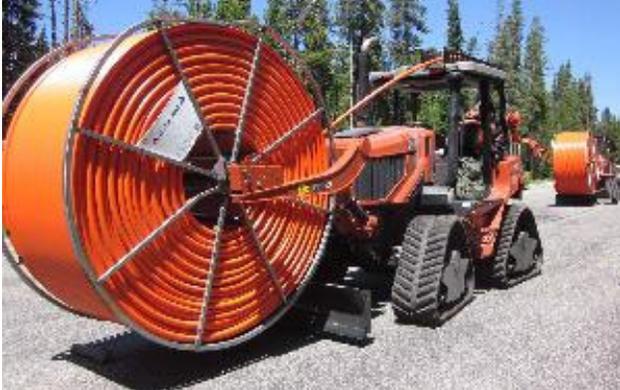
<p>Plow disturbance along roadway.</p>	<p>Plow with conduit.</p>

Use of a vibratory plow for the majority of the installation would minimize the surface disturbance caused by the project due to the slicing action of the plow, rather than open trenching which requires far more soil disturbance. Use of plow and other motorized equipment would cause localized areas of soil compaction and soil disturbance on the surface (generally less than two feet in width). The soil disturbance would be restored immediately after placement of conduit or maintenance holes to enhance regrowth. Then topsoil conservation measures would be employed in accordance with Yellowstone's Vegetation Management Guidelines (see Appendix B).

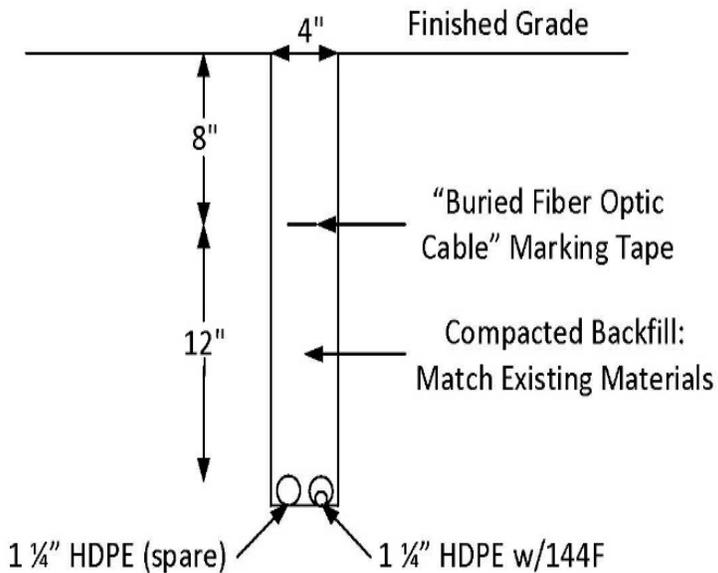
Typical Shoulder Trench

TYPICAL BACKBONE TRENCH:

2 x 1 ¼" HDPE

Each segment placed along Grand Loop Road (that is not within a designated thermal zone) would consist of placing two 1-1/4-inch HDPE conduits with one carrying a 288 single-mode fiber optic cable (about 0.69-inch in diameter) inserted by air compression after the conduit is buried (Figure 8). The extra conduit would provide for future expansion as needed, although any future expansion is speculative at this time and may be subject to additional compliance, as appropriate. In areas adjacent to thermal features where soil temperatures are elevated compared to ambient soil temperatures in other locations throughout the park, near Old Faithful for example, two 4-inch HDPE conduits would be placed with one carrying a 288 single-mode fiber optic cable (Figure 8). The larger size HDPE is required to help insulate the fiber optic cable from the ground heat in thermal zones. Lateral lines installed to service areas would consist of one 1-1/4 inch HDPE conduit, and bridge attachments would consist of one 4-inch PVC conduit.

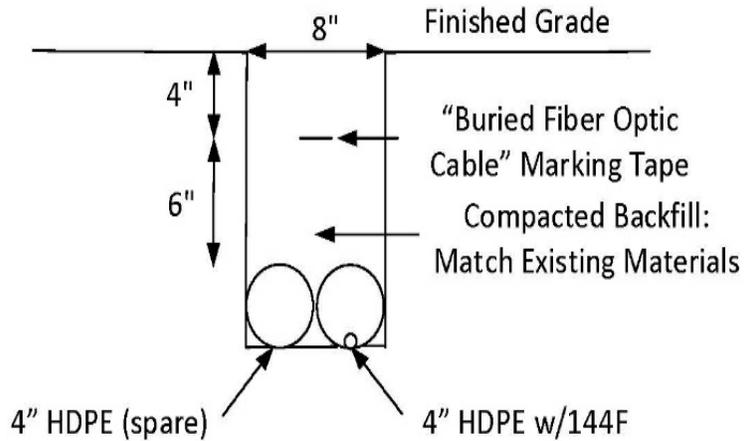
Typical Thermal Area Trench

TYPICAL THERMAL AREA TRENCH:

2 x 4" HDPE

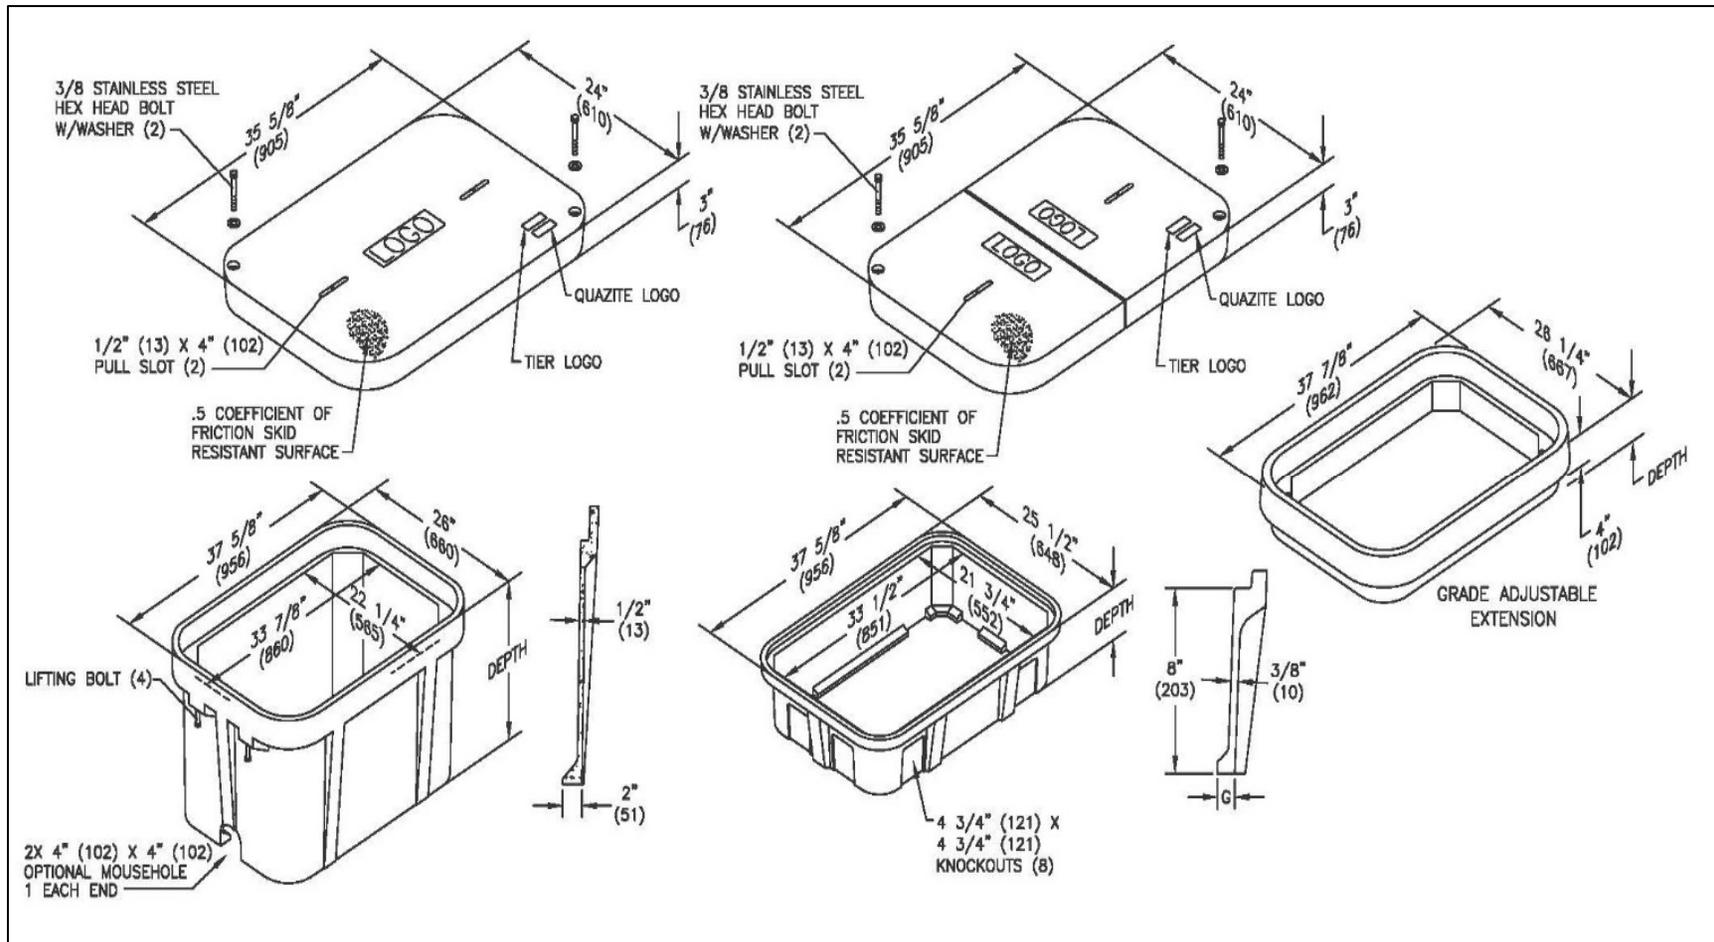
Figure 9. Details for Typical Maintenance Hole.

Work zone areas for maintenance hole placement and fiber placement, splicing, and testing would be approximately 100 feet long. The shoulder would be closed at each location during the placement of the box or during the splicing and testing of the fiber cable while equipment is at the location. Speeds would be reduced to 20 mph in the work area, but lane closures would not typically be required, except in areas where the road is very narrow or there is a sharp drop off that would not allow the equipment to operate safely in the shoulder.

The approximately 575 maintenance holes and 35 pull boxes that would be installed as part of the proposed action (described in Chapter 2, Figure 9) would not be dug in or near surface features or areas with hot ground. In the unlikely event that geothermally active substrate is encountered, additional mitigation measures would be followed and details for avoiding impacts would be determined in consultation with the park geologist. Measures include stopping work in the immediate vicinity and contacting the park geologist if any of the following conditions are encountered: 1. A pre-existing hole in the ground the size of a basketball, or larger, 2. Standing or flowing water, either hot or cold, 3. Any concentrations of either carbon dioxide or hydrogen sulfide are measured, 4. If during excavation a red clay layer is encountered, or 5. Ground temperatures above 80 degrees Fahrenheit are measured (early morning). No installation would occur in previously undisturbed areas and there would not be any direct impacts to surface thermal features. Because geothermal resources would be avoided through project design and mitigation measures, this topic has been dismissed from further analysis.
