National Park Service  
Cultural Landscapes Inventory  
2010

President's Park South  
President's Park

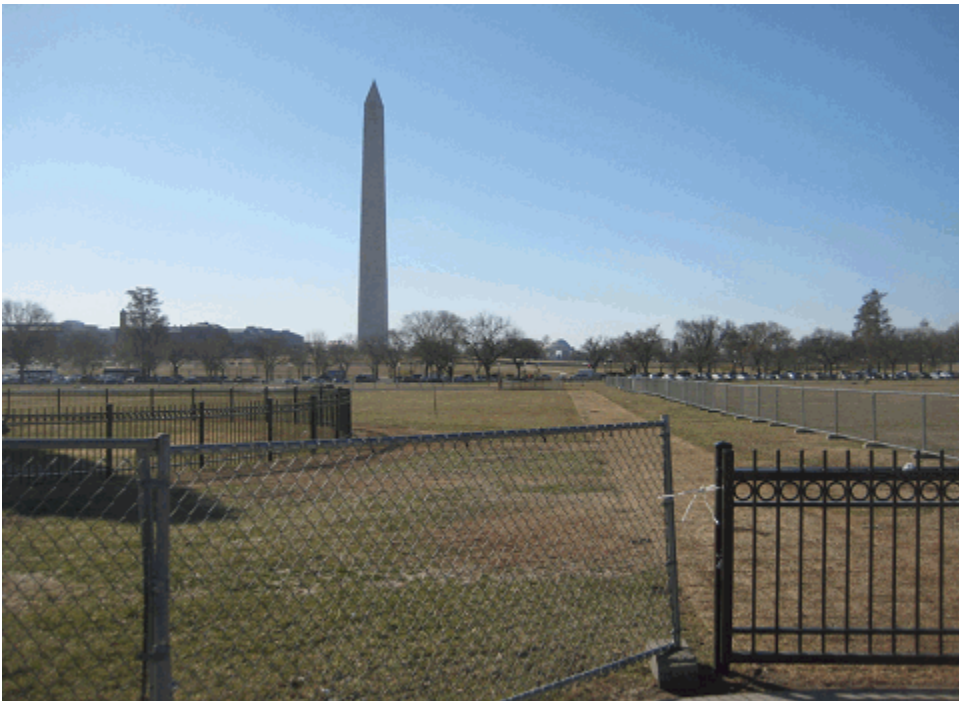
*Figure 8: Primary vista looking south from the north edge of the Ellipse, toward the Washington Monument and Jefferson Memorial (NCR CLP February 4, 2010)*

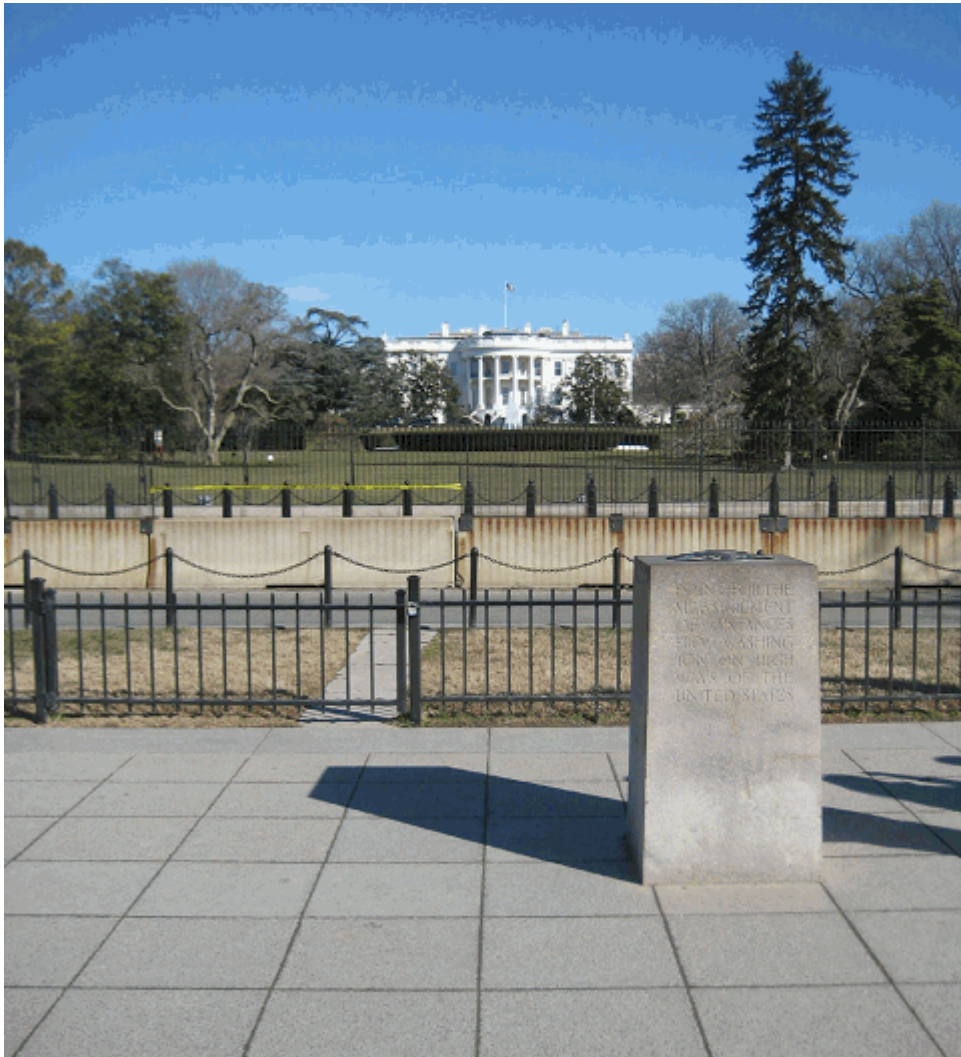
*Figure 10: Primary vista looking north from the Zero Milestone, toward the White House (NCR CLP February 4, 2010)*

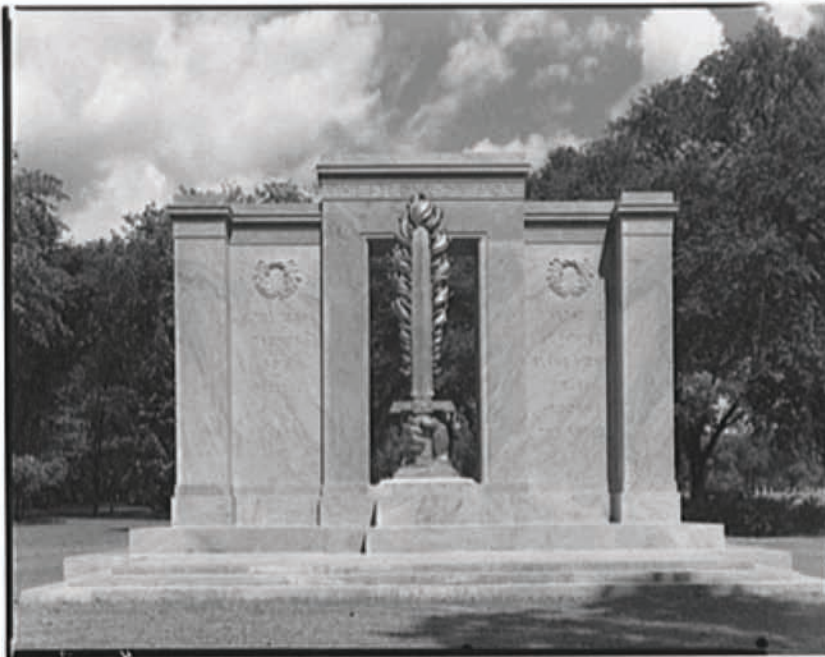
*Figure 18: Circa 1936-50 view of the Second Division Memorial, looking north from Constitution Avenue (Library of Congress, Prints and Photographs Division, Theodore Horydczak Collection)*

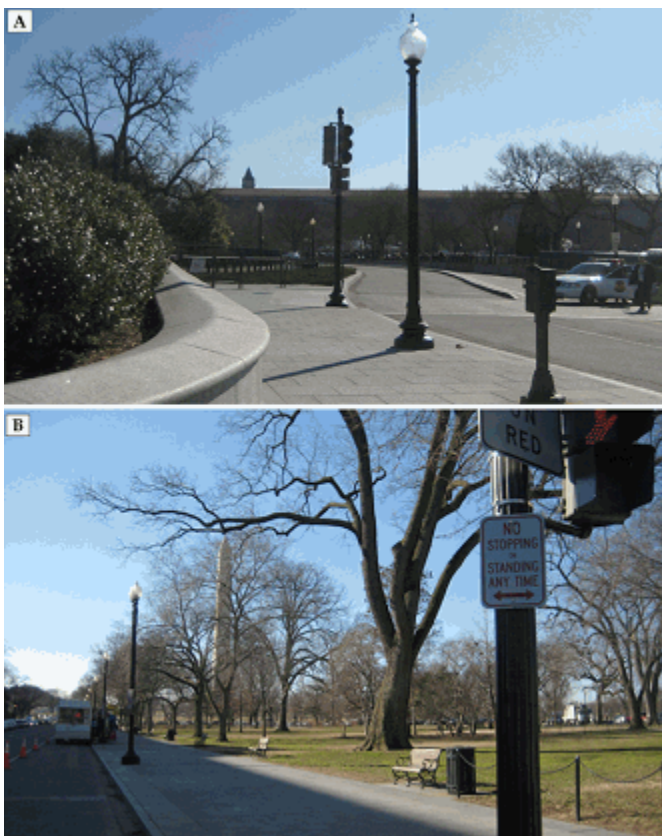
*Figure 22: Views showing small-scale features: A. Looking east across E Street, from south of the First Division Memorial, and B. Looking south along 15th Street (NCR CLP February 4, 2010)*
