Spatial Organization

Historic Changes from pre-1950 to 2000

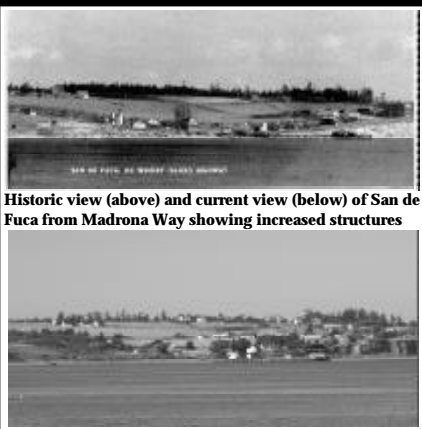
Historic view (above) and current view (below) of San de Fuca from Madrona Way showing increased structures

VIEWS/VISTAS are basically intact, particularly the sense of woods and open fields as well as bluff views. Some views have been obscured due to growth of trees and shrubs. The biggest changes have occurred in San de Fuca with the addition of structures visible from vista points across Penn Cove. Similarly, views of Coupeville have also changed with the introduction of numerous structures.

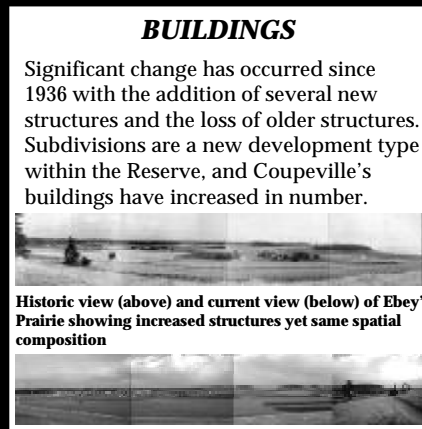
Historic view (above) and current view (below) of Ebey's Prairie showing increased structures yet same spatial composition

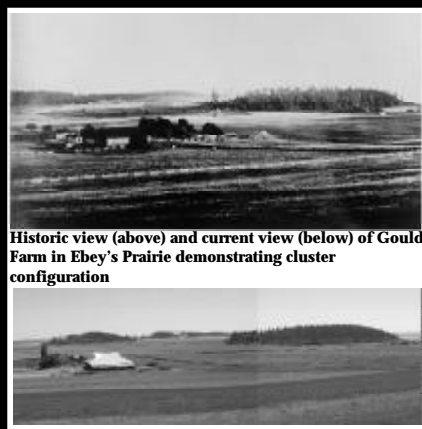
Historic view (above) and current view (below) of Gould Farm in Ebey's Prairie demonstrating cluster configuration

Building clusters are a natural outgrowth of agriculture land use, and contribute to the spatial character of the Reserve. 27 farm clusters have been identified (1983, 1995) as having integrity, and these remain intact although there have been individual structures lost or gained within some clusters. The most important farm clusters remaining are those originating from the Donation Land Claim (DLC).

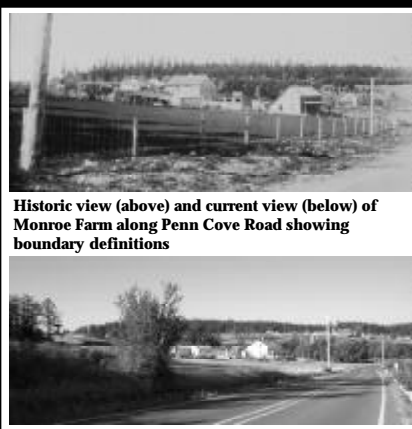
Historic view (above) and current view (below) of Monroe Farm along Penn Cove Road showing boundary definitions

Boundaries help define the Reserve's spatial organization. Physical and visual boundaries are created by roads, property divisions, field and crop patterns, and woodland edges, and include small-scale features like fences, hedges, and windbreaks. The majority of these boundaries are still intact, although new boundaries are created with additional roads and property divisions. Changes have occurred in the locations of hedgerows, and historic photographs show more widespread use of fences than appear today.
