National Park Service  
Cultural Landscapes Inventory

2005  
Revised 2011

Franklin Park  
National Mall & Memorial Parks - L'Enfant Plan  
Reservations

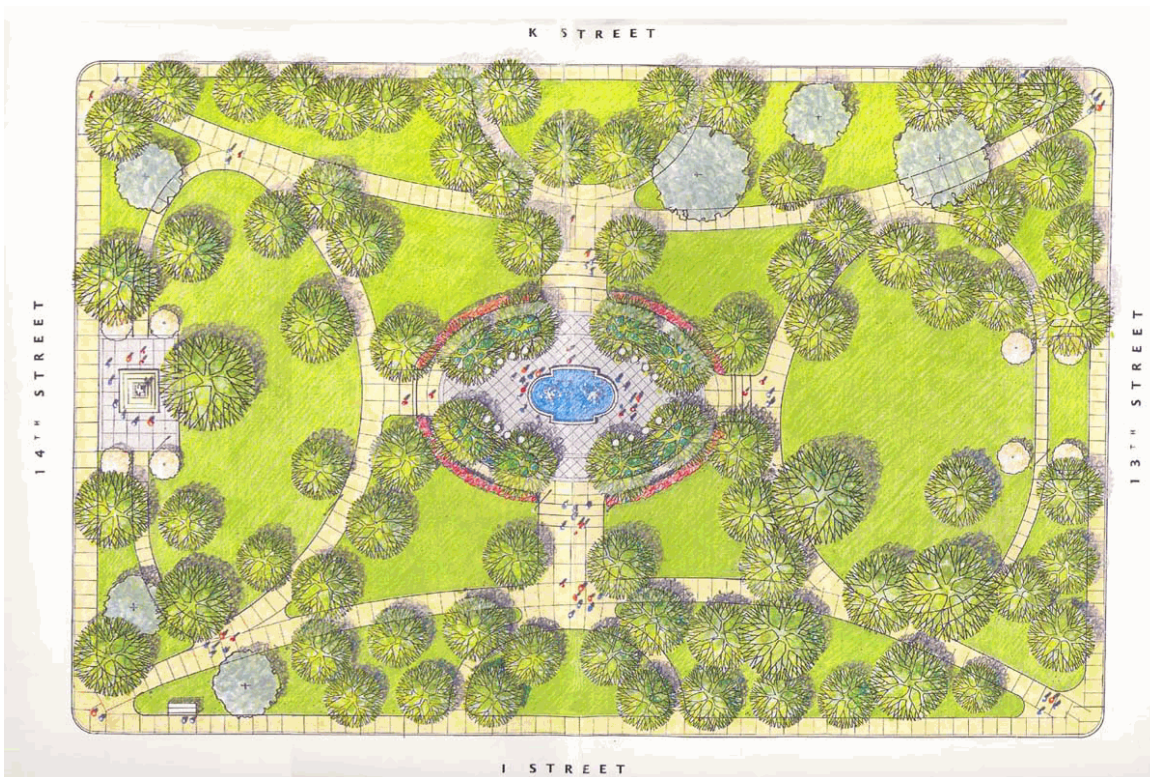
*This plan, prepared by the Downtown Business Improvement District in 2003, depicts the conditions existing in Franklin Park in 2005, except for the flower beds around the plaza, which have not been installed. ("Downtown BID franklin park plan 200")*

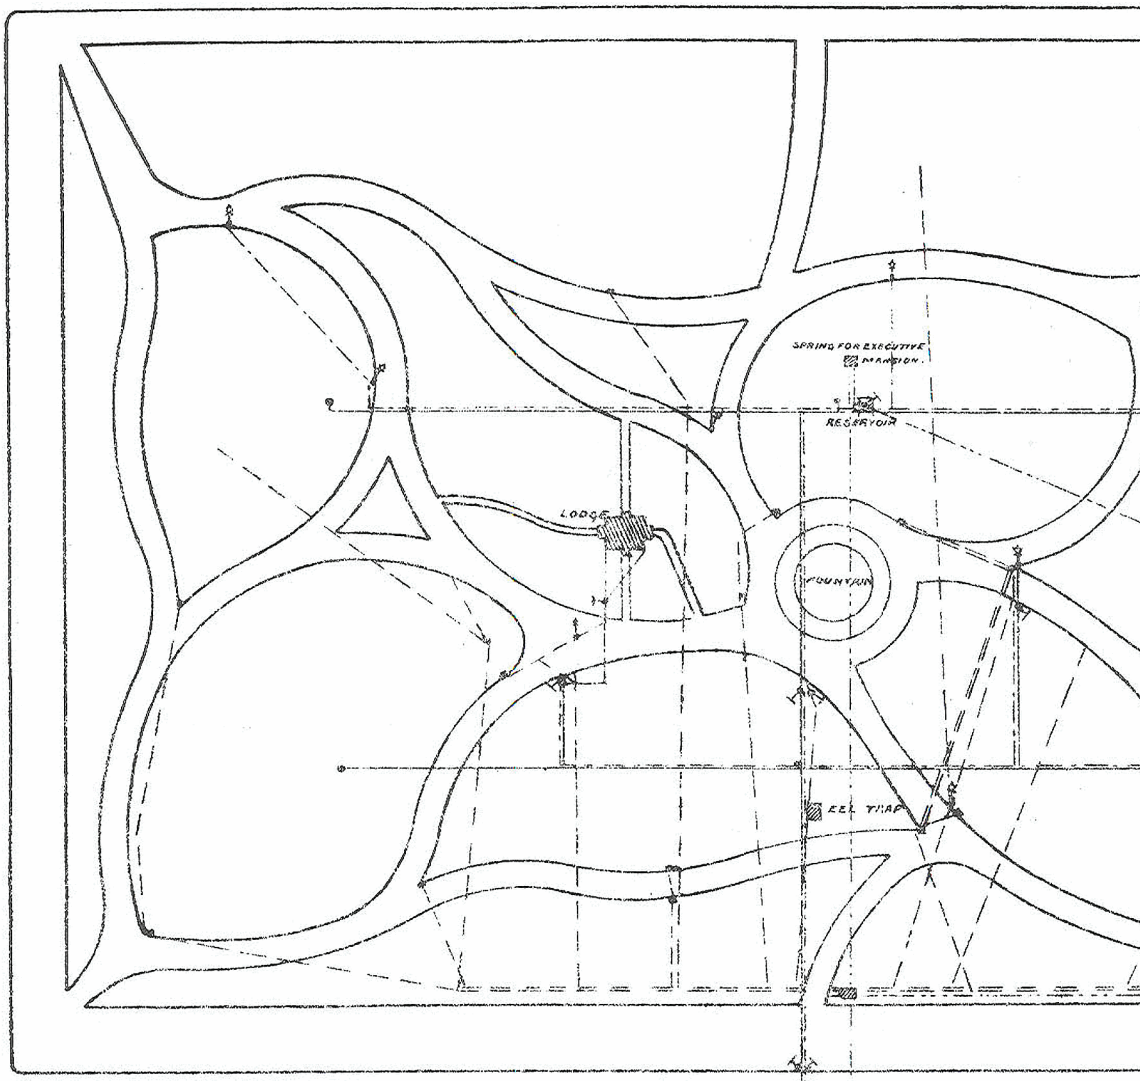
*The original circulation plan of Franklin Park was curvilinear and irregular. On this 1886 plan, the spring(s) and its reservoir appear in the upper center. (CLP digital photo, "1886 plan showing spring, cropped")*

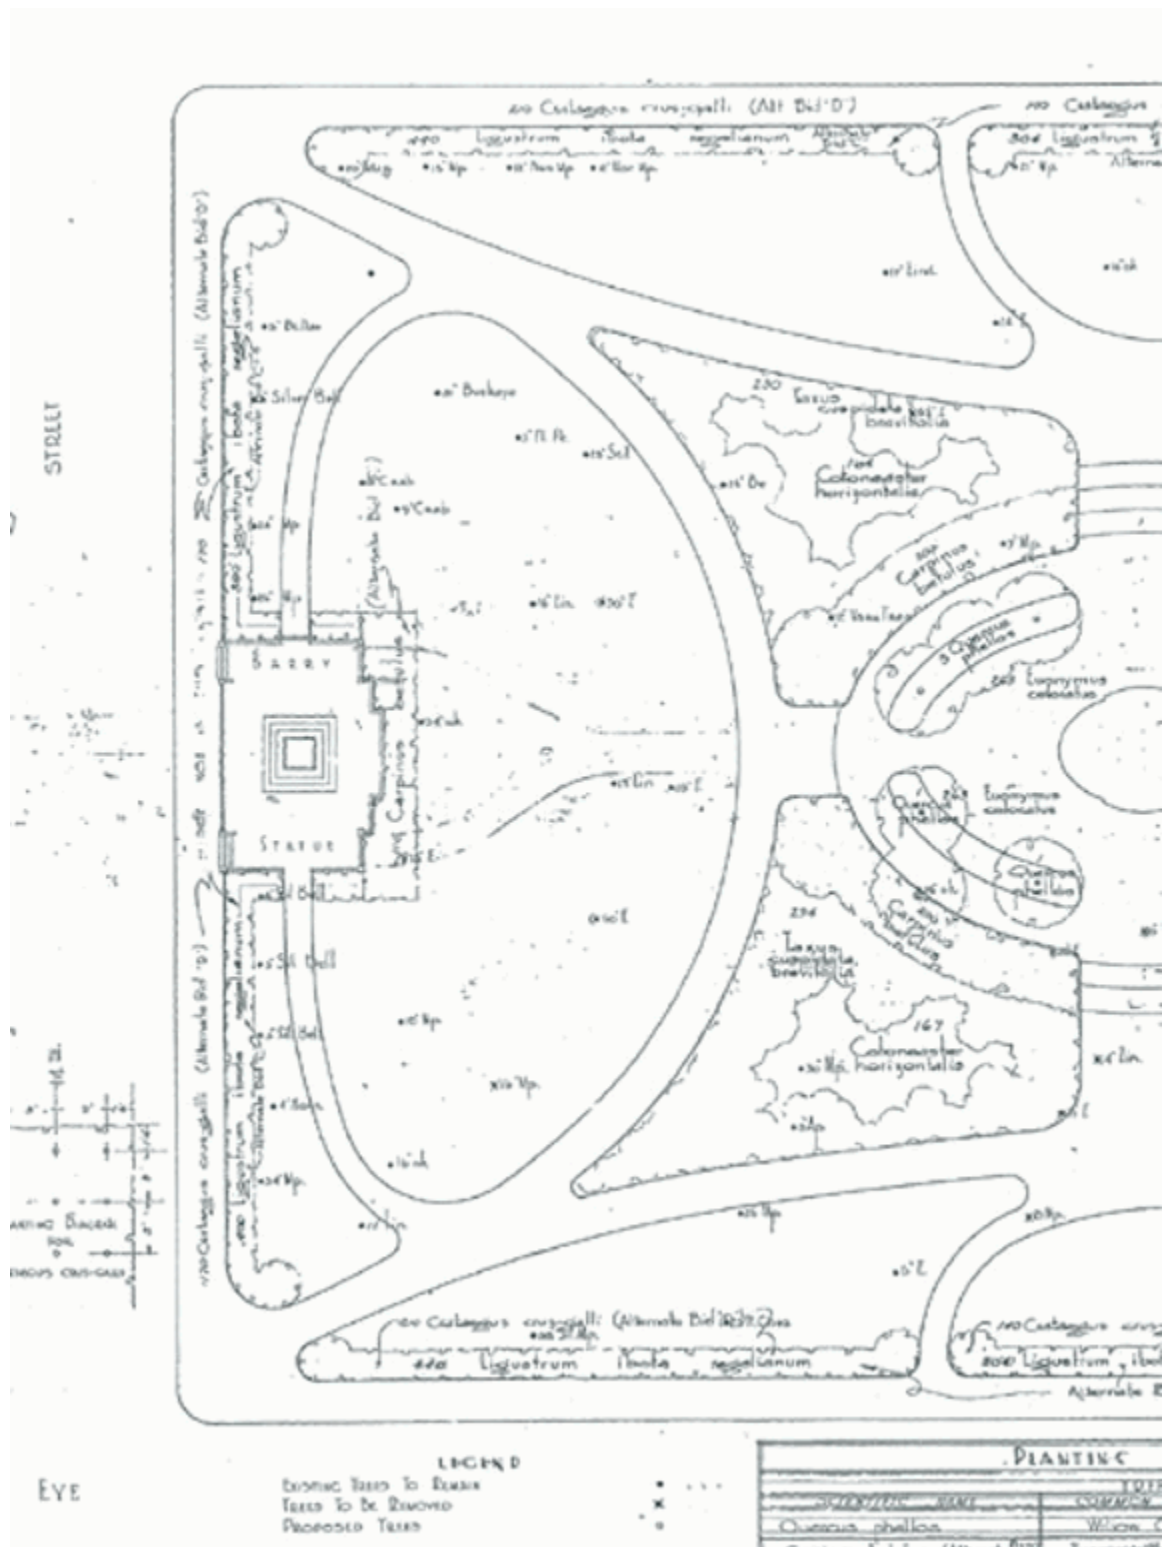
*The existing circulation system of Franklin Park was designed in 1935 and installed the following year. This plan also shows the vegetation planted at that time, which has since changed a great deal. (TIC 812\_1687 Franklin 1935 plan copy)*

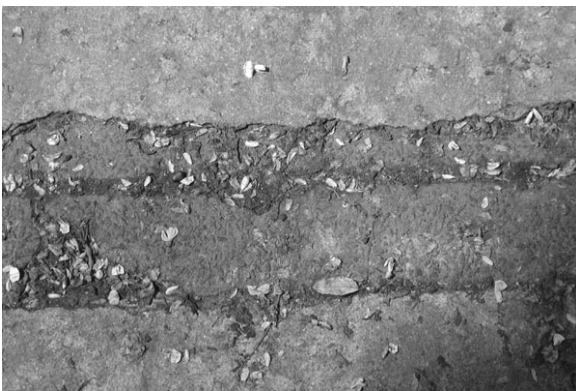
*In areas on the walks where the 1976 synthetic bitumen paving has broken off, expansion joints of the 1936 asphalt paving are visible. (July 2004; CLP digital photofile "Franklin Park/CLI/circulation/pavement joint")*

When they were built in 1936, the main walks were paved with a concrete base that was overlaid with a bituminous asphalt to reduce glare. Double bands of concrete were installed at the ends of pavement sections, with expansion joints between them. When the park was rehabilitated in the 1970s as part of the Bicentennial Program, the walks were overlaid with a beige-colored synthetic bitumen containing a mineral aggregate, known as "Pavebrite." As part of this project, joints were to have been scored above the original expansion joints; however, this was not done, with the result that cracks have since developed over the concrete bands and expansion joints. In the last year or two some damaged sections have been further overlaid with concrete.

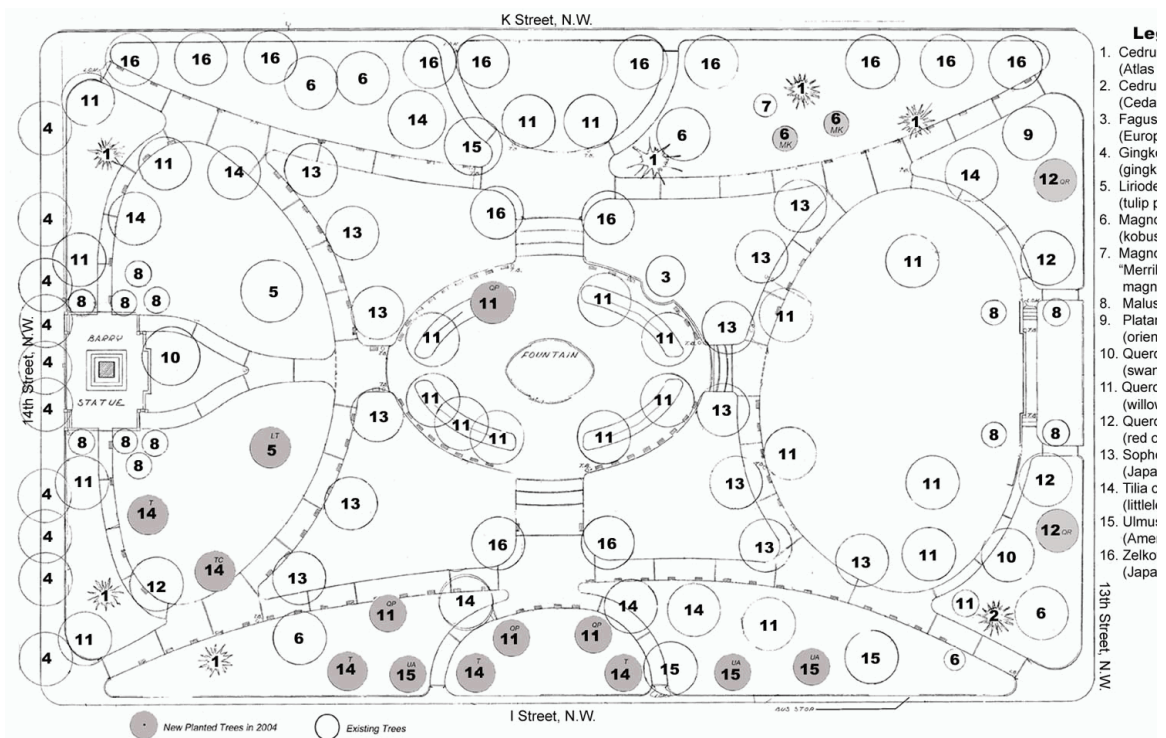
*This plan of the vegetation in Franklin Park notes trees that were added in 2004. ("Veg plan July 2005 final 250")*

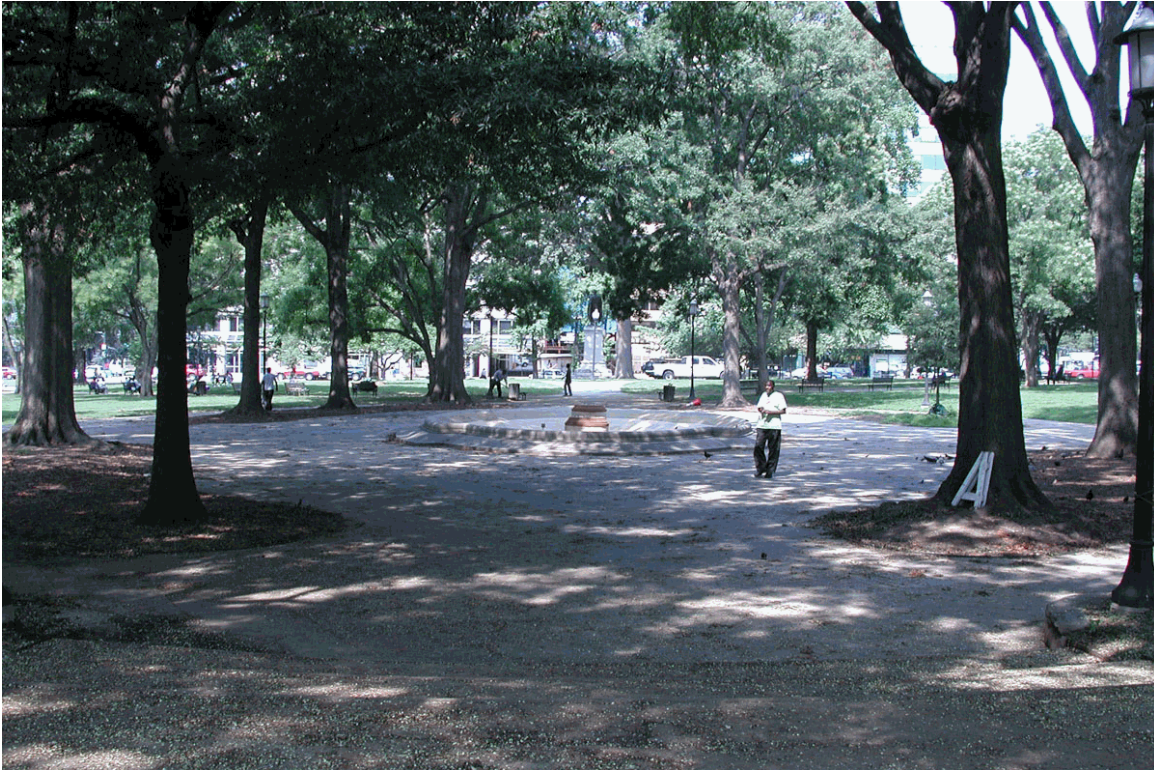
*Within the central plaza, and surrounding the fountain, are four planting areas containing willow oaks, most of which date from 1936. (July 2004; CLP digital photofile "Franklin Park/CLI/vegetation/plaza looking W 2")*

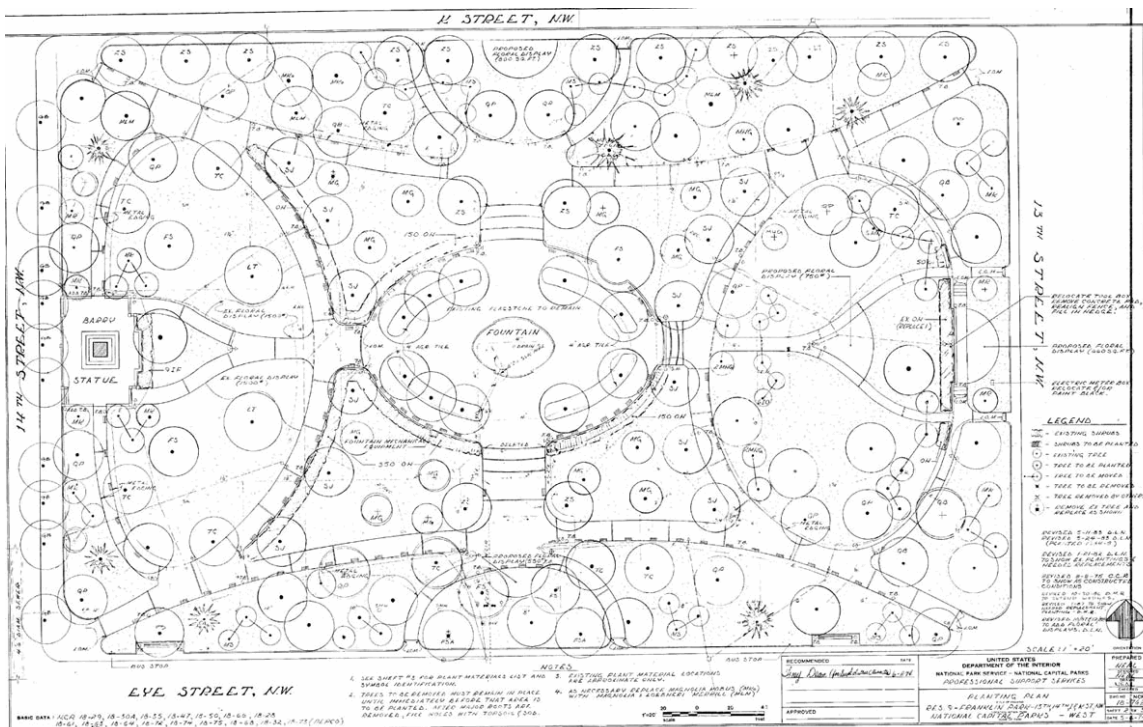
Numerous trees were added in 1974. (TIC 812\_1876E; CLP digital image, "Franklin Park planting plan 1974")

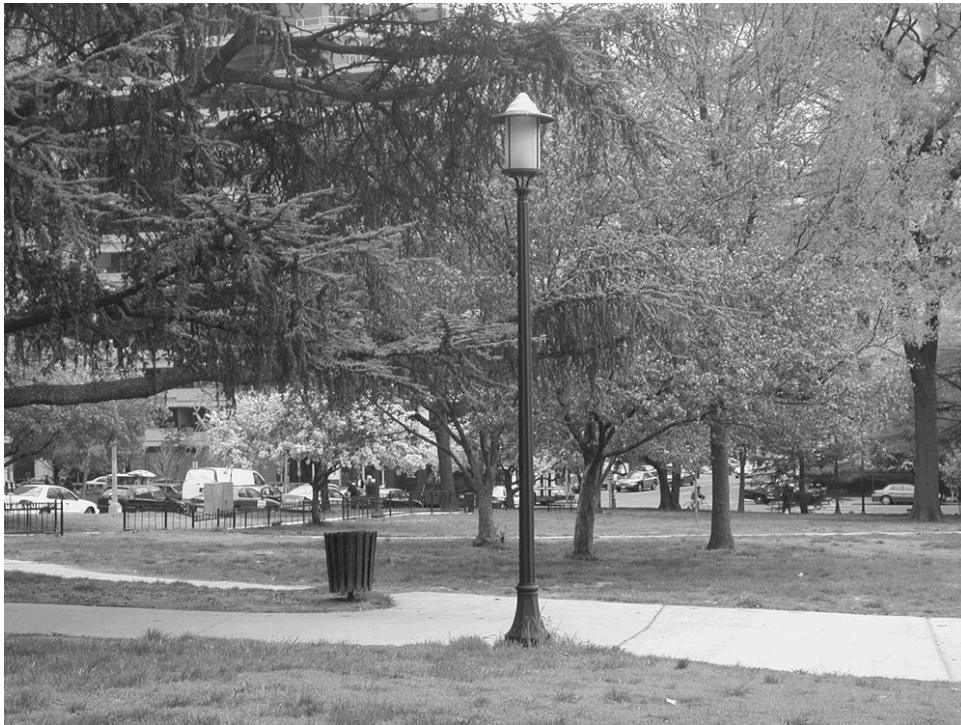
*The Saratoga lightposts, installed in the early 1990s, reproduce the park's historic lighting from the 1936. (April 2004; CLP digital photofile "Franklin Park/CLI/SSF/Saratoga light post and crabapples")*

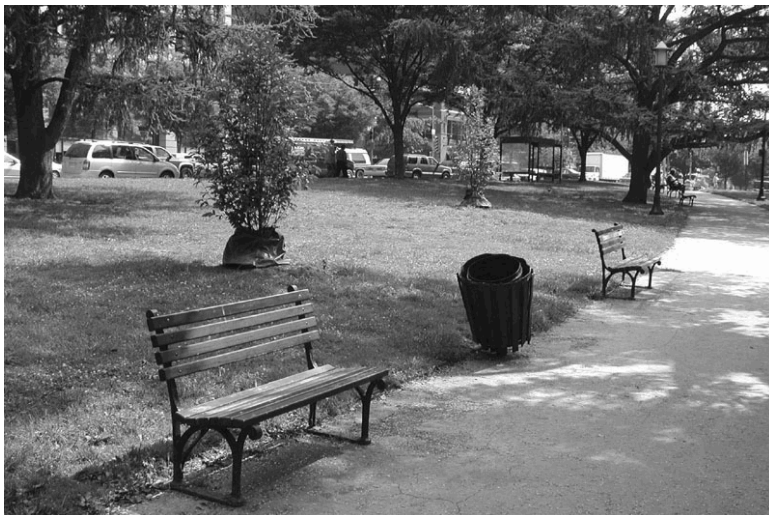
*This bench style, from 1936 rehabilitation, is still used in the park. Tulip-style trash receptacles (1960s) are in poor condition. The two Kobus magnolias were planted in 2004. (July 2004; CLP dig. photo "Franklin Park/CLI/SSF/benches can and new mags")*

should be considered contributing. The dozens of benches are all a type developed for the city's federal reservations in the 1920s or 1930s. The armless benches have curving, molded, cast-iron supports that terminate in scrolls and wood-slat seats and backs. Tulip-style trash receptacles from the 1960s are placed between some of the benches; most are in poor condition. Though recently installed in the 1980s by the Franklin Square Association, the current lights are of the "Saratoga" style used in the park in the 1930s. Other recently installed features that non-contributing include simple post-and-chain barriers, used along walks near the plaza; handicapped accessible drinking fountains; various signs; and bus-stop shelters.

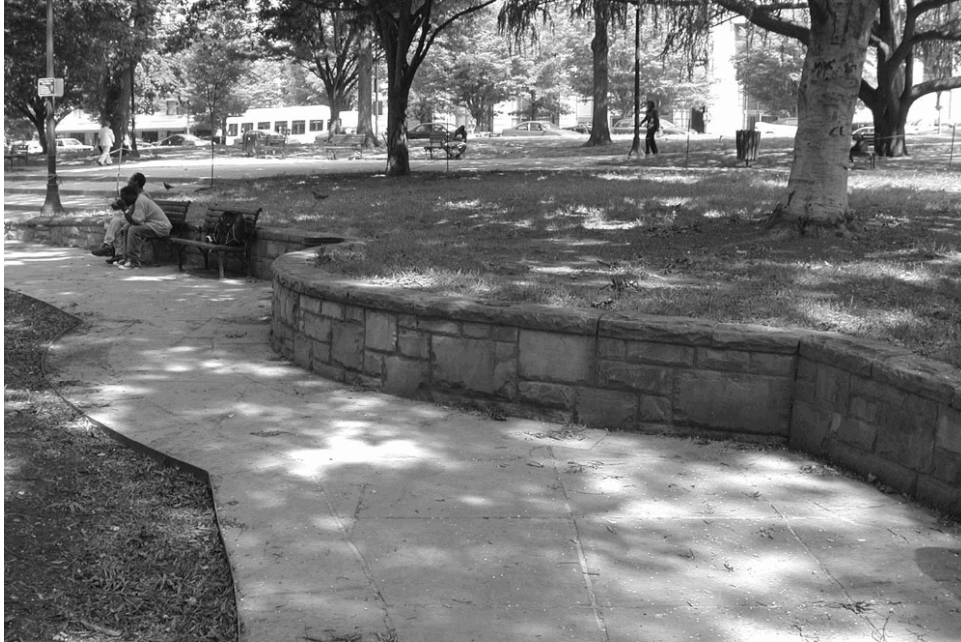
*This rough-faced ashlar stone retaining wall extends along the plaza's northeast quadrant and incorporates a rounded projection, allowing for tree roots. (July 2004; CLP digital photofile "Franklin Park/CLI/SSF/stone wall looking W")*

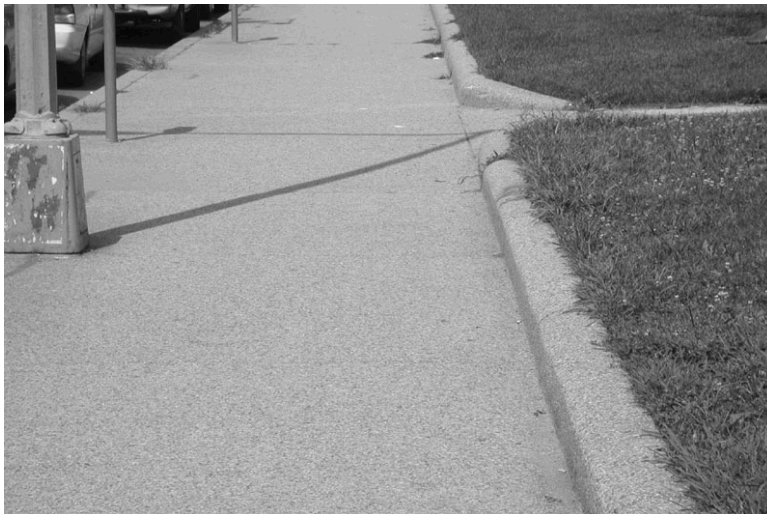
*Recent (1990) replacement of the historic curbing surrounding the park's grass panels failed to maintain the historic quarter-round profile and does not terminate in corner posts. (July 2004; CLP digital photofile "Franklin Park/CLI/SSF/curbs 1")*

The park has a limited number of standard small-scale features developed for use in the National Capital Parks during the early twentieth century. The concrete quarter-round curbing surrounding the outside edges of the grass panels was originally installed in 1904/1905; current curbs are replacements installed in the early 1990s by the District of Columbia in conjunction with perimeter sidewalks, and

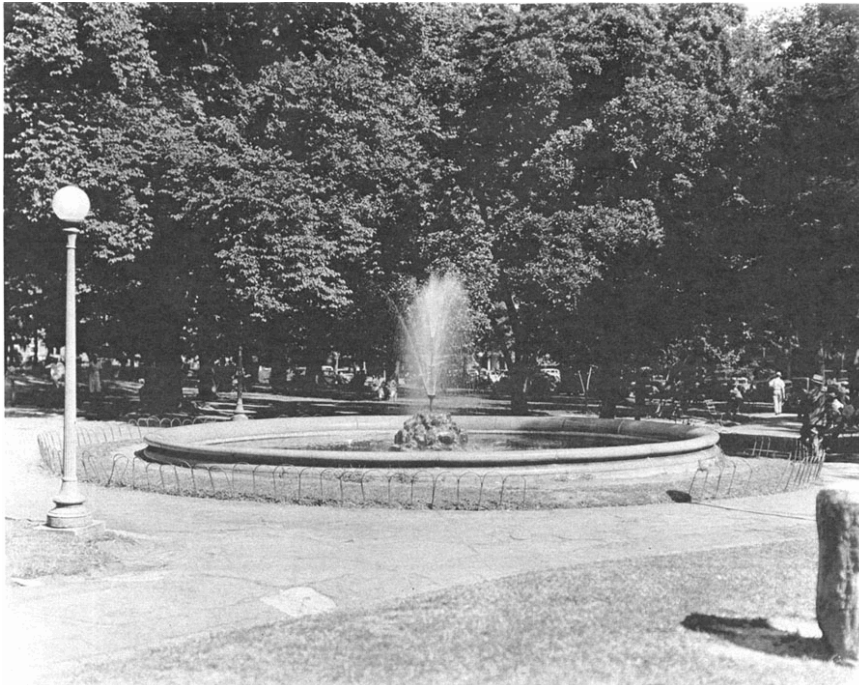
*Franklin Park's first fountain was installed in 1873; it had a coping of imported Scottish granite and a central pile of rocks. At left is typical D.C. electric arc lamp. (CLP digital photofile "Franklin Park/CLI/water feature/historic fountain in 1930")*

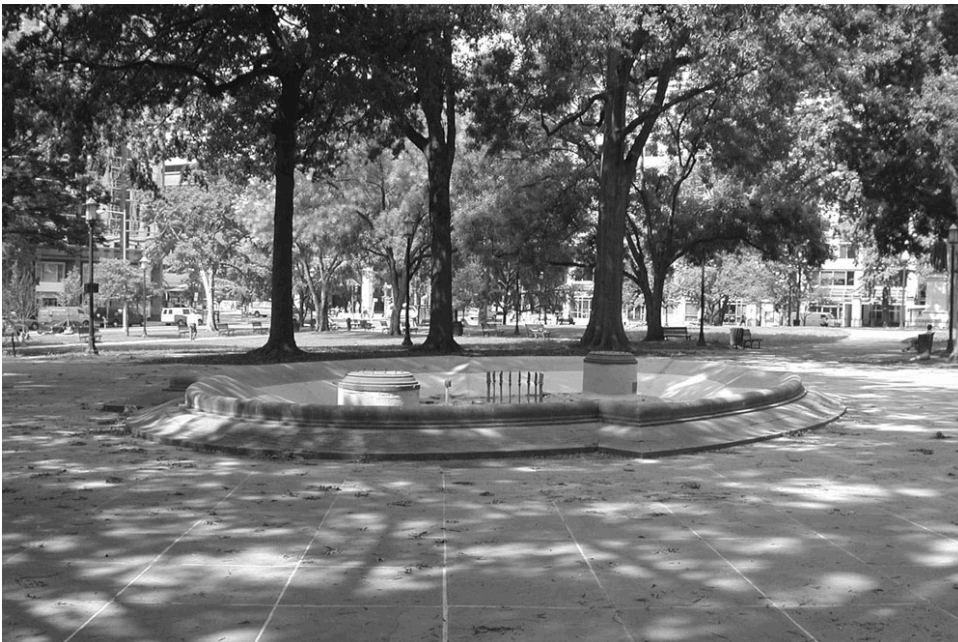
*The current fountain, from 1936, is more carefully integrated into the park's design than the original. The center fountain jets were added in 1988. (July 2004; CLP digital photofile "Franklin Park/CLI/water feature/fountain looking W")*

The focal point of Franklin Park is the elliptical, flagstone-paved plaza in the center. In turn, the central feature of this plaza is a large, elliptical fountain surrounded with a broad, simply molded sandstone coping. The fountain has two "French" jets, installed in the 1930s, and a central jet that was a later addition. (It is not known what is meant by "French jet," a term used in historic documents on the park.) Two of the three jets are operating under city water pressure. A motor replacement, sponsored by the Golden Triangle Business Improvement District (BID), is underway to make the fountain fully operational. Four curvilinear planting areas are evenly spaced within the plaza around the fountain. These beds originally had three willow oak trees; now only one bed has three. (The park intends for there ultimately to be two willow oak trees in each bed.) These willow oaks create a visual boundary defining the plaza as a distinct space (dense hornbeam hedges were originally installed in 1936 along the
