## Chapter 3: Affected Environment

# Natural Resources

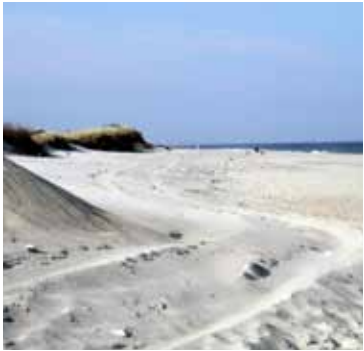
*The park is generally considered part of the Atlantic Coastal Plain province. Coastal plain materials are from formations of sand and gravel characterized by a relatively high degree of weathering.*

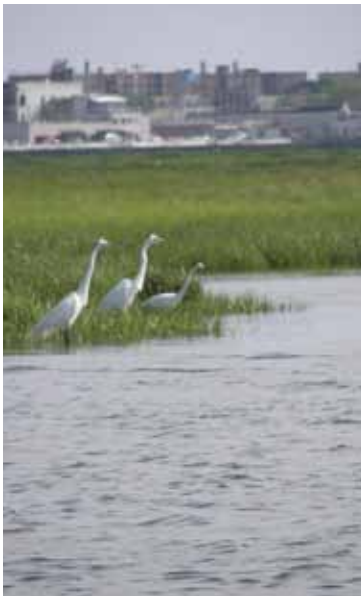
*Coastal wetlands and eelgrass beds, marine plant ecosystems once extensive throughout the estuary, perform a variety of water quality functions, including stabilizing sediments and retaining and recycling nutrients.*

Coastal wetlands and eelgrass beds, marine plant ecosystems once extensive throughout the estuary, perform a variety of water quality functions, including stabilizing sediments and retaining and recycling nutrients. Coastal wetlands can capture and attenuate high levels of nitrogen, reducing the effects of eutrophication and nitrogen loading that contribute to low DO levels. Coastal wetlands can effectively capture up to 95 percent of chemical substances discharged into the saltwater ecosystem (Ringenary, pers. comm. 2013a). In addition to continued controls on municipal and industrial outflows, restoration of coastal wetlands and eelgrass beds is an essential component of effective water quality improvement plans in the region of Gateway (USACE and PA 2009). While eelgrass beds have been virtually eliminated from the Gateway’s vicinity and are absent within the boundaries of the park, much of Jamaica Bay and the bayside coastal areas of Sandy Hook may provide suitable restoration sites (USACE and PA 2009). Wetland restoration projects could also expand the 1,200 acres of saltmarsh in Gateway, which are concentrated mostly in Sandy Hook and Jamaica Bays (Edinger et al. 2008b).

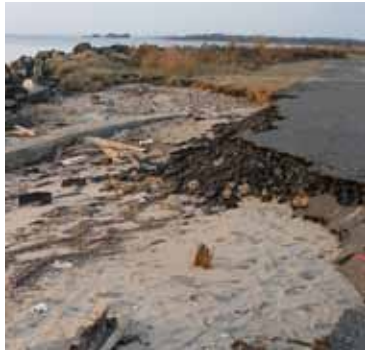
*As demonstrated in October 2012 when Hurricane Sandy struck, the area is also vulnerable to flooding from hurricanes, although by the time Sandy made landfall in New York City, it had been downgraded to post-tropical cyclone status.*

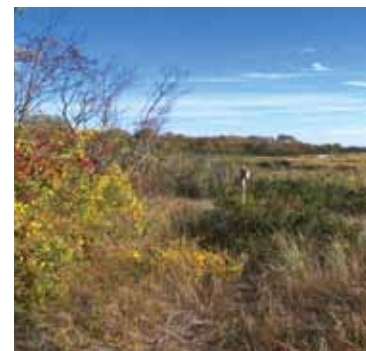
*Between high saltmarshes or beaches and more upland communities, brackish meadows are wetland grasslands dominated by switchgrass and saltmeadow cordgrass that occur on freely draining, shallow, sandy peat overlying glacial till.*

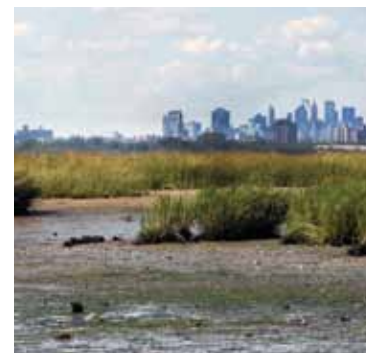
*The center of Jamaica Bay is dominated by subtidal open water and extensive low-lying islands with areas of saltmarsh, intertidal flats, and uplands important for colonial nesting waterbirds.*

Historically, Jamaica Bay was shallow, averaging 11 feet deep on average. Because of dredging for shipping channels, and borrow pits to produce material to build up John F. Kennedy International Airport and other development, the average depth has increased to 16 feet (NYCDEP 1994, 2007). The center of Jamaica Bay is dominated by subtidal open water and extensive low-lying islands with areas of saltmarsh, intertidal flats, and uplands important for colonial nesting waterbirds. Because Jamaica Bay is located at the intersection of not only cooler ocean waters from the north and warmer currents from the south but also of the Hudson River–Raritan Bay estuary, it is considered part of a regionally important fish, wildlife, and plant habitat complex that also includes Breezy Point Tip (USFWS 1997b). Shorebirds, raptors and other land birds, waterfowl, and various migratory insects are concentrated near the coastlines. These migratory species are further massed into the remaining open space and waters of Jamaica Bay by the lack of habitat in surrounding urban land.

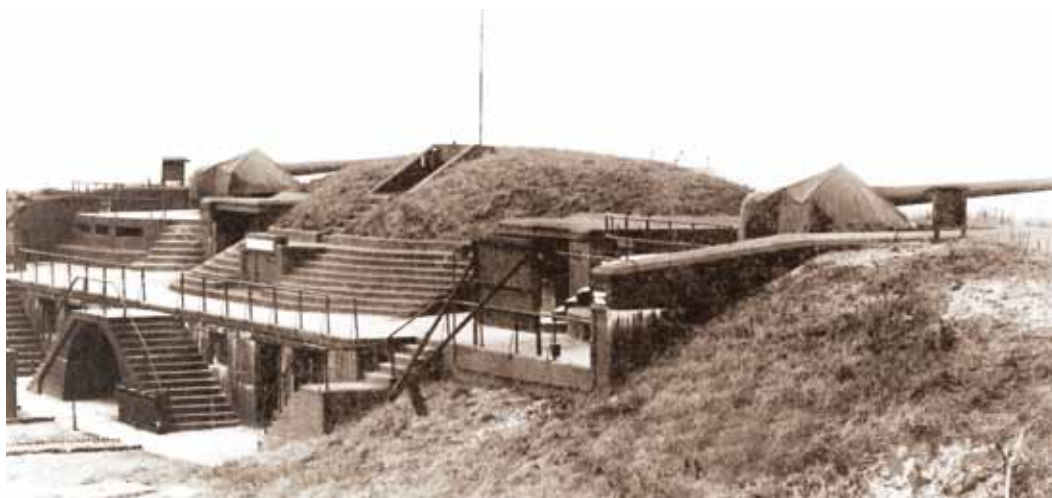
**Figure 3-4. Example of Endicott-Era Battery: Battery Peck, Open Battery Commander's Station, Circa 1905-1910, Looking Southeast.**

In 1886, the Endicott Board called for a comprehensive defense system to protect the country's most important ports and harbors from attacks from the sea (see "Military History"). Under this and later programs, Sandy Hook evolved into one of the most important complexes guarding the approaches to the New York Harbor. Once the construction of the Endicott defenses was underway at Sandy Hook, permanent facilities for a garrison were needed. The site of Fort Hancock was selected and plans for an initial 34 buildings were drawn. The site was cleared and graded and a parade was laid out with the officers' quarters arranged along a linear alignment on the western edge of the parade. The enlisted men's barracks were constructed on the eastern side. The buildings are centered on two open space areas—the parade ground and the athletic field (Layton and Foulds 2010; NPS 1984a). Many of the more than 100 buildings at Fort Hancock share stylistic similarities—distinctive buff brick and Classical Revival ornamentation—and are grouped to take advantage of views of Sandy Hook Bay to the west. The initial buildings were completed around 1899 and construction at the fort continued at a steady pace up to 1918, when it began to slow. Today the fort is composed primarily of the buildings erected at the turn of the century (NPS 1984a).

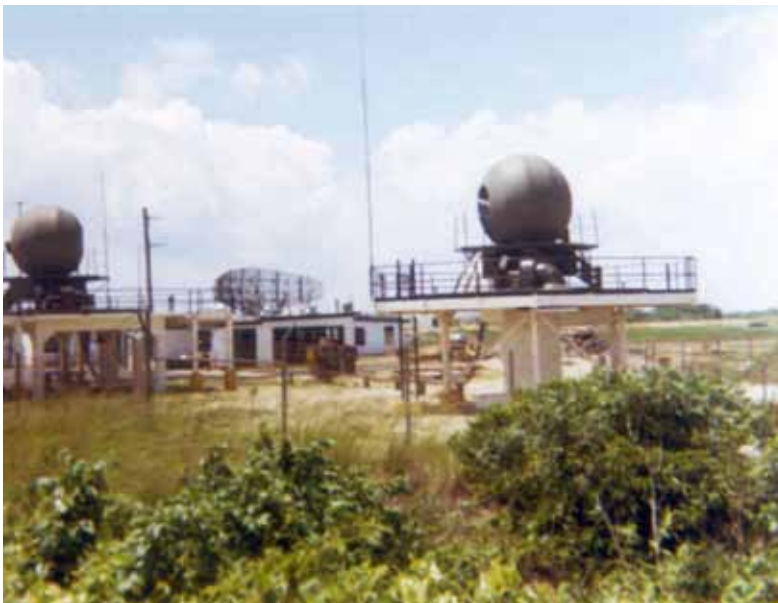
**Figure 3-5. Looking West at Target Tracking Radars, Fort Hancock and Sandy Hook Proving Ground, Control Area No. 1, Nike Radar Site, Circa 1962.**

In the 1950s, Nike Missile installations—a response to the threats of the nuclear age—were placed on Sandy Hook. The launch area (14.69 acres) consisted of the “launching complex where missiles were stored in underground silos and a radar tracking and control station with equipment for acquiring targets, tracking targets, and tracking the flight of outbound missiles” (Layton and Foulds 2010, 471). The Nike Missile installation at Fort Hancock and Sandy Hook Proving Ground was one of only a few dual battery sites built in the United States that featured two rows of missile launchers and two related groups of radar. Construction was completed on the launch site in 1955 and on the radar site in 1956 (Layton and Foulds 2010).

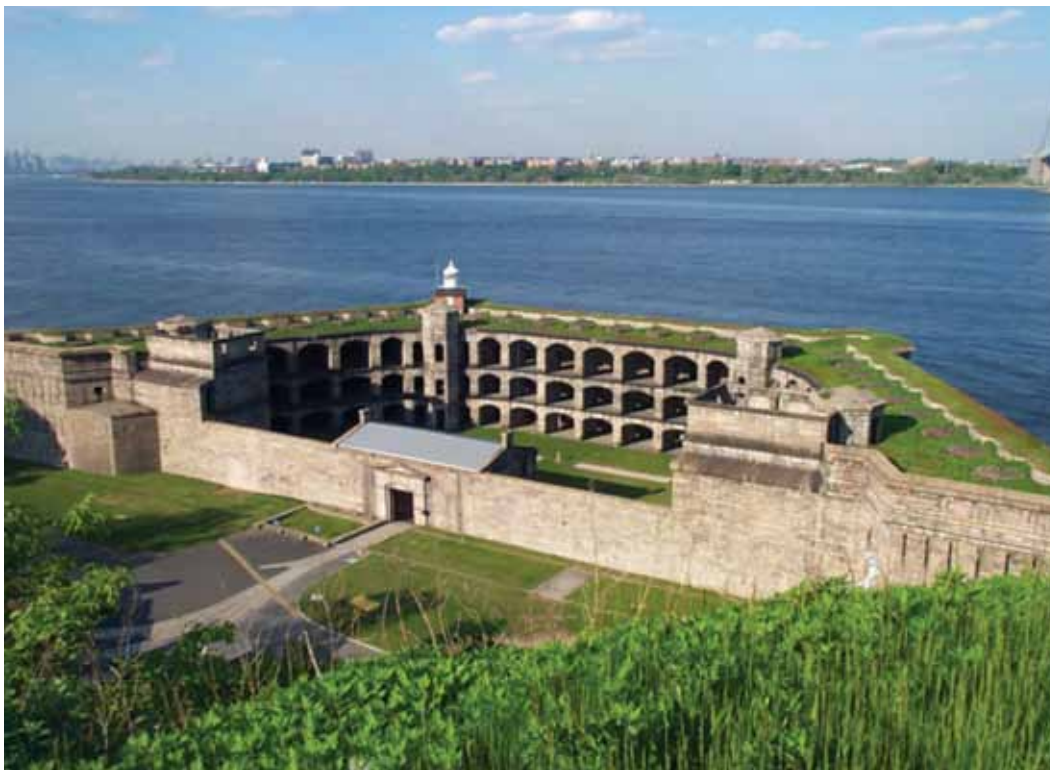
**Figure 3-8. Battery Weed Looking Northeast Across the Narrows Toward Brooklyn (2006).**

Many of the existing batteries at Fort Wadsworth are located on the sites of earlier fortifications. Battery Weed, begun in 1847, is one of the earliest structures that remains intact at the fort and was constructed on the site of the former Fort Richmond, a water battery (Black 1983). Battery Weed’s construction involved the use of granite blocks in a half-hexagon shape and included a central parade ground (figure 3-8). At the time of its completion (1861–1864) it included 116 cannons, three tiers of casemates, and a fourth barbette tier, each with gun emplacements. Access to the tiers is via circular granite staircases. A seawall follows the perimeter of Battery Weed and at one time functioned as the exterior side of a moat that once surrounded the battery. The seawall is constructed of granite blocks similar in appearance to the construction materials of the battery. Damage to Battery Weed from Hurricane Sandy in 2012 included loss of fencing and damage to the seawall (IMT 2012d).

Battery Weed was garrisoned by a large force from the Fifth Regiment New York Volunteer Artillery. It represents “an important example of a multi-tiered casemated fort—one of only three 4-tiered forts built—belonging to the Third System of American seacoast fortifications” (NPS n.d.b, 5). It is believed to retain a high degree of integrity. Battery Weed is also recognized as a Landmark Site by the New York City for its “special historical, aesthetic interest and value as part of the development, heritage and cultural characteristics of New York City” (New York City, Landmarks Preservation Commission 1967, 2).

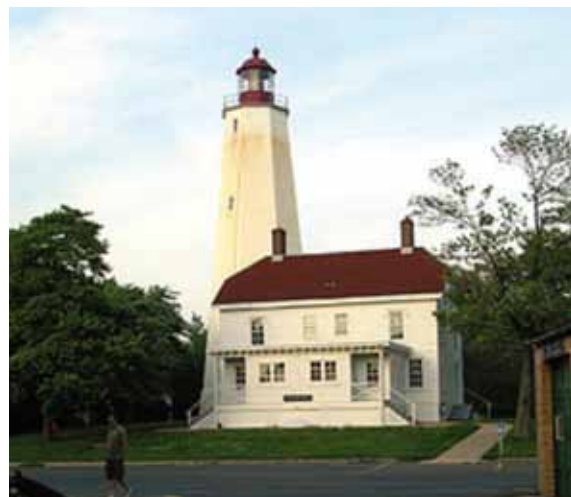
**Figure 3-9. Sandy Hook Lighthouse and Keeper's Quarters.**

diameter at the top level. It is constructed of bricks on a masonry foundation and its walls are 7 feet thick at the base. It includes 13 windows and a circular iron staircase to the upper levels. A ladder allows access through the vaulted ceiling to the beacon itself, which is protected by a glass and steel cupola. The 45,000-candlepower beacon is approximately 4 feet wide by 8 feet high and is housed in a thick circular glass lens. Graphic depictions of the light in the late 1870s and early 1880s include, among other things, the keeper's quarters, a fenced yard, a second house (probably for an assistant keeper), a farmyard, and a possible chicken coop (Bianchi 2006). Restoration work was completed on the lighthouse in 2000.

Just southwest of the light structure sits the former lightkeeper's house—a two-and-a-half story frame house with hip and gable roof constructed in the early 1880s (figure 3-9) (NPS 1971). The original exterior has not changed substantially except for the addition of asbestos shingles. The interior of the house was renovated by the Coast Guard in 1980 (NPS 1984a); a more recent renovation by the Sandy Hook Foundation occurred in 2000. While the Sandy Hook Unit sustained considerable damage from Hurricane Sandy in 2012 (see Fort Hancock and Sandy Hook Proving Grounds, above), the lighthouse and keeper's quarters do not appear to be damaged.

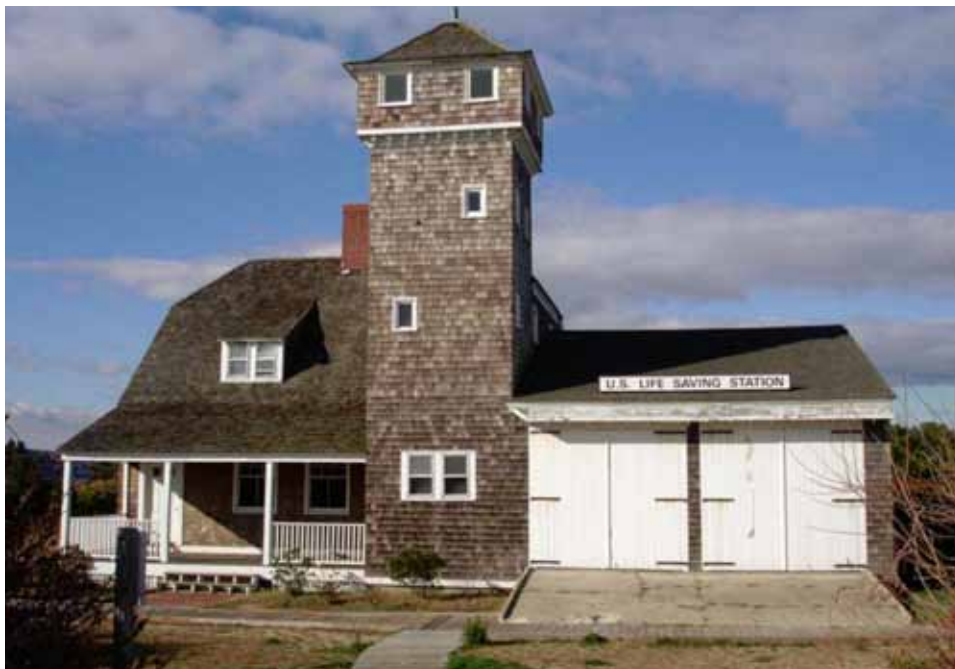
**Figure 3-10. Spermaceti Cove Life Saving Station, East Elevation.**

Between 1894 and 1949, the U.S. Life Saving Service conducted numerous rescues from this structure. The Spermaceti Cove Life Saving Station was one of the six to eight original New Jersey U.S. Life Saving Service sites. In 1949, the lifesaving station was decommissioned by

the U.S. Coast Guard and later housed administrative offices for the New Jersey State Park on Sandy Hook. Since 1974, it has served as one of Gateway's visitor centers and remains an important example of late 19th century New Jersey coastal utilitarian architecture (NPS 1981b).
