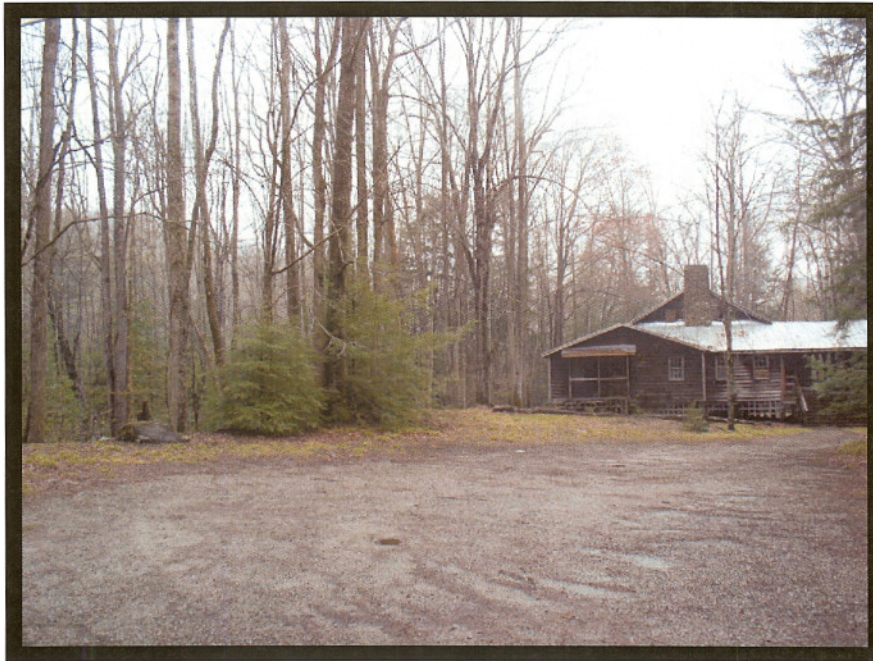
Photo 1: Parking Area at the Appalachian Clubhouse

This photo shows the existing Appalachian Clubhouse and parking area. Most of the alternatives propose restoring the Clubhouse for day use.

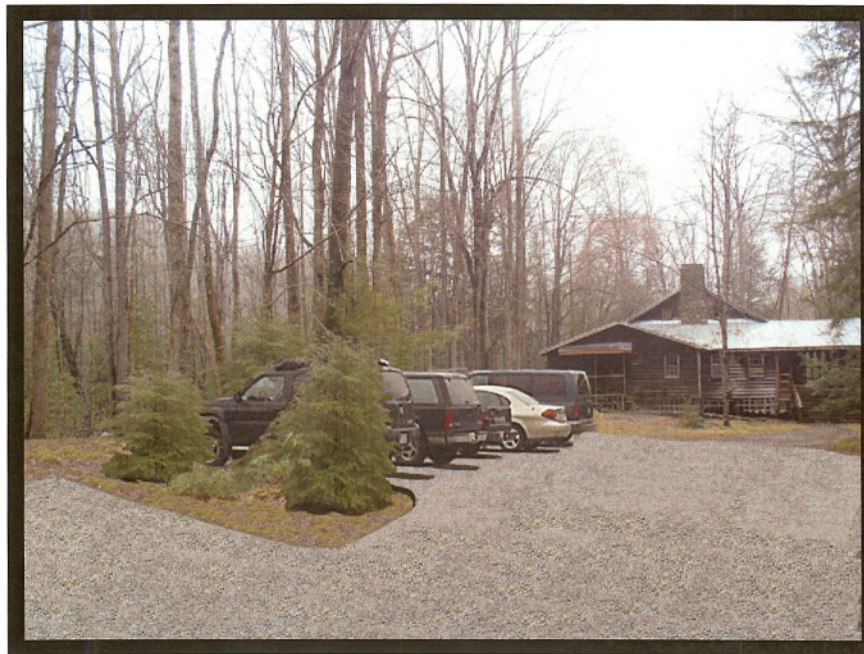
Photo 1A: Proposed Parking Area at the Appalachian Clubhouse

This simulation demonstrates mitigation of adverse visual impacts. The technique minimizes the negative effect of the parking area by screening the views of vehicles. Proposed vegetative screens would enhance the parking area at the Appalachian Clubhouse and assist in reducing the amount of visible parking area. Transplanted evergreen vegetation would provide year round screening. Pervious concrete would allow for accessibility and reduce the potential for impacts to the environment.

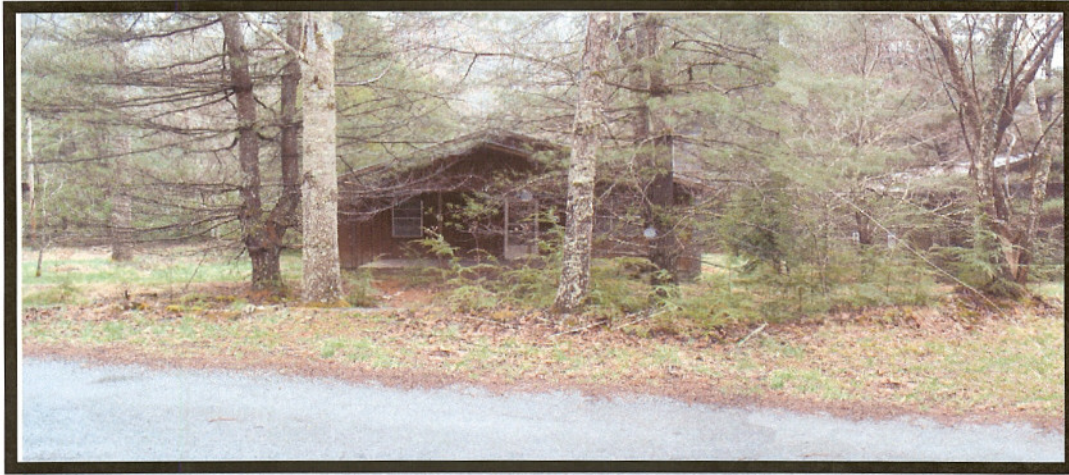
Photo 2: Existing Conditions at Proposed Parking Area

The area shown consists of the Bagley (#17) cabin and the Jamerson (#14) cabin. In some alternatives, this area has been proposed as a possible site for a parking lot.

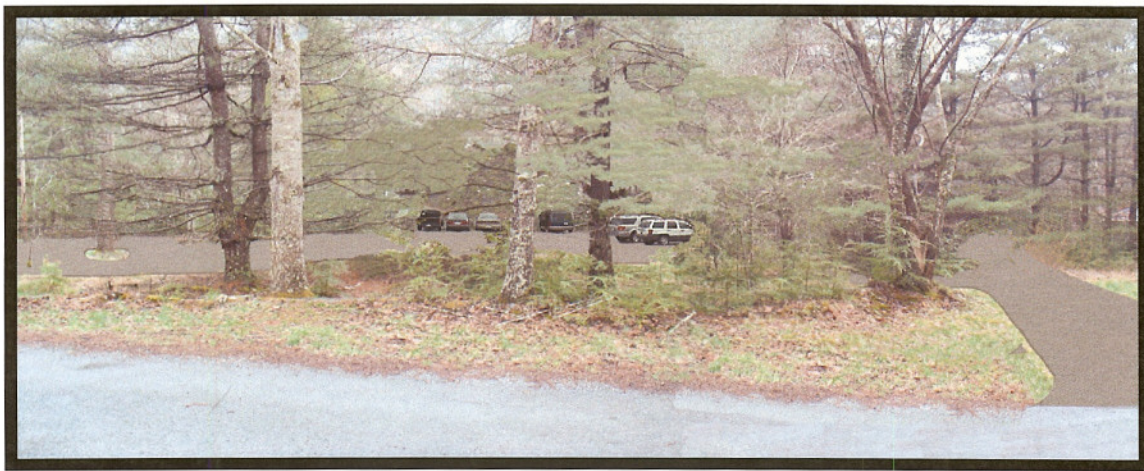
Photo 2A: Proposed Parking Area in Daisy Town

This simulation demonstrates conservation design techniques by proposing parking areas with the existing vegetation preserved. Parking lots will be placed in areas that require minimal impact to surrounding vegetation. Screening between roads and parking areas also reduces views of vehicles and pavement. Small tree seedlings from other locations in the District could be transplanted to provide additional screening.

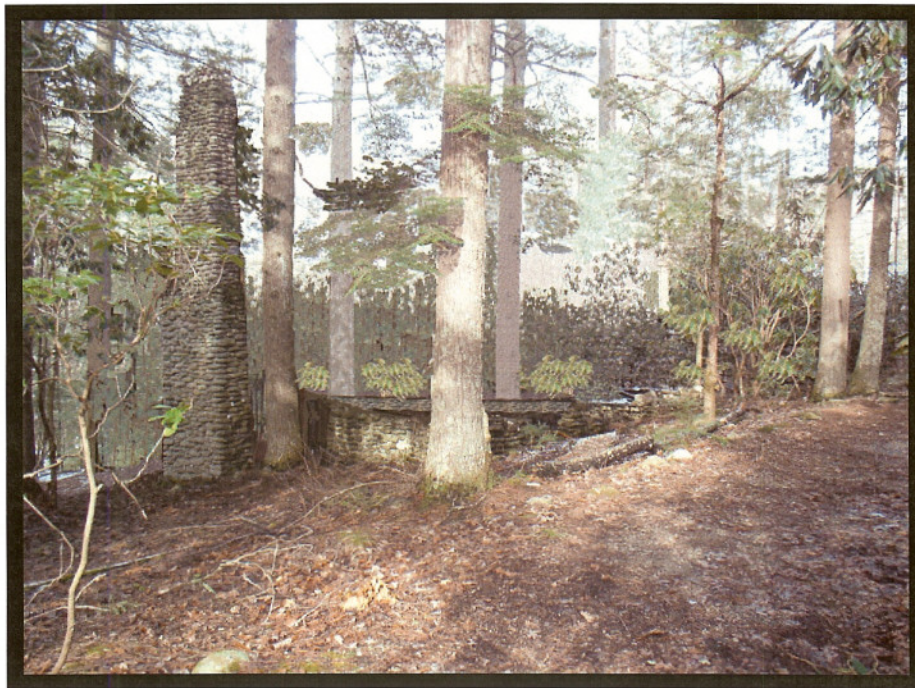
Photo 3A: Former Vernon Moore Cabin

This simulation demonstrates the effect of removal of the Vernon Moore cabin located in the Wonderland Club. This simulation depicts preservation of the rock foundation and chimney.

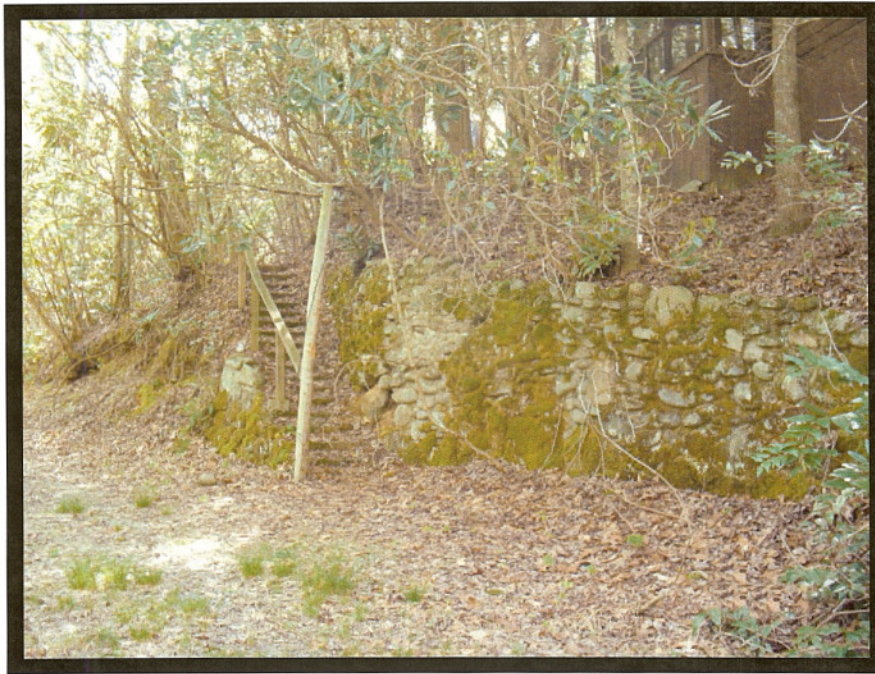
Photo 4: Existing Stone Staircase at Former Beaman Cabin
This figure shows the existing condition of the Beaman (#58- 8H) cabin and steps.

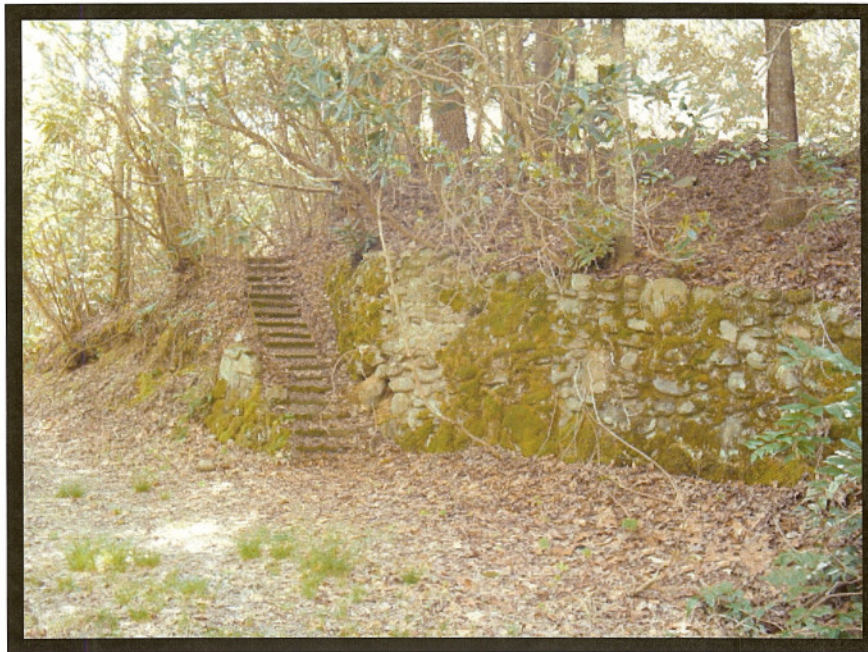
Photo 4A: Stone Staircase at Former Beaman Cabin
This simulation demonstrates the effect of removal of the Beaman (58- 8H) cabin in the Wonderland Club. The rock steps and wall are preserved to reflect the historical character of the site.

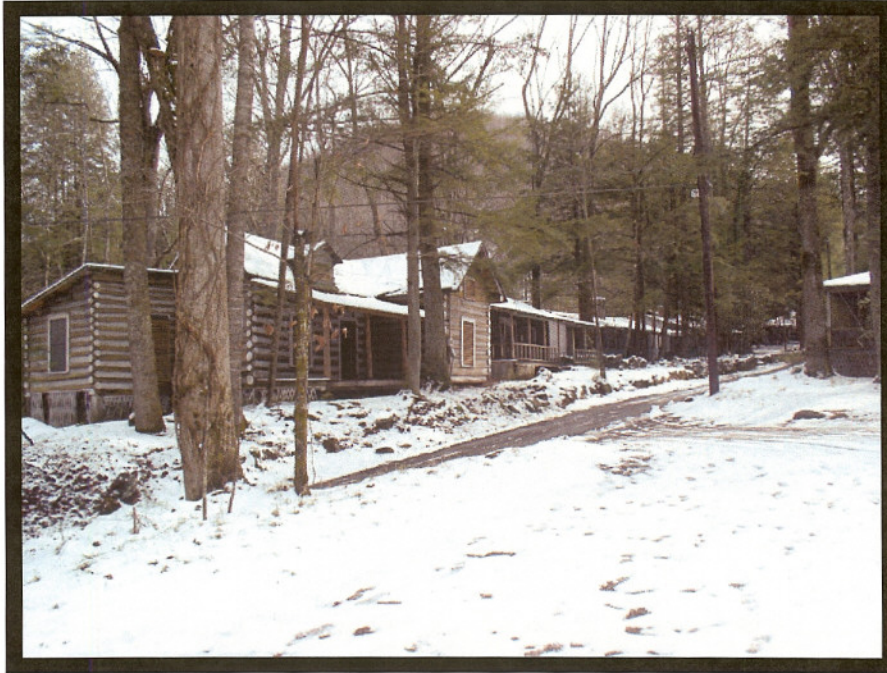
Photo 5: Viewing Platform from Parking Area at Appalachian Clubhouse

This photo depicts the existing Sneed (#1), Higdon (#3), Addicks (#5), and Smith (#2) cabins in Daisy Town.

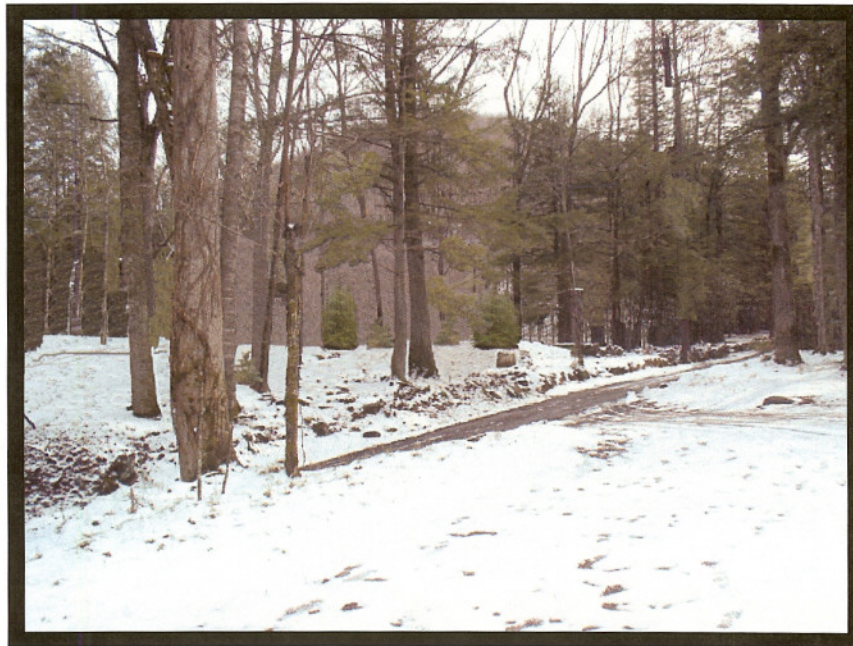
Photo 5A: Viewing Platform from Parking Area at Appalachian Clubhouse

This simulation demonstrates the visual effect of removal of cabins in Photo 5. The existing road would remain for vehicular and pedestrian circulation.

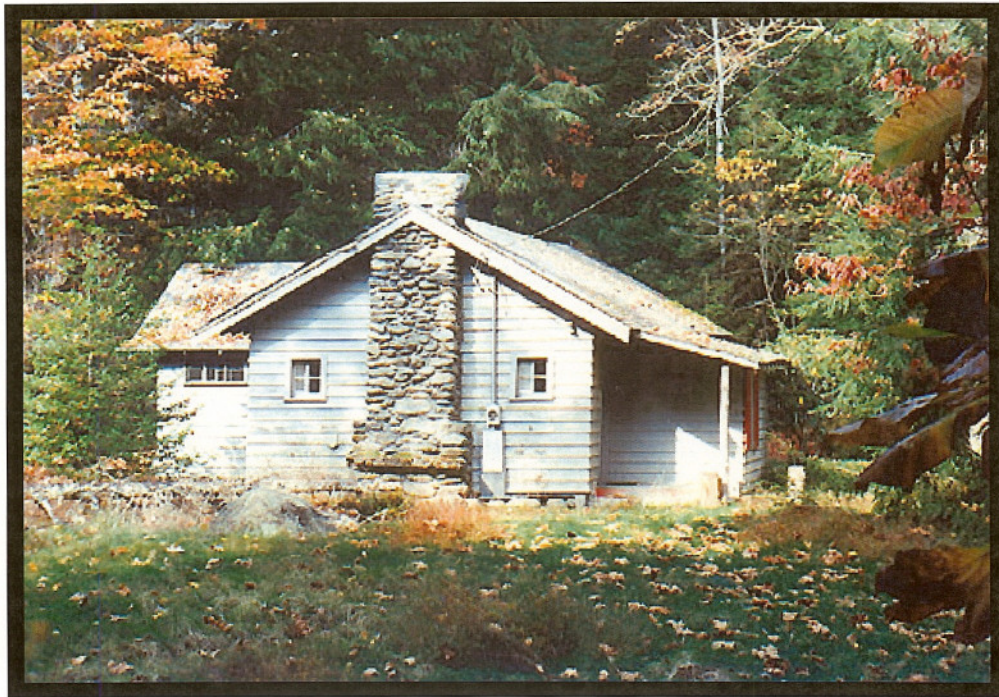
Photo 6: Parrot Cabin

This figure shows the existing Parrot (#44) cabin in Millionaire's Row.

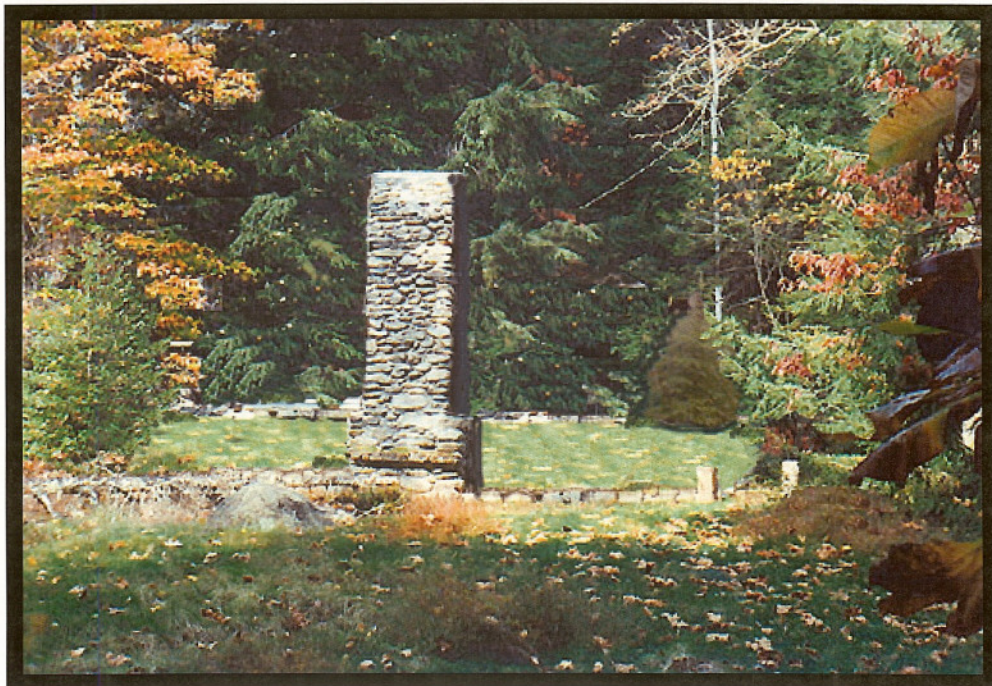
Photo 6A: Former Parrot Cabin

This simulation demonstrates the visual effect of removal of the Parrot (#44) cabin. The rock foundation and chimney could be preserved under some alternatives if they are structurally sound.
