**Site Plan: Proposed Rehabilitation/Renovation of House at Ferncliffe
(Rear, Second-Story Windows)**

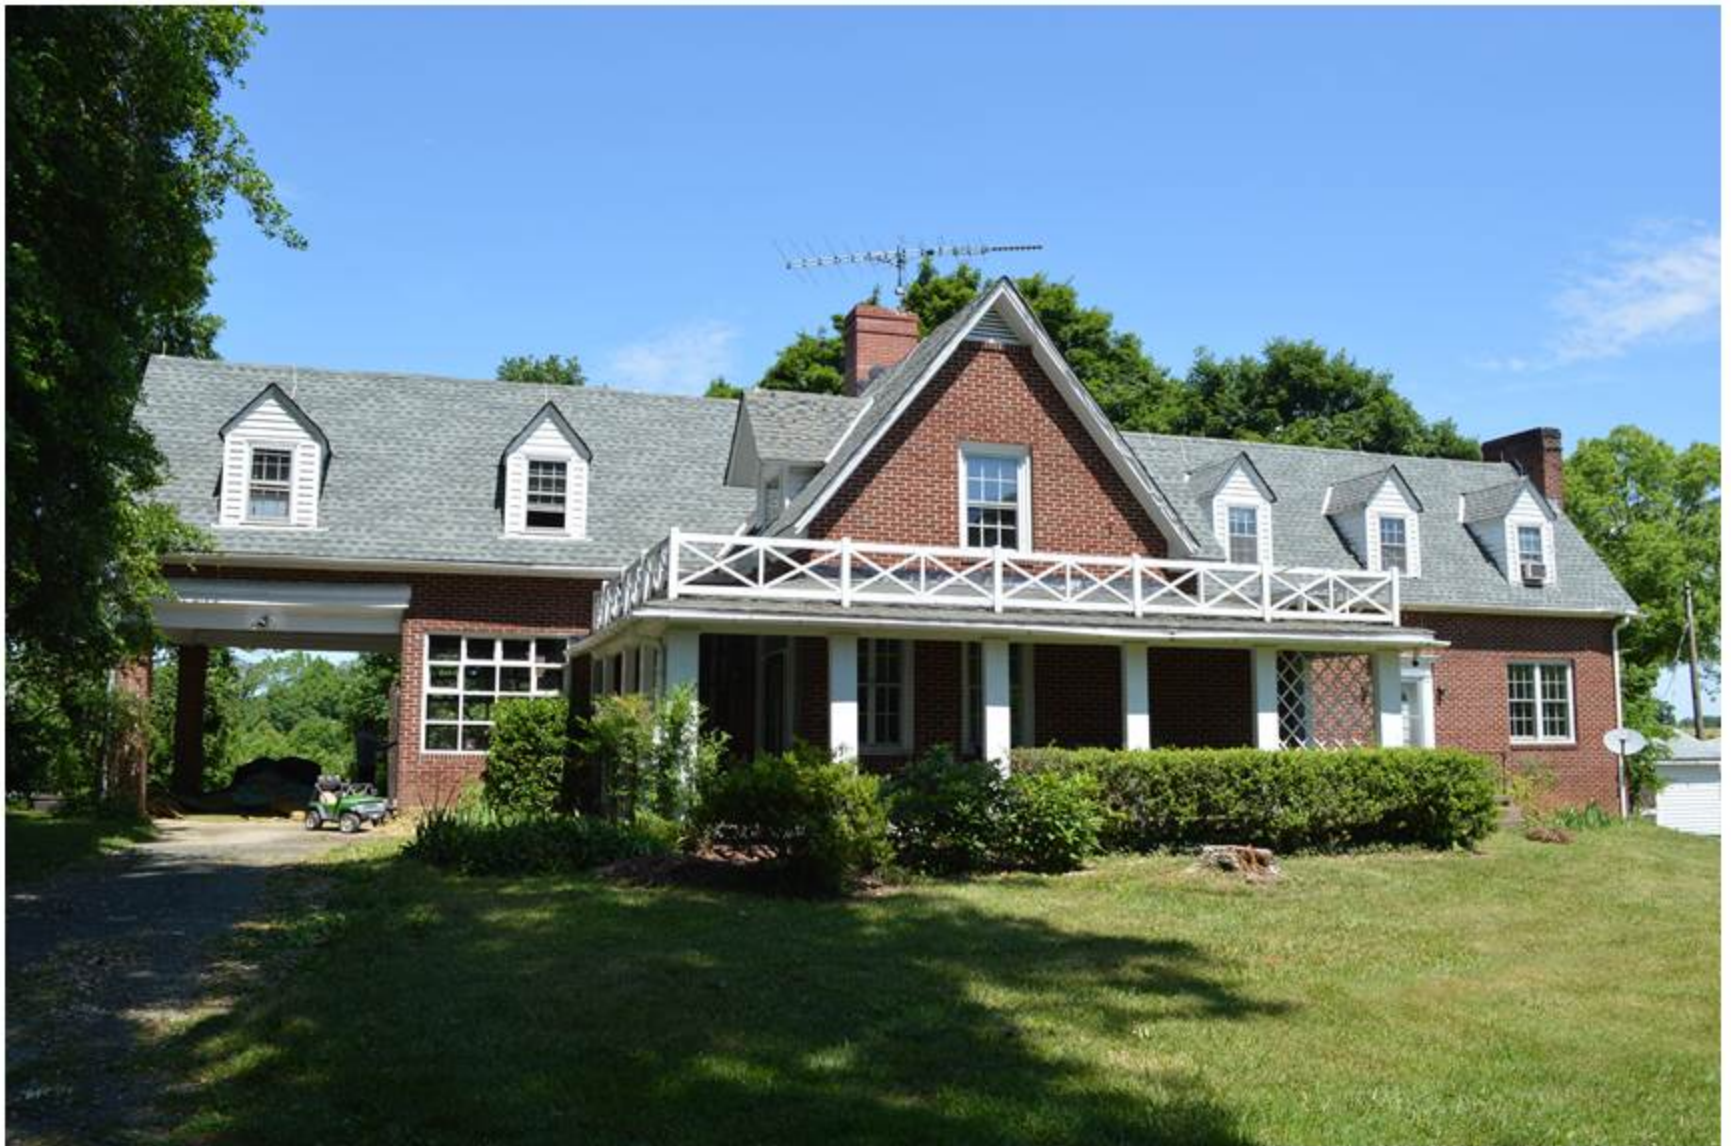
House at Ferncliffe, front (southeast) façade. Proposed rehabilitation work would affect 2nd-story windows of rear (northwest) façade.

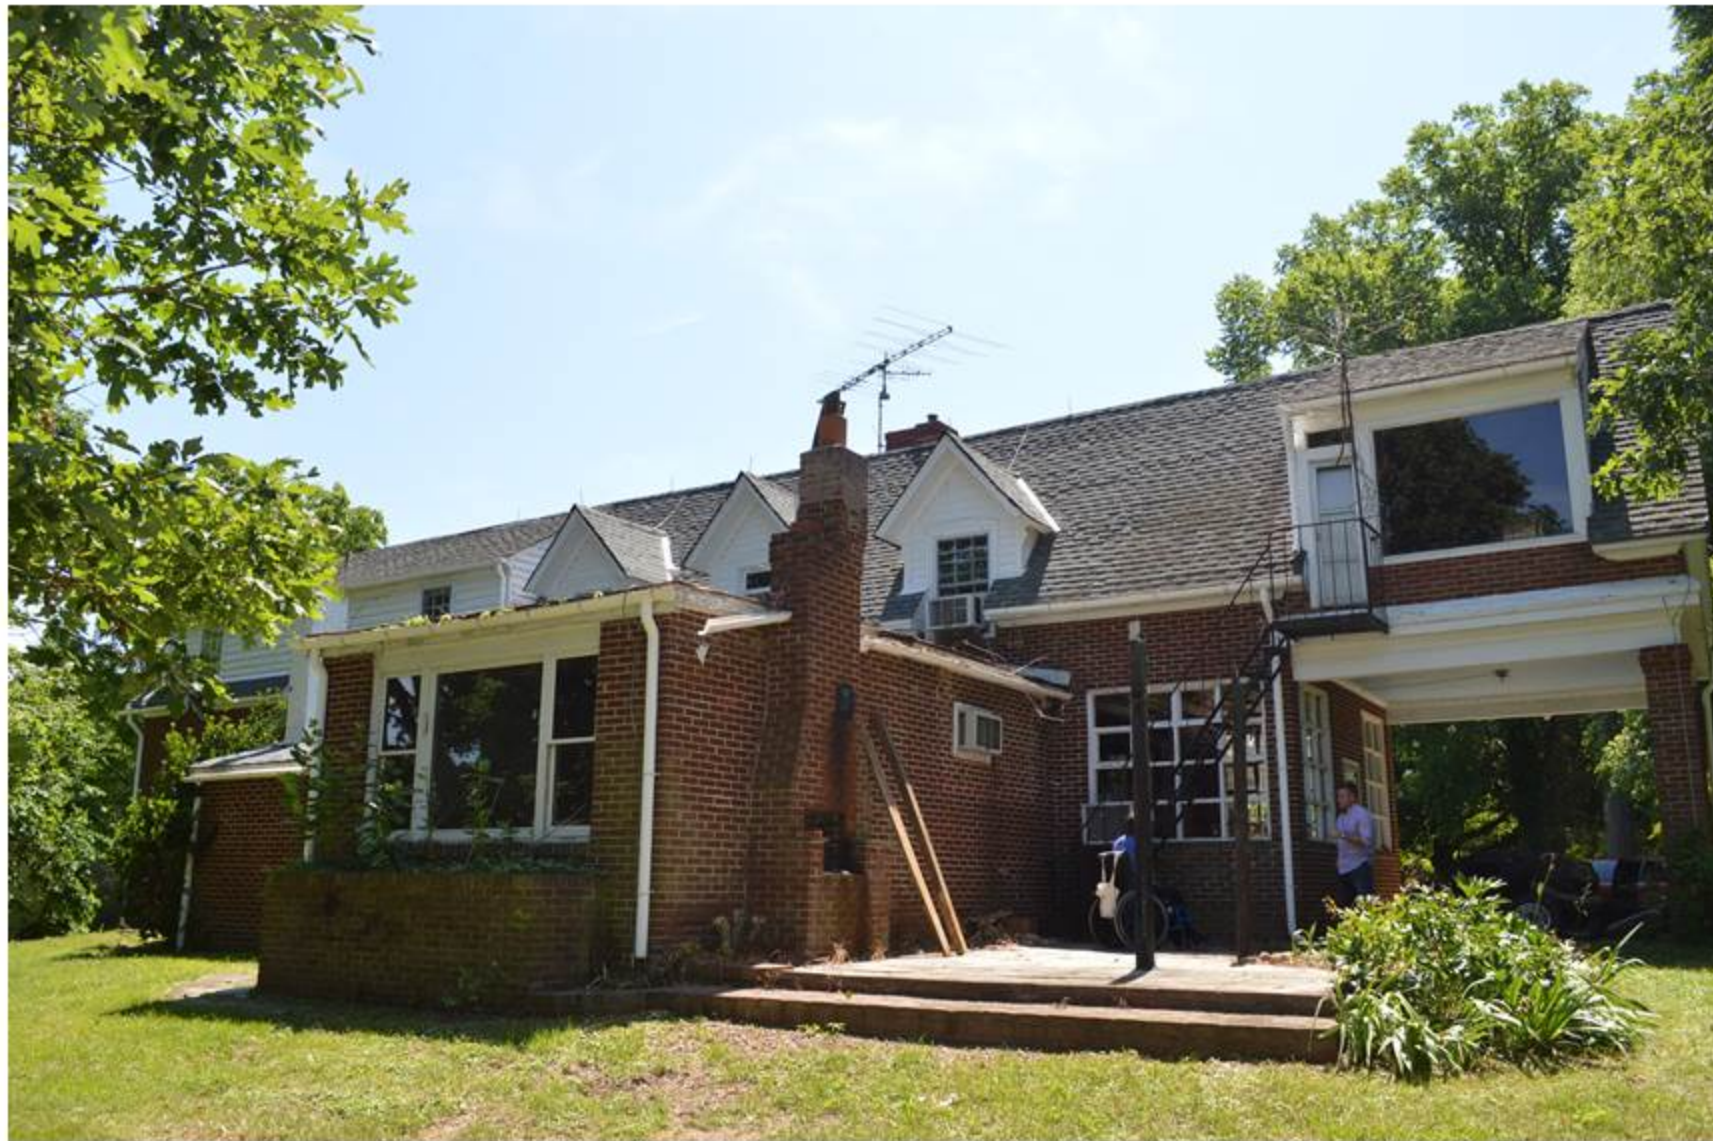
House at Ferncliffe, rear (northwest) facade, location for proposed 2nd-story rehabilitation/renovation work, involving three gable roof windows at center. Note two 2nd-story, shed-roof windows at left (and far left), and at right, picture windows, fire-escape-door and stair, and other, later alterations.

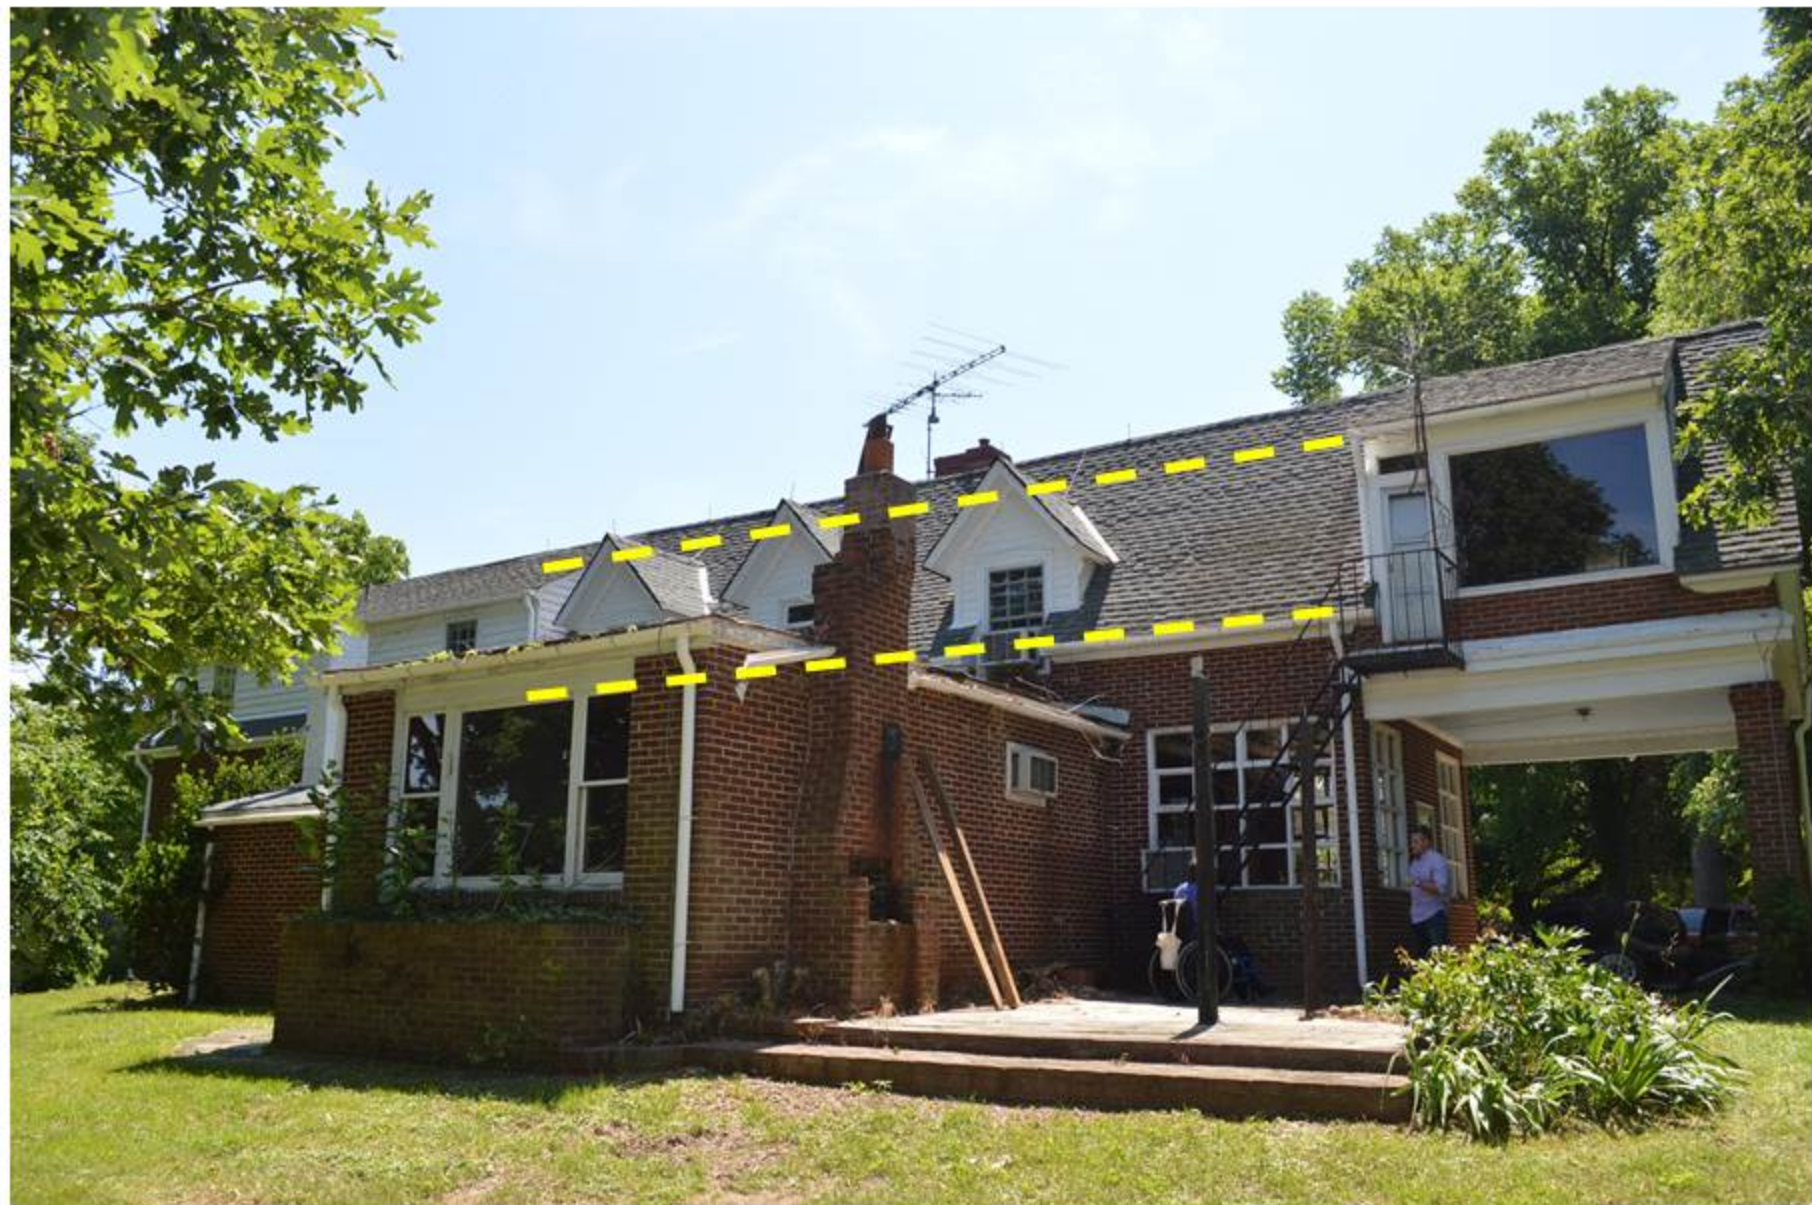
House at Ferncliffe, rear (northwest) facade. Yellow lines mark proposed replacement of individual gable-roofs for three 2nd-story windows with shed-roof-configuration connecting with and matching color, shingles, pitch and other attributes of existing shed-roofs.
