*Youngsholm  
Cultural Landscape Report,  
Environmental Assessment,  
and Schematic Design*

**Public Open House**

**Charles Young Buffalo Soldiers National Monument**

Wilberforce, Ohio - Wednesday, June 21, 2017

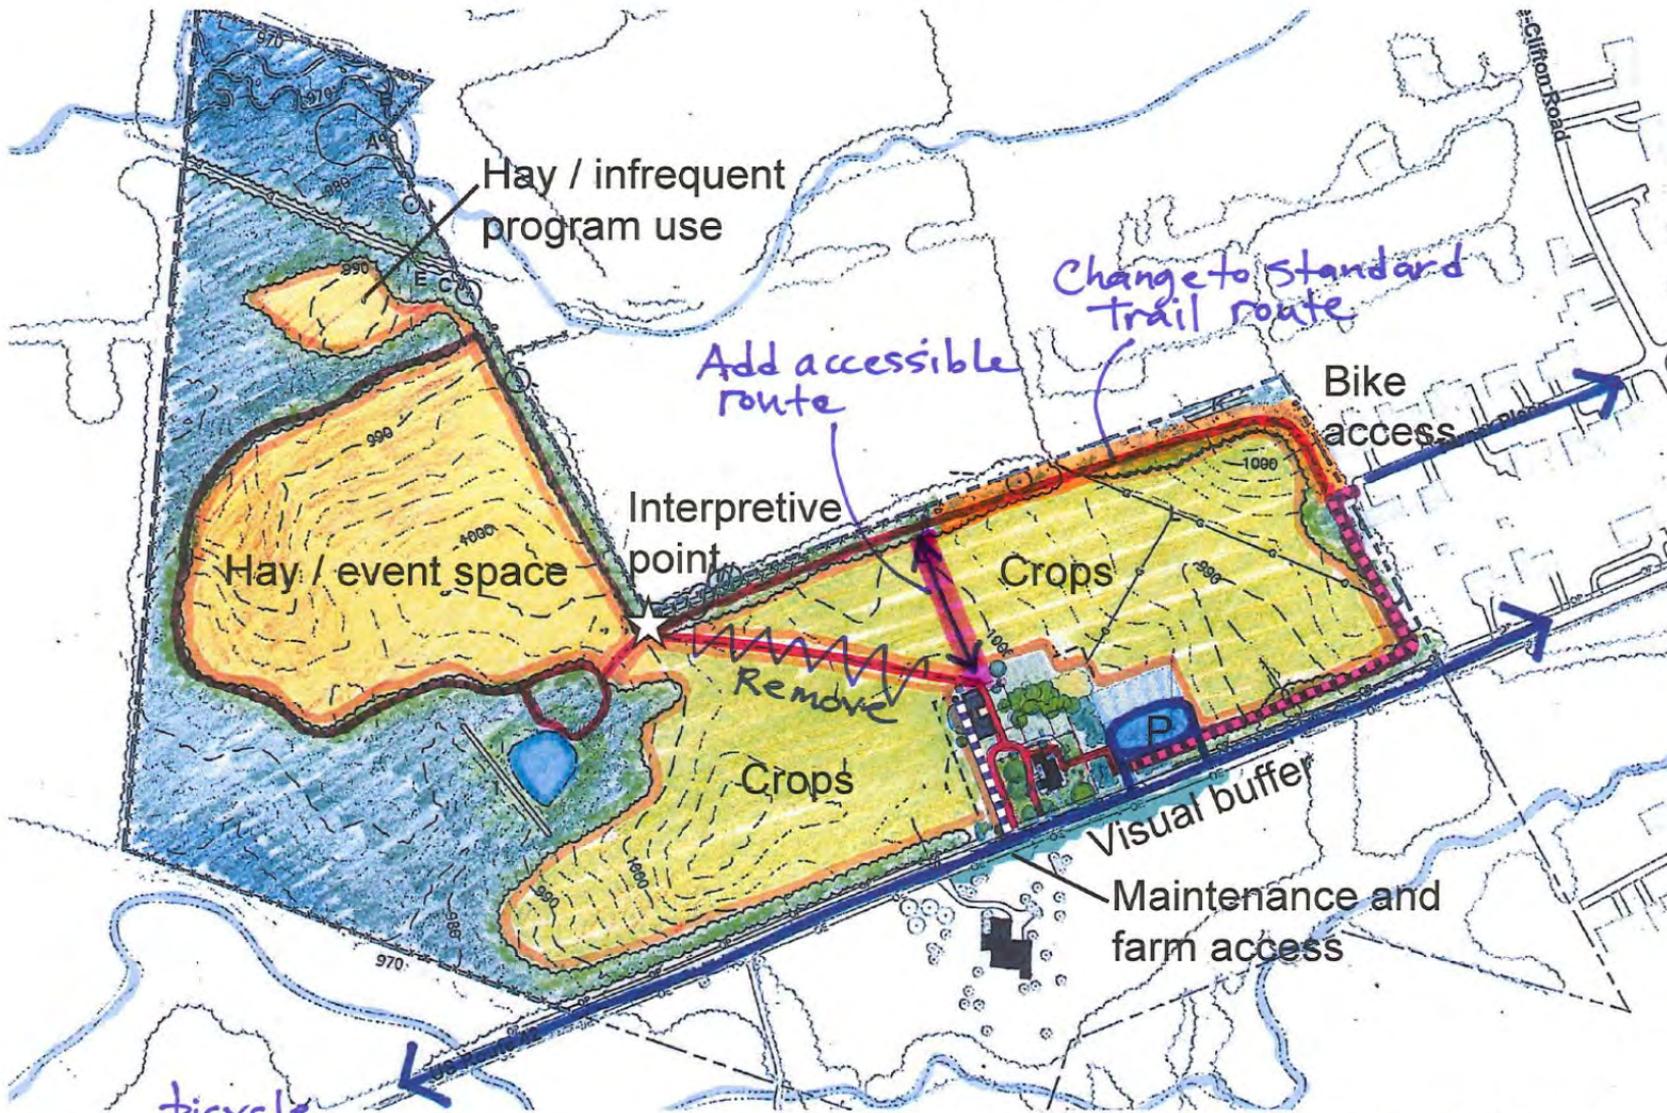
# Alternative 1: Recapture Historic Character of Core, Expand Site Access

Multi-Use route 1022 lf
-

Accessible route 2976 lf
-

Trail route 2513 lf

Farm route / field edge
-

Maintenance route
-

Visitor vehicular route

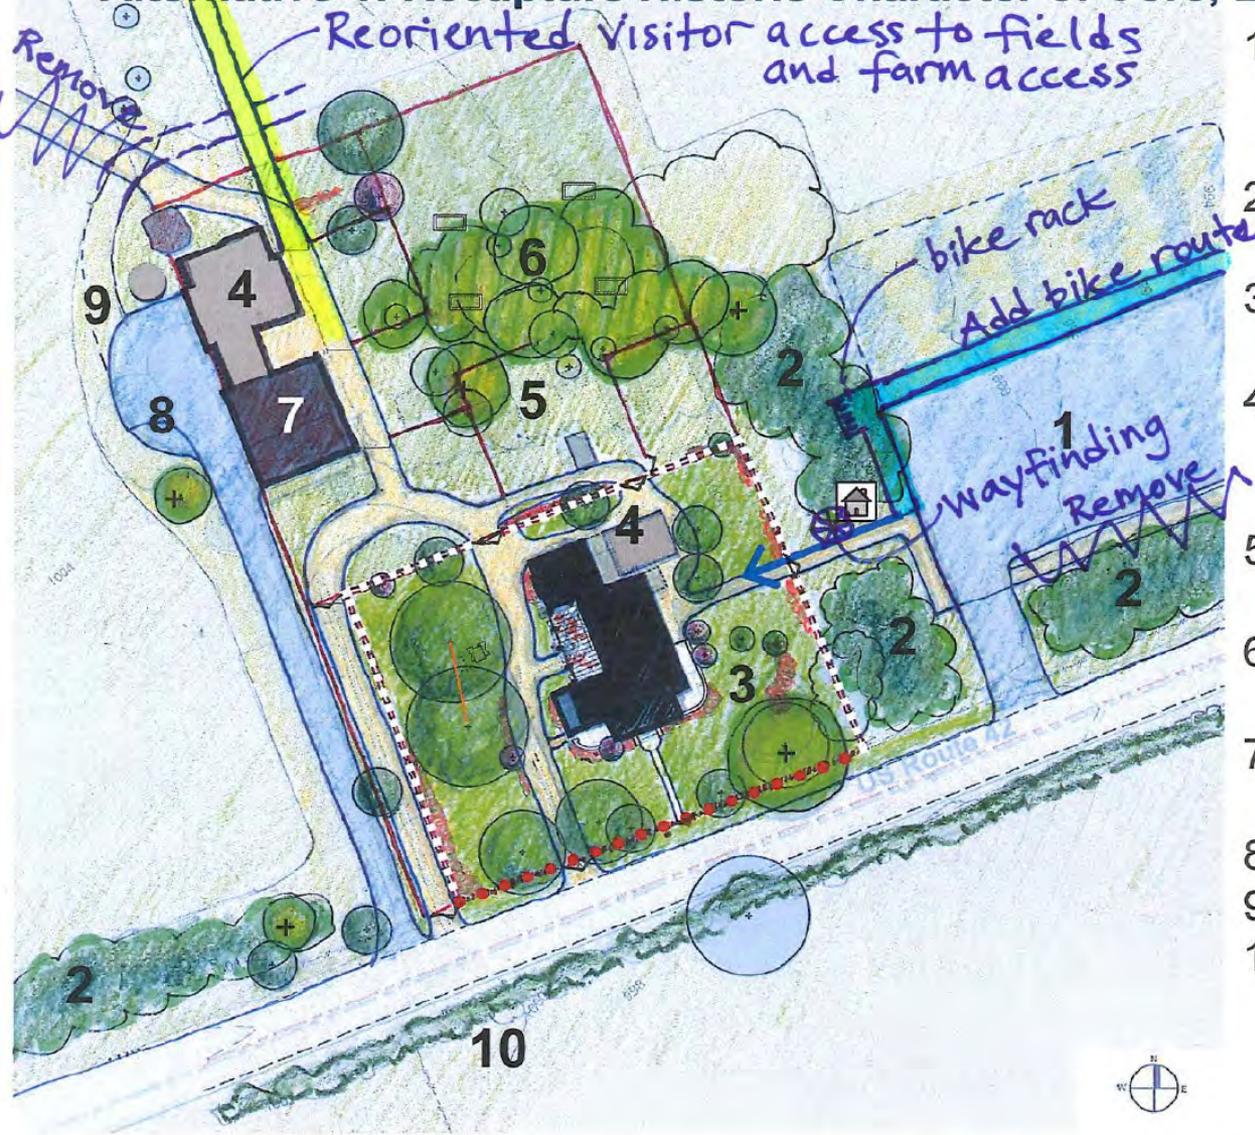
# Alternative 1: Recapture Historic Character of Core, Expand Site Access

1. Parking, overflow, bike racks, visitor orientation, and main access relocated to east
2. Vegetation management for selective views
3. Restored ornamental and domestic features
4. Interpretive feature (former outbuildings), possible alternative visitor orientation
5. Barnyard interpreted with fences for programmatic space
6. Picnic grove with trees/turf in former garden/existing woods
7. Comfort station, shelter, and maintenance
8. Maintenance access
9. Farm access
10. Screen plantings/visual buffer

Overflow parking	Lawn	Orn. Metal fence	New dec. tree
Parking	Rough turf	Picket fence	New fruit tree
Visitor route	Field edge buffer	Post and wire/rail fence	Existing tree
			Shrub or bed

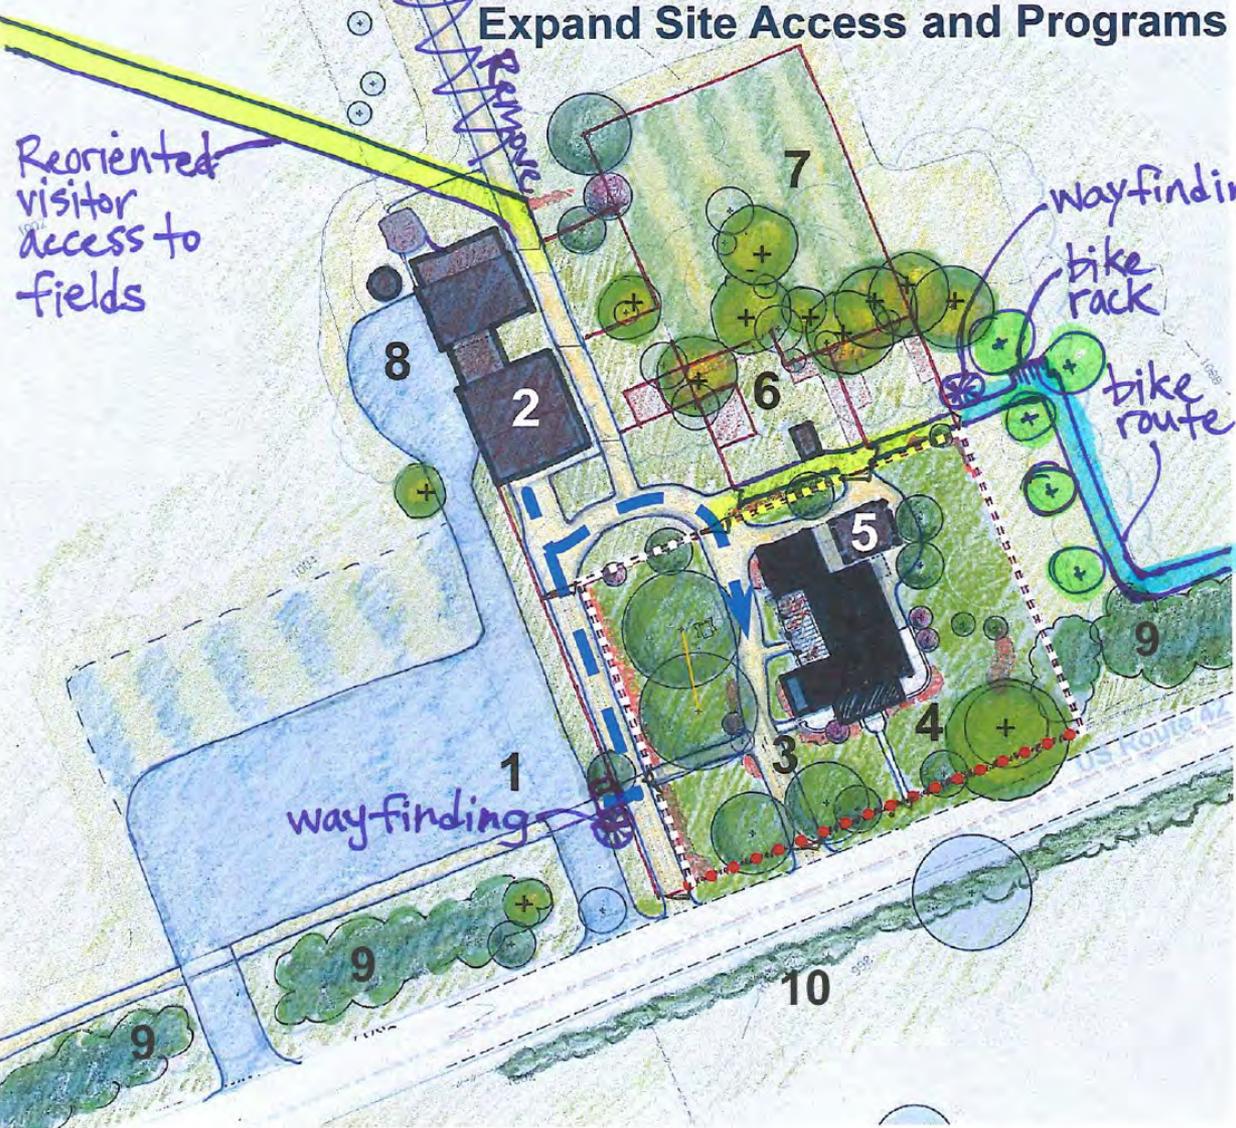
# Alternative 2: Recapture Historic Character and Features of Core,

1. Parking, overflow, and main visitor access relocated to west
2. Visitor orientation, bathrooms, shelter, offices, and maintenance at former barns
3. Access to front of house with sloped walk from drive
4. Restored ornamental and domestic features
5. Summer kitchen shell with compatible rustic tables for program/picnic support
6. Rehabilitated barnyard with multi-use benches/tables
7. Interpretive garden with selective clearing of trees
8. Maintenance and farm access
9. Vegetation management for selective views
10. Screen plantings/visual buffer

Overflow parking	Lawn	Orn. Metal fence
Parking	Rough turf	Picket fence
Visitor route	Field edge buffer	Post and wire/rail fence
		Arrival Route
		New dec. tree
		New fruit tree
		Existing tree
		Shrub or bed

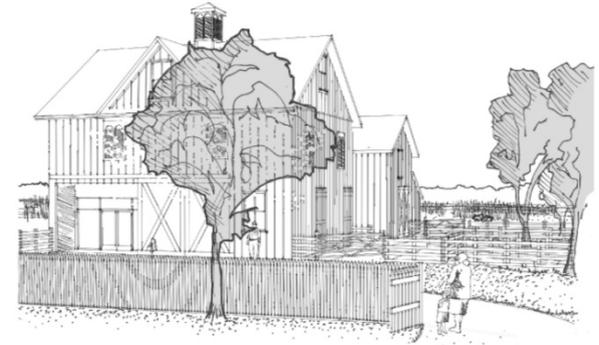
D. The visitor contact station is in the location of the historic barn complex. Visitors can walk into the fields or return to the house from this area. (source: QEA, 2017)

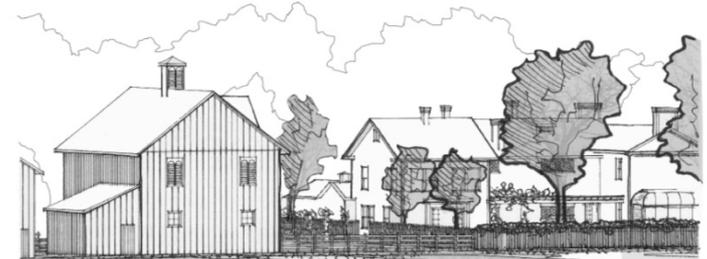
F. Addition of the visitor contact station, canopy trees, and fencing helps to redefine the spatial definition of the Homestead when viewed from the fields. (source: QEA, 2017)

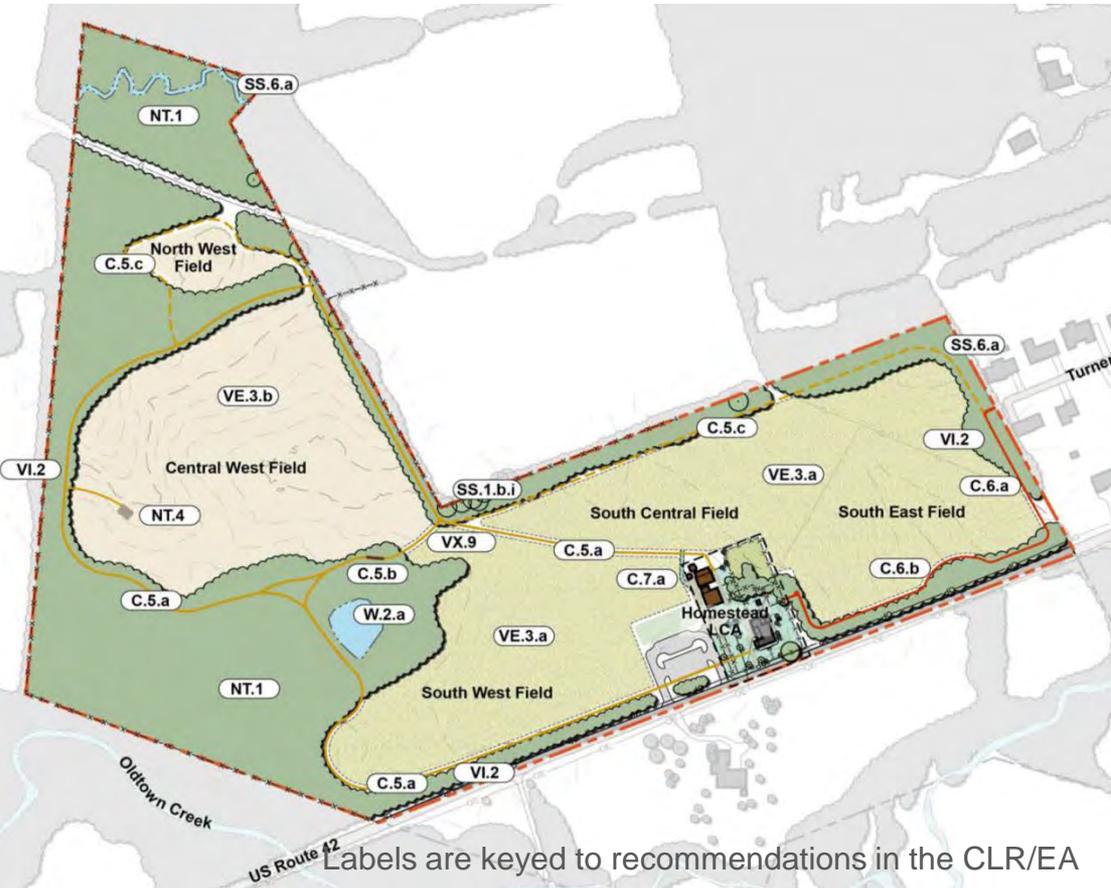
Key	
	National monument boundary
	Preserve woodland
	Maintain grassland (hay or managed meadow) (VE.3.b)
	Establish cultivated crops with 8' buffer from visitor uses (VE.3.a)
	Add new 3' wide accessible trail of dark colored crushed stone (C.5.a)
	Add boardwalk/puncheon (C.5.b)
	Add new 3' wide trail of compacted earth (C.5.c)
	Add 4' wide bicycle trail of dark colored crushed stone (C.6.a)
	Establish mown-grass farm vehicle maintenance route to fields (C.7.a)
	Preserve stream or pond

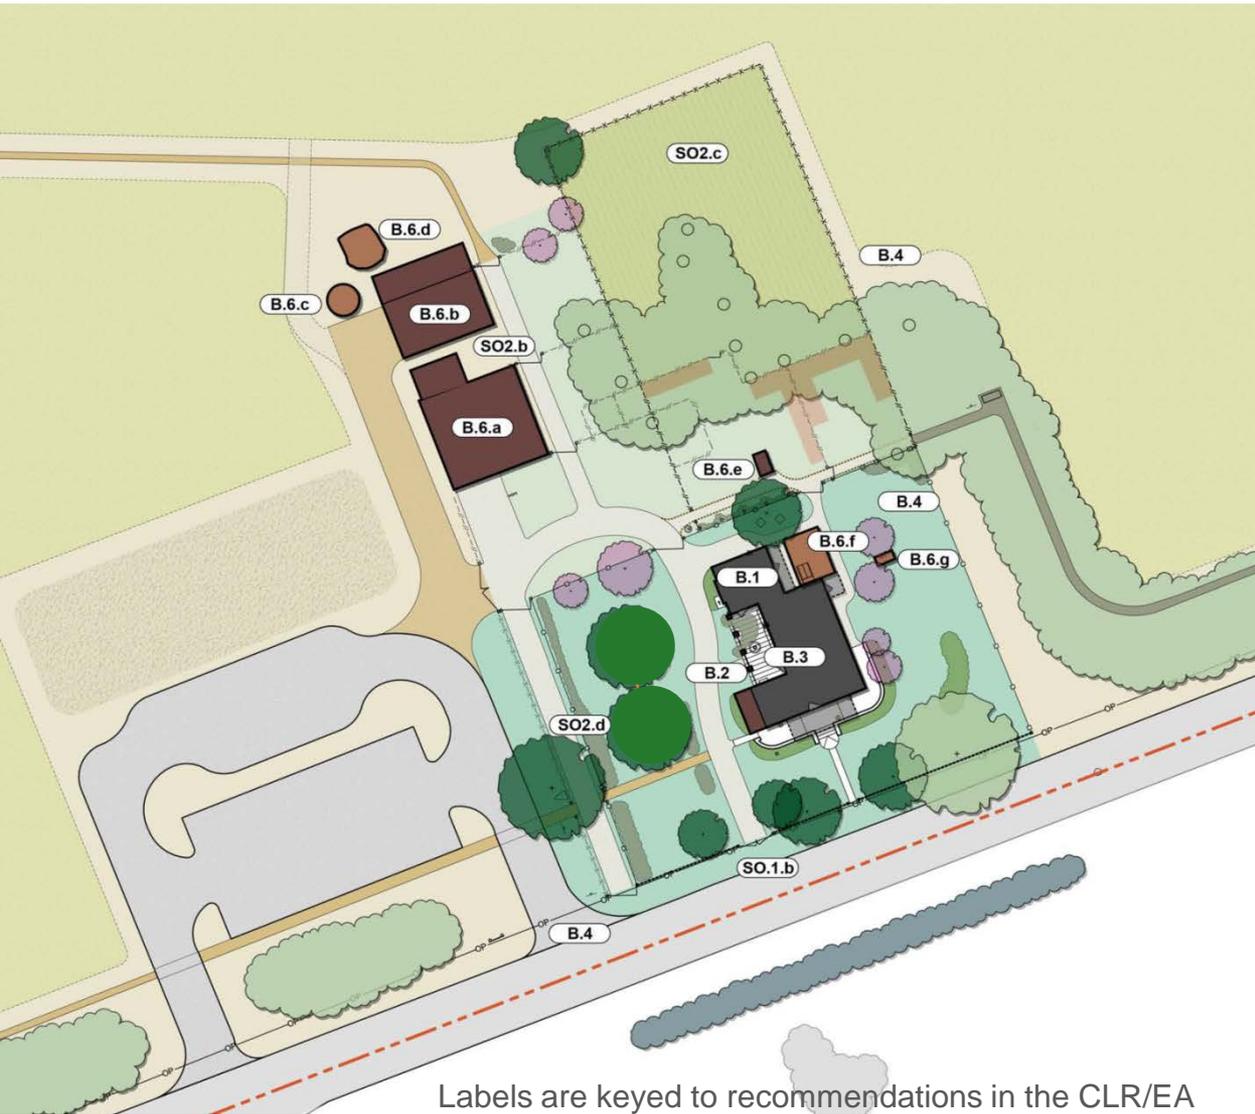
# Preferred Alternative Homestead Landscape Plan

Labels are keyed to recommendations in the CLR/EA

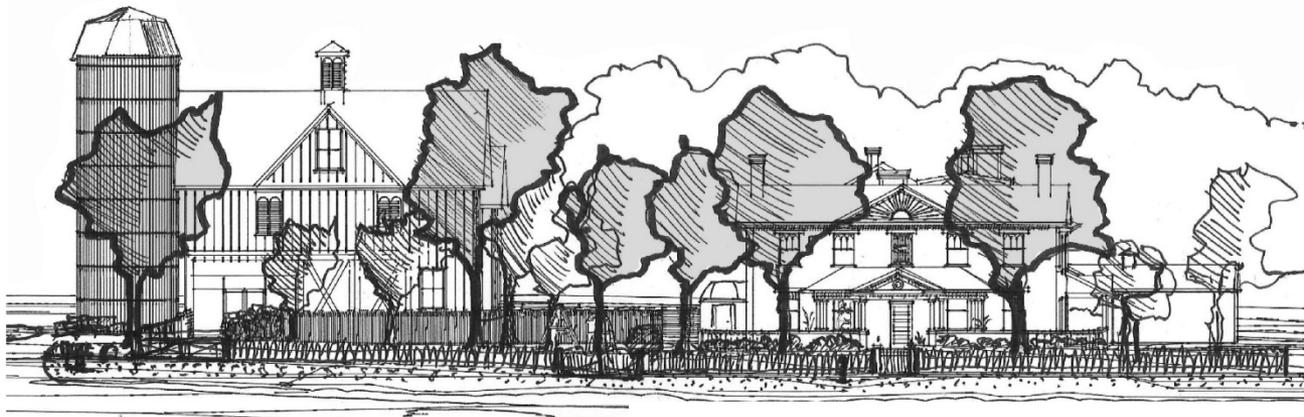
C. Upon arrival, visitors can glimpse the rehabilitated vegetation and conservatory across the Youngsholm side yard. (source: QEA, 2017)

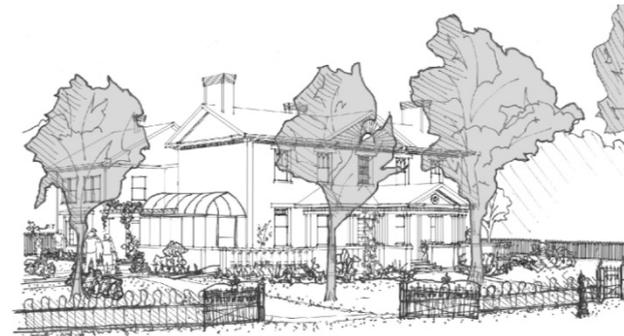
B. Restoration of small-scale elements such as fences, gates, and hitching post will enhance the historic character of the landscape. (source: QEA, 2017)

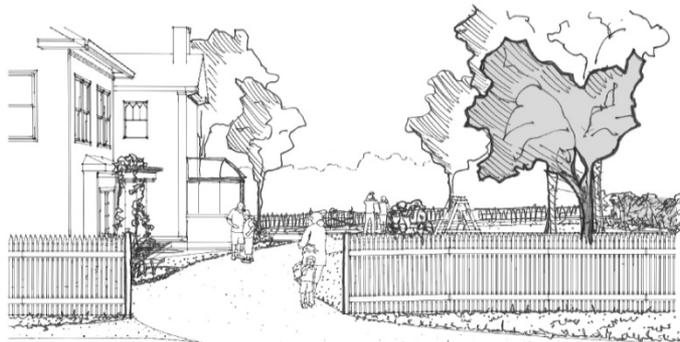
E. Picket fencing defines the boundary between the home grounds and the barnyard and pens. Lawn with trees, shrubs, rustic outdoor furniture, and a clothesline indicate the domestic character of the landscape. (source: QEA, 2017)
