# Bridalveil Fall Rehabilitation Environmental Assessment

The National Park Service (NPS) proposes to improve visitor facilities and services at Bridalveil Fall in Yosemite Valley, California. This environmental assessment (EA) identifies and evaluates three alternatives for the rehabilitation of the Bridalveil Fall area (Figure 1-1). This document is intended to meet the environmental analysis and public review requirements of section 102(2) (C) of the National Environmental Policy Act (NEPA). The park coordinated the requirements of Section 106 of the National Historic Preservation Act (NHPA) with the NEPA process. The project tiers off the *Merced Wild and Scenic River Comprehensive Management Plan Environmental Impact Statement and Record of Decision (Merced River Plan)* (NPS 2014).

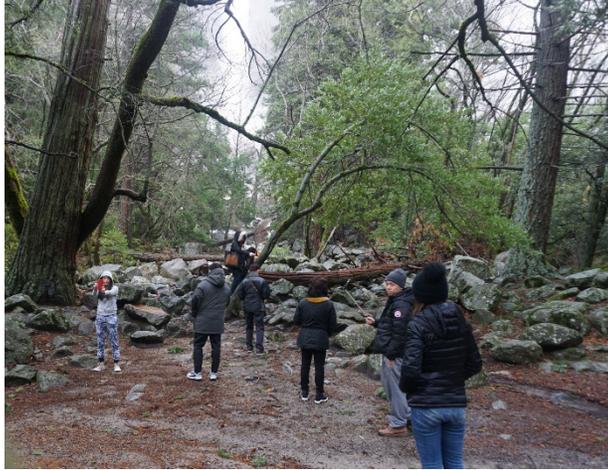
VIEWING AREA SOUTHWEST OF BRIDGE 3

The intersection of the Bridalveil Fall Trail and the trail to the existing viewing platform would be expanded for interpretation, viewing, and gathering (approximately 1,300 square feet) (16). A new viewing area would be added to the northeast side of Bridge 3, adjacent to the Bridalveil Fall Trail (approximately 100 square feet in size) (11). In addition, NPS would improve access to and delineate the viewing area at the southwest side of Bridge 3 (100 square feet). Improvements would be minor – no blasting, rock removal, or heavy grading (7). Trail decking, railings, and site furnishings will be constructed using robust decay-resistant materials, such as Alaska yellow cedar, that do not require toxic preservative treatments.

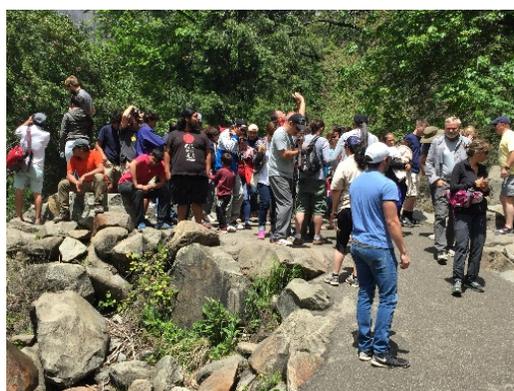
CROWDED VIEWING PLATFORM

The trails in the Bridalveil Fall area are often busy and the viewing platform is often crowded during times of peak visitation. The *Merced River Plan* determined a standard for visitors on the viewing platform of 20 square feet per person during the busiest hours of the day on the busiest days of the year (NPS 2014a). Based on a July 2017 study that evaluated visitor volumes and characteristics between the hours of 10:00 a.m. and 4:00 p.m., the average number of people arriving to the viewing platform area per hour was 630, with a maximum of 800 and a minimum of 437 (Hockett 2017). The average number of people on the platform at one time was 36 (approximately 11 square feet per person). Tour bus visitors tended to arrive within minutes of each other, causing congestion on the platform (Hockett 2017). Parking in unsanctioned areas in the parking lot and along roadways likely contributes to congestion during the busiest visitation times of the year. At lower water levels, many visitors to the Bridalveil Fall platform explore the boulders around the platform area and up to the waterfall. The boulders are slippery and accidents occur regularly.

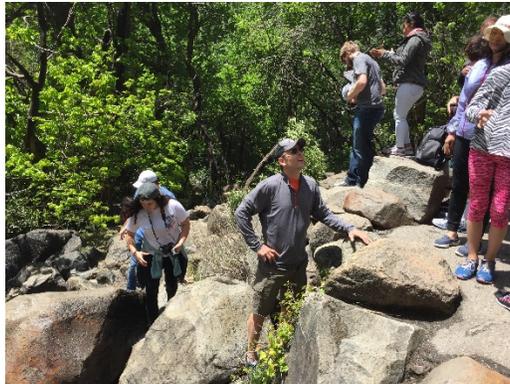
VISITORS CLIMBING ON BOULDERS NEAR VIEWING PLATFORM

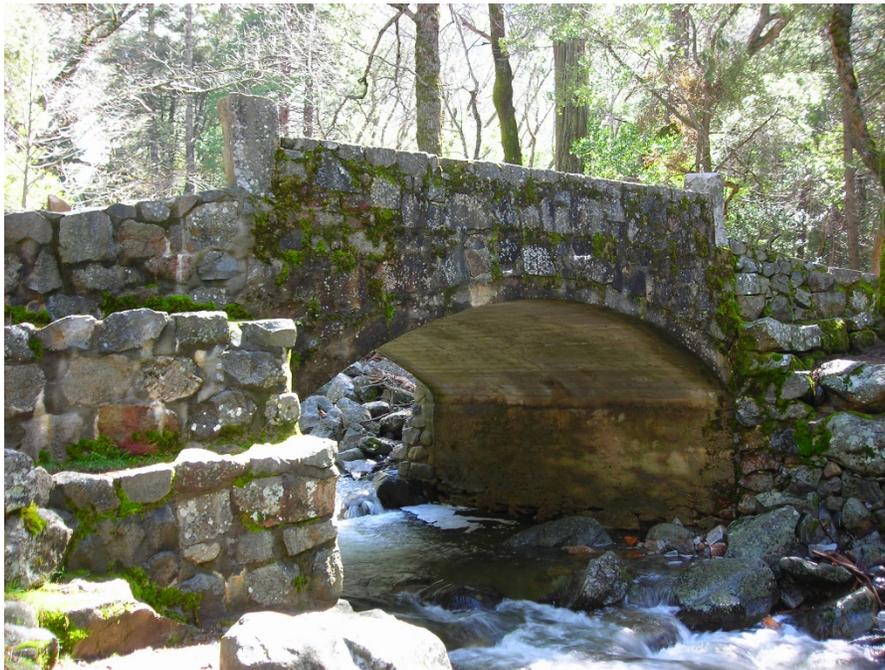
BRIDGE 3

The U.S. Cavalry contracted for the construction of Bridalveil Fall Bridges Numbers 1–3 on a carriage road below Bridalveil Fall in 1913 including the spandrel walls and the roadway (Quin 1991). The Historic American Engineering Record (HAER) documented Bridalveil Fall Bridges Numbers 1–3 as part of the Yosemite National Park Roads and Bridges (CA-117). The HAER report identifies the Bridalveil Fall Bridges Numbers 1–3 (CA-91 through CA-93) as significant for being among the last extant park structures built under the auspices of the U.S. Cavalry (1890–1914), and as representatives of the first use of reinforced concrete in bridge construction in Yosemite National

Park (Quin 1991). One of the pylons on Bridge Number 1 is missing, but no other major deterioration is evident.

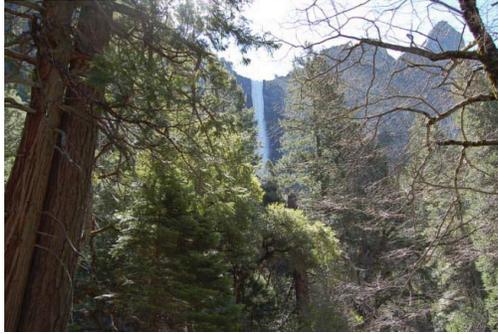
BRIDALVEIL FALL FOOT BRIDGE

**Bridalveil Fall Foot Bridge.** The Bridalveil Fall Foot Bridge is located on the Bridalveil Fall Trail below the fall. This vista is from one of three bridges built in 1913 at the waterfall. These are the oldest remaining bridges in the valley. Bridalveil Fall footbridge-work has started at this site, but is not complete.

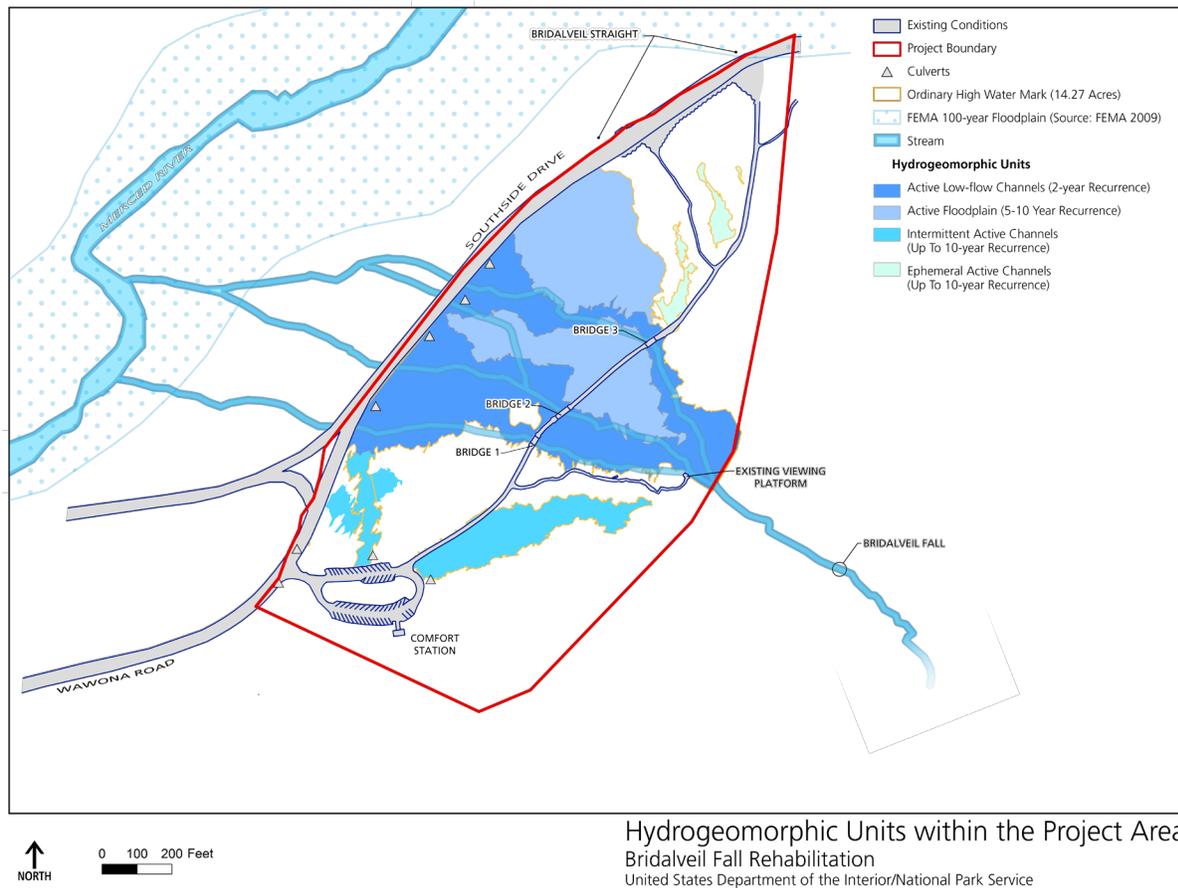
**Figure 1. Hydrogeomorphic Units in the Bridalveil Fall Project Area**

Bridalveil Creek is a tributary to the Merced River in Yosemite Valley. Bridalveil Creek descends over Bridalveil Fall and flows northwest from the base of Bridalveil Fall through the project area. At the base of the fall, Bridalveil Creek forms multiple braided stream channels as it descends a steep debris flow fan. The stream system, including the perennial Bridalveil Creek, multiple intermittent and ephemeral channels, and associated floodplains, make up the core of the Bridalveil Fall project area.

The gradient of Bridalveil Creek decreases as it reaches the edge of the project area at Southside Drive. The project area does not include the confluence of Bridalveil Creek with the Merced River, which is approximately 600 feet downstream of the project area boundary (Figure 1). The northernmost tip of the Bridalveil Fall project area is located within the 100-year floodplain of the Merced River.

Most of the Merced River in Yosemite Valley has a well-developed, relatively wide floodplain with an average slope of 0.1%. In the Bridalveil Fall area near the confluence with Bridalveil Creek, the river channel is steeper and more confined, the floodplain is narrow, and flow velocities are high. The largest documented flood events occurred in 1937, 1950, 1955, and 1997, with peak discharges measured in the range of 22,000 to 25,000 cubic feet per second at Pohono Bridge. These floods were the result of rain-on-snow events. Several large undocumented events also occurred during the 1860s and 1870s.

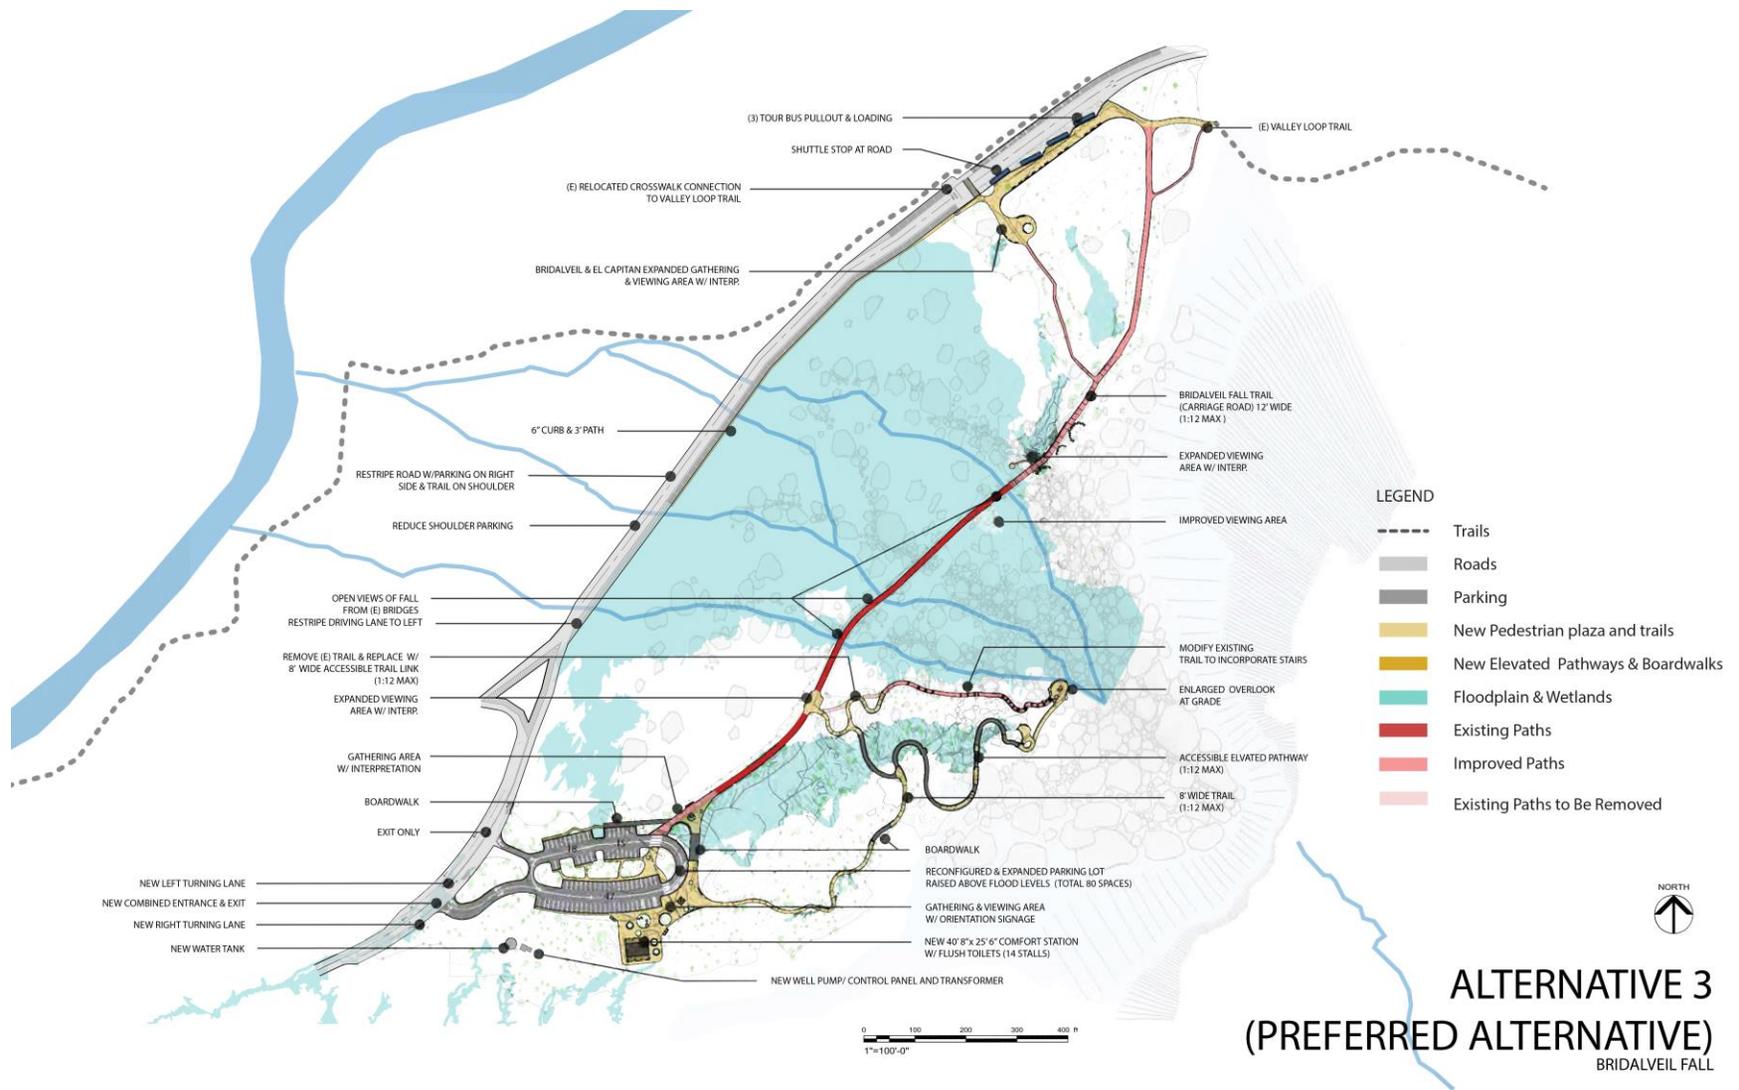
Figure 2. Preferred Alternative in Bridalveil Fall Rehabilitation Project EA

The *Bridalveil Fall Rehabilitation Project EA* considered one action alternative, Alternative 2, in addition to the preferred alternative considered in this Statement of Findings. Alternative 2 proposes additional facilities in the floodplain – a pedestrian bridge across Bridalveil Creek from the viewing platform near the base of the fall and an additional comfort station along Bridalveil Straight. The additional comfort station would be located in a non-high hazard area, outside deep flood flows and high velocities. The bridge across Bridalveil Fall would require additional Statement of Findings analysis to determine impacts on capital investment. The No Action alternative, Alternative 1, evaluated existing conditions in the area with no additional structures in the floodplain. The No Action alternative would not meet the purpose and need of the project.

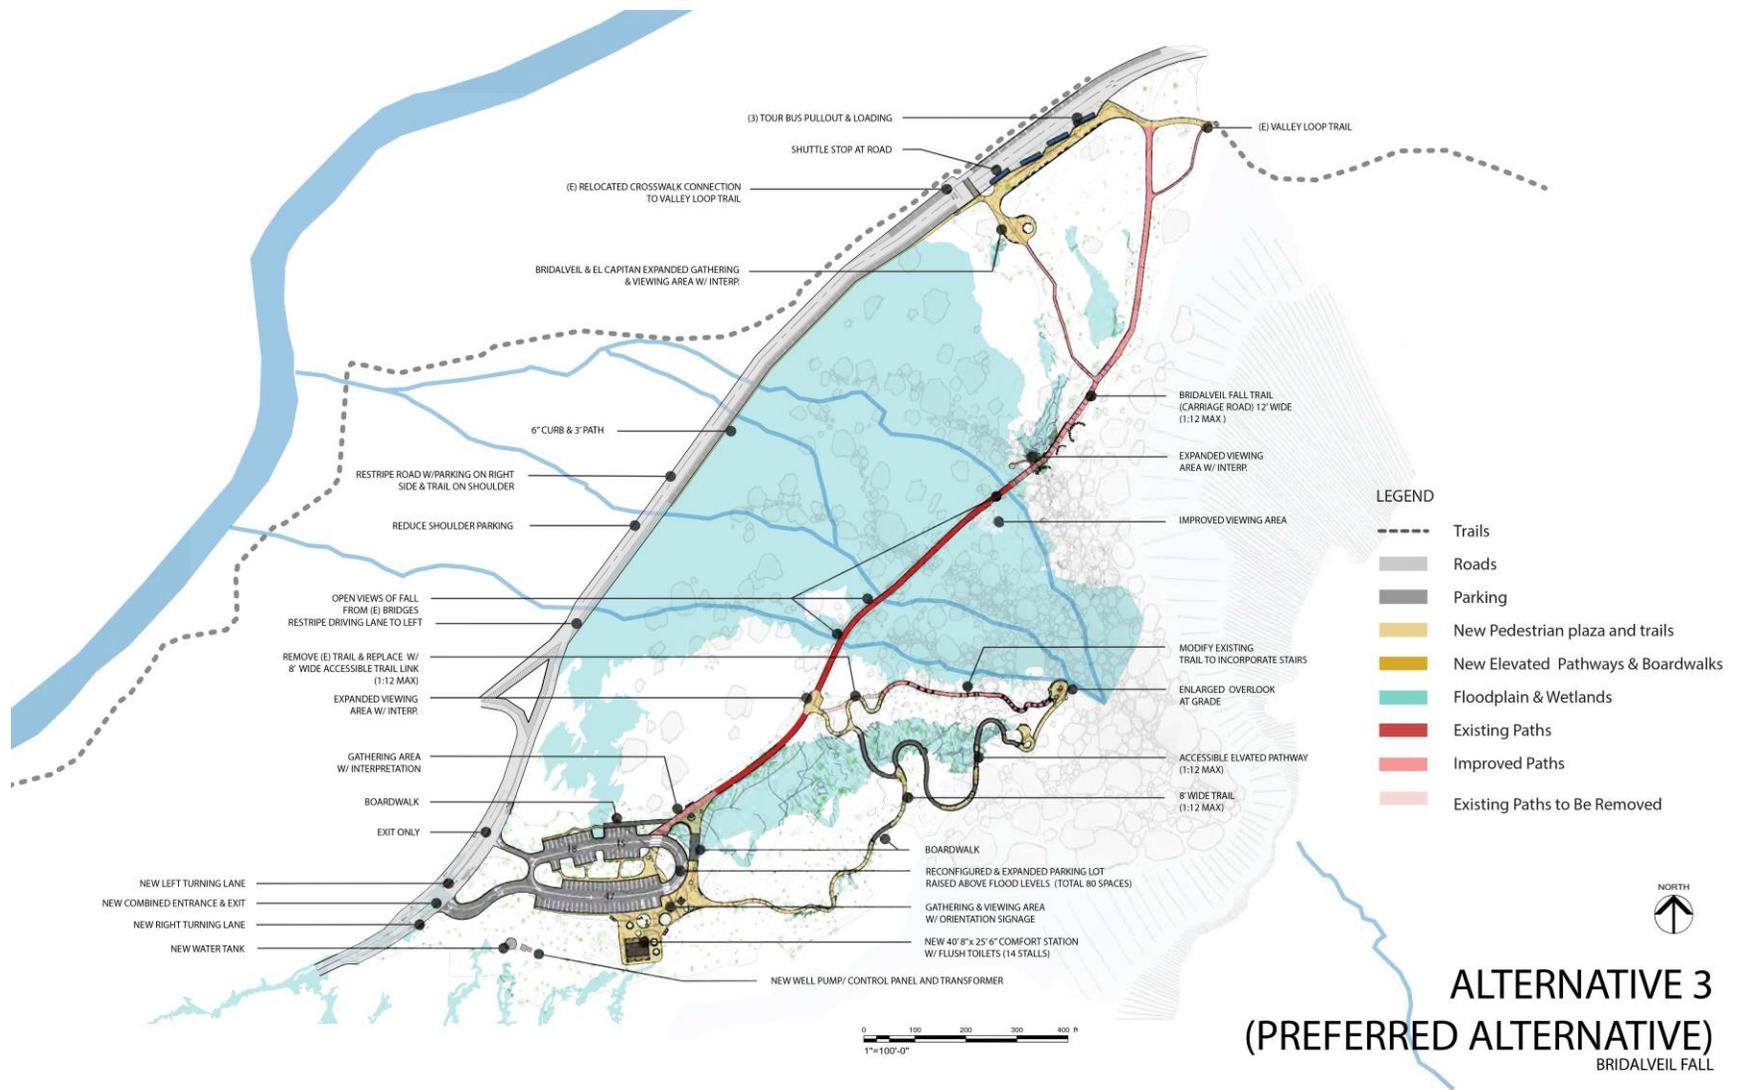
Figure F-1. Alternative 3

Project Components	Alternative 3
Trails, Bridges, and Viewing Lots	<ul style="list-style-type: none"> <li>• Add a new accessible loop trail from the parking lot to the existing viewing platform. The majority of the trail would be 8- to 10-feet wide, at-grade, and hardened with an accessibility acceptable surface. Portions of the trail would be elevated to reduce impacts to sensitive areas. Trail would be located to avoid archeological and ethnographic sites.</li> <li>• Repair the Bridalveil Fall Trail from the third bridge to the east, where it meets the Valley Loop Trail with an accessibility acceptable hardened surface.</li> <li>• Expand the intersection of the Bridalveil Fall Trail and trail to the existing viewing platform for interpretation and gathering.</li> <li>• Improve the viewing area to the northeast side of Bridge 3, adjacent to the Bridalveil Fall Trail (approximately 760 square feet in size).</li> <li>• Improve and delineate the access to the viewing area at the southwest side of Bridge 3 (760 sq. feet). Improvements would be minor - no blasting, rock removal, or heavy grading.</li> <li>• Rework the existing trail from the Bridalveil Fall Trail to the viewing platform. The trail will be a minimum of 8-feet wide with stairs as needed. Rework the stairs to meet code.</li> <li>• Expand the existing viewing platform from 400 square feet to 1,500 square feet. Install safety railing.</li> <li>• Construct an approximately 700-square foot overlook on the new accessible loop trail 120 linear feet south of the existing platform.</li> <li>• Add wayfinding and interpretive signage throughout the project area.</li> <li>• Remove small conifer trees (&lt;20 inches dbh) from within the dripline of selected mature California black oaks to improve oak habitat (&lt;50 small trees).</li> </ul>

Accessibility	<ul style="list-style-type: none"> <li>• Ensure that all new trails and pathways are accessible. The only trail in the project area that would not be accessible is a portion of the existing trail that leads from the Bridalveil Fall Trail to the viewing platform (the new loop trail would provide an accessible route to the viewing platform).</li> </ul>

Alternative 3 would replace and expand the existing platform in its current location and construct an additional viewing platform on the new accessible loop trail, in addition to the *Actions Common to Alternatives 2 and 3* listed previously. Figure 2-3 displays the Alternative 3 project components.

Under Alternative 3, the existing viewing platform at the base of Bridalveil Fall would expand from 400 square feet to approximately 1,500 square feet (28). The viewing platform would be replaced and expanded in its current location. The new viewing platform would be constructed of robust materials suitable for the site conditions. The finished elevation of the new viewing platform surface would be between 4 inches and 18 inches above the existing viewing platform. A safety railing would be installed at the edge of the overlook. In addition to the new viewing platform that would be constructed on the new

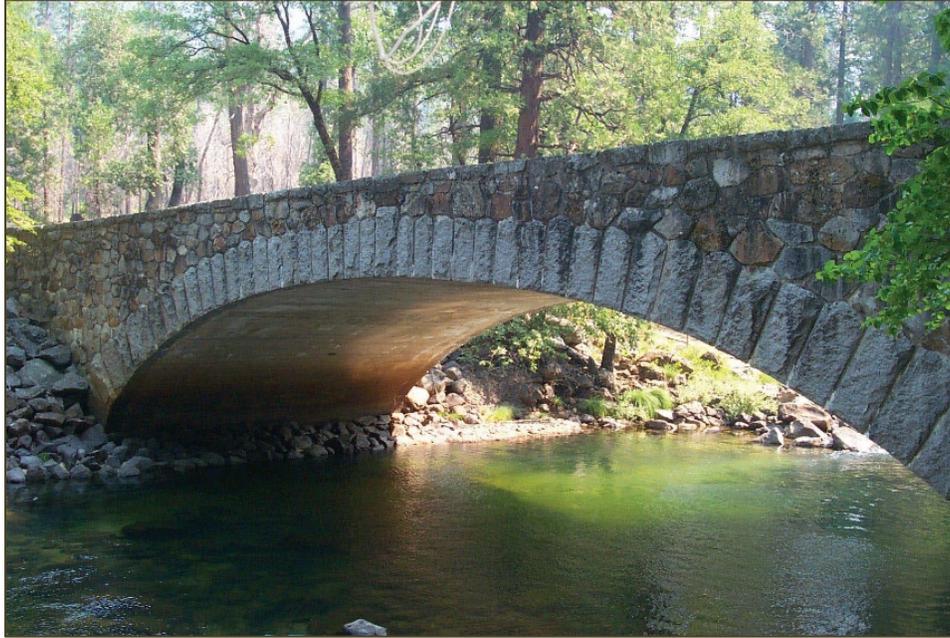
**Photo F-1. Pohono Bridge: Contributing Structure in the Yosemite Valley Historic District and Yosemite Valley Bridges.**

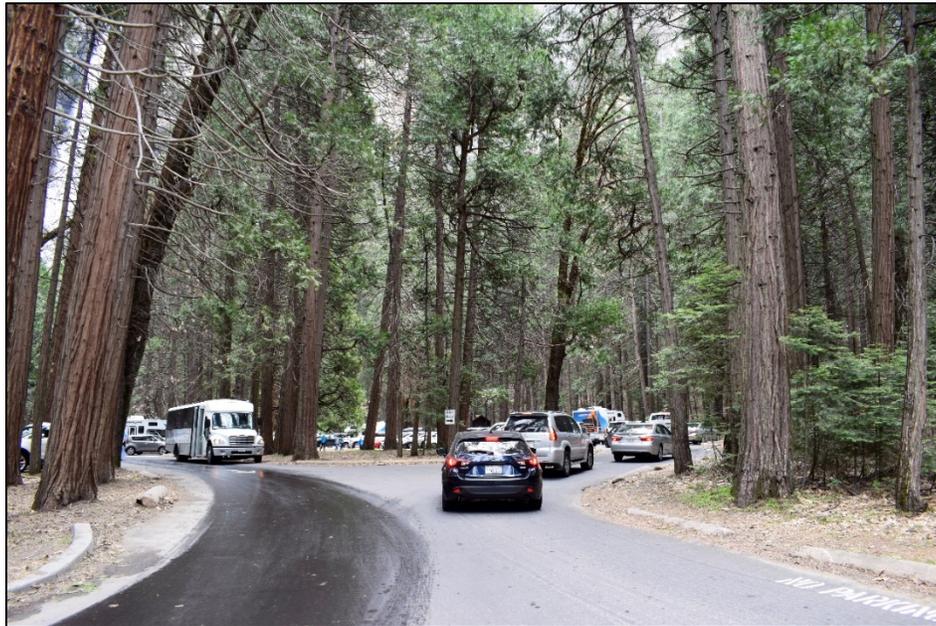
**Photo F-2. Bridalveil Fall Access Road (foreground): Contributing Structure in the Yosemite Valley Historic District. View looking east-southeast towards parking lot.**

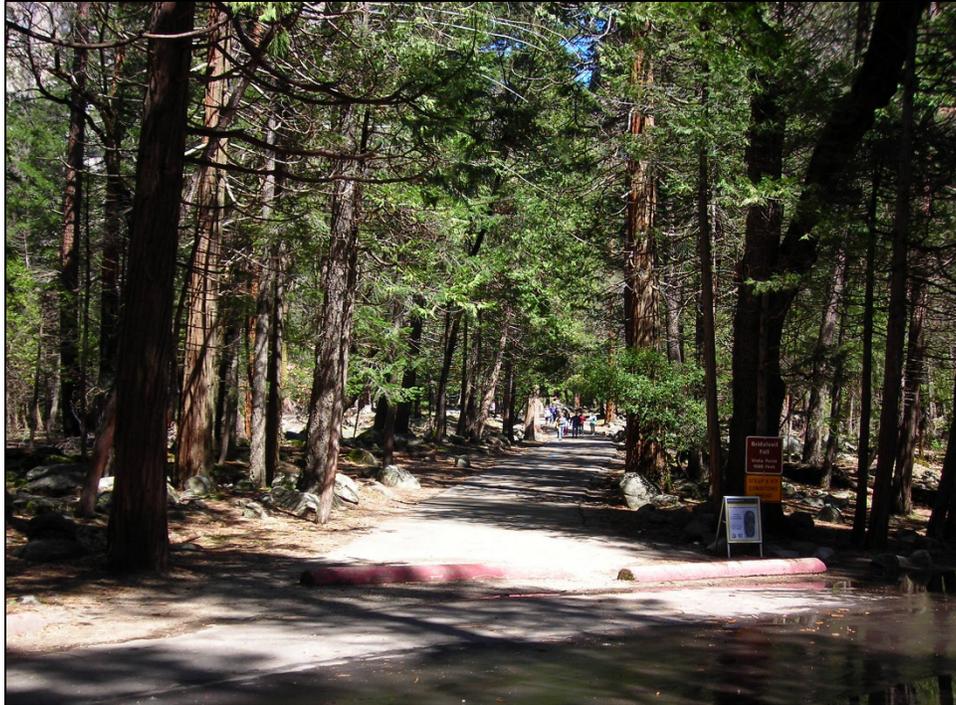
**Photo F-3. Bridalveil Fall Trail: Contributing Structure in the Yosemite Valley Historic District. Trailhead at parking lot (looking northeast).**

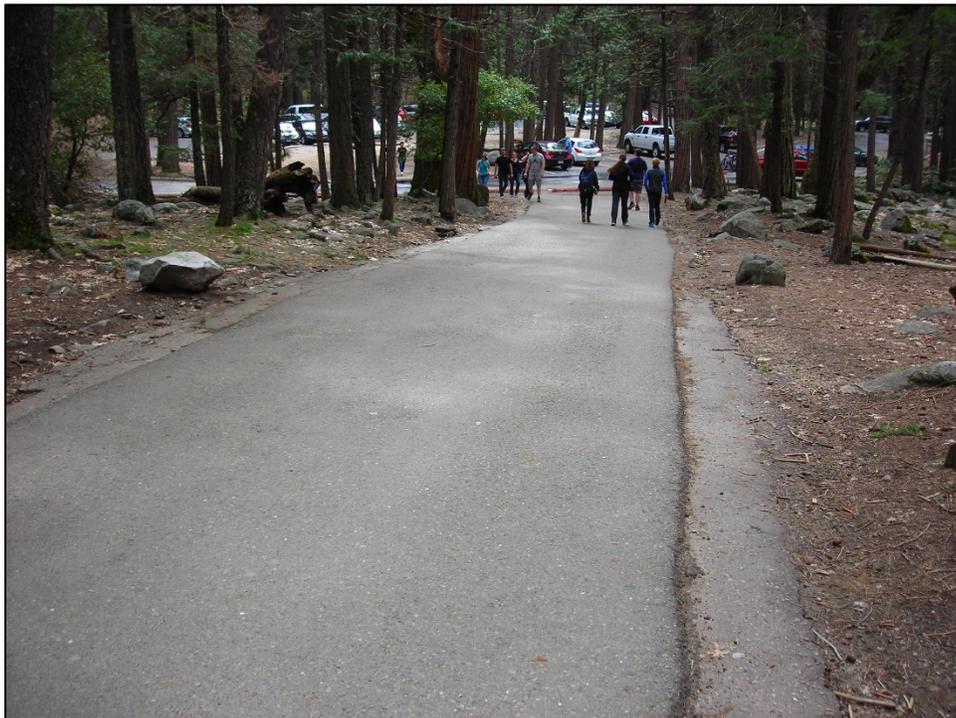
**Photo F-4. Bridalveil Fall Trail: Contributing Structure in the Yosemite Valley Historic District. View looking southwest toward connection with parking lot.**

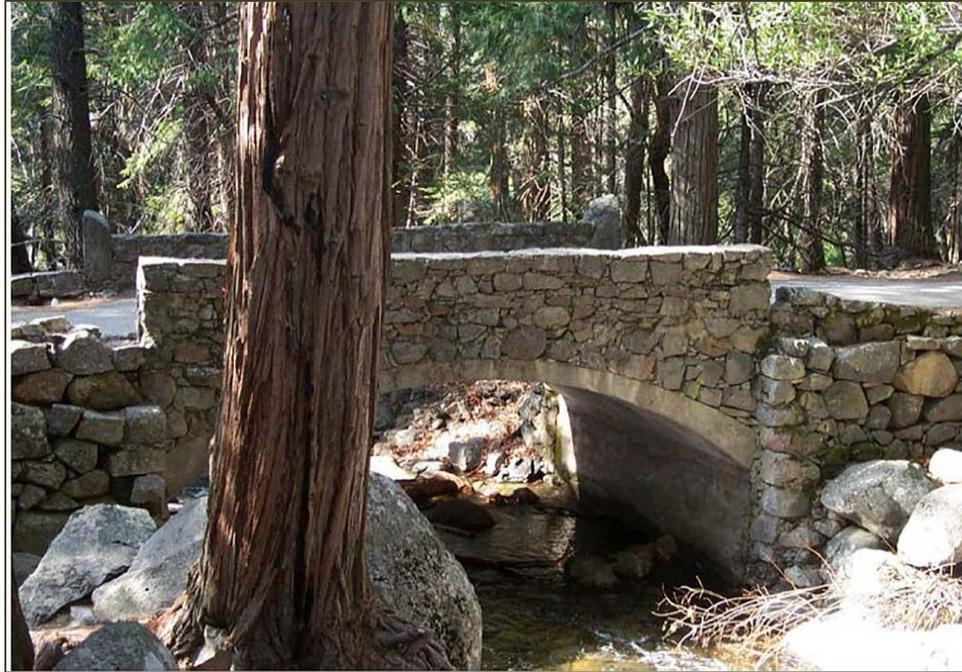
**Photo F-5. Bridalveil Fall Bridge #1: Contributing Structure to the Yosemite Valley Historic District (looking north).**

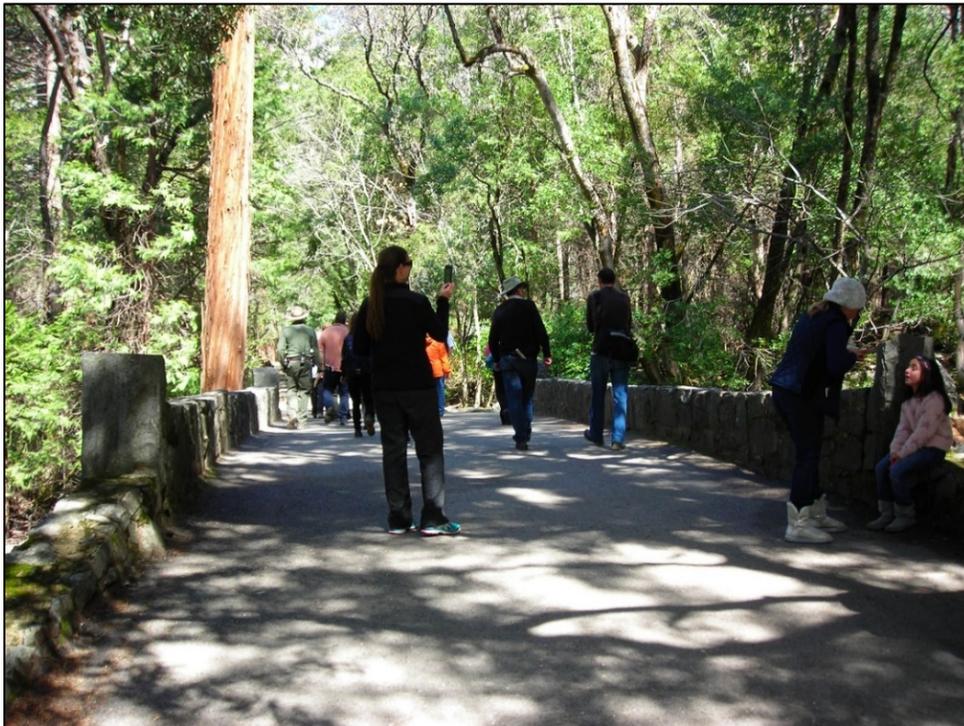
**Photo F-6. Bridalveil Fall Bridge #2: Contributing Structure to the Yosemite Valley Historic District. View from Bridalveil Fall Trail (looking northeast).**

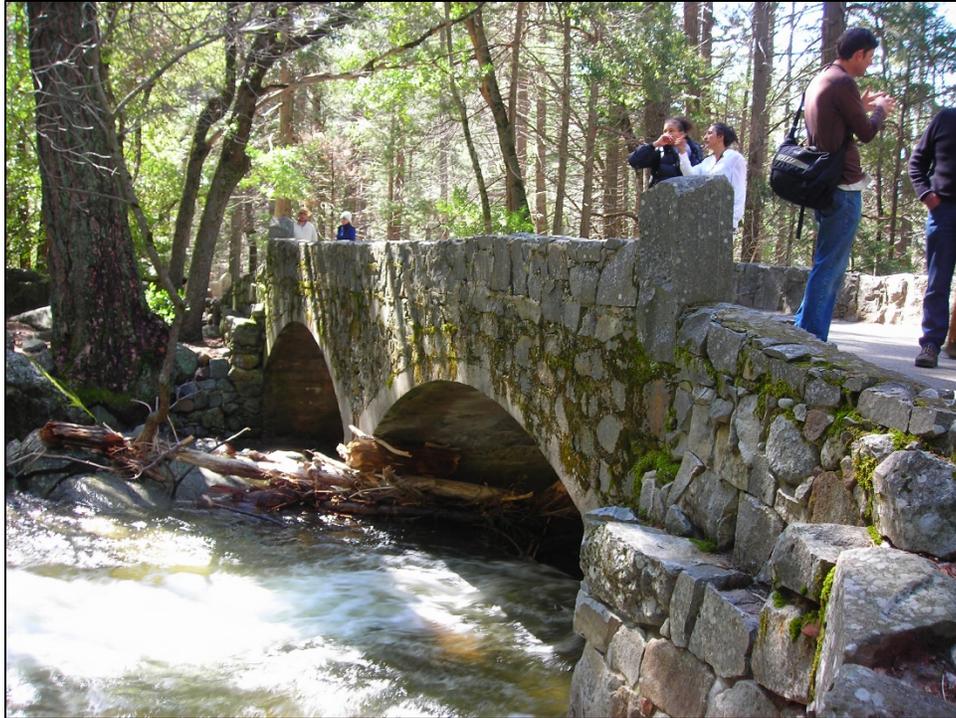
**Photo F-7. Bridalveil Fall Bridge #2: Contributing Structure to Yosemite Valley Historic District. View looking southwest from streambank.**

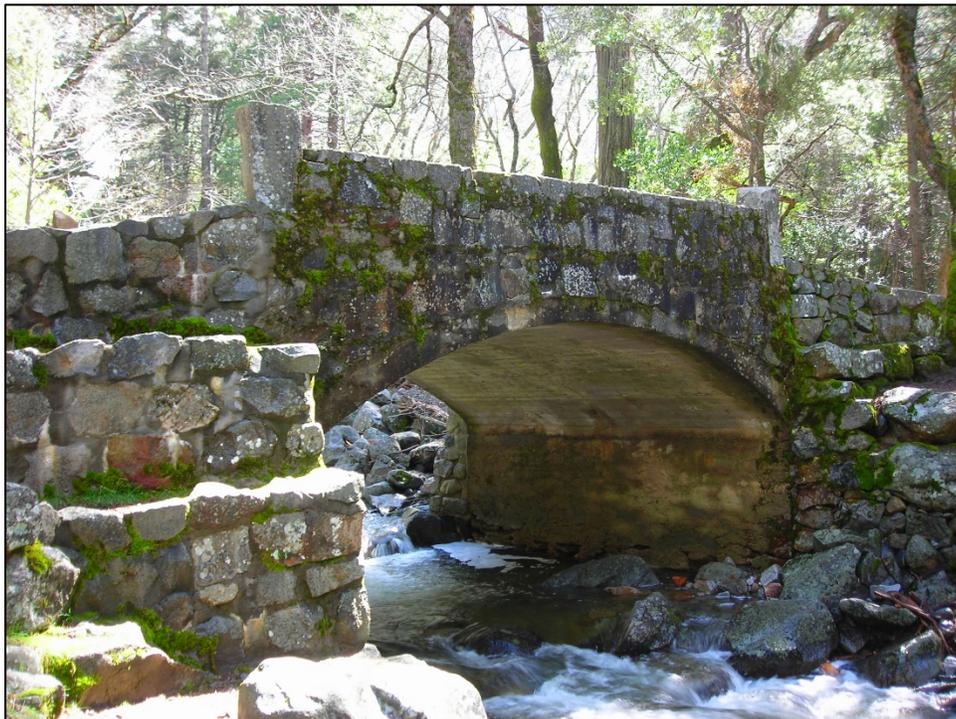
**Photo F-8. Bridalveil Fall Bridge #3: Contributing Structure in the Yosemite Valley Historic District. View looking south from streambank**

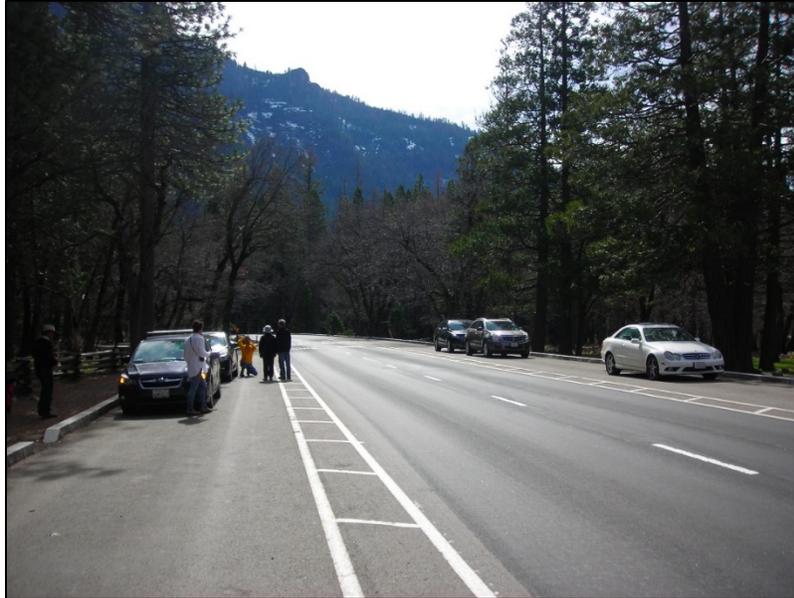
**Photo F-9. Southside Drive (Bridalveil Straight): Contributing Structure in the Yosemite Valley Historic District. View looking southwest.**

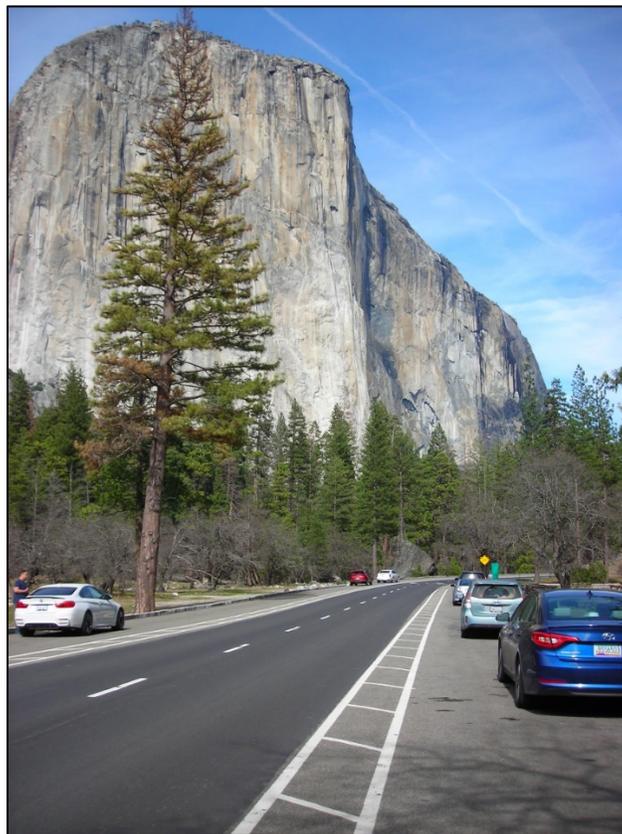
**Photo F-10. Southside Drive (Bridalveil Straight): Contributing Structure and Historic View within the Yosemite Valley Historic District. View looking northeast.**
