APPENDIX A

FIGURES

FIGURE 5A. PHOTOGRAPHS DEPICTING THE SOURCE SPRINGS AND WATER DIVERSION FEATURES OF THE LOWER SPRING AND PALM SPRING AREAS

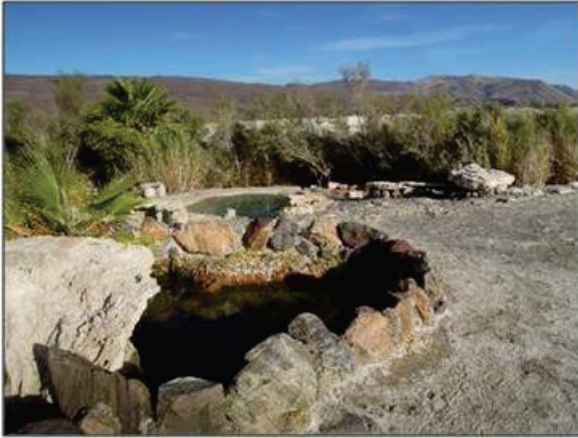
Lower Spring – Warm source spring with the Sunrise Pool in the background

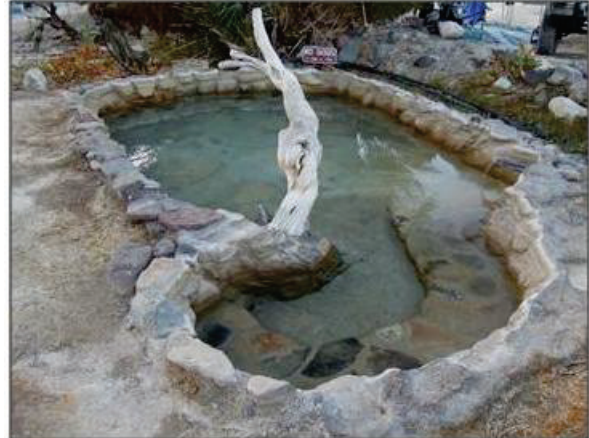
Lower Spring – Cool Pool with the piping from the cold source spring on the right

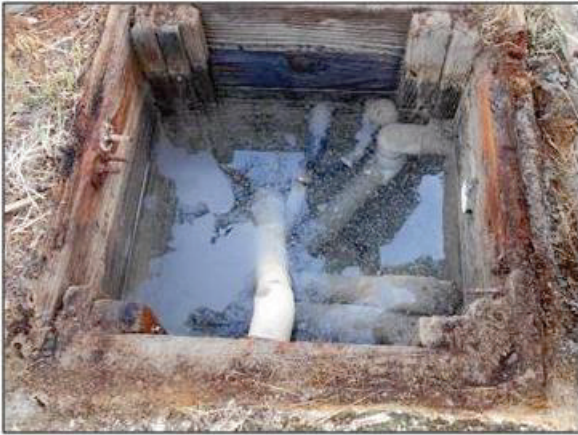
Lower Spring – Piping junction box from the warm source spring to water features

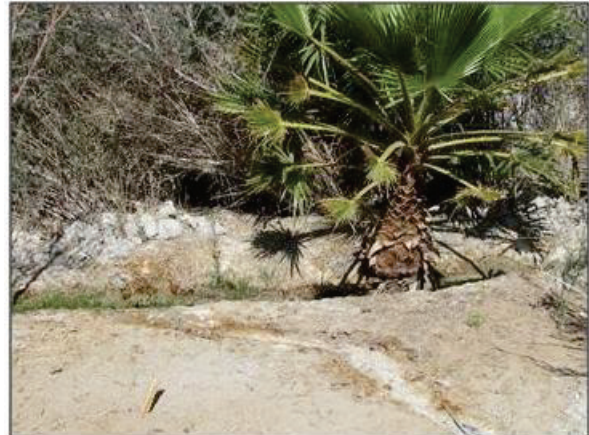
Lower Spring – Ditch that drains the Sunrise Pool and the Cool Pool to the settling pond

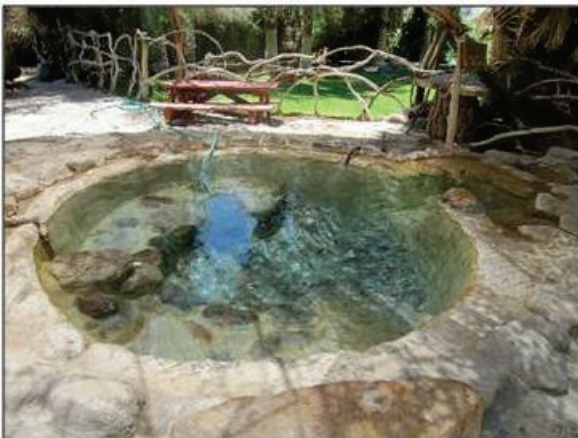
Lower Spring – Crystal Pool with hose that drains water to the settling pond

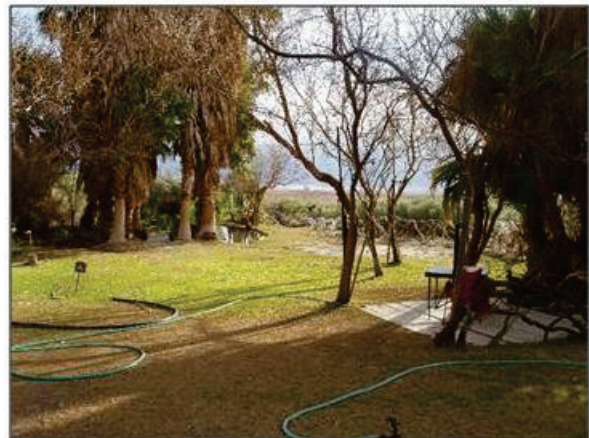
Lower Spring – Lawn with hosing and settling pond in the background

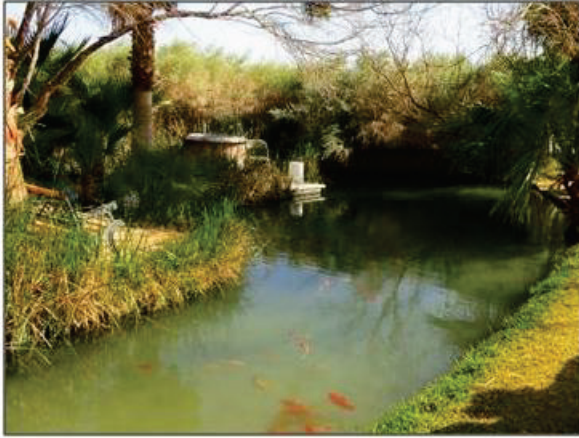
Lower Spring – Settling pond and the Children's Play Tub in the background

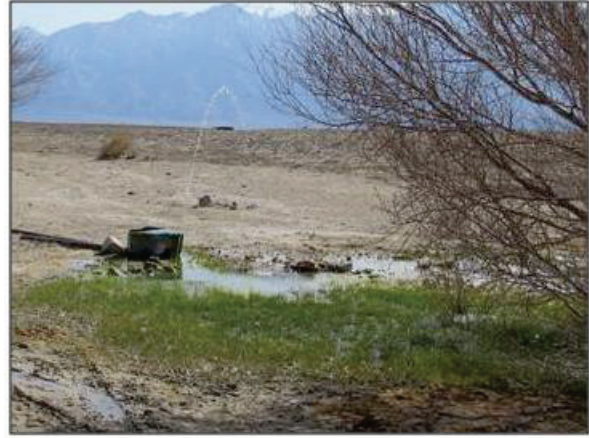
Lower Spring – Wildlife trough and surrounding vegetation that are fed by a hose from Burro Spring

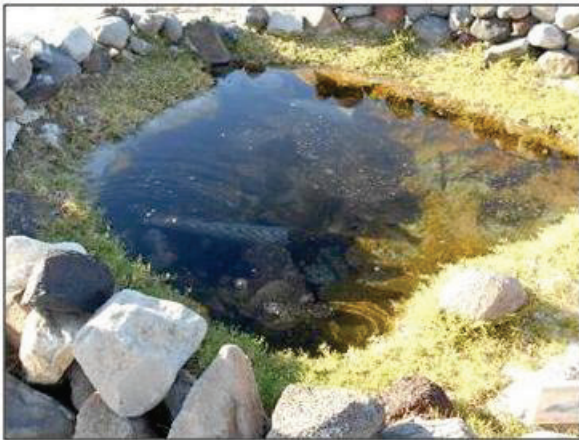
Palm Spring – Northern warm source spring with diversion pipe

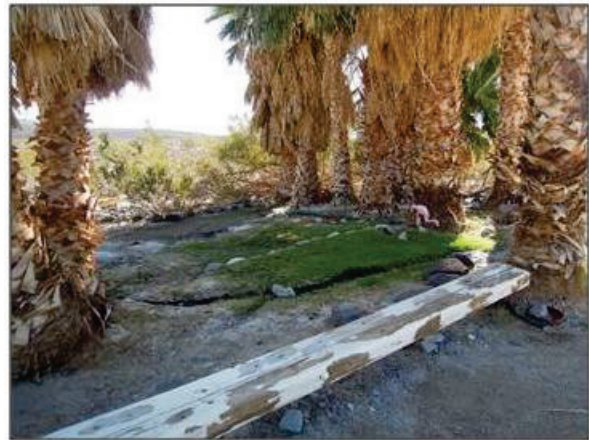
Palm Spring – Wash south of the Wizard Pool where water drains

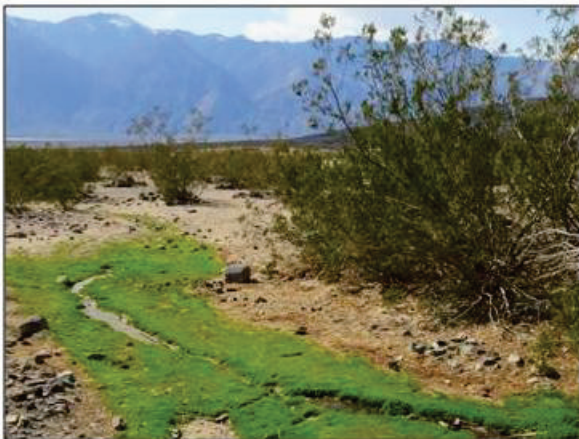
Palm Spring – Wash south of the Wizard Pool that drains the shower and the dishwashing sink

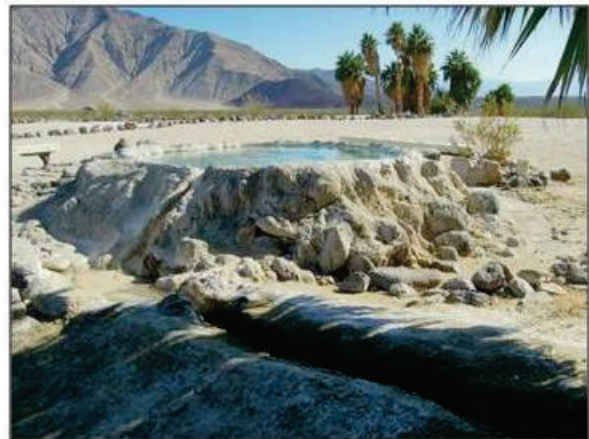
Palm Spring – Drainage from the Volcano Pool that drains water to a grove of nonnative invasive palm trees
