# Memo

**Re:** Quarry Lawn and Riverwalk Concept Design Options  
Alternatives Considered for Building No. 21 (Jig Dye House)

The purpose of this memorandum is to document alternatives considered by the design team for treatment of the remains of Building No. 21 (Jig Dye House) at the Allied Text Printers (ATP) Site in the Paterson Great Falls National Historical Park.

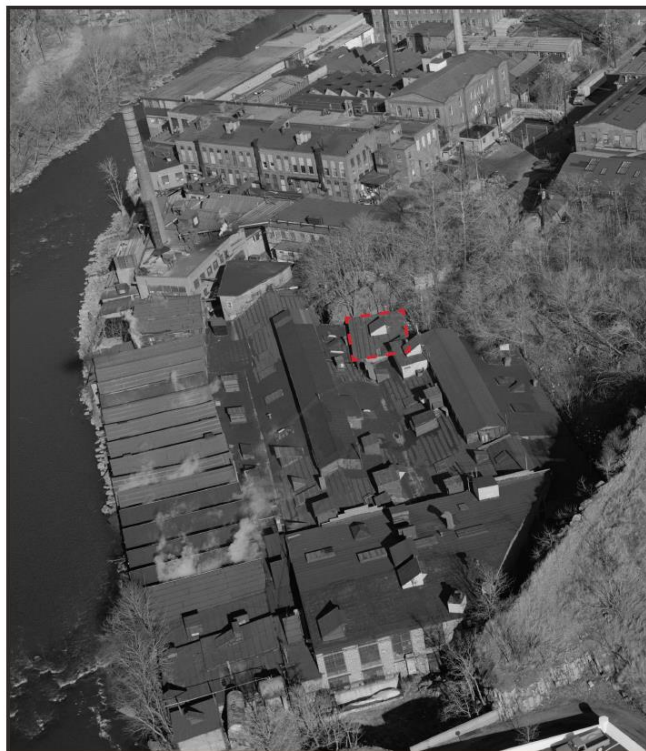
*Figure 1. ATP Site in 1974. Showing Building No. 21 (outlined in red) in its historic context prior to the fires that destroyed the adjacent buildings.*

Building No. 21 was built *circa* 1915 and had been incorporated along its south and west elevations into the much larger Building No. 20 by the 1920s (Figure 1). Building No. 20 is entirely gone except for its floor slab. Building No. 21 housed jig dyeing machinery from at least as early as the 1950s and may have had other uses in earlier years. Jig dyeing was a more mechanical, less labor intensive method of dyeing that relied on machines to spool rolled fabric back and forth through a tank of dye stuff. It was a less expensive method of dyeing that was technically preferable in some specific circumstances.

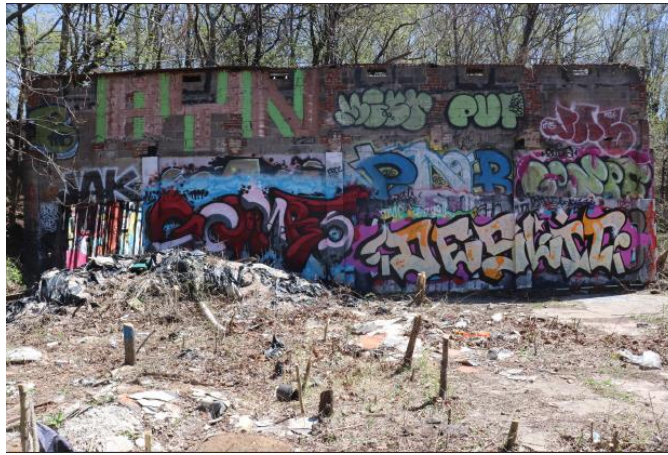
*Figure 2. Building No. 21's East Elevation. The door is visible at the lower left corner.*

Building No. 21 has a rectangular plan of 50 ft. x 38 ft. enclosed by four concrete and brick walls that stand 18 ft. tall (Figures 2 and 3). The upper 6 ft. of the walls are composed of concrete block while the lower 12 ft. section is poured concrete between brick columns that likely encase steel I-beams. The upper concrete-block section appears to be related to a modification made at a later date to raise the building's roof, possibly to accommodate the jig dyeing process. The north and east sides of the building back close to the rock face of the former Mount Morris quarry. The steel I-beam roof joists survive but the roof has collapsed. All windows and doors are missing with some window openings below the roof line having been blocked up at a later date. There are double-wide door openings near the corners of the south and west elevations. No machinery related to jig-dyeing process survives but the building's size is suggestive of the scale of the operations and the basins and machinery mounts in the concrete slab floor relate to the location of the machines and the capturing and directing away of waste water from the dyeing process.

Building No. 21's masonry walls are in fair to poor condition. The upper 6 ft. of concrete block is in the poorest condition with some missing blocks and losses of upper courses, particularly around the windows of the east elevation. The original wood substrate with asphaltic membrane roof is a total loss, and along with the deteriorated steel joists, represents a public safety hazard and is in an active state of collapse. There are no extant doors, although two door openings remain. Wood hopper window frames below the roof line are a total loss. There is one larger window opening, missing frame and sash, in the northern elevation adjacent to the door; it is currently boarded over. Another doorway in the southern elevation was bricked up prior to the cessation of industrial activities.

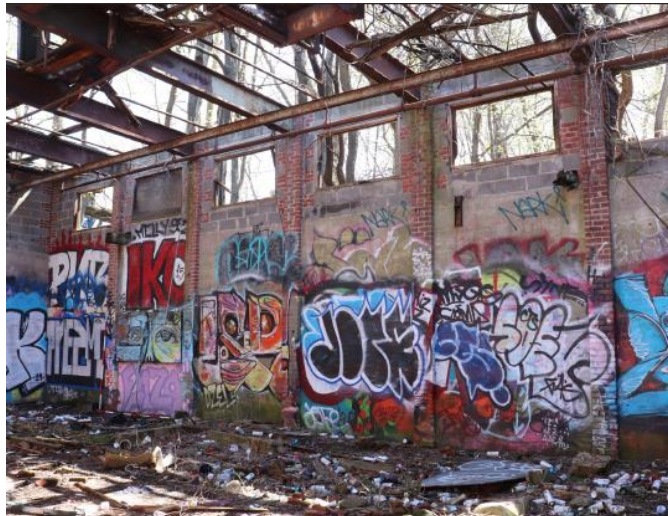
*Figure 3. View of the interior of the eastern wall and roof.*
