National Register of Historic Places Registration Form

Historic name: Elk Creek Visitor Center

Other names/site number: Center Point Visitor Center

City or town: Gunnison State: Colorado County: Gunnison

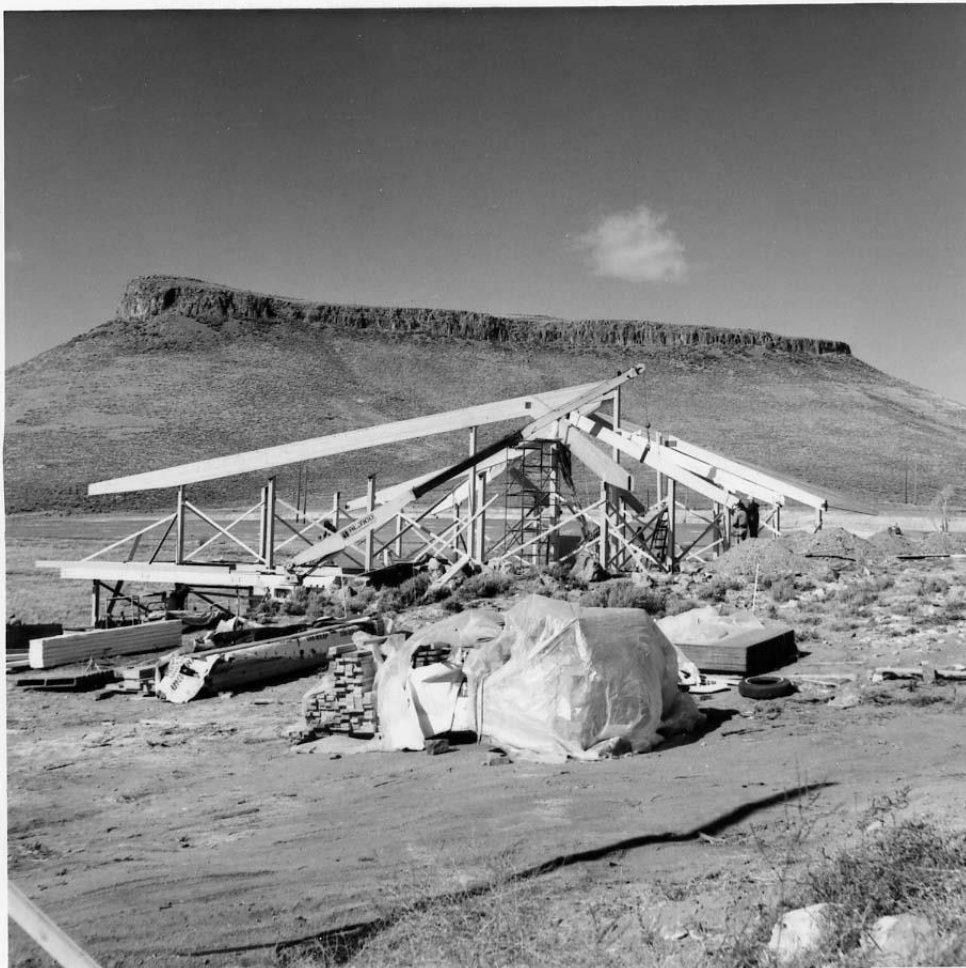
2 of 15

View of Elk Creek Visitor Center under construction looking north. Source: Curecanti NRA archives.

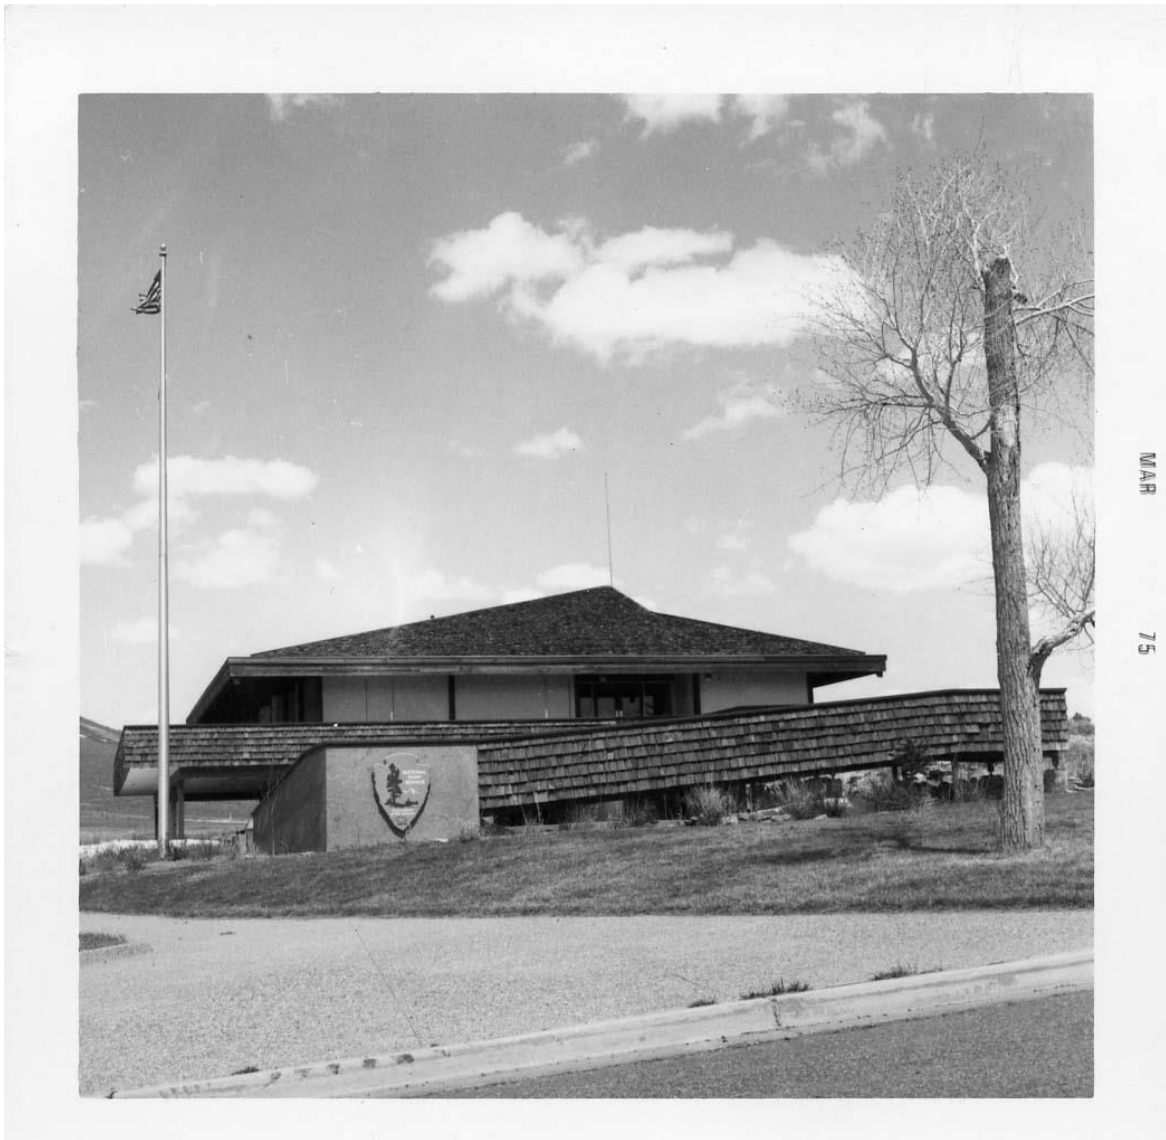
3 of 15

View of Elk Creek Visitor Center looking north at entrance ramp. Source: Curecanti NRA archives.

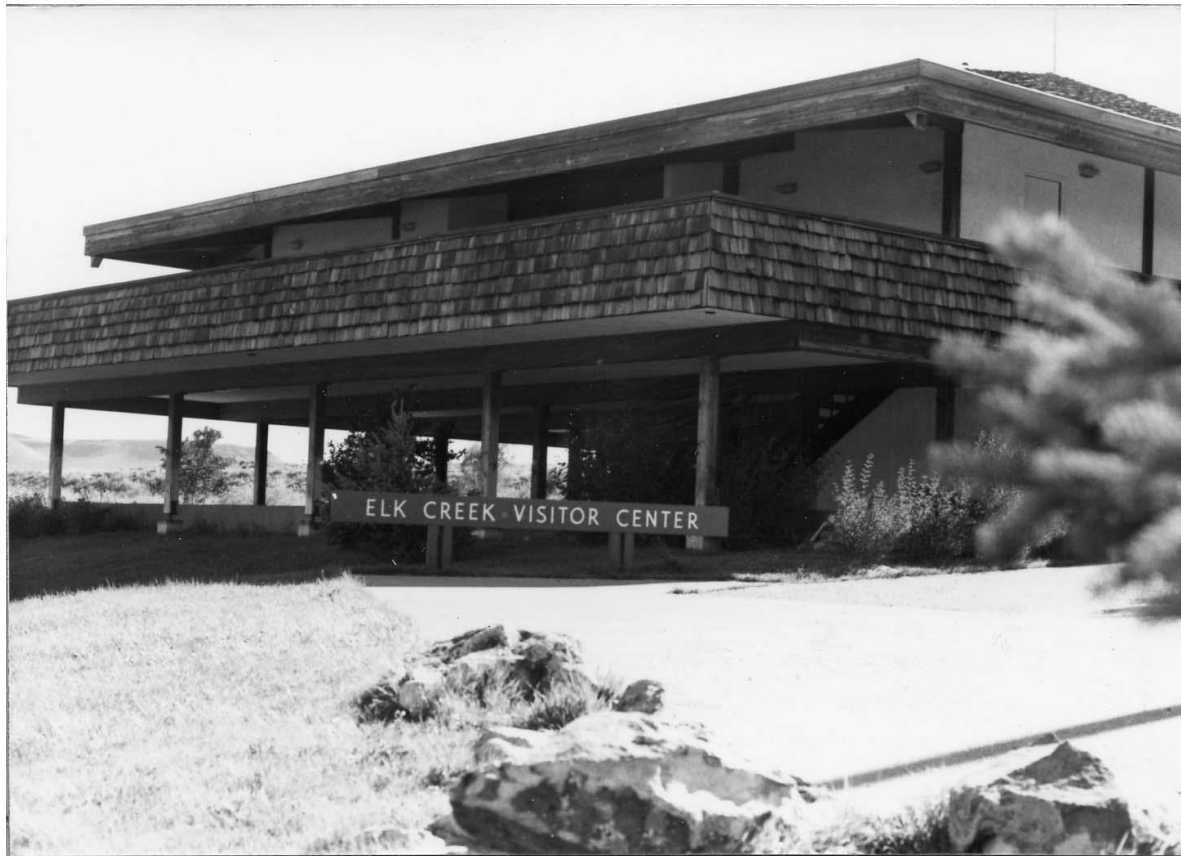
5 of 15

View of Elk Creek Visitor Center looking northeast at upper and lower terrace. Source: Curecanti NRA archives.

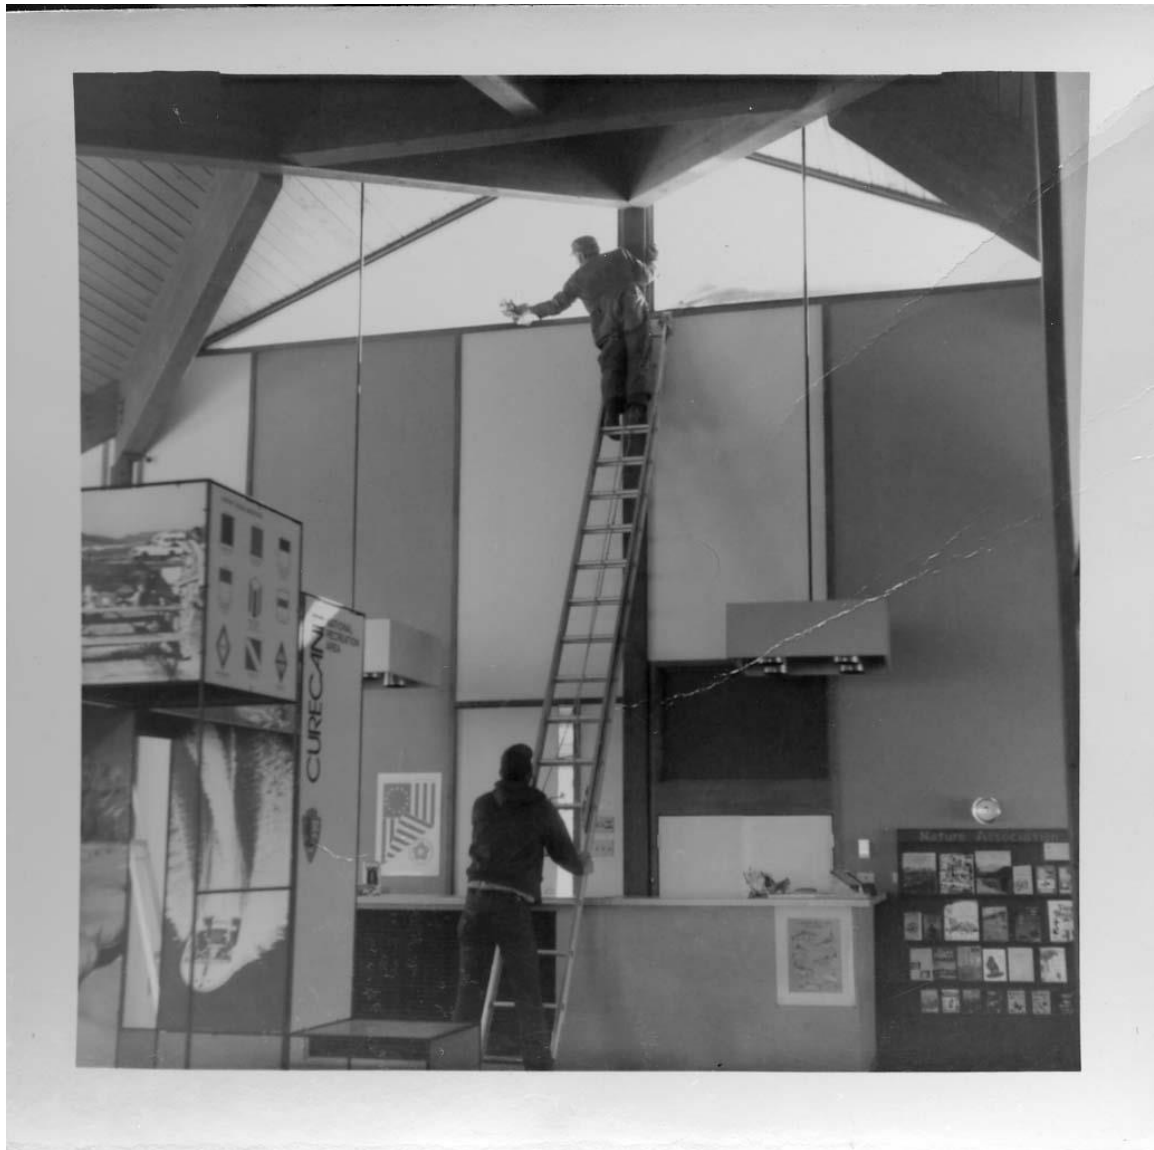
View of Elk Creek Visitor Center interior looking at skylight and interpretative area. Source: Curecanti NRA archives.

The roof is supported by exposed timber beams which are visible in the main interior space creating regulating lines within the building. The low pitched gabled roof is constructed of tongue and groove wooden planking that is exposed on the interior and stained to match the beams. The wooden framing seen on the exterior is topped with aluminum flashing for waterproofing and finished with wooden shingles. The wooden shingle finish is also exposed on the exterior of the upper level balcony wall that wraps around the perimeter of the enclosed interior space on the northeast, northwest and southwest sides.

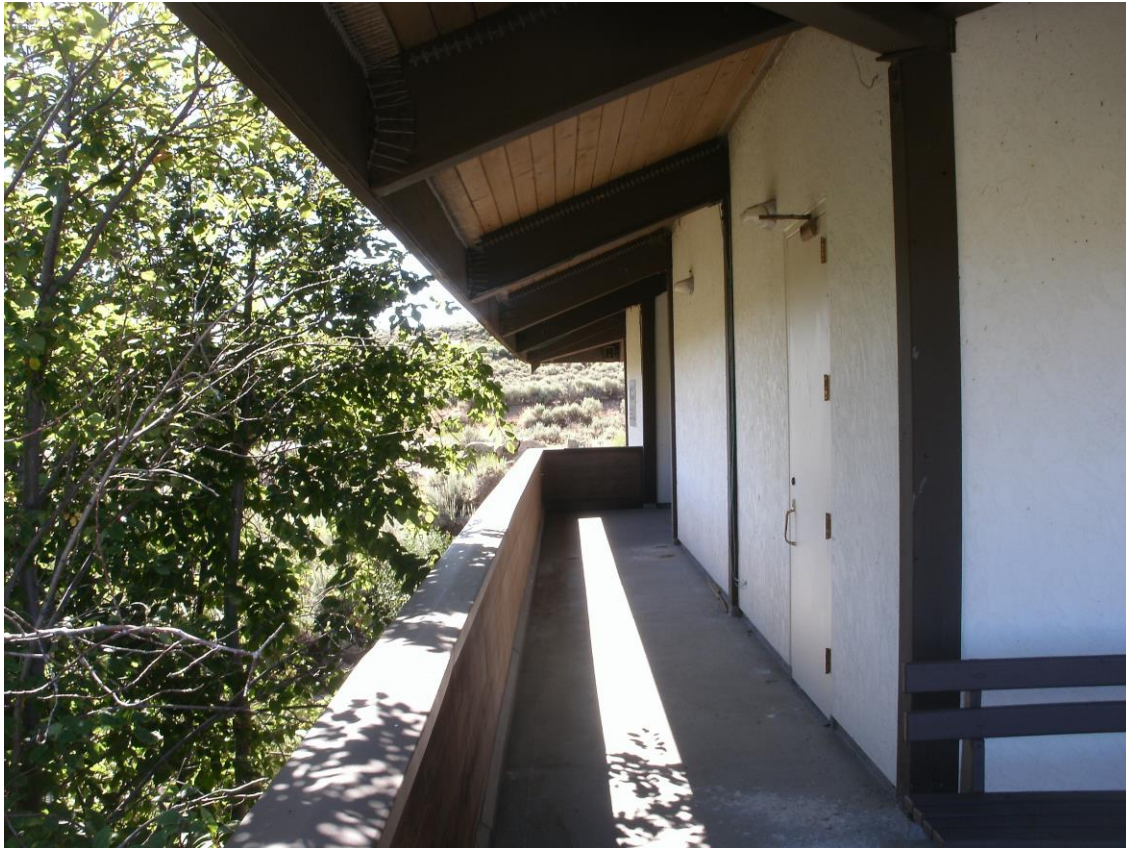
11 of 15

View of Elk Creek Visitor Center looking east on 1st floor covered porch.

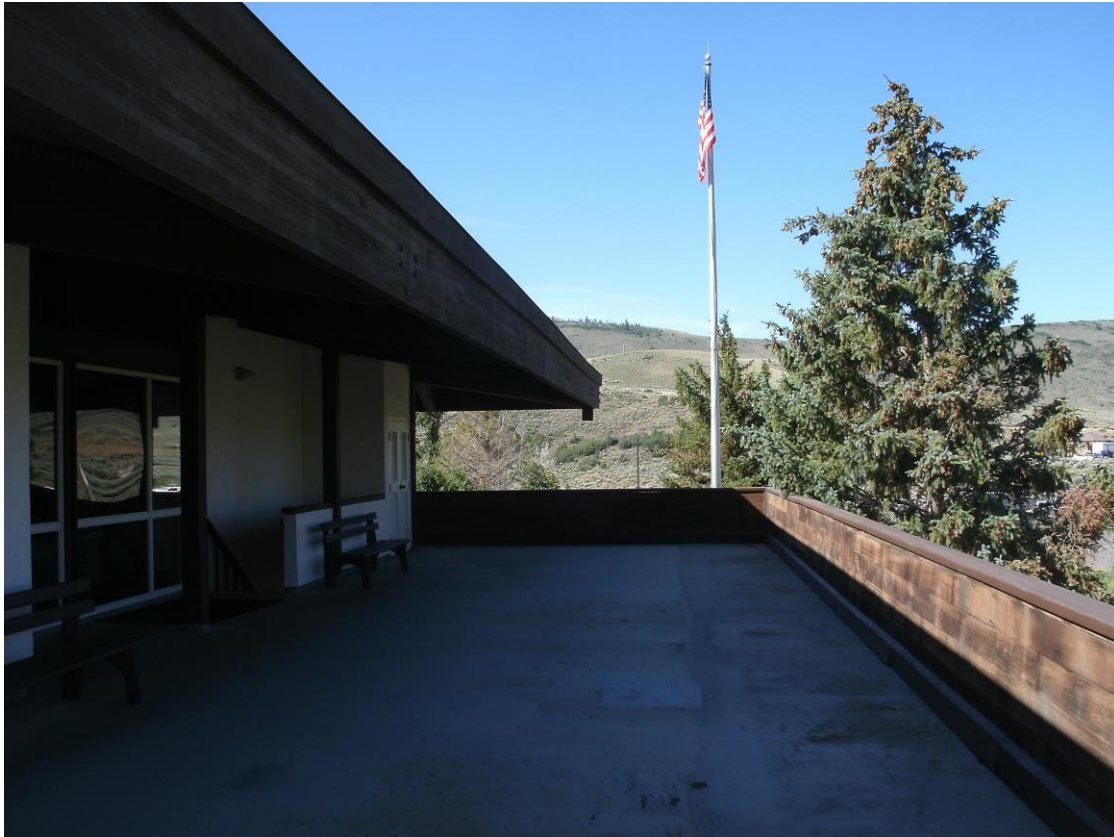
12 of 15

View of Elk Creek Visitor Center looking south on 1st floor covered porch.

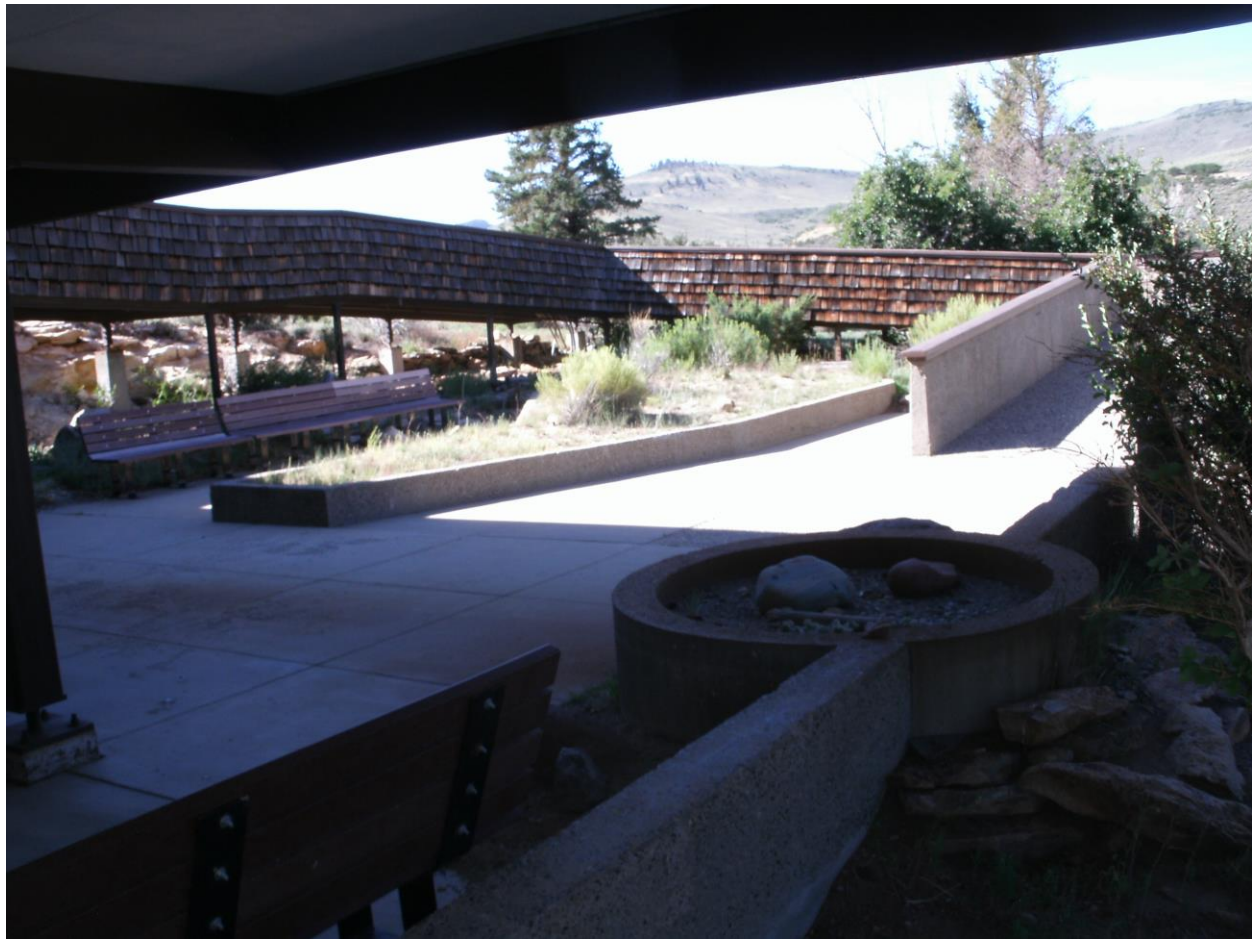
14 of 15

View of Elk Creek Visitor Center entrance ramp looking south to converted planter island (pond).

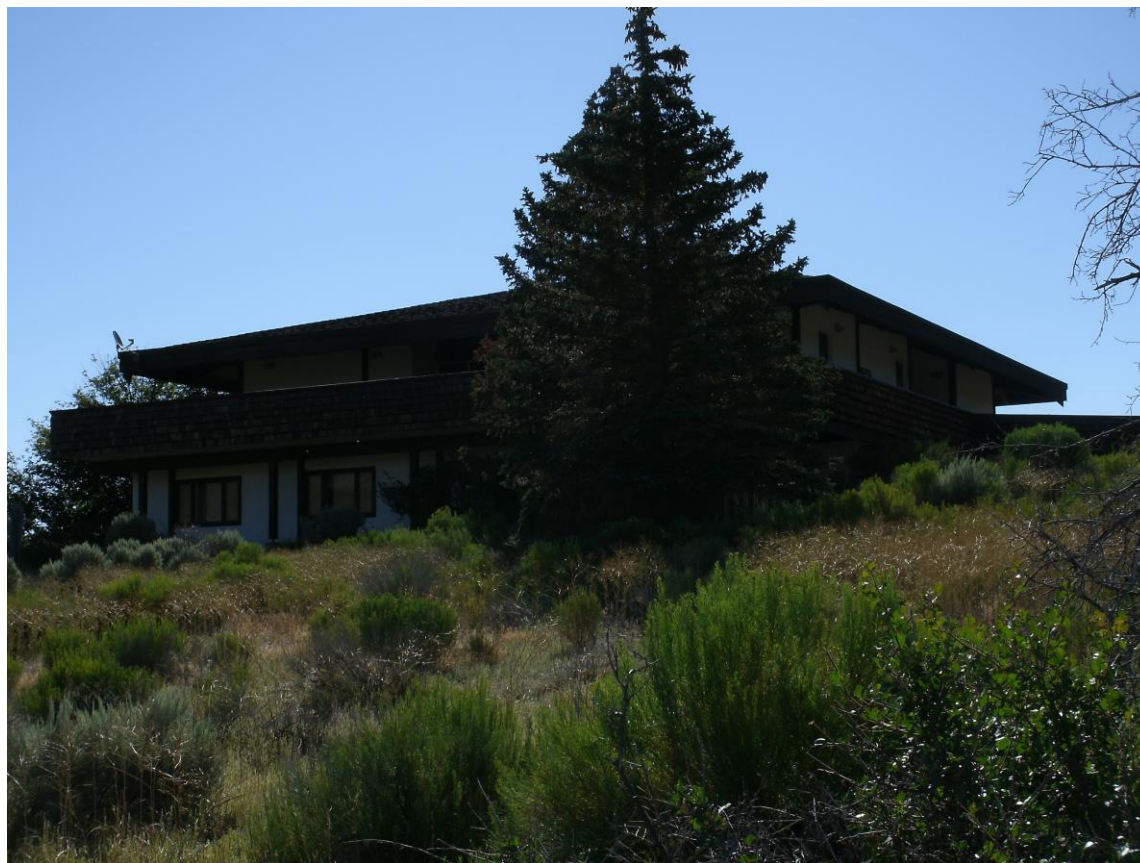
15 of 15

View of Elk Creek Visitor looking east to enclosed ground floor terrace.
