Waterproof Foundation and Improve Drainage for the Fredericksburg Battlefield Visitor Center Photos

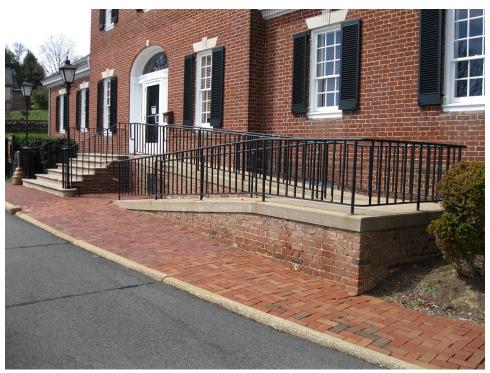
American Disabilities Act (ADA) Ramp on the front of the Fredericksburg Battlefield Visitor Center. The ramp was constructed in 1985. It will be removed and rebuilt, but will be 1-2 feet longer and 1-2 feet wider to comply with more recent ADA requirements.

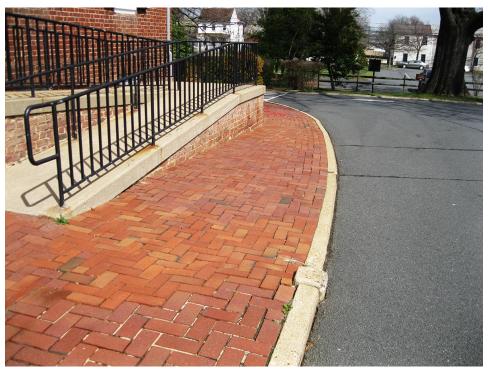
American Disabilities Act (ADA) Ramp on the front of the Fredericksburg Battlefield Visitor Center. The ramp was constructed in 1985. It will be removed and rebuilt, but will be 1-2 feet longer and 1-2 feet wider to comply with more recent ADA requirements.

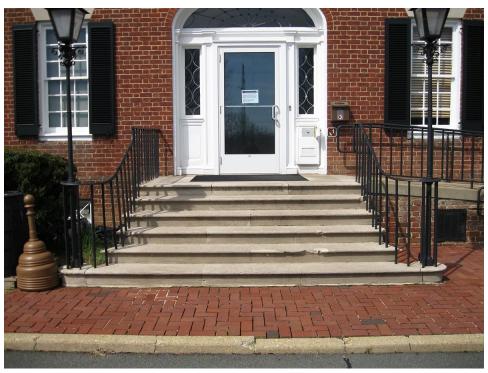
The original 1935-1936 front steps of the Fredericksburg Battlefield Visitor Center. The steps will be removed and replaced. Any damaged material will be replaced with in-kind materials and with in-kind design. To include railings and light poles.

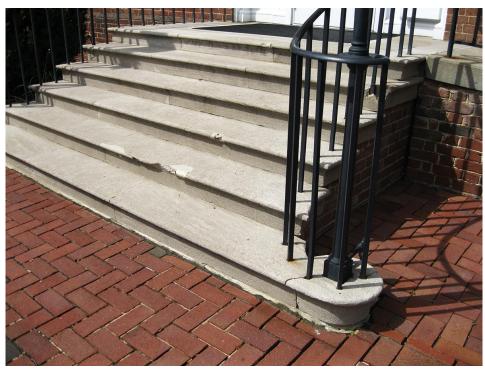
The original 1935-1936 front steps of the Fredericksburg Battlefield Visitor Center. The steps will be removed and replaced. Any damaged material will be replaced with in-kind materials and with in-kind design. To include railings and light poles.

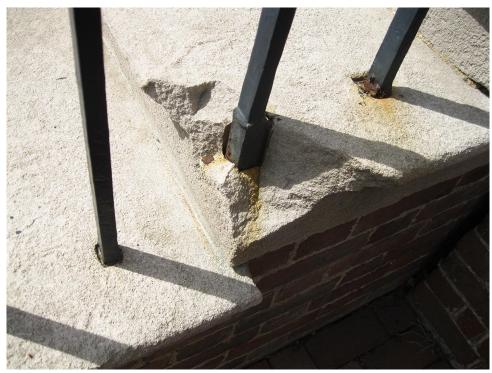
The original 1935-1936 front steps of the Fredericksburg Battlefield Visitor Center. The steps will be removed and replaced. Any damaged material will be replaced with in-kind materials and with in-kind design. To include railings and light poles.

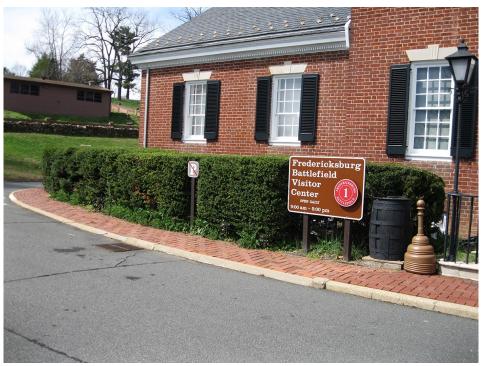
The post-1965 plantings and vegetation will be removed and replaced with plantings that more reflect the original 1937 planting plan.

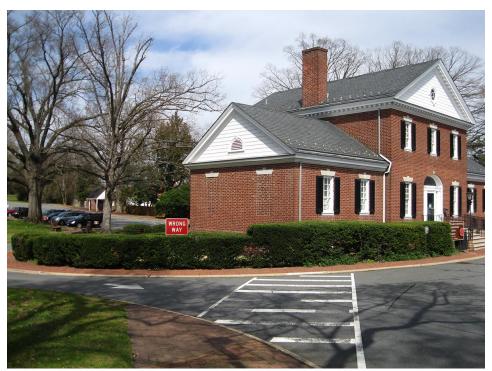
The post-1965 plantings and vegetation will be removed and replaced with plantings that more reflect the original 1937 planting plan.

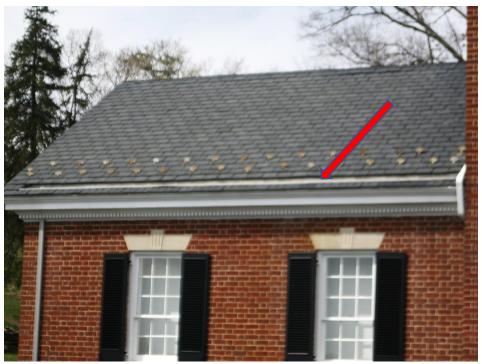
Interior gutters on the Fredericksburg Battlefield Visitor Center. The visible temporary downspouts will be removed, and new exterior gutters and downspouts installed.

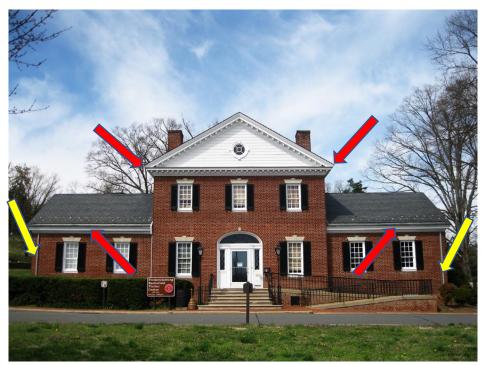
Four exterior gutters will be installed- two on the front of the two wings and two on the sides of the central portion – identified by red arrows. Two downspouts will be installed on the front of the building – one on each wing – identified by the blue arrows.

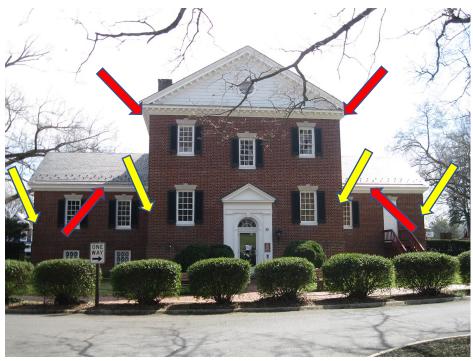
Four exterior gutters will be installed- two on the back of the two wings and two on the sides of the central portion – identified by red arrows. Two downspouts will be installed on the front of the building – one on each wing – identified by the blue arrows.

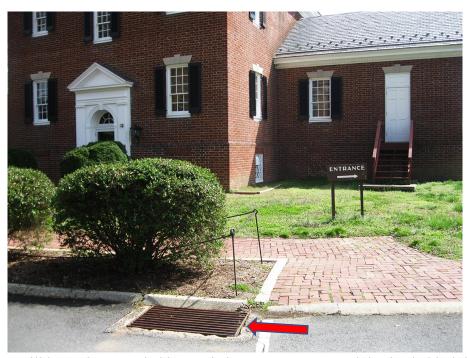
Downspouts will be undergrounded into existing storm water catch basins behind the building
