Dinosaur National Monument
Utah/Colorado

Final Environmental Impact Statement / Assessment of Effect for the Quarry Visitor Center Treatment Project

March 2008

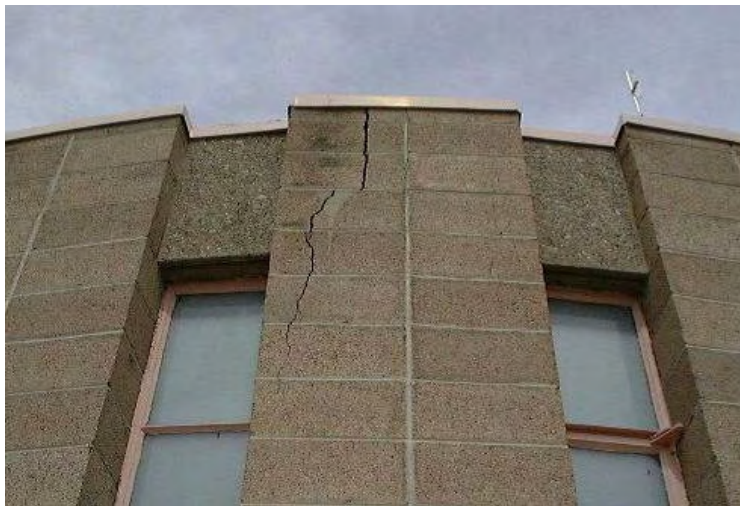
The Quarry Visitor Center is situated on expansive soils (commonly called “bentonite”) that have high shrink-swell capacity when they come in contact with water. The upward movement of the soil is causing substantial damage to the building. This has included heaving of interior floor slabs by as much as 8 inches, a subsequent drop in the interior viewing gallery floor by as much as 12 inches, and tilting of the Administrative Wing roof in excess of 10 inches. The movement of surface soils results in continuing upheaval of the floor slabs beneath the Administrative Wing and South Wing, producing cracks and deterioration that can readily be seen on the brick and mortar exterior of the South and Administrative wings (Figure 3).

FIGURE 3. CRACKED EXTERIOR WALL ON ADMINISTRATIVE WING

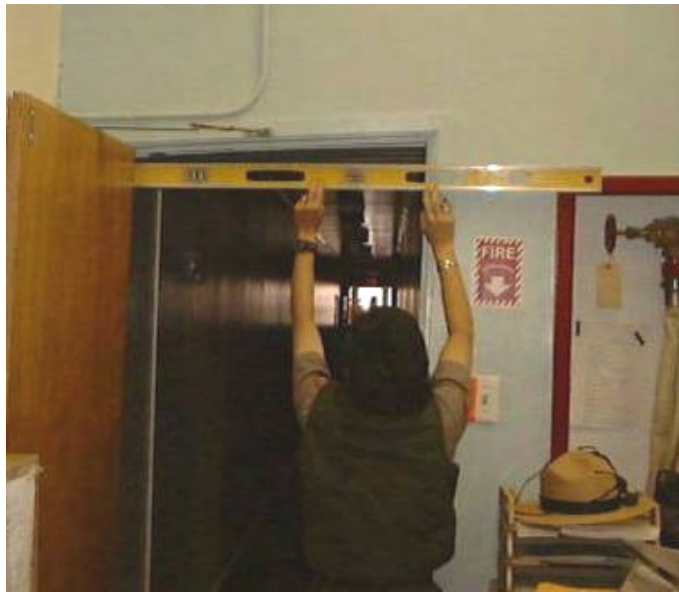
Rising floors cause progressive cracking and buckling of interior walls (Figure 4). In December 2003, an interior wall in the South Wing (between the staff workroom and reference library) failed during the night, collapsing bookshelves. In the Administrative Wing, compression of the first floor between the rising floor slab and second story above has resulted in ceiling joist failure. A manually-operated jack has been placed at this site and is monitored and adjusted to protect against ceiling failure. Shifting floor surfaces have also produced ruptures of plumbing piping and fixtures, which has released water and exacerbated the shrink-swell problems.

FIGURE 4. DISTORTED DOORFRAME IN PALEONTOLOGY LAB

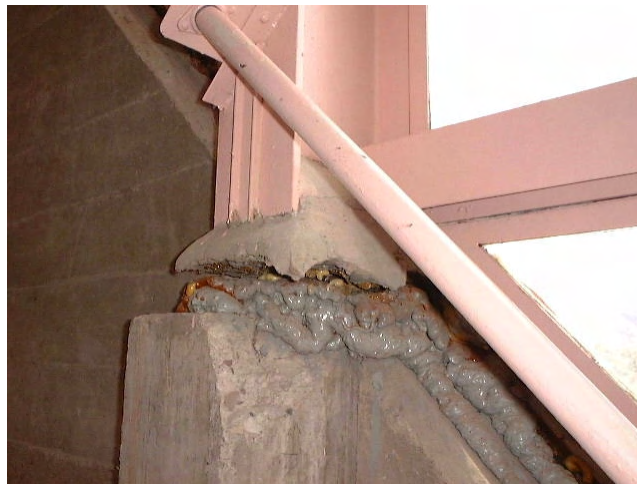
On the east wall of the Exhibit Hall, the glass portion of the wall and the foundation are no longer structurally connected (Figure 5). Even during moderate winds, the glass portion of the wall sways back and forth. A variety of other problems were found to exist in the building. For example, the upper floor of the Exhibit Hall had broken free from its attachment to a few of the cantilevered support beams and had displaced upward by as much as 2 inches. Because of those concerns, the NPS decided that the prudent course of action would be to close the building on July 12, 2006 rather than continue to put park staff and visitors at risk (NPS 2006a).

FIGURE 5. WINDOW CURTAIN SUSPENDED ABOVE FOUNDATION IN EXHIBIT HALL

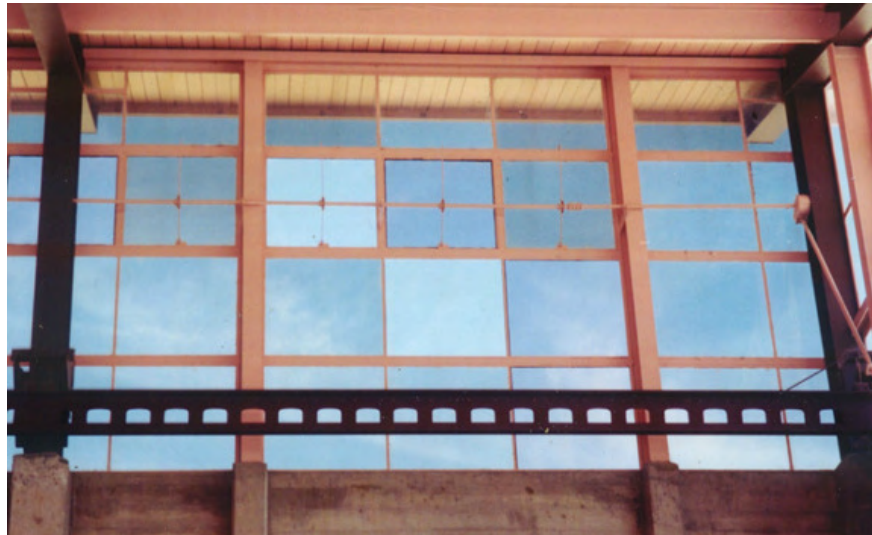
Failure of individual glass panes over time has led to replacement with a mixture of glass types and Plexiglas® panels (Figure 7) that have a variety of tolerance for expansion/contraction and structural movement. Some panes have been lined with protective film intended to prevent broken glass from falling and injuring staff or visitors. This glazing mixture presents a checkerboard appearance of dark and light panes in the Exhibit Hall.

FIGURE 7. VARIETY OF REPLACEMENT GLASS IN EXHIBIT HALL

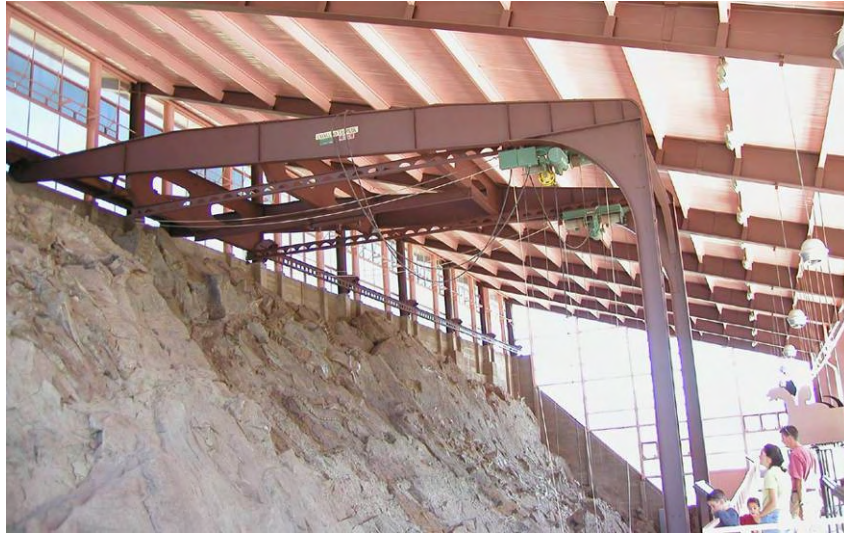
A light-duty, traveling gantry crane designed for working and maintaining the fossil wall is housed in the Exhibit Hall (Figure 8). The gantry crane travels along two rails, similar to railroad tracks. The northern rail is located on the top of the wall, and the southern rail is located on the exhibit floor. The gantry crane was operational until approximately 2003, but structural movement has caused interference at the east end of the railings, and the range of travel is now limited (Andrews & Anderson Architect, JVA Inc. *et al.* 2004).

FIGURE 8. THE GANTRY CRANE

Loss of crane function hampers cleaning, monitoring, and repair of the fossil wall. Staff now performs these duties by climbing directly on the formation.

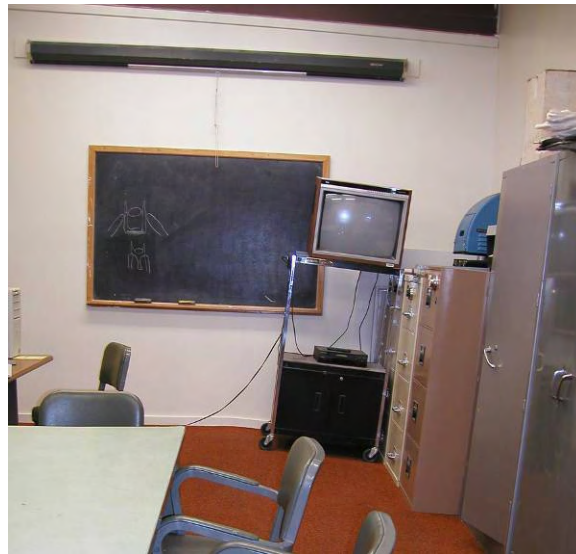
FIGURE 23. UNEVEN FLOOR IN STAFF WORK AREA
