EXISTING CONDITIONS

Aside from documenting the existing condition of the cemetery landscape, this chapter of the Cultural Landscape Report provides an overview of the cemetery's environmental conditions, regional context, and setting (immediate environs). It is based on the site history and on fieldwork completed in June 2006, discussions with Facility Manager Jerry Helton and Ranger Betsy Dinger-Glisan, and on the park's GIS database. For the purposes of this report, the cemetery landscape (area owned or managed by NPS) is organized into six parts: approach road, Odom tract, inclosure (perimeter), lodge grounds, service yard, and burial grounds. Also included is a brief overview of current cemetery operations pertaining to the landscape. The chapter is supported by an existing conditions plan and current photographs.

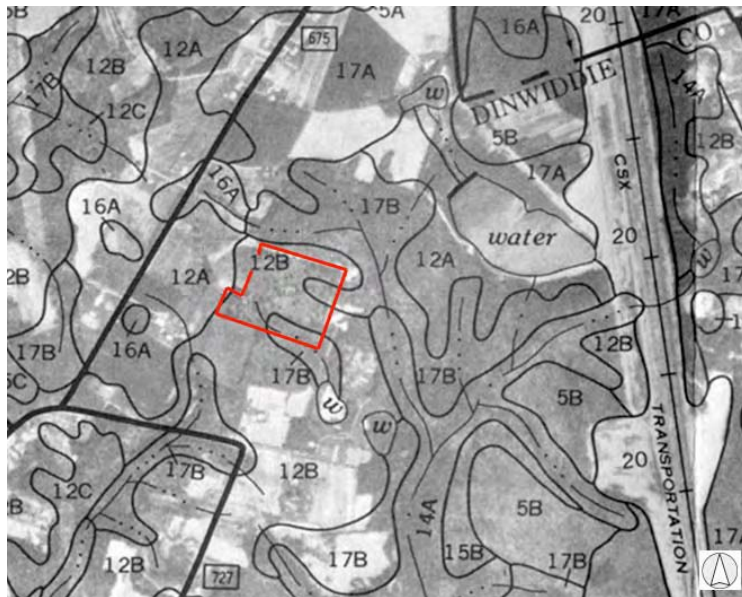
Figure 2.1: Soils map showing Mattaponi sandy loam (12A, B) and Slagle sandy loam (17B) within cemetery and along approach road. U. S. Department of Agriculture in cooperation with Virginia Polytechnic Institute and State University, *Soil Survey of Dinwiddie Area, Virginia* (Washington, D.C.: U.S.D.A., August 1996), detail of map 18.

Native surface soils within the cemetery and along the approach road are Mattaponi and Slagle sandy loams, which are moderately well drained and very deep soils formed in loamy and clayey sediments deposited by ancient rivers and seas. [Figure 2.1] Depth to bedrock is generally more than sixty inches. These soils are prone to wetness due to slow to moderately slow permeability; allow for

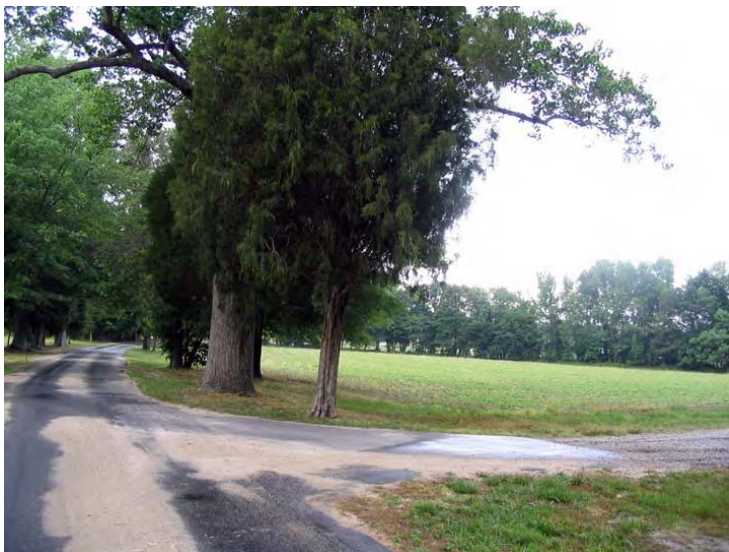
Figure 2.9: The approach road in the right-of-way, view looking west toward Vaughan Road from the private entrance drive (at right) showing asphalt pavement with sand top coat, private agricultural field, and mix of remnant allee and volunteer trees along the road. SUNY ESF, 2006.

The one-lane approach road is approximately eleven feet wide with mown shoulders, and is paved in asphalt with a sand top coat. [Figures 2.9, 2.10] The land approximately ten feet to either side of the pavement was historically planted with an allee of deciduous trees spaced at twenty-five foot intervals. Today, only scattered specimen trees remain from this allee, which was originally planted in 1879 and last replanted in 1931. These mature trees are identified by circular metal inventory tags, probably installed in the late 1930s by NPS as part of the cemetery master plan completed in c.1941. The allee has largely been replaced by volunteer red cedars and deciduous woods [see Drawing 5]. Through the right-of-way, the approach road borders working agricultural fields, except for a triangular woodlot at the intersection with Vaughan Road that has grown up since 1970. Through the NPS Odom tract, the approach road borders woods, mown field, and a parking lot.

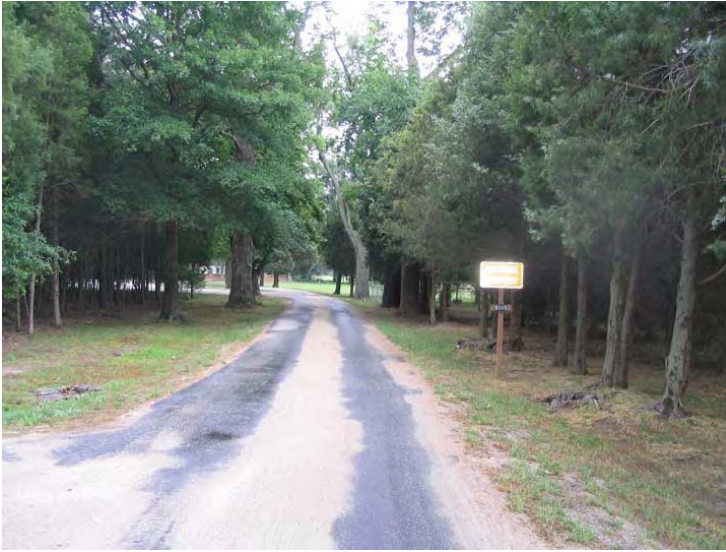
Figure 2.10: The approach road (c.1866), view looking east toward the cemetery through the NPS Odom tract showing asphalt pavement with sand topcoat, irregular mown shoulder, and mix of remnant allée and volunteer trees. SUNY ESF, 2006.

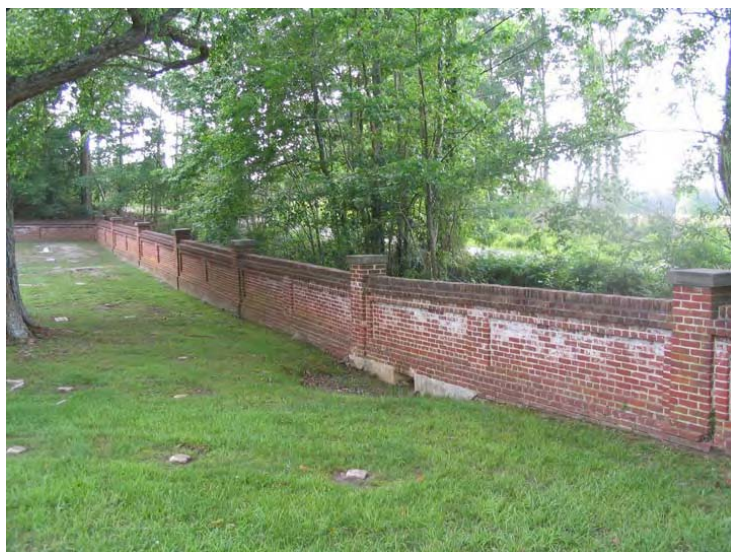
Figure 2.13: The inclosure wall (1876), view looking northwest from the topographic low point near the northwest corner of the cemetery showing drain opening. Visible in the background is the c.1972 private drive to the Blaha and Peterson houses. Note lack of vegetation allowing views out. SUNY ESF, 2006.

At eight low points, there are drainage openings in the wall that originally fed from a system of brick gutters and culverts along the cemetery drives [see Drawing 5]. Today, grass swales drain into these openings. Several contain brick or concrete spillways that extend beyond the wall, including one at the cemetery low point (northwest corner) that feeds into a culvert that runs beneath the private access drive into wetlands to the north. This drainage often backs up, resulting in standing water remaining within the cemetery often for days after a heavy rain.

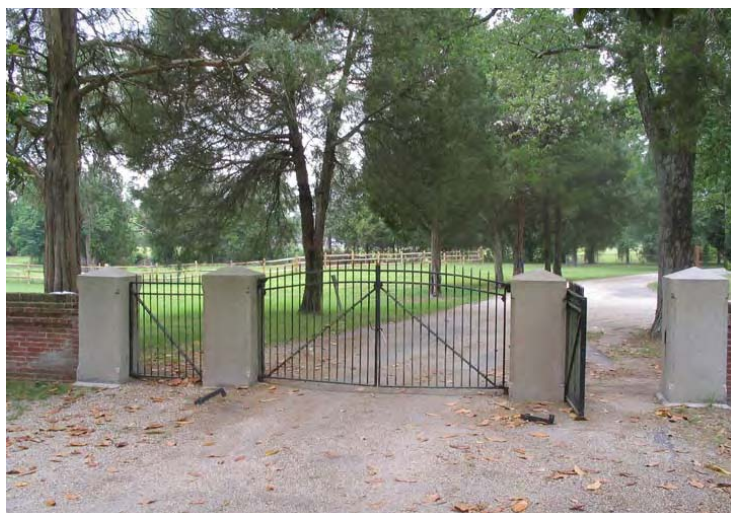
Figure 2.14: The main entrance gateway (1876), view looking west from inside the cemetery. SUNY ESF, 2006.

The cemetery gateway, built as part of the inclosure wall in 1876, consist of wrought-iron swinging gates hung from granite posts with chamfered edges and pyramidal crowns. [Figure 2.14] The gateway has a central vehicular entrance with paired gates flanked on each side by pedestrian entrances with single gates. The vehicular gates swing inward to iron stops at former edges of the drive. Cast metal shields with the inscription “U. S. National Cemetery” are affixed to the piers to either side of the vehicular entrance. These were added after 1933.

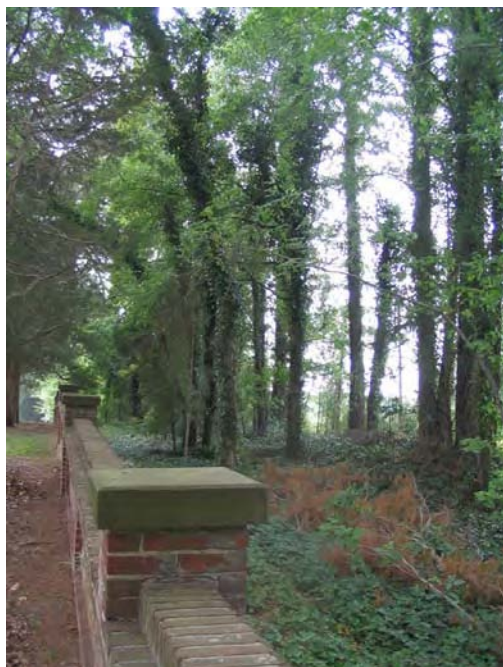
Figure 2.15: Woods in the north enclosure, view looking west along the north boundary illustrating groundcover of English ivy and open understory allowing views out. SUNY ESF, 2006.

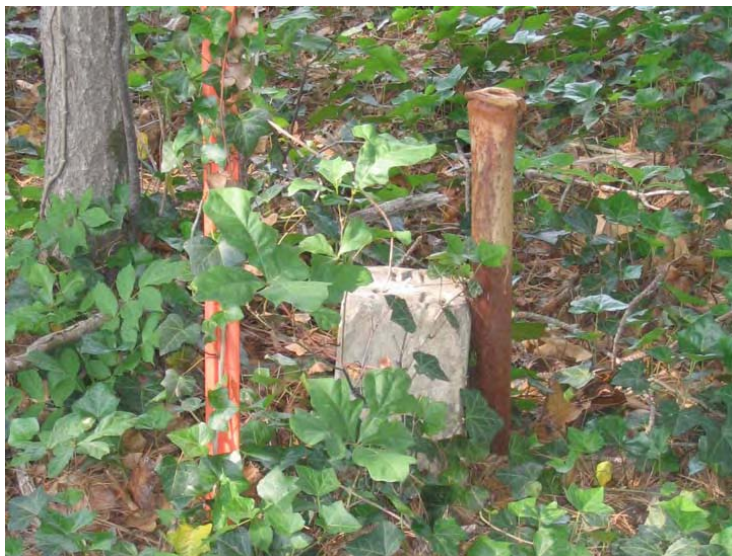
Figure 2.16: A typical stone boundary marker (1877) with later pipe and stake markers. SUNY ESF, 2006.

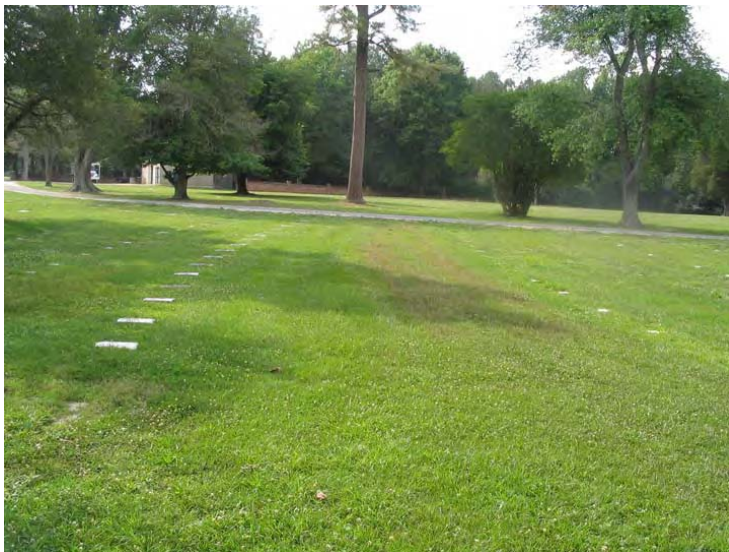
Figure 2.19: The garage (1929), and east end of the service yard, view looking northwest across the main drive and Division E. Note large boxwoods at left. SUNY ESF, 2006.

The service yard, a small section at the entrance to the cemetery north of the main drive, is the cemetery's maintenance area [see Drawing 5]. The service yard is defined on the west and north sides by the inclosure wall, and is open on the remaining sides. To the east, the service yard abuts the graves in Division E. At the rear of the yard, close to the inclosure wall, is the garage (utility building) that replaced several earlier outbuildings. It was built in 1929 at the same time as the restroom building and in a similar Colonial Revival style according to plans by the Quartermaster General Third Corps Area, Baltimore. [Figure 2.19] Originally designed as a stable and garage with a loft, it is a one story building measuring 38 feet by 22 feet, with two sets of swinging garage doors, six-over-six sash windows, unpainted stucco siding, and a standing-seam metal gable roof with eaves returns. At the rear of the building is a later frame shed addition. The garage is presently used to house the cemetery's maintenance equipment.

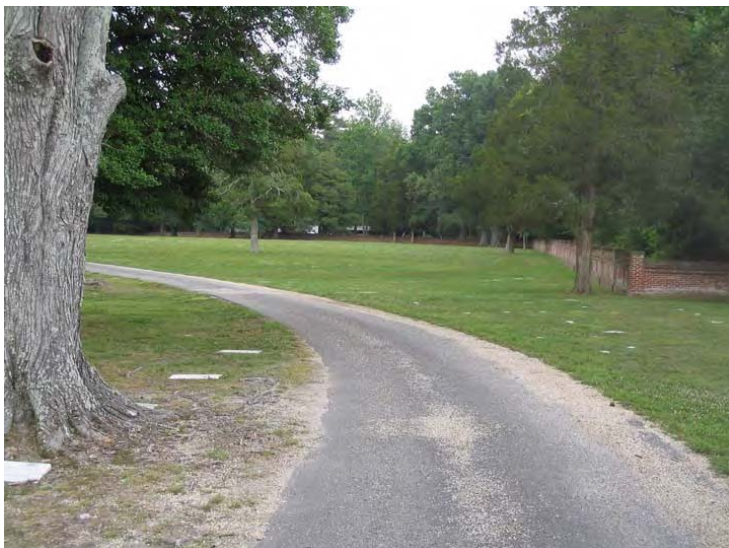
Figure 2.21: The main drive, view looking east from near the rostrum showing asphalt paving with gravel surface coat. SUNY ESF, 2006.

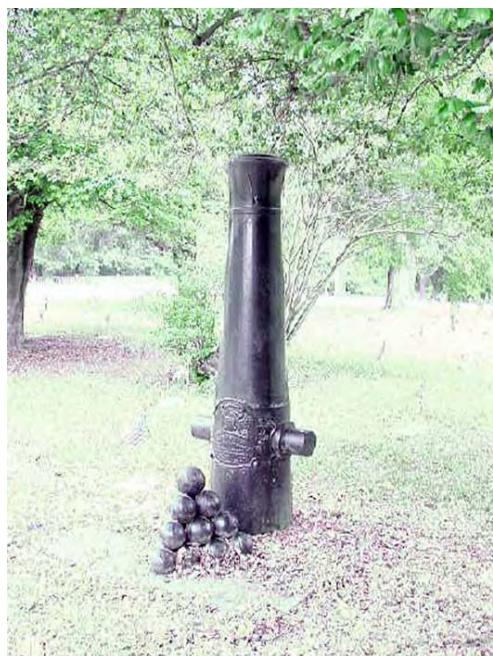
Figure 2.23: The remnant gun monument, view looking northwest. Note bronze shield, presently painted black. SUNY ESF, 2005. [need better photo]

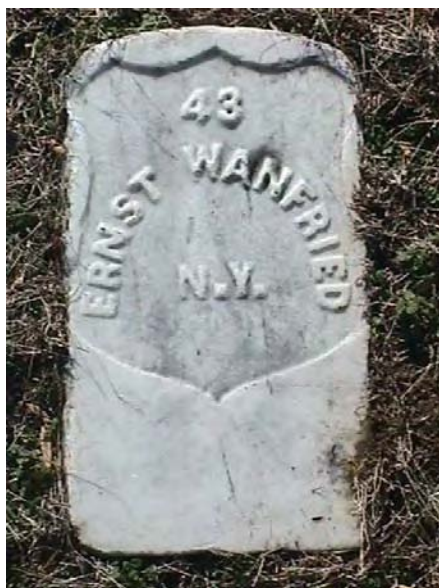
Figure 2.25: Typical Civil War-type headstone lying flush as a ledger stone, at grave #43 in Section A. This stone has been recently cleaned. Petersburg National Battlefield, 2005.

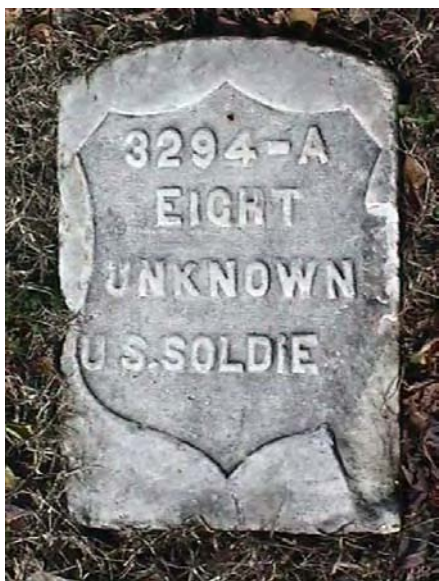
Figure 2.26: Later type of Civil War-type headstone, at grave 3294-A. This stone was installed in 1931 for the reinterment of Union soldiers found at The Crater. Petersburg National Battlefield, 2005.

inscription. Two variations on this style, with different fonts, were used for later graves or replacement markers through the 1930s. [Figure 2.26]

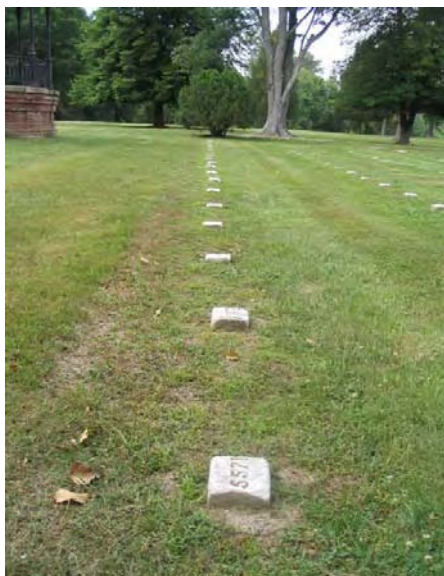
Figure 2.27: Typical Civil War-type blocks (unknown graves) in Section F, looking north. These reflect raising that was done in 1957. Note heavily chipped edges. SUNY ESF, 2006.

The blocks, measuring six inches square and originally designed to be six inches above grade, feature just the grave number incised into the top surface. [Figure 2.27] There were originally 3,355 blocks set in 1877; since then, approximately seventy-eight have been replaced with headstones of various types, leaving approximately 3,277 blocks, or fifty-eight percent of all grave markers in the cemetery. The block grave marker was discontinued by the War Department in 1904.

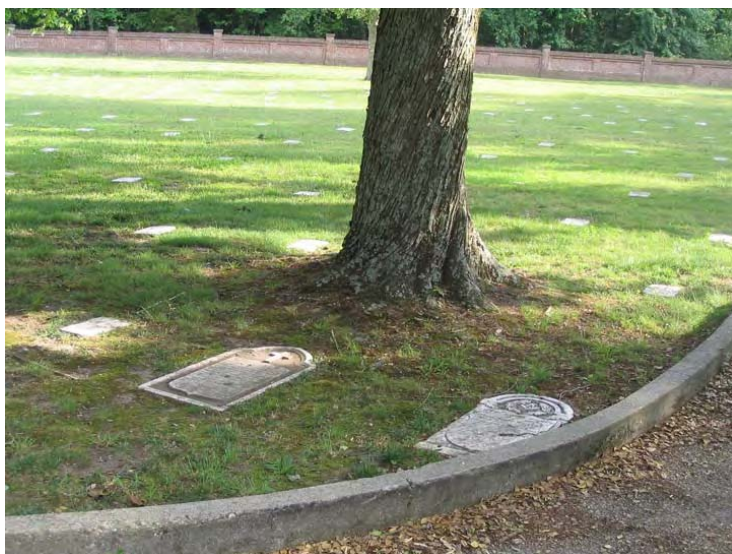
Figure 2.28: Two of the five private markers, view looking southwest from the central loop on the main drive. Note concrete curbing added in 1931. SUNY ESF, 2006.

In addition to the standard grave markers, there are three [check] Civil War graves that are marked by a private (rather than government-furnished) headstone, and approximately four others that are just a simple slab with incised lettering. The private markers are larger marble slabs with distinctive lettering, and funerary and Masonic symbolism. Like the government headstones, these private markers were cut and laid flush with the ground in 1933. Two of the private headstones are located along the central loop of the main drive, adjoining the concrete curbing added in 1931. [Figure 2.28]

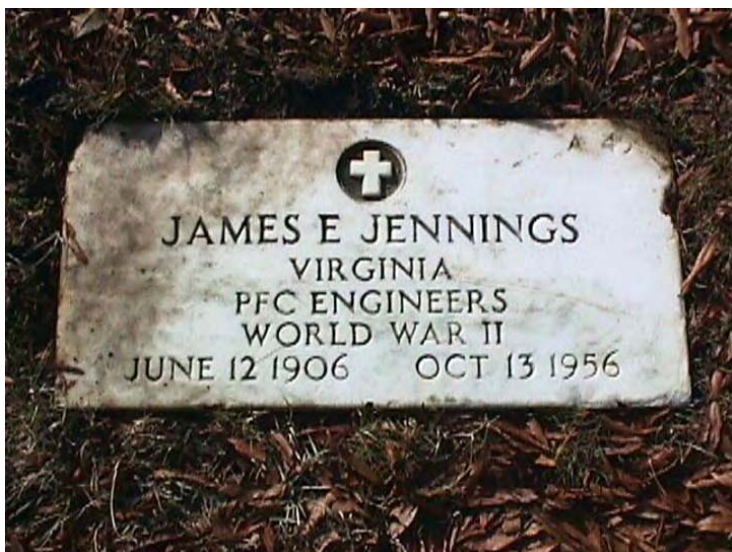
Figure 2.29: Flat headstone used beginning in c.1939, located in Section A. Note staining and chipping. Petersburg National Battlefield, 2005.

A third type of headstone, introduced in c.1939, is rectangular and designed to lay flush with the ground.⁸ [Figure 2.29] These marble headstones, measuring approximately twenty-four inches long by twelve inches wide and four inches thick, have incised inscription with name, state, rank, organization, and dates of death, and usually feature a religious symbol at the top, such as a cross. This new style was used for new burials and for replacement stones scattered throughout the cemetery. A variation of this headstone, executed in bronze, marks the single grave of a Medal of Honor recipient, which replaced a Civil War-type marker at some point after 1940.

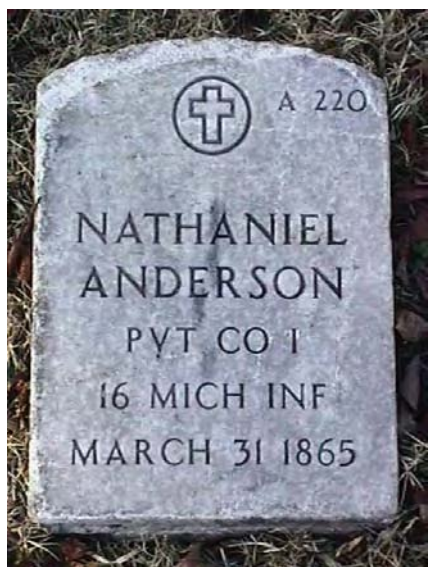
Figure 2.30: Typical standard “General”-type national cemetery headstone, installed at some point after 1960 as a replacement stone for grave 220 in Section A. Note heavy chipping along the edges. Petersburg National Battlefield, 2005.

A fourth type of headstone, used at Poplar Grove for replacements and reinterments beginning in c.1960, is the “General” type headstone, without the base stem and laid flush in the ground. [Figure 2.30] There are approximately nine of these headstones at Poplar Grove. The General, introduced after World War I, is the current standard headstone used by the Department of Veterans Affairs in national cemeteries. Although similar in shape to the Civil War-type headstones, these new slabs have no recessed shield, incised rather than raised block lettering, a religious symbol at the top, and date of death.

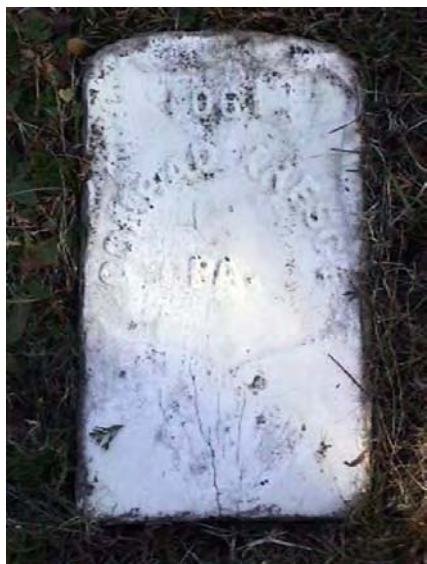
Figure 2.31: Original Civil War-type headstone illustrating erosion and staining of the marble. Petersburg National Battlefield, 2005.

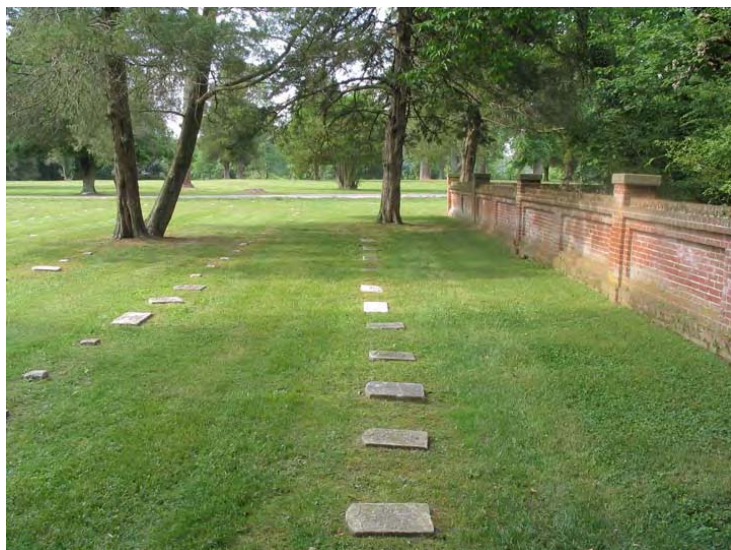
Figure 2.32: Grave markers dating from 1918 to 1942 in Division F (Block XX), view looking north showing various types along with staining and alignment problems. Note red cedars, planted in 1937. SUNY ESF, 2006.

The grave markers at Poplar Grove are overall in fair condition with respect to their legibility. The park keeps the grass trimmed off the stones, raises those that sink below grade, and has cleaned stains and algae from roughly half of all stones. The heaviest stained stones are generally in shady and wet locations. With respect to their physical condition, the stones are in poor condition characterized almost universally by heavy chipping along the edges resulting from impact by mowers. Others are cracked and eroded. [Figure 2.31, see also Figures 2.24-2.30]. Without a firm foundation, many of the stones have settled and drifted out of alignment in their rows. [Figure 2.32]

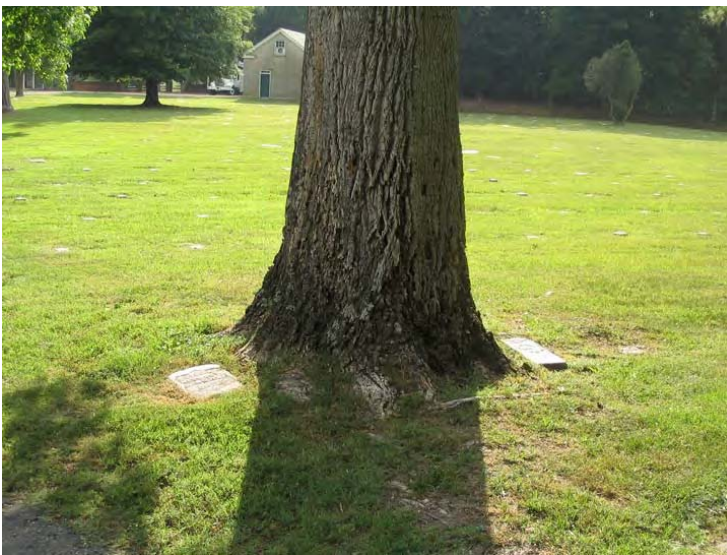
Figure 2.34: Mature sweet gum in grave row in Division D (Block XIV), view looking west showing heaving of adjoining headstones. SUNY ESF, 2006.

rows, causing upheaval of gravestones. [Figure 2.34] The dominant tree is red cedar (38) followed by holly (9), red maple (5), willow oak (5), and loblolly pine (4). Species numbering three or fewer include ash, pignut hickory, red oak, Southern magnolia, sugar maple, sweetgum, tulip-poplar, white-cedar (false cypress), and yellow birch [check] [see Appendix H]. The trees generally are between fifty and eighty years old, with a few specimens more than one hundred years old, and several trees younger than thirty years old. Specimens notable for their age and large size include two water oaks in the southeast corner in divisions A and B (blocks IV, VIII), a Southern magnolia north of the flagstaff in division A (block IX), four loblolly pines in division D (blocks XIV, XVI), and a white cedar in division C (block xi). [Figure 2.35] The loblolly pines are most likely a second generation to the many loblolly pines that existed at the time of the cemetery's initial establishment. The trees are generally in good condition, although one of the loblolly pines is nearly dead, and a number of the red cedars are declining.
