Upgrade Doors and Hardware at War Department Maintenance Building
Photos

War Department Maintenance Building (Chief Ranger Office)

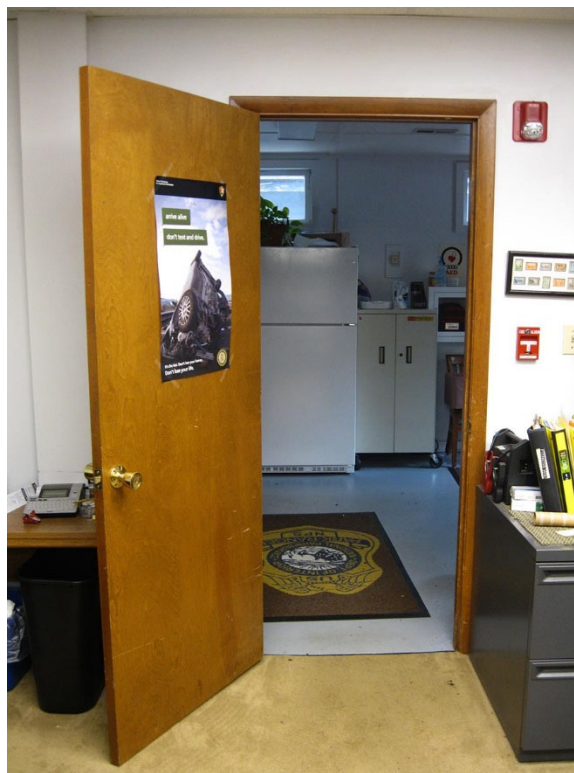
Interior non-historic 32 in. x 80 in. hollow core interior will be door removed. The new door will be a flush panel steel door, metal jam with hinges and lock set.

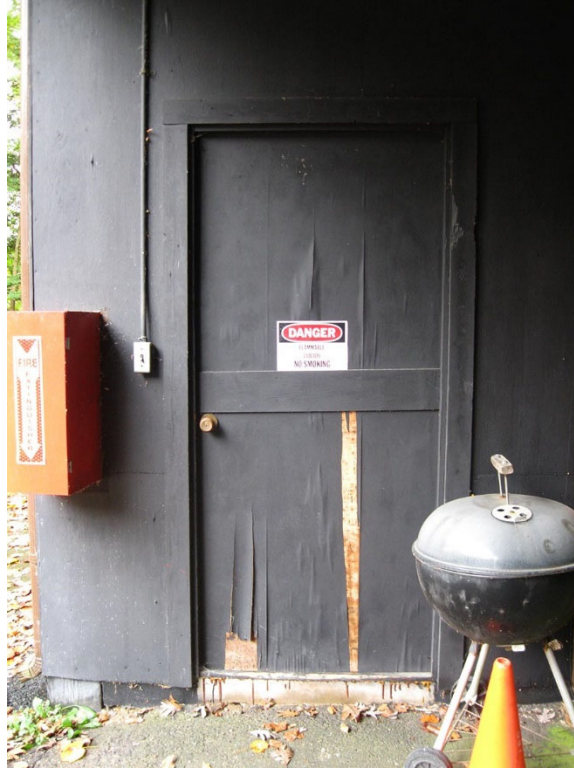
The lands office has been identified as a physical security issue. The current door has been cut into two pieces. The security assessment recommends removing the non-historic door and replacing it with a in-kind one piece solid wood door. The new door will be stained to match the exterior wood surfaces.
