Accessibility and Self-Evaluation and Transition Plan

Mount Rainier National Park

September 2023

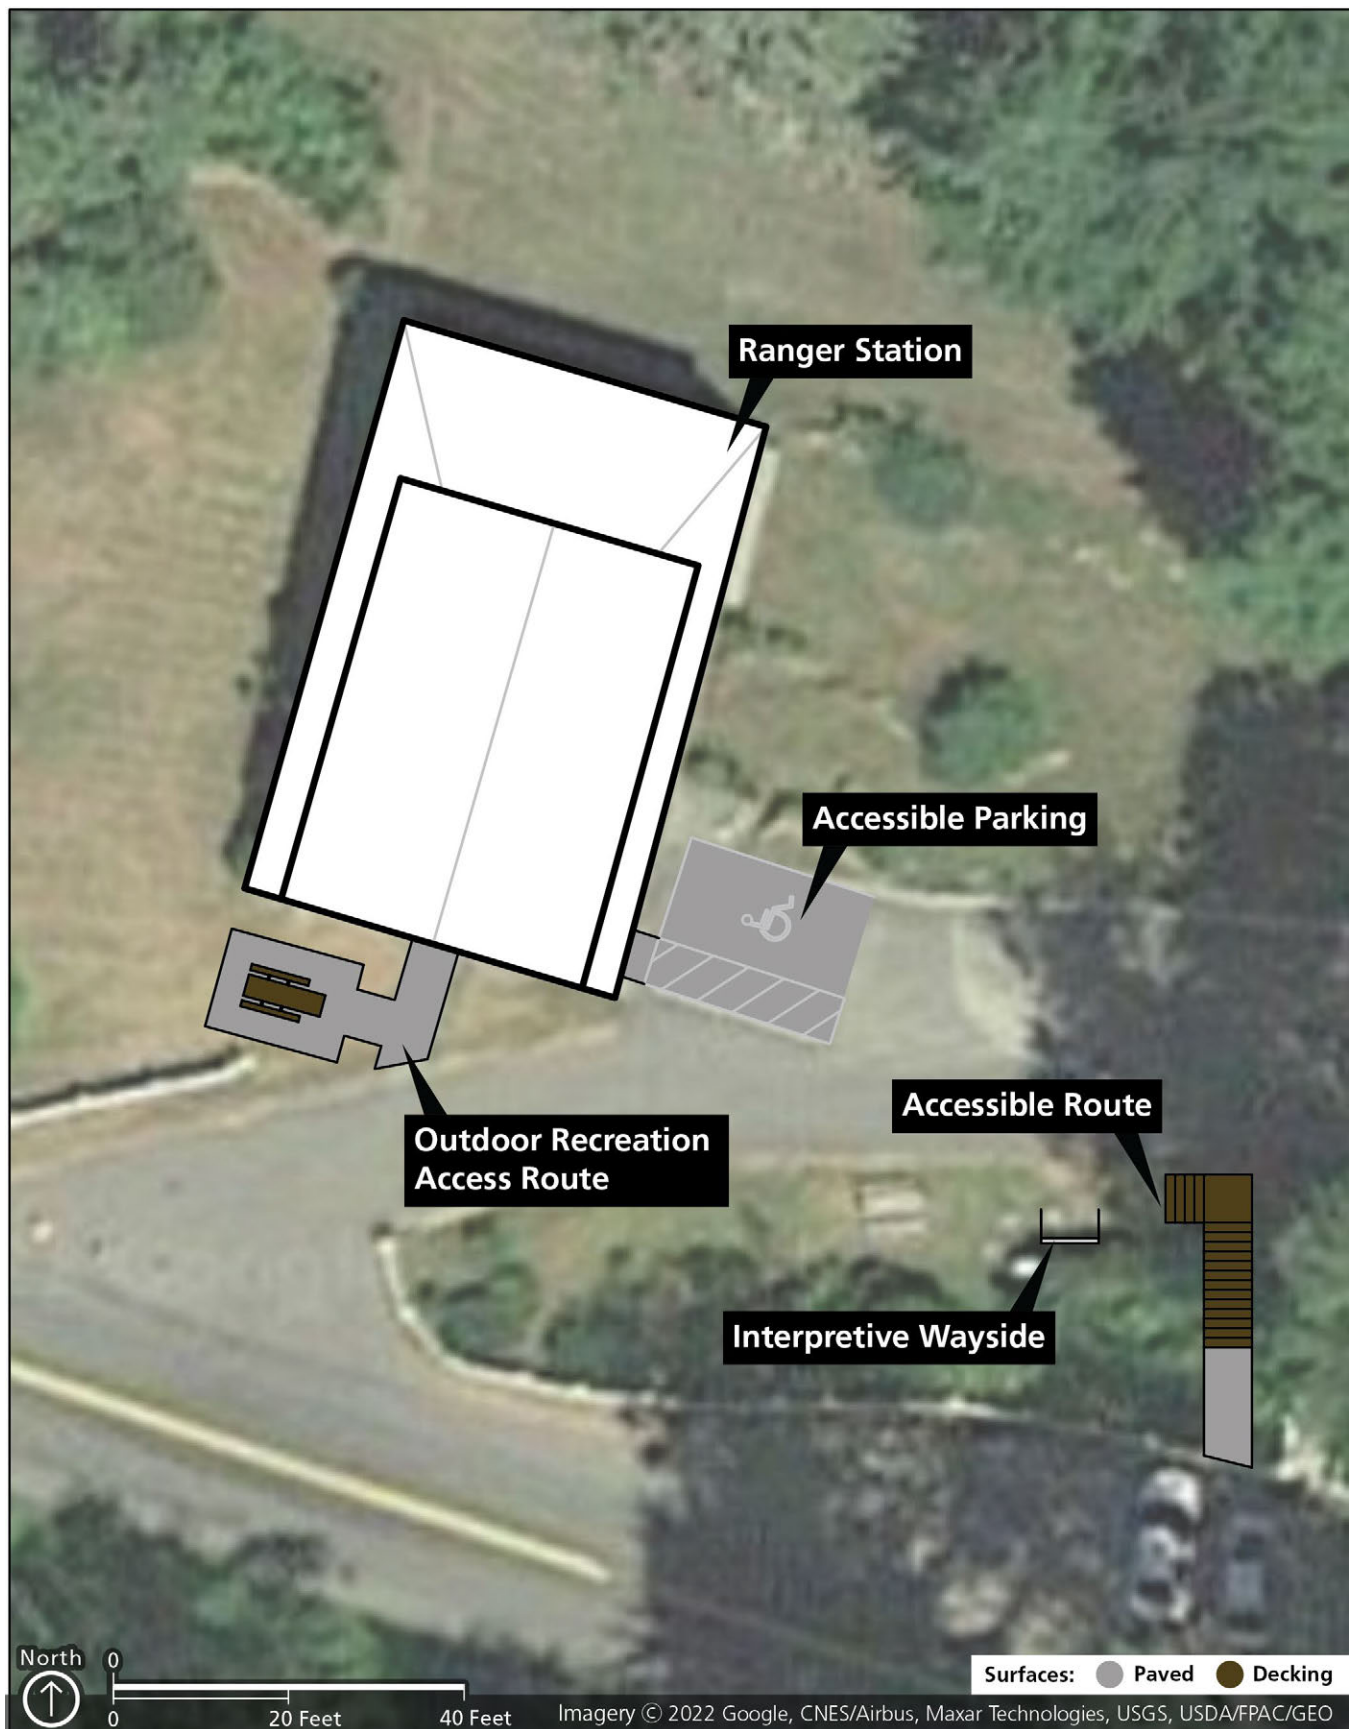
Carbon River Ranger Station Site Plan

Nestled in the northwest corner of the park, Carbon River Ranger Station and Carbon River Trailhead provide visitors a more secluded experience away from more developed facilities and services. Visitors can first stop at the small ranger station where an accessible parking space is provided, but improved signage would enhance the visitor experience. The interior of the ranger station has good circulation and a dual-height information counter. Slight improvements to the picnic facilities, wayside exhibit, and stairs leading up to the road would help create a more accessible experience at the ranger station.

- **Parking:** Improve the slopes, signage, and striping for the accessible parking space.
- **Ranger Station Building:** Improve the routes in the building, create clear space in front of exhibits and information, and add a service counter with an accessible forward approach.
- **Routes:** Reduce thresholds and openings, improve surfaces for routes to the picnic area, and improve the stairs with lowered handrails and closed risers.

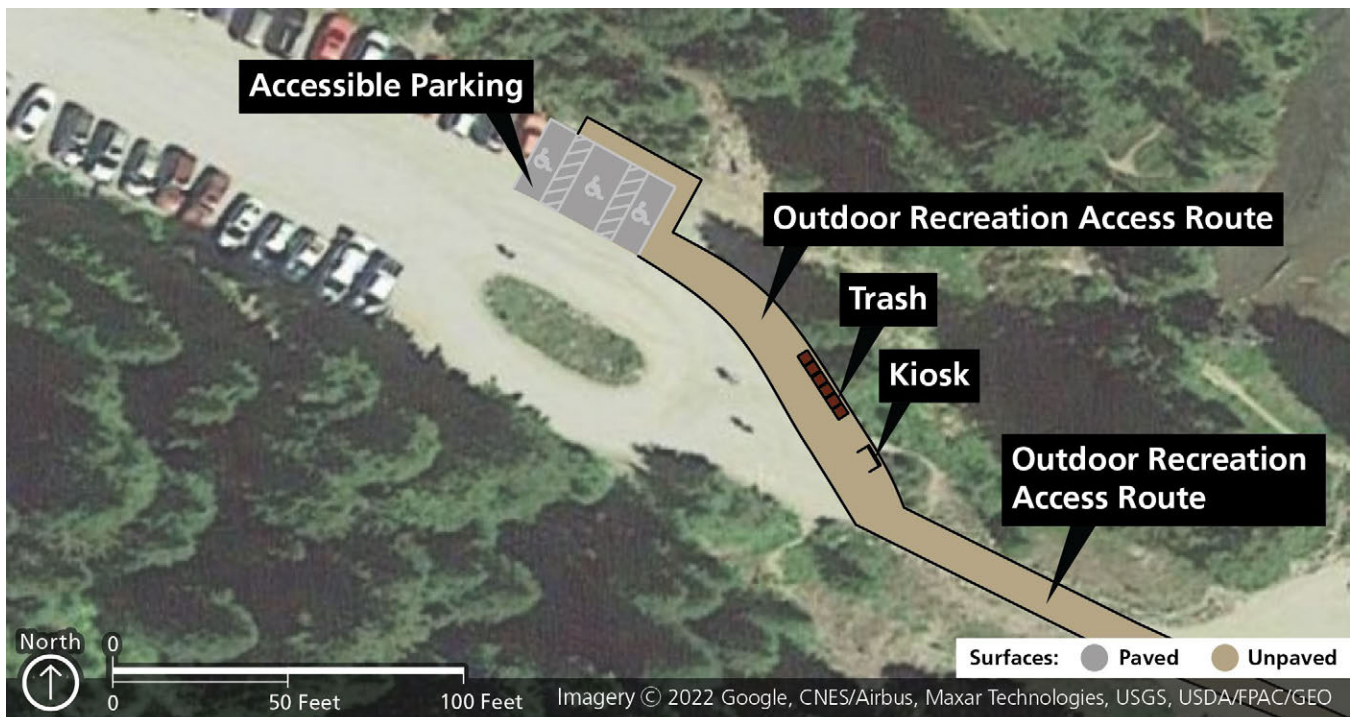
Mowich Lake Campground Site Plan

An unpaved gravel road takes visitors on a winding path up to the scenic Mowich Lake, situated adjacent to one of the trailheads for the popular Wonderland Trail. A minimally signed entrance fee station area, also known as the Paul Peak Trailhead near the national park boundary, is just off the unpaved road and provides a generally flat, but gravel, surface for visitors to park, pay entrance and camping fees, picnic, and use the vault toilets that are provided. Designating an accessible parking space and improving the surface by the signage and trash would increase accessibility at the entrance fee area.

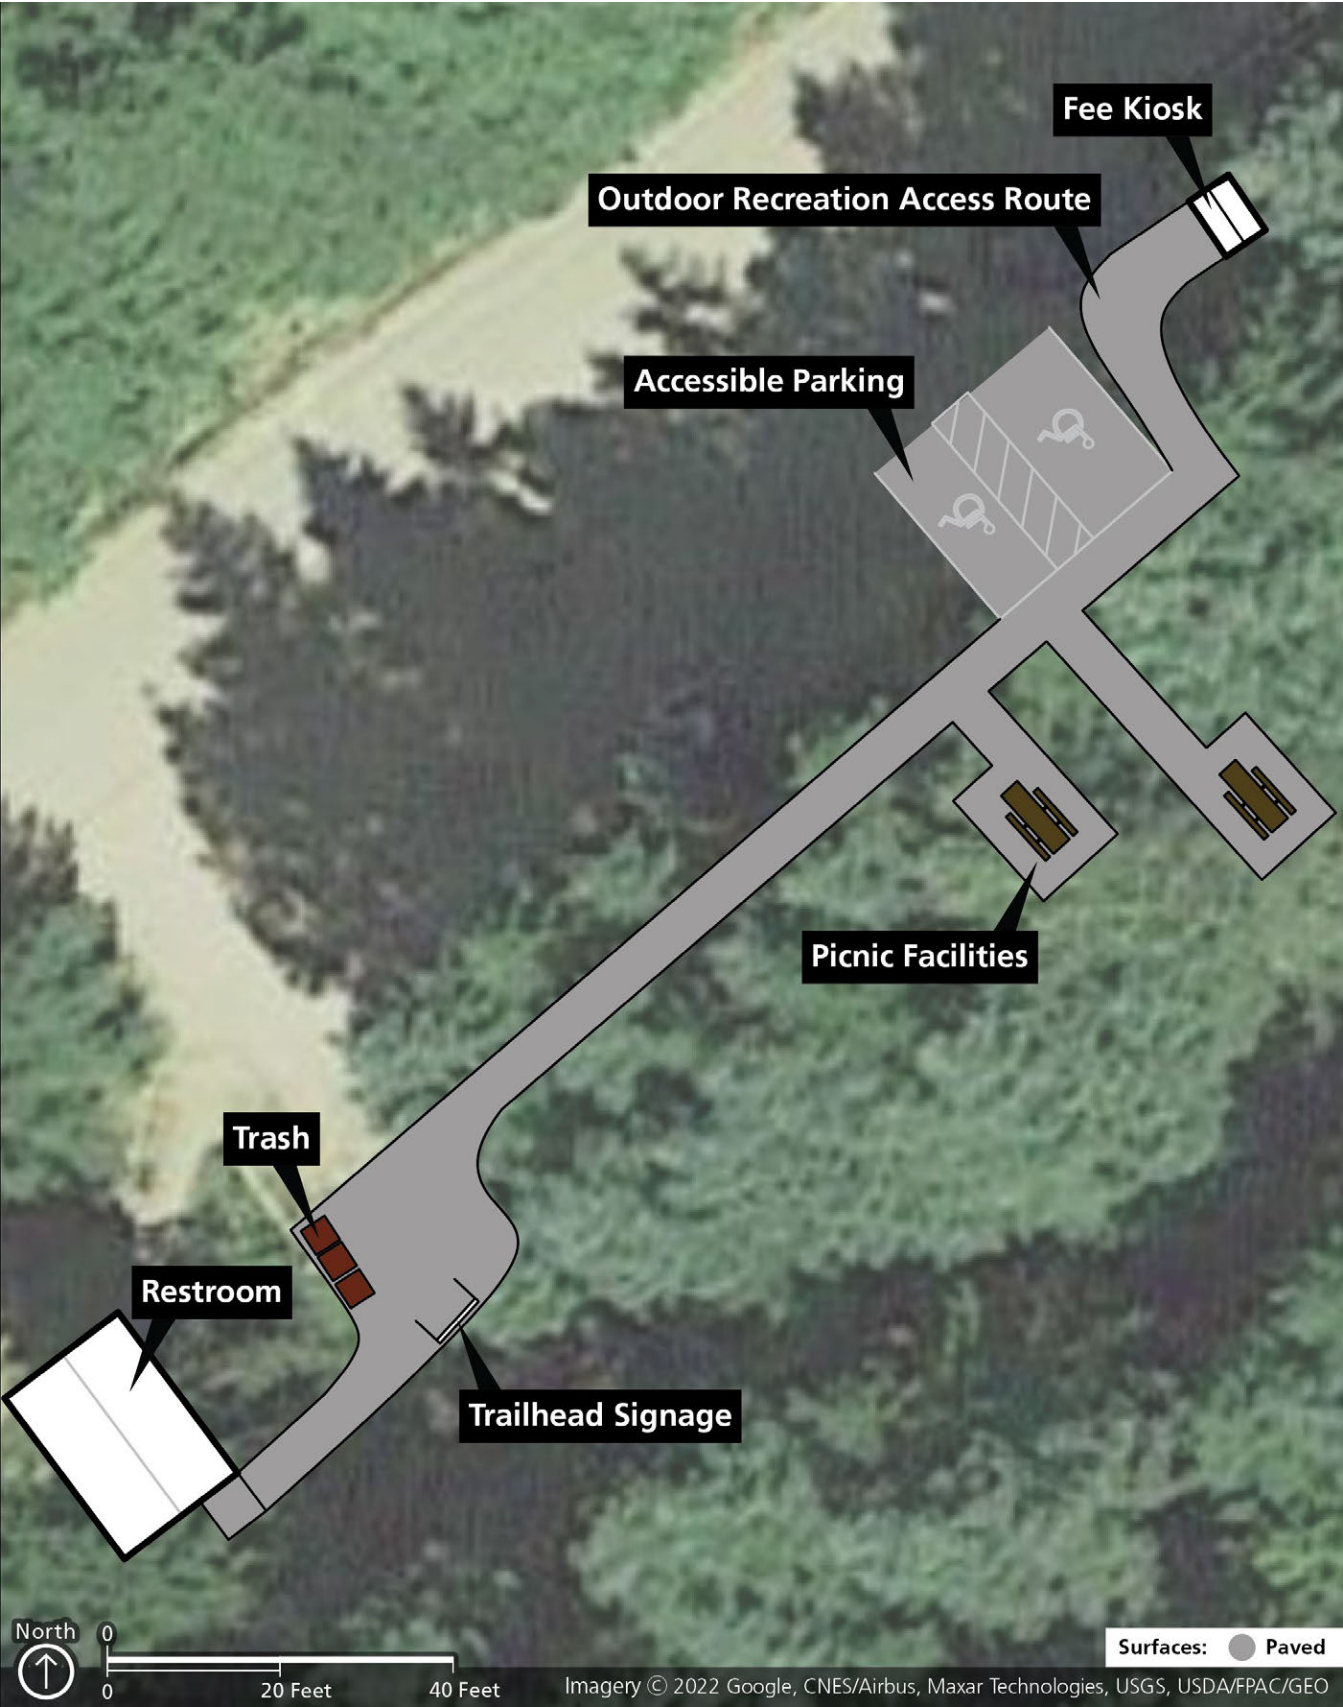
Mowich Lake Fee Station (Paul Peak Trailhead) Site Plan

- **Parking:** Add accessible parking.
- **Routes:** Improve hardened surfaces to the fee kiosk.
- **Picnic Facilities:** Add accessible picnic tables and trash cans, and improve the clear space around features.
- **Trailhead:** Add trailhead signage that outlines trail conditions, and reduce slopes and reduce obstacles in front of the kiosk.

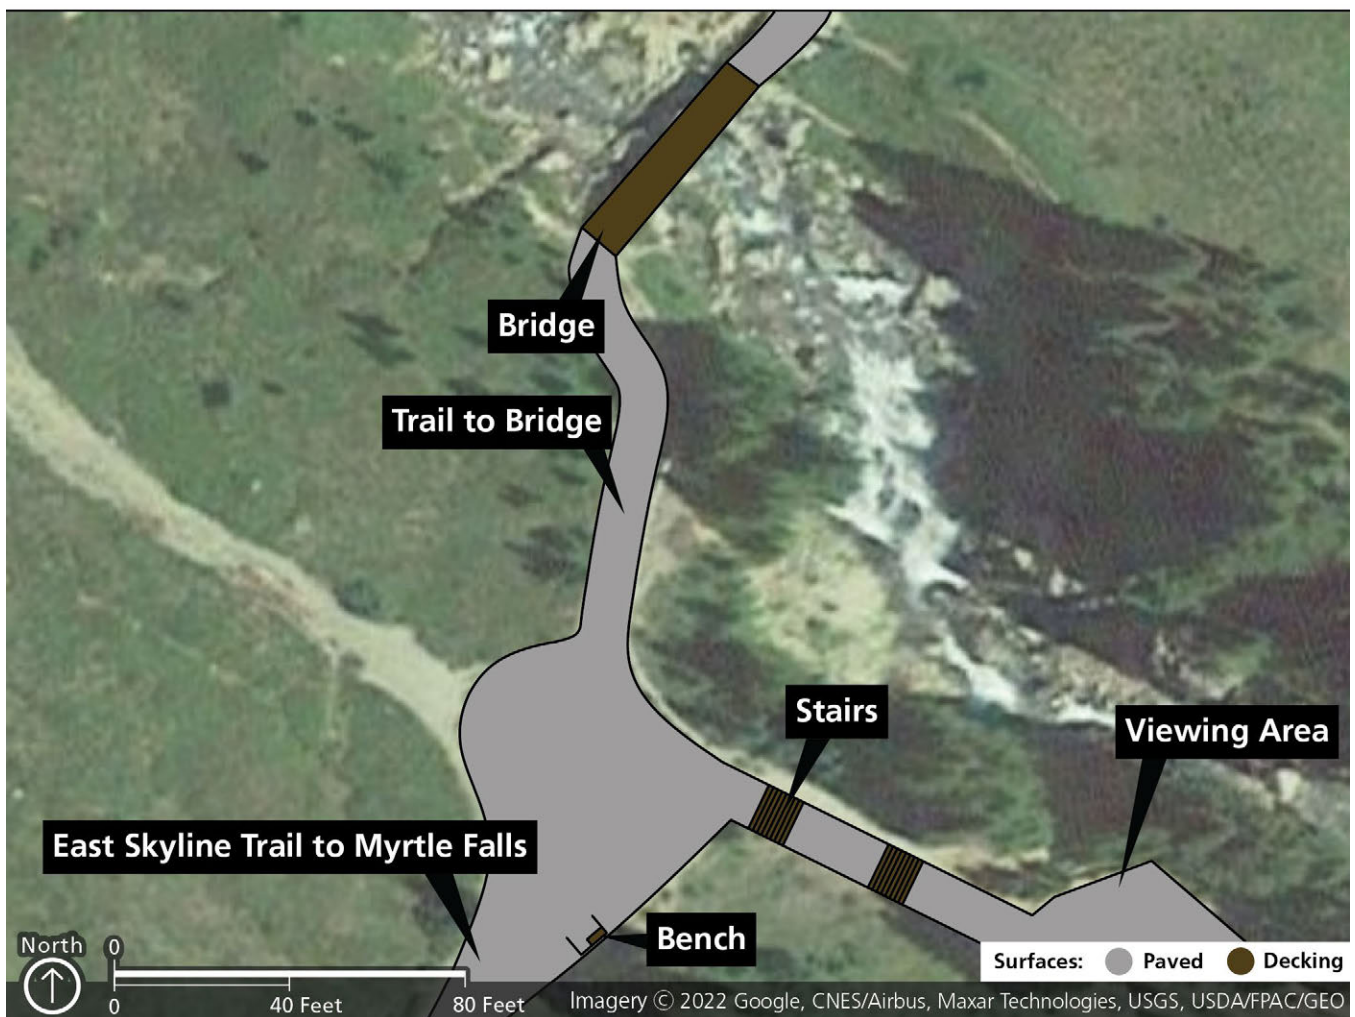
Paradise Myrtle Falls Site Plan

Myrtle Falls is a popular trail that starts from the main paved plaza in between the visitor center and the ranger station. The trailhead provides an overview of trails in the area, but more information about specific trail conditions, such as running and cross slopes, surface material, and obstacles, is needed so visitors can make informed decisions about what trails are usable to them. Myrtle Falls Trail is 0.5 miles from the main trailhead. It is paved and very wide, with

occasionally steep slopes. Benches and waysides are provided along the trail, but the clear spaces in front of them need improvements. At the end of the trail, visitors must either take stairs or walk up a steep slope with a step to a wooden bridge to view the falls below. Providing a flat viewing area and trailhead information signage that outlines trail conditions would allow more visitors to enjoy the beauty of Myrtle Falls.

- **Trailhead:** Add trailhead signage that outlines trail conditions.
- **Trail:** Lower slopes, and reduce obstacles and gaps on the trail surface.
- **Interpretive Waysides:** Improve slopes in front of interpretive waysides.
- **Benches:** Add level wheelchair seating adjacent to the benches and armrests, and add backrests on the benches, with raised bench heights.
- **Viewing area:** Add handrails on the stairs to the lower viewing area, and remove the step on to the bridge that leads to the upper waterfall viewing.
