Vicksburg National Military Park
Environmental Assessment for Landscape
Rehabilitation

Statement of Findings for Executive Order 11990
(Protection of Wetlands)

STATEMENT OF FINDINGS FOR EXECUTIVE ORDER 11990
(PROTECTION OF WETLANDS)

Final Report

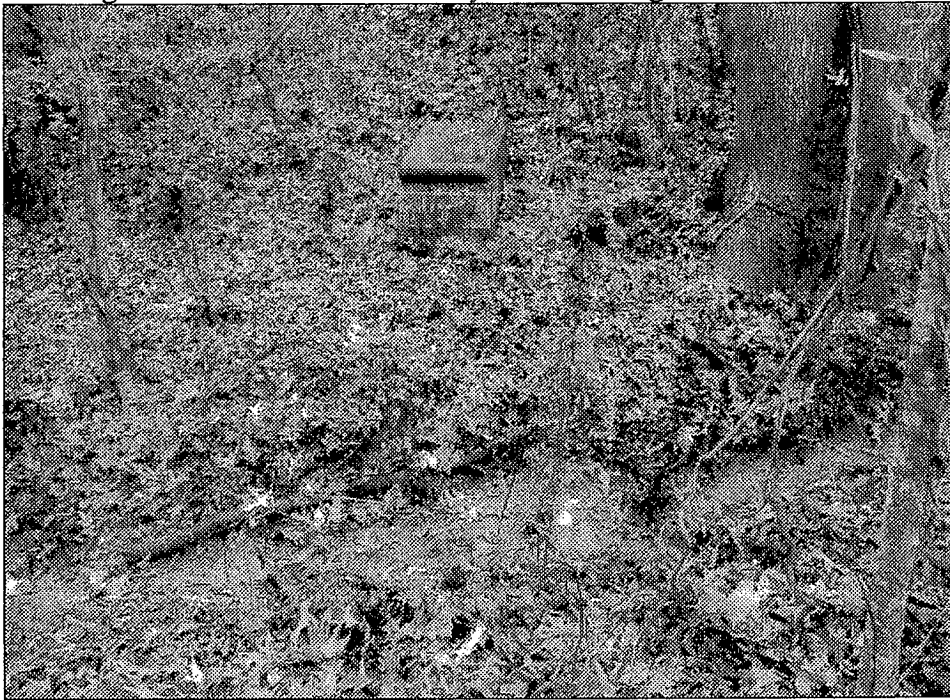
Photograph 3-1 Ephemeral Stream in Two-Mile Creek Area.

Note marker showing location of Illinois 97th Infantry. View looking west.

As with many of the riparian areas within the park, the wetlands in this area have become dominated by Chinese privet, an invasive species that the park is currently attempting to control. Clearing in this area would allow for the removal of privet and the re-establishment of native wetland and riparian species within the cleared areas. Photos 3-1 and 3-2 document the existing conditions of the Two-Mile Creek tributaries.

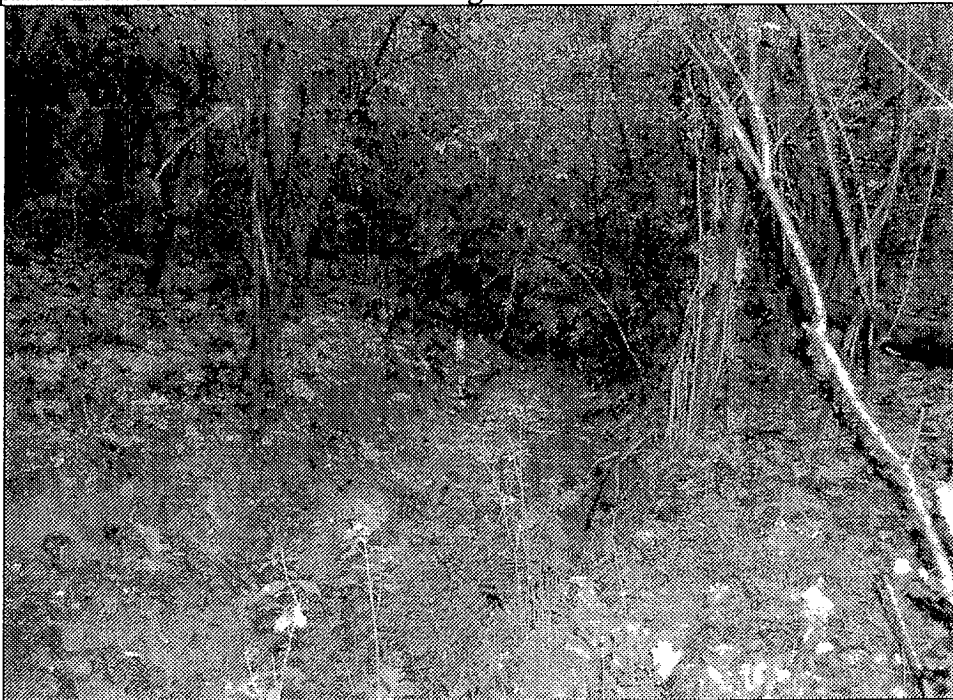
Photograph 3-2 Intermittent Stream in Two-Mile Creek Area.

Note thick privet in stream overbanks. View looking south.

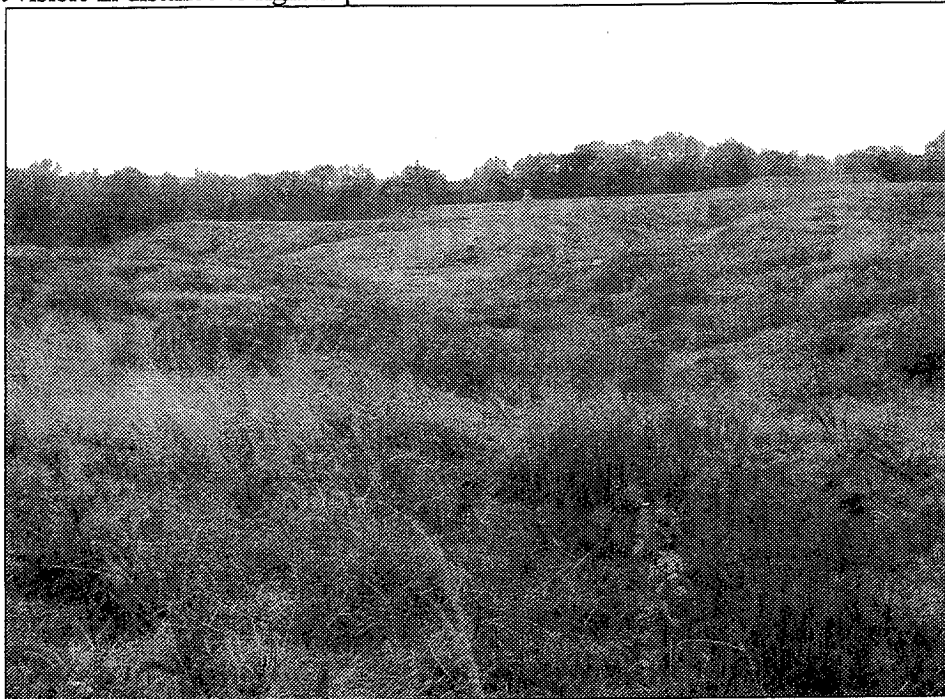
Photograph 3-3 View from Kentucky Monument to Fort Garrott.

Fort Garrott visible in distance to right in photo. Area cleared in 1998. View looking southwest.

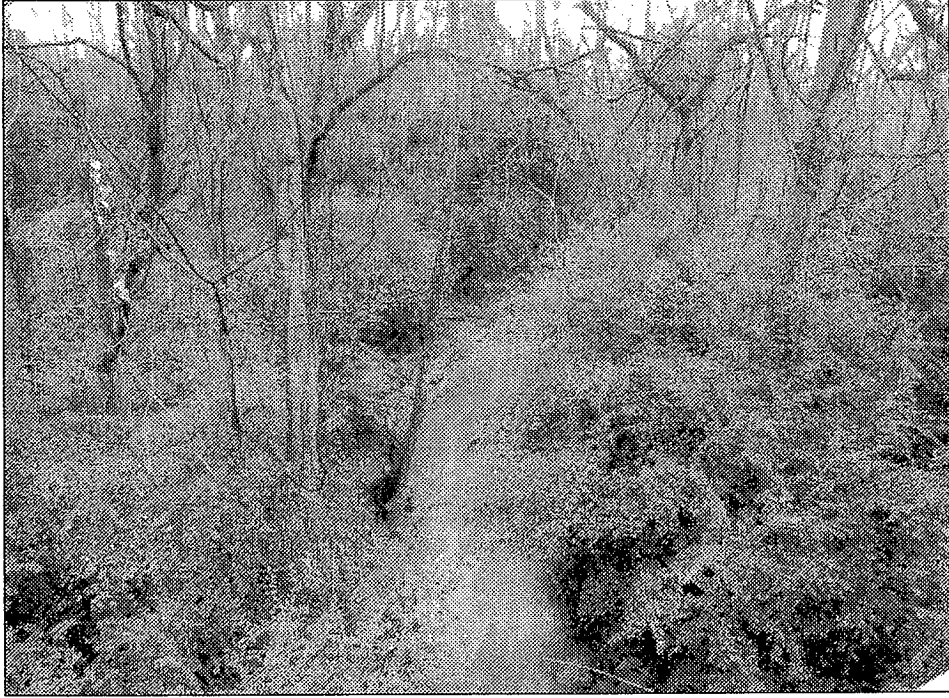
Photograph 3-4 View of Durden Creek from Union Avenue.

Looking downstream from Union Avenue bridge. Note thick privet in stream overbanks. View looking south.

The wetlands in this area have become dominated by privet. Clearing in this area would allow for the removal of privet and the re-establishment of native wetland and riparian species within the cleared areas. Removal of exotic plants allows for the regrowth of native vegetation, which benefits fauna using the wooded areas. Photos 3-4 and 3-5 document the existing conditions of Durden Creek and its tributaries.

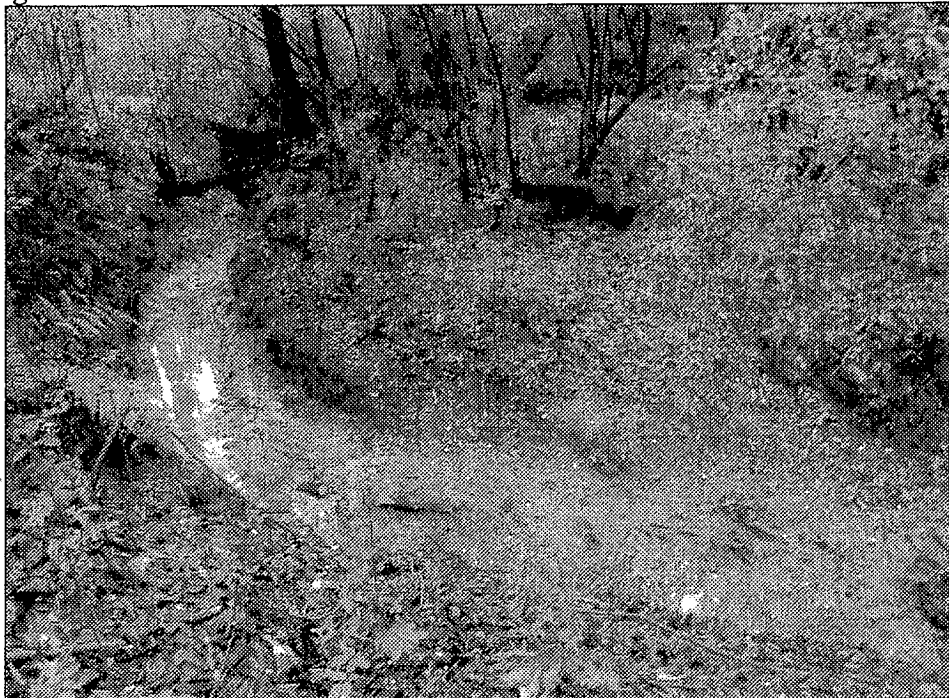
Photograph 3-5 View of Durden Creek Tributary.

View looking east.

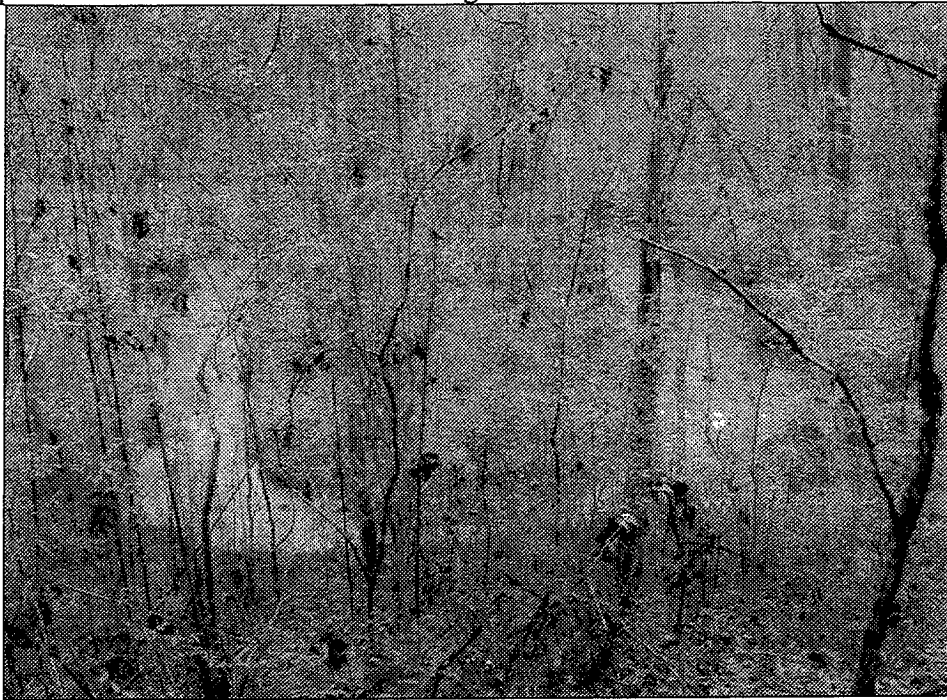
Photograph 3-6 View of Glass Bayou Tributary.

Note thick privet in stream overbanks. View looking south.

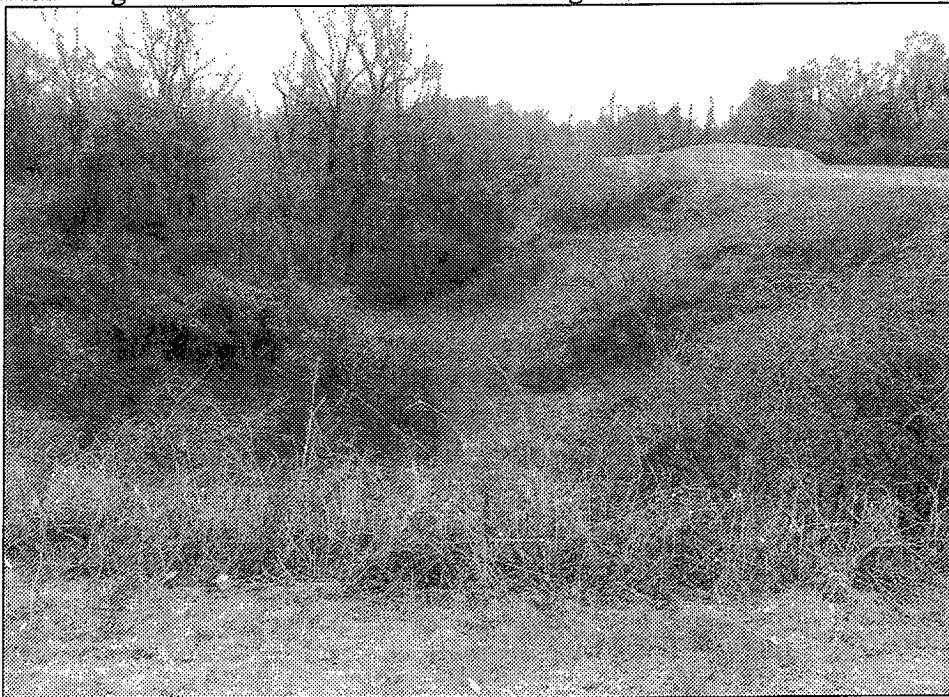
Photograph 3-7 View of Cleared Swale in Glass Bayou Area.

Confederate earthworks visible to right in photo, along Confederate Avenue. Proposed clearing would remove additional vegetation within this swale. View looking south.

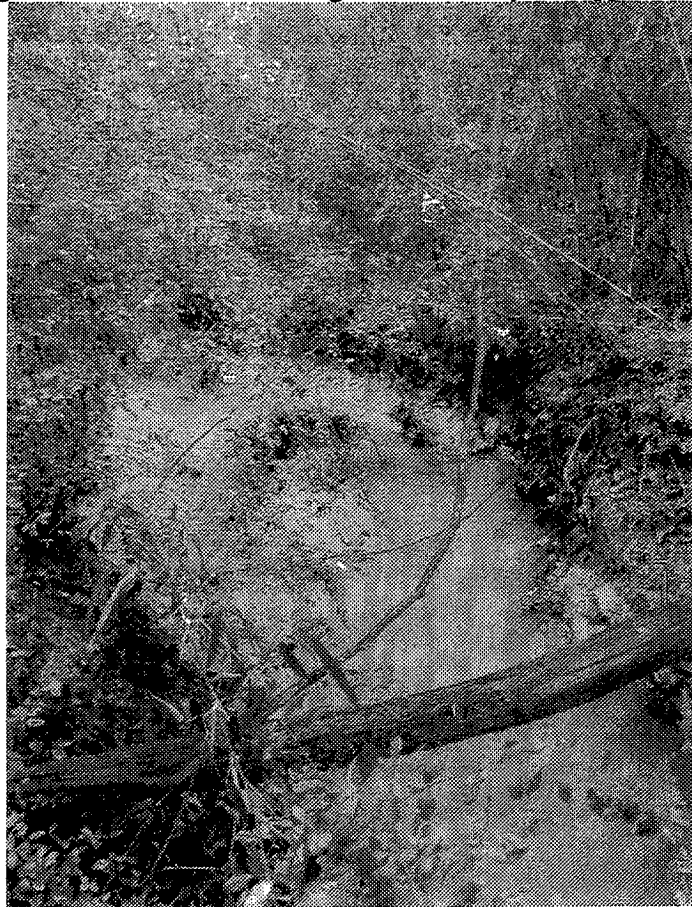
Photograph 3-8 View of Unnamed Mint Spring Bayou Tributary.

Note thick privet along stream banks. View looking east from Thayer's Approach.

The wetlands in this area have become dominated by privet. Clearing in this area would allow for the removal of privet and the re-establishment of native wetland and riparian species within the cleared areas. Photo 3-8 documents the existing condition of the Mint Spring Bayou tributaries.

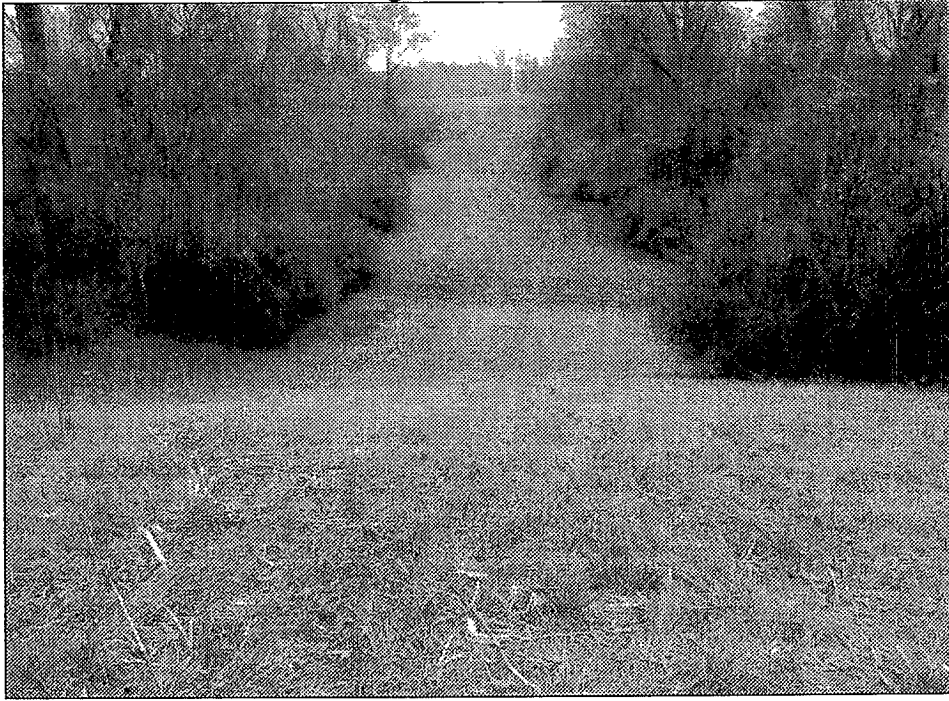
Photograph 4-1 Cleared Wetland Downslope from Michigan Monument

Cleared area to be restored to native forest vegetation.

- 0.20 acres of wetland currently maintained in herbaceous vegetation along Union Avenue downslope from the Michigan Monument would be replanted with native plant species (Photo 4-1). This area, cleared over 30 years ago and currently maintained as a grassed field, would be allowed to return to a forested wetland. Species to be replanted are listed above.

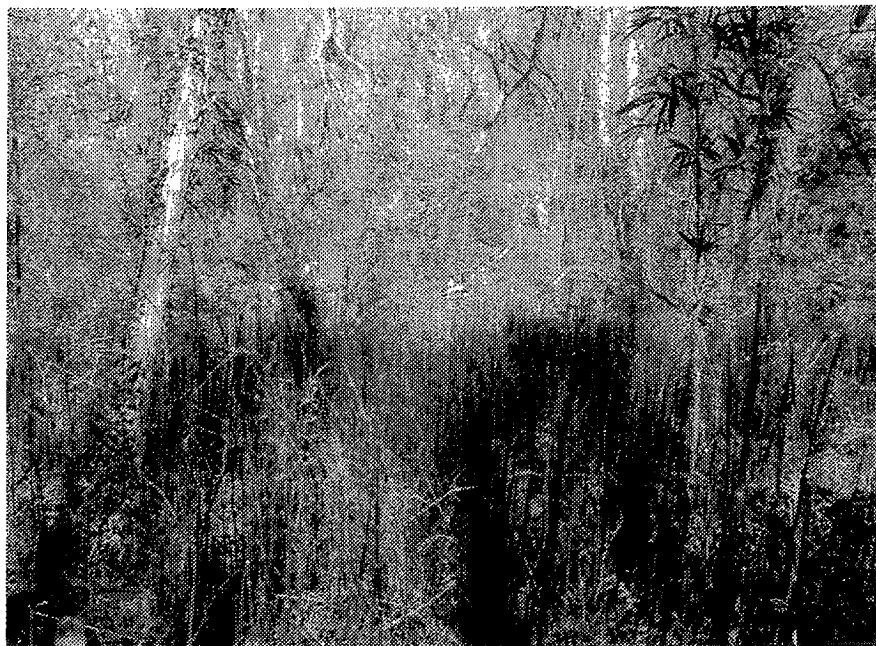
Fig. 1. Scouring rush-boxelder riverine wetland community

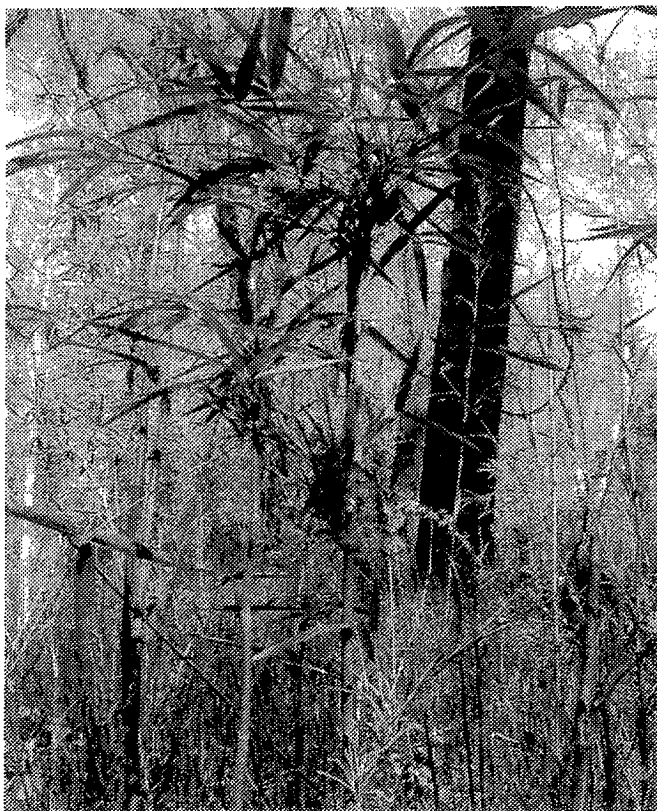
Fig. 2. Giant cane-sycamore riverine wetland community

Wetland functions are commonly assessed using hydrologic, biogeochemical, and biologic function criteria. Hydrologic functions of slope wetland commonly include ground and surface water interception and water retention and groundwater export. Water interception is a fundamental property of slope wetlands (Stein *et al.* 2004). Removal of vegetation outside of park boundaries as well as in some areas of the park may have led to increased siltation in nearby streams (Dibble, 2003). Therefore, forested wetlands of the park may play an important role in control of erosion and siltation. Dense growth of Chinese privet may compromise this and habitat wetland functions: observations indicate very sparse herb and other shrub cover and lack of extensive root system in gullies overgrown with privet, whereas nearby areas dominated by giant cane (*Arundinaria gigantea*) had a more extensive root system in the upper part of the soil (Fig. 2).

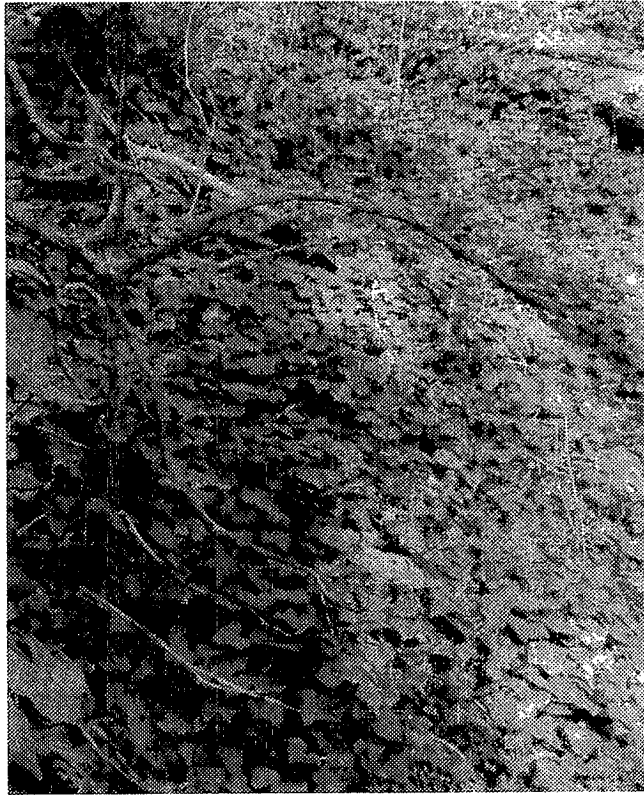
Fig. 3. Riverine wetland overgrown by English ivy.

Many hydrophytic plant communities include boxelder (*Acer negundo*), sycamore (*Platanus occidentalis*), sugarberry (*Celtis laevigata*), sweetgum (*Liquidambar styraciflua*), and, less frequently, willow oak (*Quercus phellos*), swamp chestnut oak (*Q. michauxii*), water oak (*Q. nigra*), and American hornbeam (*Carpinus caroliniana*) as canopy-forming vegetation with giant cane (*Arundinaria gigantea*) and scouringrush horsetail (*Equisetum hyemale*) in the understory (Figs. 1 and 2). Understory vegetation was often dominated by invasive plants, which complicated determination of its wetland status. For example, English ivy (*Hedera helix*) is a non-hydrophyte but was nevertheless observed in mesic areas of the park, displacing hydrophytic vegetation (Fig. 3). A list of commonly occurring plants and their indicator status is presented in Table 1.
